The Styczykowski Report 4165 Hwy 82, Elgin AZ

Date: 6/2/2016

PROPERTY INSPECTION SUMMARY REPORT

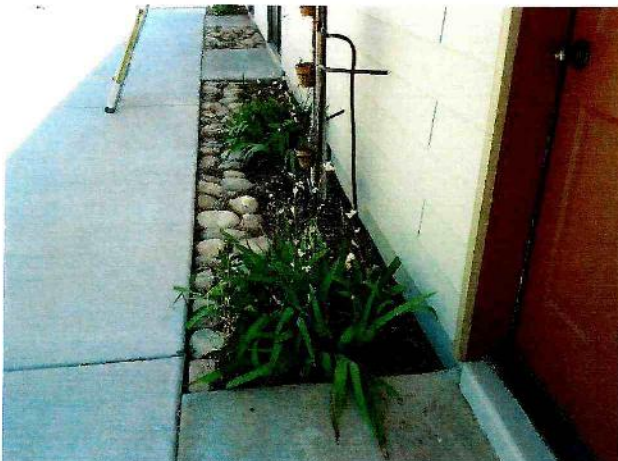
1. **Monitor:** The building site at the right side area and the rear side area shows signs of poor drainage with the roof run off dumping into a contained area or planter box against the buildings foundation. This condition may cause moisture and/or wood destroying organism related damage to the structure. The interior surfaces should be monitored for any adverse conditions and repaired as necessary. We recommend that this area be monitored for drainage performance and repaired as necessary.

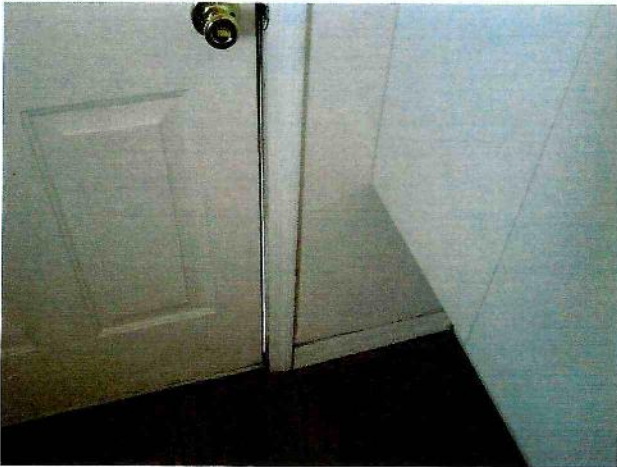
2. **Repair:** The exterior rear laundry entrance door(s) had damaged or missing weather stripping at the door stop trim. We recommend that the weather stripping be repaired or replaced.

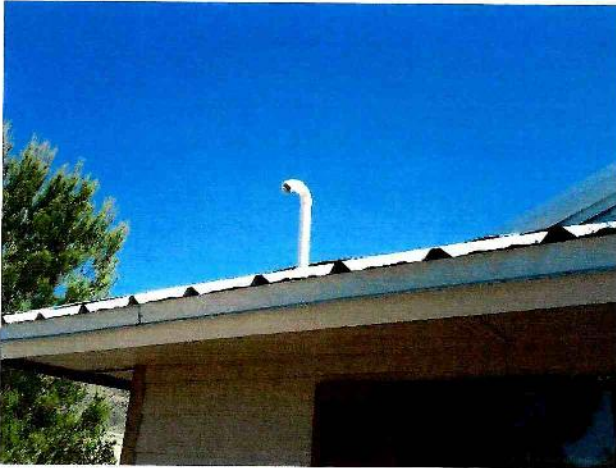
8. **Repair:** The water heater PVC vent flue stack was not painted as required. We recommend painting to protect the material from the UV rays of the sun.

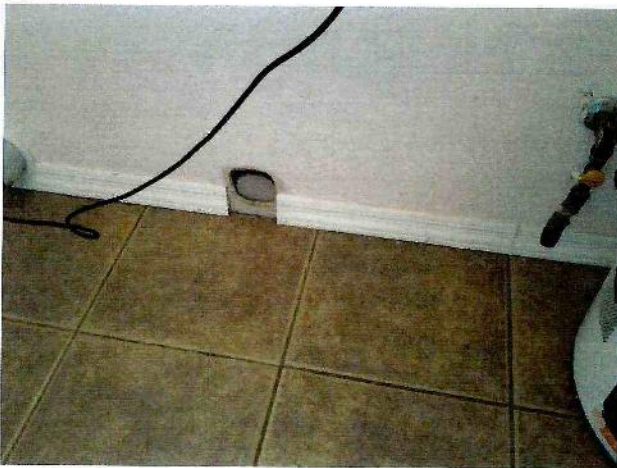
9. **Safety Concern:** The laundry area water heater combustion air supply was blocked at both upper and lower areas. Air supply is necessary for the complete and safe combustion of fuel. We recommend that the blockage be removed as required for safe use of the area.

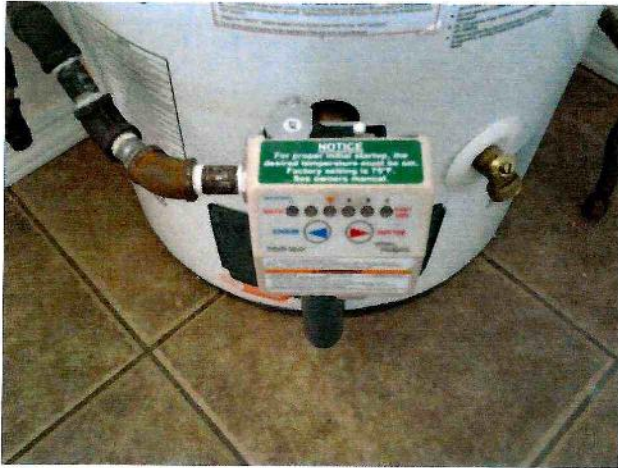
11. **Further Review:** The laundry water heating system electronic controls were not working at the time of inspection. We recommend further review of the water heating system for a better understanding of replacement/repair costs and present condition.

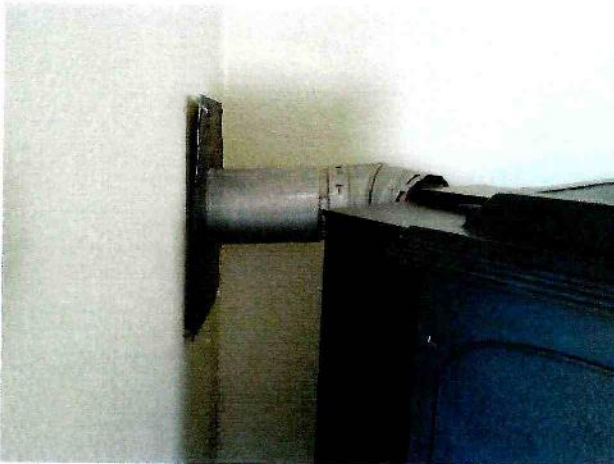
13. **Repair:** The exhaust vent of the pellet stove was not properly pitched to the flue stack or chimney. All vents should be mechanically secured at all joints and installed with an upward pitch of 1/4" per foot to the flue stack/chimney. Failure to properly pitch the vent can lead to failure due to condensation, back drafting or other serious defects. We recommend that the vent be reconnected and fastened properly.

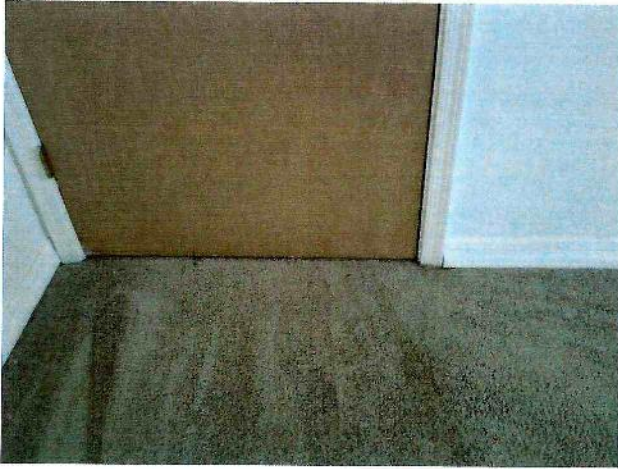
14. **Further Review:** The return air flow back to the heating/cooling unit at the bedrooms is hampered by the doors being too close to the flooring in several areas. We recommend that the doors be undercut or wall registers be installed so that the required unrestricted air flow back to the unit is achieved as designed.

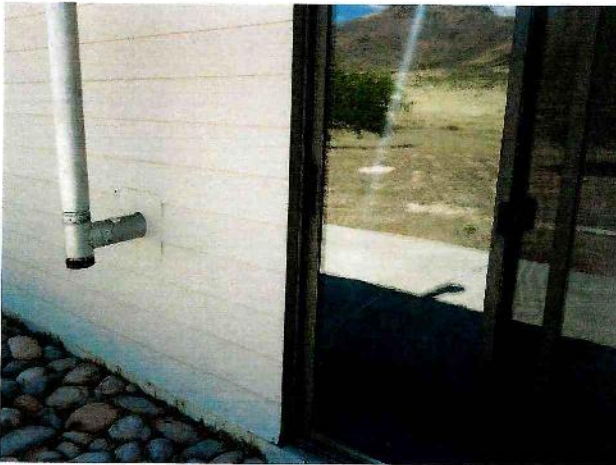
16. **Repair:** The sliding glass doors at family room and master bedroom presented symptoms of a breach seal or film failure between the two pieces of glass. This often takes the form of striations, molting, fogging, discoloration or condensation between the panes of an insulated glass unit. These failures are not always apparent at the time of inspection due to lighting conditions, dirt build up and/or attached sunscreens. We recommend evaluation of all the windows by an appropriate person with replacement as necessary.

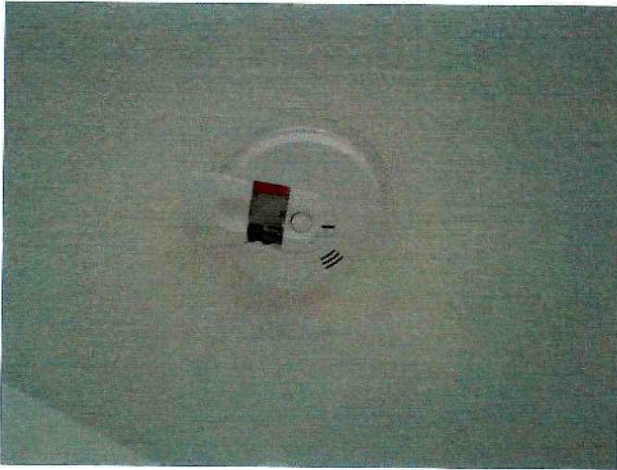
18. **Safety Concern:** One or more of the smoke detectors were missing their batteries. The latest standards require that smoke detectors be installed in all bedrooms and hallways leading to bedrooms. We recommend the Installation of any needed detector and batteries to bring the building into present day industry standards.

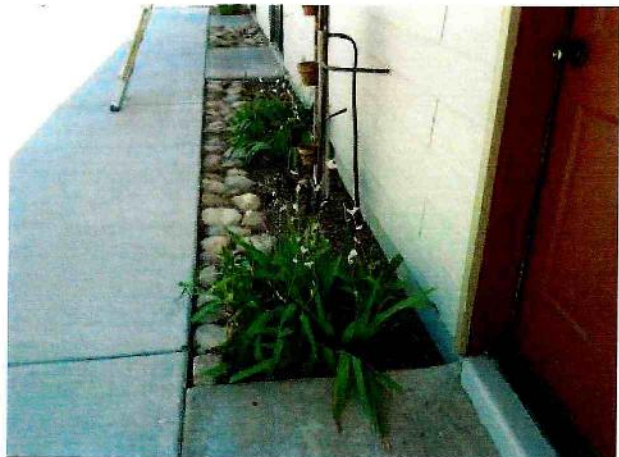
Monitor: The building site at the right side area and the rear side area shows signs of poor drainage with the roof run off dumping into a contained area or planter box against the buildings foundation. This condition may cause moisture and/or wood destroying organism related damage to the structure. The interior surfaces should be monitored for any adverse conditions and repaired as necessary. We recommend that this area be monitored for drainage performance and repaired as necessary.

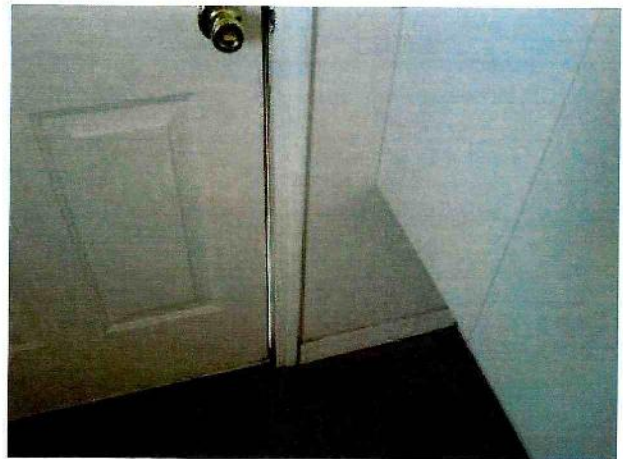
Repair: The exterior rear laundry entrance door(s) had damaged or missing weather stripping at the door stop trim. We recommend that the weather stripping be repaired or replaced.

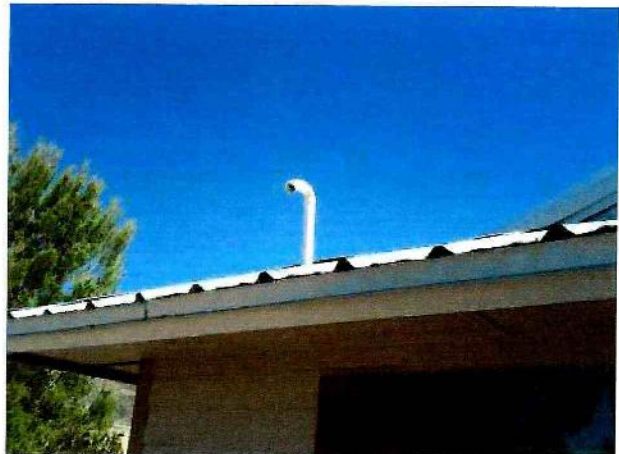
Repair: The water heater PVC vent flue stack was not painted as required. We recommend painting to protect the material from the UV rays of the sun.

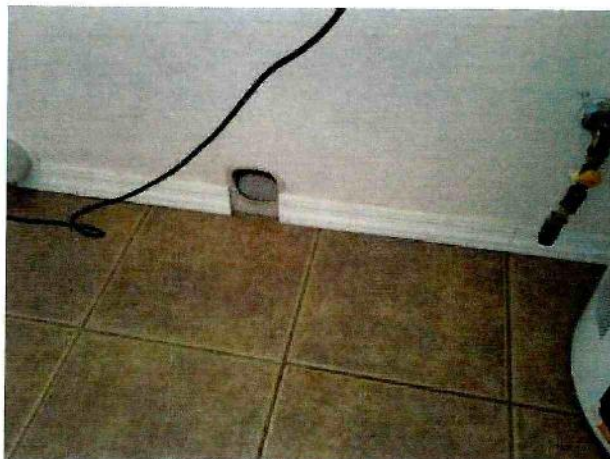
Safety Concern: The laundry area water heater combustion air supply was blocked at both upper and lower areas. Air supply is necessary for the complete and safe combustion of fuel. We recommend that the blockage be removed as required for safe use of the area.

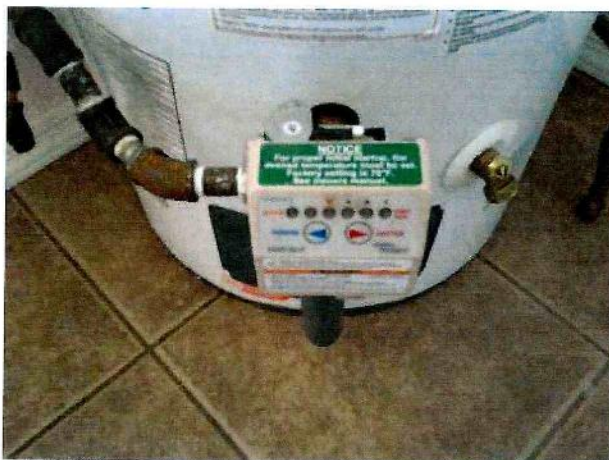
Further Review: The laundry water heating system electronic controls were not working at the time of inspection. We recommend further review of the water heating system for a better understanding of replacement/repair costs and present condition.

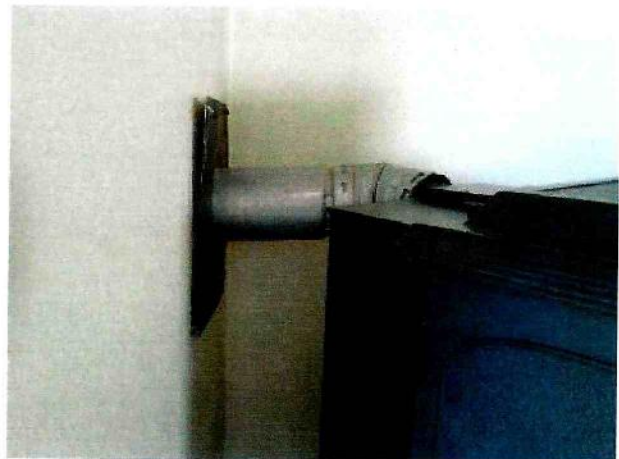
Repair: The exhaust vent of the pellet stove was not properly pitched to the flue stack or chimney. All vents should be mechanically secured at all joints and installed with an upward pitch of 1/4" per foot to the flue stack/chimney. Failure to properly pitch the vent can lead to failure due to condensation, back drafting or other serious defects. We recommend that the vent be reconnected and fastened properly.

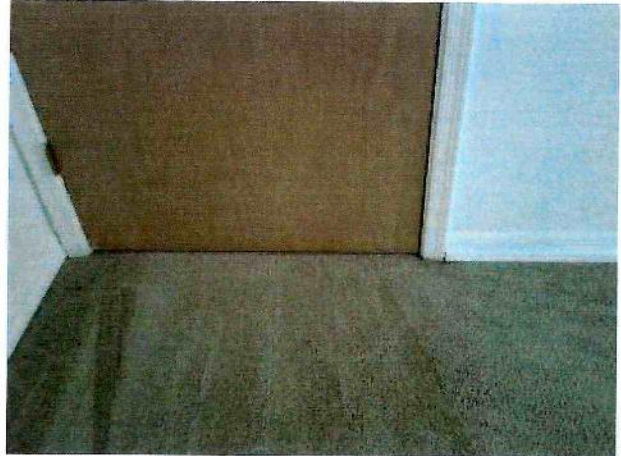
Further Review: The return air flow back to the heating/cooling unit at the bedrooms is hampered by the doors being too close to the flooring in several areas. We recommend that the doors be undercut or wall registers be installed so that the required unrestricted air flow back to the unit is achieved as designed.

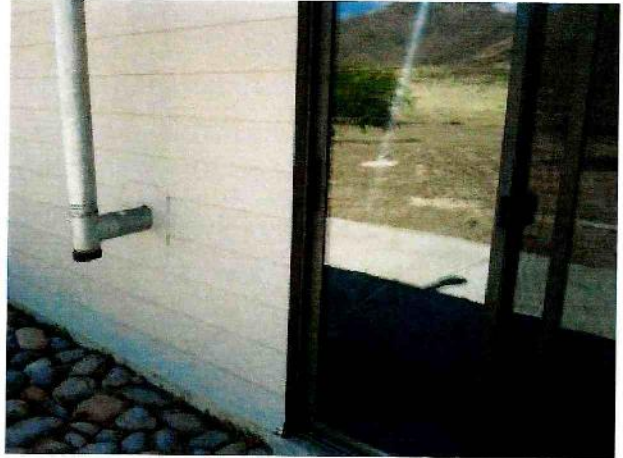
Repair: The sliding glass doors at family room and master bedroom presented symptoms of a breach seal or film failure between the two pieces of glass. This often takes the form of striations, molting, fogging, discoloration or condensation between the panes of an insulated glass unit. These failures are not always apparent at the time of inspection due to lighting conditions, dirt build up and/or attached sunscreens. We recommend evaluation of all the windows by an appropriate person with replacement as necessary.

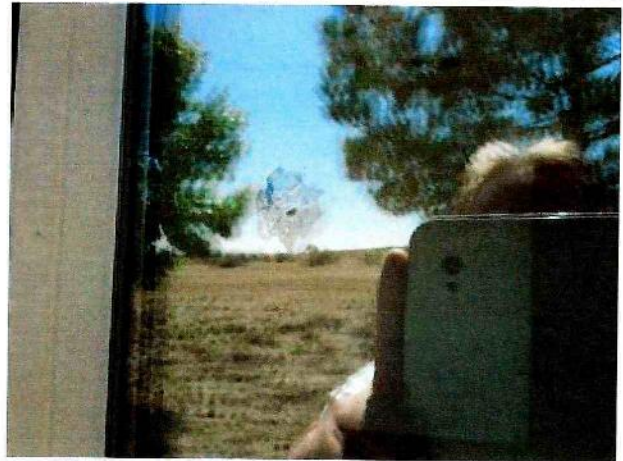
Safety Concern: A BB type crack or hole was observed at the dining room and front middle bedroom. We recommend immediate replacement for all cracked or broken windows. This is a safety concern and should be addressed.

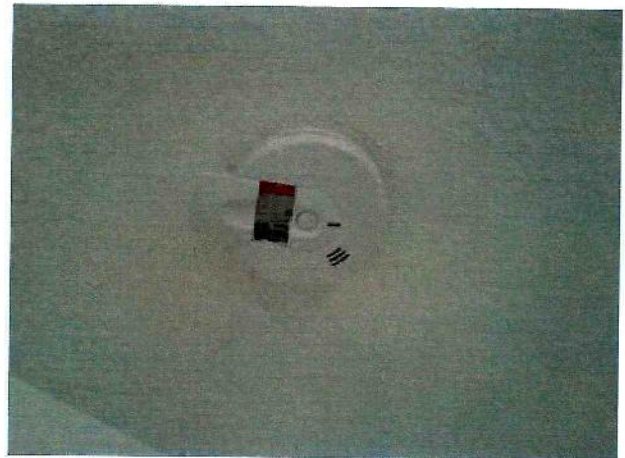
Safety Concern: One or more of the smoke detectors were missing their batteries. The latest standards require that smoke detectors be installed in all bedrooms and hallways leading to bedrooms. We recommend the Installation of any needed detector and batteries to bring the building into present day industry standards.
