## General Summary

**Inspection Date: 3/2/2017**

**Inspection Address:**  
**32366 West San Lorenzo Drive**  
**Maricopa AZ 85138**

## Inspection Report

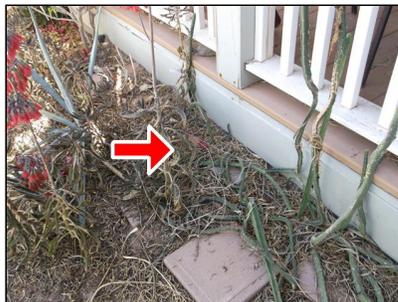
(5) Soil was too high at the structure, correction is needed as required at the building perimeter to prevent moisture and termite intrusion - Attention.

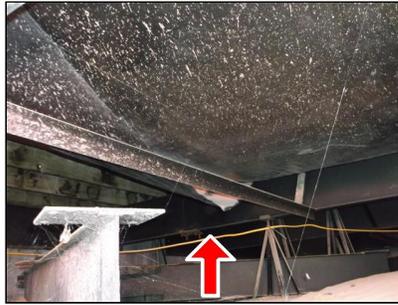
- (5) Crawlspace screen cover(s) are damaged and should be repaired or replaced - Attention.
- (6) Damage/ open seams at the vapor barrier were observed. Attention.

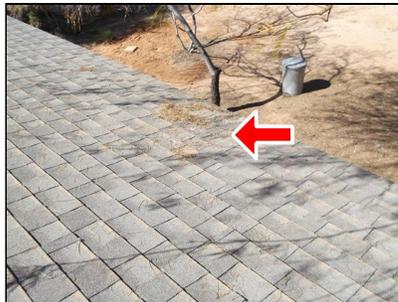
- (1) Debris has accumulated at the roof and should be removed - Review.

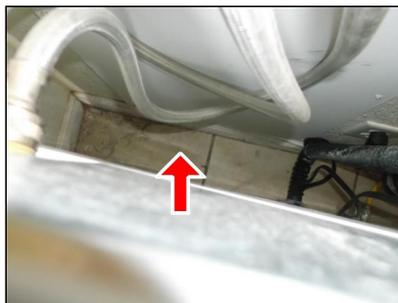
- (2) Moisture stains/damage was observed behind the washing machine. Review.

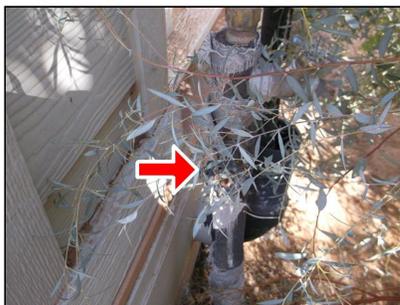
The main water shut off valve is an older/original gate valve, suggest replacement with a ball valve - Review.

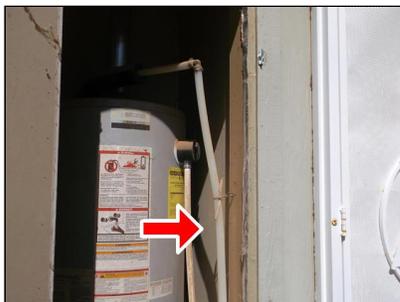
(2) Distribution piping was not properly anchored/supported - Attention.

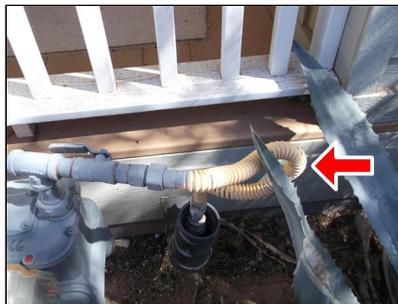
(2) There is a flexible copper supply line at the gas meter that may not be rated for gas use, further review with gas supplier or a qualified contractor is suggested. Review.

(3) The gas meter is in a traffic corridor and does not have protection to shield it from damage - Review.

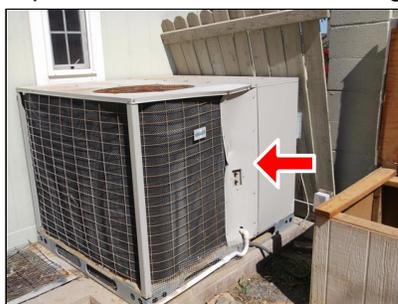
The HVAC unit appears to have impact damage, this may affect components not visible and may have affect the life span of the unit. A complete review with a qualified HVAC contractor is suggested. Attention.

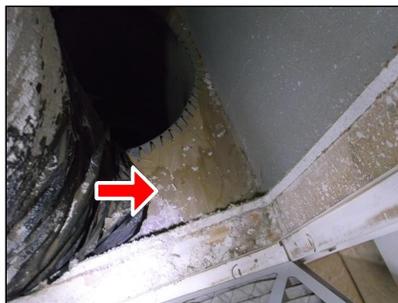
(2) Moisture stains were observed in the air return, may indicate a past/ current leak. Review.

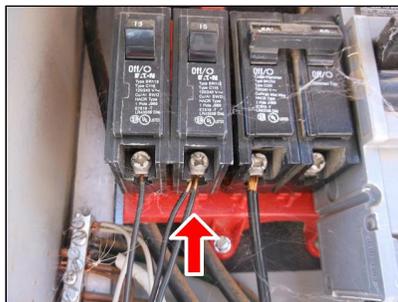
Overcurrent device(s) in the main panel is serving multiple circuits (double-tapping). This condition should be evaluated and corrected - Attention.

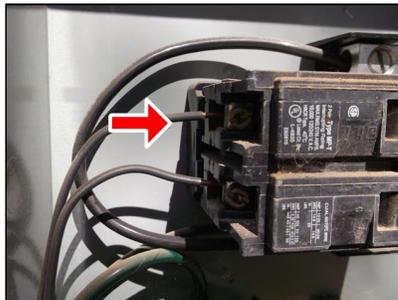
Overcurrent device(s) in the sub-panel are serving undersized wires, this condition is known as overfusing and creates a fire hazard that should be corrected by an electrician - Attention.

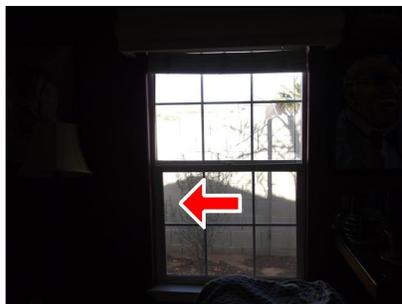
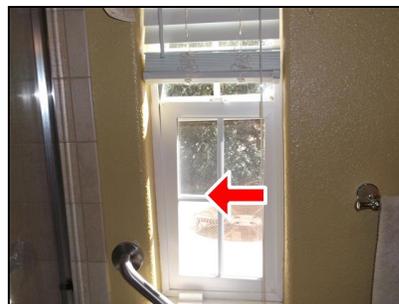
- (2) Windows were difficult to operate, damaged glides/ springs, recommend further review/ repair with a qualified contractor - Review.

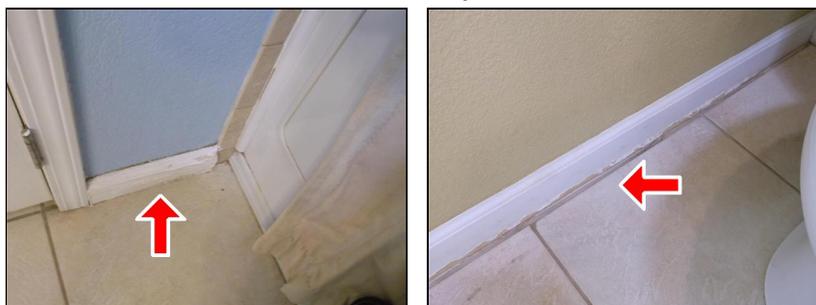
(2) Moisture damage was observed at the wall/ base board adjacent to the hall tub and master shower . Review.

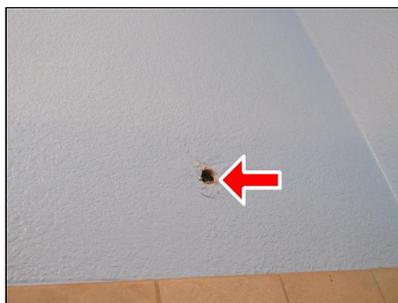
(3) Holes in drywall should be patched as needed. Review.

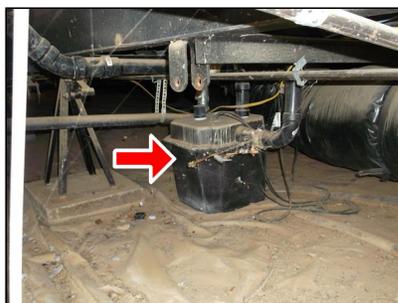
(2) There is a pump type device plumbed into the waste system, function is unknown, further review with a qualified contractor is suggested. Attention.

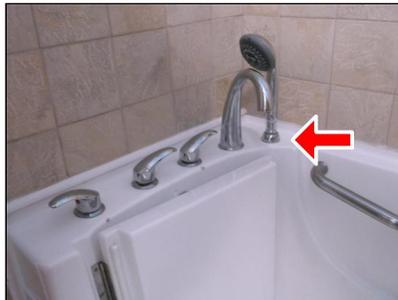
The hall stand up tub faucet continually drips and should be serviced. Attention.

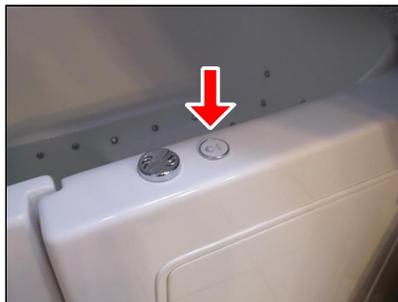
- (1) Top side power button at the whirlpool tub did not operate. Attention.

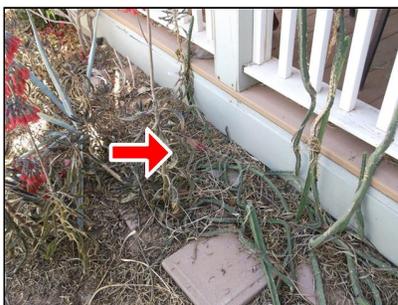
- (2) Suggest monitoring site drainage performance, confirmation of the flow path of surface water was not made by visual observation - Monitor.
- (3) Curb & gutter is not provided in the area (drainage conditions unknown). Surface water can sheet flow across a property with multiple contributing sources. This condition is often magnified when no curb & gutter is provided in the area - Review.
- (4) Stored fire wood should be removed from the side of the structure - Review.
- (5) Soil was too high at the structure, correction is needed as required at the building perimeter to prevent moisture and termite intrusion - Attention.

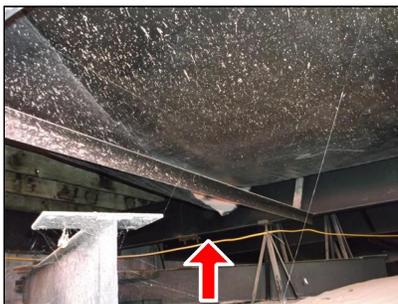
- (1) We were unable to locate a hold-down system for the building - Review.
- (2) Evidence of insects was observed at the raised foundation area - Consult a Pest Expert.
- (3) Evidence of rodents was observed at the raised foundation area - Consult a Pest Expert.
- (4) Evidence of past moisture was observed at the raised foundation area - Review.
- (5) Crawlspace screen cover(s) are damaged and should be repaired or replaced - Attention.
- (6) Damage/ open seams at the vapor barrier were observed. Attention.

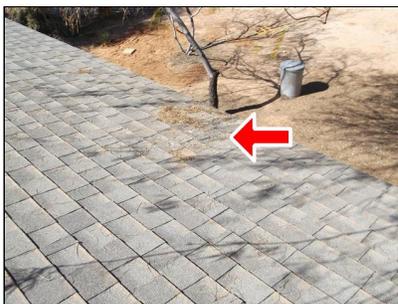
(1) Debris has accumulated at the roof and should be removed - Review.

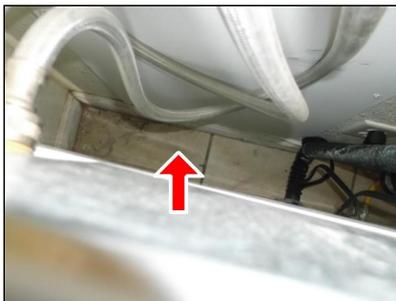
- (1) The laundry area appeared Satisfactory.
- (2) Moisture stains/damage was observed behind the washing machine. Review.

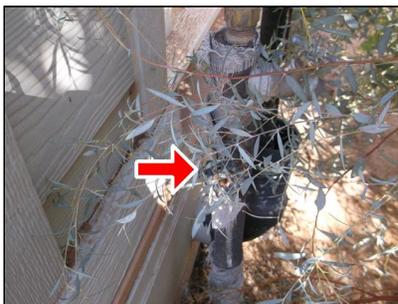
The main water shut off valve is an older/original gate valve, suggest replacement with a ball valve - Review.

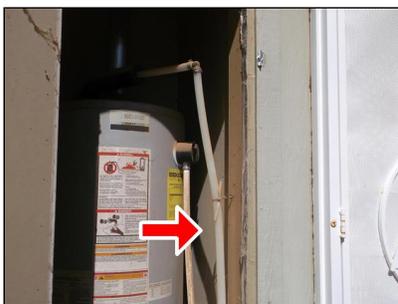
- (1) The distribution piping was Operational (functional flow Satisfactory).
- (2) Distribution piping was not properly anchored/supported - Attention.

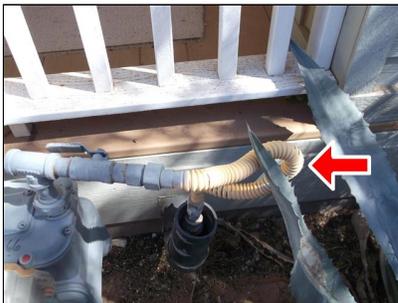
(2) There is a flexible copper supply line at the gas meter that may not be rated for gas use, further review with gas supplier or a qualified contractor is suggested. Review.

(3) The gas meter is in a traffic corridor and does not have protection to shield it from damage - Review.

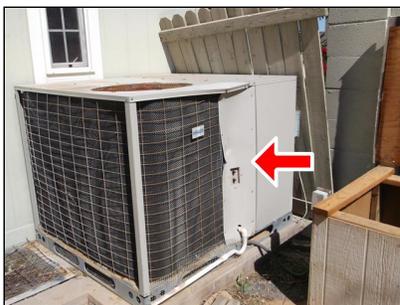
The HVAC unit appears to have impact damage, this may affect components not visible and may have affect the life span of the unit. A complete review with a qualified HVAC contractor is suggested. Attention.

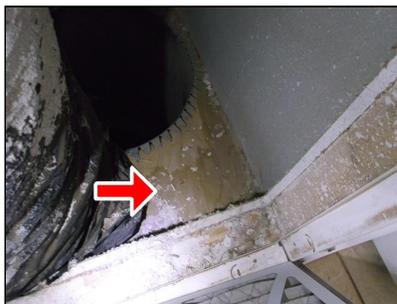
(2) Moisture stains were observed in the air return, may indicate a past/ current leak. Review.

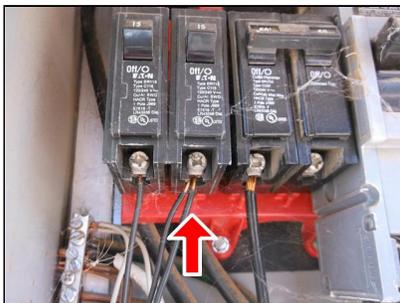
Overcurrent device(s) in the main panel is serving multiple circuits (double-tapping). This condition should be evaluated and corrected - Attention.

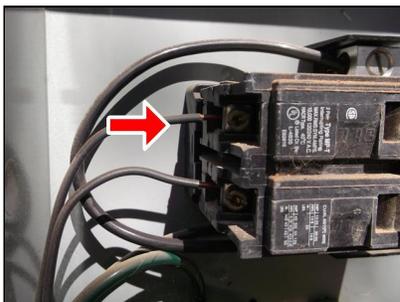
Overcurrent device(s) in the sub-panel are serving undersized wires, this condition is known as overfusing and creates a fire hazard that should be corrected by an electrician - Attention.

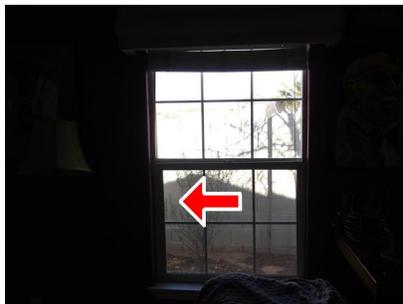
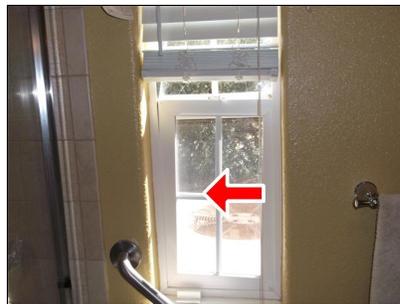
- (1) The evaluated windows were Operational.
- (2) Windows were difficult to operate, damaged glides/ springs, recommend further review/ repair with a qualified contractor - Review.

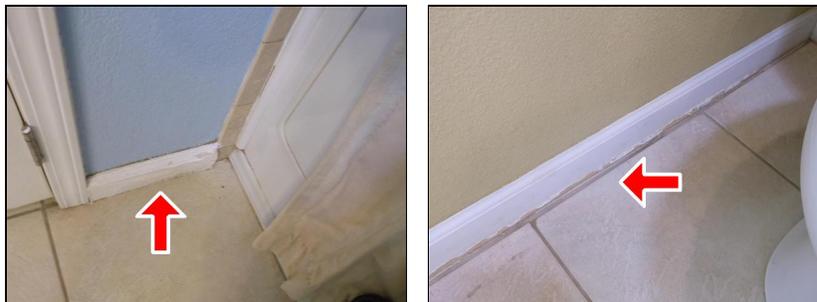
- (1) The walls and ceilings were Satisfactory where visible.
- (2) Moisture damage was observed at the wall/ base board adjacent to the hall tub and master shower . Review.

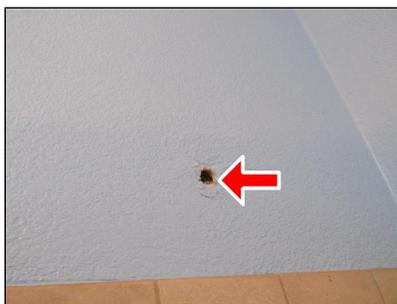
- (3) Holes in drywall should be patched as needed. Review.

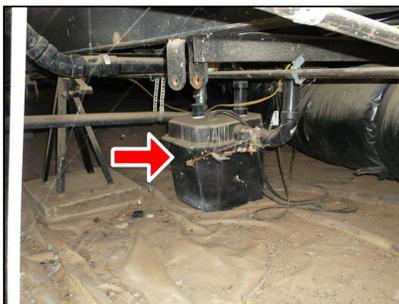
- (1) Excessive amount of possessions exist at the property, this condition severely limits the inspection. Seller was in middle of move out at time of inspection - Review.
- (2) There is a pump type device plumbed into the waste system, function is unknown, further review with a qualified contractor is suggested. Attention.

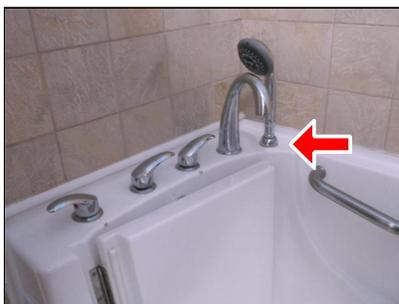
The hall stand up tub faucet continually drips and should be serviced. Attention.

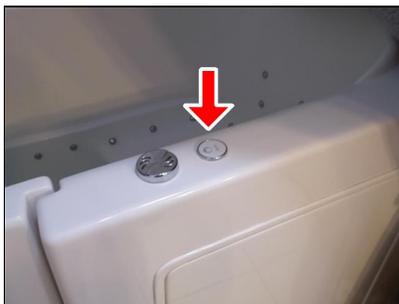
- (1) Top side power button at the whirlpool tub did not operate. Attention.
