Perfection Home Inspections
1042 E. Fairbrook Circle
Mesa, AZ 85203
602-524-2916
perfectionhomeinspections.com

Client Information: Record Number 7507

Genova, John
7800 E. Boulders Parkway #4
Scottsdale, AZ 85266

Inspected 2/12/18 9:00 AM
Built 1992
2262 sf

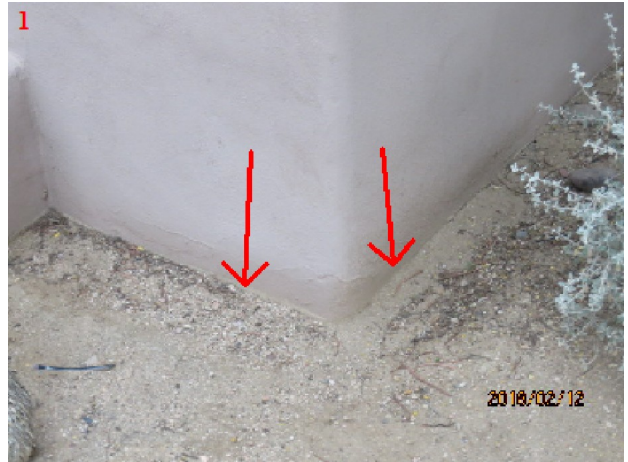
Service/Repair Wall Covering \ Cladding - Stucco To Soil

The stucco is too close to the ground in some areas. Recommend a minimum of a 4 inch gap between the bottom of the stucco and the finished grade and a minimum of 2 inches above the cement. Stucco need to be able to drain moisture out of the walls through the bottom of the stucco and termites and other pests may enter the home undetected if this distance is not maintained. Running stucco to the ground is a common practice for masonry homes in this area.

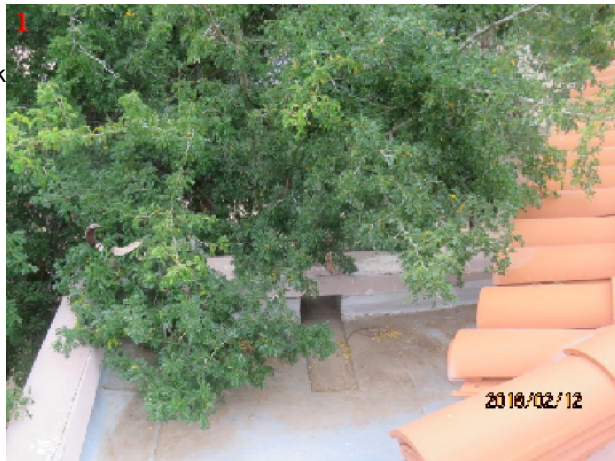
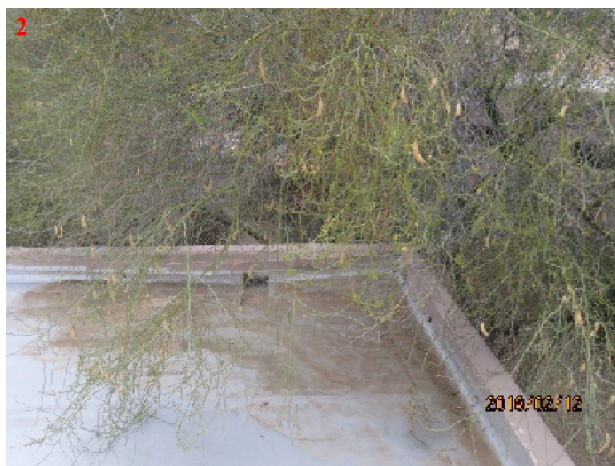
Service/Repair **Vegetation - Checked, Trees On Roof**

Trees or bushes over hanging the roof cause debris to build up on the roof and also damages the roof when the wind blows the branches across the roof. Recommend cutting trees or bushes back to protect the roof and removing all debris on the roof. See picture

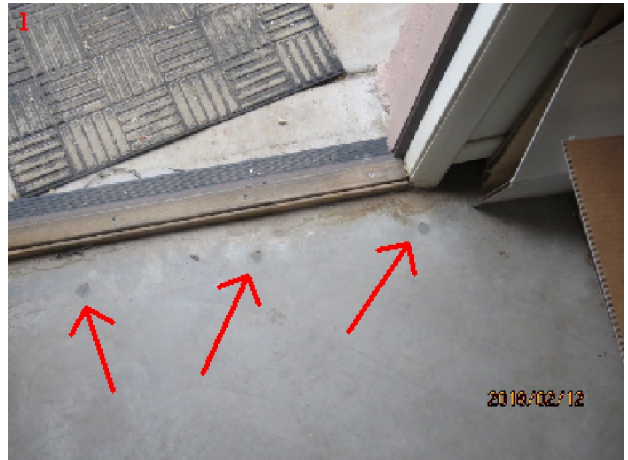
Recommend Further Investigation Other - Past Treatment

Drill marks in the slab are signs of past termite treatment. Recommend asking seller for more information on past termite treatment and what caused the treatment and if there a warranty on this treatment?

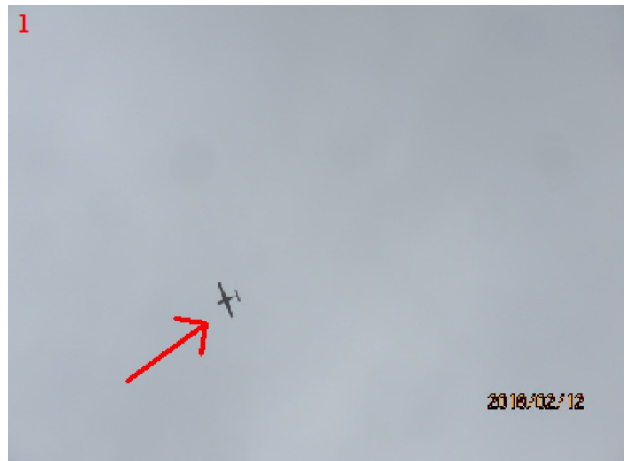
Recommend Further Investigation GROUNDS - Aircraft

This home appears top be in a flight patch of a local airport. An aircraft flew by during the home inspection. Recommend further investigation.

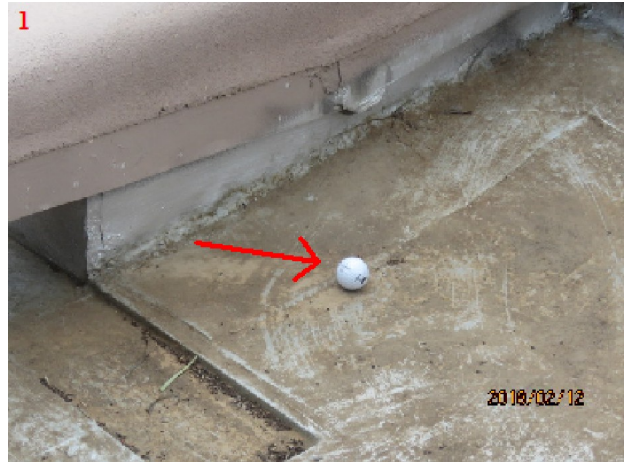
How Inspected - Walked on Roof

Walked on the flat roof only.
Golf ball on the roof. Golf balls can and do crack roof tiles and damage stucco. Recommend watching for golf balls and damage caused by golf balls.

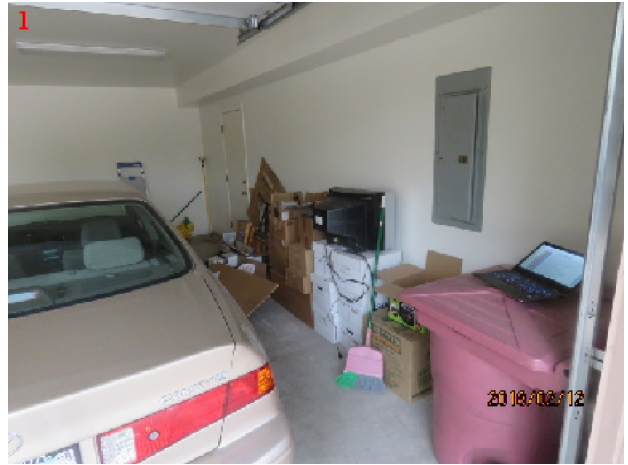
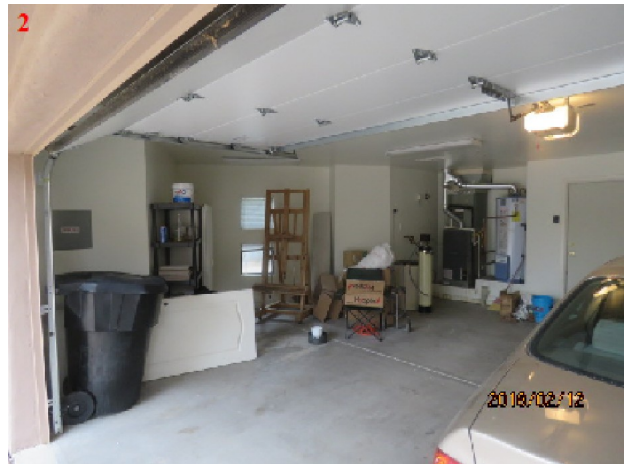
Satisfactory GARAGE - Garage Stuff

Stuff in the garage blocks view of the interior of the garage.
Recommend inspecting garage area after the stuff is removed.

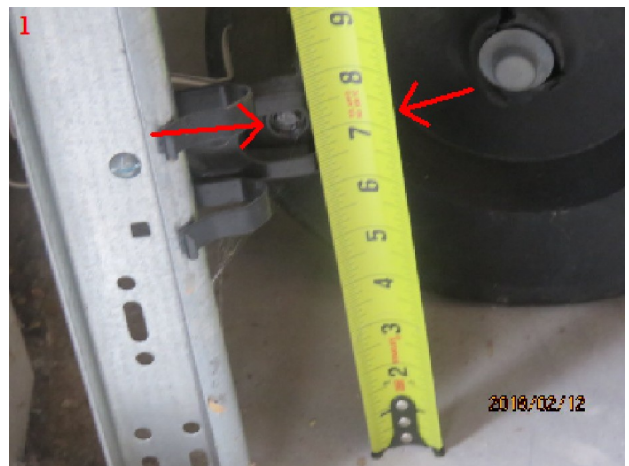
Safety Concern Garage Electronic Eye - More Than 6 Inches

The electronic eye sensor beam used to stop the automatic garage door from closing if something is in its path is more than the recommended height of 6 inches above the garage floor. This is a safety hazard. Recommend installing this sensor eye beam 4 to 6 inches above the garage floor.

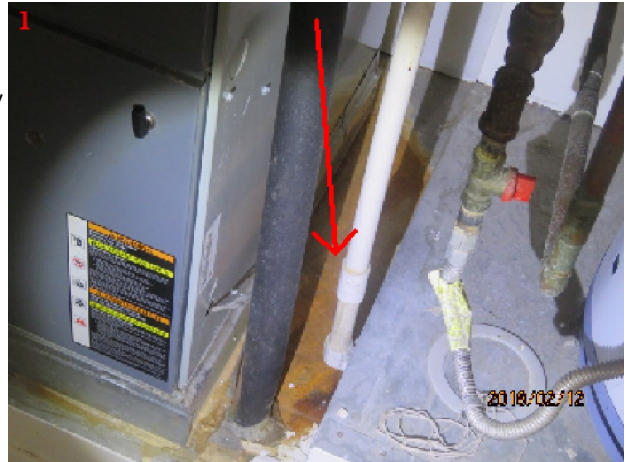
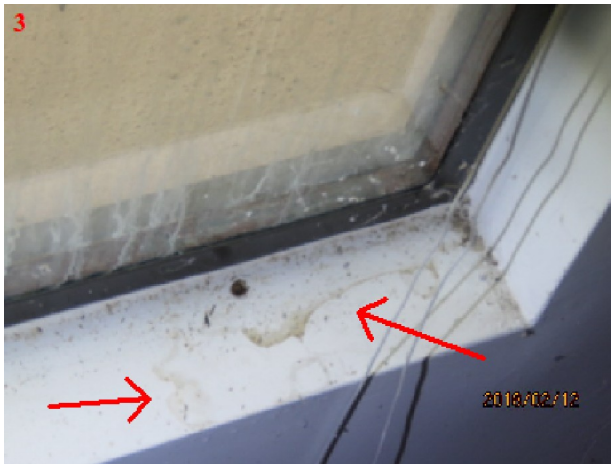
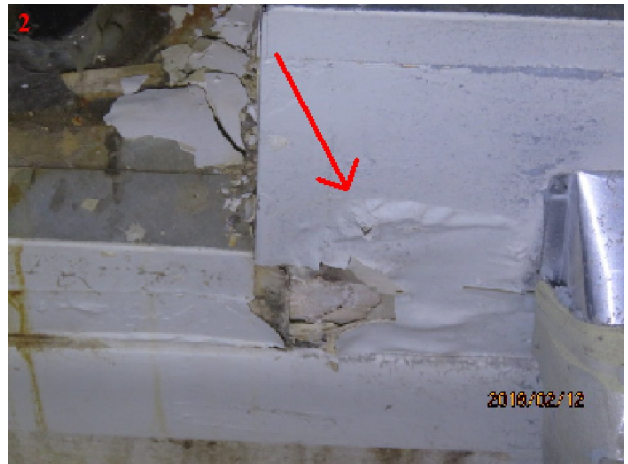
Service/Repair Garage Interior Walls - Drywall\Plaster, Water Heater Leak

Water stains in the garage at the water heater area and air handler area. Water stains on the window seal in the garage and water damage to the drywall by the water heater. Recommend a qualified contractor evaluate and make all necessary repairs.

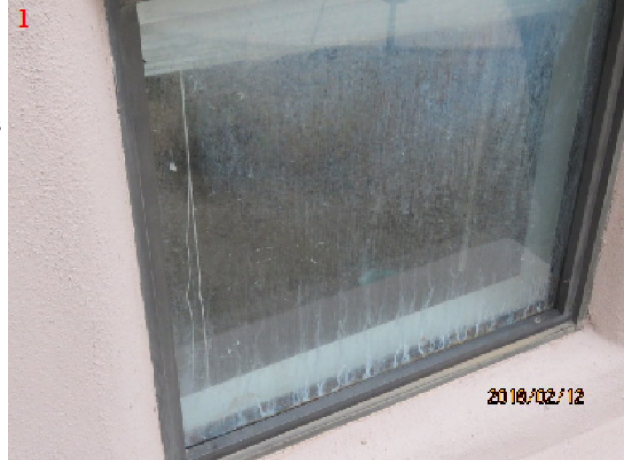
Service/Repair **Garage Windows - Stationary**

Lower garage window has a defective its seal.
When a window seal between the window panes is found to leak all the windows should be suspect of having a seal problem. Since all windows are normally purchased at the same time from the same batch when one goes the others may be soon to follow. Sometimes it is difficult to see the moisture between the panes. Recommend a qualified window contractor evaluate all sealed windows and make all necessary repairs.
Most window manufacturers warranty sealed windows for a minimum of 10 years and some for life.

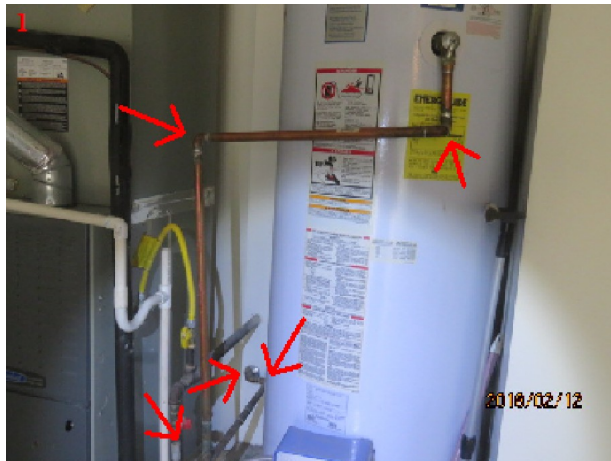
Safety Concern **Temp. Pres Relief Valve and Pipe - 5 + bends**

Temperature and pressure relief valve extension pipe has too many bends. Too many bends in a pipe restricts water flow. Recommend a qualified plumbing contractor evaluate and make all necessary repairs.

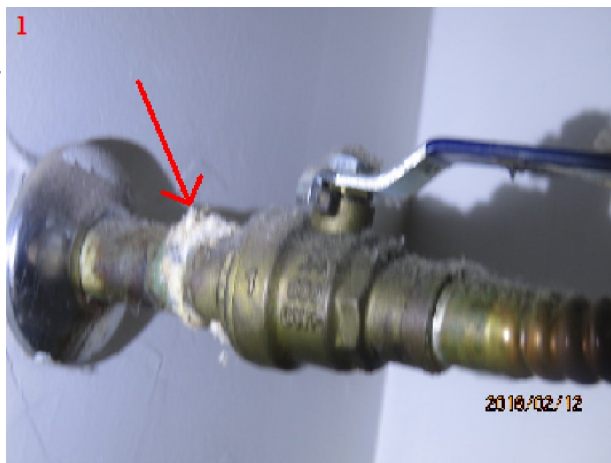
Service/Repair **Water shutoff Valve - Present, Corrosion**

Corrosion on the water heater water shutoff valve is an indication of a small leak. Recommend a qualified contractor evaluate and make all necessary repairs.

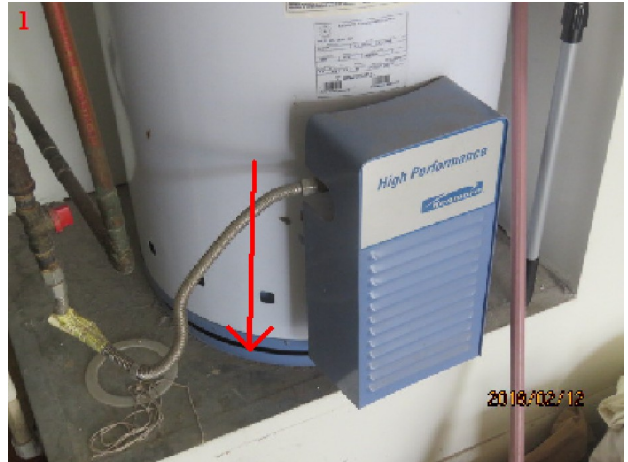
Service/Repair **Overflow Pan - None**

No pan installed under the water heater.
Recommend installing an overflow pan under the water heater and installing a drain line from this pan if possible to the exterior.

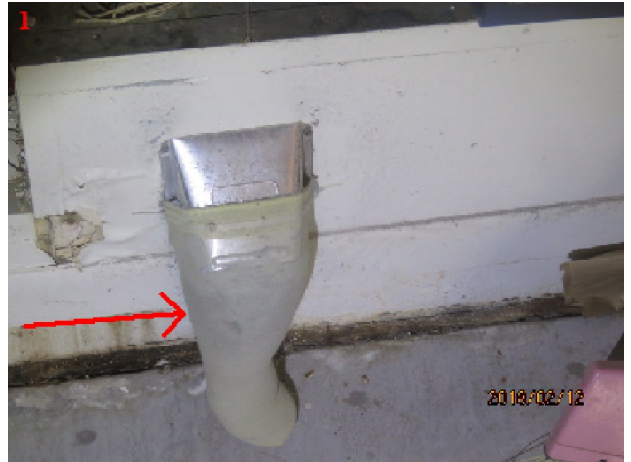
Dryer Vented - Wall

This dryer vents into the garage. Recommend venting to the exterior.

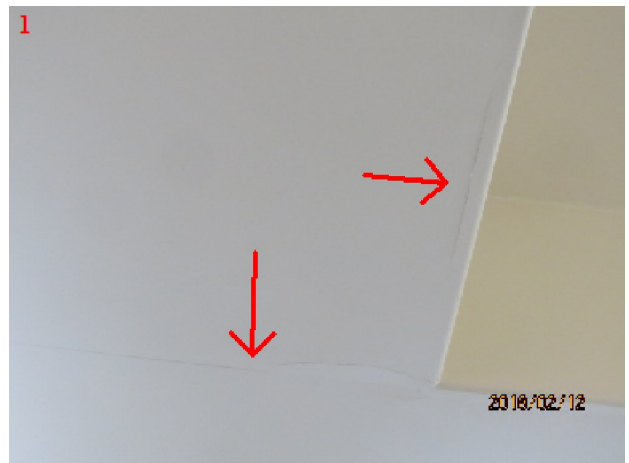
Recommend Further Investigation **Interior Walls and Ceiling - Inspected, Settling Cracks**

Some drywall/plaster cracks from normal settling found. Recommend patching and painting when convenient.

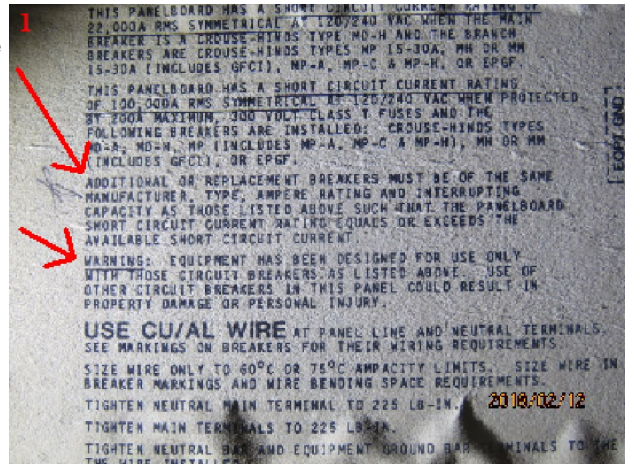
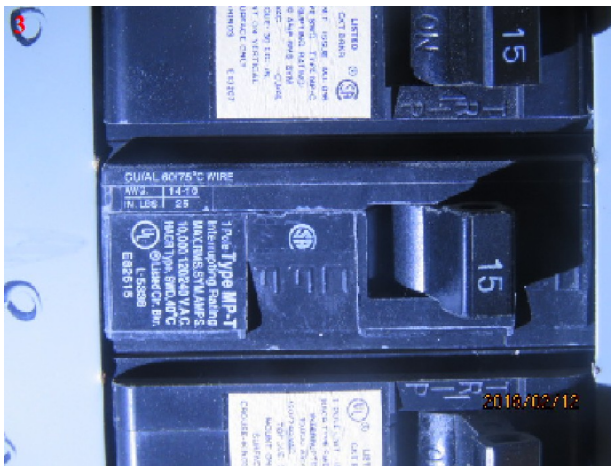
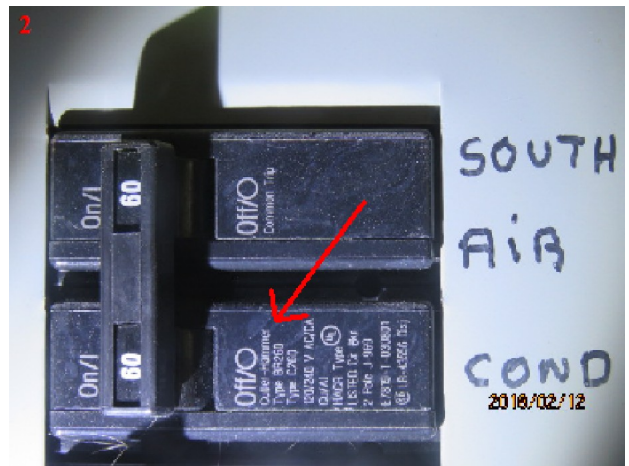
Safety Concern Compatibility Issues - Wrong Breaker(s)

The electric panel calls for breakers made by the manufacturer of the panel and this panel has one or more breakers installed that are not made by the manufacturer. The wrong breakers can be a fire hazard and or a shock hazard. Recommend a qualified contractor evaluate and make all necessary repairs.

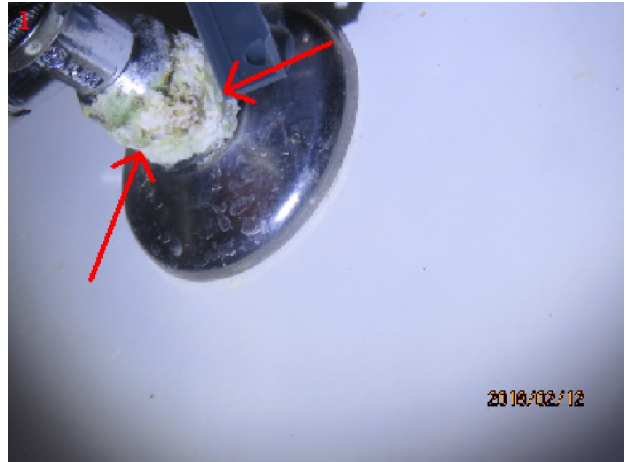
Service/Repair Sink Faucet - Tested, Corrosion

Corrosion on the left side hot water supply valve under the master bathroom sink. This is an indication of a slow leak. Recommend a qualified contractor evaluate and make all necessary repairs.

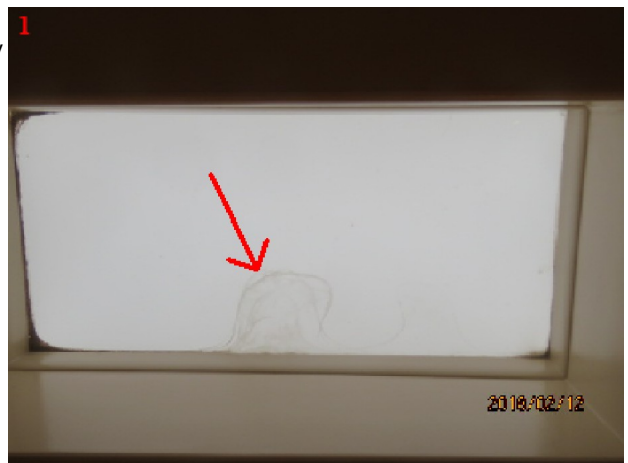
Service/Repair Switches and Fixtures - Wall, Ceiling, Skylight

Water stains on the lower skylight panel in the master bathroom. Recommend a qualified contractor evaluate and make all necessary repairs.

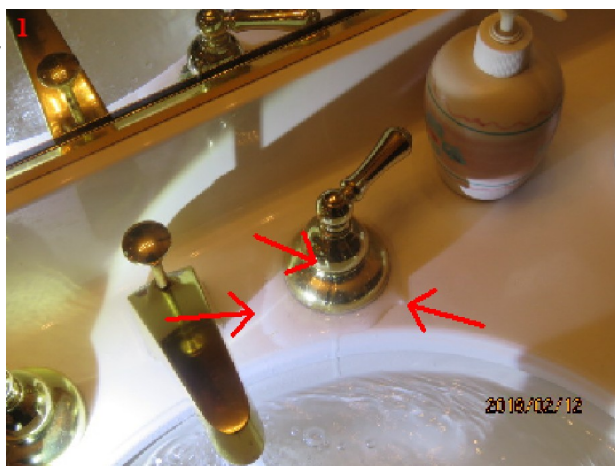
Service/Repair Sink Faucet - Tested

The sink faucet cold water valve handle leaks.
Recommend a qualified contractor evaluate and make all necessary repairs.

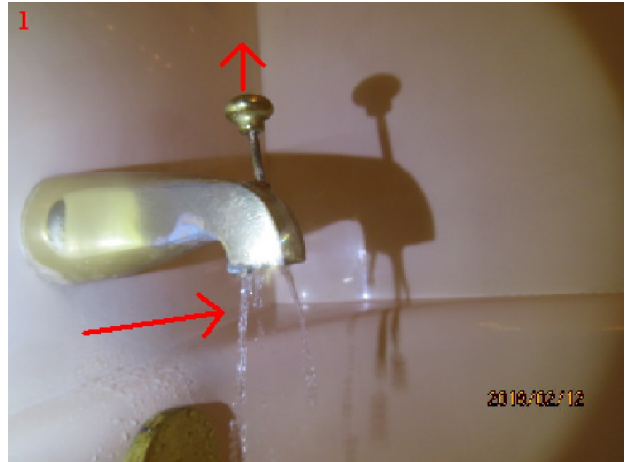
Service/Repair Tub/Shower Faucet - Adequate Flow, Divert Valve Leaks

Shower diverter valve is defective. It does not completely shut off the water to the tub when the shower is on. Recommend replacing defective diverter valve.

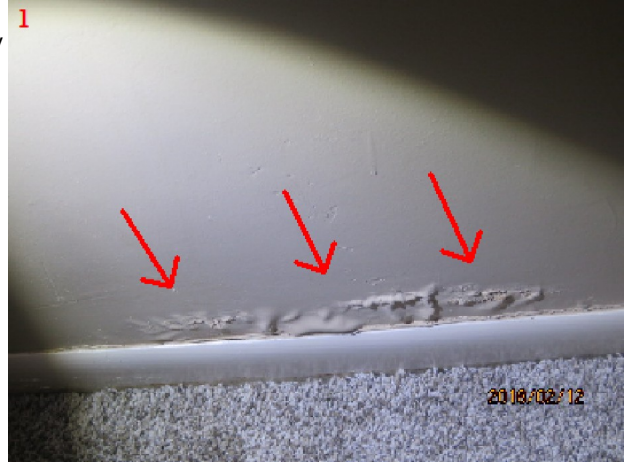
Service/Repair Walls & Ceiling - Inspected

Water damage to the west wall in this room.
Recommend a qualified contractor evaluate and make all necessary repairs.

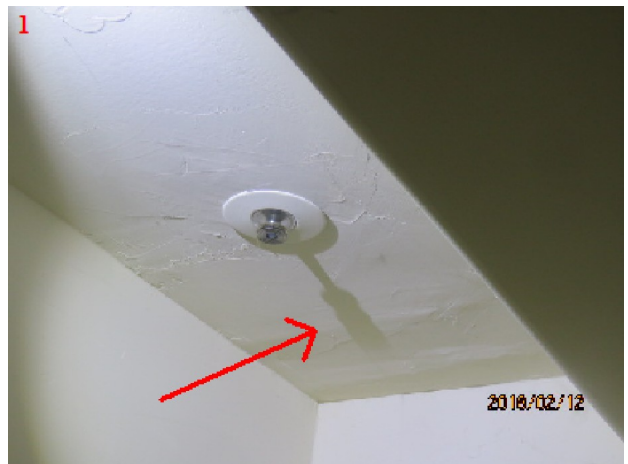
Recommend Further Investigation Closet - Door(s) & Pole

There is a drywall patch on the ceiling on the closet. Recommend asking the seller what caused this issue.
