Cover Page

Date : 10/25/2018

35635 N Meander Way
Carefree, AZ 85377

Arizona Department of Agriculture
Pest Management Division
WOOD DESTROYING INSECT INSPECTION REPORT

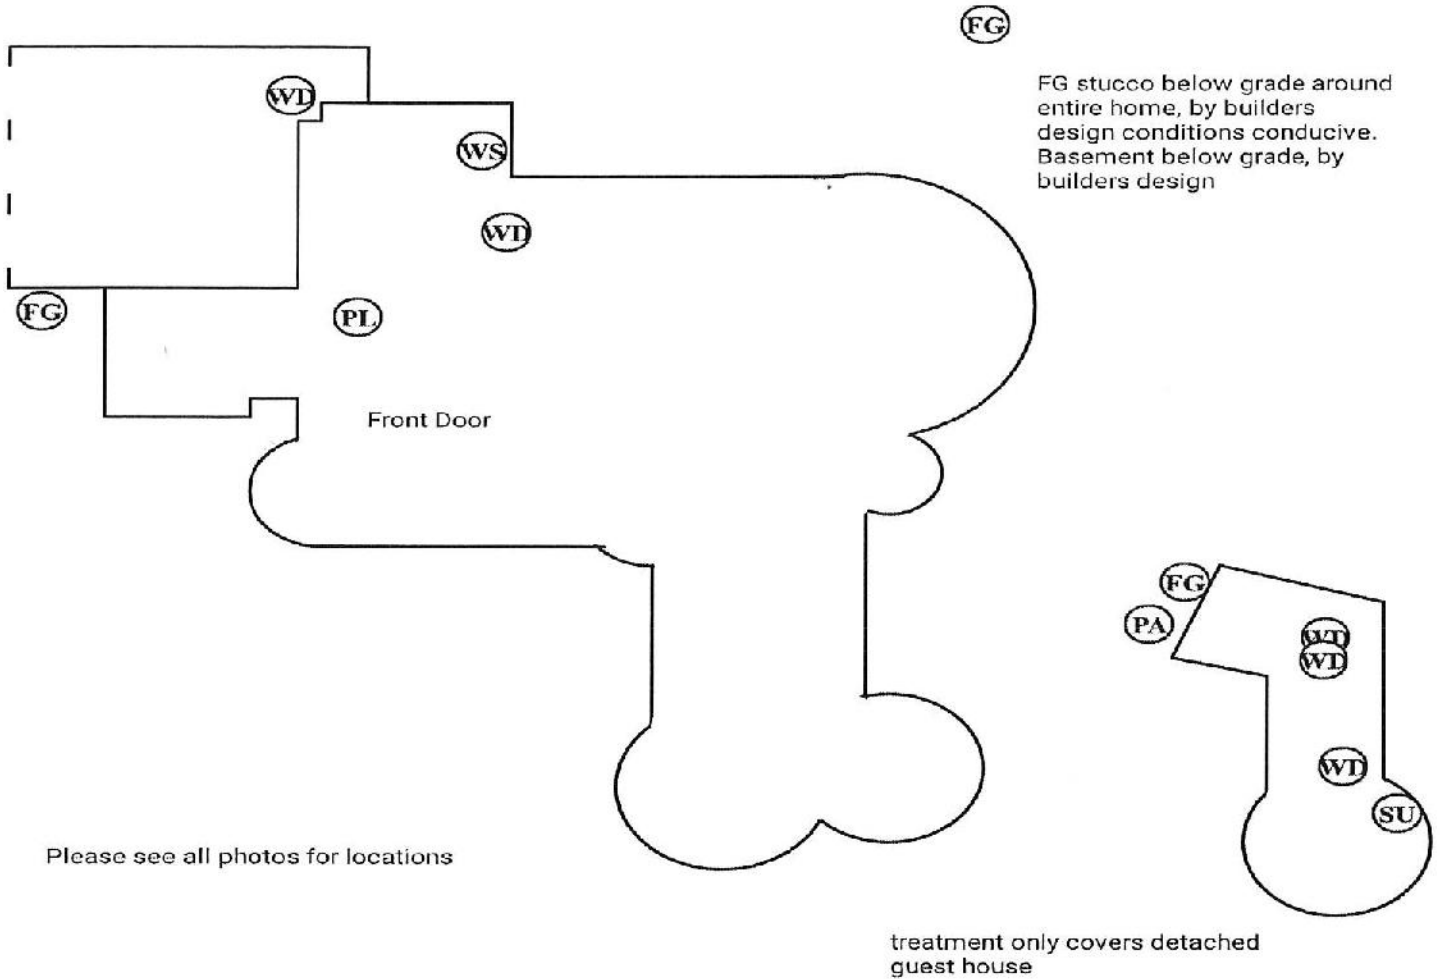
GRAPH OF STRUCTURE(S)

- ☒ A. Visible evidence of wood-destroying insects was observed.
Describe evidence observed: Subterranean termite tube - See Diagram/See Photos
Type of Wood-Destroying Insects observed: Subterranean Termites
- ☐ B. No visible evidence of infestation from wood-destroying insects was observed.
- ☐ C. Visible evidence of infestation as noted in 8A. Proper control measures were performed on (date): _____
- ☐ D. Visible damage due to _____ was observed in the following areas: _____
- ☐ E. Visible evidence of previous treatment was observed. List evidence. (See also Item 20, page 2.): _____

This structure has IA, please see comments on page 2 box 19 of AZ WDIIR Form

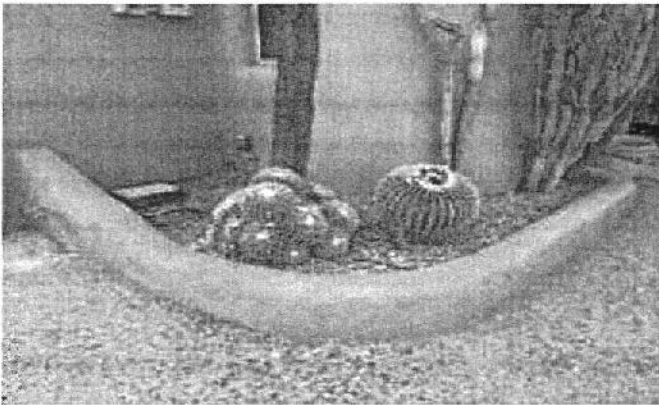
FG planterbox front of garage

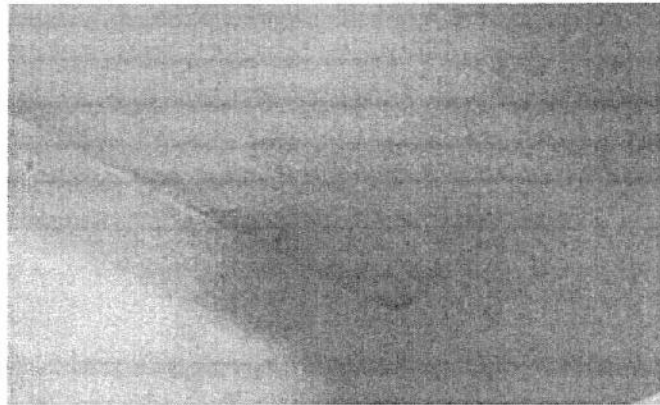
WD garage ceiling, tested dry at time of inspection

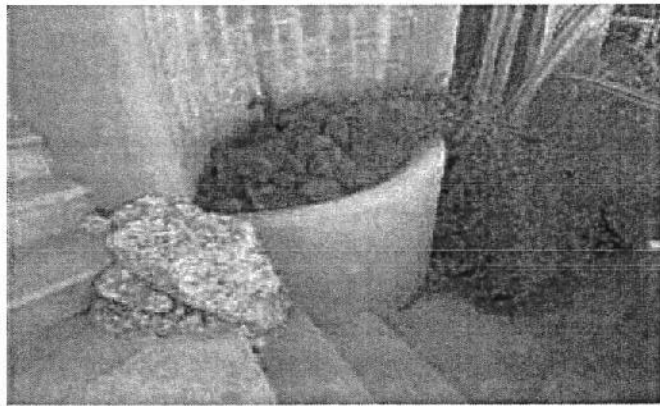
FG planterbox front of detached guest house

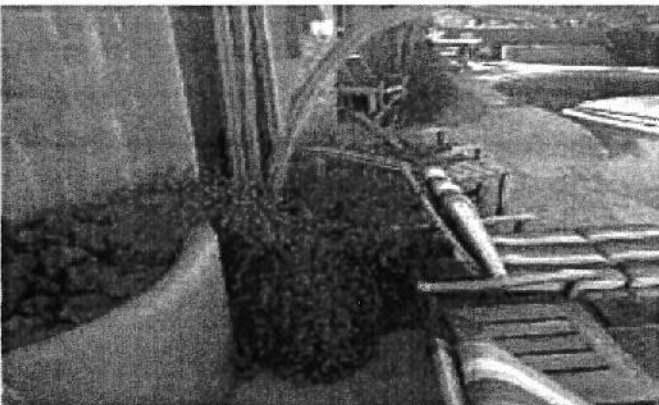
PA plants abutting detached guest house

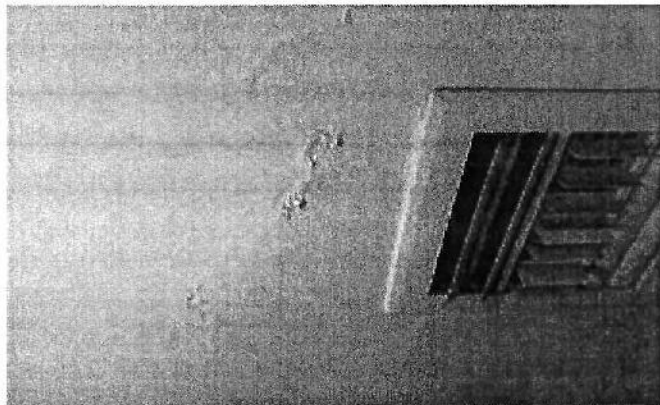
WD detached guest house bathroom ceiling, tested dry at time of inspection

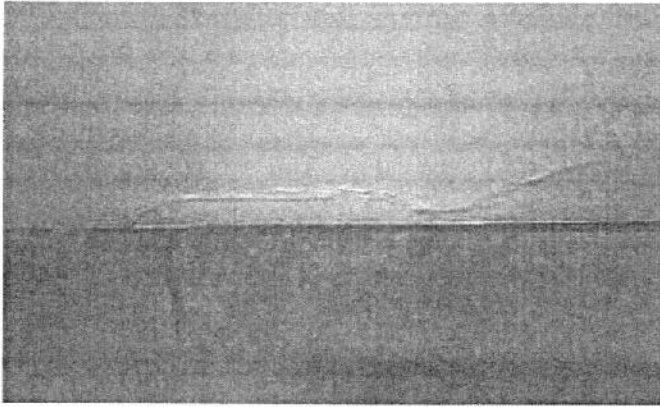
WD detached guest house wall bathroom area, tested dry at time of inspection

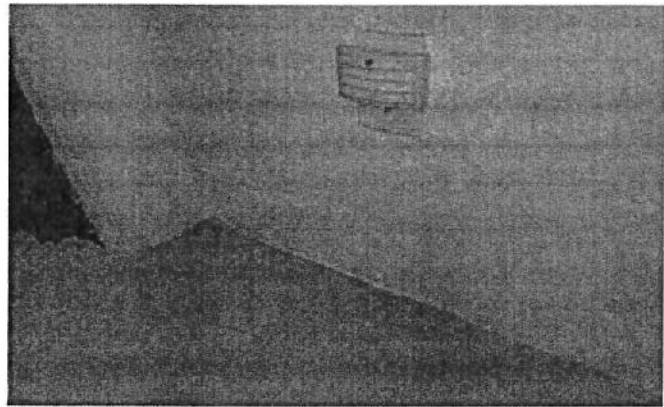
WD detached guest house wall bathroom area, tested dry at time of inspection

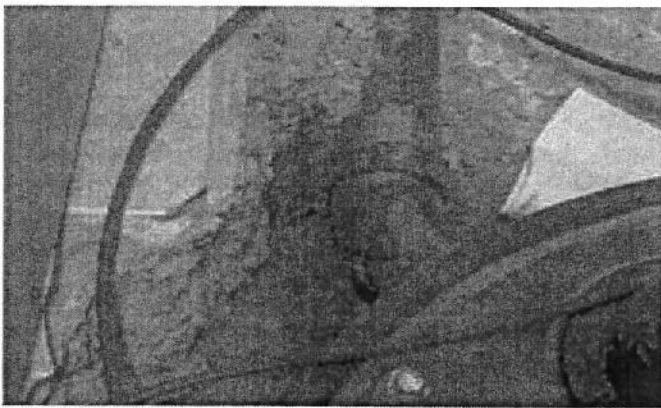
PL improper condensation line drainage

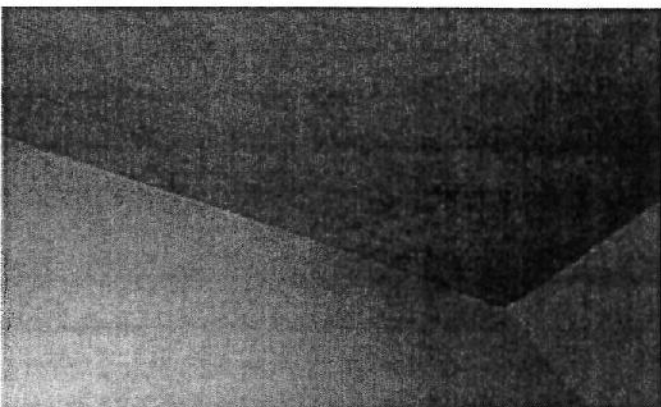
WS NE bedroom ceiling, tested dry at time of inspection
