## House Inspection and Repairs

The property was inspected by King Home Inspections on February 15, 2019.

# Property Inspection Report

14016 S. Rockhill Rd., Phoenix, AZ 85048

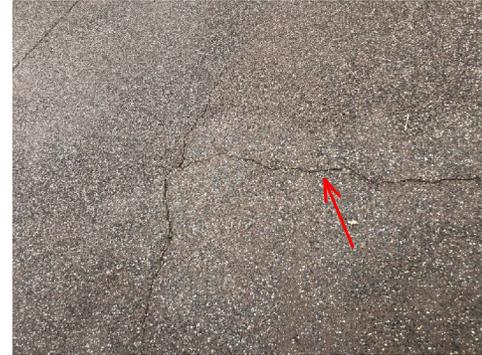
1. Driveway Concrete There are cracks with separation in the driveway.

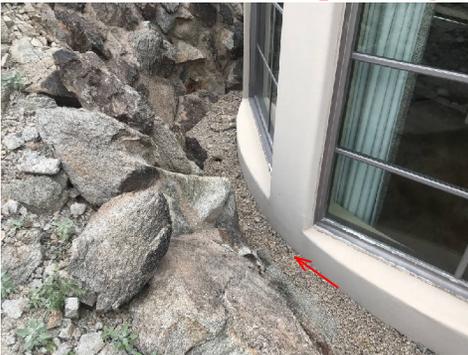
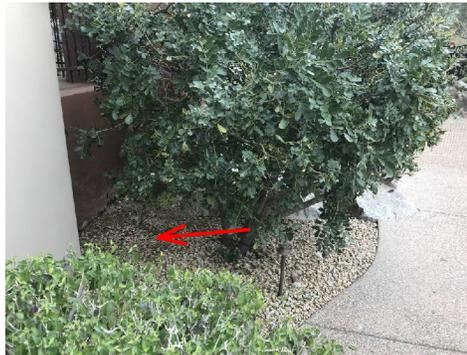
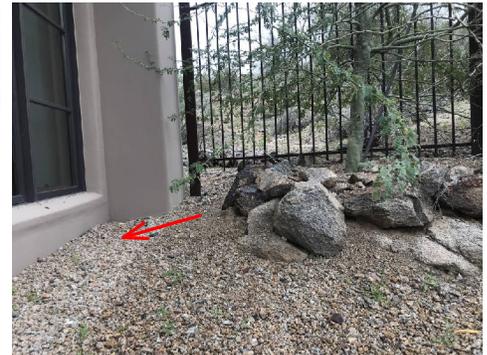
3. Drainage Issue The soil is above the slab onto the framed wall in multiple locations around the perimeter of the house. The soil slopes toward the house and there is evidence of water ponding between the house and the front walk.

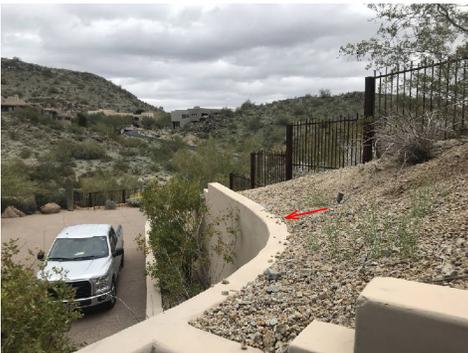
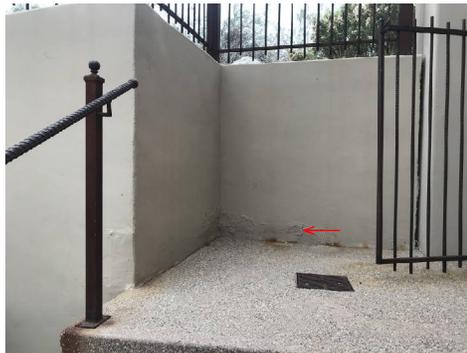
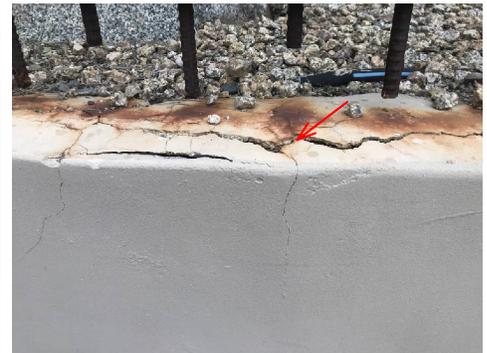
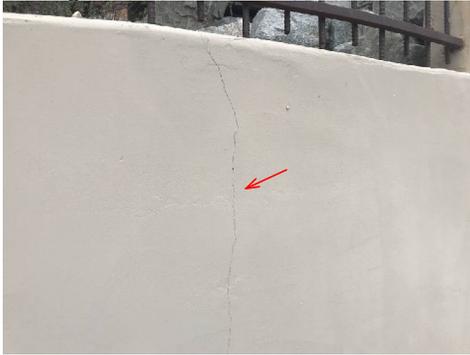
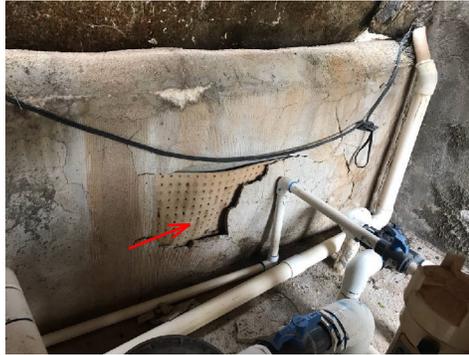
4. Retaining Wall Concrete There are walk offs greater than 30 inches with no guard rail in multiple places. There is evidence of moisture stains/damage/cracks to the face and top of the retaining walls in multiple places. There are no visible weep holes at the bottom of the retaining walls. The retaining wall surface is deteriorated in the pump area for the front waterfall.

1. Retaining wall were constructed and installed per building code at the time of contraction. All walls have iron fencing around them.
2. Settling crack in rear patio roof inspected and is normal wear and tear.

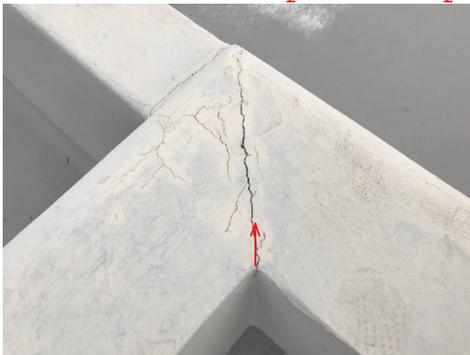
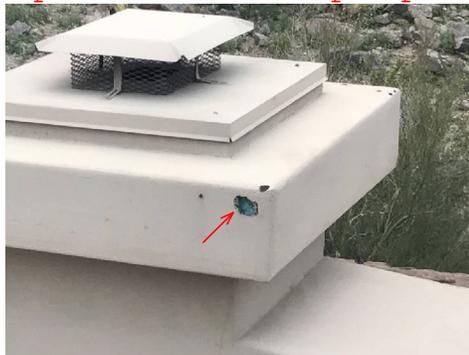
5. Wall Covering/Trim Material Stucco, Stone The stucco is damaged in multiple places. There are cracks at the top of the parapet wall in multiple places.

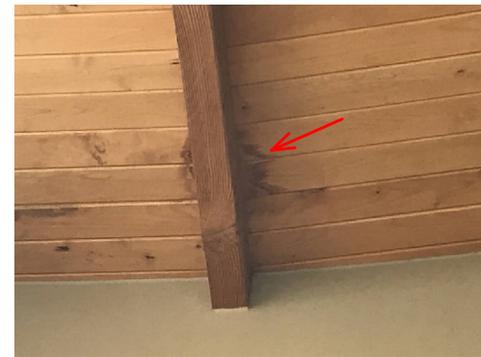
6. Eaves/Fascia/Soffits Material Wood There is evidence of moisture stains/damage to the eaves and fascia at multiple places.

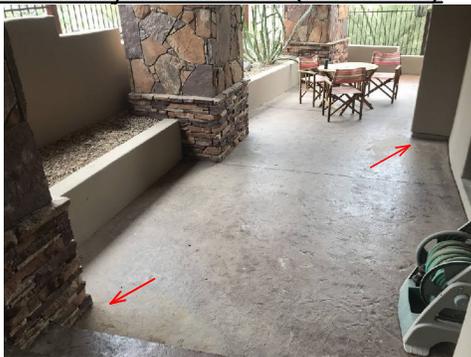
7. Patio/Courtyard Material Concrete There is evidence of water ponding in the outdoor entertainment area, the pool equipment area, the north west patio.

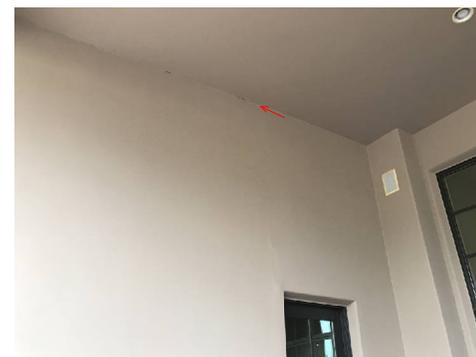
8. Patio Cover Material **Drywall** There are cracks in the edge of the rear patio cover at the north end.

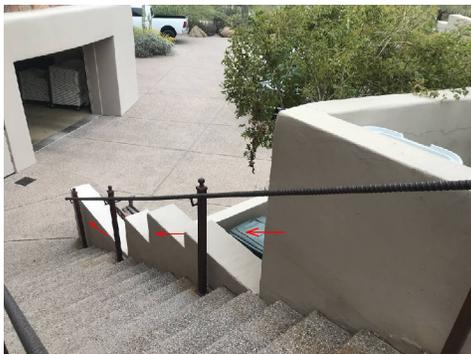
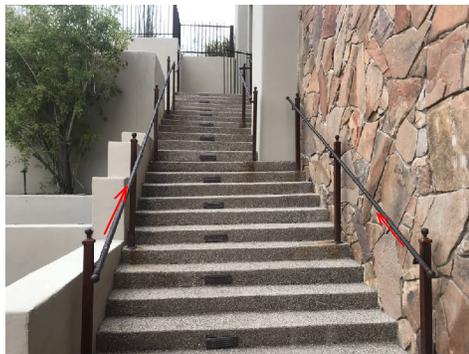
9. Exterior Stairs Material .. **Concrete** There are no vertical balusters for the guard rail on the exterior stairs at the east side of the house. The handrails are loose on the east side of the house.

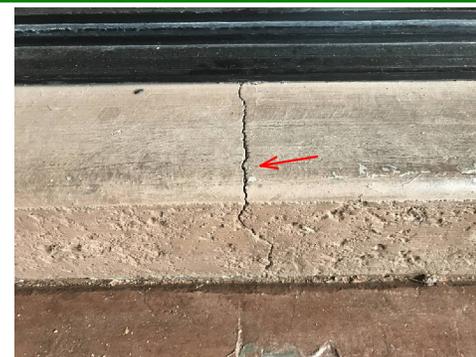
10. Stem Wall/Slab **concrete** There are cracks in the stem wall in multiple places.

3. Stem wall cracks do not manifest themselves through to the walls of the house and are normal for age of house.
4. \$6,000 spent on roof repairs and sealing.

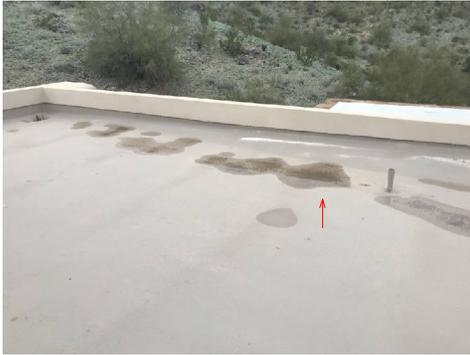
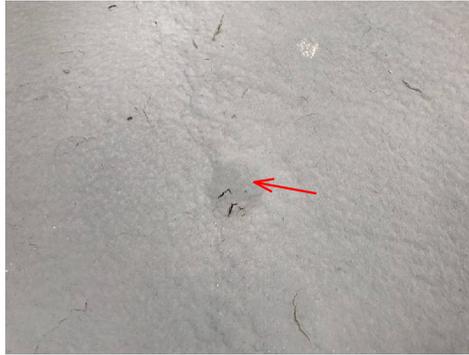
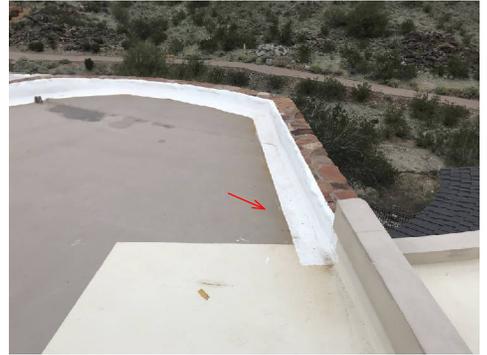
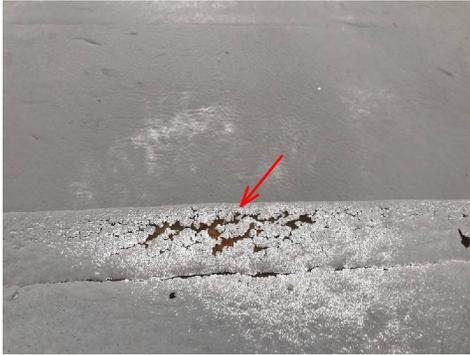
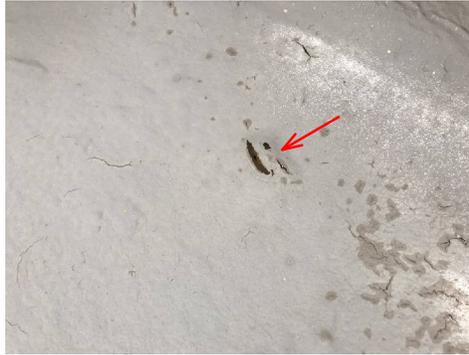
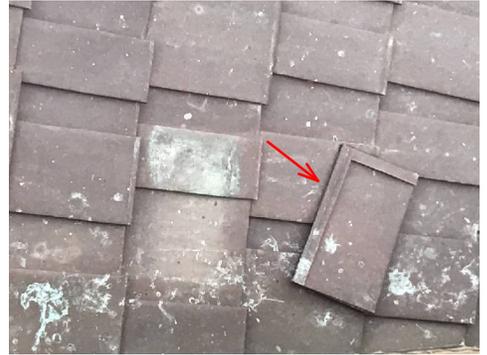
11. Condition of Main Roof **Issue** There is evidence of water ponding in multiple locations on the roof. There are blisters/cracks/openings in the roof surface in multiple places. There is evidence of prior repairs in multiple places.

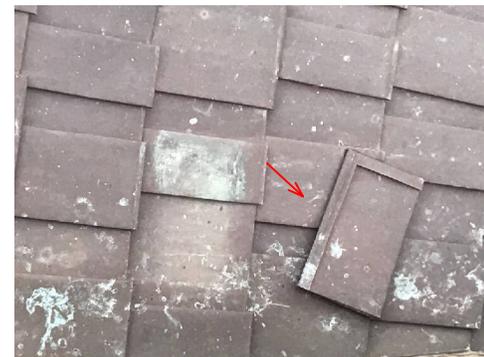
12. Condition of Patio/Deck Covers Issue The copper shingles are displaced in a few places.

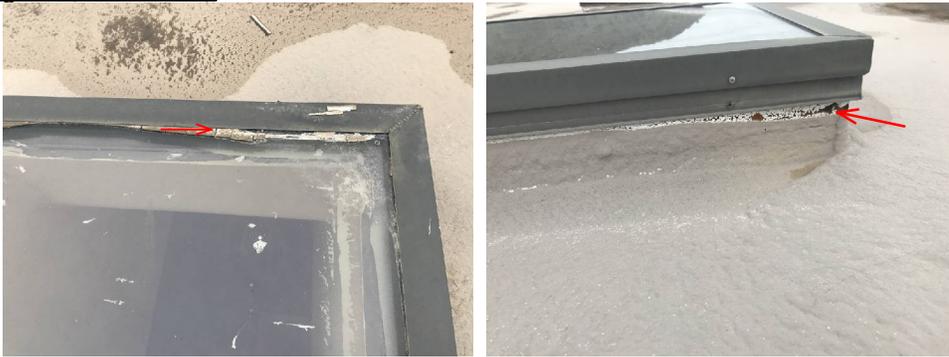
13. Skylights Issue The sealant is deteriorated at the edges of the skylights.

5. Skylights resealed with caulk
6. The "reverse direction drain" is not a drain but a passthrough for exterior water to get to a drain in the corner of the house.

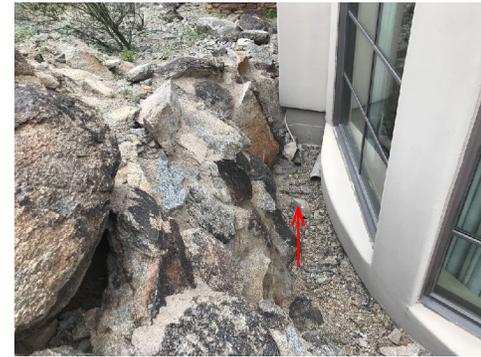
The downspout drains in a negative direction on the back of the master bedroom.

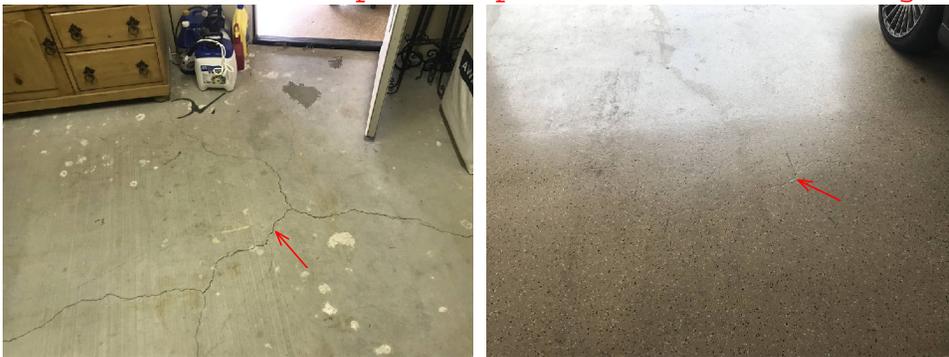
15. Floor Issue There are cracks with separation in the storage room floor in the garage. There is evidence of prior repairs to cracks in the garage floor.

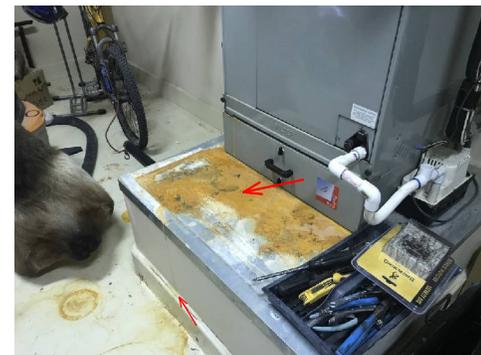
16. Walls Issue There is rust and evidence of moisture stains/damage to the air handler platform in the garage.

7. Rust on the a/c unit pedestal was remedied 2 years ago when the drain pipes were cleaned and maintained.
8. Door knob in internal room in garage installed

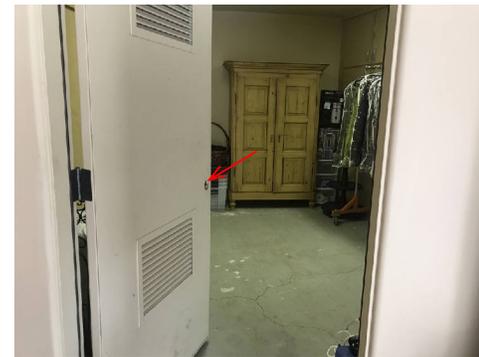
18. Pedestrian Door Issue There is no door knob on the door to the storage closet in the garage.

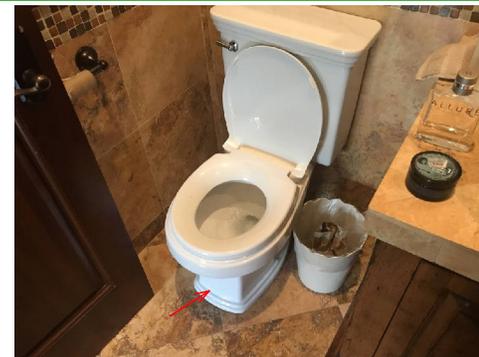
19. Toilets Issue The toilet is loose from the floor in the north east secondary bedroom bathroom.

9. Toilet secured in north east bathroom
10. Sink stopper connected in north east bathroom.
11. No evidence of new leakage in pool room....just received 2 inches of rain.

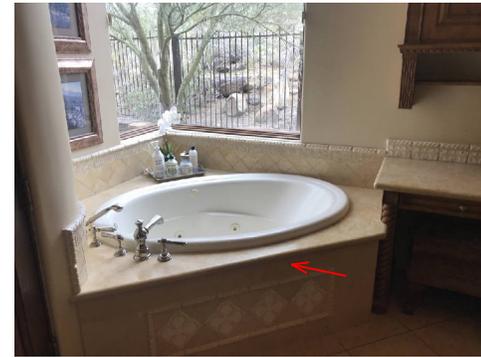
21. Tubs Issue It does not appear the jetted tub is GFCI protected in the master bathroom.

16. Jetted Tub is GFCI
17. Based reconnected in Guest bedroom
18. New filters for R/O installed and soft water system served Friday, Feb 22.

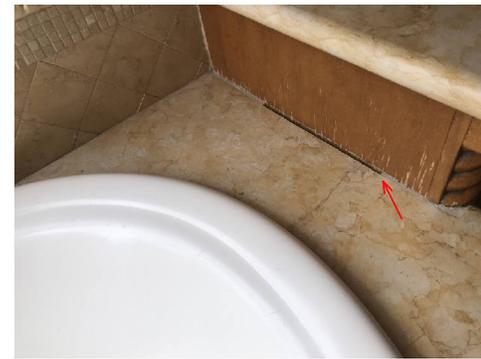
22. Tub Surrounds Issue The grout is missing between the tub surround and the cabinet in the master bathroom.

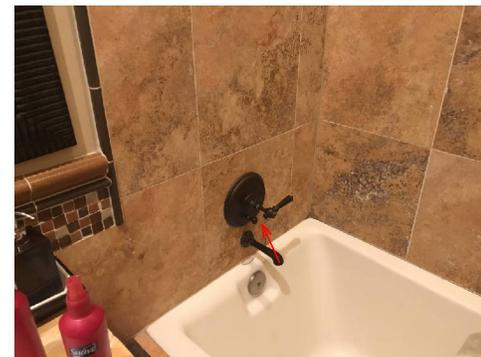
23. Tub Faucets Issue The shower diverter does not close all the way in the north east secondary bathroom.

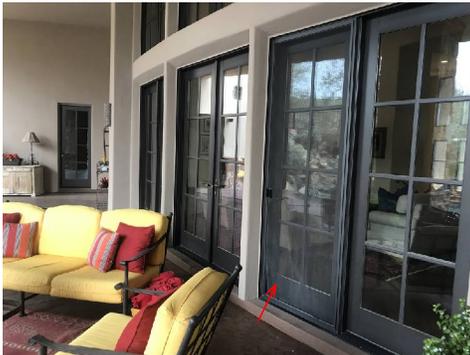
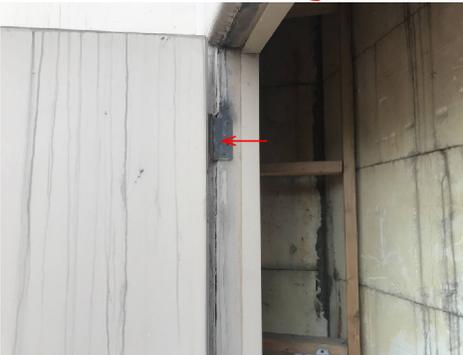
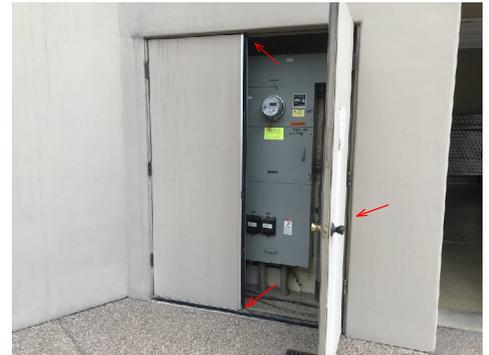
24. Exit Doors/Others Issue The screen door is damaged on the rear of the house. The screws are stripped at the top hinge, the header/threshold pins do not engage on the double door and the door knob does not function for the main electrical service panel closet. The exterior doors difficult to close at the eating nook.

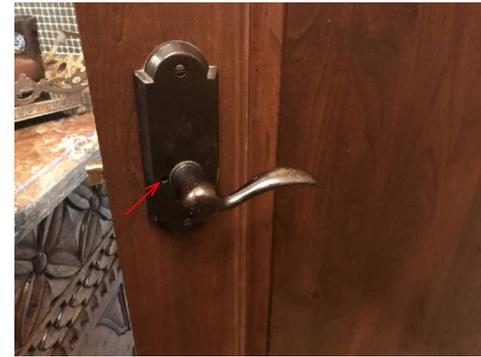
25. Interior Doors Issue The lock button has been removed in multiple places on the interior doors.

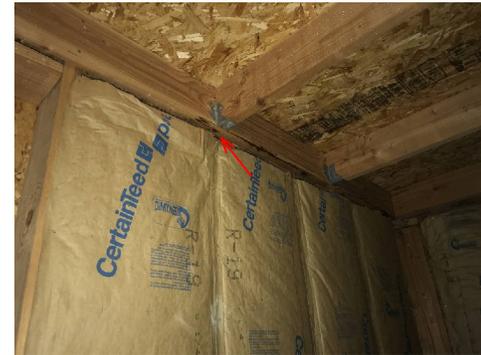
26. Ceilings Issue There is evidence of moisture stains/damage to the ceiling in the pool equipment room.

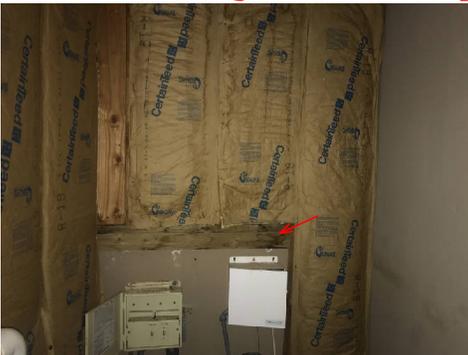
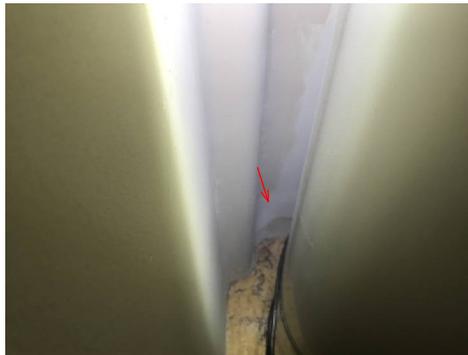
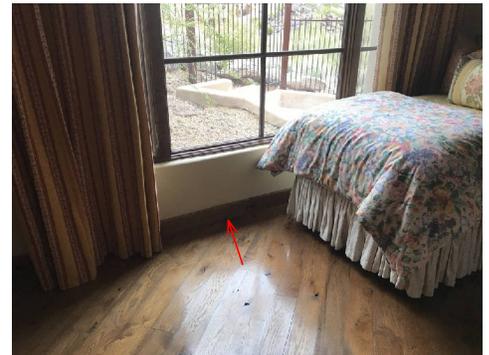
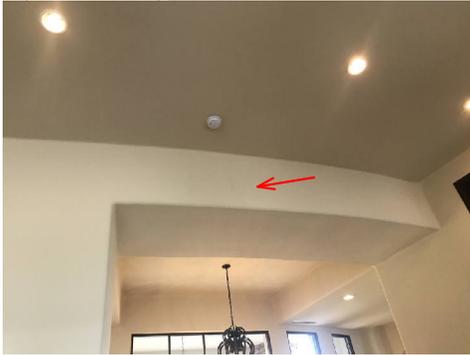
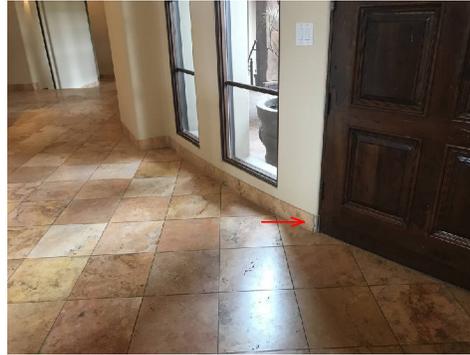
27. Walls Issue There is evidence of moisture stains/damage to the walls in the pool equipment room. There is evidence of moisture stains behind left water heater in the water heater closet. The base is pulled away from the wall in the guest bedroom. There are stains on the wall in the living room above the entry stairs. There is a small piece of tile missing at the entry door.

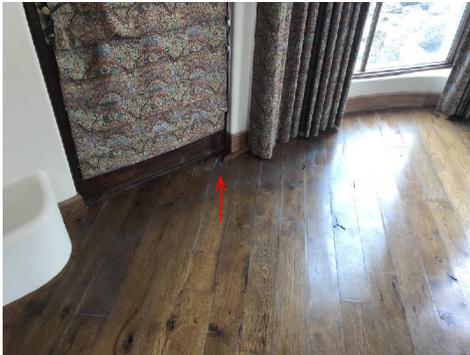
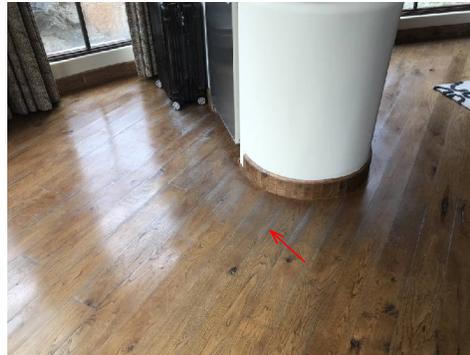
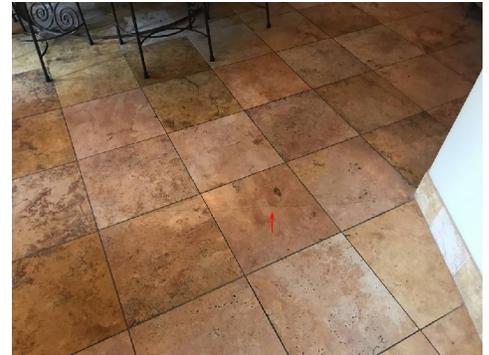
**28. Floors Issue** There is evidence of moisture stains/damage to the floor in the master bedroom. There is a crack in the tile between the entry and eating nook.

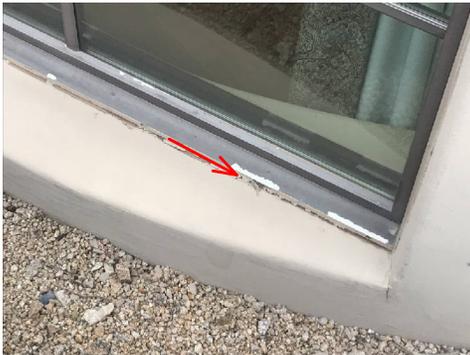
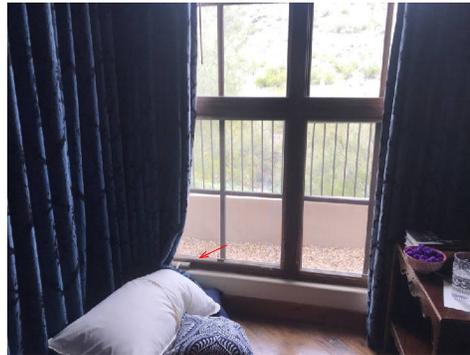
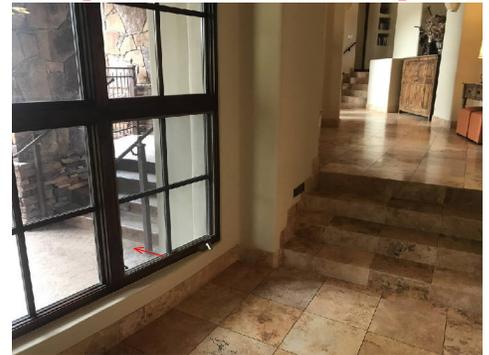
**29. Windows Issue** The caulking is deteriorated on the exterior windows in multiple places. The window lock does not function on the north east secondary bedroom and entry hallway.

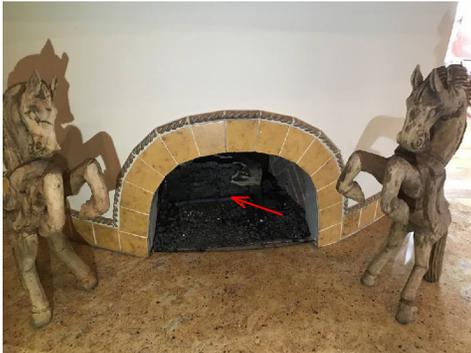
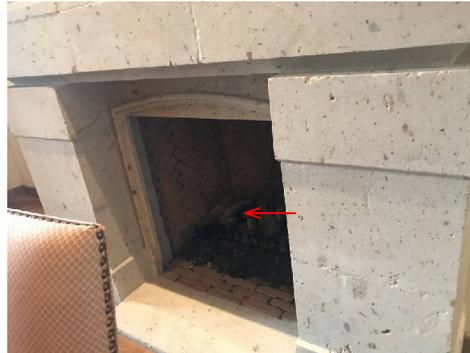
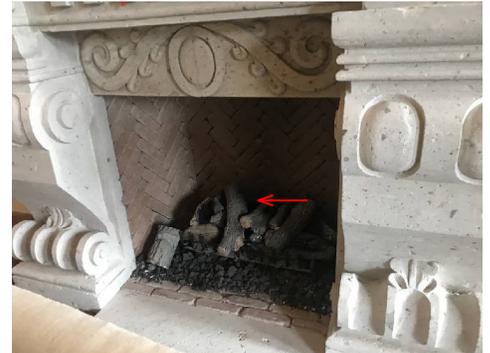
34. Glass Door/Screen Issue There is no screen/glass door on the fireplace in the kitchen dining room and living room.

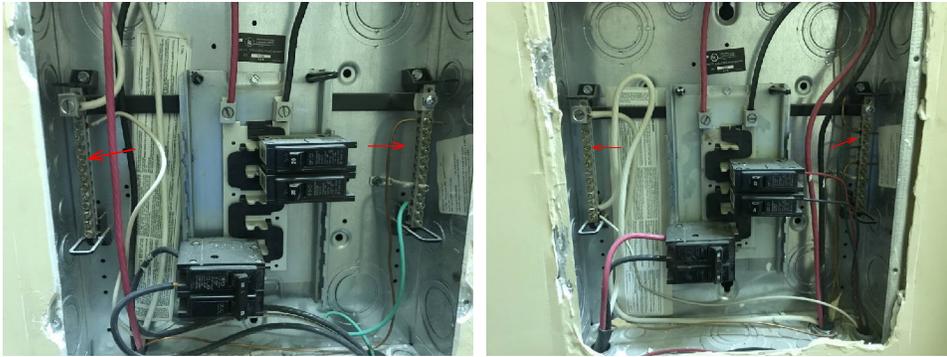
38. Buses Issue The buses are tied together for the sub-panel at pool equipment sub panels one and two.

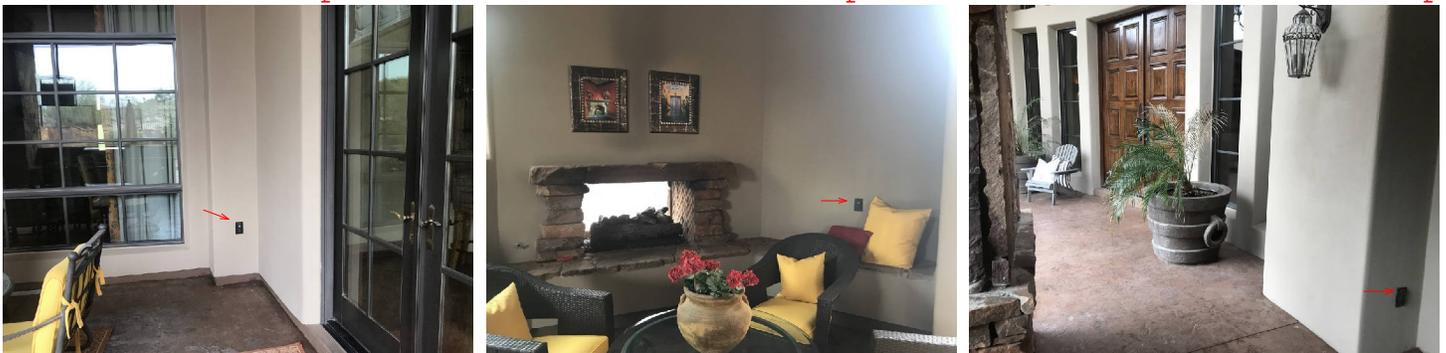
40. GFCI's Issue The GFCI outlet tested no power and will not reset at the rear patio. The GFCI does not respond to the test button at the outdoor entertainment area. The GFCI outlet does not respond to the test button or inspectors test button at the front patio.

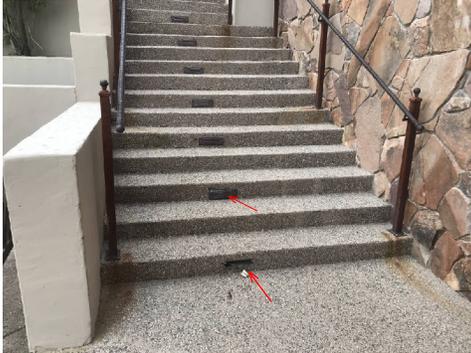
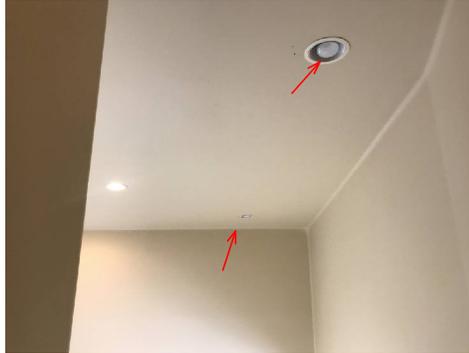
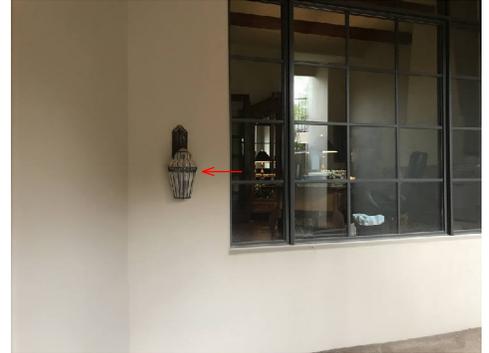
- 41. Lights Issue** The lights are missing/damaged in the exterior stairs in multiple places. Light/Lights did not respond to a switch in multiple places on the interior and exterior.

12. New sink fixture installed in outside kitchen
13. Bedroom fuse replaced.
14. Replaced bulbs in house and outdoor fixtures.
15. Blower and "lo" notice on spa to be addressed and fixed on Monday Feb. 25.

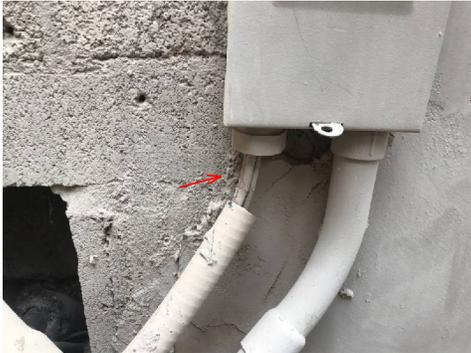
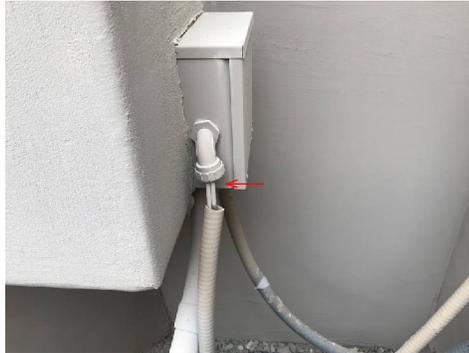
- 42. Conduit Issue** The conduit is not properly connected exposing the wiring at the electrical disconnect for the heat pump on the east and west side of the house.

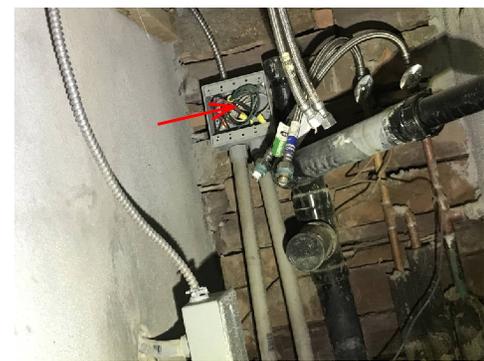
- 43. Junction Boxes Issue** There is a junction box missing the cover exposing the wiring below the sink at the outdoor kitchen.

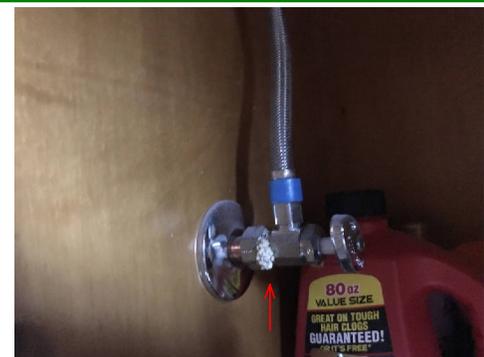
- 44. Supply Line Shut Off Valves .. Issue** There is corrosion on the shut off valves in multiple places throughout the house.

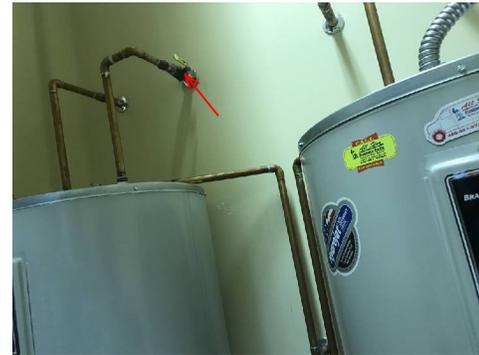
45. Water shut-off valve Issue There is corrosion on the shut off valve of the left water heater.

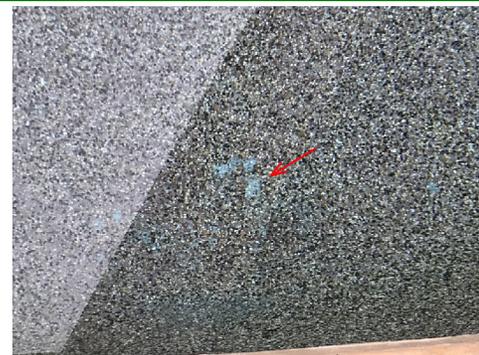
48. Pool/Spa Finish Materials Pebble Surface The pebble surface is stained.

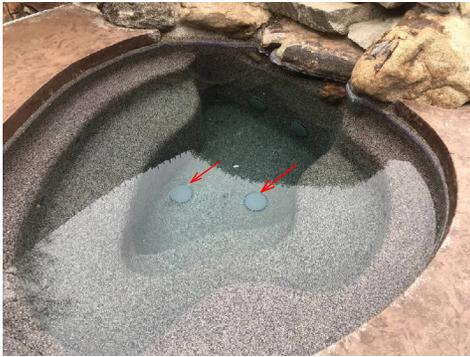
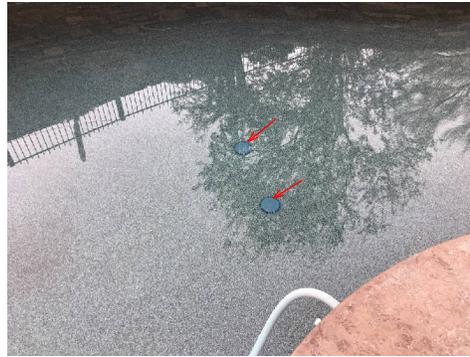
50. Bottom Drain Resistant Strainers Issue I am unable to determine if the main drain covers are child resistant.

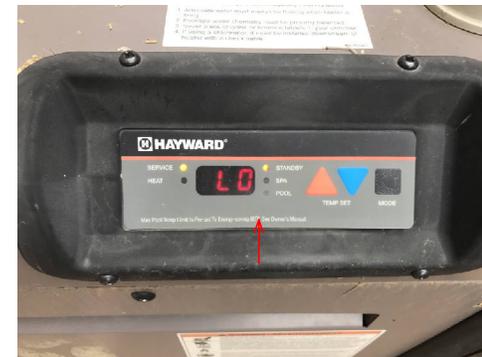
51. Heater Condition Issue Heater functions but there is a service lamp illuminated and an error message LO.

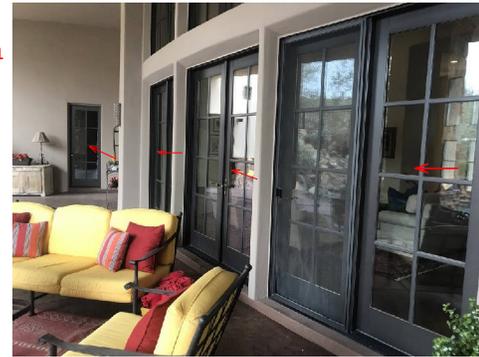
54. Doors with Pool Access Issue The doors across the back of the house have pool access and are not self-closing/latching with a latch 54" above the floor..

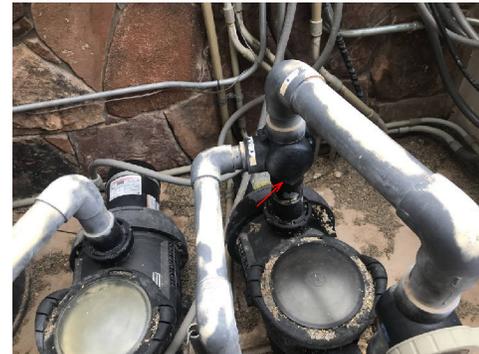
55. Water Feature .. Issue The water feature pump plumbing leaks.
