**Perfection Home Inspections**  
**Mesa, AZ 85203**  
**602-524-2916**  
**perfectionhomeinspections.com**

Inspected By:  
**Greg Oswalt Arizona Lic. 38752**

**Trust, M. T.**  
**2357 W. El Moro**  
**Mesa, AZ 85202**

# Inspection Summary

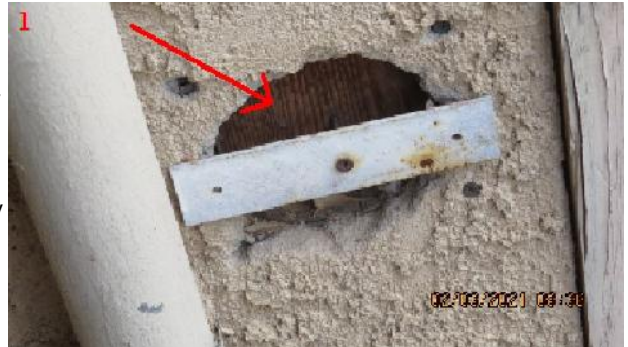
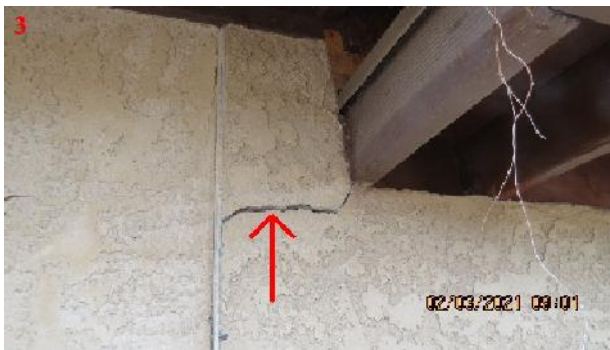
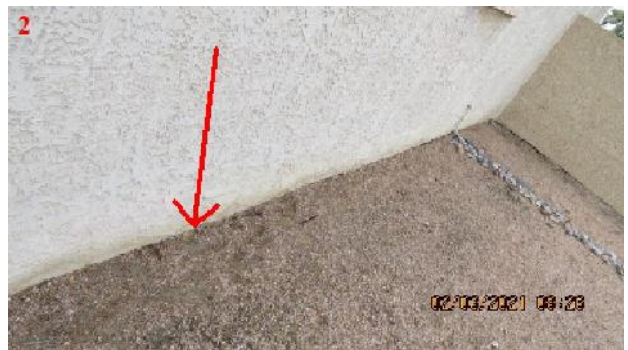
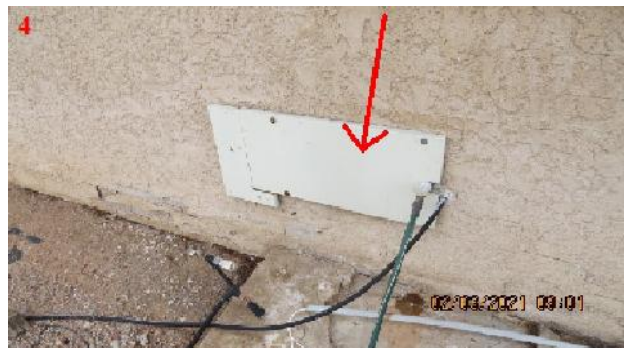
Recommend a minimum of a 4 inch gap between the bottom of the stucco and the finished grade and a minimum of 2 inches above the cement. Stucco need to be able to drain moisture out of the walls through the bottom of the stucco and termites and other pests may enter the home undetected if this distance is not maintained.

Running stucco to the ground is a common practice for masonry homes in this area. Stucco should not go to the ground for framed wall construction.

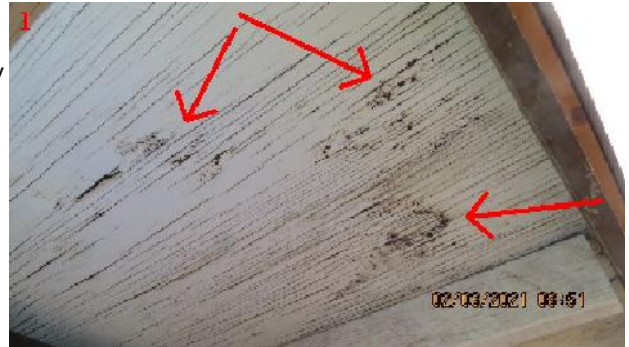
### **Service/Repair** Soffit\Eaves\Fascia - Wood

Water damage to the soffit in front of the shed addition on the east side.  
Recommend a qualified contractor evaluate and make all necessary repairs.

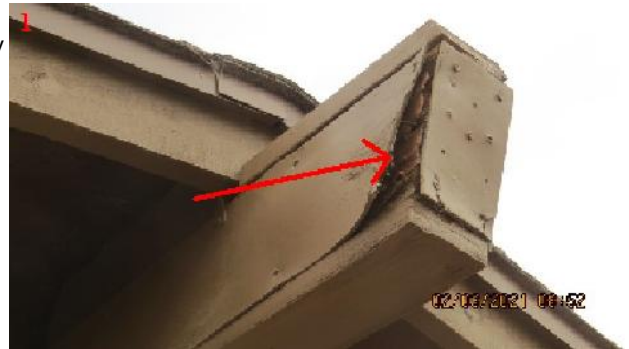
### **Service/Repair** Flashings and Trim - Wood/Imitation Wood

Wood rot in a beam in the front of the home.  
Recommend a qualified contractor evaluate and make all necessary repairs.

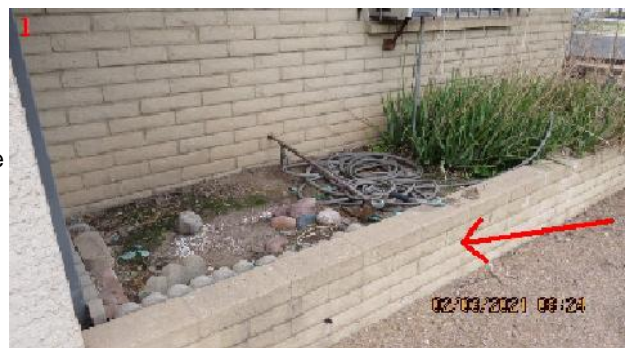
Planters installed next to the house hold water against the house foundation and sometimes raise the soil level above the house slab level. Recommend finding a way to drain water from this area to help protect the house foundation. When soil is against the house and above the house slab water and pests like termites may enter the home undetected. Recommend keeping planters away from the house foundation.

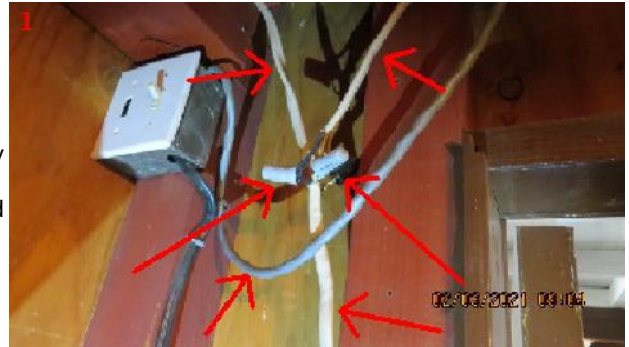
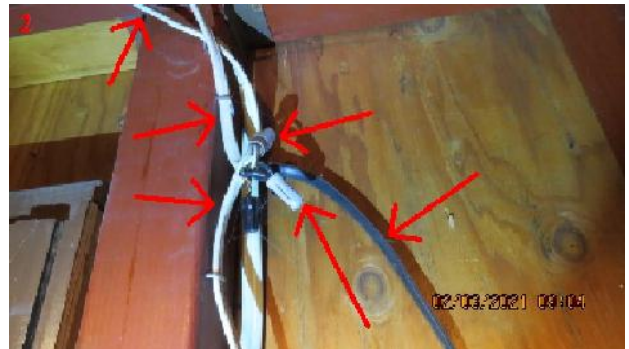
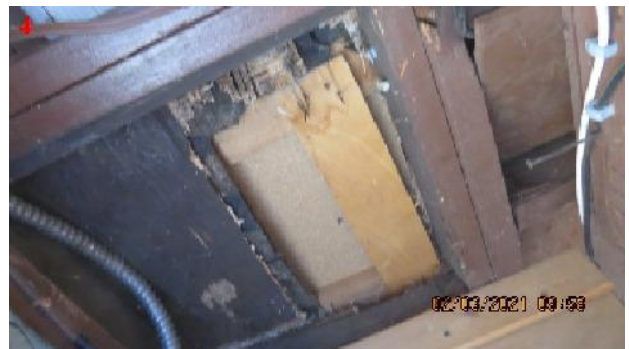
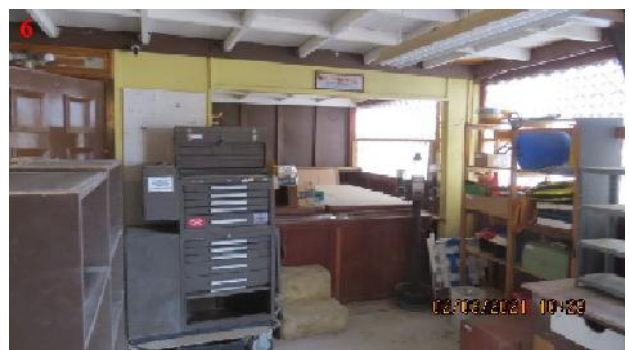
Lots of stuff stored in the shed area. Stored stuff blocks access and ability to view parts of the home;

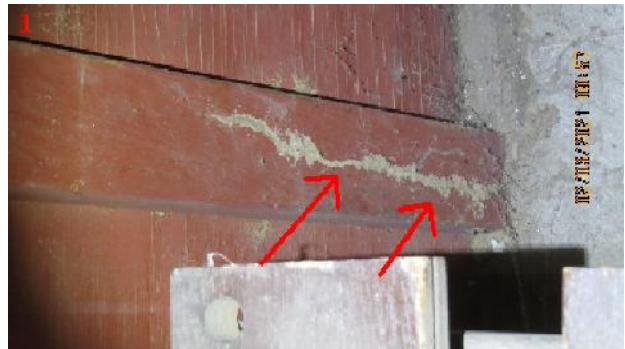
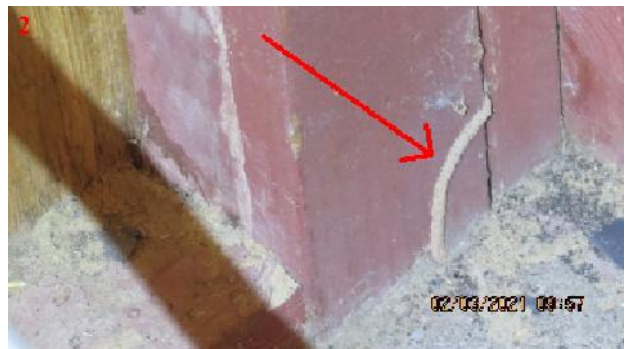
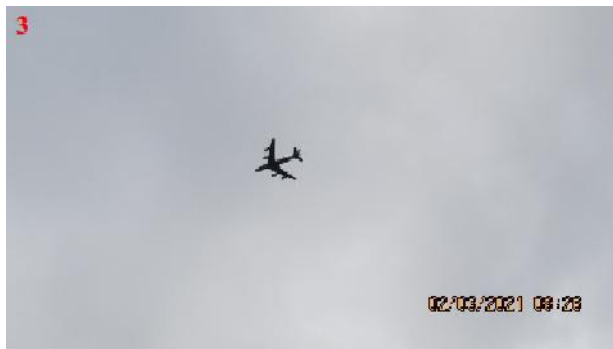
### Service/Repair Other - Termite Tubes, Airplane

An aircraft flew over the property during the home inspection. This property appears to be in a flight path. Recommend further investigation.

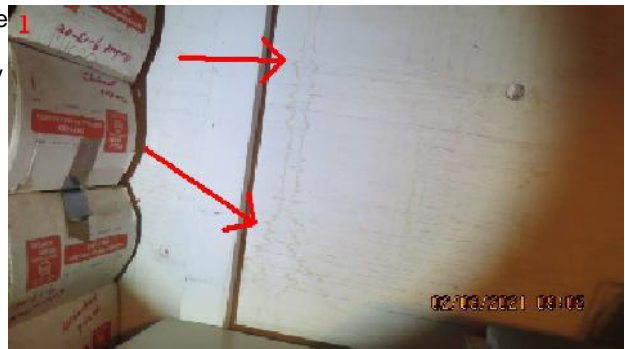
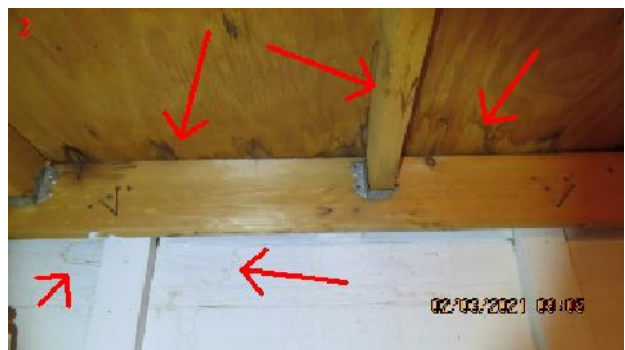
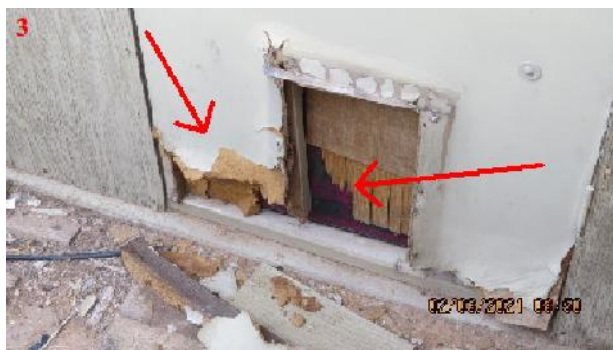
Water stains on the walls and ceiling in the attached shed area. The shed door to the exterior is damaged. Recommend a qualified contractor evaluate and make all necessary repairs.

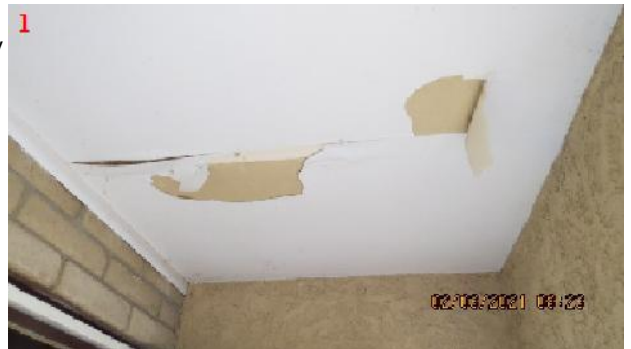
Damaged drywall on the front porch ceiling.  
Recommend a qualified contractor evaluate and make all necessary repairs.

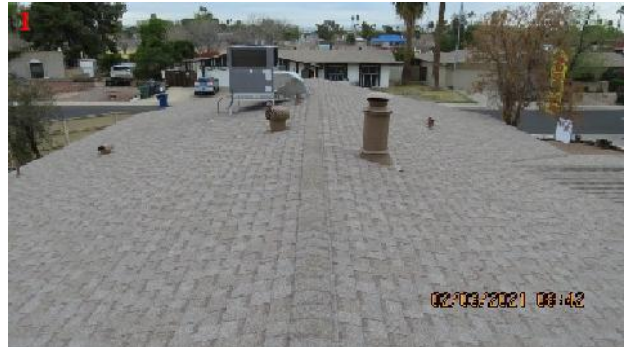
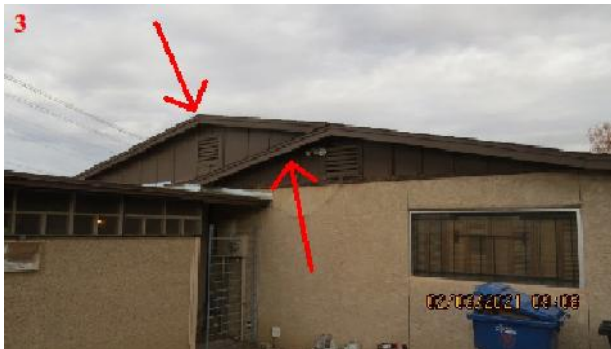
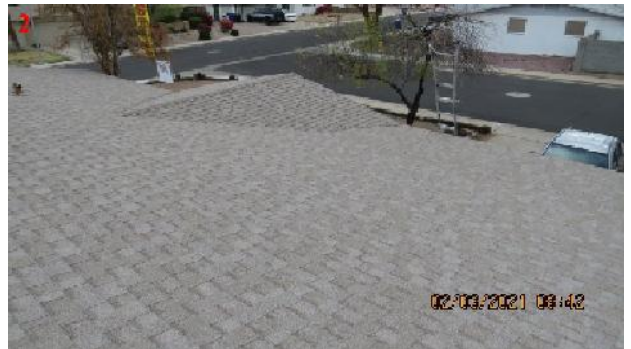
See sample picture of the roof. A roof has been installed over another roof for the addition area off the kitchen.

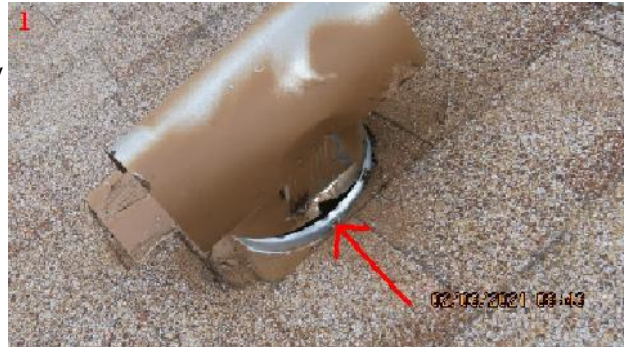
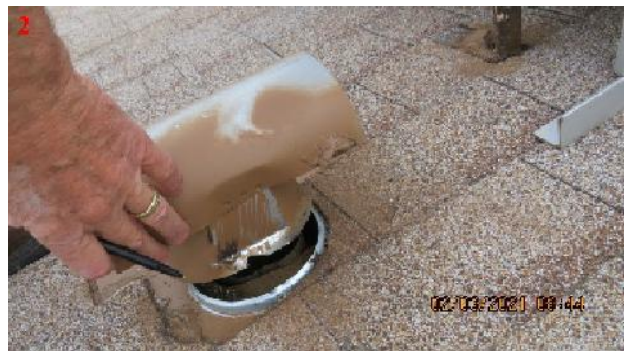
The visible roof flashings were inspected. Roof flashing next to the heat pump is damage and will cause a leak. Recommend a qualified contractor evaluate and make all necessary repairs.

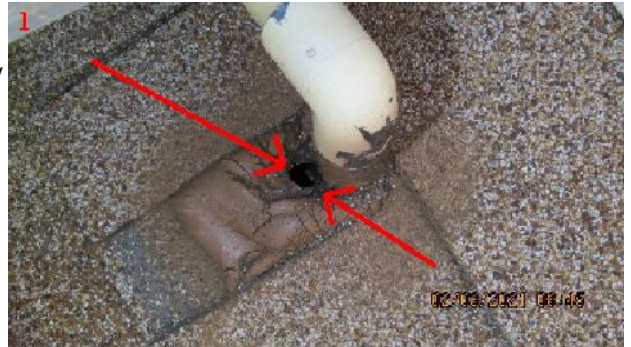
There is a hole in the roof at the AC condensation drain line. This will allow water to enter the attic. Recommend a qualified contractor evaluate and make all necessary corrections.

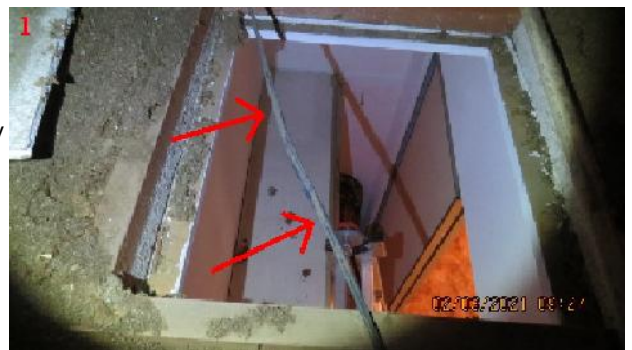
Romex type wires installed too close to the attic hatch are not properly protected.  
Romex type wires should not be installed within 6 feet of an attic hatch without being properly protected.  
Recommend a qualified contractor evaluate and make all necessary repairs.

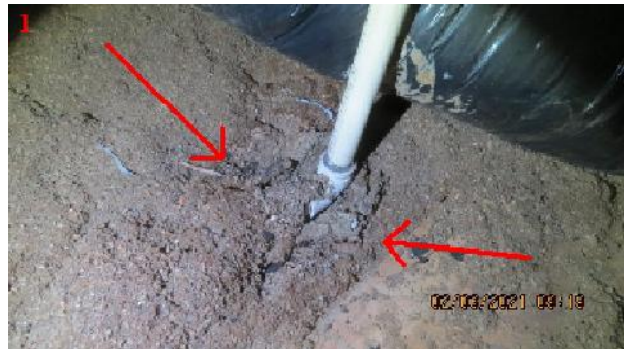
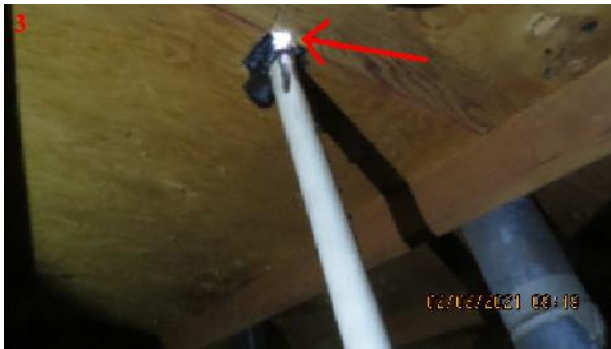
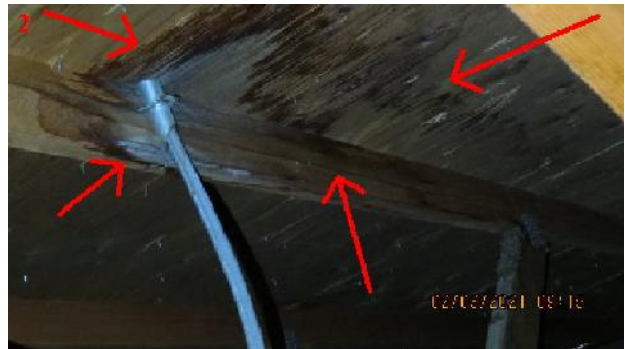
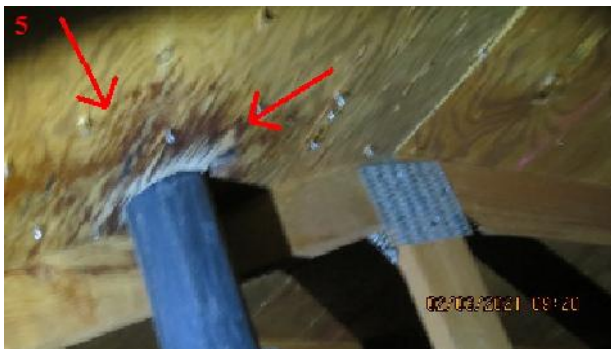
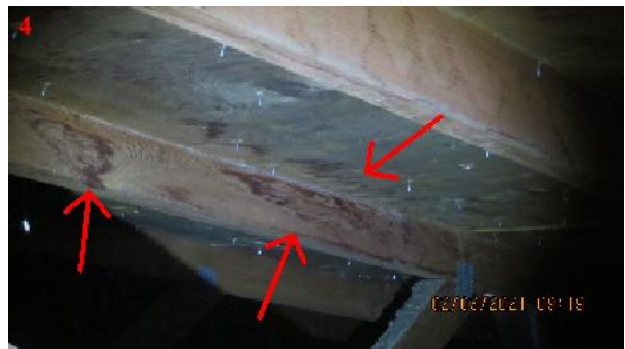
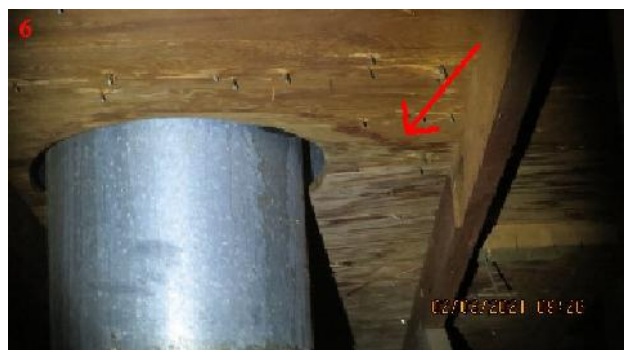
### Attic Leaks

Signs of prior roof leaks in attic. Sheathing has water stains in several areas. Recommend asking seller if this problem has been solved and if not recommend a qualified roofing contractor evaluate and make all necessary repairs. See picture

Signs of prior leaks found around waste vent pipes in the attic. Recommend sealing around all vent pipes on the roof and monitoring for leaks. See picture

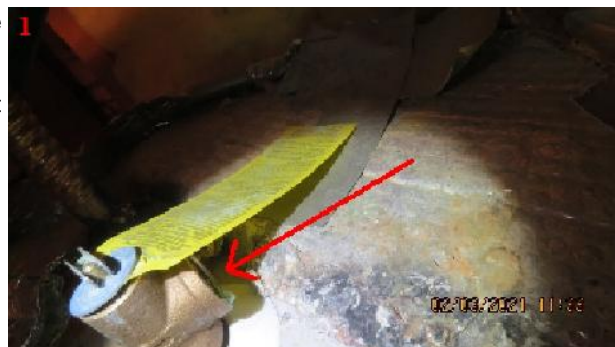
Recommend the water heater temperature and pressure relief valve have a pipe extended from the valve a maximum of 24 inches to a minimum of 6 inches above the floor, and point straight down it should not terminate in the pan under the water heater. The current arrangement is a safety issue. Scalding steam can unexpectedly blow out the end of this pipe and the chances of someone getting burned increases the further the pipe gets above the ground. The water heater temperature pressure relief valve was not operated unless other wise noted in this section of the report.

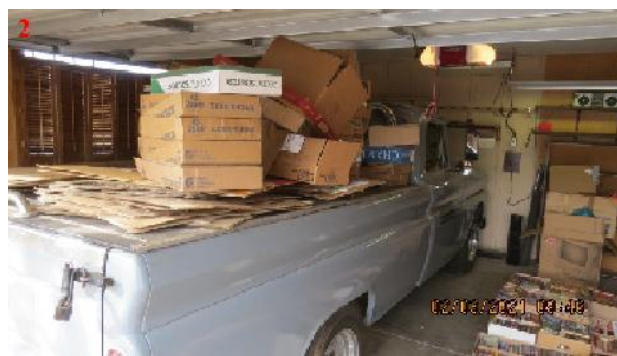
Stuff in the garage blocks view of the interior of the garage.  
Recommend inspecting garage area after the stuff is removed.

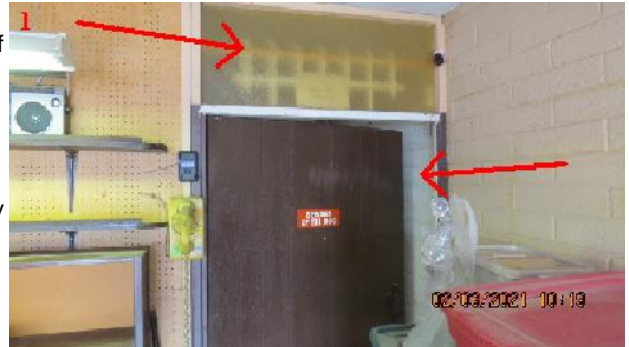
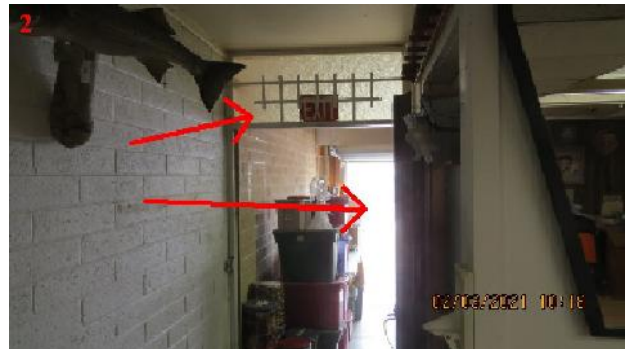
No automatic closure on the door from the garage to the house. This door acts as a fire stop and helps keep carbon monoxide out of the house. Recommend installing auto door closures. This is an indication the garage is on an older home and or permits may not have been obtained to add this garage. Recommend a qualified contractor evaluate and make all necessary repairs. The plastic window above the door is not fire rated. Recommend a qualified contractor evaluate and make all necessary repairs.

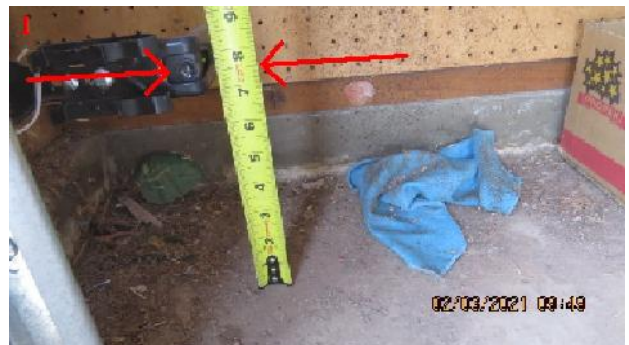
The electronic eye sensor beam used to stop the automatic garage door from closing if something is in its path is more than the recommended height of 6 inches above the garage floor. This is a safety hazard. Recommend installing this sensor eye beam 4 to 6 inches above the garage floor.

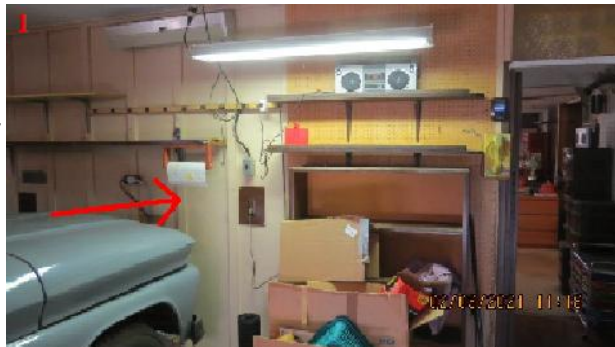
The wall between the house and the garage is covered with a wood siding. This wall should be fire rated and this siding is not fire rated. This is an indication permits may not have been obtained to convert the carport into an enclosed garage. This is a fire hazard. Recommend a qualified contractor evaluate and make all necessary repairs.

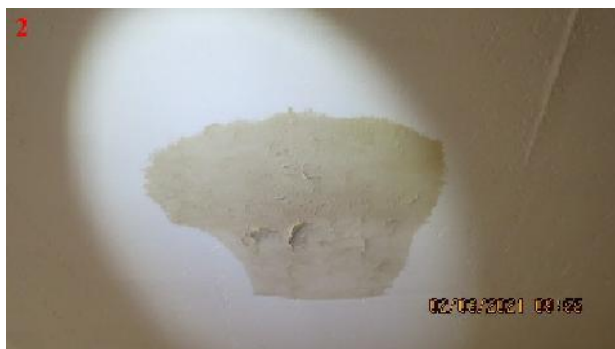
Water stains, water damage and loose drywall tape on the garage ceiling. See picture Recommend a qualified contractor evaluate and make all necessary repairs.

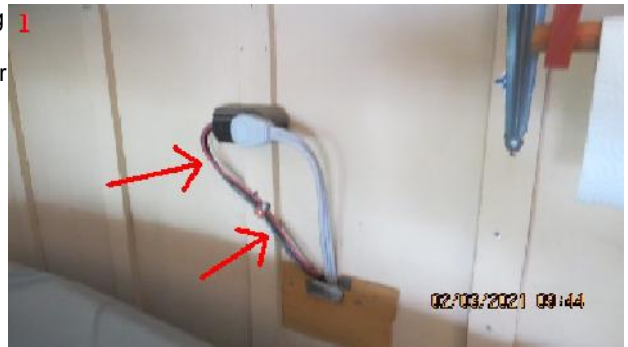
Exposed single insulated wires for the 220 volt dryer. Wires sticking into the garage area and below the shelf in the laundry. This is a shock hazard. Recommend a qualified electrical contractor evaluate and make all necessary repairs. See picture

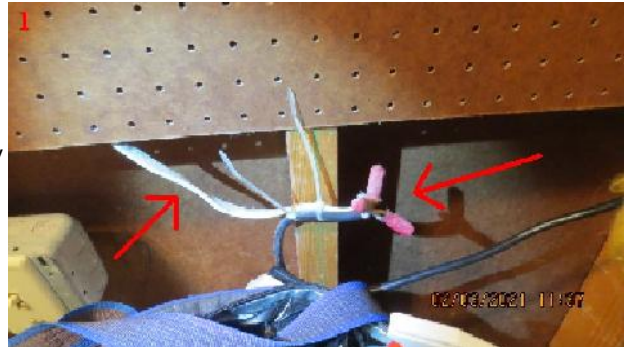
Exposed romex type wires found in the laundry room less than 7 feet above the floor. This is considered a shock hazard. Recommend all exposed romex less than 7 feet above the floor be properly protected.  
Exposed spliced wires with wire nuts.  
Recommend a qualified contractor evaluate and make all necessary repairs.

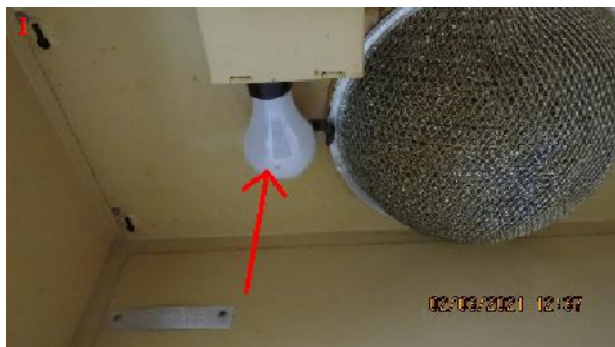
The light bulb cover for the stove hood is missing. This may allow steam from the stove top to explode the light bulbs. Recommend installing missing bulb cover. See picture

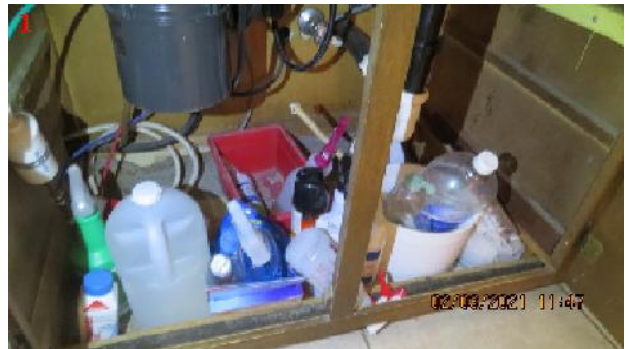
The base of the kitchen sink cabinet is missing. Recommend installing base of cabinet.

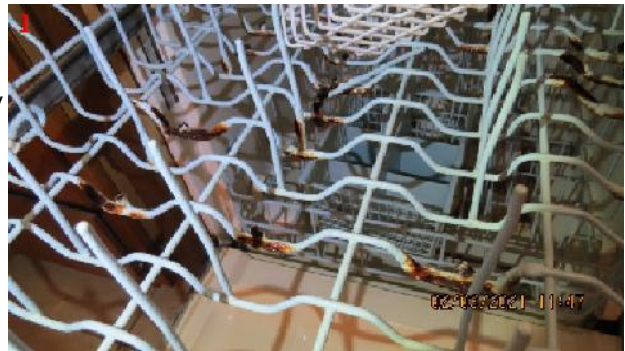
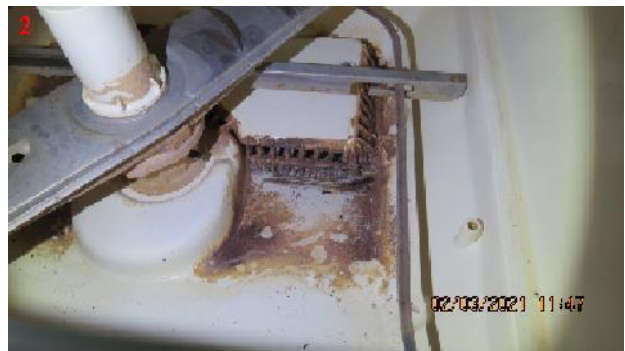
The dish rack in the dishwasher is rusted. Recommend replacing the rusted rack. Water does not drain all the way out of the bottom of the dishwasher making a blob of stuff at the bottom. Recommend a qualified contractor evaluate and make all necessary repairs.

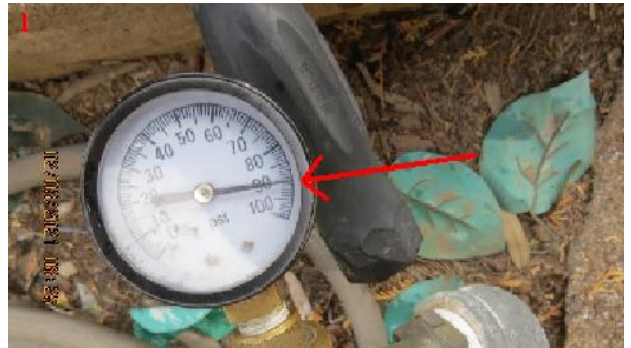
A water pressure regulator is recommended for homes with water pressure in excess of 80 psi.

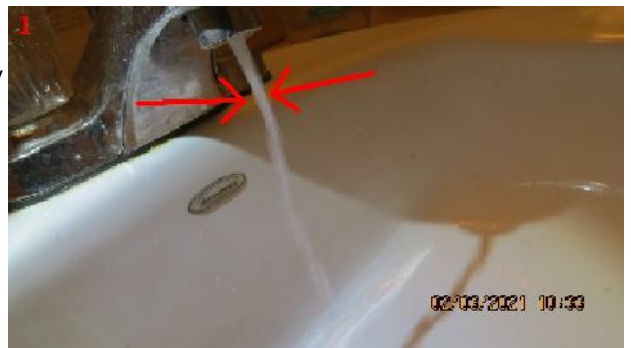
Poor water flow from the sink faucet. The aerator may be partly clogged.  
Recommend a qualified contractor evaluate and make all necessary repairs.

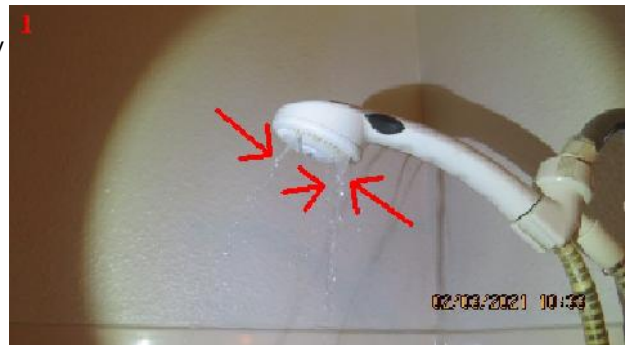
Poor water flow to the master bathroom shower.  
Recommend a qualified contractor evaluate and make all necessary repairs.

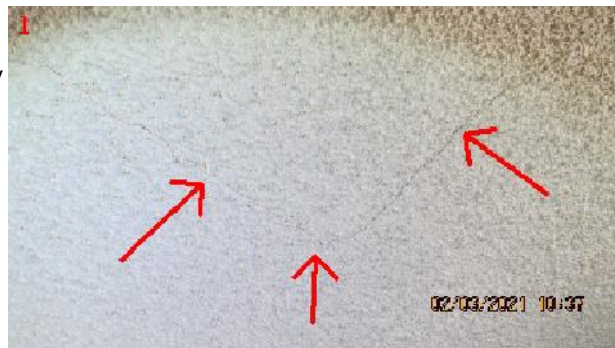
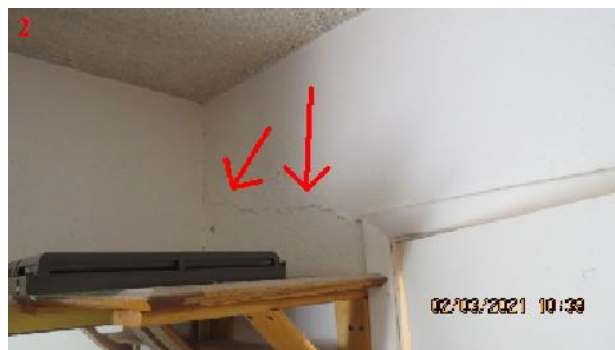
There is a crack in the master bedroom ceiling and on the wall by the closet.  
Recommend a qualified contractor evaluate and make all necessary repairs.

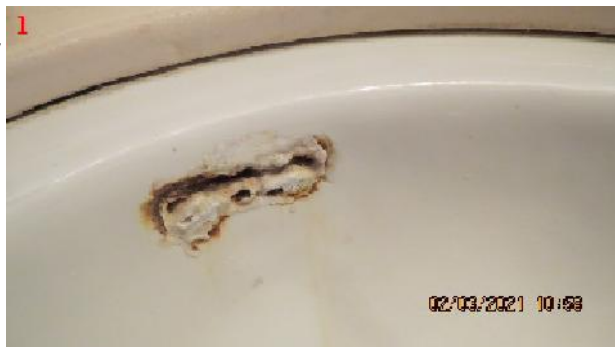
Sink rusted at overflow. See picture  
Recommend a qualified contractor evaluate and make all necessary repairs.

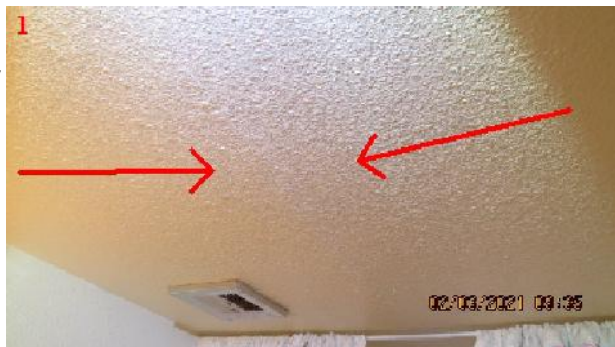
The hall bathroom ceiling is bowed down with a crack running down the center.  
Recommend a qualified contractor evaluate and make all necessary repairs.

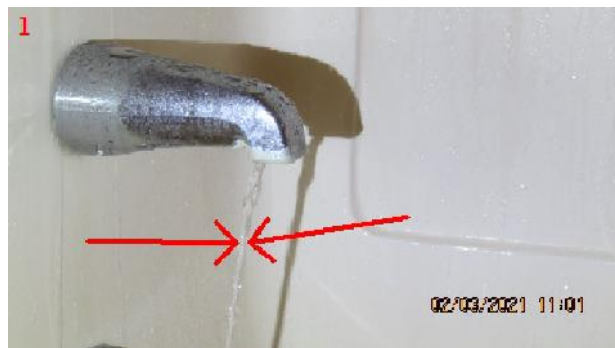
The diverter valve in this shower is defective. Water does not shut off to tub when the shower is running. Recommend replacing shower diverter valve.

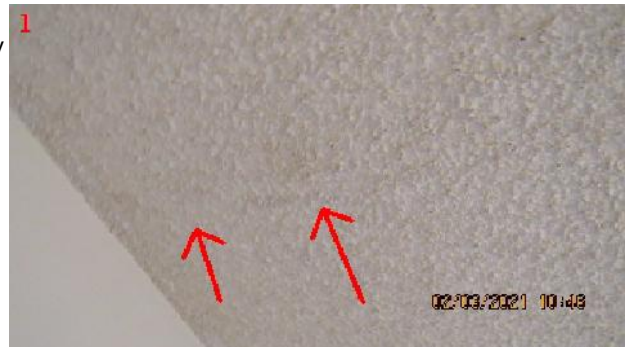
Water stain on the ceiling in front of the closet.  
Recommend a qualified contractor evaluate and make all necessary repairs.

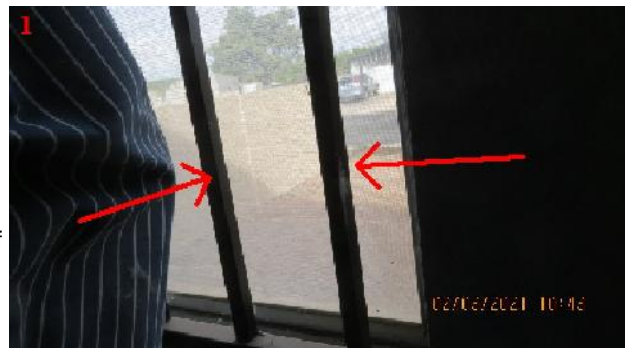
Bars installed on window with or without a quick release are a fire escape hazard. Recommend removing bars from window before sleeping in room. Bars on windows are a fire escape hazard even if they have a quick disconnect. How can a fireman enter if no one opens the bars??

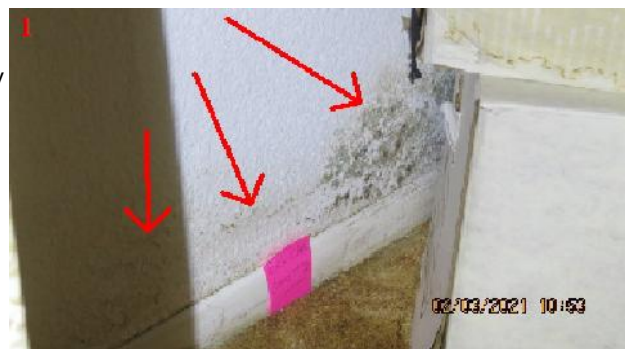
Water damage and a black colored substance on the wall in the closet. Recommend checking for mold. Recommend a qualified contractor evaluate and make all necessary repairs.

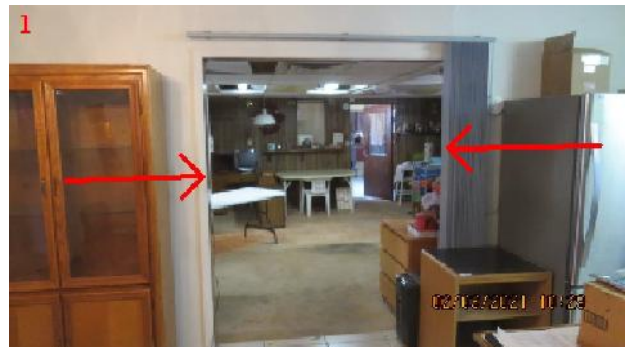
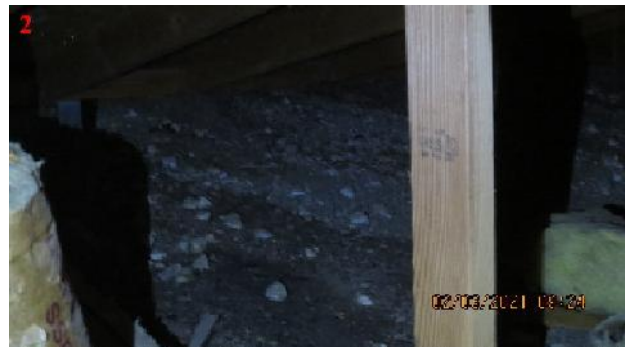
This room is the addition room. Looks like this room was a patio and is now converted to possible living space but there the fire barrier between this room and the garage does not meet current standards and the ceiling looks like it was attached to the laundry room fascia and or rafters. The Main house stops at the kitchen. Looks like a sliding glass door was removed from the kitchen to incorporate the patio as part of the home. Recommend verifying proper permits were obtained and signed off for this addition. A roof has been installed over part of the laundry room roof and extended to the back of the home. This make an odd looking double roof in the back.

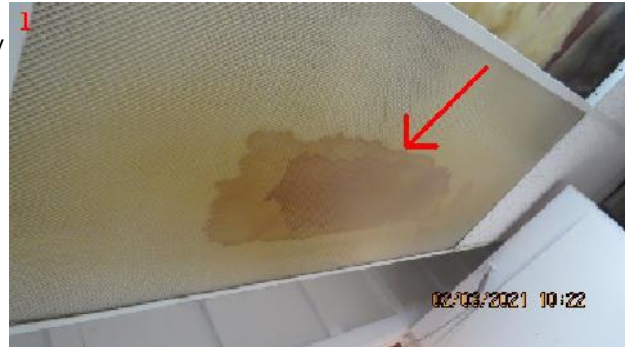
Water stains in a light fixture in the addition area.  
Recommend a qualified contractor evaluate and make all necessary repairs.
