Perfection Home Inspections
Mesa, AZ 85203
602-524-2916
perfectionhomeinspections.com

Client Information: Record Number 8613

Sturgeon, Melanie
1211 S. Barkley
Mesa, AZ 85204
480-881-6717

Inspected 7/24/21 8:00 AM
Built 1980
1688 sf

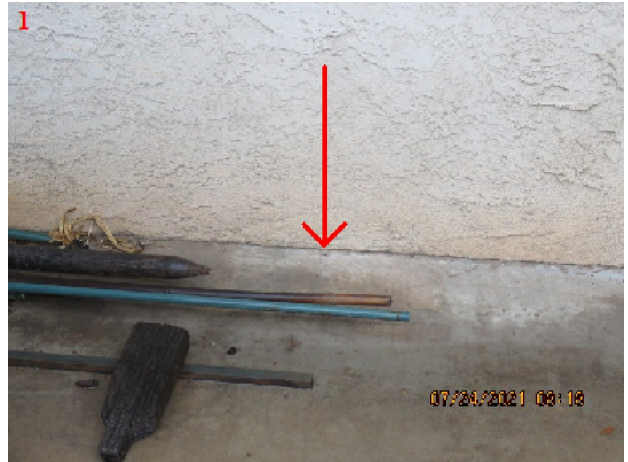
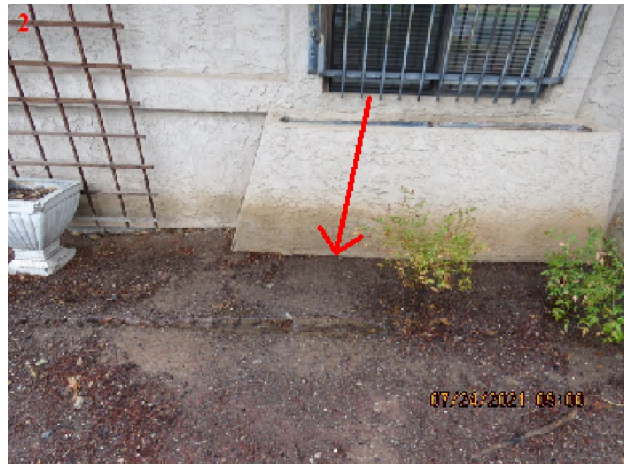
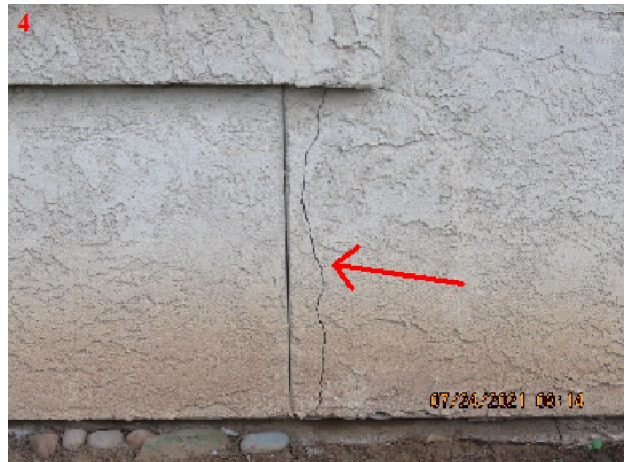
Crack in the stucco. Recommend repair.

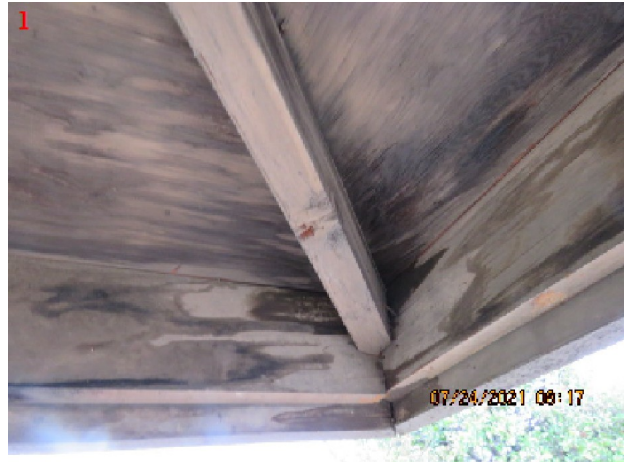
Lots of water stains in the soffit area around the home but no signs of an active leak at this time.

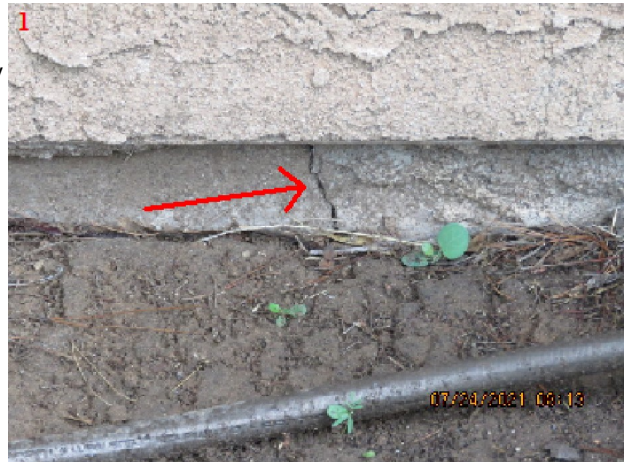
There is a crack in the house foundation on the side of bedroom three.
Recommend a qualified contractor evaluate and make all necessary repairs.

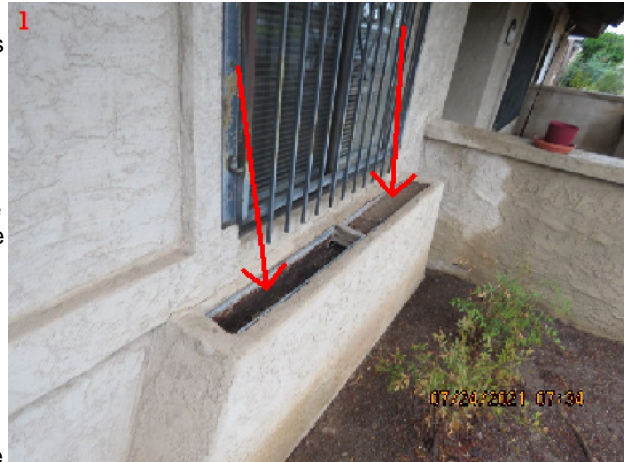
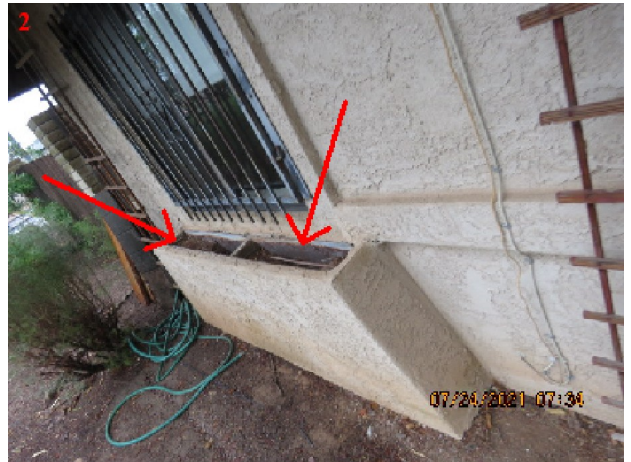
Planters installed next to the house hold water against the house foundation and sometimes raise the soil level above the house slab level. Recommend finding a way to drain water from this area to help protect the house foundation. When soil is against the house and above the house slab water and pests like termites may enter the home undetected. Recommend keeping planters away from the house foundation.

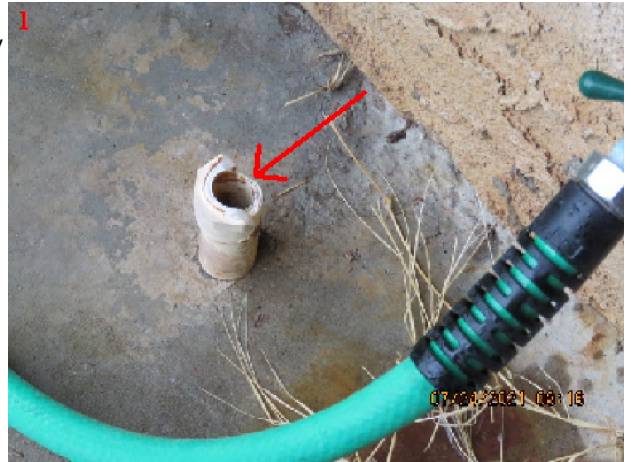
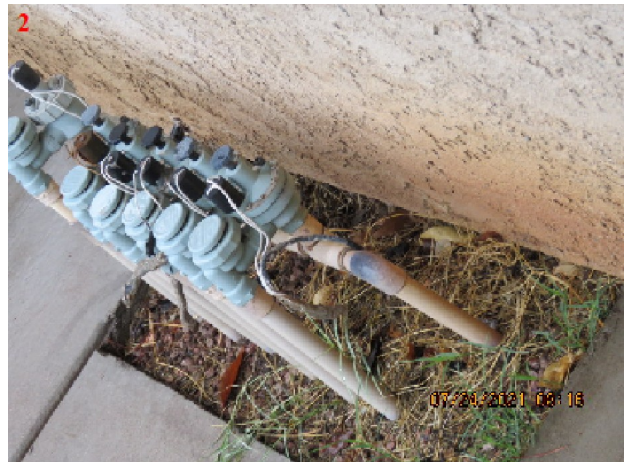
The water line to the sprinkler system in the back has been cut. Recommend a qualified contractor evaluate and make all necessary repairs.

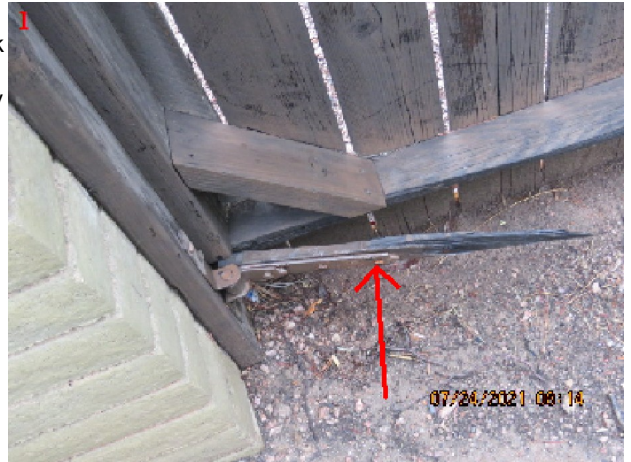
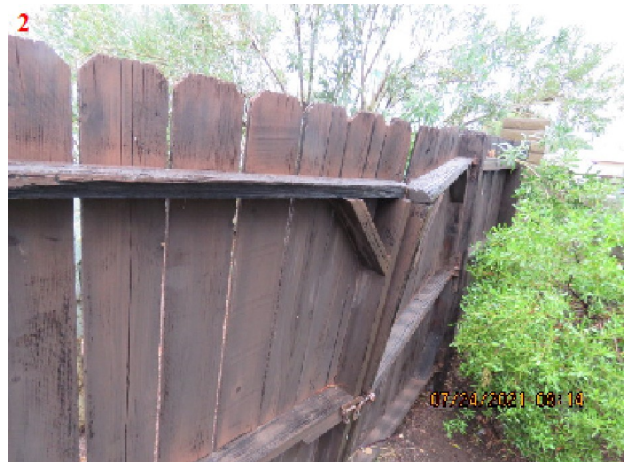
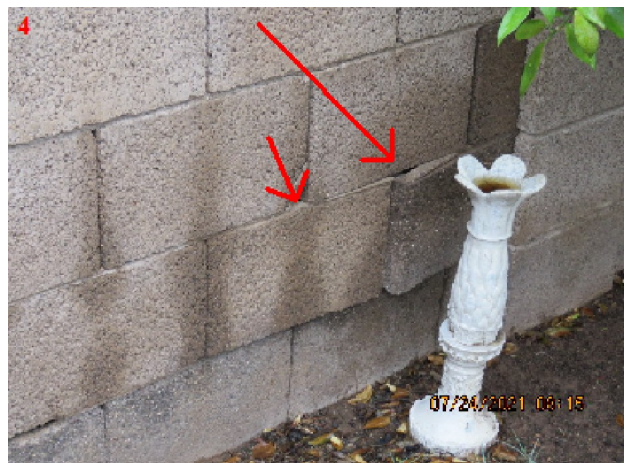
Service/Repair Yard Fences - Masonry, Wood

The fence gate in the front is falling over. There is a fence gate in the side yard to the neighbors back yard. Damage block in the back fence wall. Recommend a qualified contractor evaluate and make all necessary repairs.

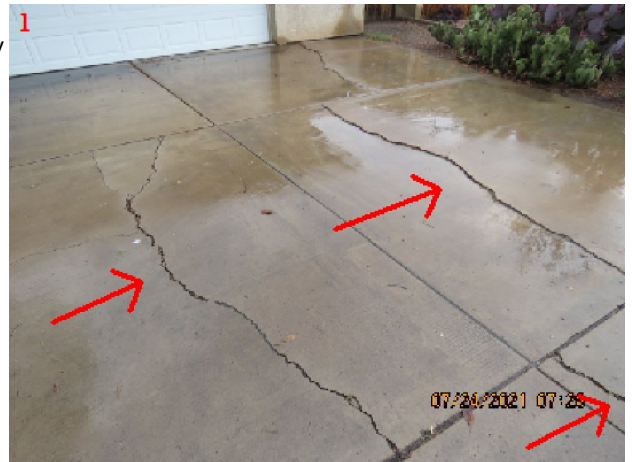
Lots of large cracks in driveway.
Recommend a qualified contractor evaluate and make all necessary repairs.

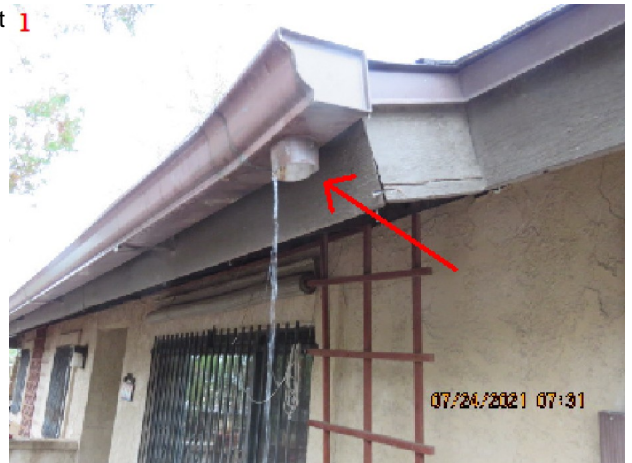
Gutter down spouts are missing. Recommend installing down spout and directing all roof water away from the house foundation.

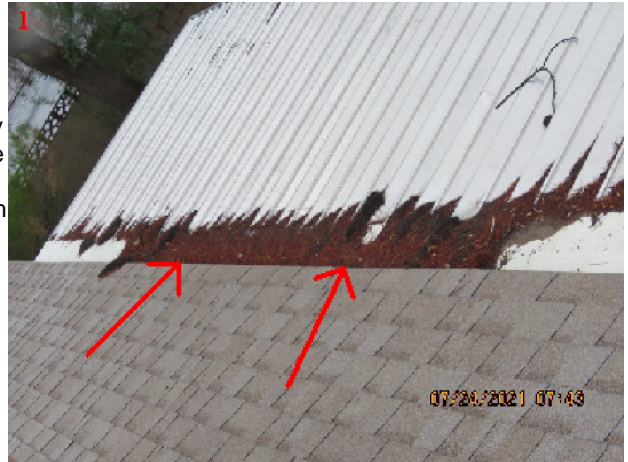
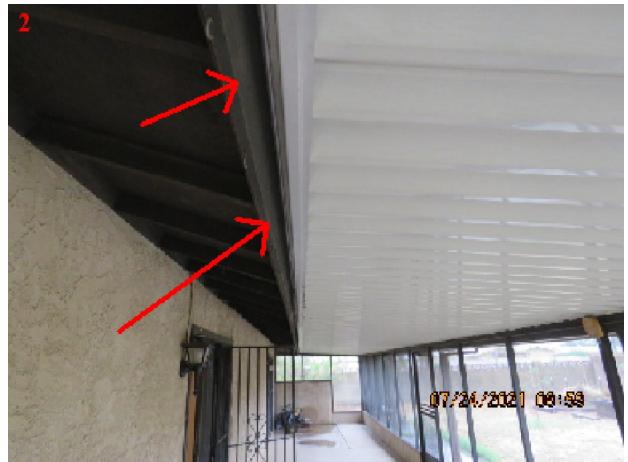
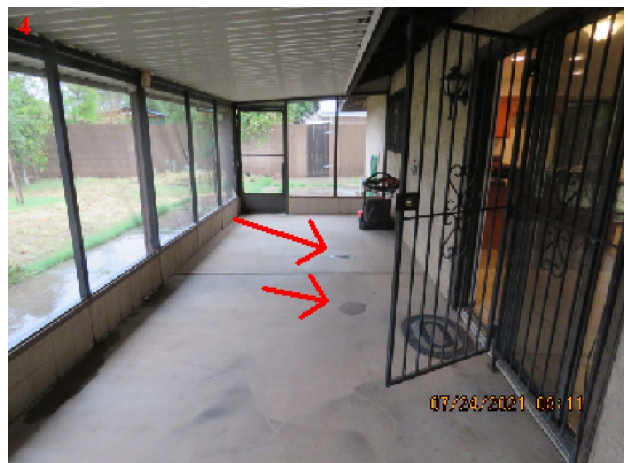
The back patio roof has been attached to the fascia wood. This is a good indication the patio addition was installed without a permit. Water leaking between the patio roof and the house room in the patio area. Recommend a qualified contractor evaluate and make all necessary repairs. Recommend asking the seller for permits obtained from the city to install the patio roof. Debris on the back patio roof. Recommend removing all debris from the roof.

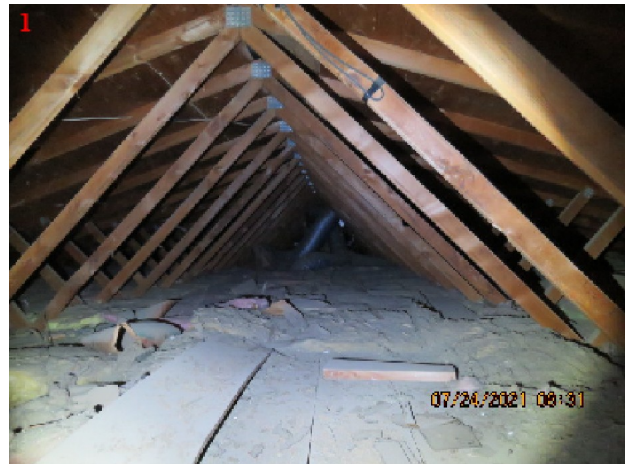
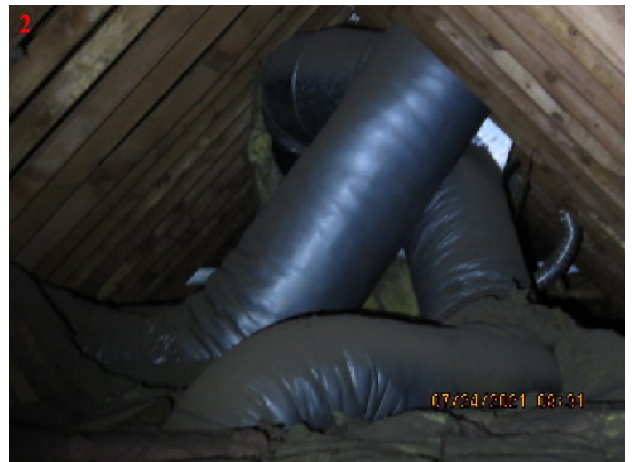
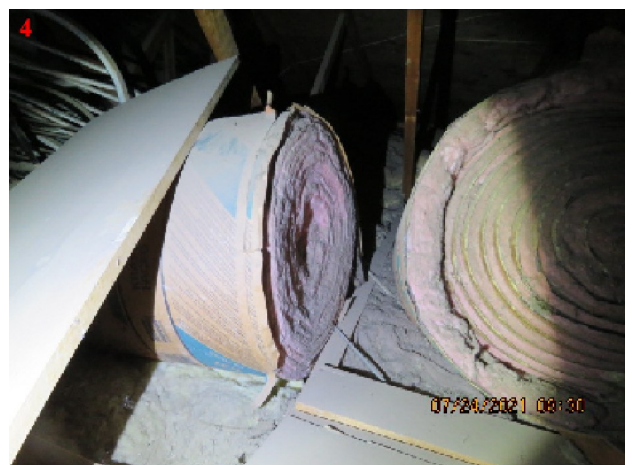
Sample attic picture. Stuff stored in the attic. Recommend removing the stuff.

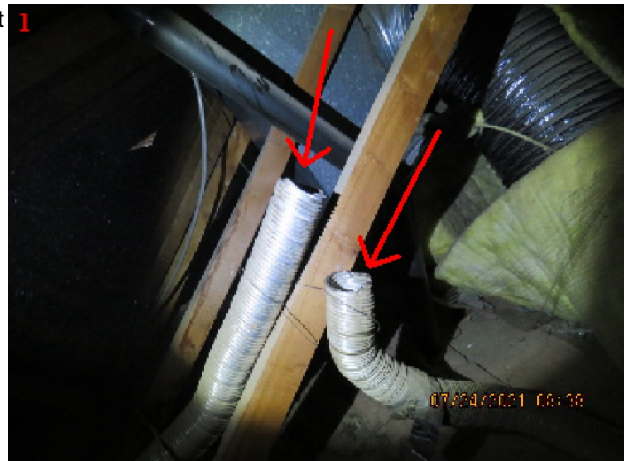
Vent pipes not properly connected to roof vent. Recommend all vent pipes be directed outside, however in the dry climate of southern Arizona venting into attics may not cause a moisture problem. See picture

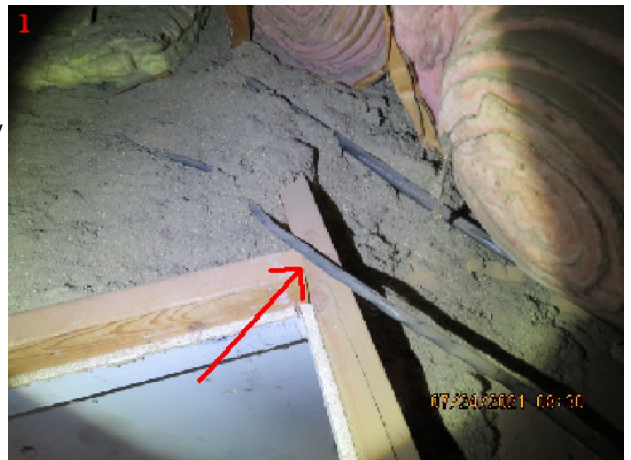
Safety Concern Attic Entry Access - Hatch, Romex Wires

Romex type wires installed too close to the attic hatch are not properly protected.
Romex type wires should not be installed within 6 feet of an attic hatch without being properly protected.
Recommend a qualified contractor evaluate and make all necessary repairs.

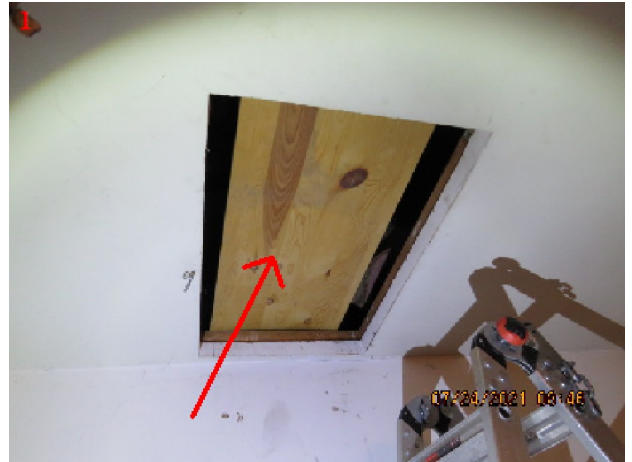
Safety Concern Attic Access Location - Garage, Not Fire Rated

Attic hatch in garage is not properly fire rated. Recommend installing fire resistant hatch as needed. Recommend a 5/8 inch thick type x drywall be used as an attic hatch cover. Some area no longer require this to be fire rated if there is no habitable space above the garage.

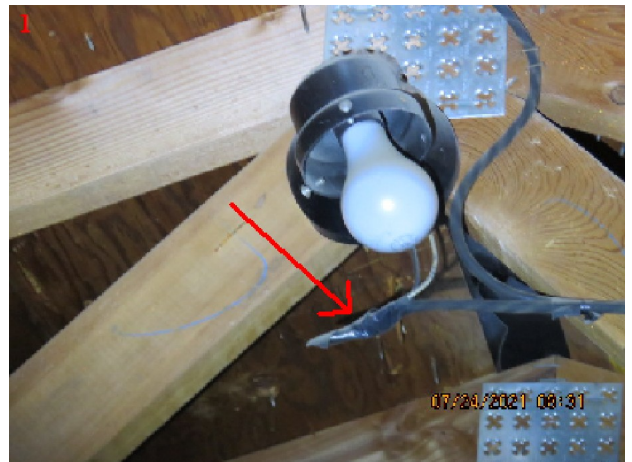
Safety Concern Attic Wiring - Spliced Wires

Spliced wires in attic not properly installed in electrical junction box. This is a shock hazard. Recommend placing all spliced wires in an electrical junction box. Recommend a qualified electrical contractor make all necessary repairs. See Picture

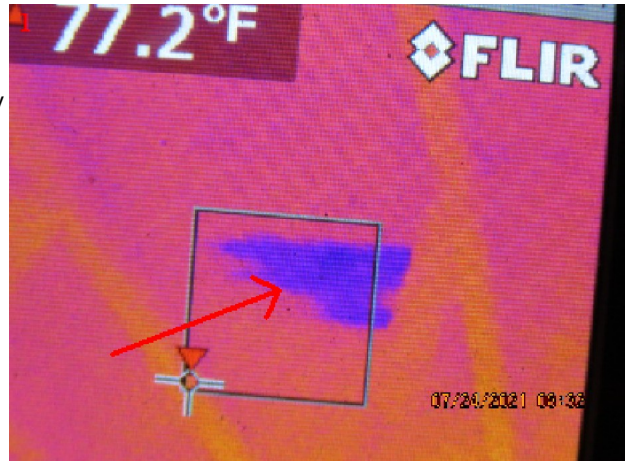
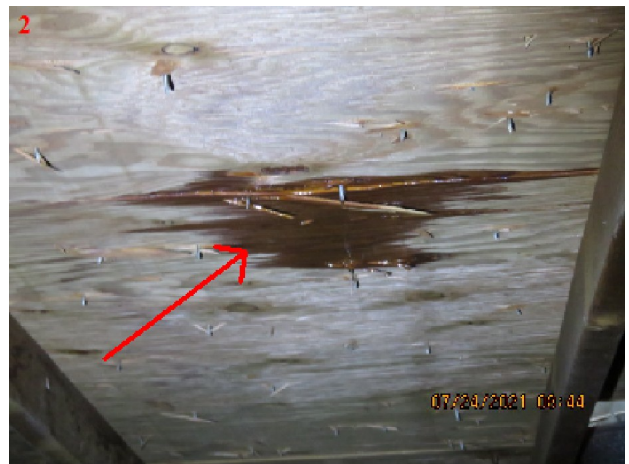
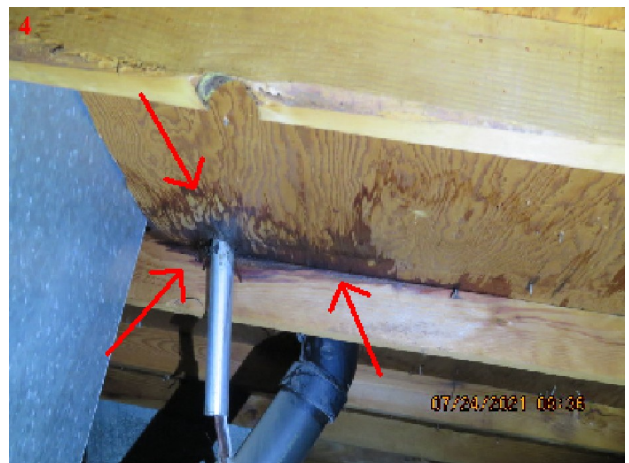
Service/Repair Attic Leaks - Sheathing

Roof leak in the attic at the AC electric line and on the sheathing near the attic hatch above the kitchen area. Sheathing has water stains in several areas. Recommend a qualified contractor evaluate and make all necessary repairs.

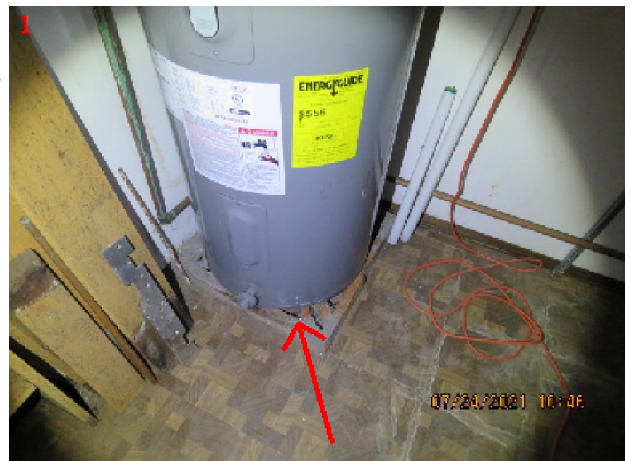
No pan installed under the water heater.
Recommend installing an overflow pan under the water heater and installing a drain line from this pan if possible to the exterior. This is normally best done when changing water heaters.

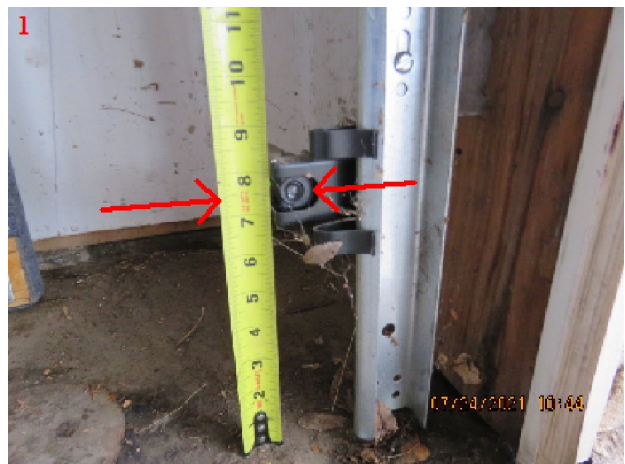
The electronic eye sensor beam used to stop the automatic garage door from closing if something is in its path is more than the recommended height of 6 inches above the garage floor. This is a safety hazard. Recommend installing this sensor eye beam 4 to 6 inches above the garage floor.

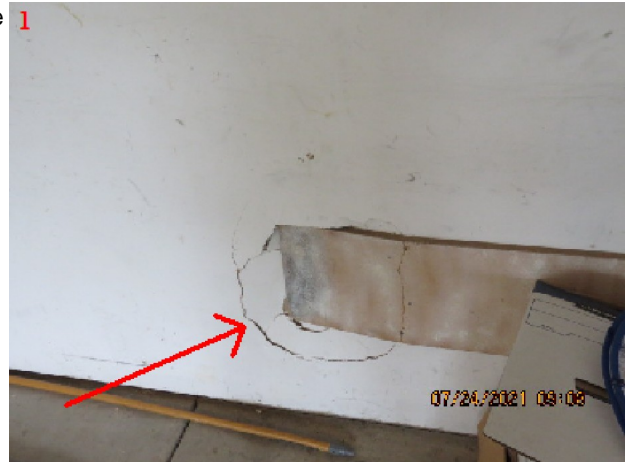
Hole or holes in the drywall on the wall or ceiling between the house and the garage. This drywall is a fire stop and a carbon monoxide stop between the house and the garage. Recommend patching all holes in the wall between the garage and the house. See picture

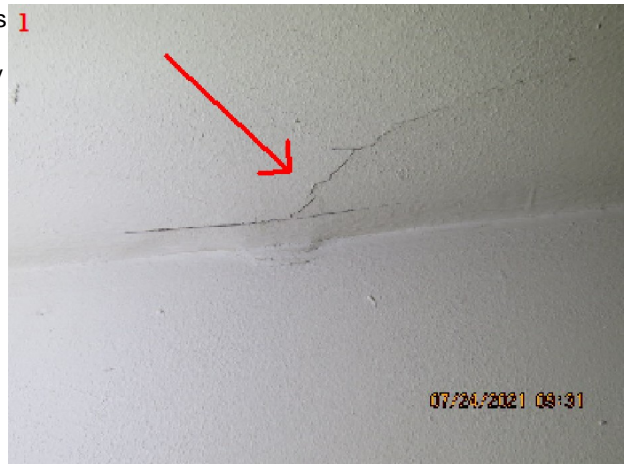
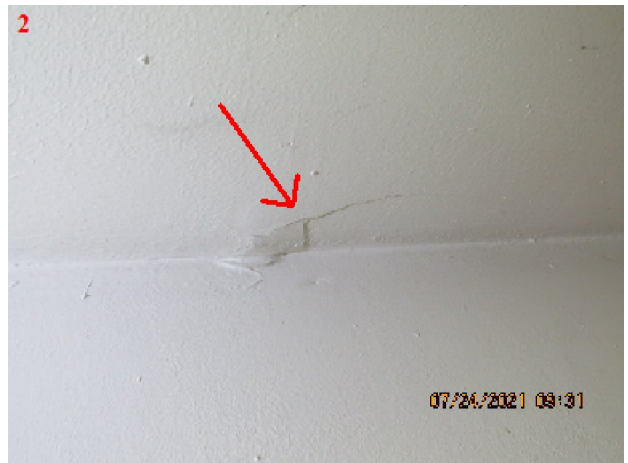
Water stains on the laundry wall at the washer hookup area. Cracks on the ceiling.
Recommend a qualified contractor evaluate and make all necessary repairs.

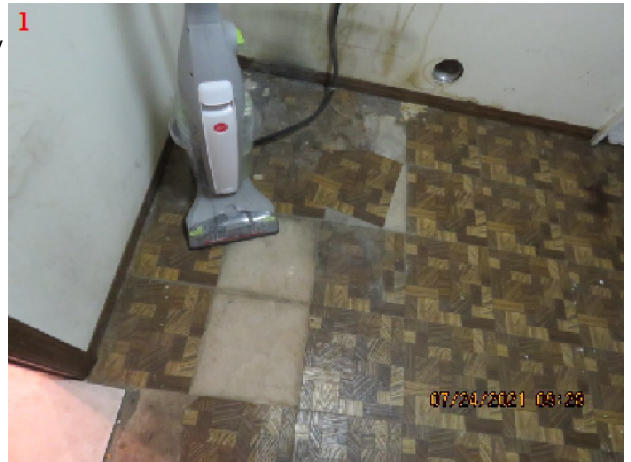
Laundry flooring loose with parts missing.
Recommend a qualified contractor evaluate and make all necessary repairs.

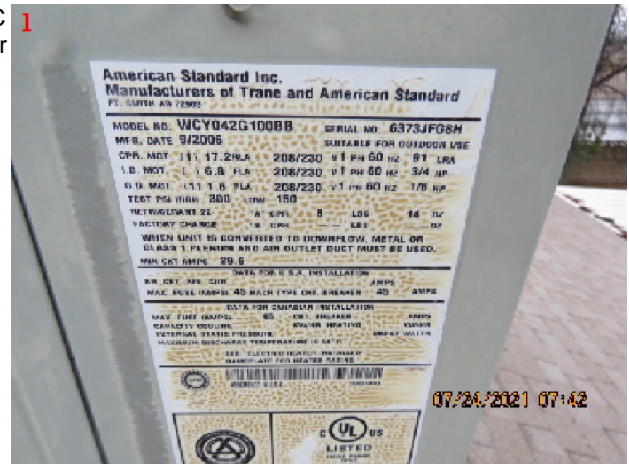
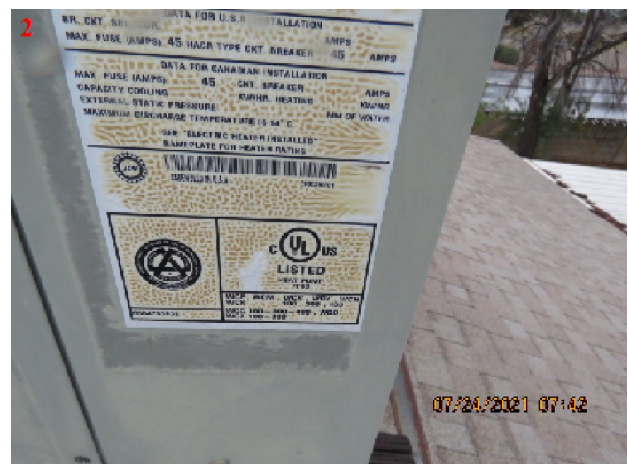
This unit looks like it is over 15 years old. The average life of an AC system in the Phoenix area is 12 to 15 years. This unit may be near the end of its useful life. Typical AC has only 50% of its initial efficiency after 20 years. So a 12 SEER would have a 6 SEER rating.

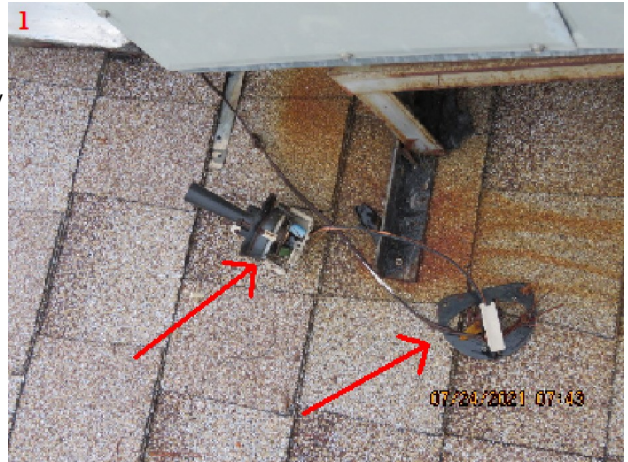
Cooling coil(s) made by Trane.
There is some electrical debris on the roof at the heat pump. Not sure what is is but is it damaged.
Recommend a qualified contractor evaluate and make all necessary repairs.

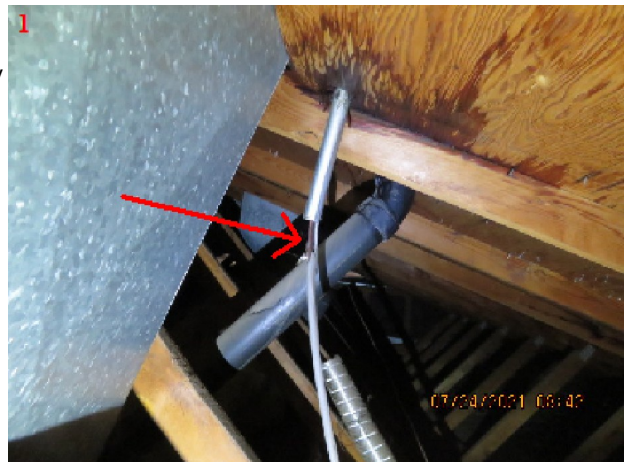
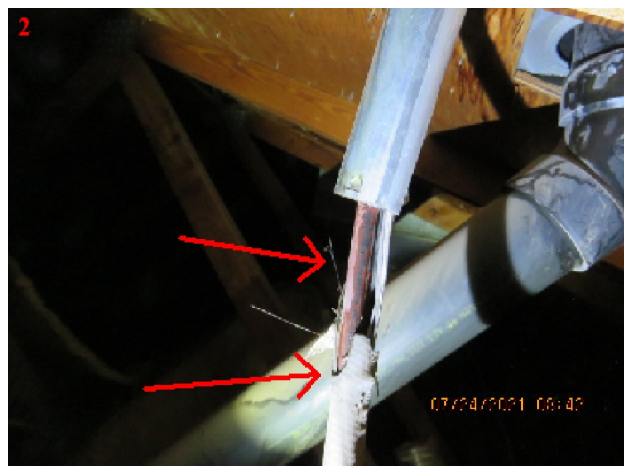
The heat pump electrical line outer layer of insulation is damaged in the attic.
Recommend a qualified contractor evaluate and make all necessary repairs.

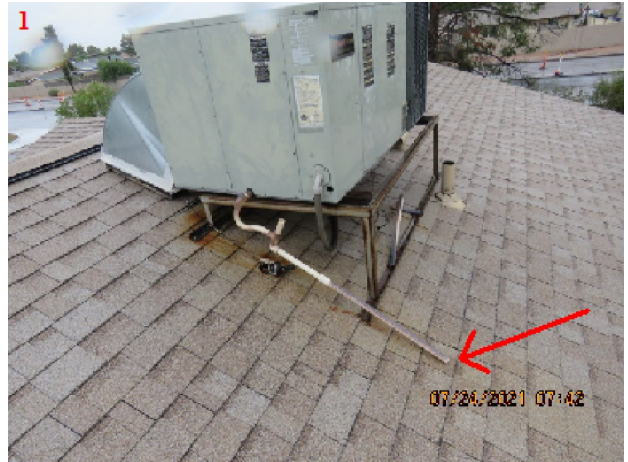
Condensate lines clogged, not properly attached or not properly extended off the roof will allow condensate water to leak onto the roof and this will cause a roof leak. Recommend properly attaching condensate line and extending off roof.

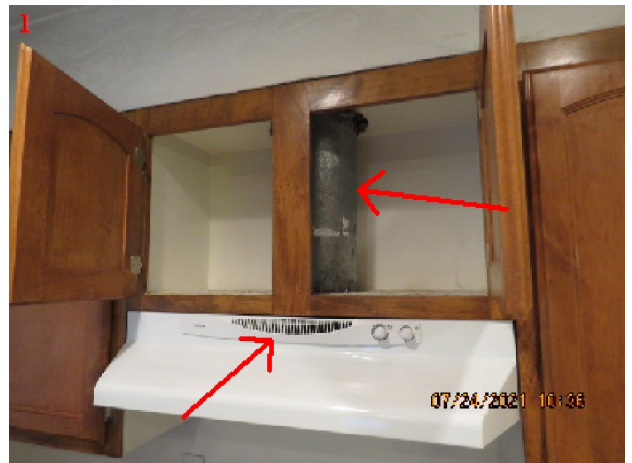
The exhaust hood has a vent pipe but it vents the air back into the kitchen through slits in the top or front of the hood. This is a ductless type hood installed with a duct. Recommend a qualified contractor evaluate and make all needed repairs.

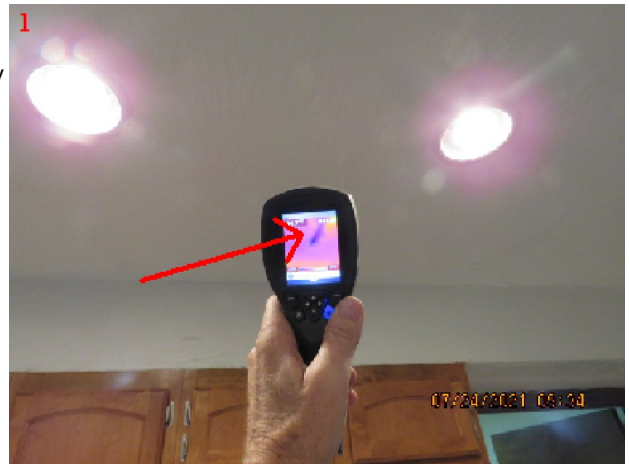
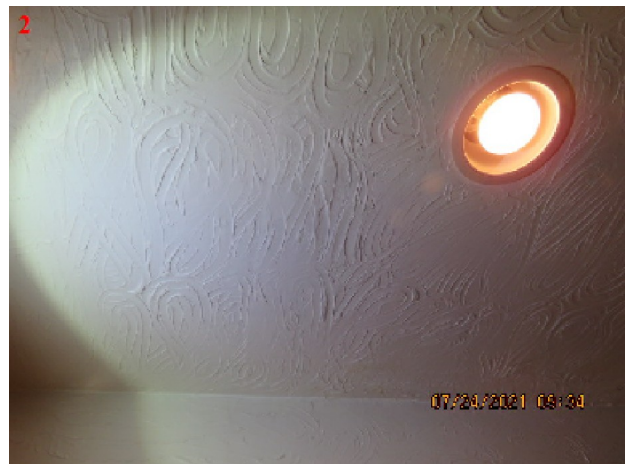
Service/Repair Kitchen Ceiling and Walls - Inspected

Active water leak on the kitchen ceiling in front of the refrigerator area. See Infrared picture. See attic leak near attic hatch. Recommend a qualified contractor evaluate and make all necessary repairs.

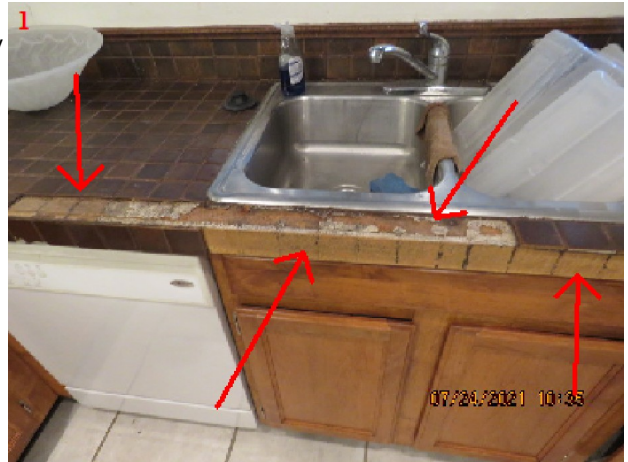
Lots of missing counter top tiles in the kitchen.
Recommend a qualified contractor evaluate and make all necessary repairs.

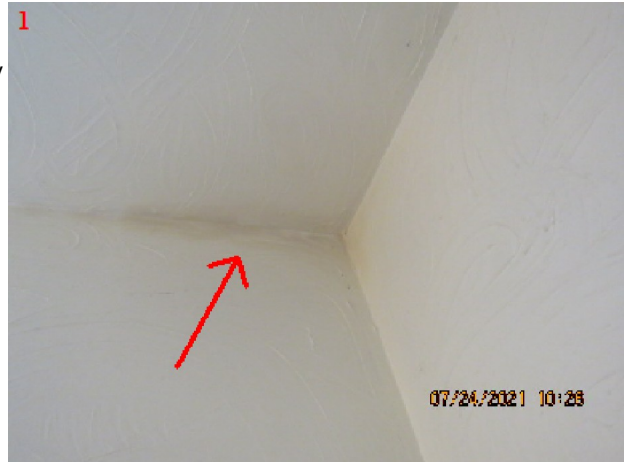
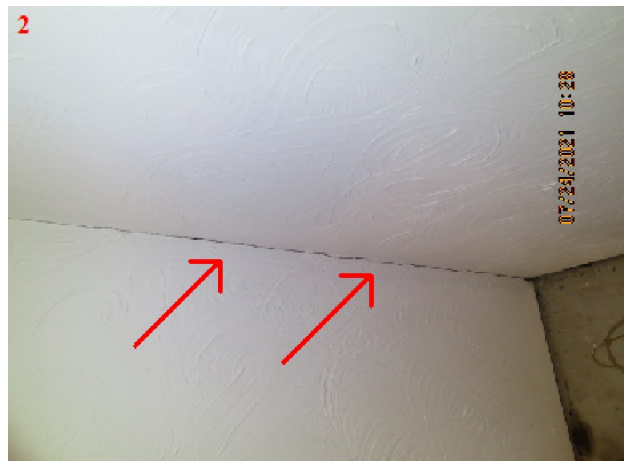
Cracks in the living room walls and water stain on the family room ceiling in the corner.
Recommend a qualified contractor evaluate and make all necessary repairs.

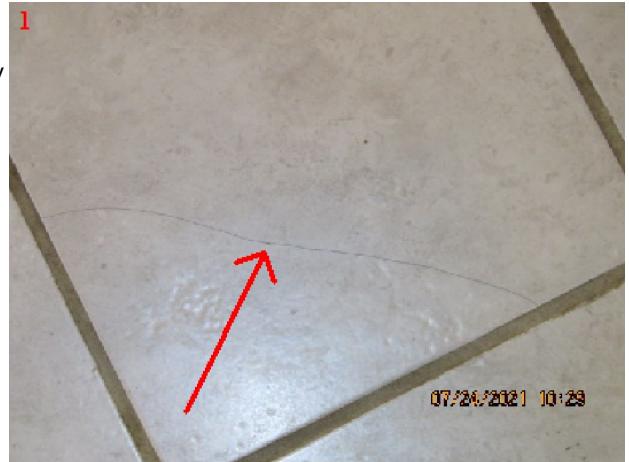
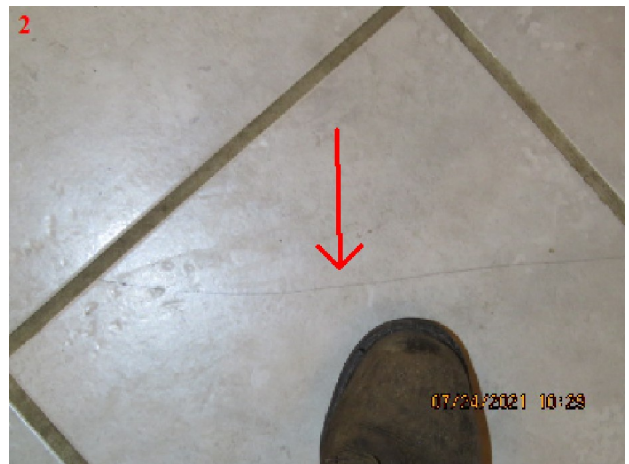
Service/Repair Interior Floor Covering - Inspected

Crack floor tiles in the family room and no floor covering in the living room.
Recommend a qualified contractor evaluate and make all necessary repairs.

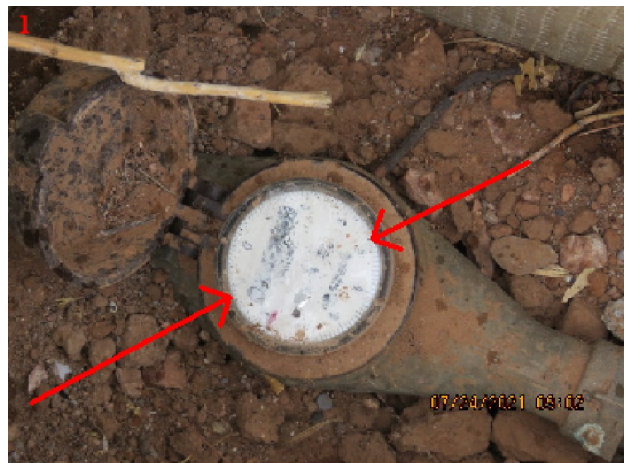
Water inside the glass cover of the water meter. This water meter by the street may be defective and I cannot read it. Recommend calling the water company and having it replaced or repaired.

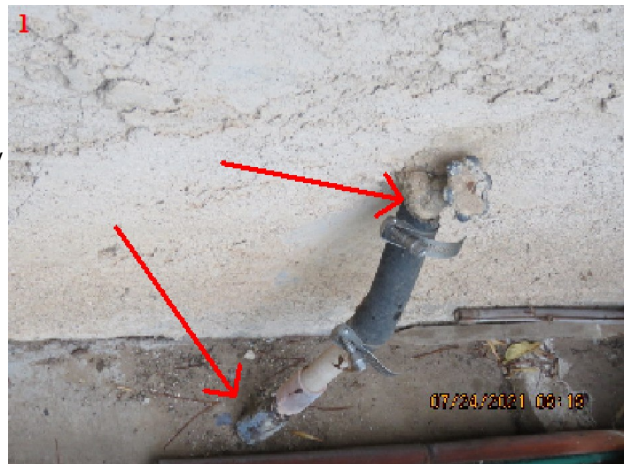
Tested all accessible exterior hose bibbs for water flow and leaks. Interior bibbs such as in a garage are not tested. There is a hose bibb on the south side of the house that is hooked to a pipe running into the ground. This hose bibb valve handle is stuck and I do not know where this pipe is going to. Recommend a qualified contractor evaluate and make all necessary repairs.

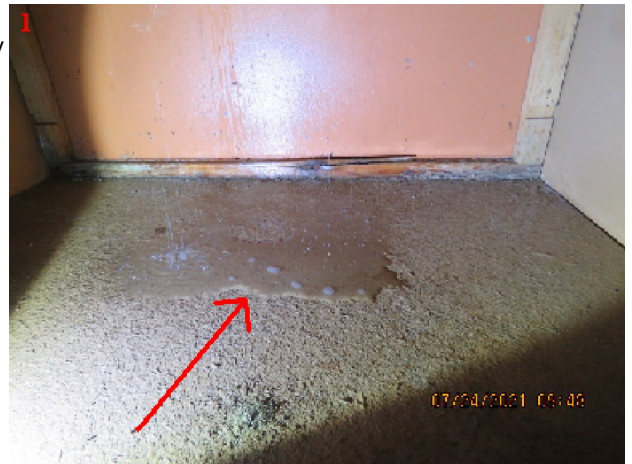
Water damage to the base of the master bathroom sink cabinet. Recommend a qualified contractor evaluate and make all necessary repairs.

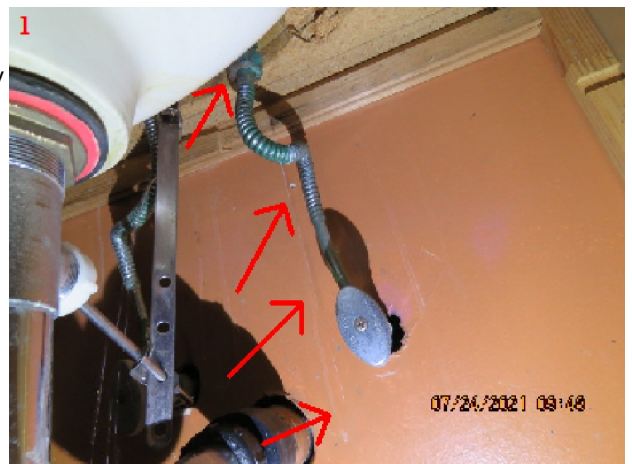
When the master bathroom sink faucet is running water leaks to the base of the sink cabinet below. Recommend a qualified contractor evaluate and make all necessary repairs.

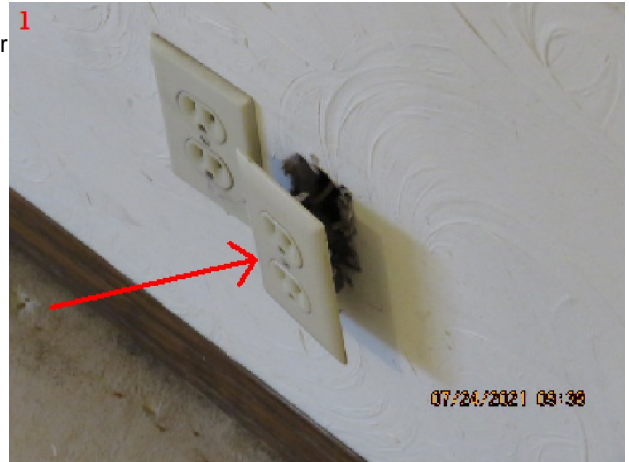
One outlet in the master bedroom is hanging out of the wall. This is a shock hazard. Recommend a qualified electrical contractor evaluate and make all necessary repairs.

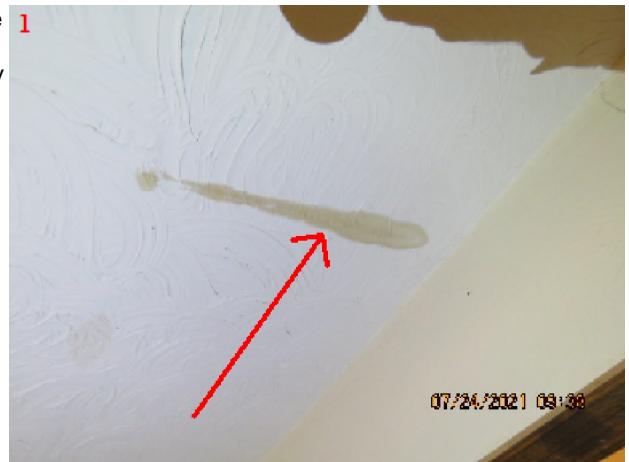
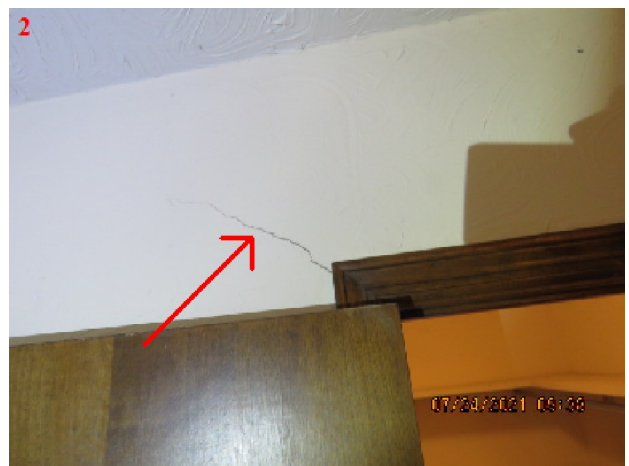
Service/Repair Walls and Ceiling - Ceiling Stains

Stains on the ceiling look like water stains. There is a crack on the wall in the master bedroom. Recommend a qualified contractor evaluate and make all necessary repairs.

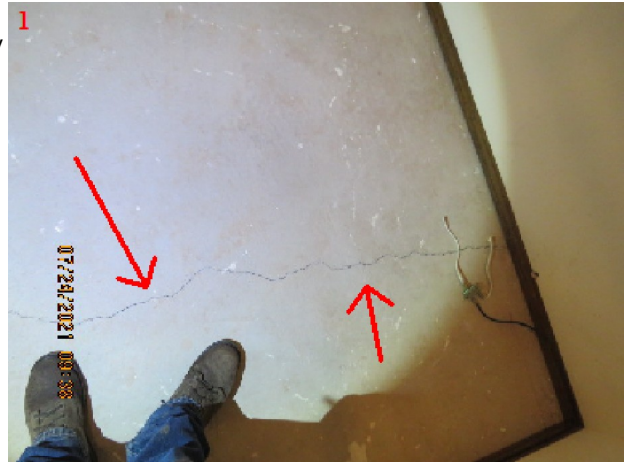
There is a small crack in the concrete slab in this bedroom.
Recommend a qualified contractor evaluate and make all necessary repairs.

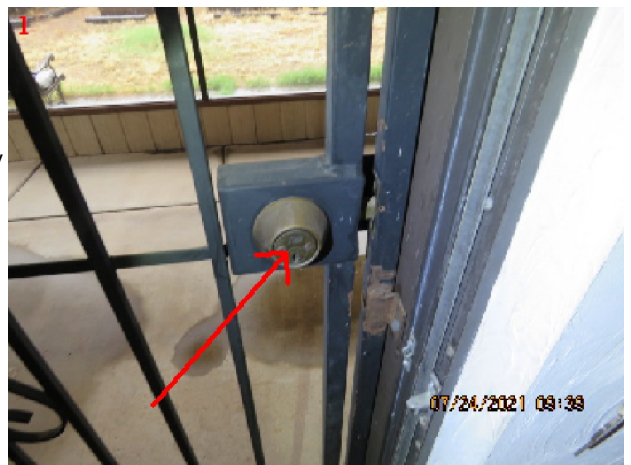
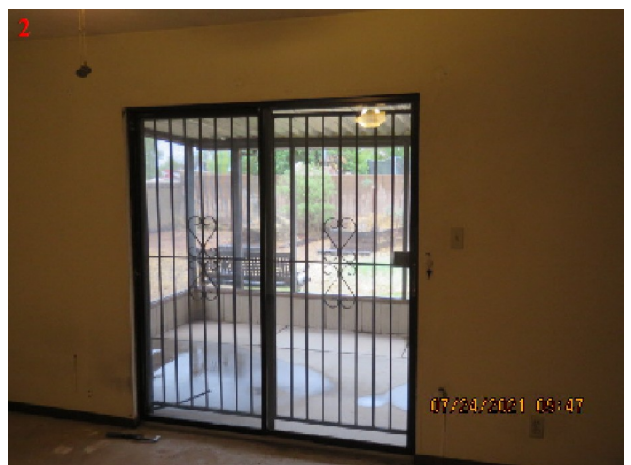
No window or door leading directly to the exterior from this master bedroom.
All residential bedroom are required to have a door or window directly to the exterior allow egress to and from the bedroom for a fire escape.
Recommend a qualified contractor evaluate and make all necessary repairs.
Double cylinder dead bolt used on door to the enclosed patio.
Recommend using standard dead bolts type of lock on exterior doors because double dead bolt locks block fire escapes.

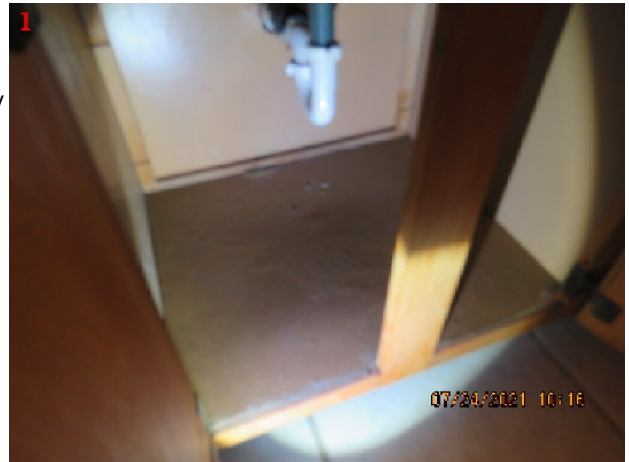
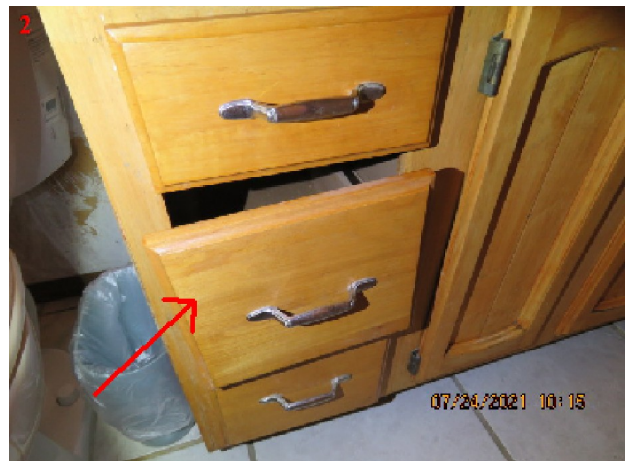
Some water damage to this bathroom sink cabinet from prior water leaks. A drawer in the hall bathroom sink cabinet is not properly attached. Recommend a qualified contractor evaluate and make all necessary repairs.

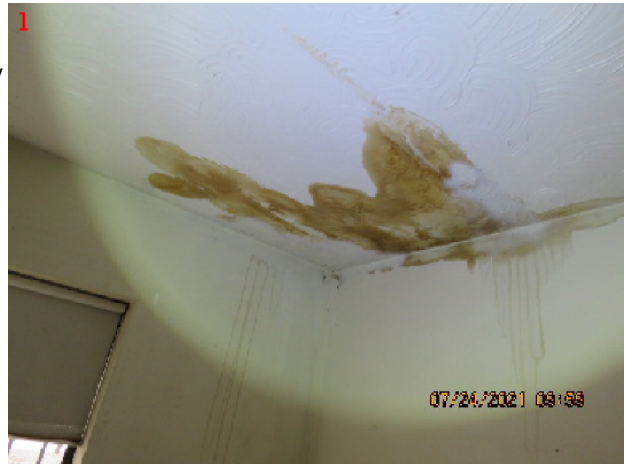
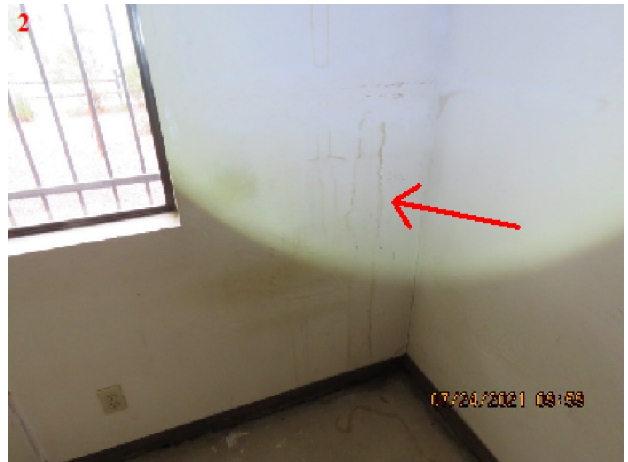
Massive water strains on the ceiling and walls in this bedroom. Not wet at this time and it is raining outside. Recommend a qualified contractor evaluate and make all necessary repairs.

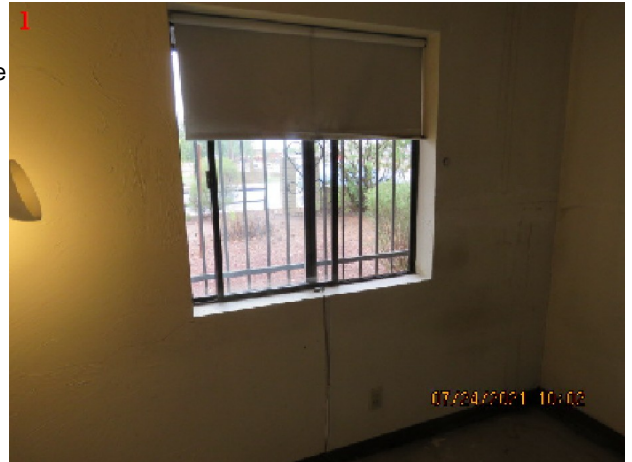
Bars permanently installed outside of window without a quick release are a fire escape hazard. Recommend removing bars from window before sleeping in room. Bars on windows are a fire escape hazard even if they have a quick disconnect. How can a fireman enter if no one opens the bars??

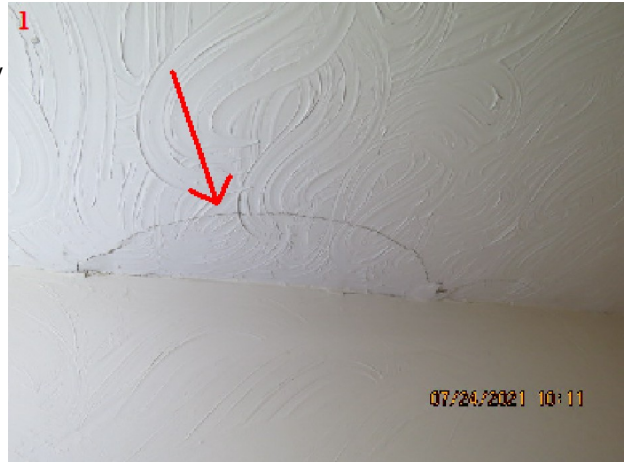
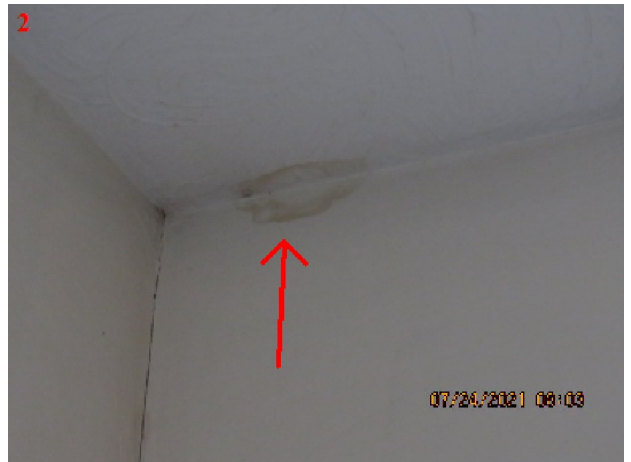
Cracks on the ceiling and wall in this room and water stains on the ceiling and wall but on wet at this time.
Recommend a qualified contractor evaluate and make all necessary repairs.

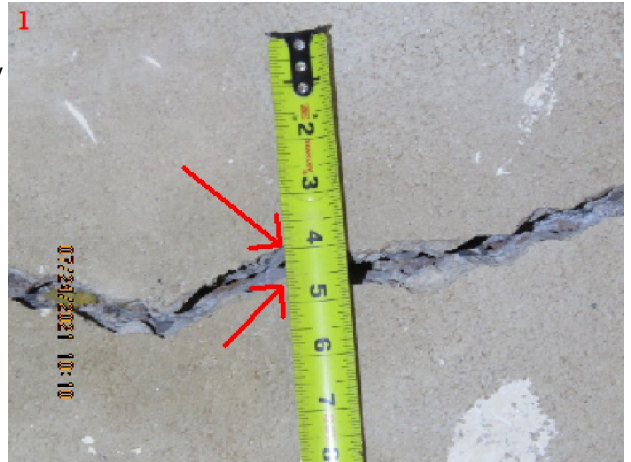
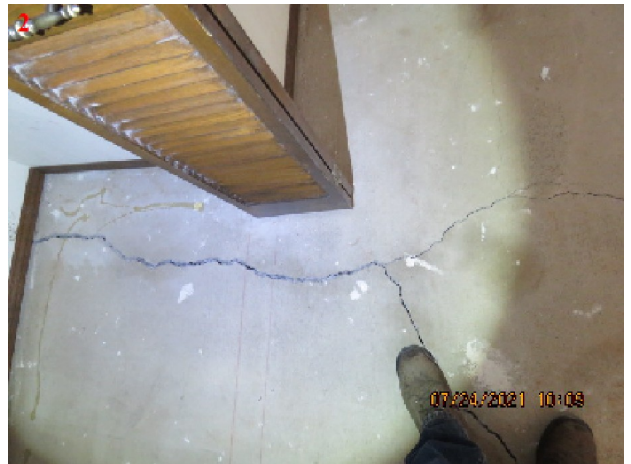
There is a large crack running through the closet and most of the bedroom and it is up to 1/2 of an inch wide.

There is a large crack running through the closet and most of the bedroom and it is up to 1/2 of an inch wide. Recommend a qualified contractor evaluate and make all necessary repairs.

Recommend a qualified contractor evaluate and make all necessary repairs.

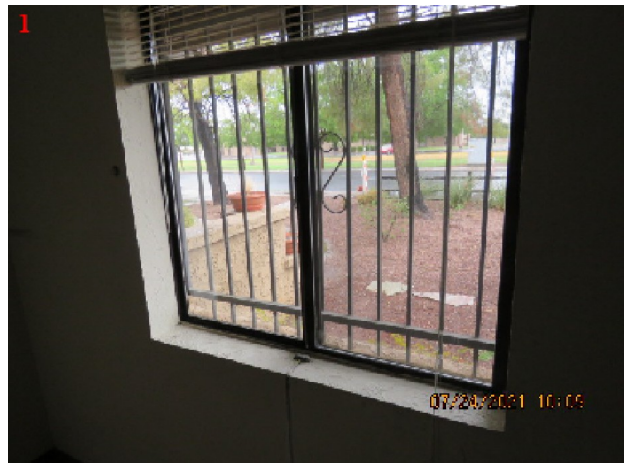
Bars permanently installed on window without a quick release are a fire escape hazard. Recommend removing bars from window before sleeping in room. Bars on windows are a fire escape hazard even if they have a quick disconnect. How can a fireman enter if no one opens the bars??
