## Termite Inspection Report

1646 E Hermosa Dr Tempe AZ 85282

**Arizona Department of Agriculture**  
**Pest Management Division**  
**WOOD DESTROYING INSECT INSPECTION REPORT**

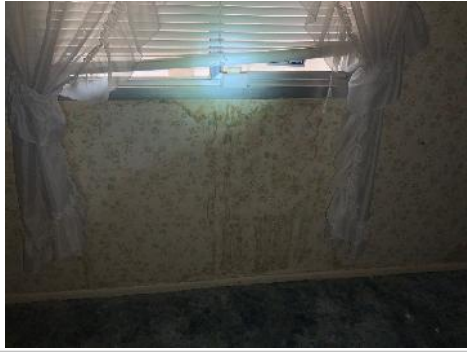
Water stains

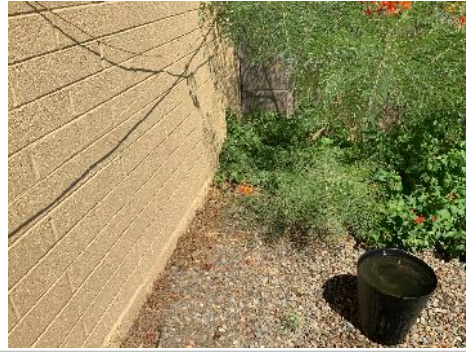
Plants abutting structure

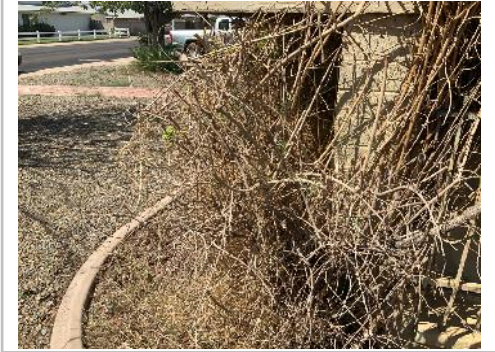
Plants abutting structure

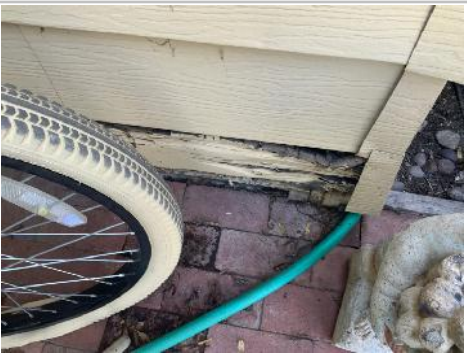
Water damage
