Perfection Home Inspections
Mesa, AZ 85203
602-524-2916
perfectionhomeinspections.com

1646 E. Hermosa Drive

Inspected 9/4/21 8:00 AM

Inspection Summary

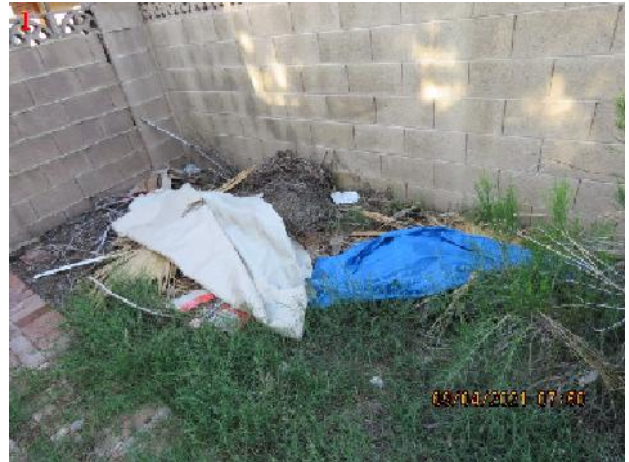
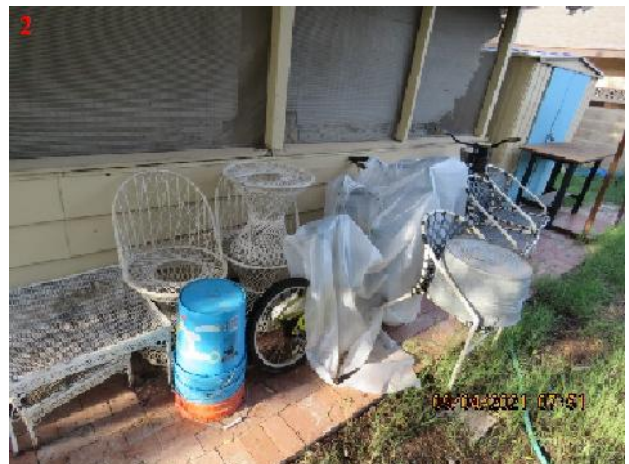
Debris in the yard. Recommend removing all debris.

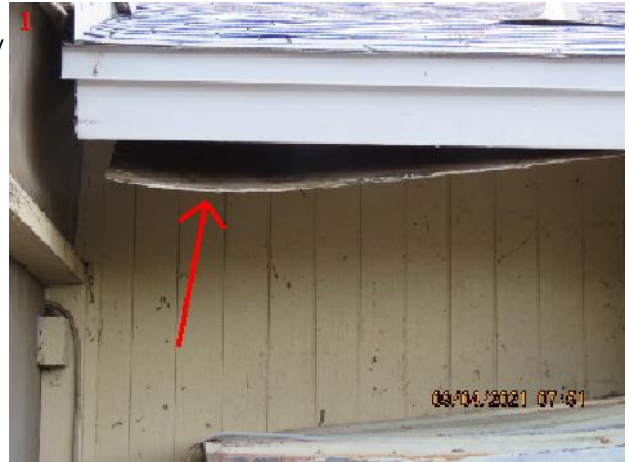
Loose soffit cover in the back.
Recommend a qualified contractor evaluate and make all necessary repairs.

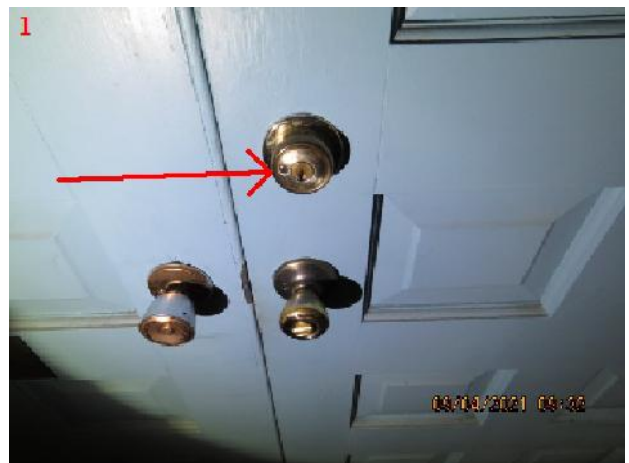
Exterior entrance door tested and found to be in proper working order.
Double sided dead bolt locks used on exterior doors. These type of locks require the use of a key to exit so they are a fire escape hazard. Recommend replacing all double dead bolts with standard dead bolt locks.

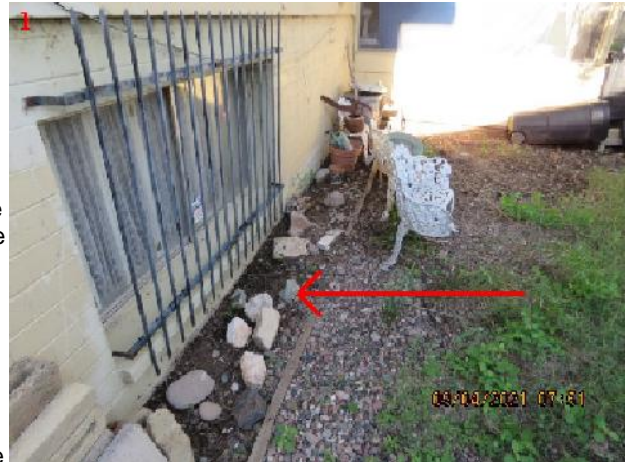
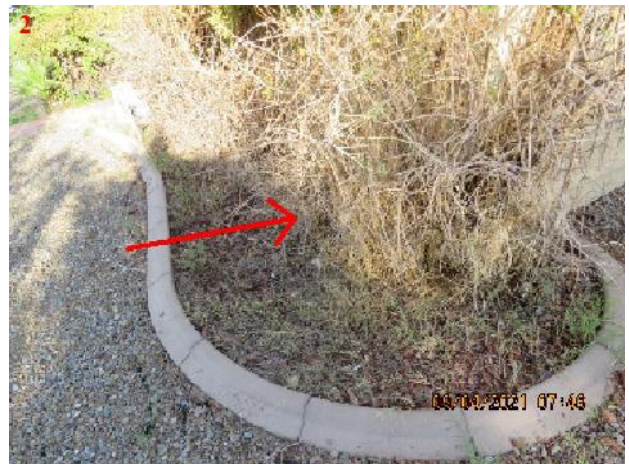
Soil or the concrete is not properly sloped away from the house foundation in the front and in the back. Perimeter areas should be sloped away from house and drains installed as needed for proper drainage to protect the foundation.

When water is allowed to accumulate or flow towards the house foundation due to improperly sloped soil foundation problems may develop.

Planters installed next to the house hold water against the house foundation and sometimes raise the soil level above the house slab level. Recommend finding a way to drain water from this area to help protect the house foundation. When soil is against the house and above the house slab water and pests like termites may enter the home undetected. Recommend keeping planters away from the house foundation.

Recommend a minimum fall of 6 inches within the first 10 feet of the house foundation and or installing drains or slope the yard to ensure drainage away from the foundation.

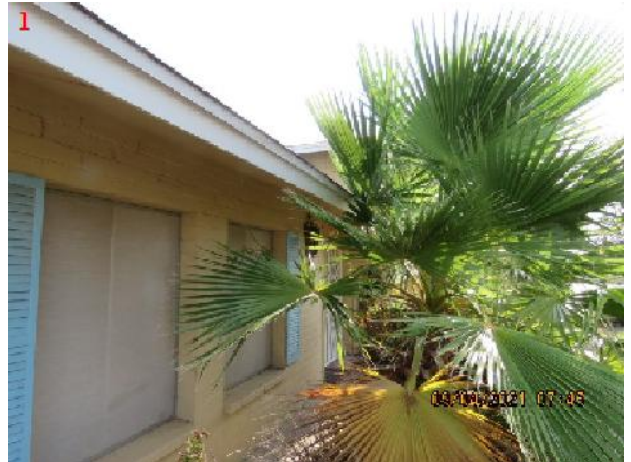
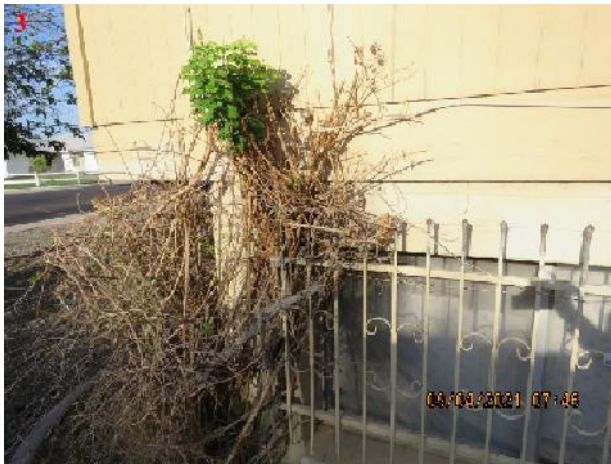
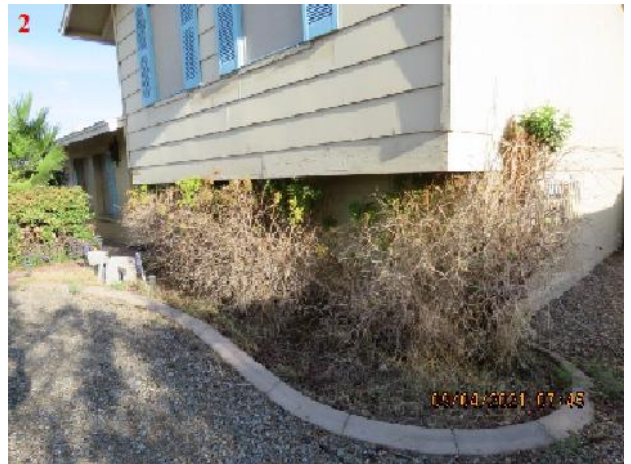
Vegetation and or other plants on the house are not recommend. Plants and vines hold moisture against the siding and can damage the siding and soffit area. Recommend keeping all vegetation and plants off the exterior of the house.

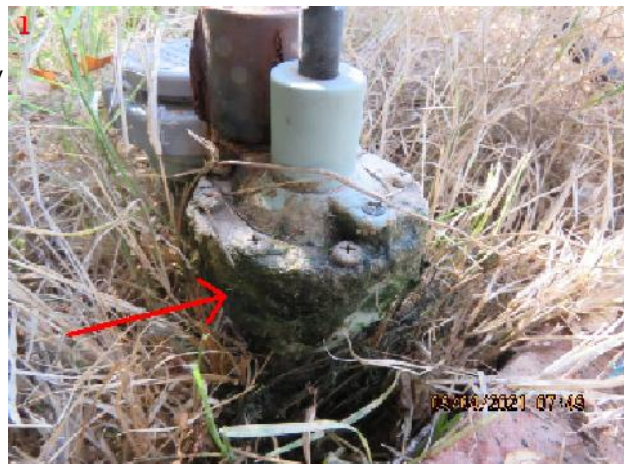
Sprinkler valve in the front yard not connected to a timer and it is leaking..
Recommend a qualified contractor evaluate and make all necessary repairs.

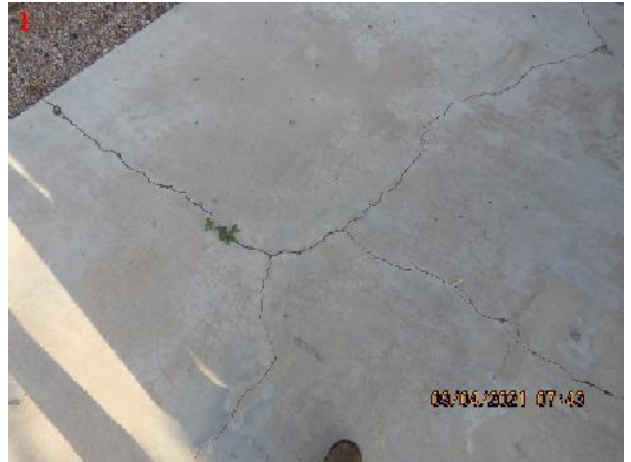
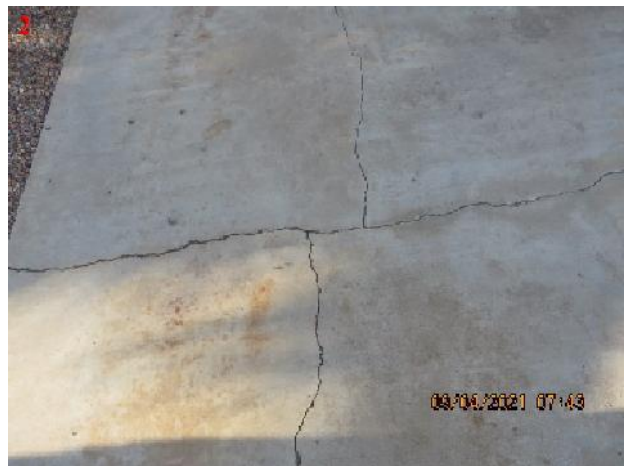
Cracks in driveway. Recommend sealing cracks to keep moisture out and help keep the cracks from spreading.

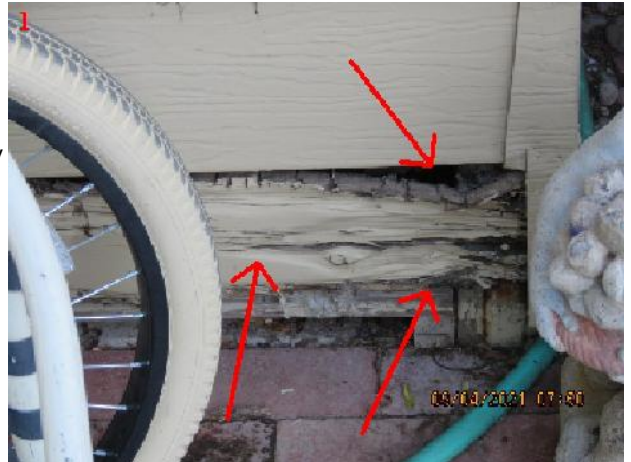
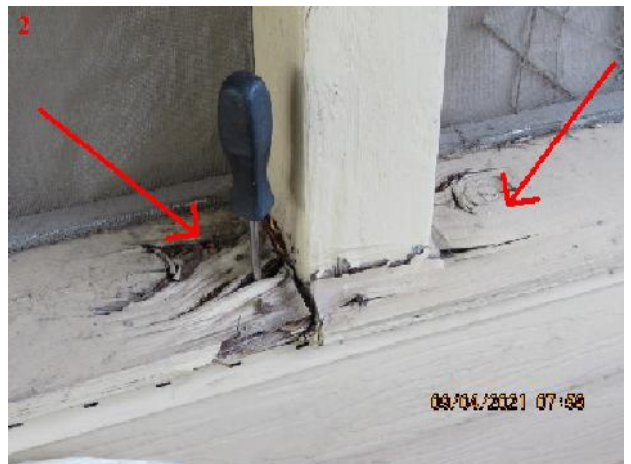
The patio has been enclosed and converted in to an Arizona room. Recommend checking for permits to convert this patio in to an enclosed room. Wood siding on this enclosed patio has lots of wood rot. Wood trim has wood rot. Recommend a qualified contractor evaluate and make all necessary repairs.

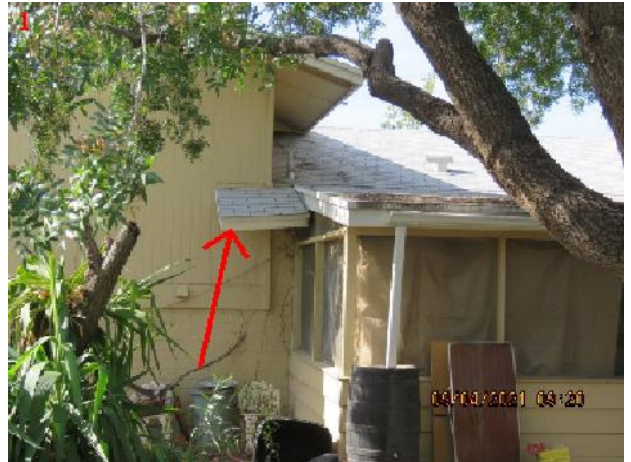
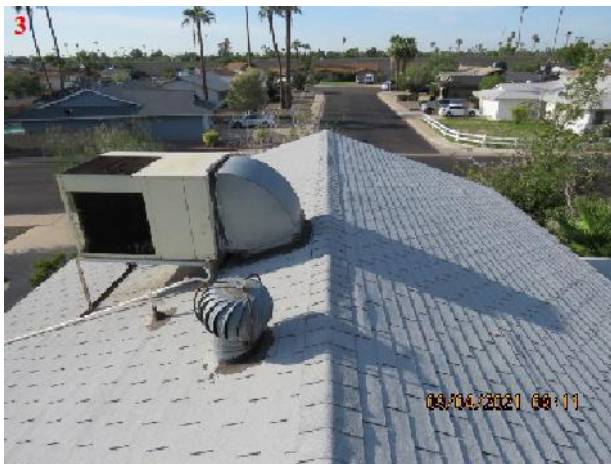
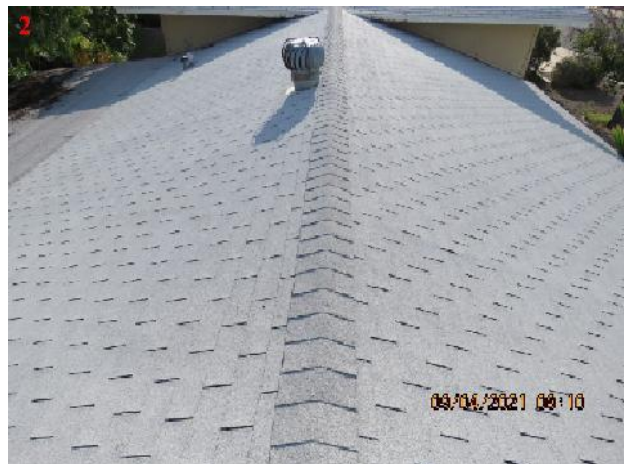
Tiny section of roof in the back is loose and not properly supported.
Recommend a qualified roofing contractor evaluate and make all necessary repairs.

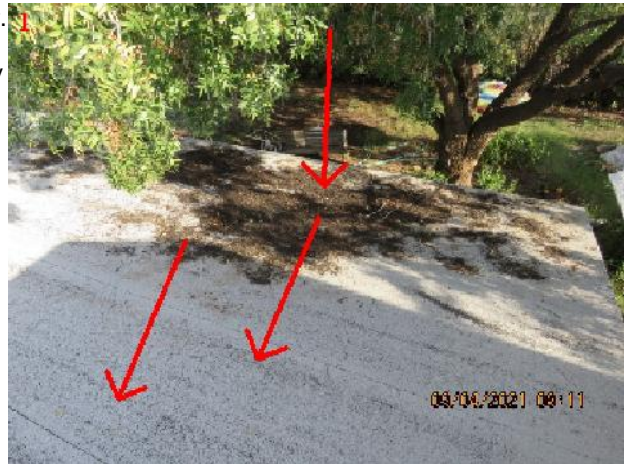
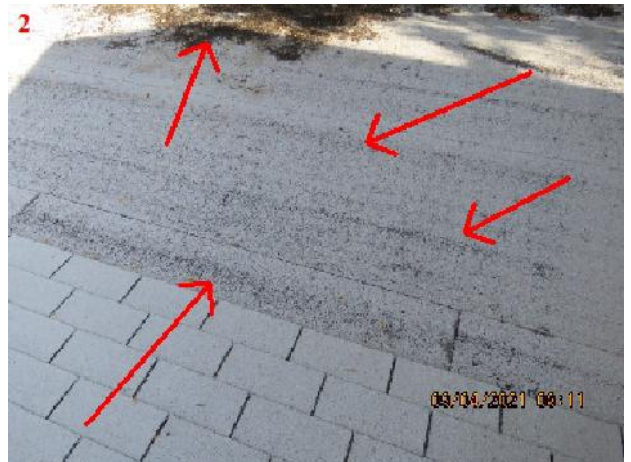
Lots of debris on the back patio roof and it has lost some rock cover.

Recommend a qualified contractor evaluate and make all necessary repairs.

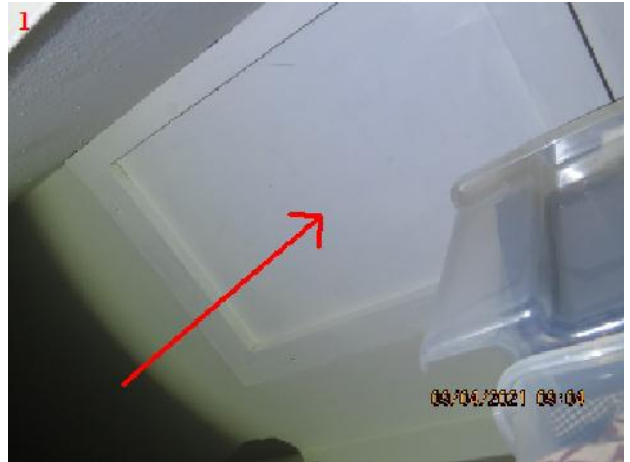
No access to the house attic area. The attic hatch is sealed shut. Can not check attic for electrical, insulation, plumbing or roof leaks. Recommend inspecting attic after proper access is provided.

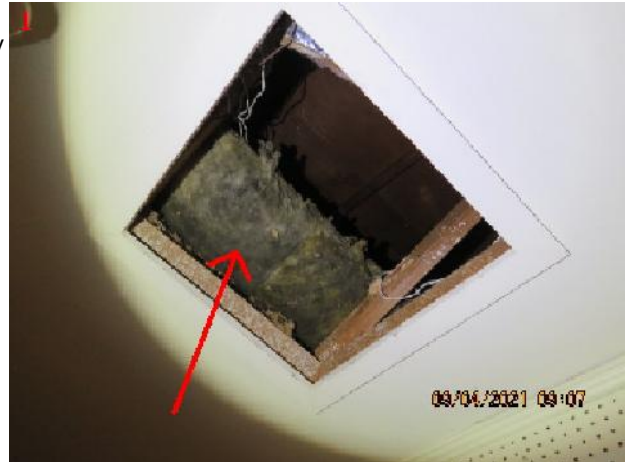
The attic hatch is partly blocked by a rigid HVAC duct. Recommend a qualified contractor evaluate and make all necessary repairs.

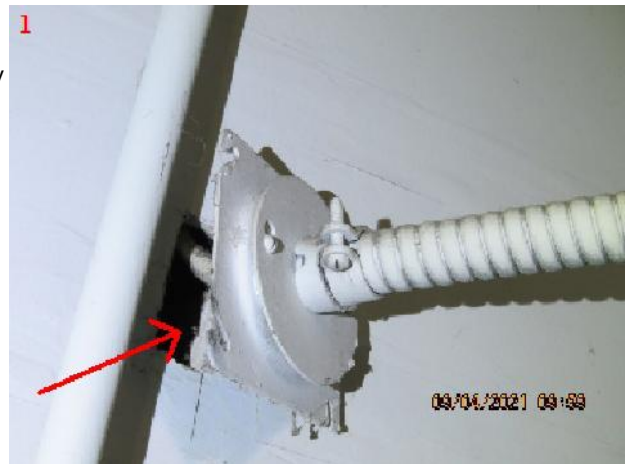
The water heater electrical junction box cover is not properly attached.
Recommend a qualified contractor evaluate and make all necessary repairs.

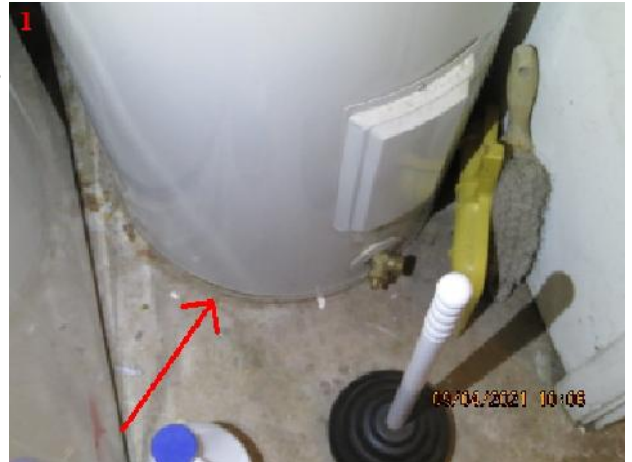
No pan installed under the water heater.
Recommend installing an overflow pan under the water heater and installing a drain line from this pan if possible to the exterior. This is normally best done when changing water heaters.

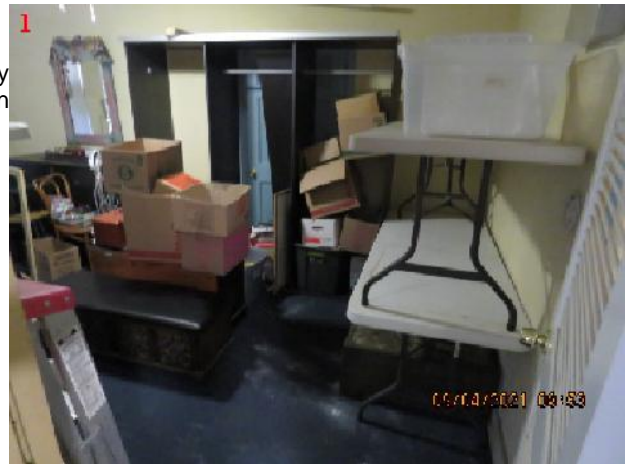
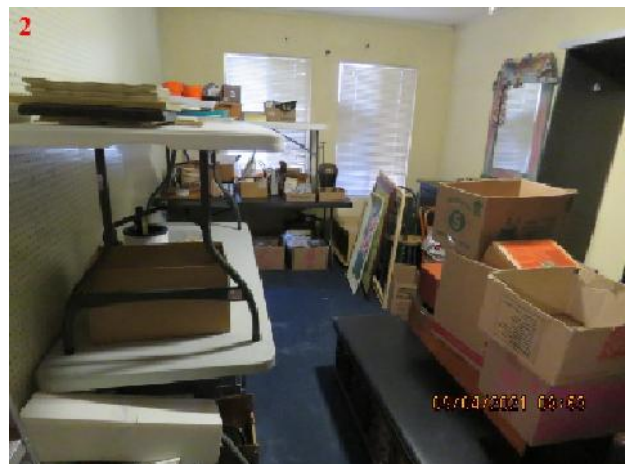
Stuff in the garage blocks view of the interior of the garage. Recommend inspecting garage area after the stuff is removed.

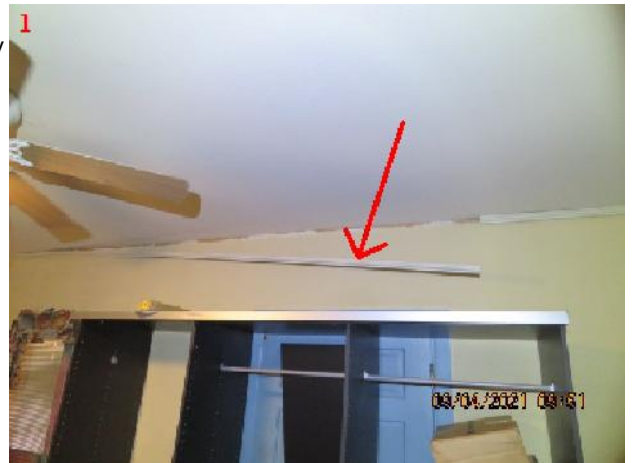
Loose trim at the ceiling on the west wall.
Recommend a qualified contractor evaluate and make all necessary repairs.

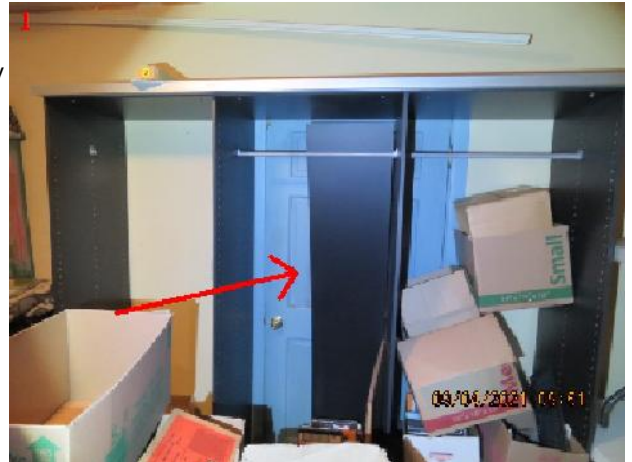
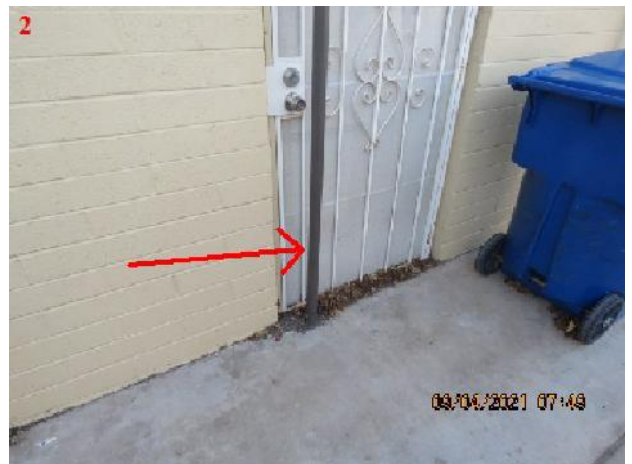
The door to the side yard is blocked on the inside with stuff and on the outside with a metal pole.
Recommend a qualified contractor evaluate and make all necessary repairs.

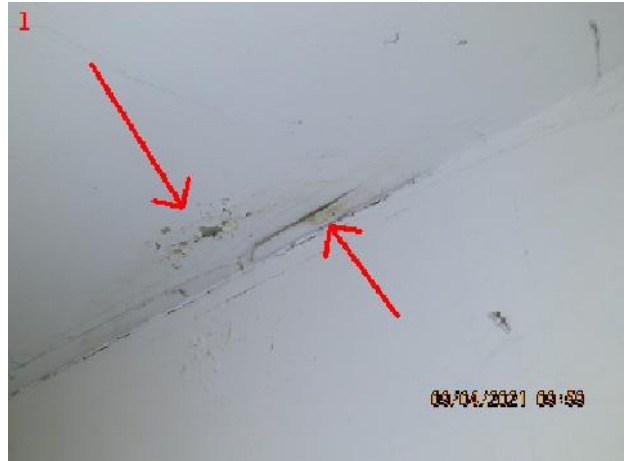
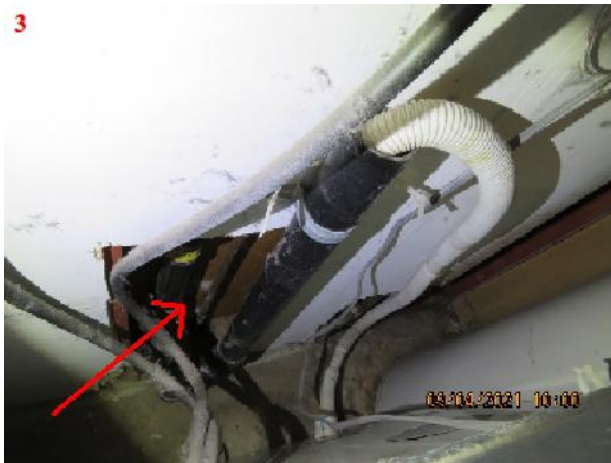
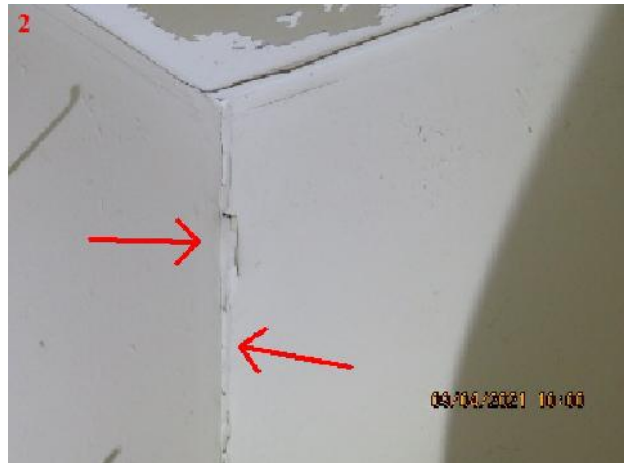
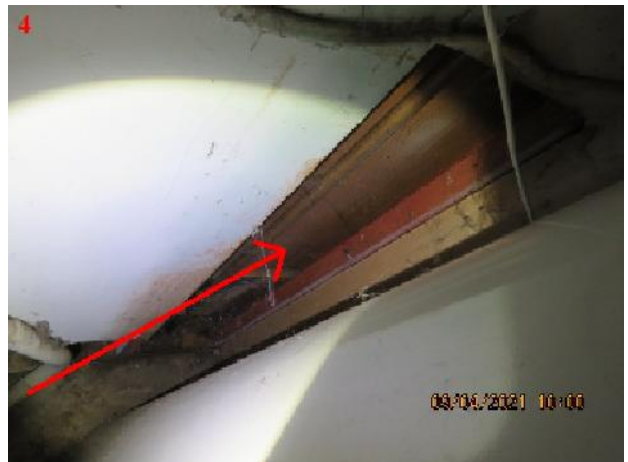
Water stains on the ceiling in the laundry room and loose drywall joint tape. Holes in the laundry wall behind the washer and dryer and water heater. Recommend solving this problem then have a qualified contractor evaluate and make all necessary repairs.

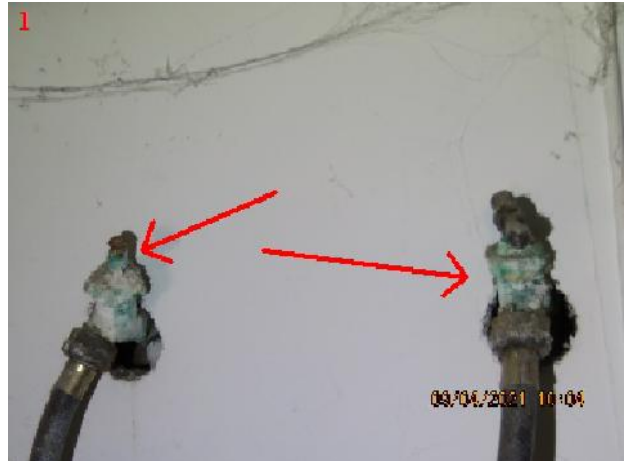
The laundry washing machine water supply valves are stuck and corroded and the clod water valve handle is missing . Recommend a qualified contractor evaluate and make all necessary repairs.

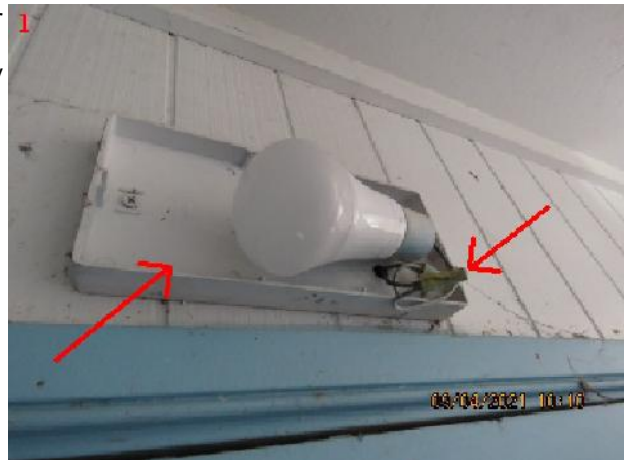
The light at the entrance to the laundry room is missing a bulb cover and has exposed wire nuts and wires.
Recommend a qualified contractor evaluate and make all necessary repairs.

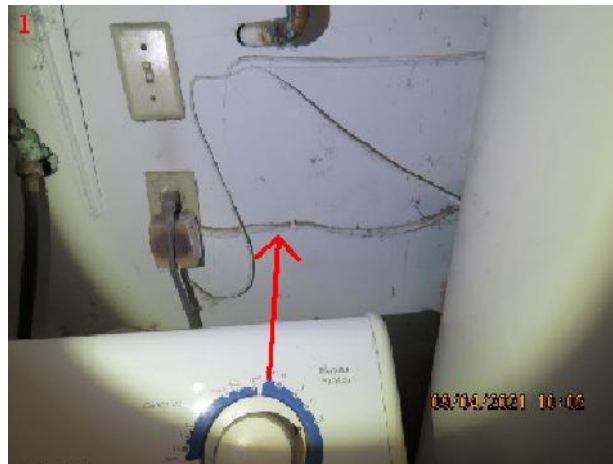
Exposed romex type wires found in the laundry room less than 7 feet above the floor. This is considered a shock hazard. Recommend all exposed romex less than 7 feet above the floor be properly protected.

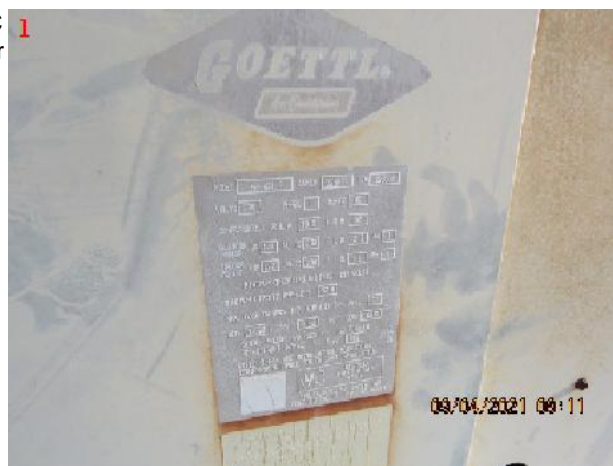
This unit looks like it is over 20 years old. The average life of an AC system in the Phoenix area is 12 to 15 years. This unit may be near the end of its useful life. Typical AC has only 50% of its initial efficiency after 20 years. So a 12 SEER would have a 6 SEER rating.

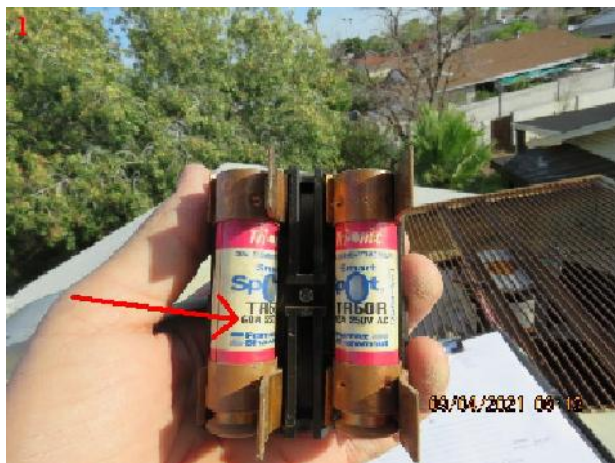
Oversized breaker or fuse used on air conditioning unit. Over sizing of both the fuse and breaker may damage the AC unit. The maximum breaker/fuse rating for this unit is 50 and the breaker/fuse used is 60. Recommend replacing breaker or fuse with one that is lower than or meets the manufactures requirements.

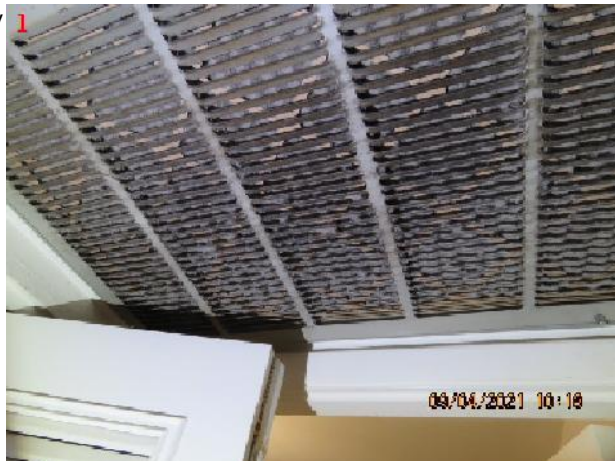
Dirty air filters. I recommend service for all HVAC systems with dirty and or damaged air filters.
When air filters get dirty the chances of dirt and other contaminants getting by the filter and into the duct system increases. Recommend replacing or cleaning air filters once a month and sooner when needed. Dirty filters also put a strain on the heating and cooling system and may cause the system to malfunction.

Recommend replacing or cleaning air filters once a month and sooner when needed. Dirty filters also put a strain on the heating and cooling system and may cause the system to malfunction.

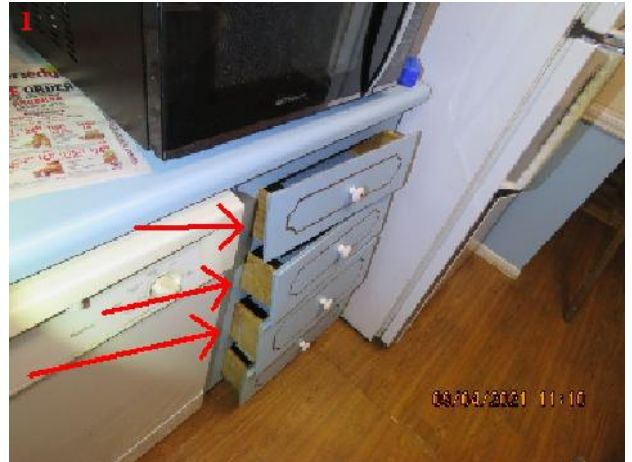
Some drawers in the kitchen cabinets have missing or defective guide hardware. Recommend repair.

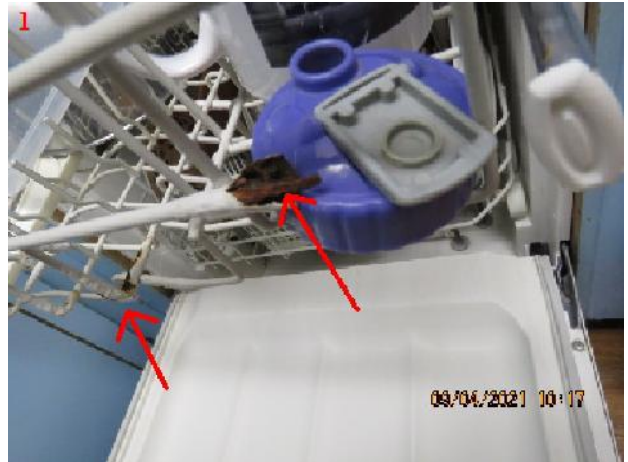
The dish rack in the dishwasher is rusted. Recommend replacing the rusted rack.

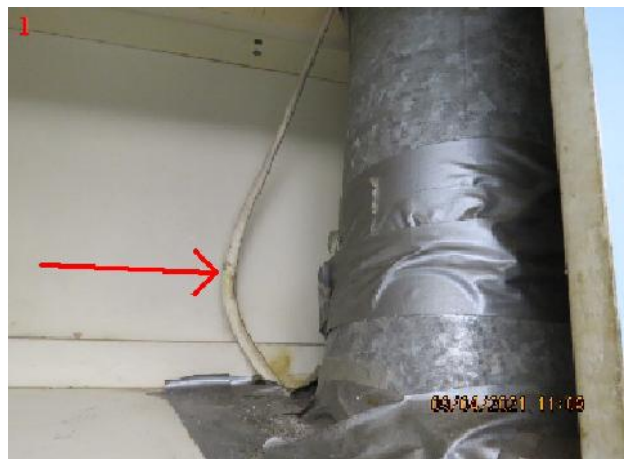
Exposed romex type wire found in a kitchen cabinet. Recommend all exposed romex type wire less than seven feet above the floor be installed in conduit or properly protected.

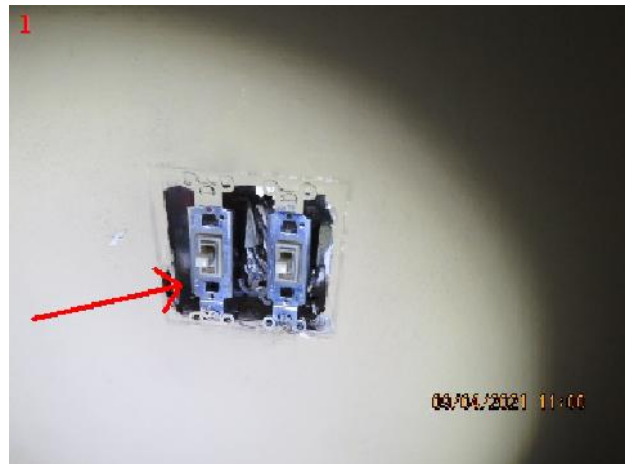
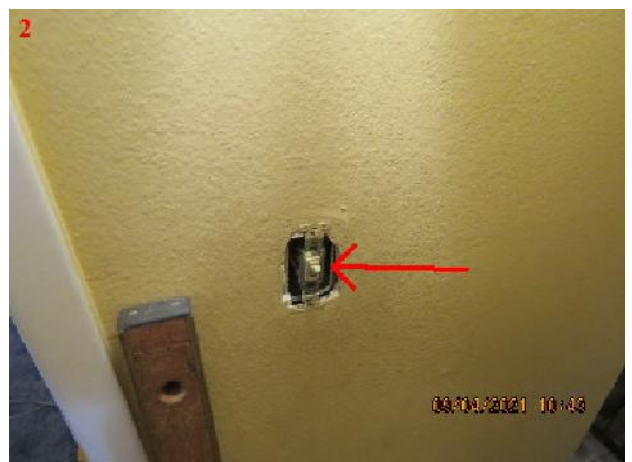
Missing switch cover plates. Recommend installing all missing electrical cover plates to avoid shocks.

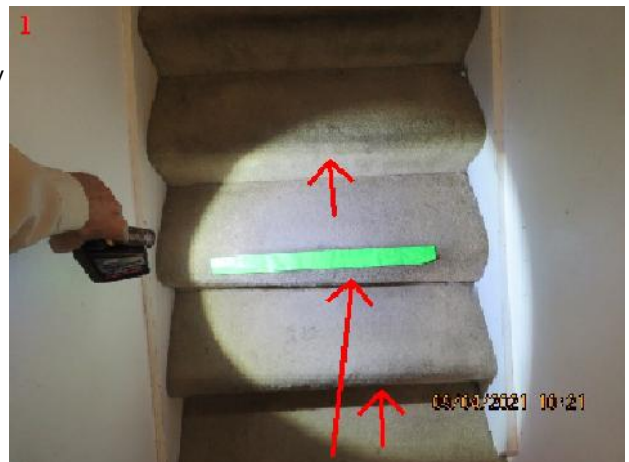
Loose carpet on the steps both upper and lower sections are a trip hazard.
Recommend a qualified contractor evaluate and make all necessary repairs.

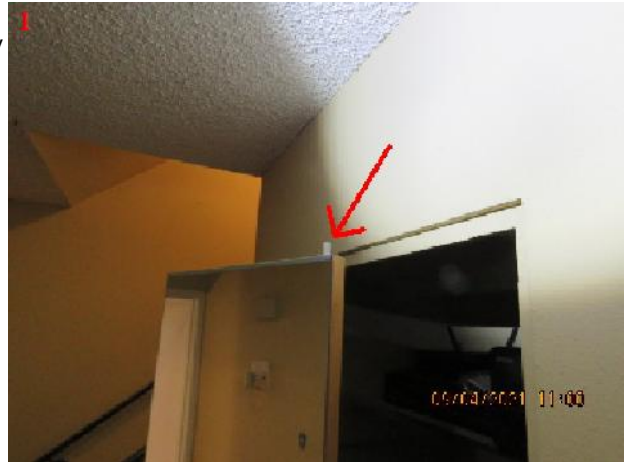
Living room closet doors not properly attached at the top.
Recommend a qualified contractor evaluate and make all necessary repairs.

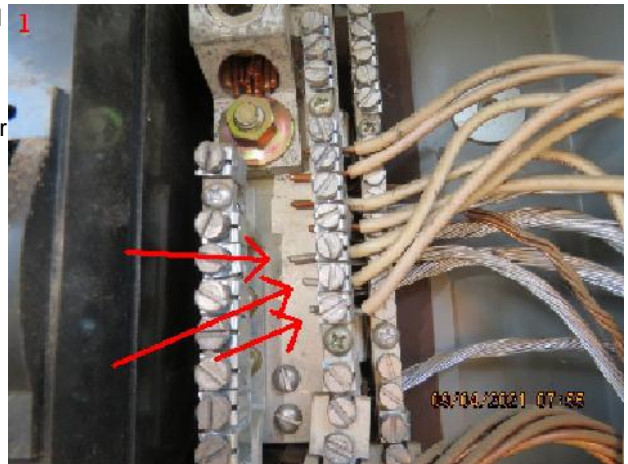
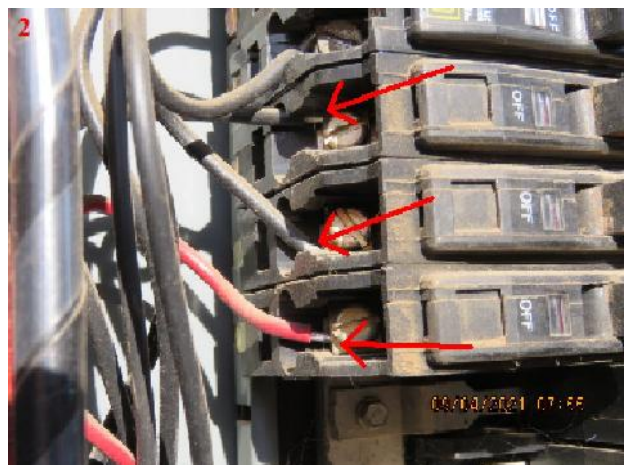
Between 1964 and 1974 many homes were built using single strand aluminum wire alloy that caused problems. This type of wire tends to oxidize and then overheat and it is incompatible with many electrical fittings. A new type of AL ware was introduced between 1972 and 1974 to solve overheating problems. Homes with the older type single stranded aluminum wires are up to 55 times more likely to have a electrical fire. Recommend an electrician check all connections to ensure proper outlets, switches, and connectors have been used. See www.cpsc.gov/cpscpub/pubs/516.pdf Arc-Fault breakers may help reduce the fire issue.

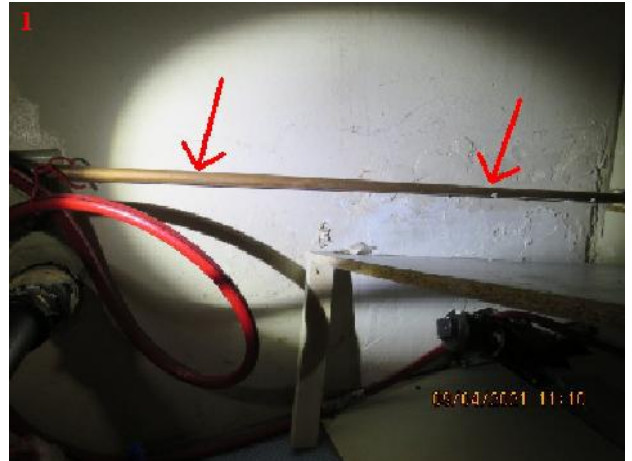
Water supply pipe under the kitchen sink not properly supported.
Recommend properly supporting all pipe. See sample picture

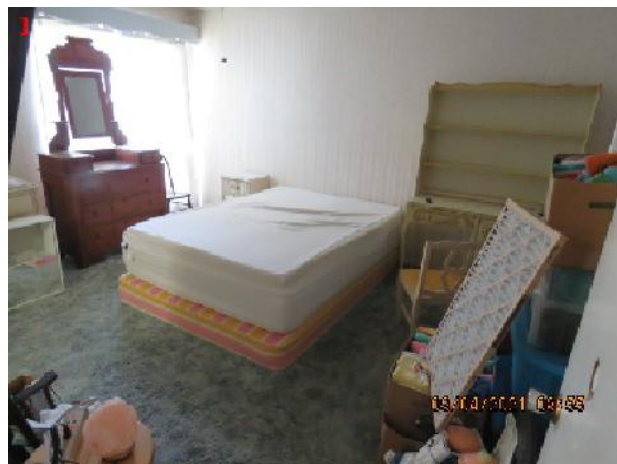
Lots of stuff in this bedroom.

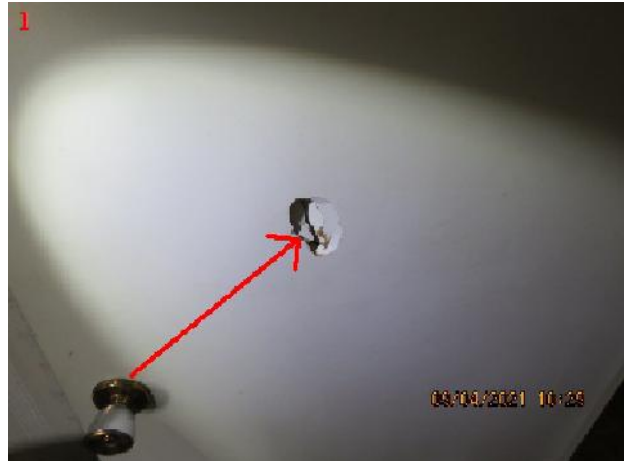
The master bedroom door is damaged. Recommend replacing this door.

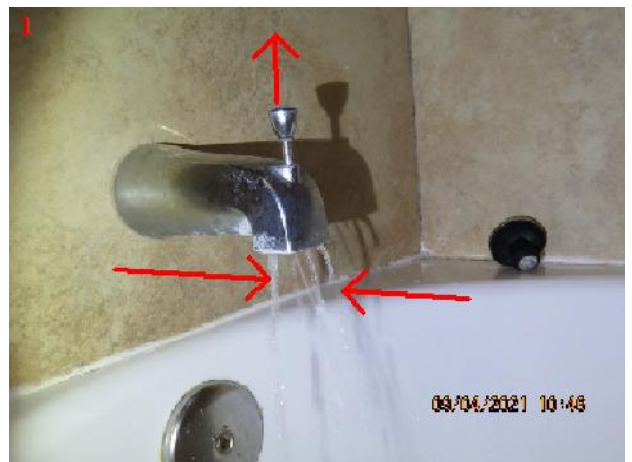
The diverter valve in this shower is defective. Water does not shut off to tub when the shower is running. Recommend replacing shower diverter valve.

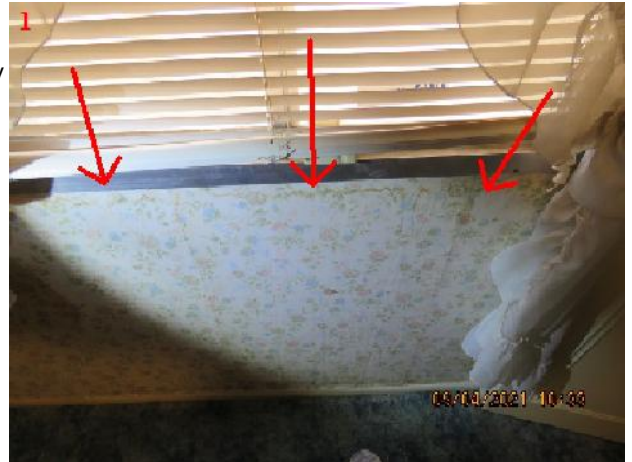
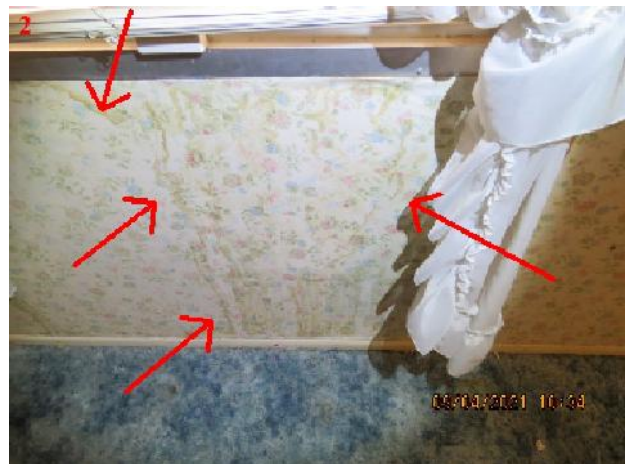
Water stains on the front facing wall below both windows in this bedroom.
Recommend a qualified contractor evaluate and make all necessary repairs.

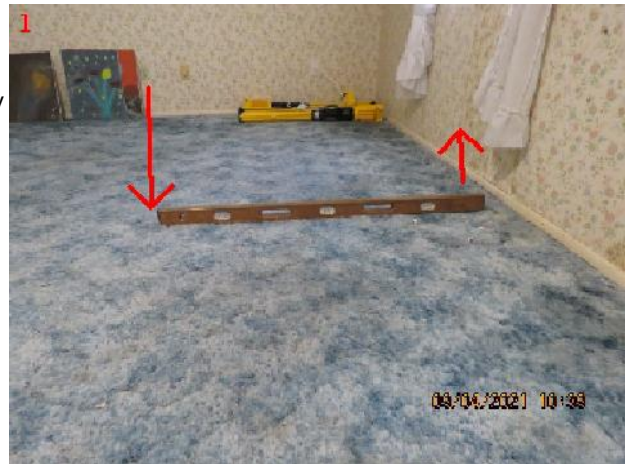
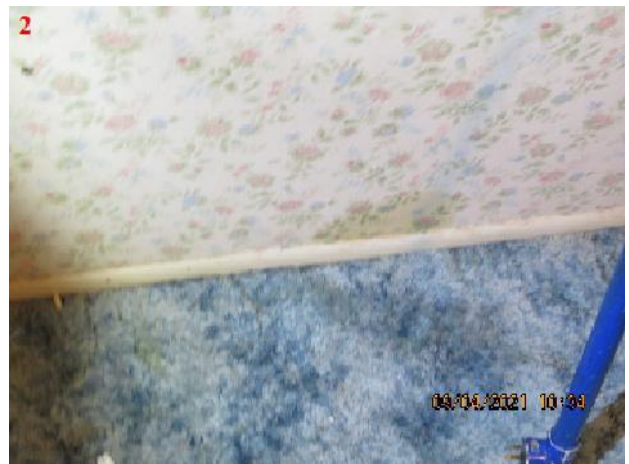
The floor is sloped down from the front wall to the bedroom and the subfloor is creaky making popping noise in the area in front of the windows when walked on. Stains on the carpet. Recommend a qualified contractor evaluate and make all necessary repairs.

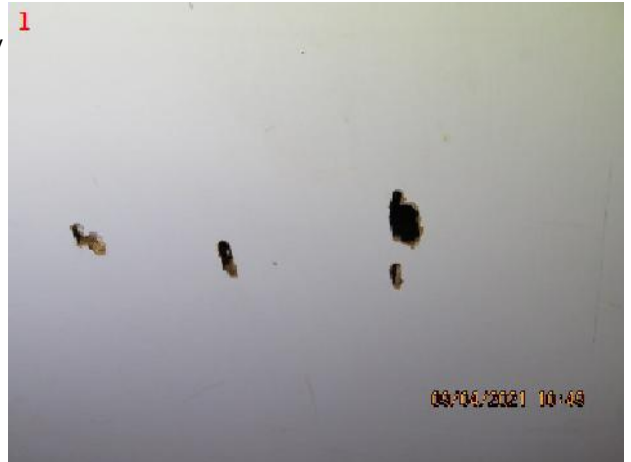
Holes in the door to this bedroom.
Recommend a qualified contractor evaluate and make all necessary repairs.

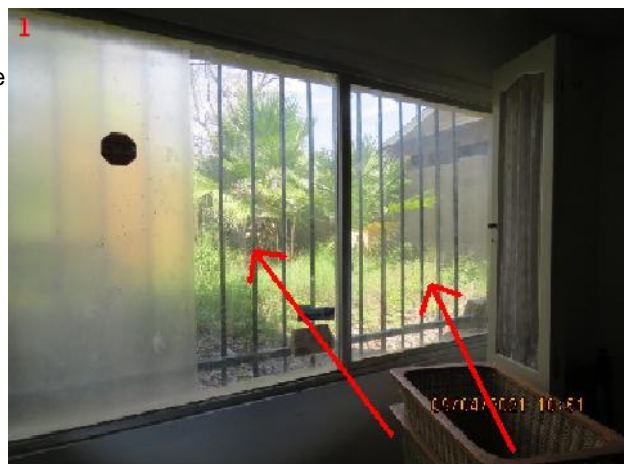
Bars permanently installed outside of window without a quick release are a fire escape hazard. Recommend removing bars from window before sleeping in room. Bars on windows are a fire escape hazard even if they have a quick disconnect. How can a fireman enter if no one opens the bars??

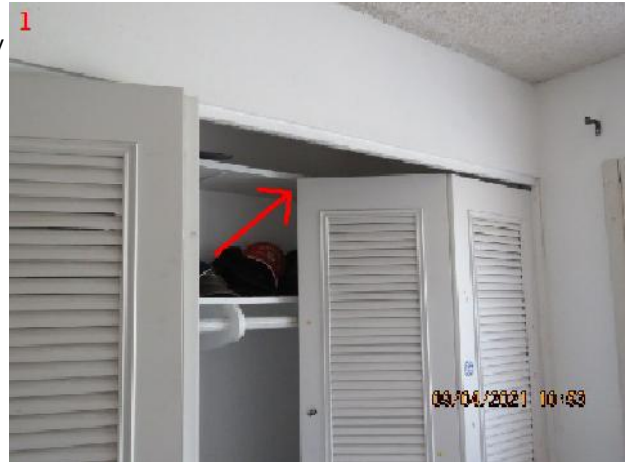
The closet door are not properly attached in this bedroom
Recommend a qualified contractor evaluate and make all necessary repairs.

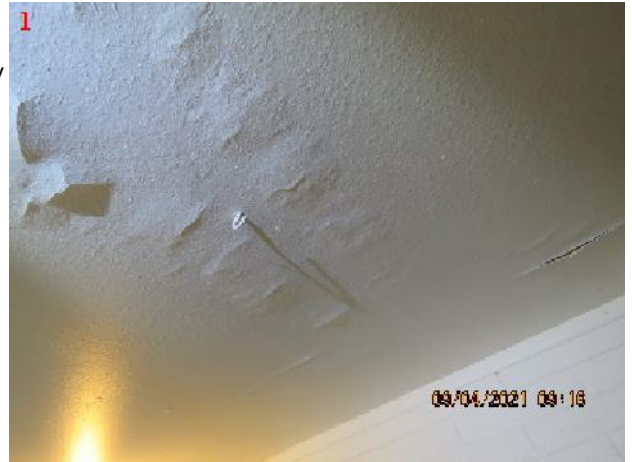
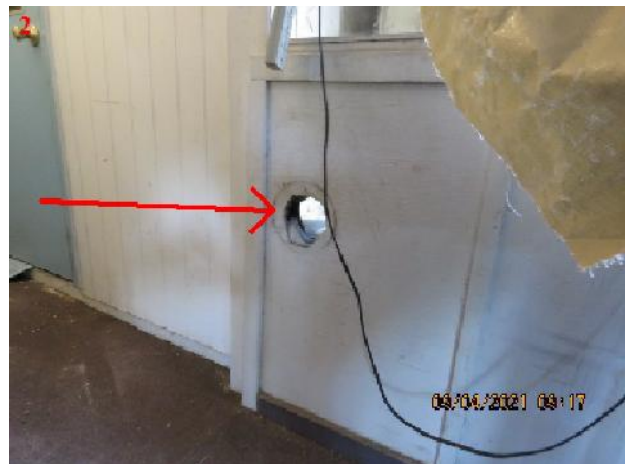
Cracked and loose paint on the ceiling in the Arizona room.
Hole in the AZ room wall.
Recommend a qualified contractor evaluate and make all necessary repairs.

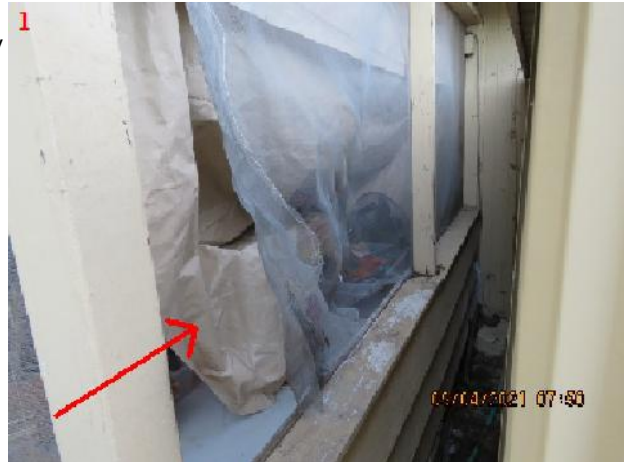
Screened in areas for windows and the screen is loose in spots. Recommend a qualified contractor evaluate and make all necessary repairs.

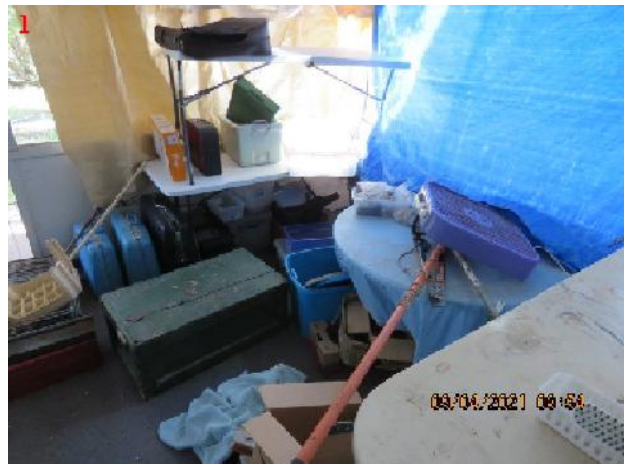
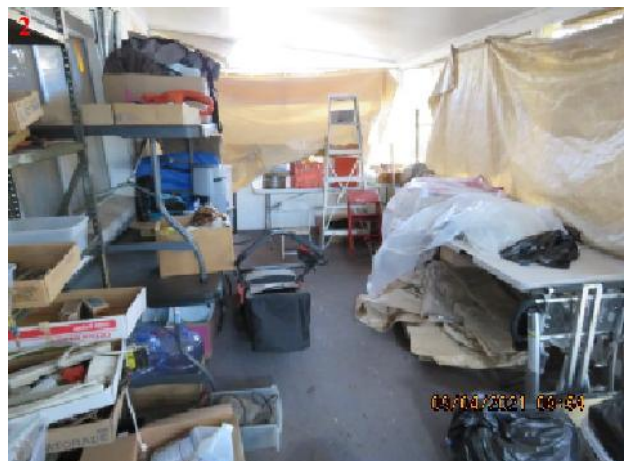
Massive amounts of stuff in this room blocks access to much of this room.
