Perfection Home Inspections
Mesa, AZ 85203
602-524-2916
perfectionhomeinspections.com

Client Information: Record Number 8680

1615 N. Date Drive
Tempe, AZ 85281

Inspected 10/26/21 8:00 AM
Built 1961
2046 sf

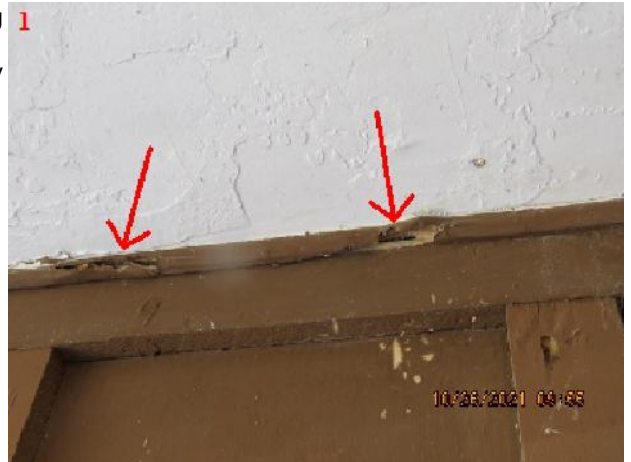
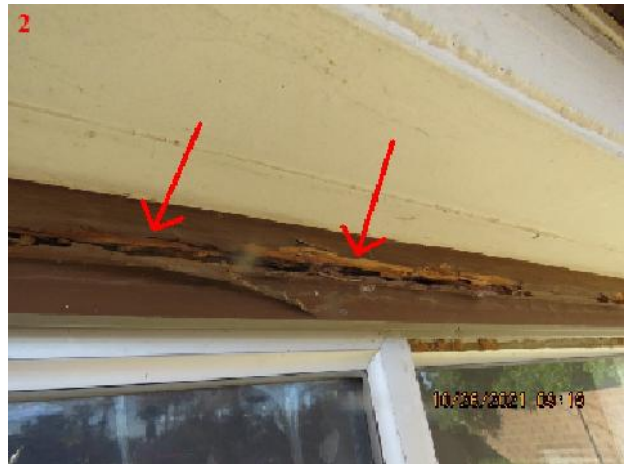
Termite damage to the trim at the front porch and at the back sliding glass door trim.
Recommend a qualified contractor evaluate and make all necessary repairs.

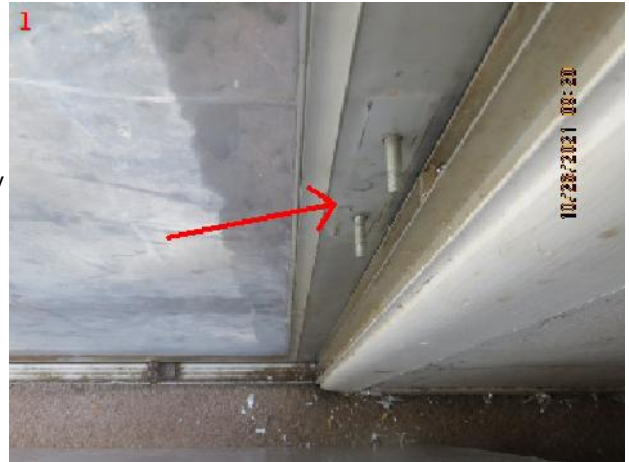
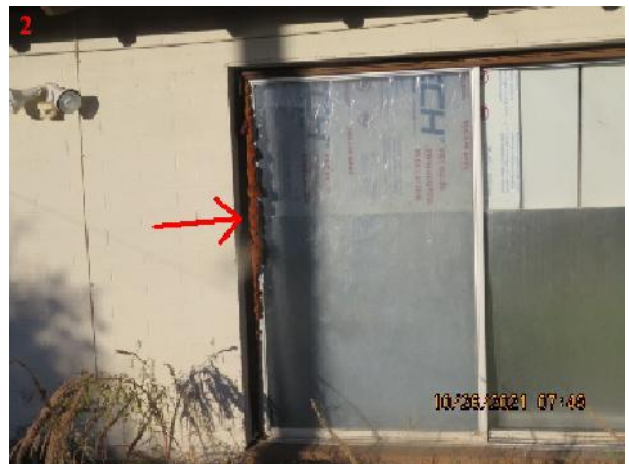
Exterior patio and or back door(s) tested and the door does not lock and the sliding door is on the exterior making it difficult to block the door closed. No door handle installed and the door is difficult to open.
Safety glass installed. Foam sprayed along the side of the sliding glass door.
Recommend a qualified contractor evaluate and make all necessary repairs.

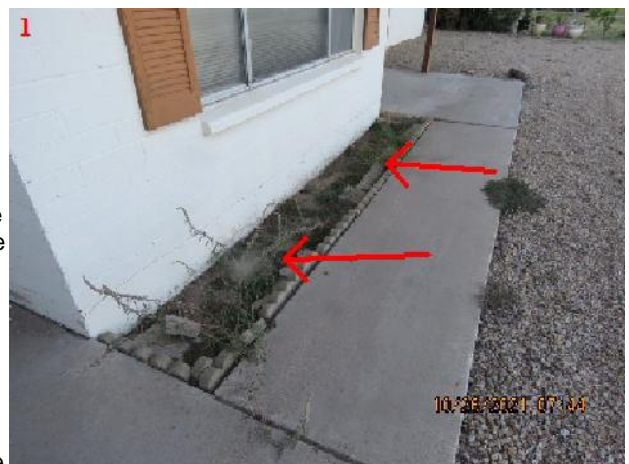
Service/Repair Grading\Surface Drainage - Inadequate, Planter

Soil or the concrete is not properly sloped away from the house foundation. on the side of the garage and in the front. Perimeter areas should be sloped away from house and drains installed as needed for proper drainage to protect the foundation.
When water is allowed to accumulate or flow towards the house foundation due to improperly sloped soil foundation problems may develop.
Recommend a minimum fall of 6 inches within the first 10 feet of the house foundation and or installing drains or slope the yard to ensure drainage away from the foundation.

Planters installed next to the house hold water against the house foundation and sometimes raise the soil level above the house slab level. Recommend finding a way to drain water from this area to help protect the house foundation. When soil is against the house and above the house slab water and pests like termites may enter the home undetected. Recommend keeping planters away from the house foundation.

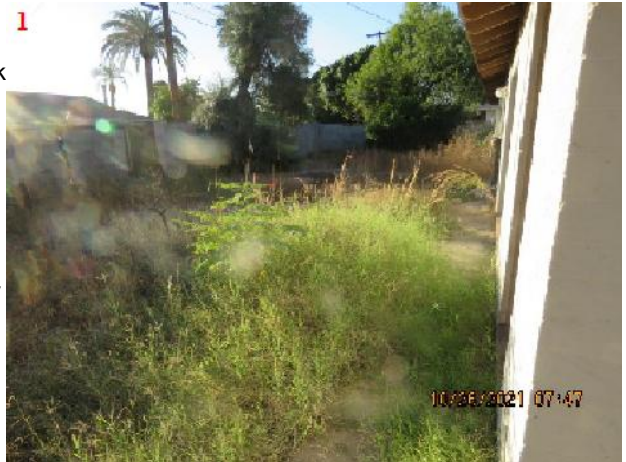
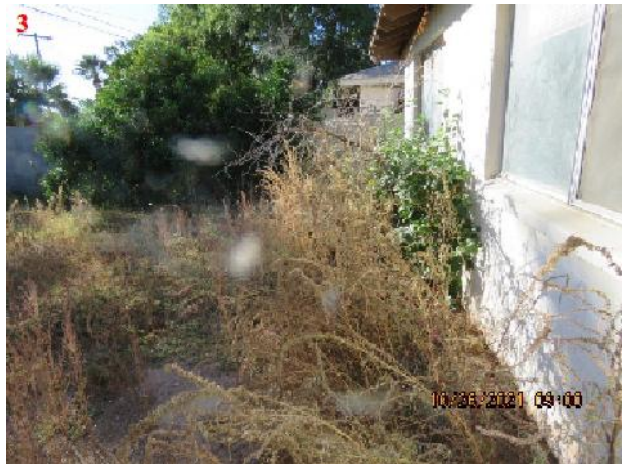
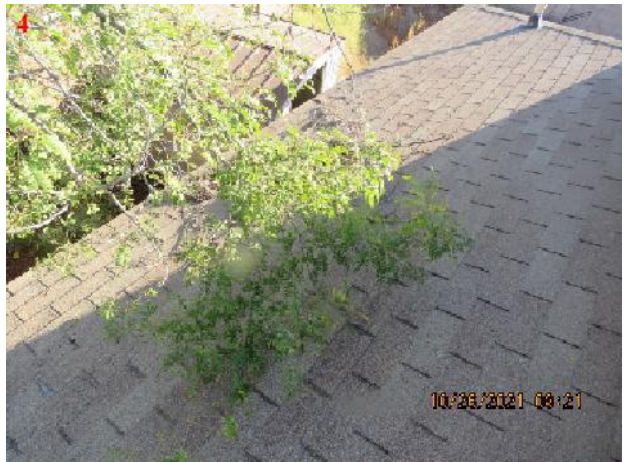
Weeds and vegetation out of control in the back yard. Recommend a qualified contractor evaluate and make all necessary repairs.

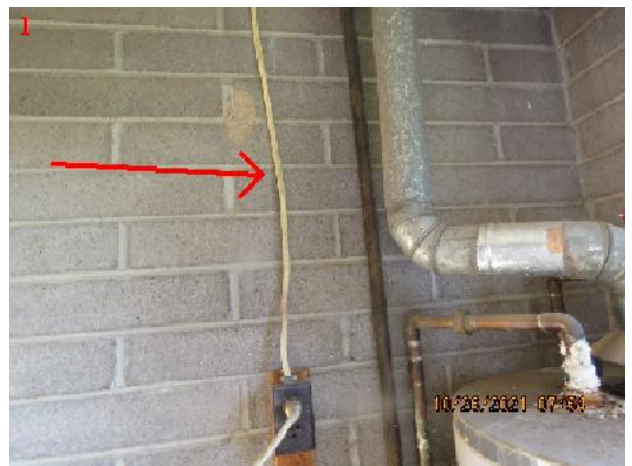
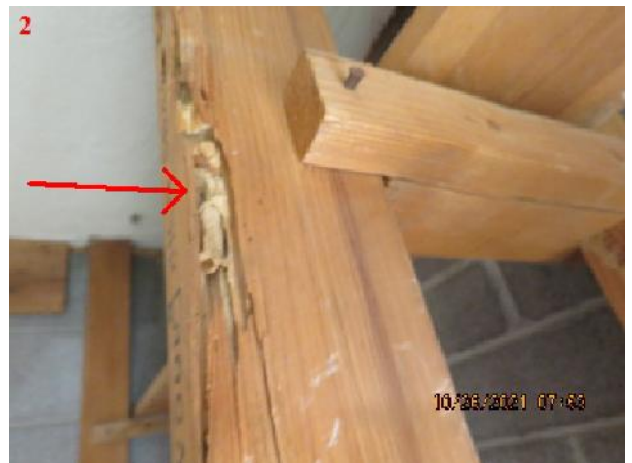
Exposed romex in the storage room in a poor location and termite tubes and termite damage. Recommend a qualified contractor evaluate and make all necessary repairs.

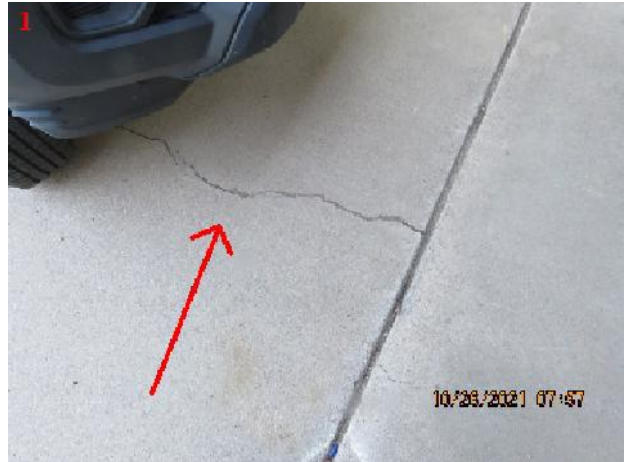
Service/Repair Driveway - Concrete, Cracks

Cracks in driveway. Recommend sealing cracks to keep moisture out and help keep the cracks from spreading.

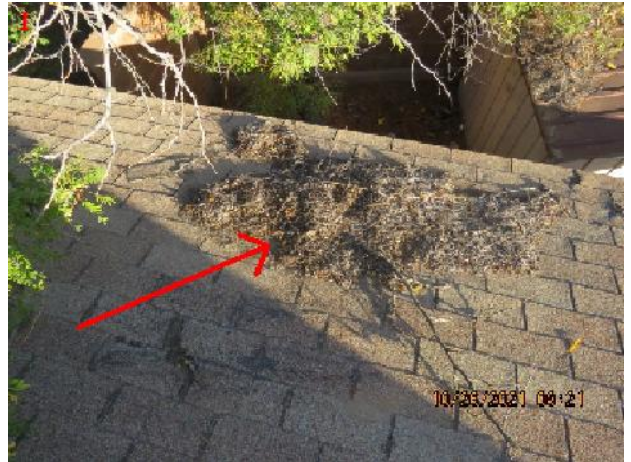
Debris on the roof should be removed. Debris can cause water to backup on the roof and create a roof leak.

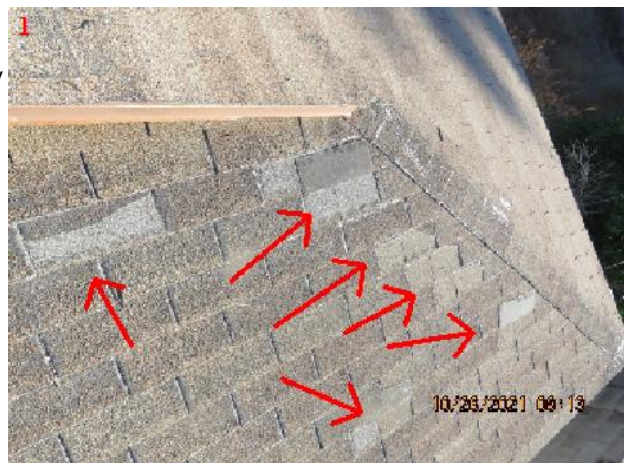
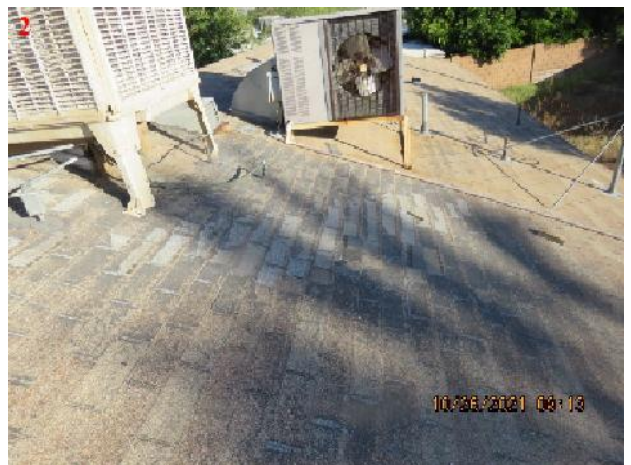
Service/Repair Roof Covering - Asphalt Shingles

This roof is in poor condition and at the end of its useful life. Multiple missing shingle tabs. Recommend a qualified contractor evaluate and make all necessary repairs. A common cause of roof leaks is missing or broken wind blown shingle tabs. Recommend replacing damaged shingles. See picture

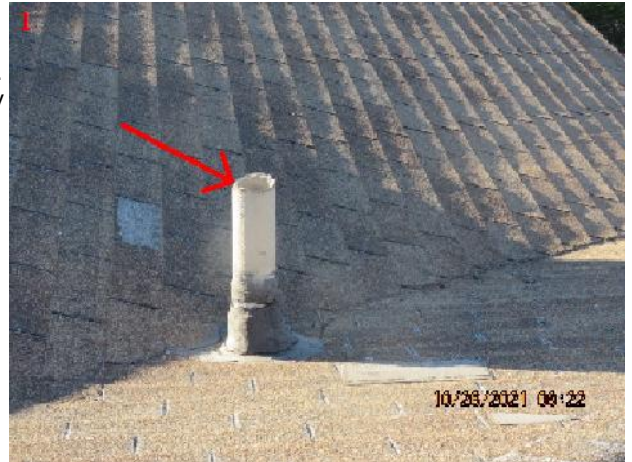
The visible roof flashings were inspected.
Flashing cover for a vent pipe missing. Water can leak inside this pipe. This is not a drain or plumbing pipe so it needs to be covered.
Recommend a qualified contractor evaluate and make all necessary repairs.

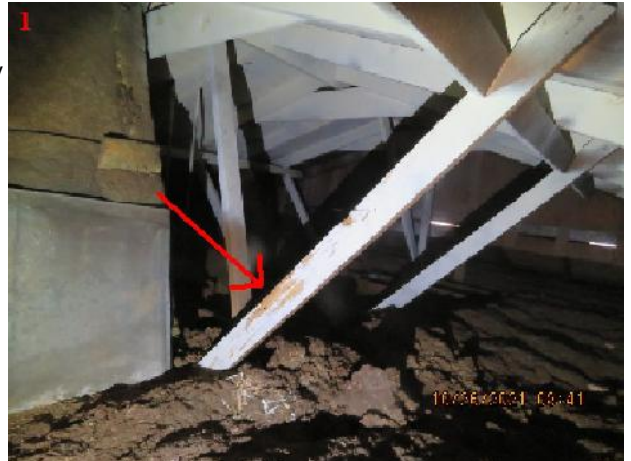
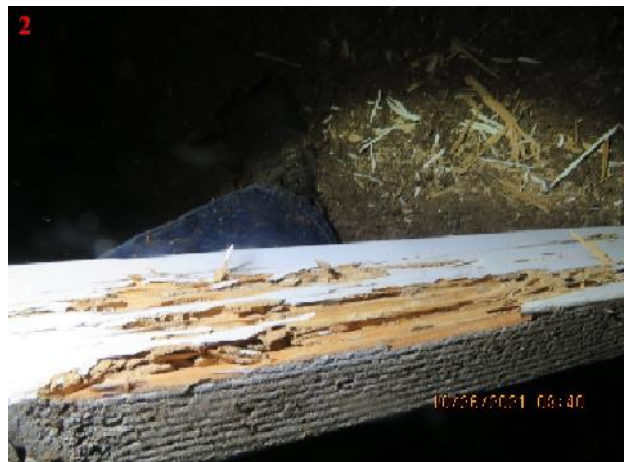
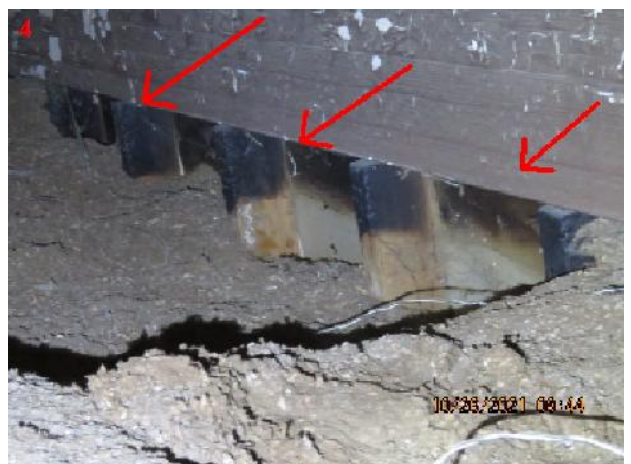
Termite damage to support wood and ceiling joists in the attic. Also some fire damage in the attic.
Recommend a qualified contractor evaluate and make all necessary repairs.

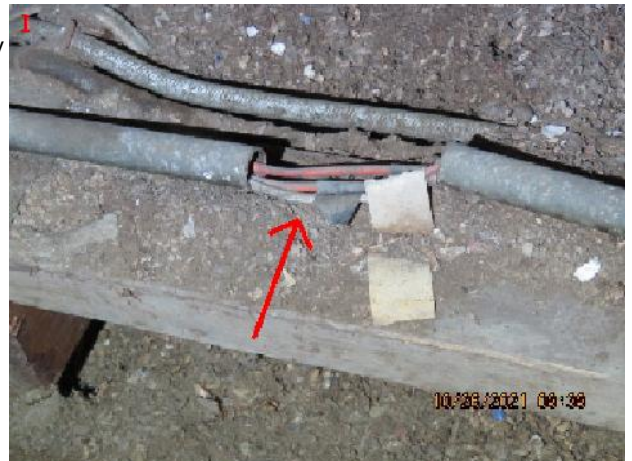
Wires in attic sticking out of conduit.
Recommend a qualified contractor evaluate and make all necessary repairs.

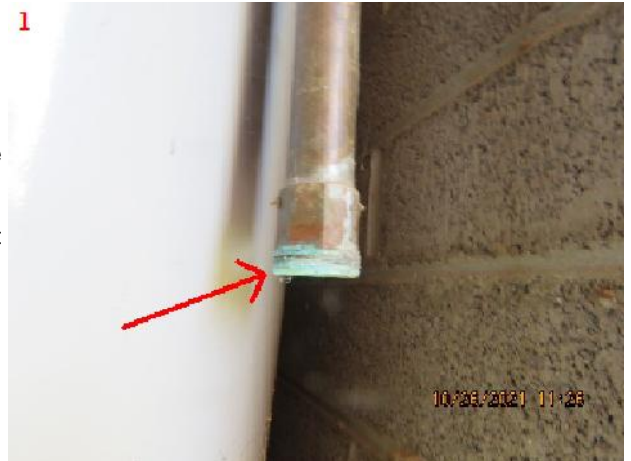
Recommend the water heater temperature and pressure relief valve have a pipe extended from the valve a maximum of 24 inches to a minimum of 6 inches above the floor, and point straight down it should not terminate in the pan under the water heater. The current arrangement is a safety issue. Scalding steam can unexpectedly blow out the end of this pipe and the chances of someone getting burned increases the further the pipe gets above the ground. The water heater temperature pressure relief valve was not operated unless other wise noted in this section of the report.

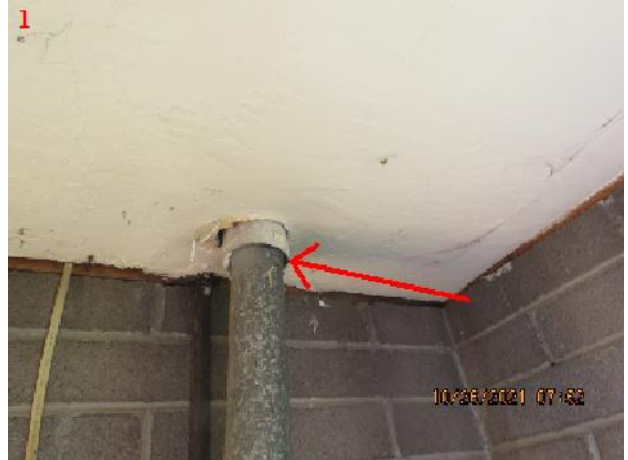
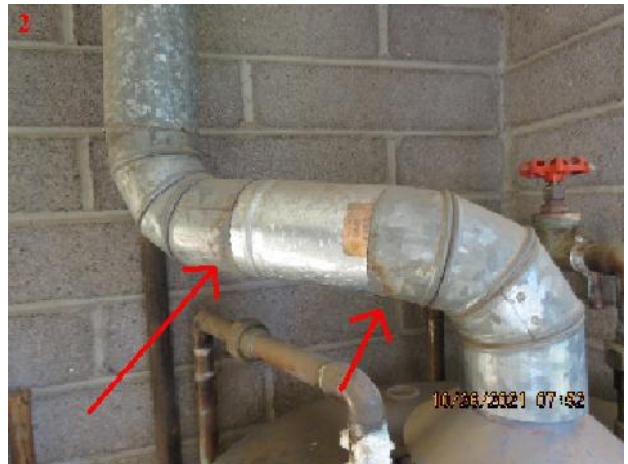
The water heater single walled vent pipe is attached to the transite vent pipe at the ceiling. Attaching metal vent pipes to transite vent pipes is not recommend. See picture
Recommend a qualified mechanical contractor evaluate and make all necessary repairs.

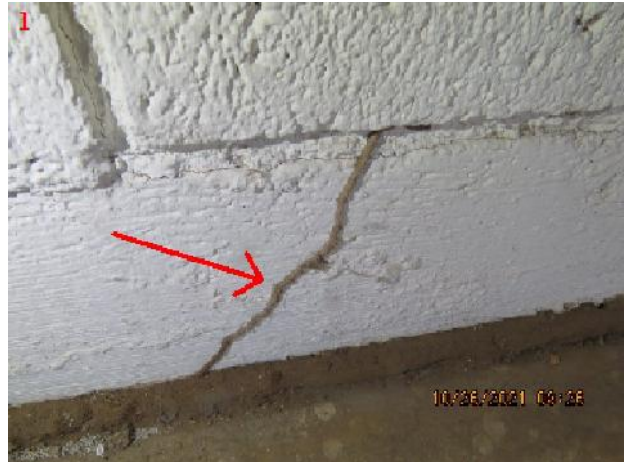
Termite tubes found in the garage on the foundation stem wall. Recommend a qualified termite inspector evaluate and make all necessary repairs.

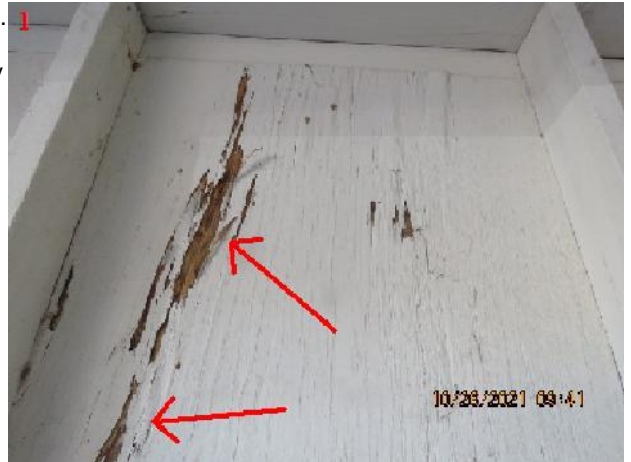
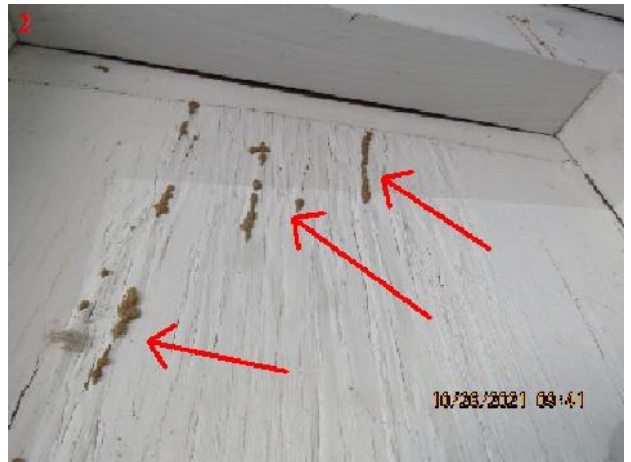
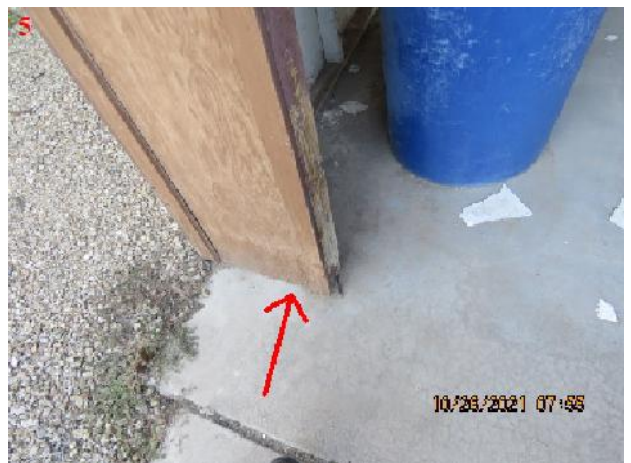
Termite tubes and termite damage to the exterior garage wall siding. The front facing garage walls are loose at the bottom. Recommend a qualified contractor evaluate and make all necessary repairs.

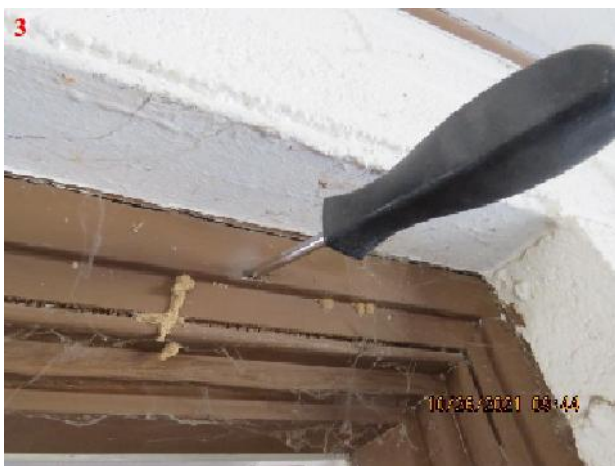
Termite tubes and termite damage to this door Jamb. Recommend a qualified contractor evaluate and make all necessary repairs.

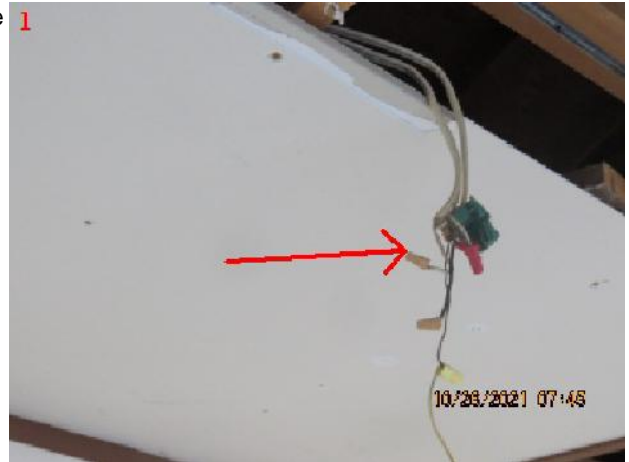
One of more of the garage light fixtures have been removed and the wires left uncovered. Recommend installing light fixture or cover plate to cover the exposed wires.

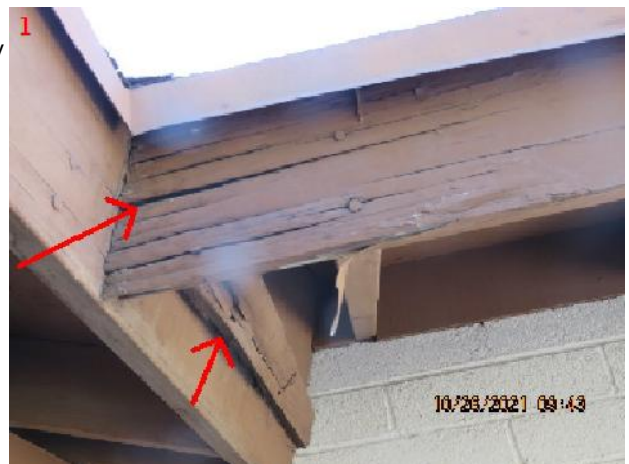
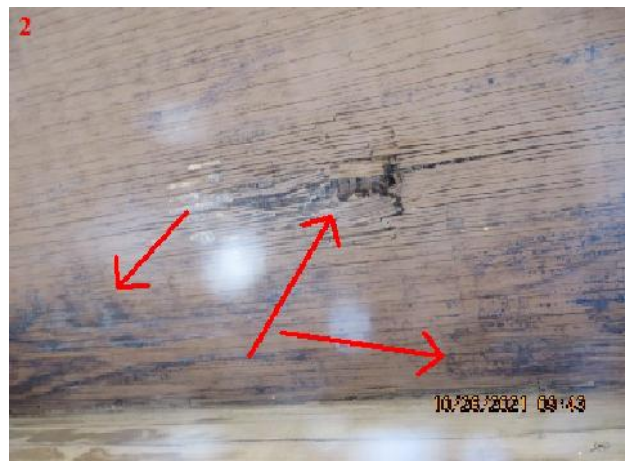
Wood rot in the garage fascia, trim and roof sheathing in the front. Recommend a qualified contractor evaluate and make all necessary repairs.

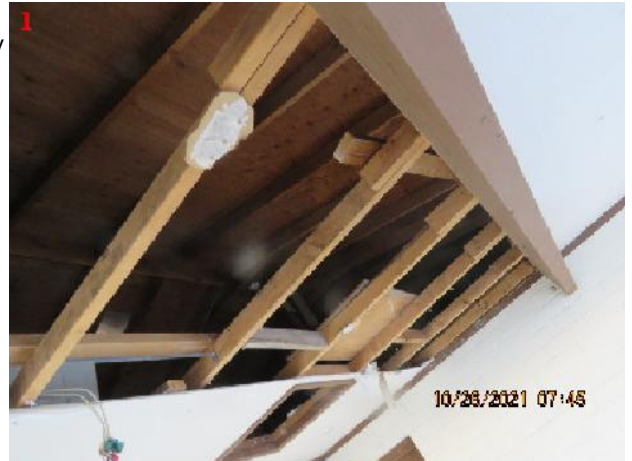
Large section of the garage ceiling drywall has been removed.
Recommend a qualified contractor evaluate and make all necessary repairs.

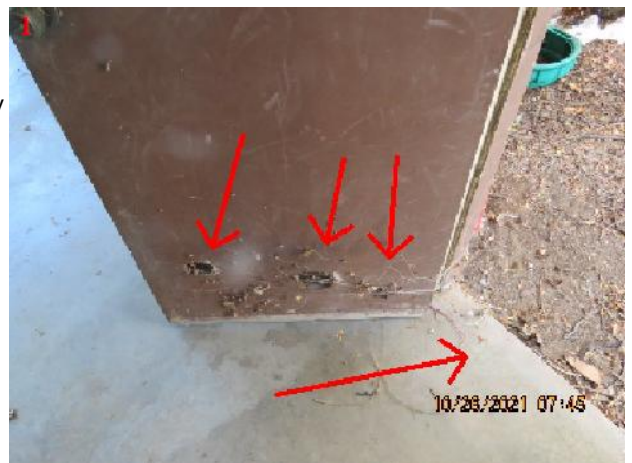
Garage door to side yard tested and found to be in proper working order but there are holes in the exterior of this door and no threshold.
Recommend a qualified contractor evaluate and make all necessary repairs.

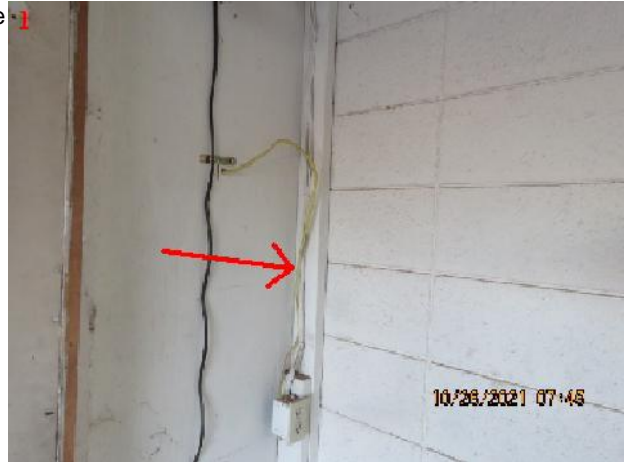
Exposed romex type wire found in the garage less than 7 feet above the floor. This is a shock hazard. Recommend a qualified contractor evaluate and make all necessary repairs. See sample picture.

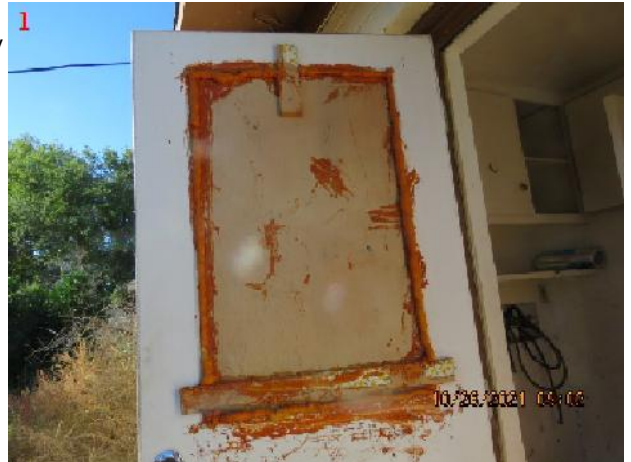
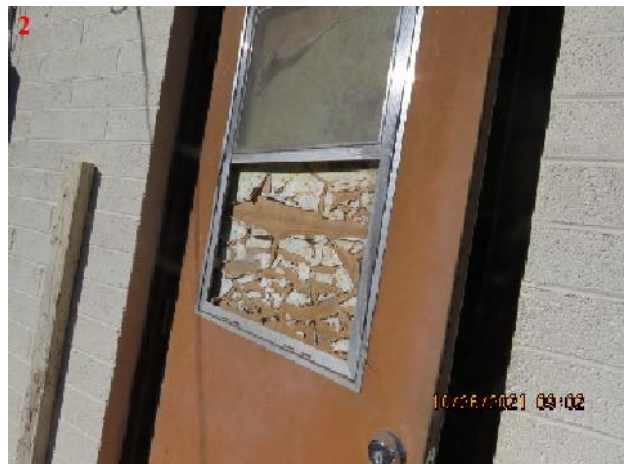
The laundry door to the back is rusted and has a smashed window. Recommend a qualified contractor evaluate and make all necessary repairs.

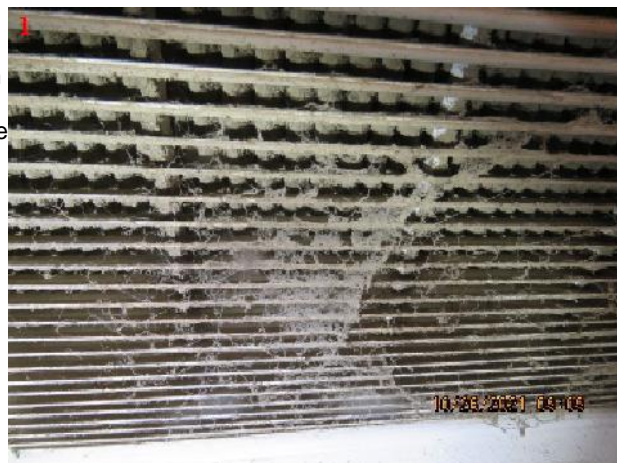
Recommend replacing dirty air conditioner filter or cleaning permanent air filters. When air filters get dirty the chances of dirt and other contaminants getting by the filter and into the duct system increases. Recommend replacing or cleaning air filters once a month and sooner when needed. Dirty filters also put a strain on the heating and cooling system and may cause the system to malfunction. I recommend Beyond Image Cleaning for duct cleaning 480-649-6497.

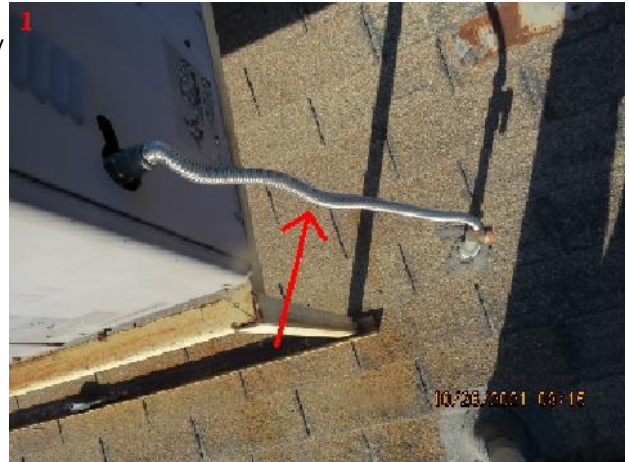
The gas line to the furnace is too tight.
Recommend a qualified contractor evaluate and make all necessary repairs.

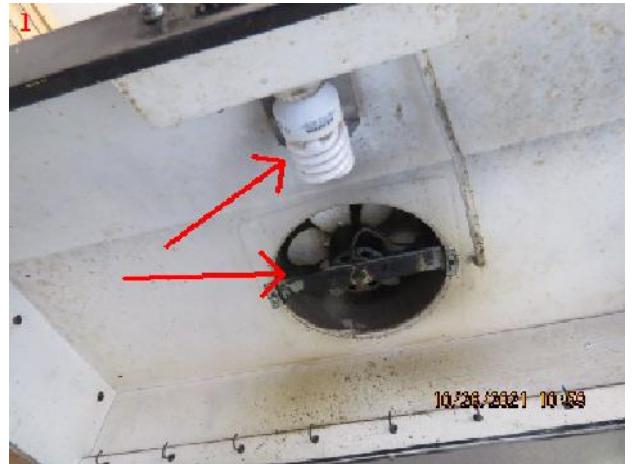
The light bulb cover for the stove hood is missing. This may allow steam from the stove top to explode the light bulbs. Recommend installing missing bulb cover. See picture

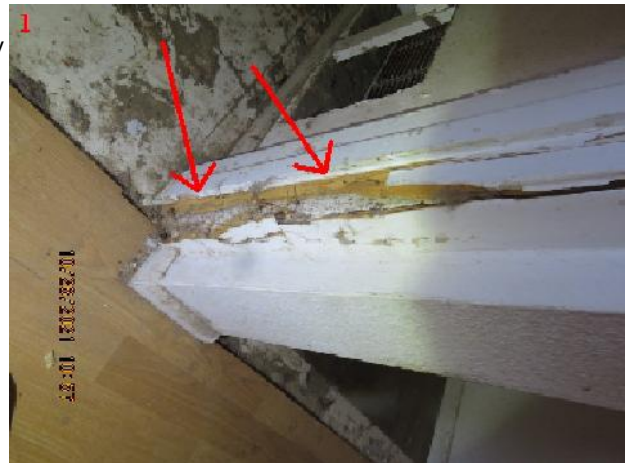
Termite damage to the pantry door jamb and the door is missing. Recommend a qualified contractor evaluate and make all necessary repairs.

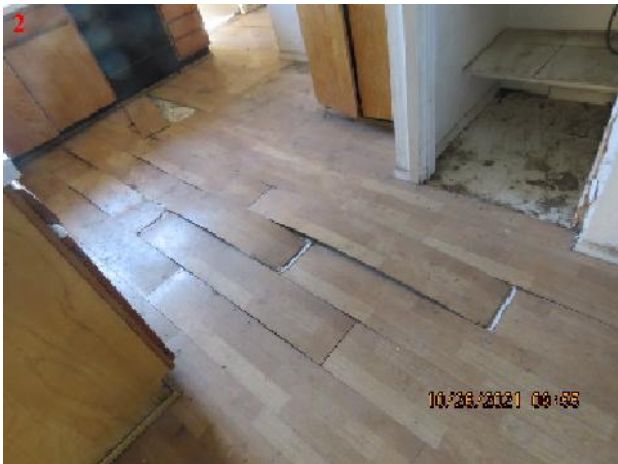
Service/Repair Kitchen Floors - Inspected

Kitchen floor covering poor condition.
Recommend a qualified contractor evaluate and make all necessary repairs.

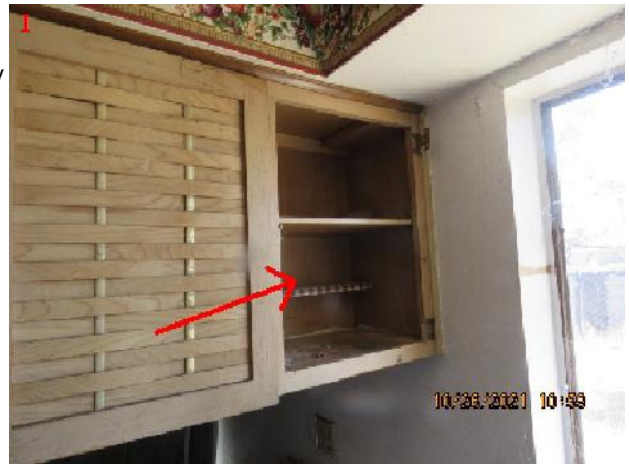
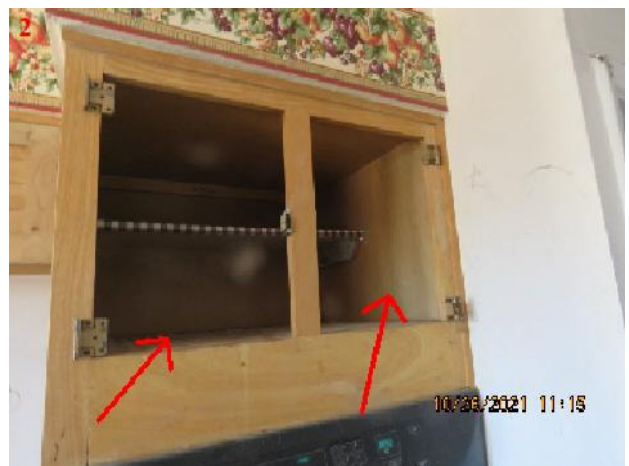
Kitchen cabinet upper doors missing and one damaged. Water damage to the base of the kitchen sink cabinet. Recommend a qualified contractor evaluate and make all necessary repairs.

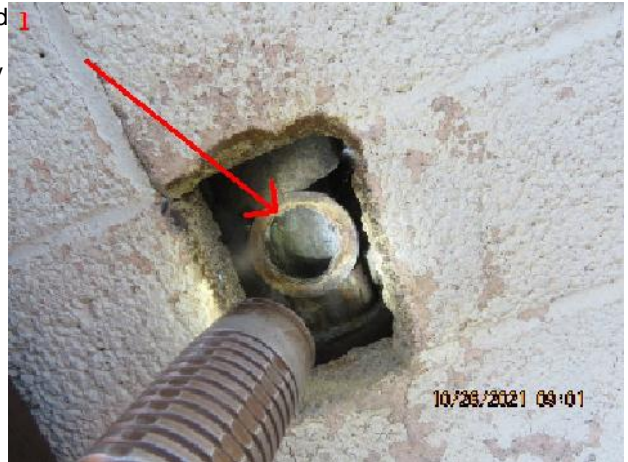
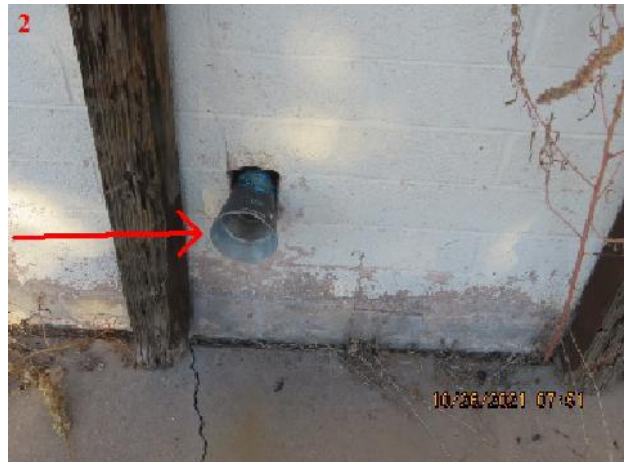
The kitchen sink drain drains into the back yard. A cup was installed to keep water from draining in the wall. Recommend a qualified contractor evaluate and make all necessary repairs.

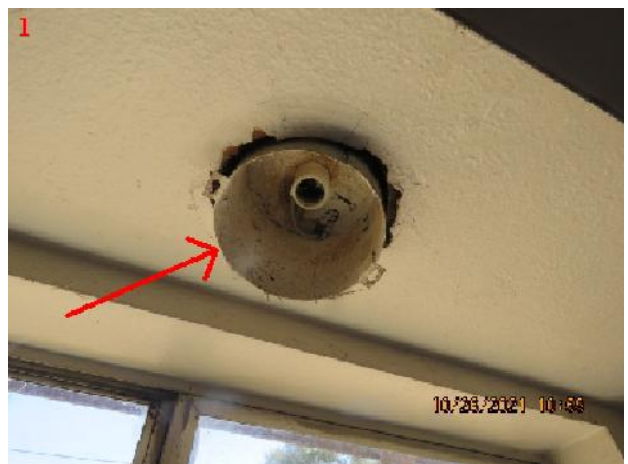
Service/Repair Kitchen Switches Fixtures - Recessed

Recessed light fixture in the kitchen hanging out of the ceiling and not working. Recommend a qualified contractor evaluate and make all needed repairs.

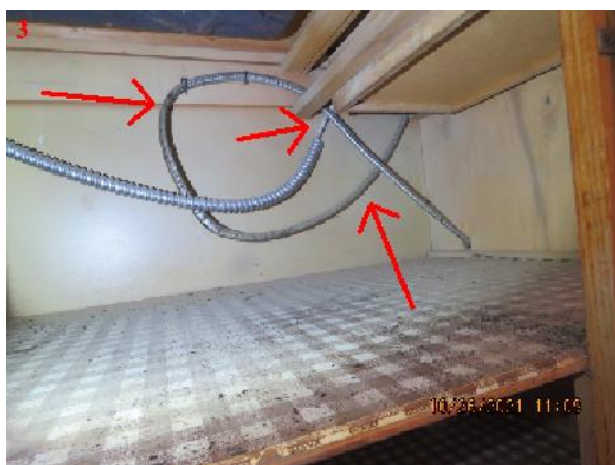
Exposed romex type wire found in kitchen cabinets upper and lower with exposed wire nuts on romex wires under the kitchen sink. Recommend all exposed romex type wire less than seven feet above the floor be installed in conduit or properly protected. This is a shock hazard. Recommend a qualified electrical contractor evaluate and make all needed repairs.

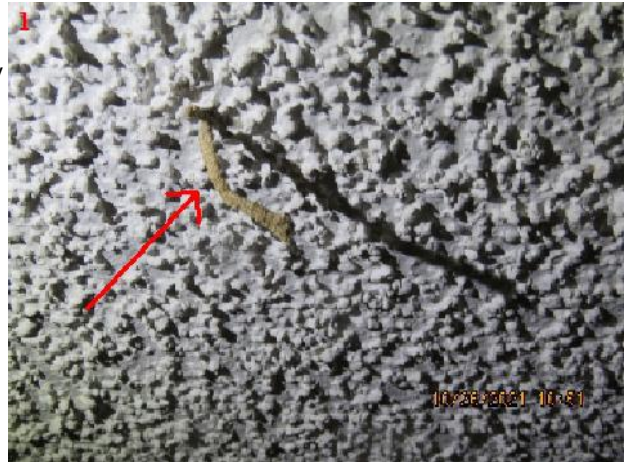
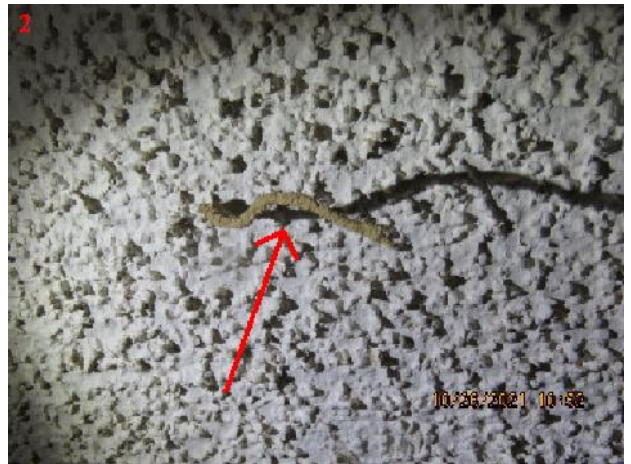
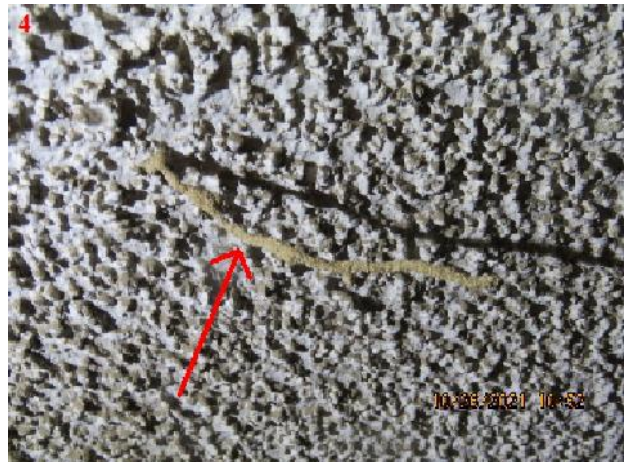
Lots of long termite tubes hanging from the ceiling in the family room. See sample pictures
Recommend a qualified contractor evaluate and make all necessary repairs.

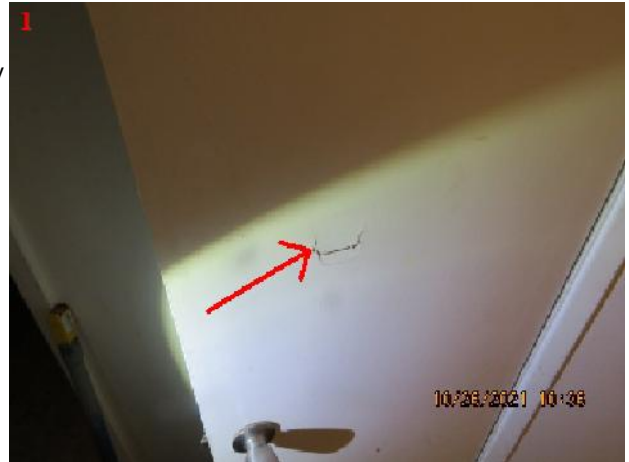
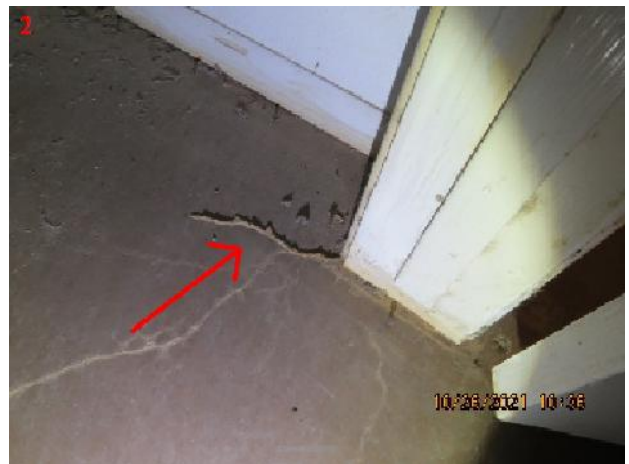
Hall closet door damaged, the lock does not latch and there is a termite tube on the floor.
Recommend a qualified contractor evaluate and make all necessary repairs.

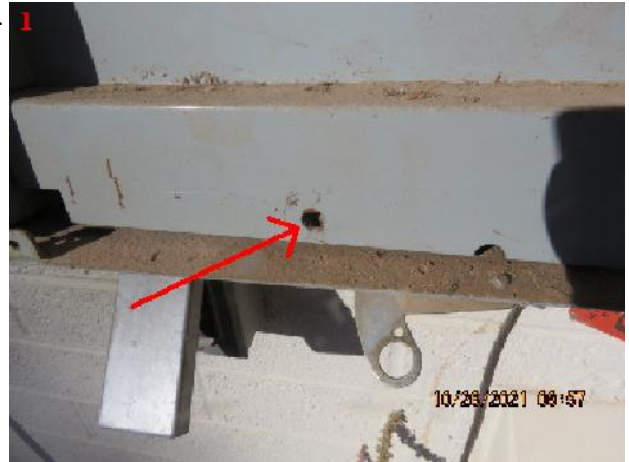
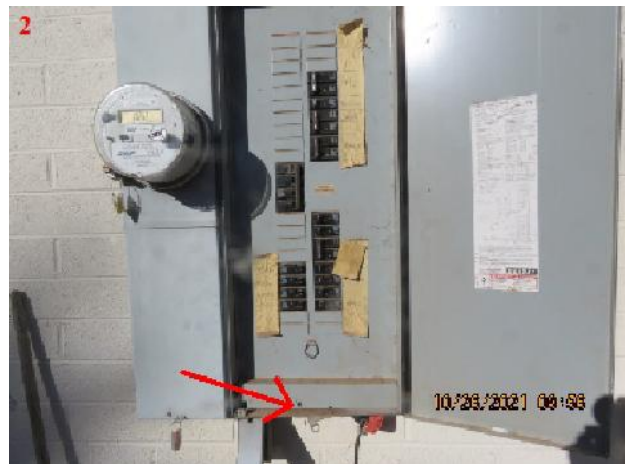
Screw missing for the breaker cover plate at the main electric panel. Recommend installing screw to properly hold the breaker cover plate in place.

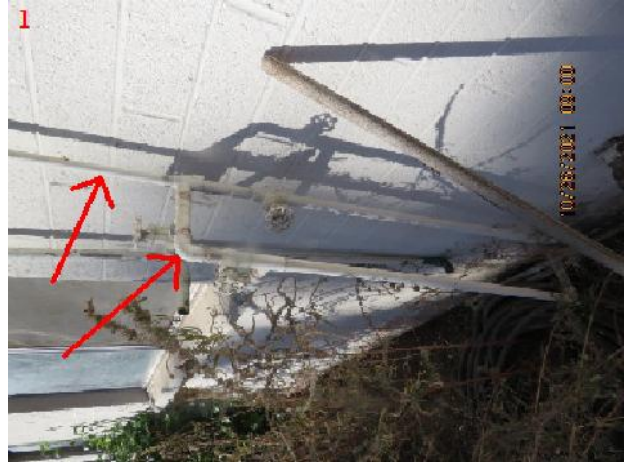
Loose copper pipes on the back of the house.
Recommend properly supporting all pipe. See sample picture

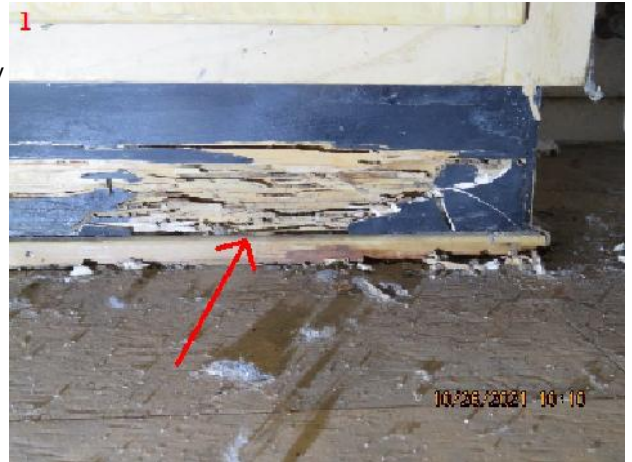
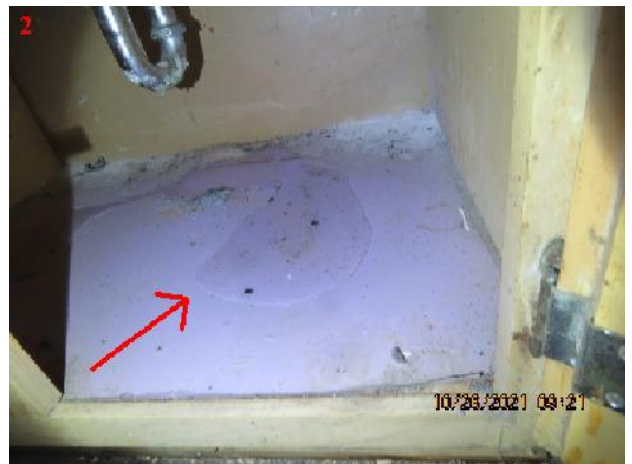
Termite damage to the base of the master bathroom sink cabinet and water stain and water on the base of the sink cabinet. Recommend a qualified contractor evaluate and make all necessary repairs.

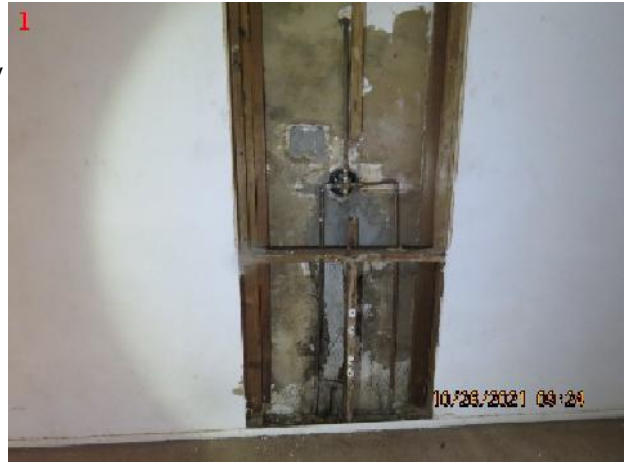
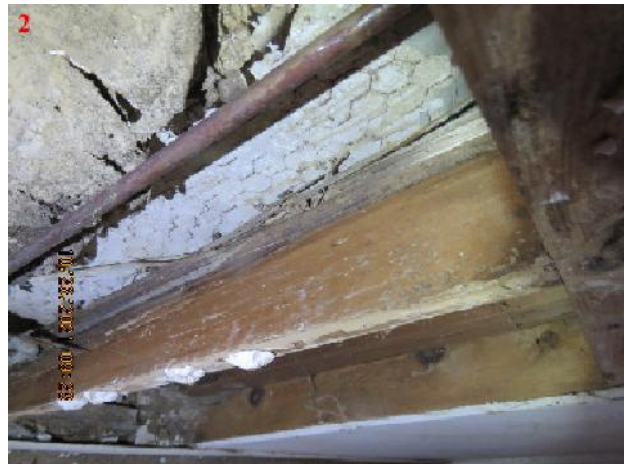
Termite tubes and termite damage to the master shower wall and plaster missing on the living room side of this wall. Recommend a qualified contractor evaluate and make all necessary repairs.

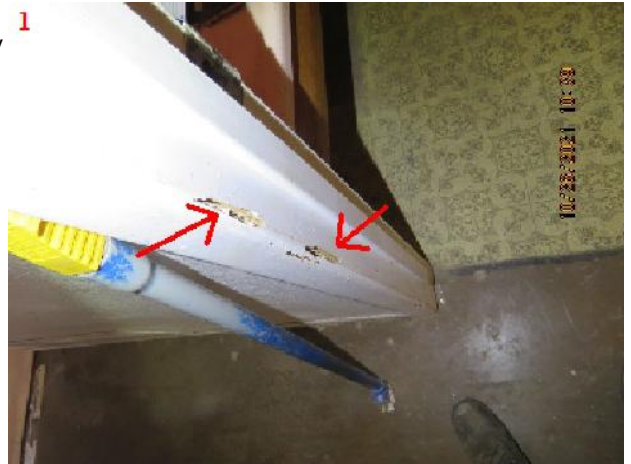
Termite damage to the hall bathroom door jamb.
Recommend a qualified contractor evaluate and make all necessary repairs.

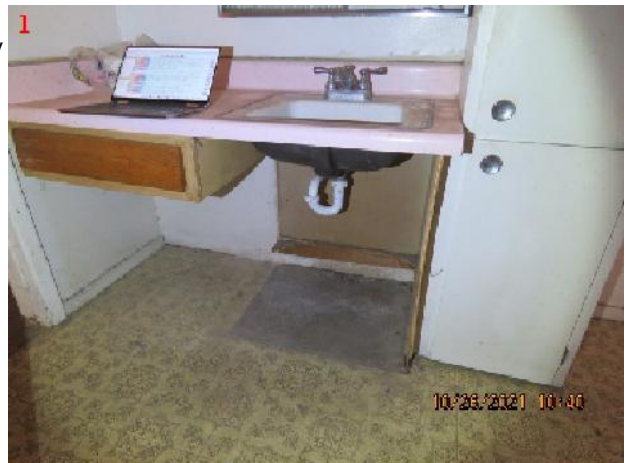
Most of the sink cabinet has been removed.
Recommend a qualified contractor evaluate and make all necessary repairs.

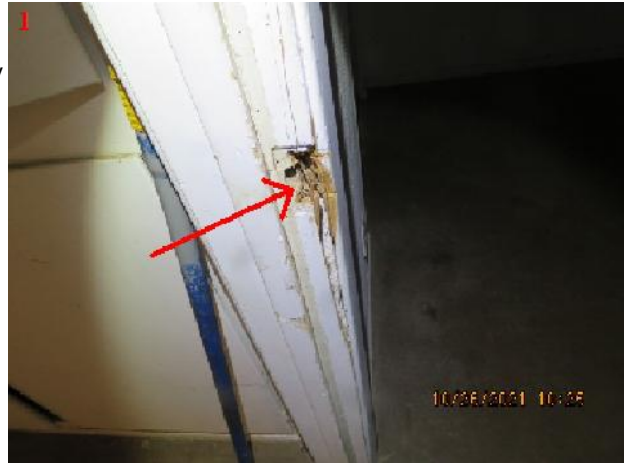
The entrance door to this bedroom is missing and the door jamb damaged.
Recommend a qualified contractor evaluate and make all necessary repairs.

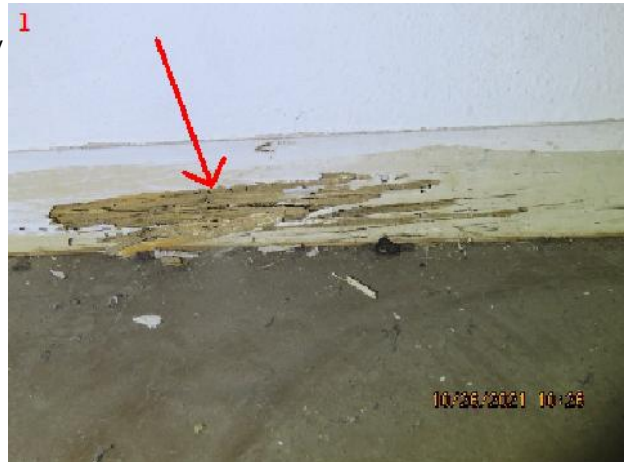
Termite damage to the baseboard in the closet.
Recommend a qualified contractor evaluate and make all necessary repairs.

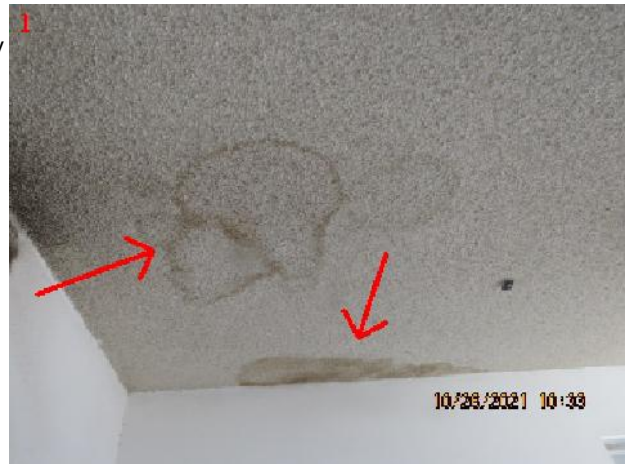
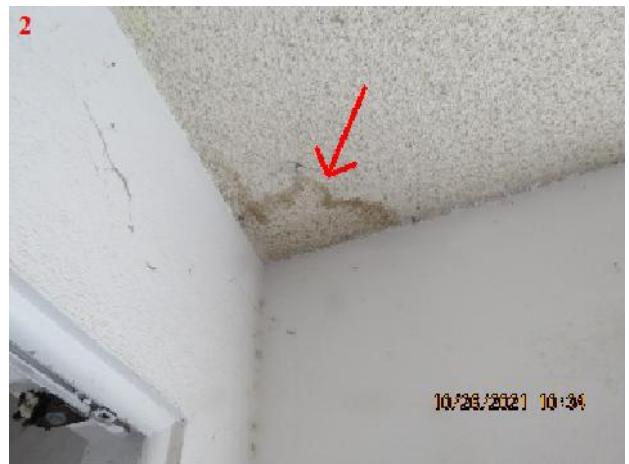
Large water stains on the ceiling in this bedroom.
Recommend a qualified contractor evaluate and make all necessary repairs.
