Perfection Home Inspections
Mesa, AZ 85203
602-524-2916
perfectionhomeinspections.com

Client Information: Record Number 8777

Lawsen, Stewart
16932 E. Monterey Drive
Fountain Hills, AZ 85268
480-861-2530

Inspected 4/5/22 8:00 AM
Built 2002
3070 sf

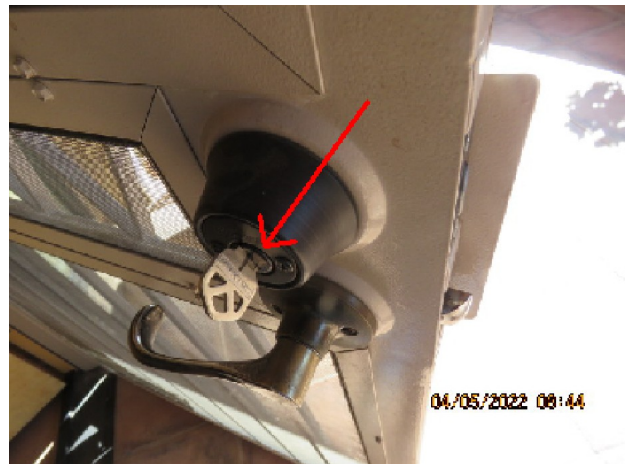
Double sided dead bolt locks used on the front exterior security screen door. These type of locks require the use of a key to exit so they are a fire escape hazard. Recommend replacing all double dead bolts with standard dead bolt locks.

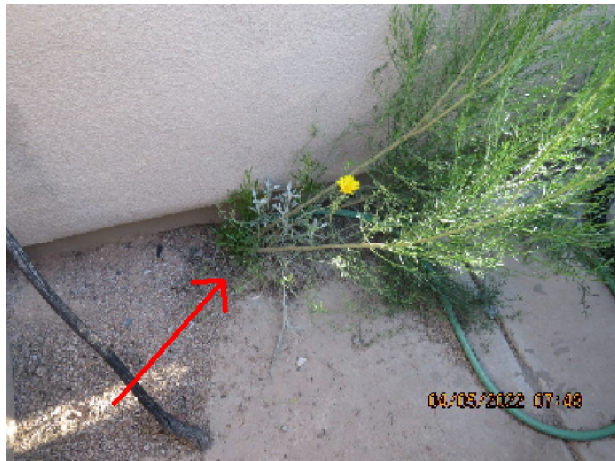
Vegetation and or other plants on the house are not recommend. Plants too close to the house foundation may damage the foundation. Recommend keeping all vegetation and plants off the exterior of the house.

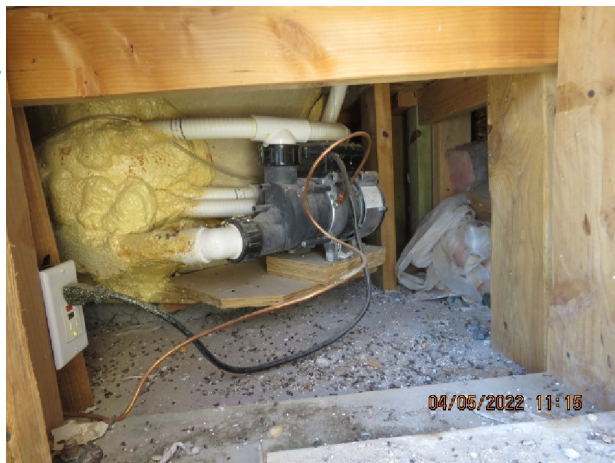
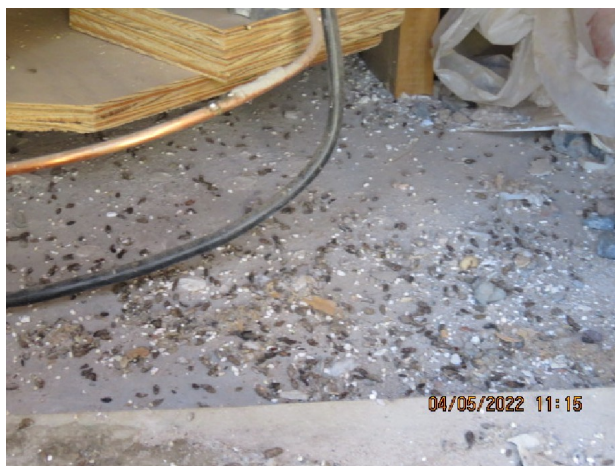
Rodent dung in the master bathroom spa access panel accessed from the exterior.
Recommend a qualified contractor evaluate and make all necessary repairs.

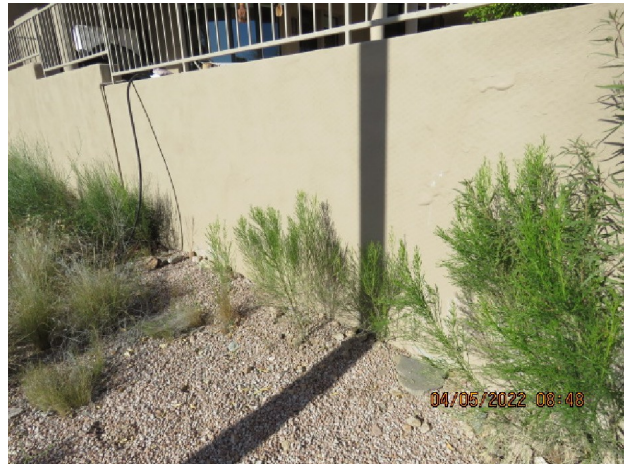
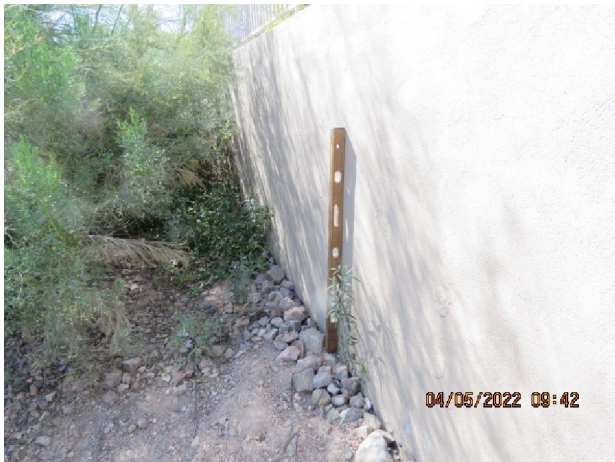
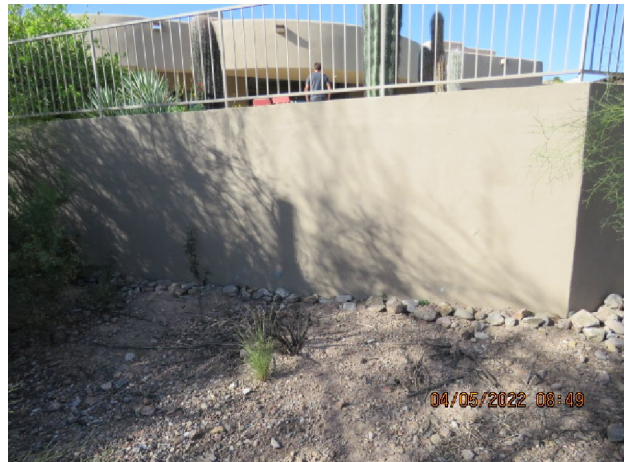
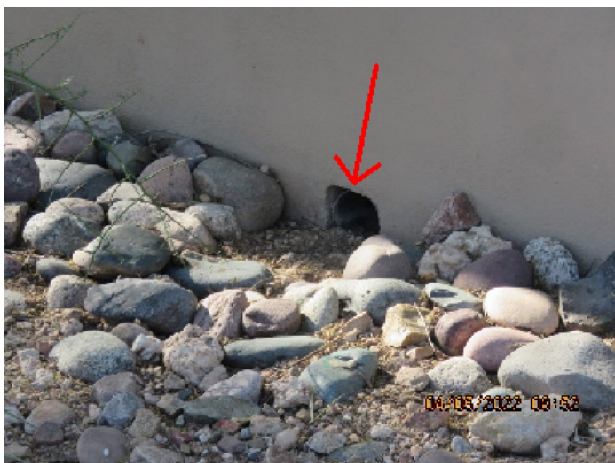
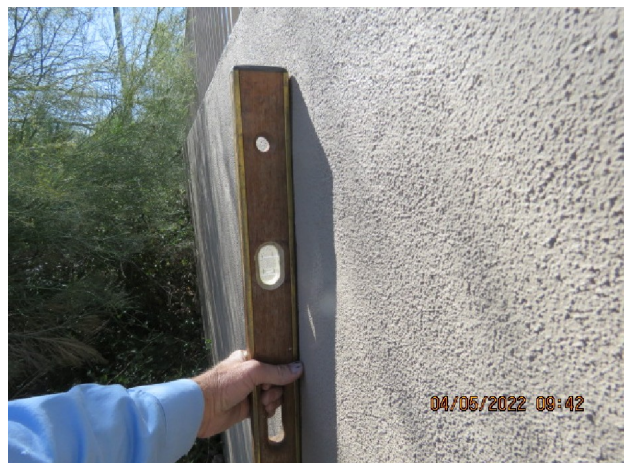
Retaining walls in front and back. Retaining wall in the back does not appear to have enough lower wall drains. I did find a few drains and others maybe underground. This wall is level but I recommend finding all retaining wall drains and making sure they are able to drain water from behind the wall.

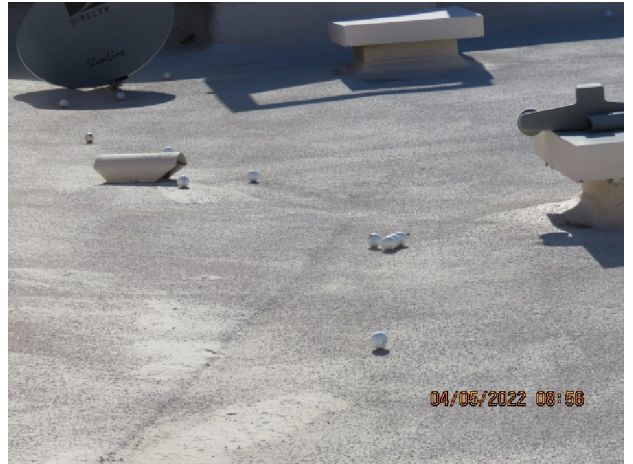
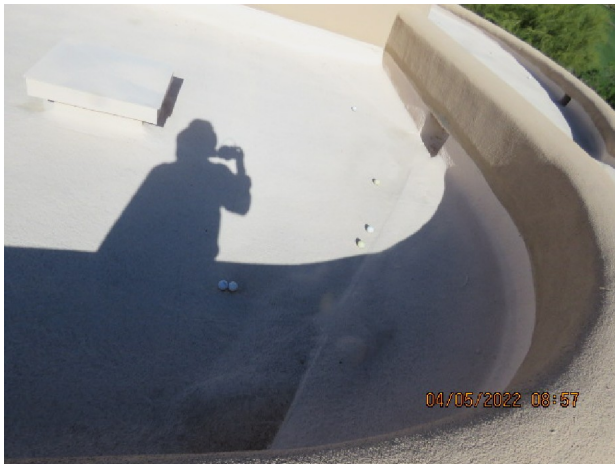
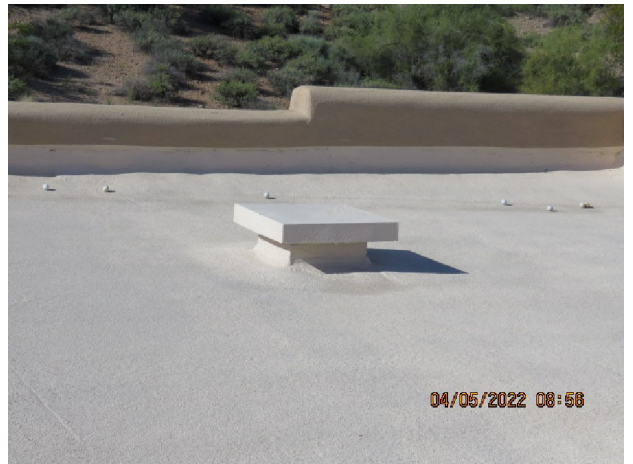
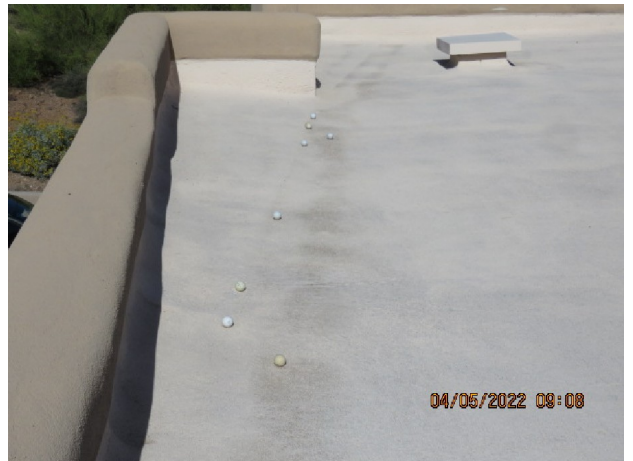
See sample picture of the roof. Lots of golf balls om the roof. Golf balls can damage the roof. Recommend finding a way to keep golf balls off the roof.

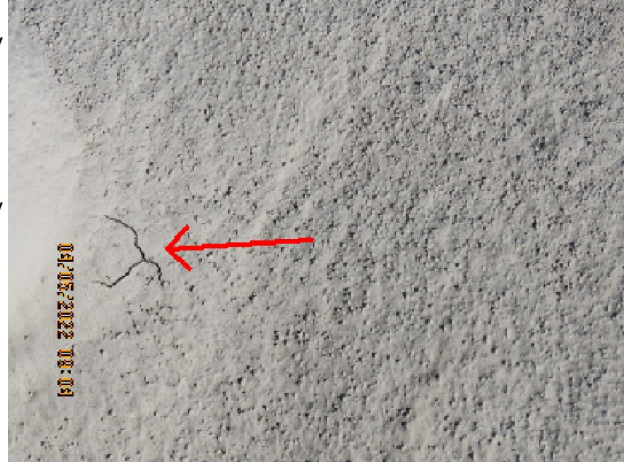
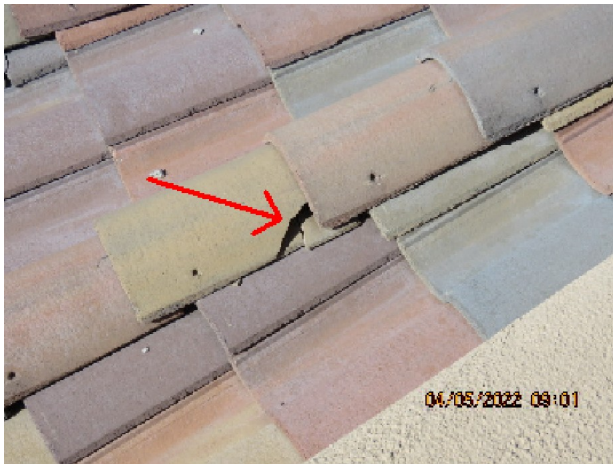
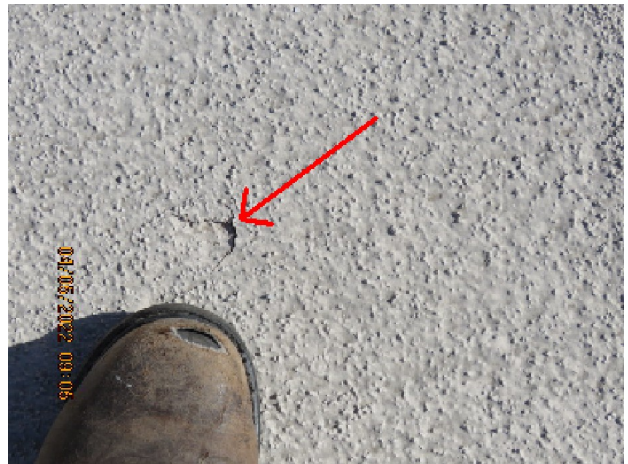
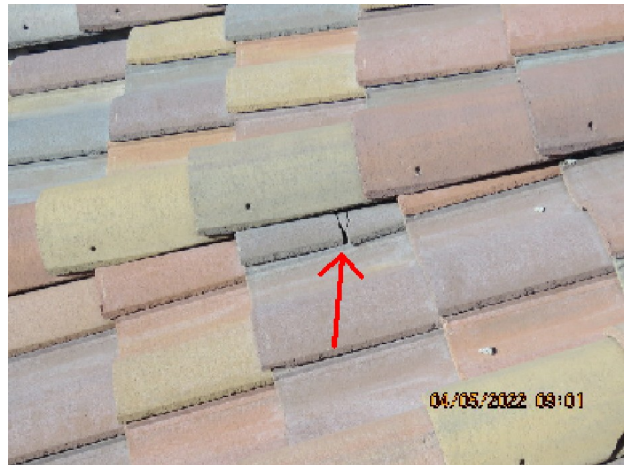
There are a few cracks in the roof surface from golf ball strikes. Recommend a qualified contractor evaluate and make all necessary repairs.

S style concrete roof tiles installed on the front porch roof. several cracked roof tiles found see rows 7,6,and 12 for cracked or broken roof tiles. Recommend a qualified contractor evaluate and make all necessary repairs. See sample pictures

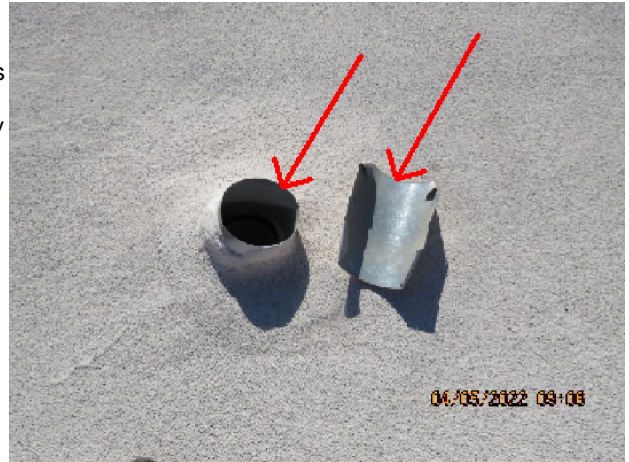
The visible roof flashings were inspected.
Roof flashing cover missing for the kitchen hood vent. This will allow rain to enter this home. Recommend making sure the cover is properly attached so it cannot blow off.
Recommend a qualified contractor evaluate and make all necessary repairs.

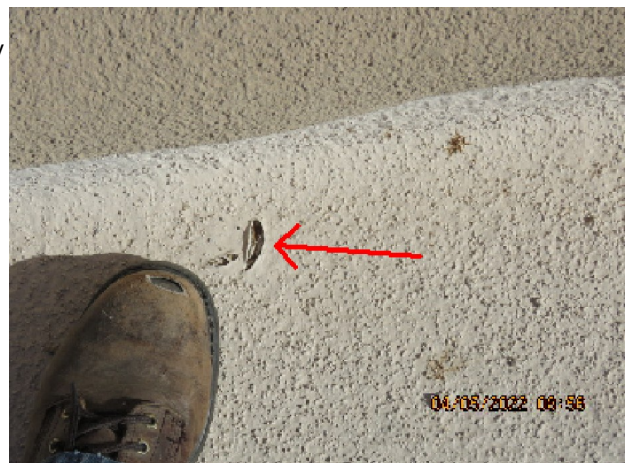
Crack in the roof covering above the patio roof.
Recommend a qualified contractor evaluate and make all necessary repairs.

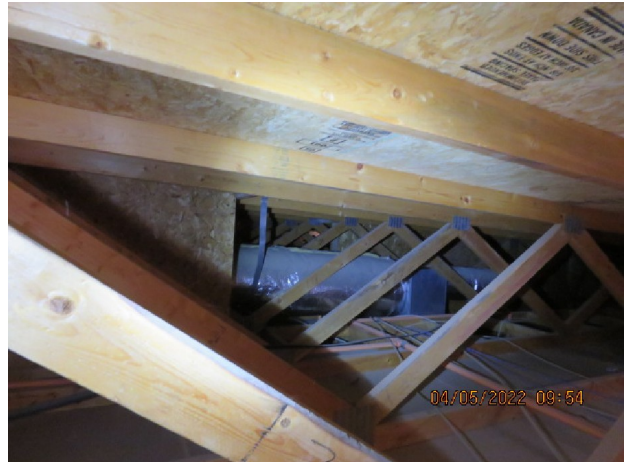
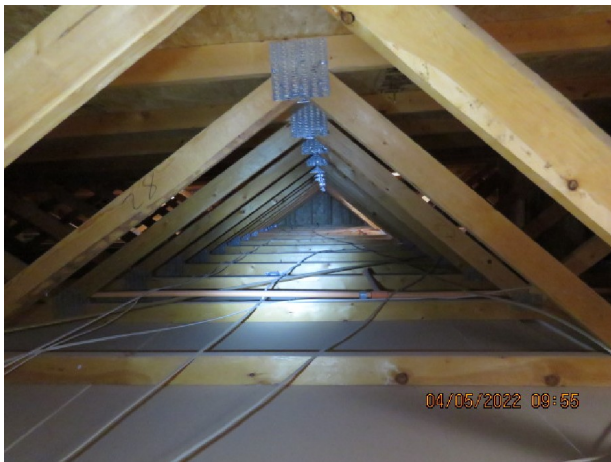
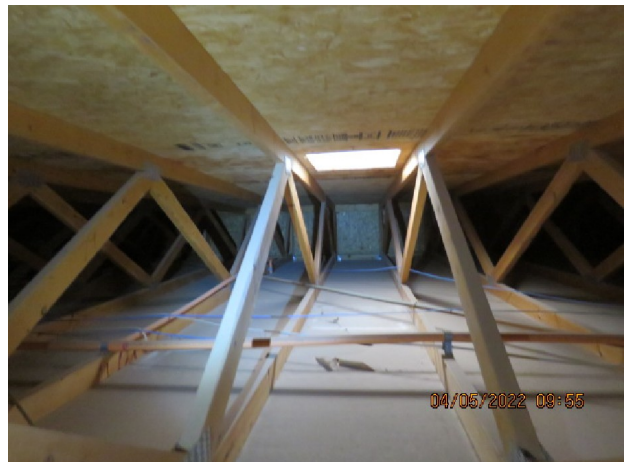
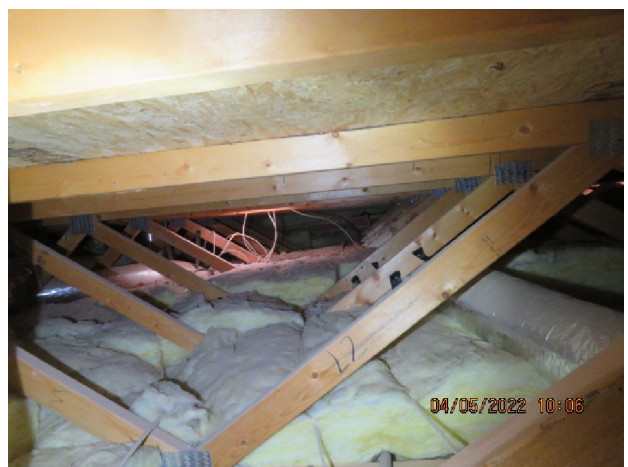
The attic area was viewed from the attic access hole and within 8 feet in from the access hole. Recommend installing more attic access holes so more of the area can be inspected. Garage attic is connected to the house attic but an HVAC duct blocks access from on attic space to another.

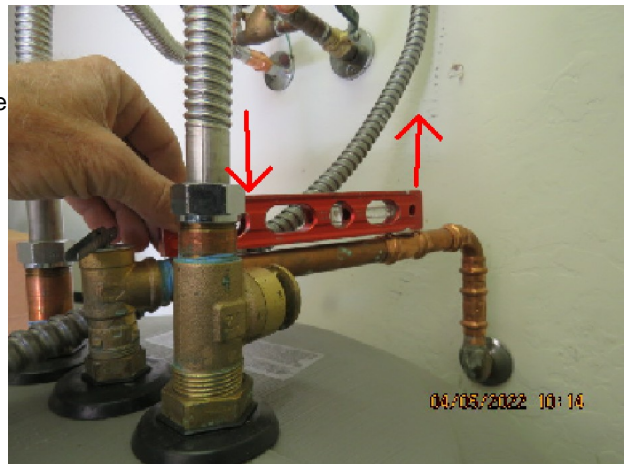
The temperature and pressure relief valve drain line is installed going up hill. This may allow the temperature and pressure relief valve to become clogged and not work properly. This is a safety hazard. Recommend properly installing drain line as required by the manufacturer.

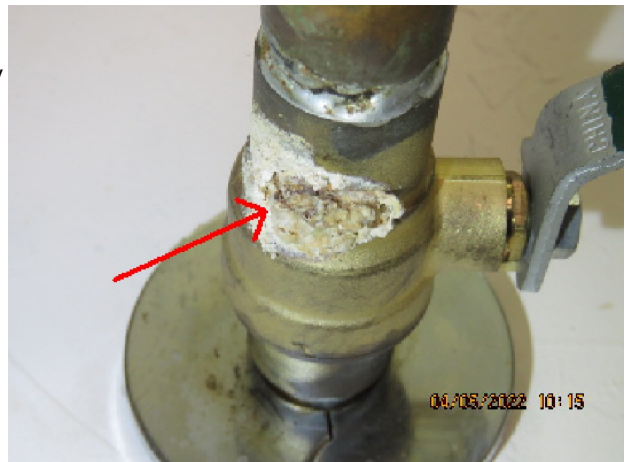
Corrosion on the water heater water shutoff valve is an indication of a small leak. Recommend a qualified contractor evaluate and make all necessary repairs.

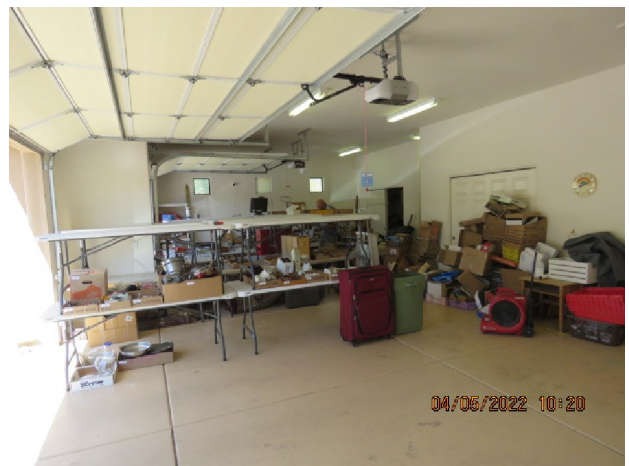
Stuff in the garage blocks view of the interior of the garage.
Recommend inspecting garage area after the stuff is removed.

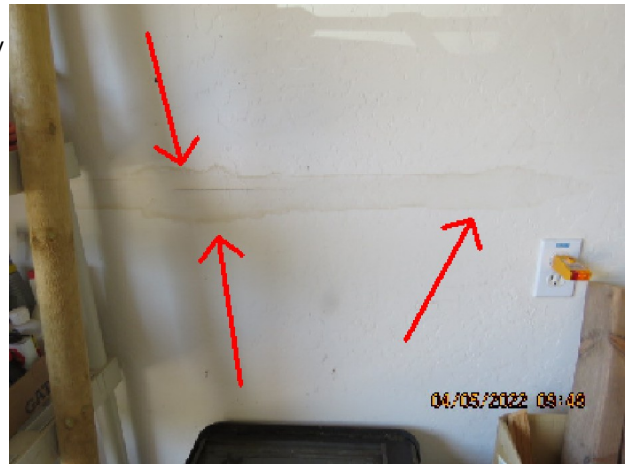
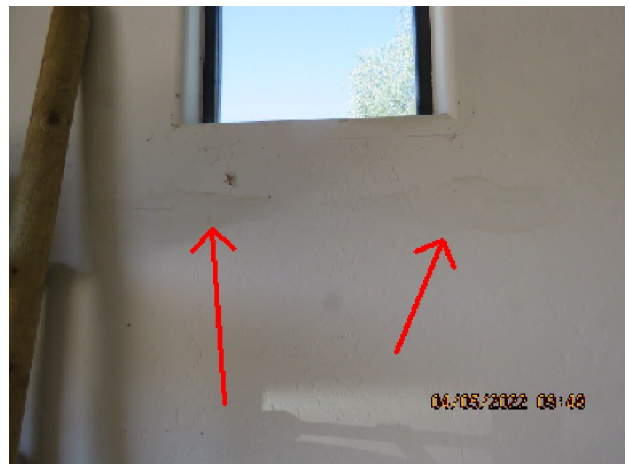
Water stains on the west wall in the garage.
Recommend a qualified contractor evaluate and make all necessary repairs.

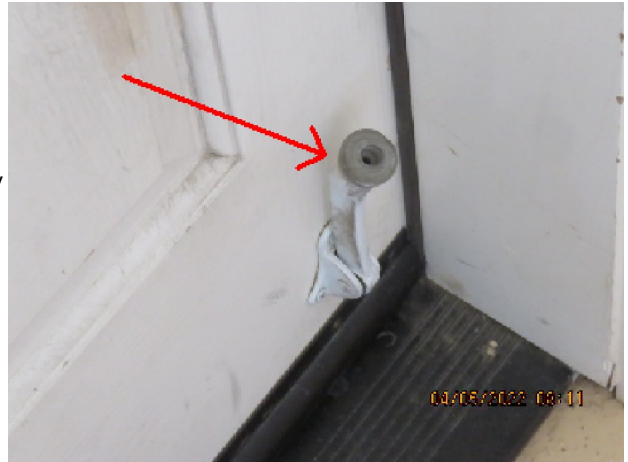
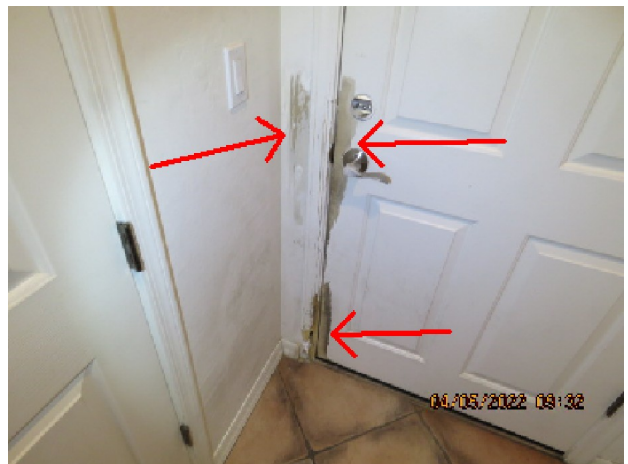
No latch or door stopper of any type should be installed on the garage door to the house that keeps the door from automatically closing. This may allow carbon monoxide gas to enter the home. Recommend removing any type of such latch. Damage to the door wall and wall molding at the entrance to the garage. Recommend a qualified contractor evaluate and make all necessary repairs.

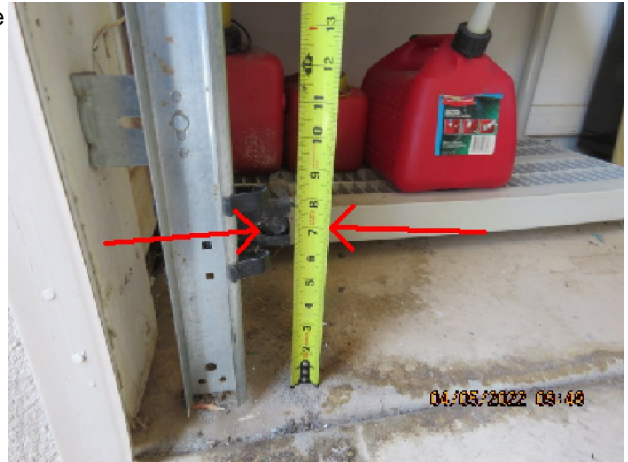
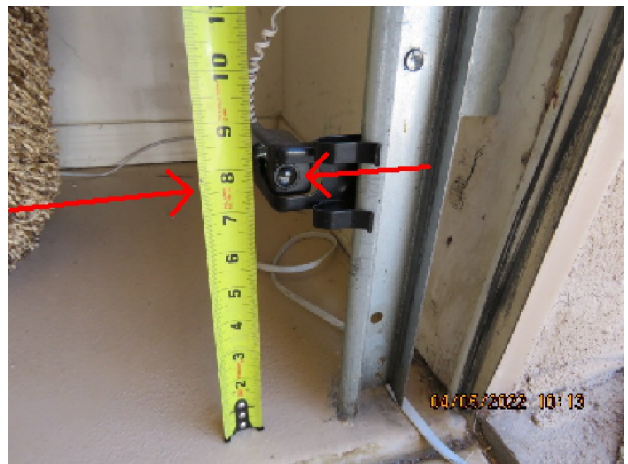
The electronic eye sensor beams used to stop the automatic garage doors from closing if something is in their path are more than the recommended height of 6 inches above the garage floor. This is a safety hazard. Recommend installing this sensor eye beam 4 to 6 inches above the garage floor.

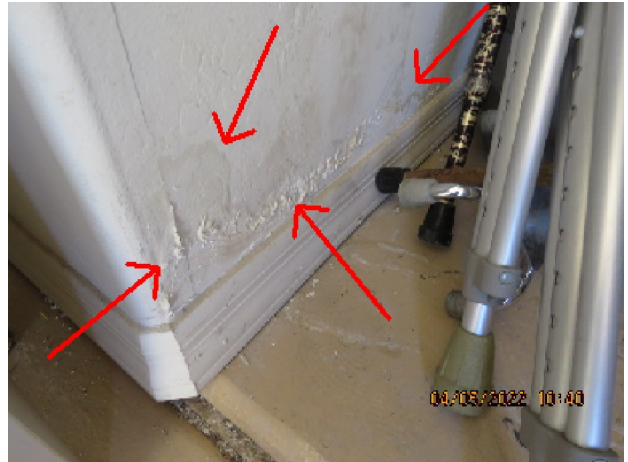
Water stains in the garage at the water heater area. Recommend a qualified contractor evaluate and make all necessary repairs.

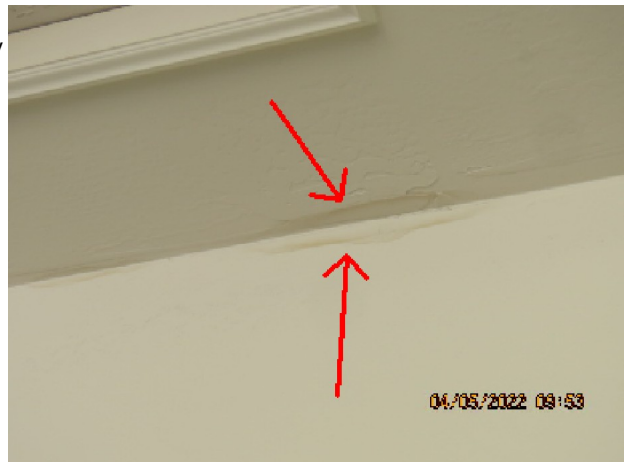
Water stains on the garage ceiling by the attic hatch. See picture. Recommend a qualified contractor evaluate and make all necessary repairs.

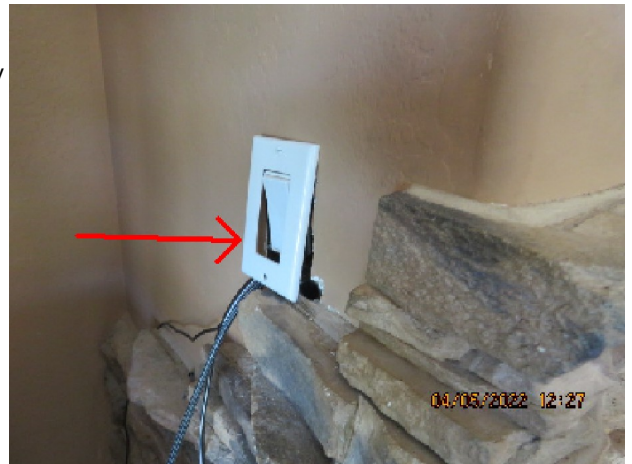
The switch for the fireplace is not properly attached and the cover plate is loose. Recommend a qualified contractor evaluate and make all necessary repairs.

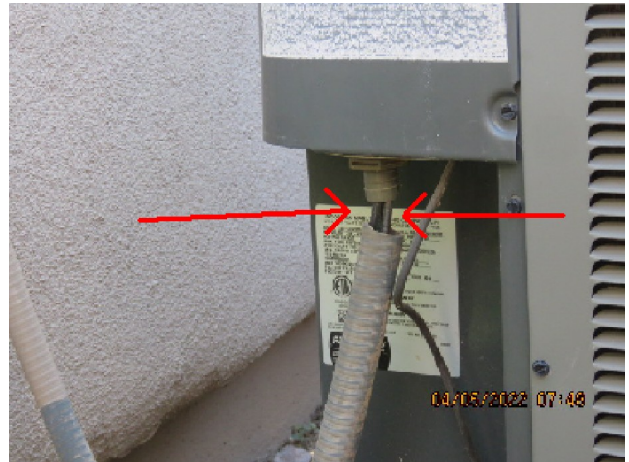
Electrical conduit supplying power to the AC unit is not properly attached to the front AC coil. This could short out the wire. Recommend a qualified electrical contractor evaluate and make all necessary repairs. See picture

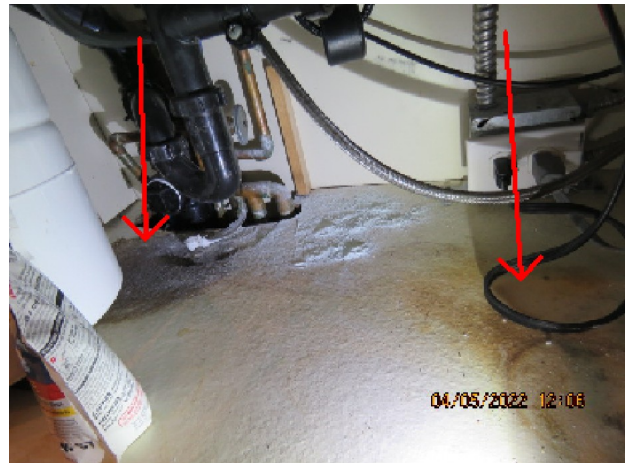
The base of the kitchen sink cabinet has bowed down from water leaking under the sink. Recommend a qualified contractor evaluate and make all necessary repairs.
See picture

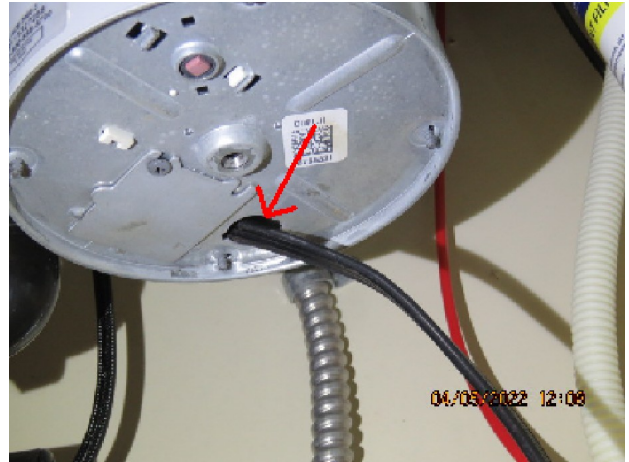
Electrical cable not properly attached to disposal. Recommend properly attaching cord to disposal. Possible shock hazard. See picture

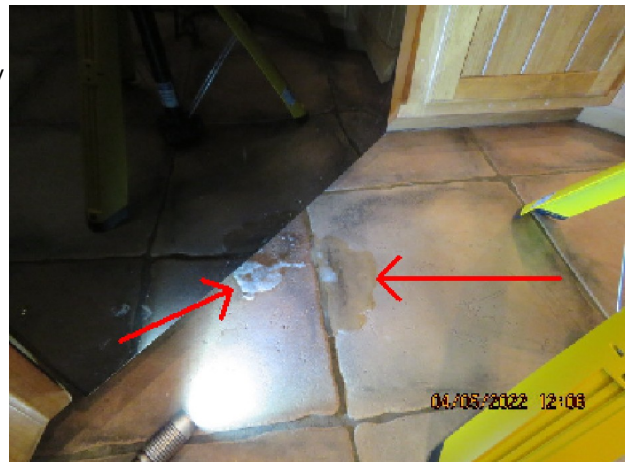
The dishwasher did not drain and water leaked on to the floor when tested. Recommend a qualified contractor evaluate and make all necessary repairs.

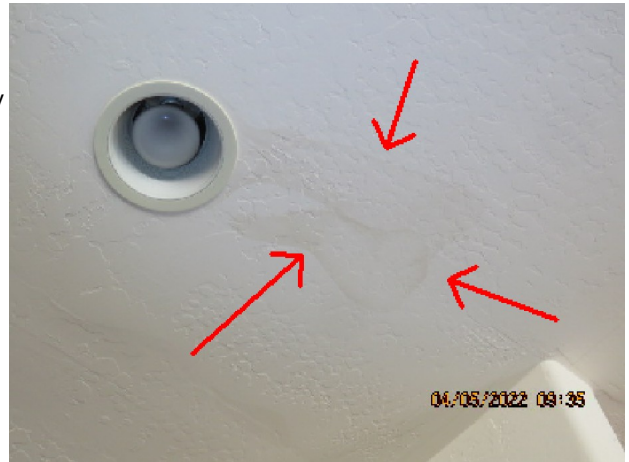
Waters stain on the living room ceiling near the kitchen wall and a light fixture. This is the area below the roof where a vent cover is missing. Recommend a qualified contractor evaluate and make all necessary repairs.

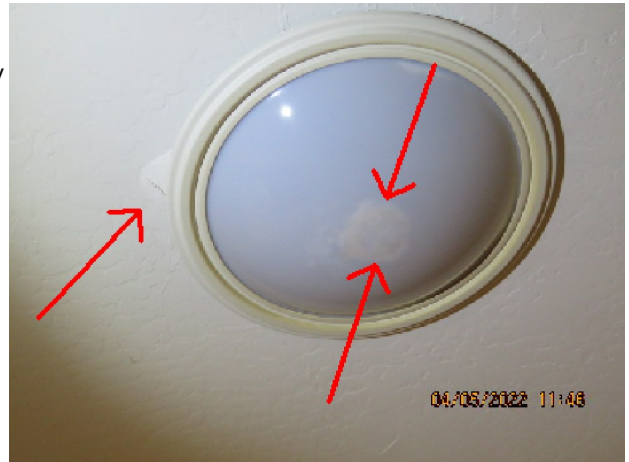
Skylight in the hall in front of the hall bathroom has water stains on the cover and damage to the drywall next to the light. Recommend a qualified contractor evaluate and make all necessary repairs.

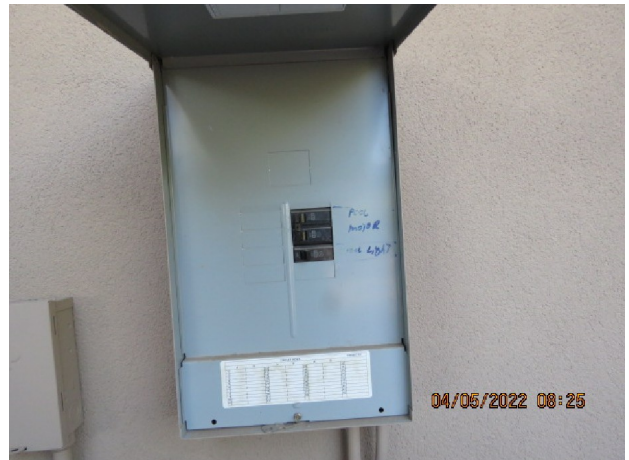
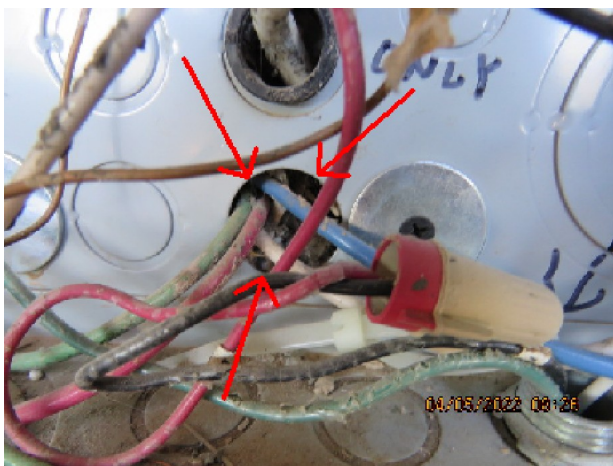
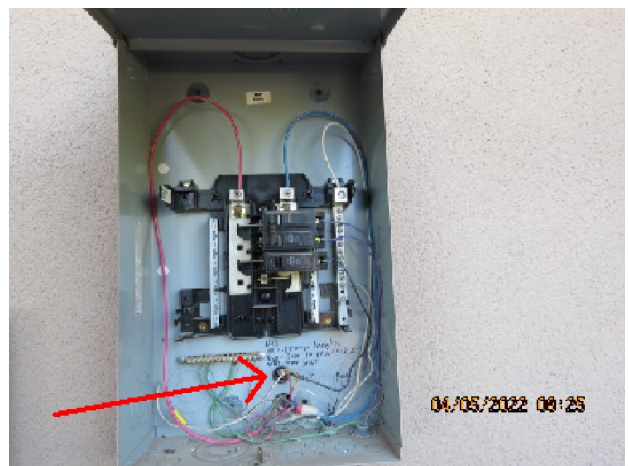
Grommet missing in the back of the sub-electric panel at the pool equipment area. This may cause wires to short out on the metal electric panel
Recommend a qualified electrical contractor evaluate and make all necessary repair.

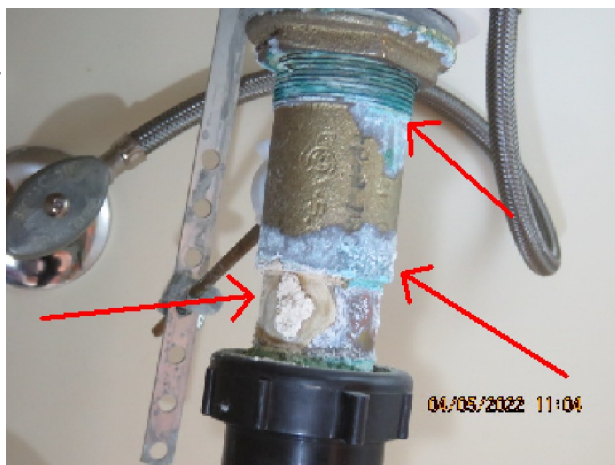
Corrosion on the right side master bathroom sink drain pipe. Corrosion is an indication of a slow leak or a past leak. Recommend a qualified contractor evaluate and make all necessary repairs.

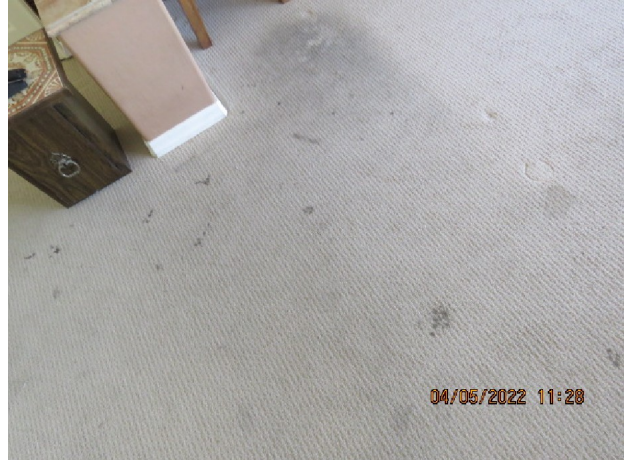
The master bedroom carpet is stained and soiled. Recommend replacing this carpet.

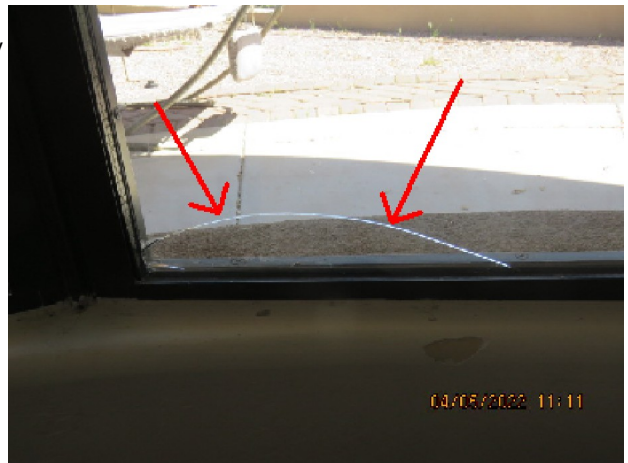
Master bedroom window pane is cracked. Recommend a qualified contractor evaluate and make all necessary repairs.

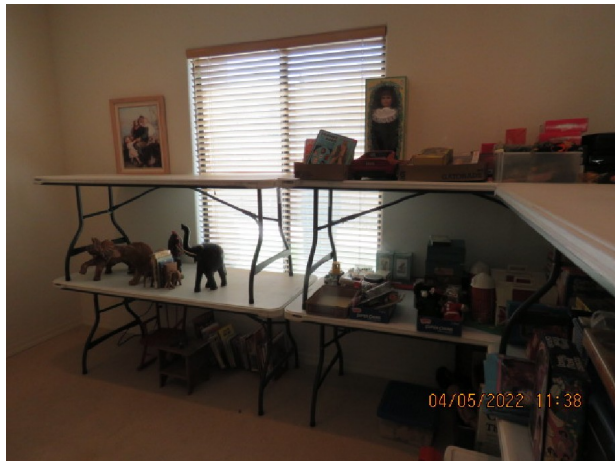
No access to the window in this bedroom so it was not inspected.
Recommend inspecting after access is provided.

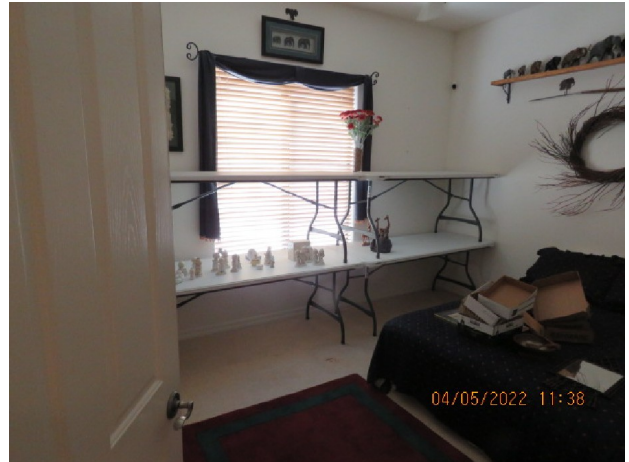
No access to the window in this bedroom so it was not inspected.
Recommend inspecting after access is provided.s

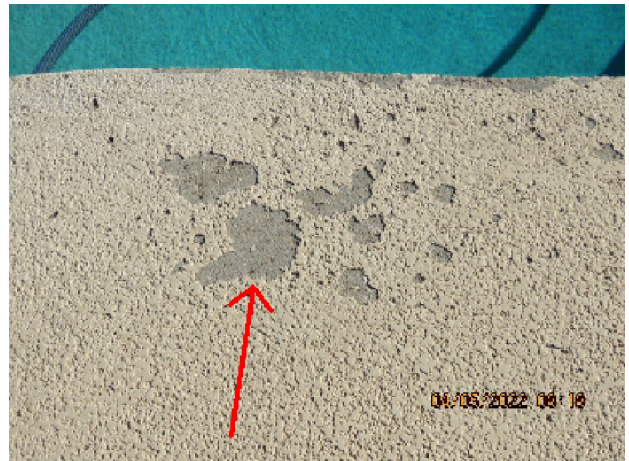
Some of the pool cool decking is peeling off the concrete. Recommend a qualified contractor evaluate and make all necessary repairs.

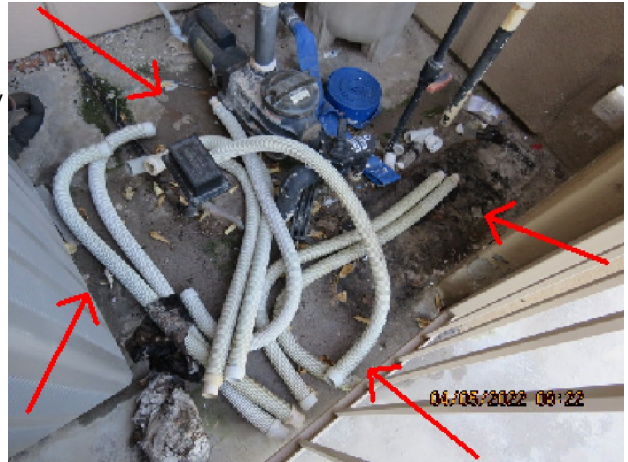
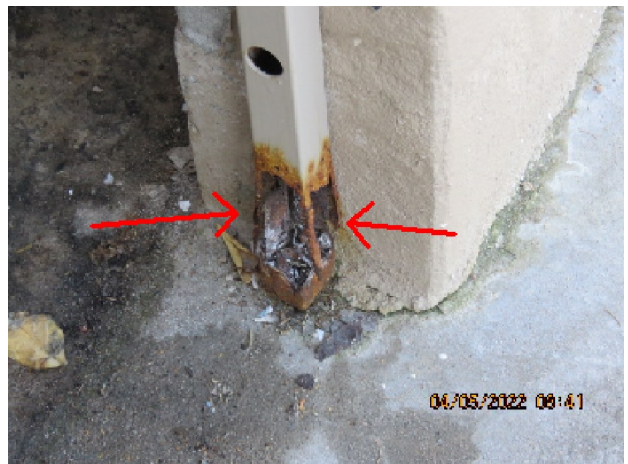
Water on the ground at the pool equipment area, There may be a leak. Recommend further investigation.
The pool fence gate post is rusted at the bottom.
Recommend a qualified contractor evaluate and make all necessary repairs.
