## 4-Point Inspection Form

Address Inspected 515 NW Lake Lona Loop, Lake City, FL 32055.

Actual Year Built: 1983. Date Inspected: 5/5/2022.

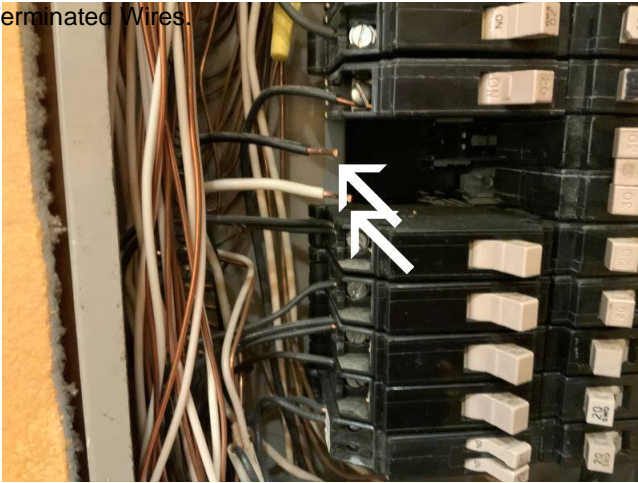
Terminated Wires.

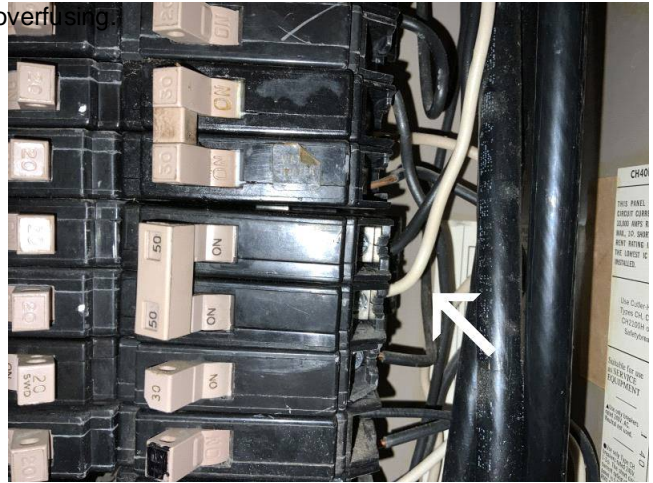
overfusing.

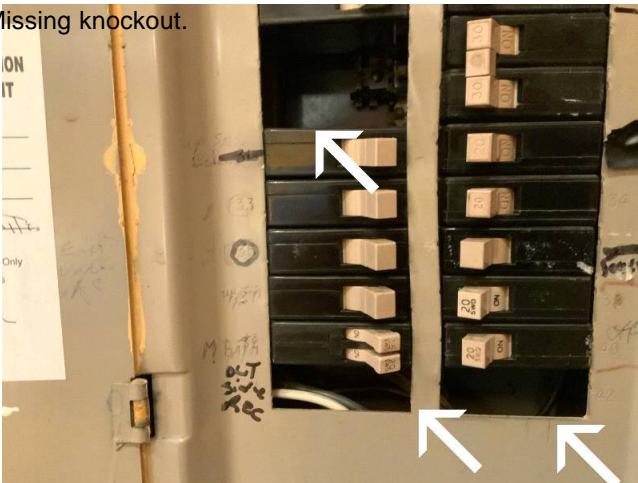
Missing knockout.
