Above And Beyond Home Inspection
6721 COUNTY ROAD 248
OBRIEN FL 32071
386-697-1356
HOMEINSPECTOR386@GMAIL.COM

Inspection reference: 2438

Confidential Inspection Report

515 NW Lake Lona Loop
Lake City FL 32055

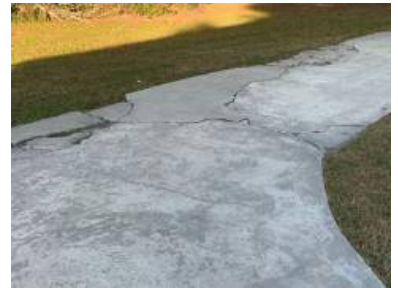
Driveway Type: Concrete, Asphalt,
Cracks noted are major.

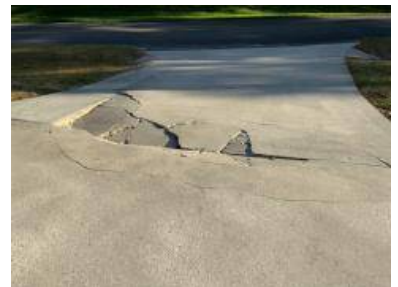
☐ ☐ ☒ Erosion noted.

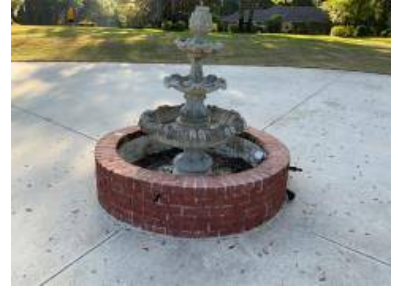
☐ ☒ ☐ Fountain inoperable.

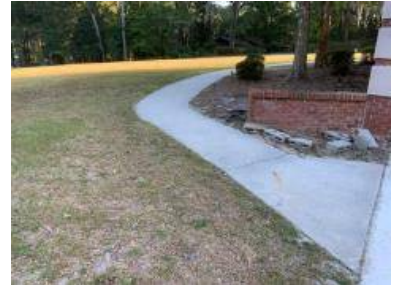
OK MM RR
☒ ☐ ☐ Sidewalk type: Concrete, Cracks noted.

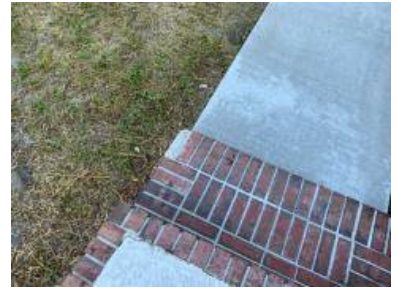
☐ ☒ ☐ Missing brick.

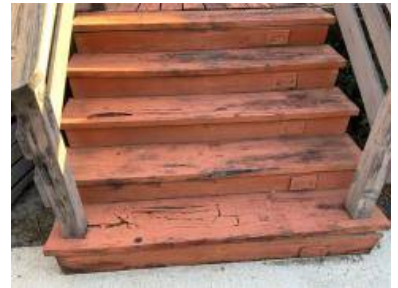
☐ ☐ ☒ Wood rot at rear steps.

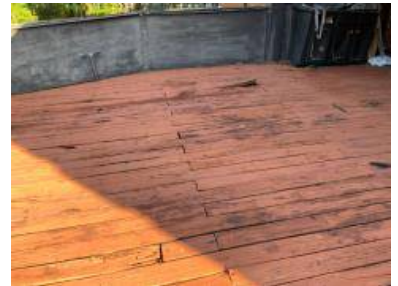
☐ ☐ ☒ Bowed boards. Wood rot at rear porch.

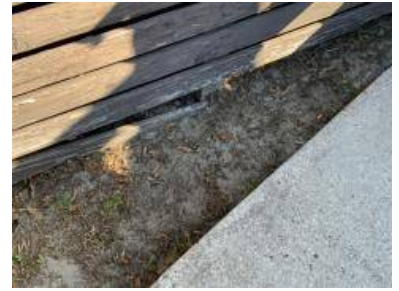
☐ ☐ ☒ Wood rot noted at structure.

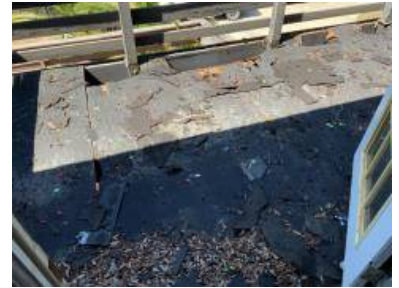
☐ ☐ ☒ Balcony floor and structure rotted.

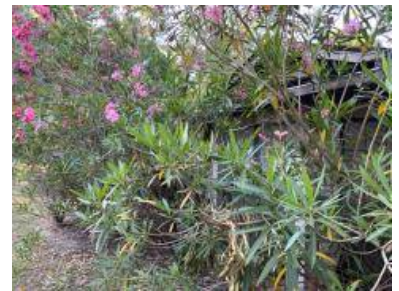
☐ ☒ ☐ Trim plants away from structure.

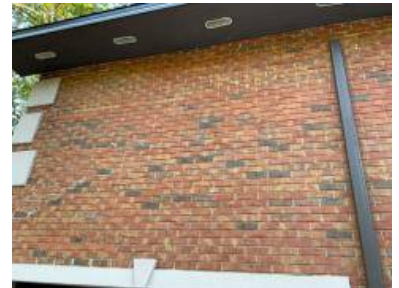
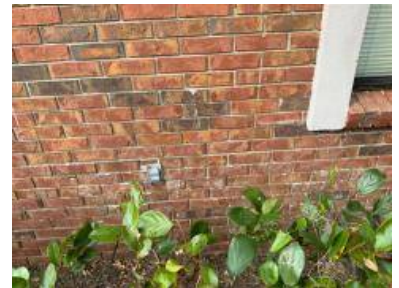
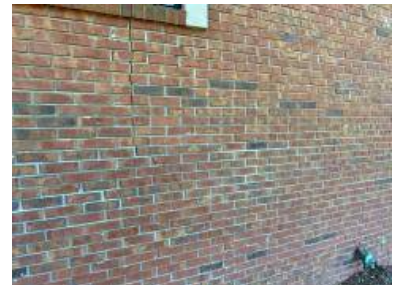
☒ ☐ ☐ Brick/ stucco siding noted.☐ ☐ ☐ Inoperable at front.☐ ☐ ☒ Settlement crack noted at right side of home. Crack is over 1/4". Further evaluation is recommended by a licensed foundation expert.

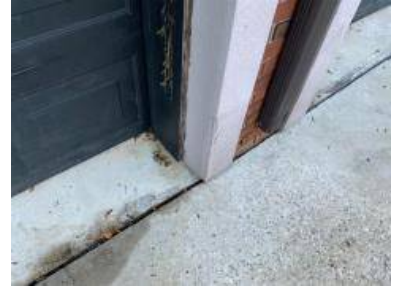
☐ ☒ ☐ Damage noted at rear.

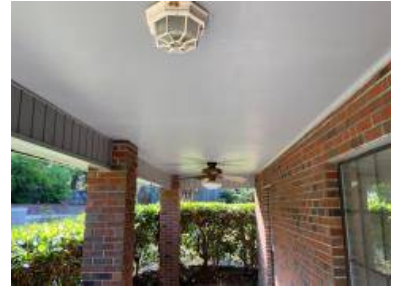
☐ ☐ ☒ Fixtures inoperable.

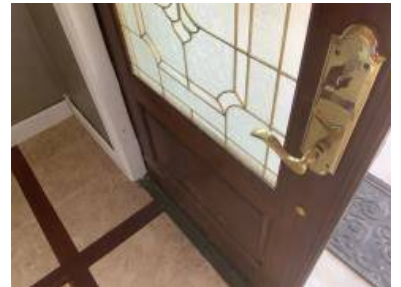
☐ ☒ ☐ Door hardware damaged door bell inoperable.

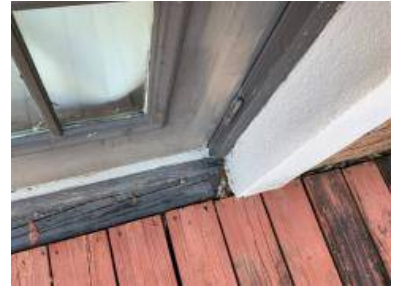
Wood rot noted at rear doors. Rear doors are deteriorated.

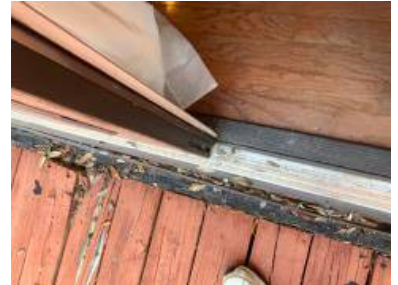
Hardware missing. Hardware needs adjustment.

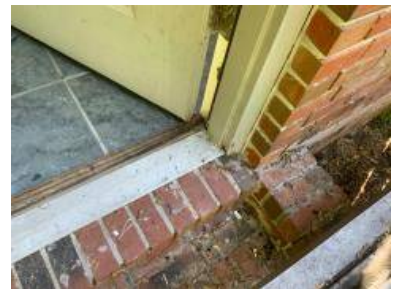
Wood rot noted at door trim. Dead bolt lock needs adjustment.

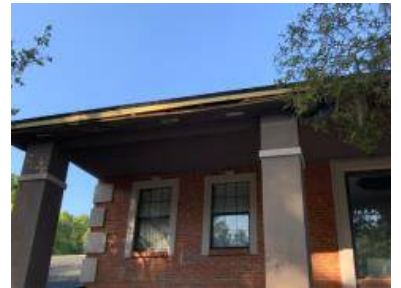
☐ ☐ ☒ Wood rot and loose soffit at front.

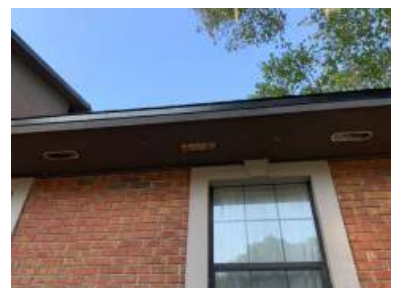
☐ ☒ ☐ Screens missing front and rear.

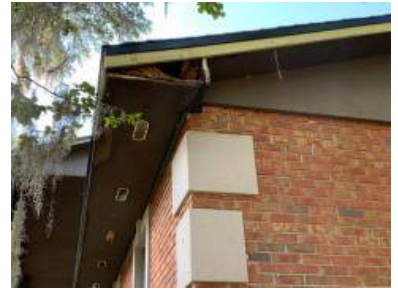
- ☐ ☐ ☒ Wood rot noted at front fascia.
Vermin entry present.

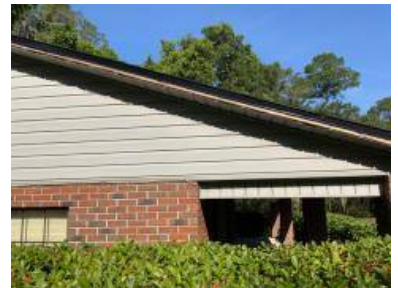
- ☐ ☒ ☐ Fascia metal is missing.

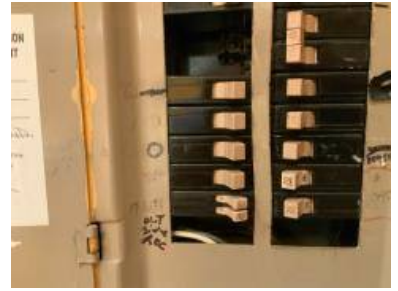
☐ ☐ ☒ Missing knockouts.

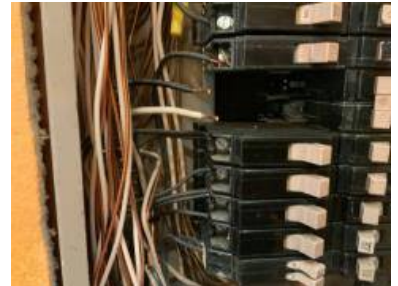
☐ ☐ ☒ Double taps and terminated wiring noted in panel.

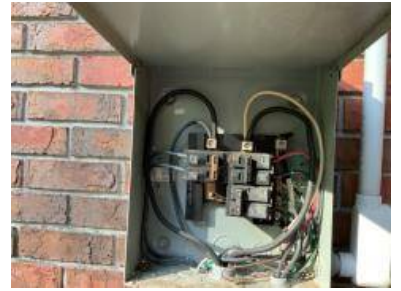
An second electrical load is improperly connected and drawing power from the subpanel.

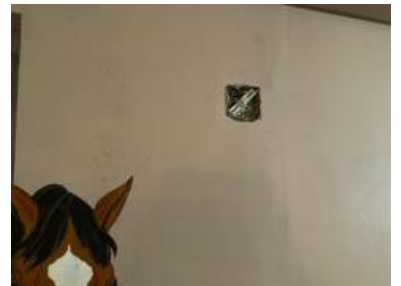
Living Room Mil

Exposed splices are noted.

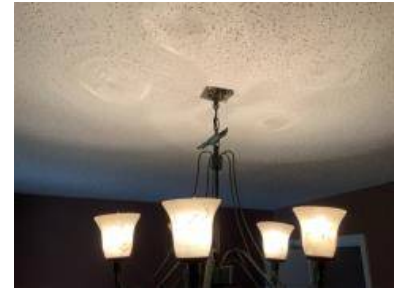
Upstairs Bedroom #2:

Exposed splices are noted.

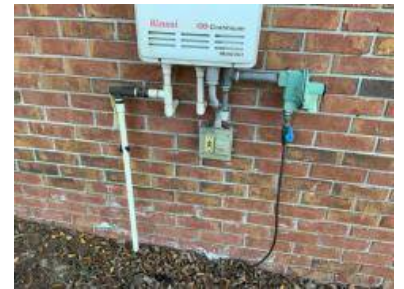
☐ ☒ ☐ Exterior covers missing.

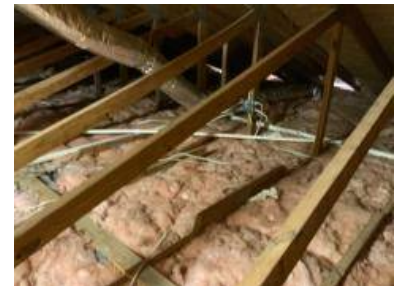
☐ ☐ ☒ Open junction boxes are noted.

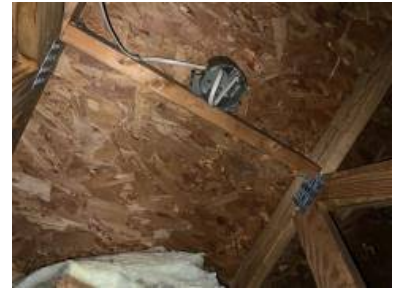
☐ ☐ ☒ Open j box.

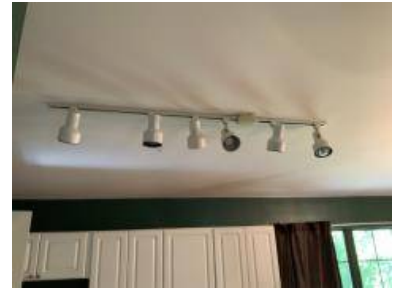
Kitchen Interior:

Fixture is inoperable.

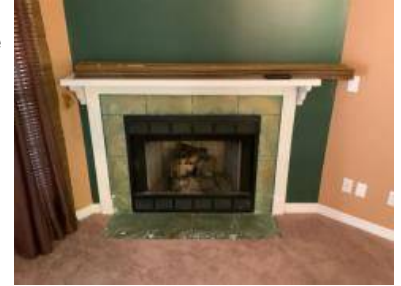
Fireplace chimney has been removed. Chimney can not be used for wood burner.

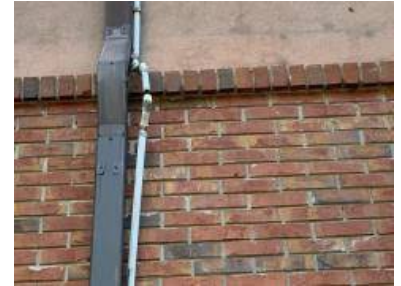
Line is disconnected.

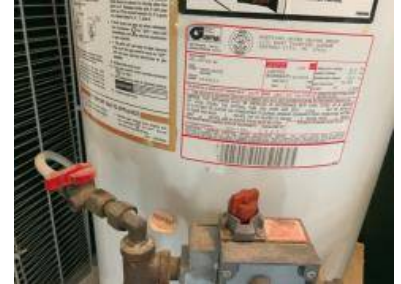
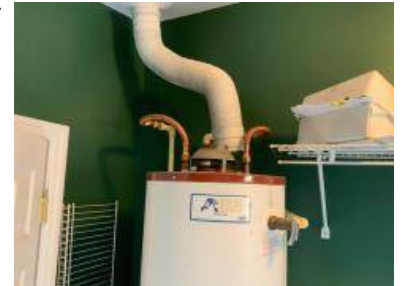
Condition: ☐ ☐ ☒ Flue is disconnected. DO NOT
USE UNTIL REPAIRED.

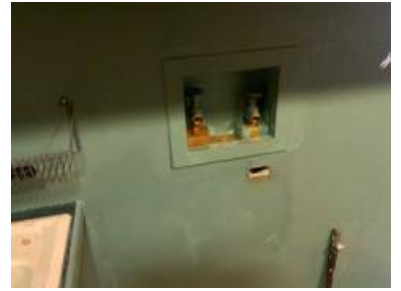
☐ ☐ ☒ Dripping.

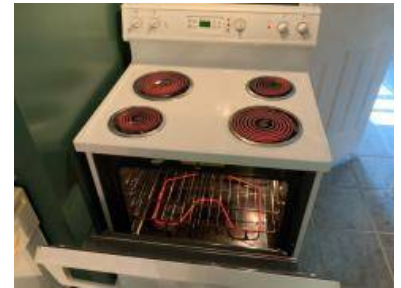
☒☐☐Electric, Combination, Flashing
code but operational.

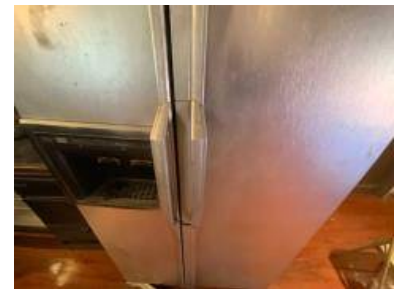
☐ ☒ ☐ Damage noted.

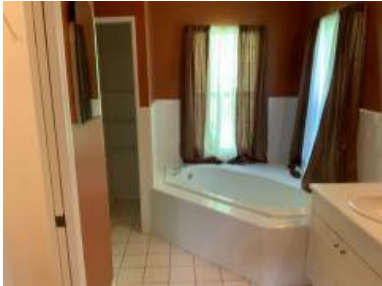
OK	MM	RR		
<i>Master Bath:</i>	<input type="checkbox"/>	<input checked="" type="checkbox"/>	<input type="checkbox"/>	The following problems were noted at the drain: Stopper did not operate properly.

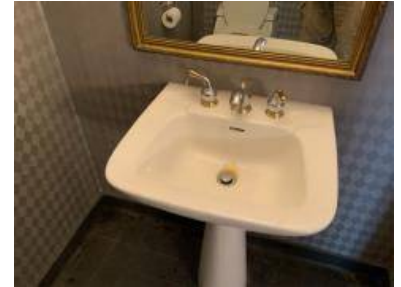
Half Bath

OK	MM	RR	
<input type="checkbox"/>	<input checked="" type="checkbox"/>	<input type="checkbox"/>	Low pressure.

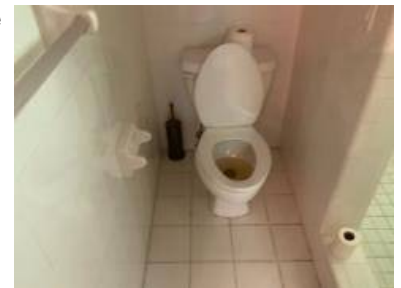
Master Bath Mil

<input type="checkbox"/>	<input checked="" type="checkbox"/>	<input type="checkbox"/>	Minor plumbing repairs will be needed to restore proper operation.
--------------------------	-------------------------------------	--------------------------	--

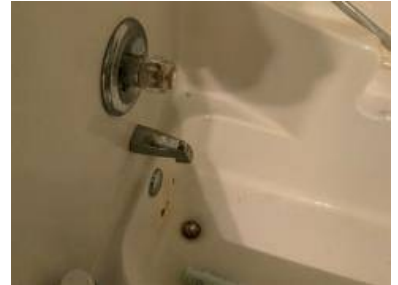
*Hall Bath Mil*

OK	MM	RR	
<input type="checkbox"/>	<input type="checkbox"/>	<input checked="" type="checkbox"/>	Diversion valve will not close.

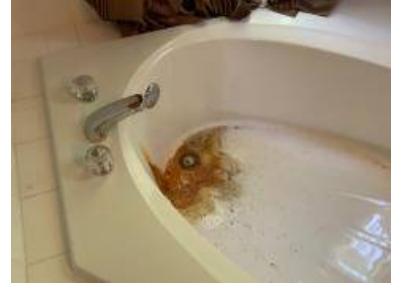
Master Bath Mil

<input type="checkbox"/>	<input checked="" type="checkbox"/>	<input type="checkbox"/>	Damage noted.
--------------------------	-------------------------------------	--------------------------	---------------

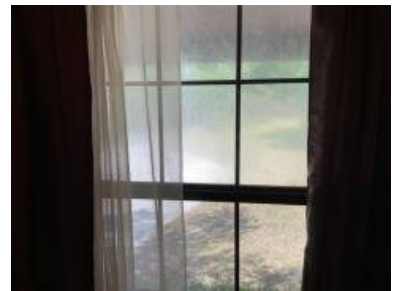
<i>Upstairsmaster Bedroom:</i>	At least one window or associated hardware in this room needs repair. The thermal seal is broken. Although it is keeping the elements out, it has a clouded appearance. This condition will worsen.	
<i>Upstairs Bedroom #2:</i>	At least one window or associated hardware in this room needs repair. Locking hardware needs repair or replacement, The thermal seal is broken. Although it is keeping the elements out, it has a clouded appearance. This condition will worsen.

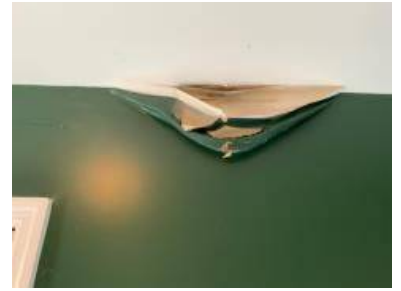
Laundry Mil

Damage noted from past leak.

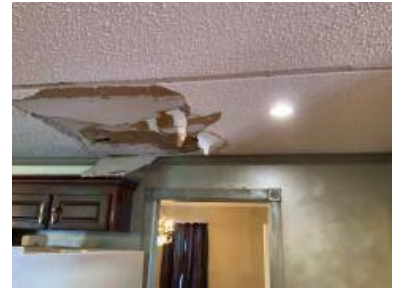
Kitchen Interior:

Damage noted from past leak.

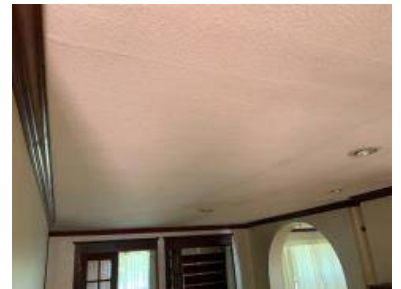
Master Bedroom:

Patches noted.

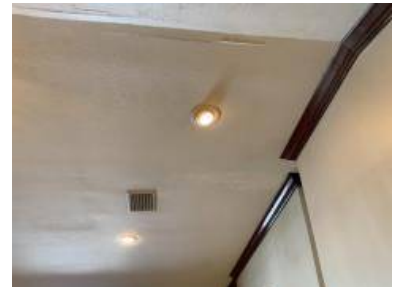
Previous Leak - There are signs of a previous water leak in the ceiling in this room. It does not appear to be an active leak.

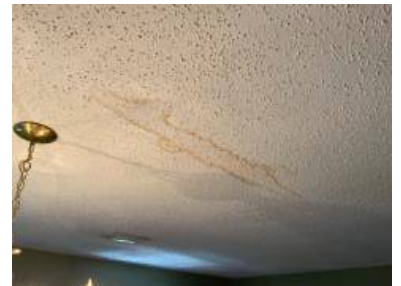
Upstairsmaster Bedroom:

Previous Leak - There are signs of a previous water leak in the ceiling in this room. It does not appear to be an active leak.

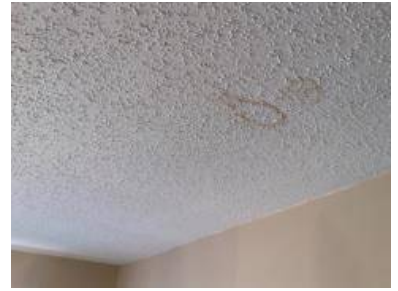
Upstairsbedroom #3:

Previous Leak - There are signs of a previous water leak in the ceiling in this room. It does not appear to be an active leak.

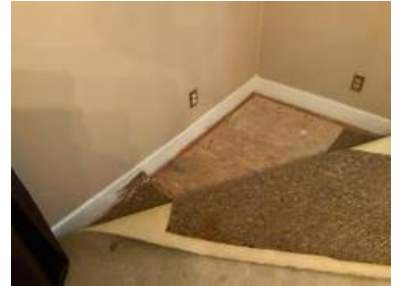
Base board and floor damage noted.

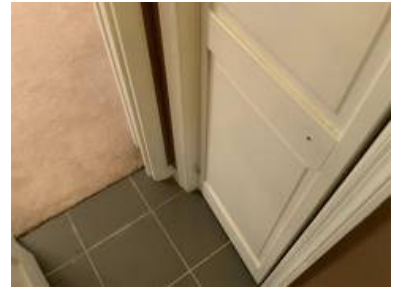
Bath Between Bedrooms:

Missing knob.

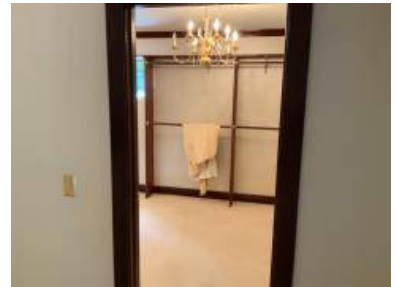
Master Bedroom:

Door missing.
