Inspection Report

Property Address:
511 Cedar Grove Road
York SC 29745

Carolinas Premier Inspections

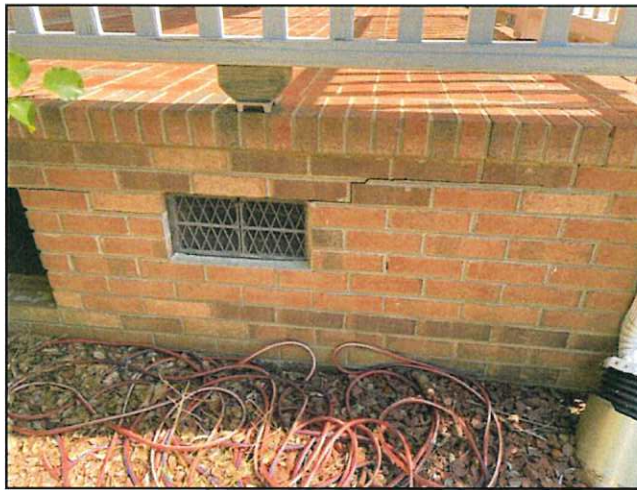
There was/were hairline crack(s) noted in the following locations. Point up and continue to monitor. No corresponding cracks were noted inside the home at these areas and all windows and doors around the area were functioning as intended at the time of inspection.

1. front porch- left side

Note: Crack monitoring kits can be purchased at Lowe's, Home Depot, and various other locations. They are a slide which is glued to the veneer over the middle of the crack so that one side is attached on either side of the crack. They will crack if there is future movement which would warrant further investigation by a licensed engineer at that time.

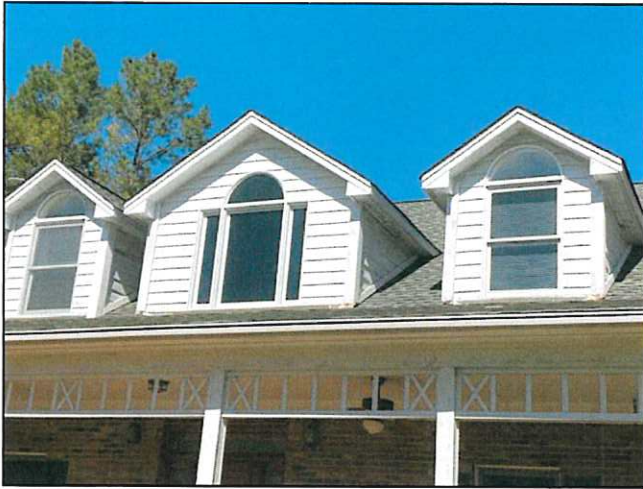
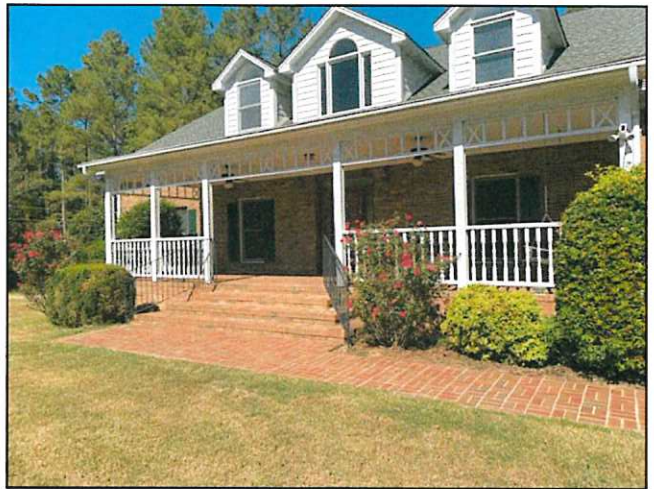
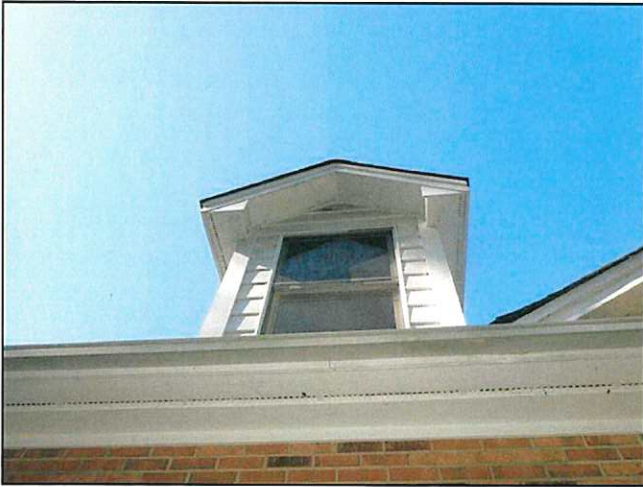
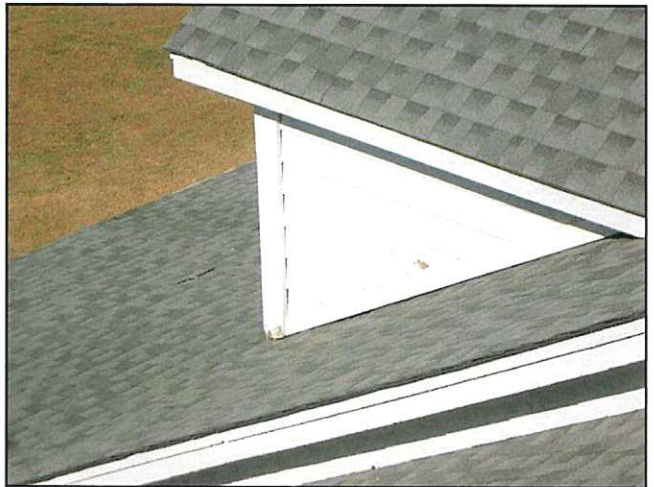
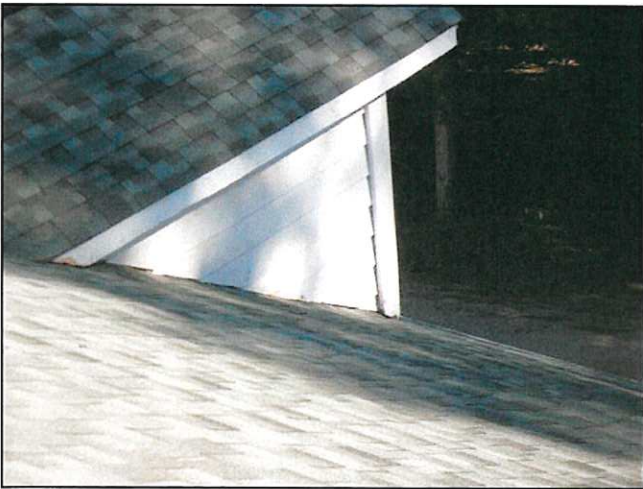
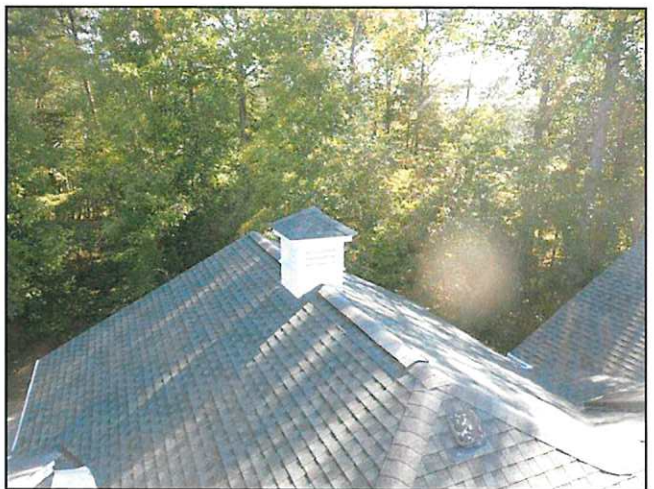
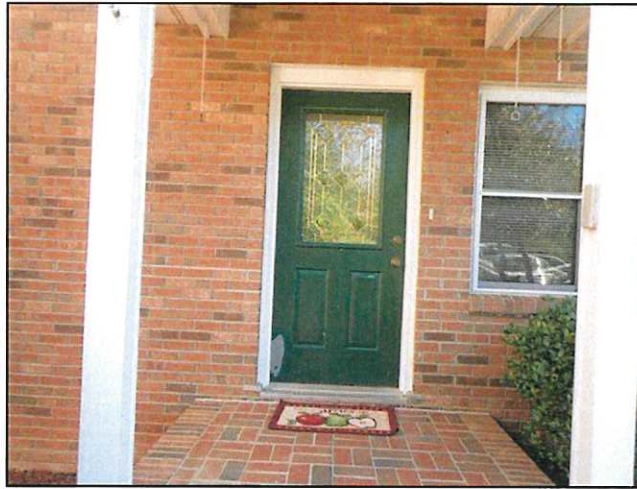
There is exposed wood that needs re-painting or finishing noted all around the home to prevent water penetration and/or wood rot. Contact a licensed contractor for review and make any additional repairs as needed.

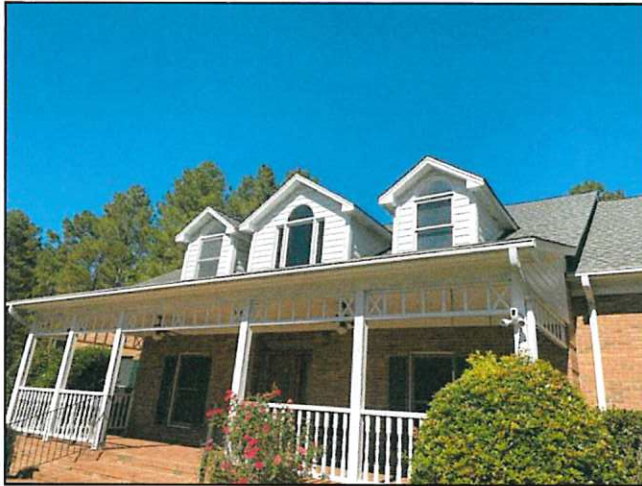
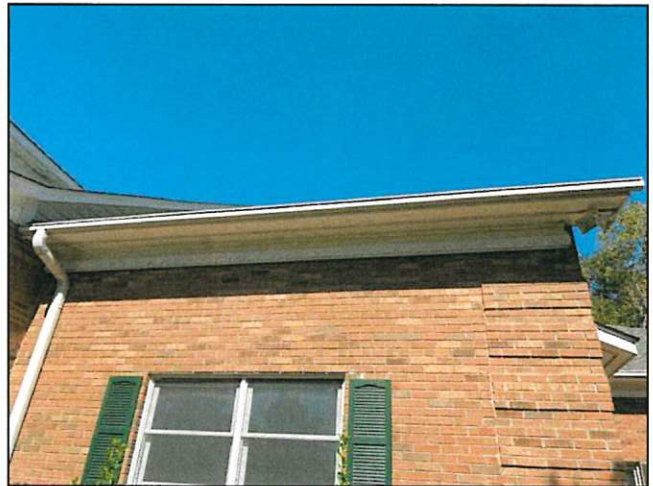
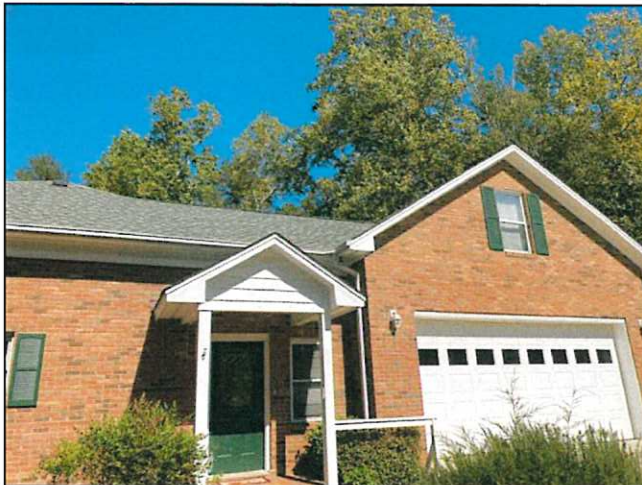
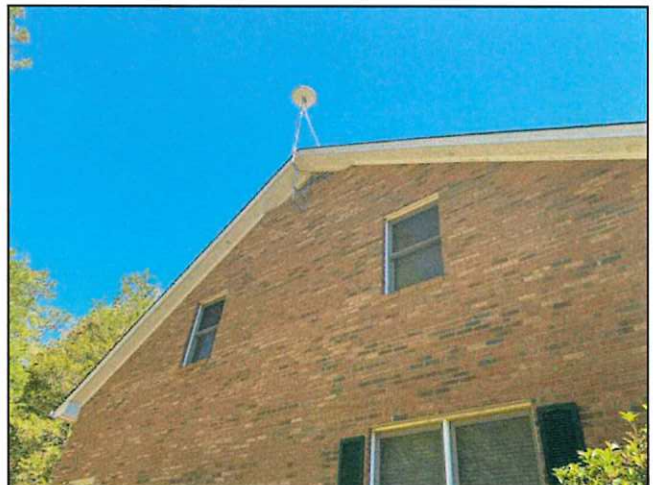
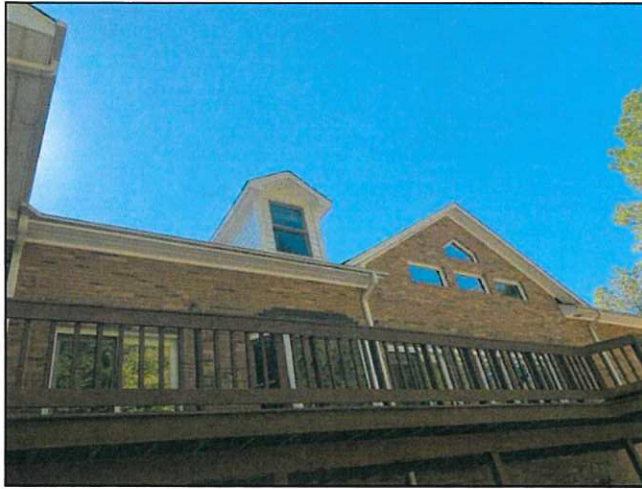
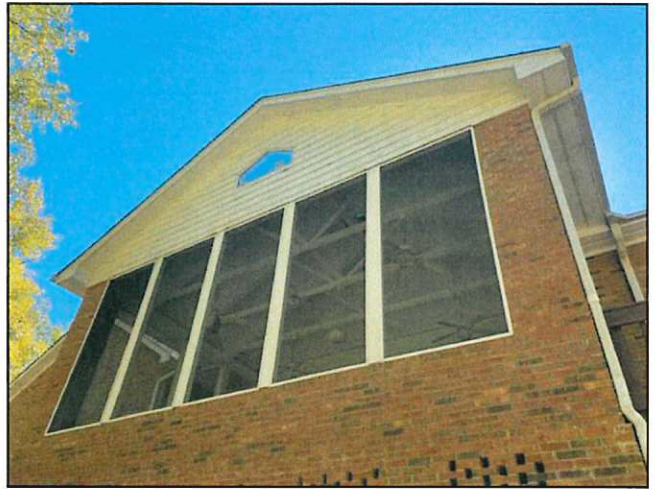
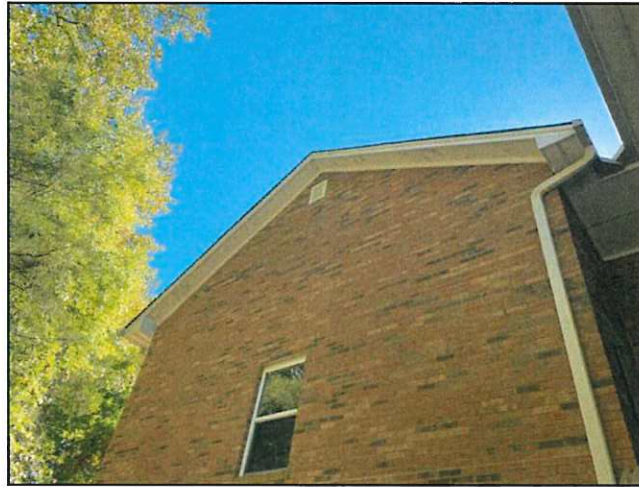
There is exposed wood that needs re-painting or finishing at the fascias around the home. Re-sealing is needed to prevent water damage and/or possible wood rot. Contact a licensed contractor for review and make repairs as needed.

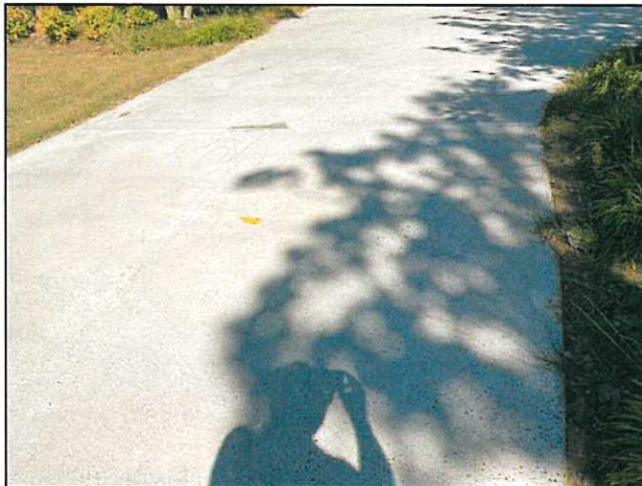
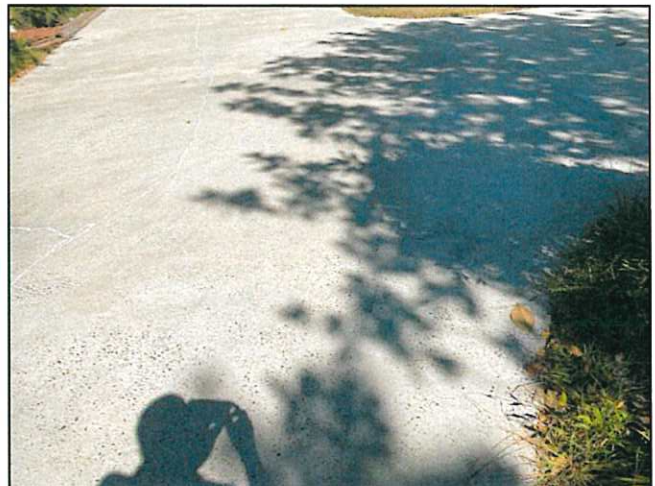
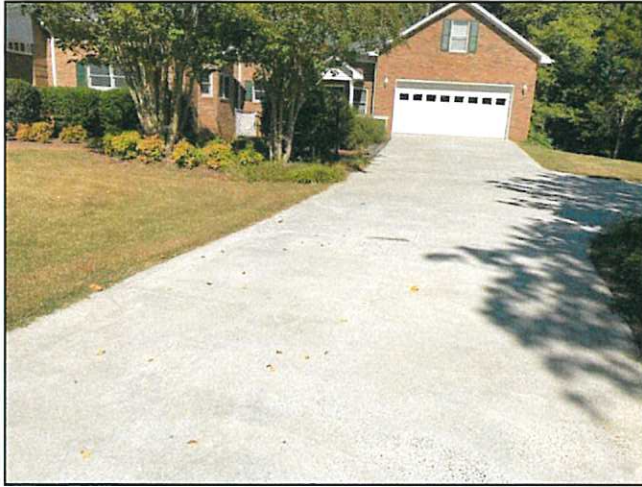
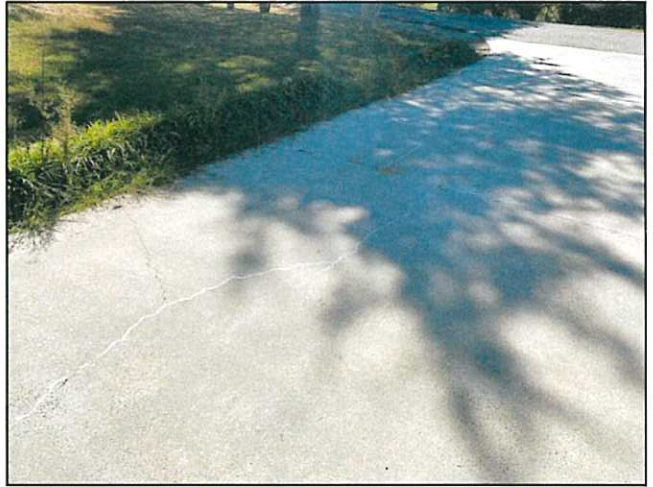
(1) There are cracks noted at the driveway that need to be sealed and/or repaired properly to prevent water penetration and/or continual cracking. Continue to monitor and make additional repairs as needed. Contact a qualified professional for repair.

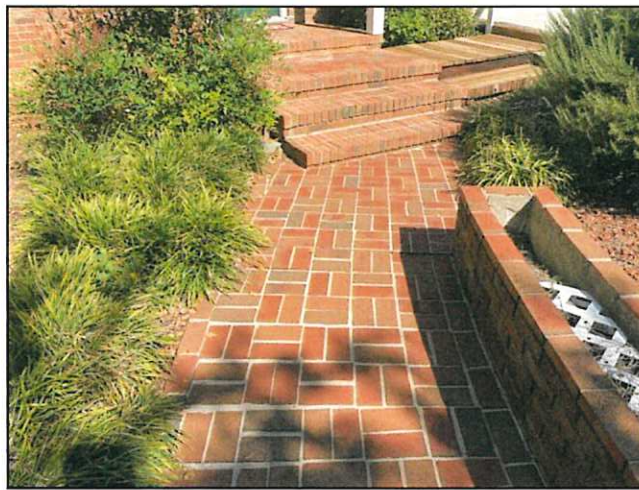
(2) There was a trip hazard noted in the sidewalk at the front right side of the home. Contact a licensed contractor for review and make repairs as needed.

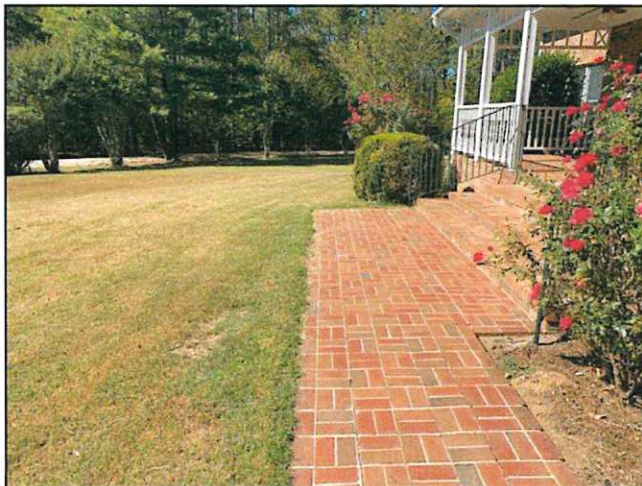
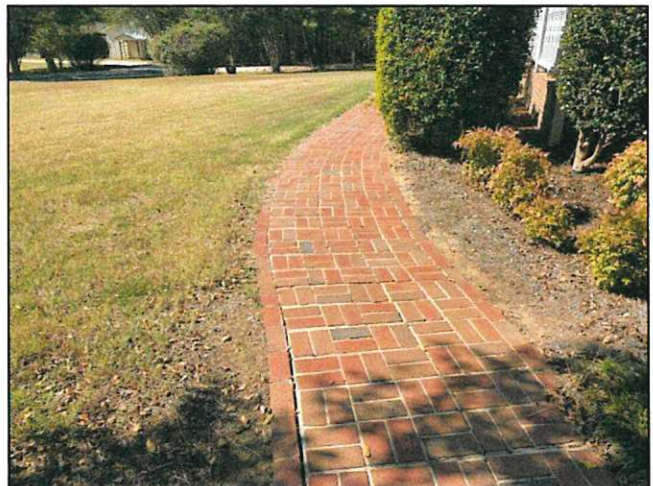
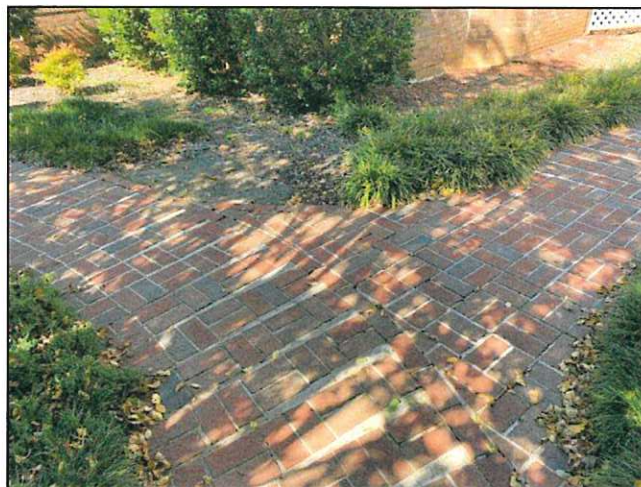
(3) The sidewalk needs to be pointed up (more mortar) in several areas where there are gaps. This is needed prevent water penetration. Contact a licensed contractor for review and make repairs as needed.

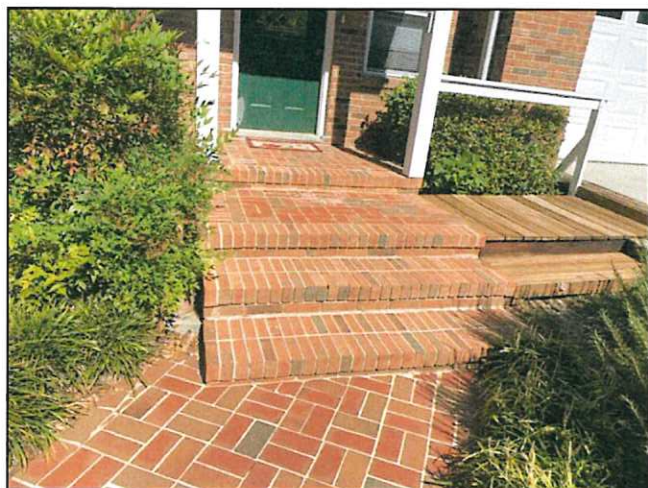
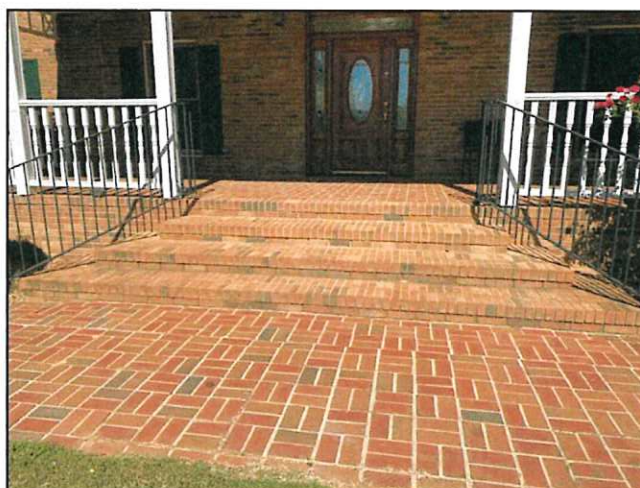
The front porch steps need to be pointed up (more mortar) in several areas where there are gaps. This is needed to prevent water penetration. Contact a licensed contractor for review and make repairs as needed.

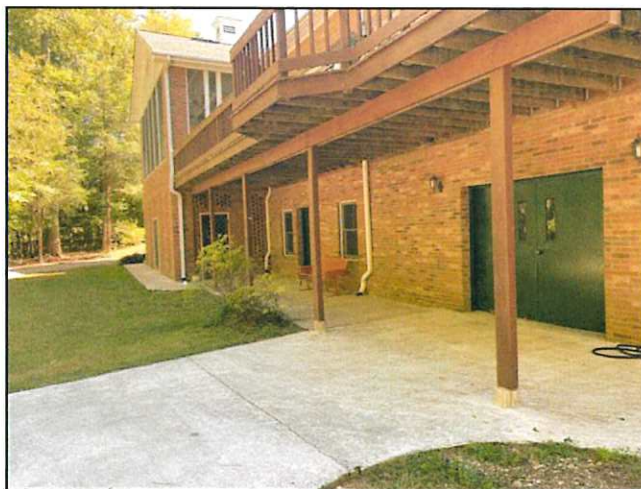
(1) There are no cross braces installed on the deck. Cross bracing should be at least 1/3 of the height of the post to prevent the deck from racking. Contact a licensed contractor for review and make repairs as needed.

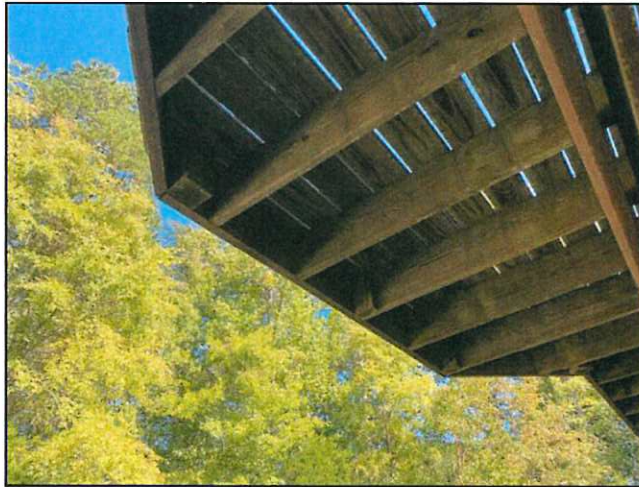
(2) The floor joists are not secured by any type of ledger or joist hanger. A ledger or joist hanger gives the joist additional support and also prevents it from twisting. A ledger or joist hanger needs to be installed. Contact a licensed contractor for repair.

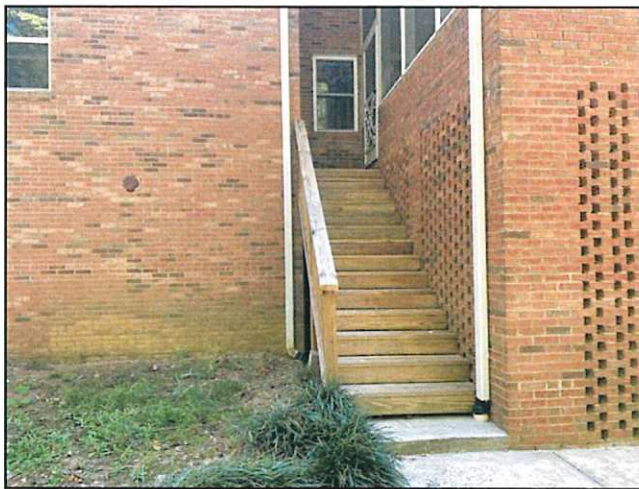
(3) The top plate for the handrail is too wide at the rear deck/porch. Repair as needed so that if someone were to fall they;d be able to grab it. Contact a licensed contractor for repair.

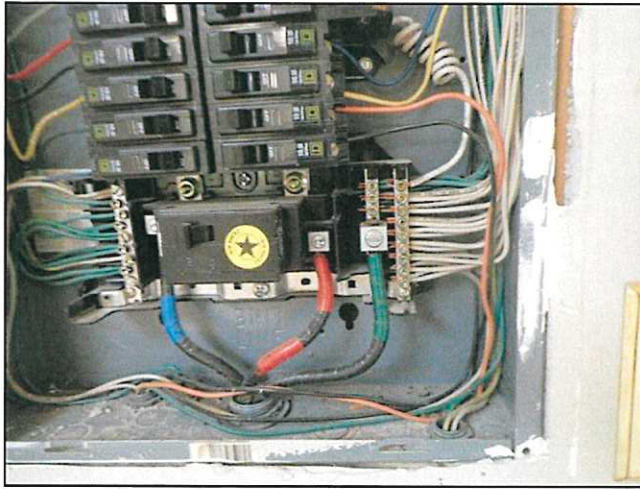
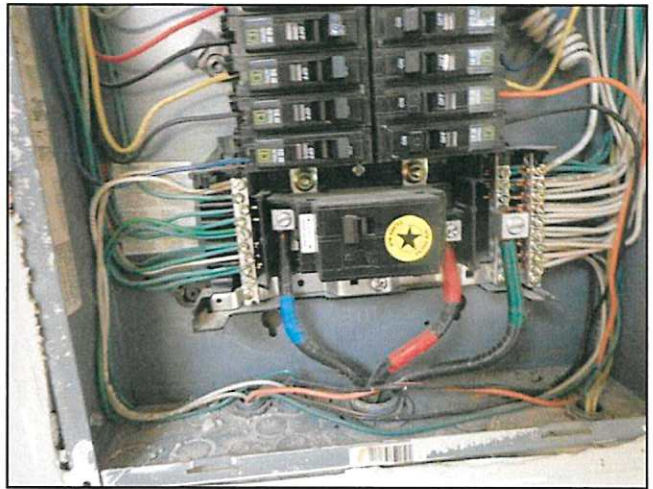
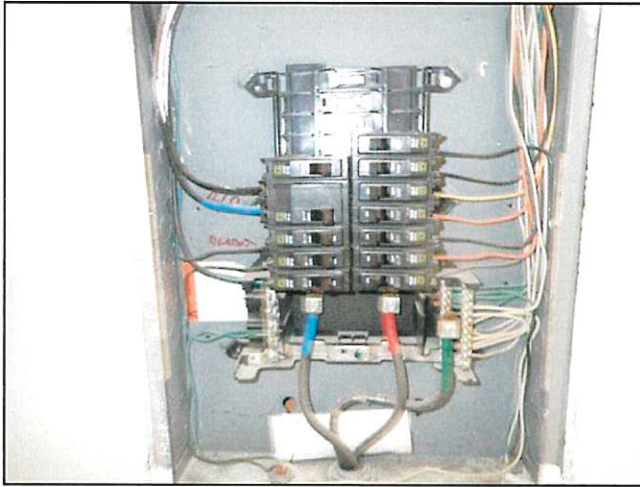
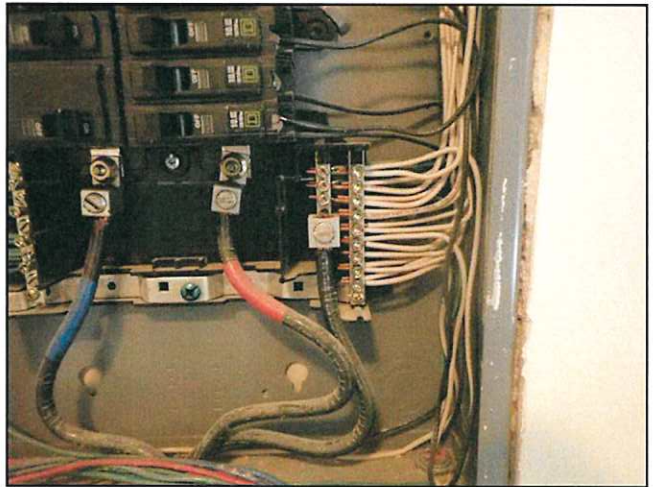
(1) Locations: sub panels in the workshop, bedroom, bonus room, and 1/2 bathroom - There are more than one neutral wires secured in a lug of the panel bus bar. This can cause loose connections and overheating of the lines. The neutral wires should each be in an individual lug/screw of the bus bar. Contact a licensed electrician for repair.

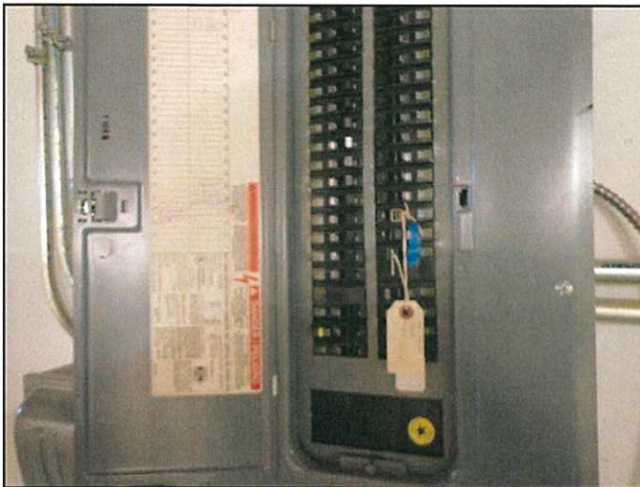
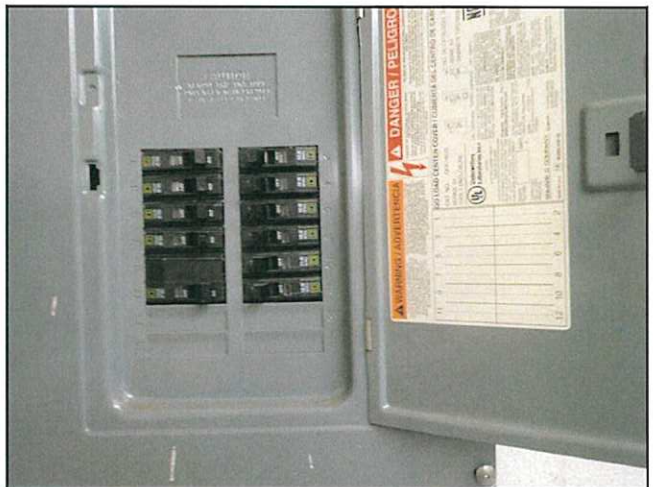
(2) Location: left side of the basement and sub panel in the bedroom- The electrical panel was not labeled for all its uses. All breakers should be labeled. Contact a licensed electrician for repair.

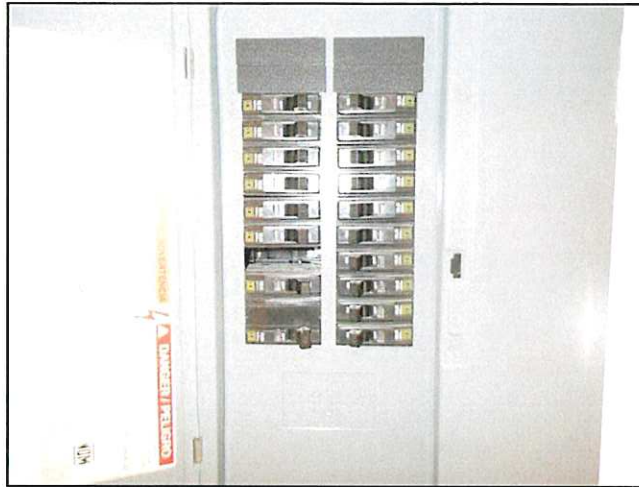
(3) Location: sub panel in the 1/2 bathroom- Missing breakers/spacing was noted at the electric panel. This is a safety hazard. Contact a licensed electrician for repair.

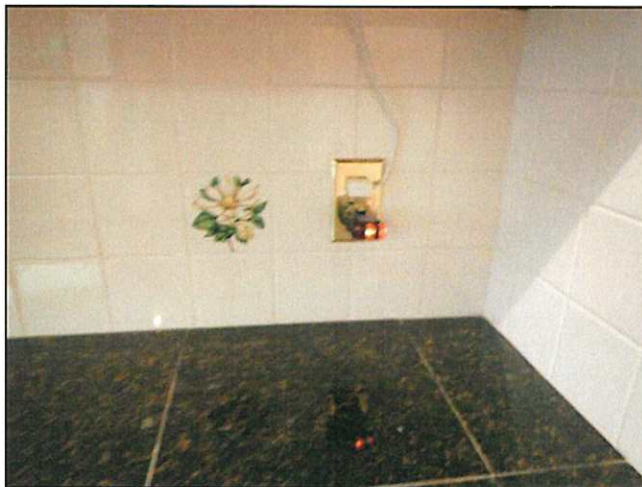
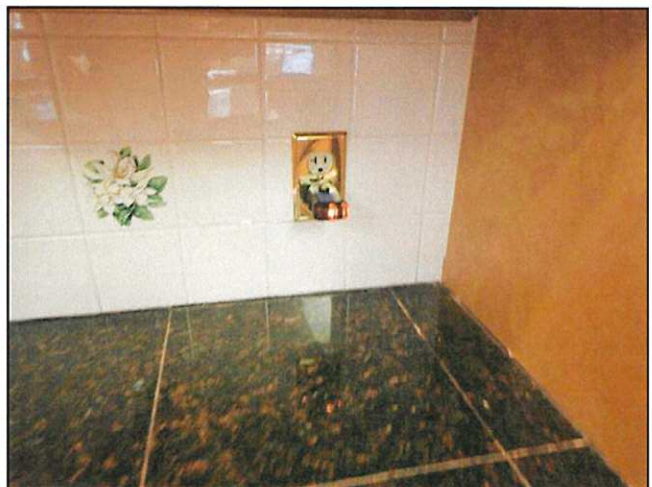
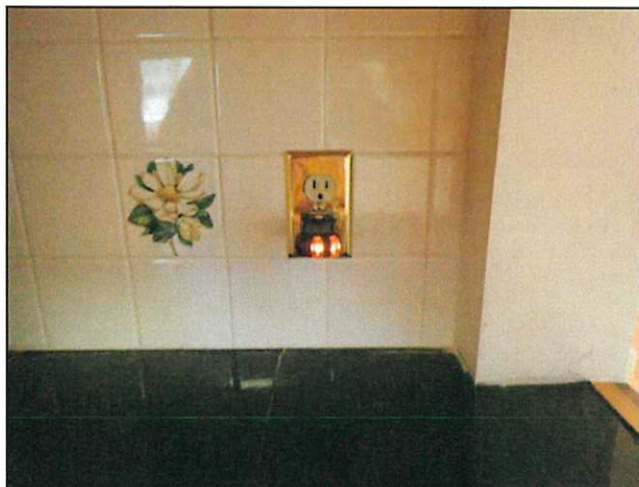
The following outlet(s) are not protected by a GFCI. These are needed in "wet" locations to allow the circuit to turn off in case of an emergency. Contact a licensed electrician for repair. :

1. front left wall of the kitchen
2. left wall of the kitchen- both sides of the oven

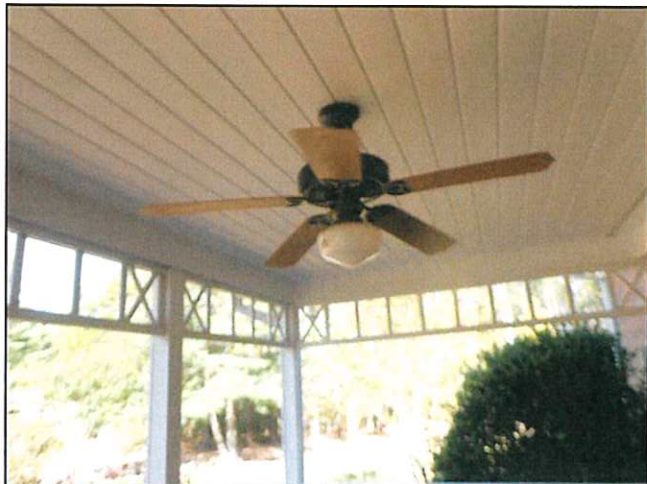
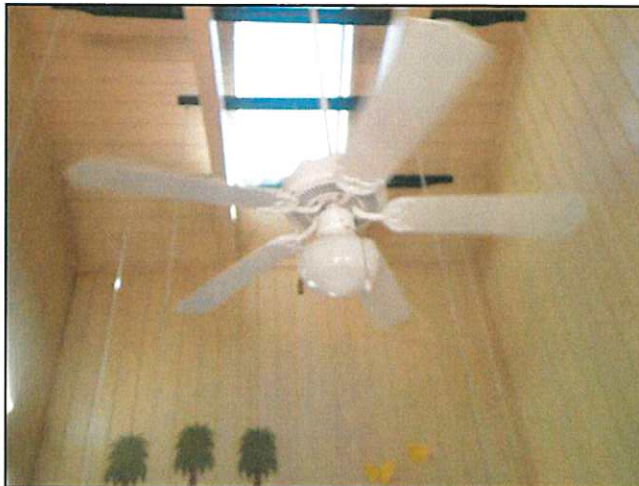
(1) The following ceiling fan(s) was not balanced properly and needs adjustment, repair or replacement to prevent it from shaking loose from the ceiling mount. Contact a qualified professional for repairs.:

1. left side of the front porch
2. front right foyer

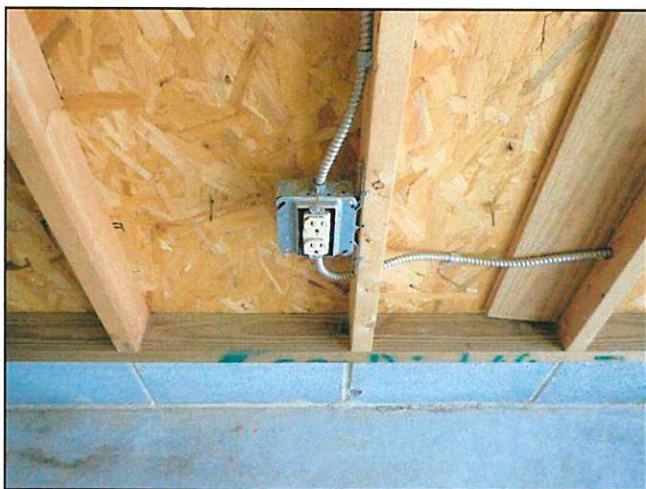
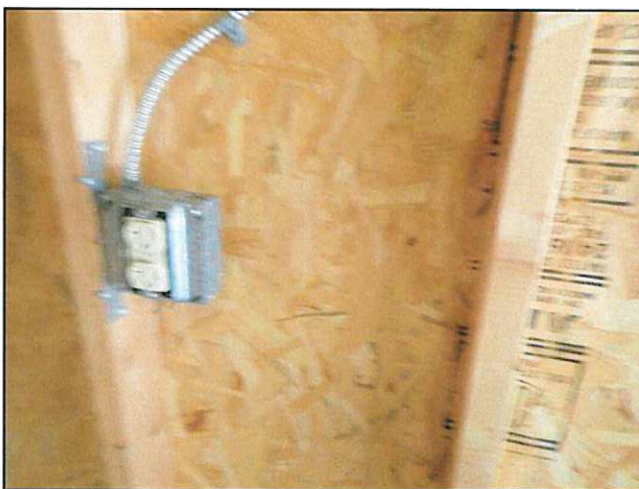
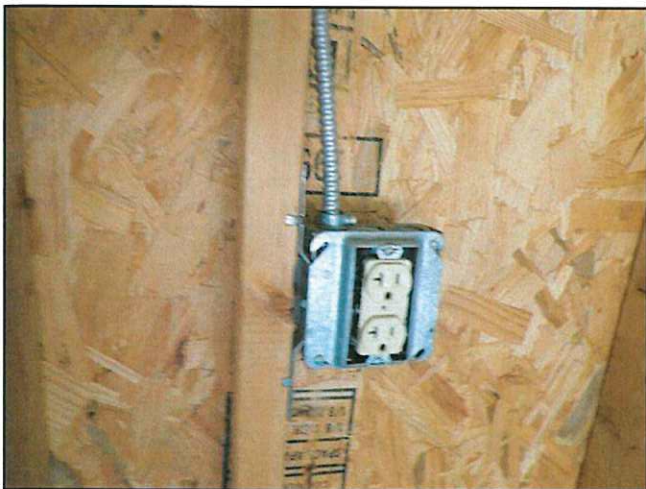
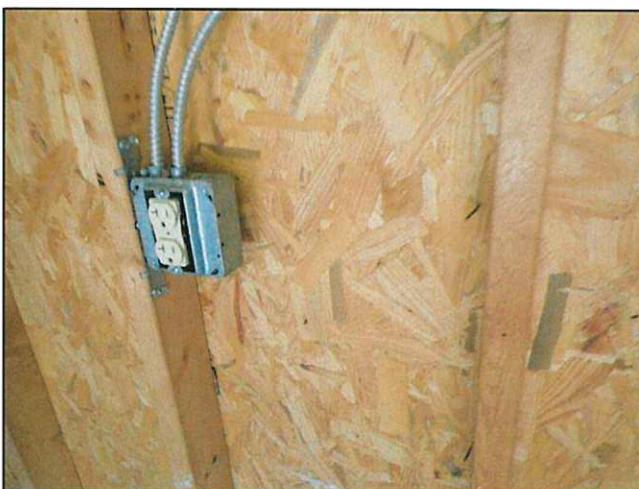
(2) Missing cover plates viewed in the following location(s). New cover plates need to be installed to prevent personal harm. Contact a licensed electrician for repairs.

1. garage - multiple

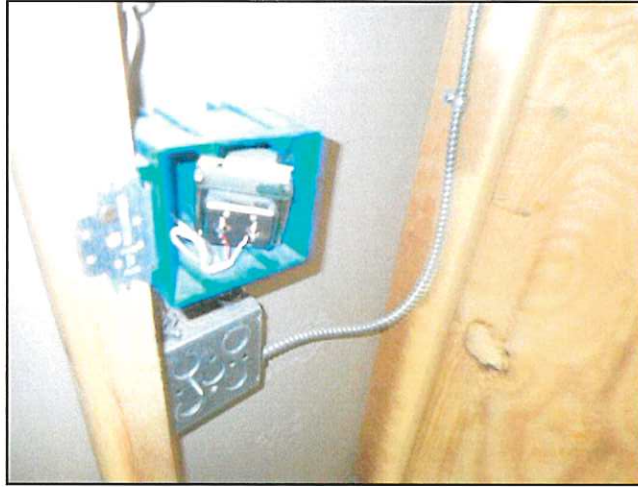
(3) There is a open junction box that needs to be capped at the basement HVAC utility closet. Safety hazard. Contact a licensed electrician for repair.

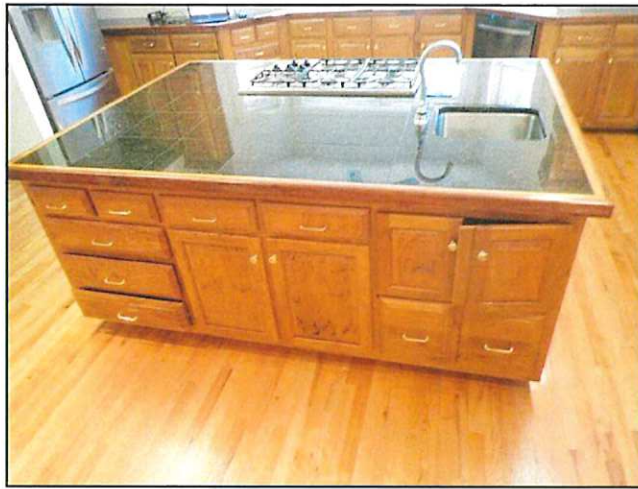
(4) There was no receptacle located at the kitchen island. This is not typical of construction standards. Contact a licensed electrician for repair.

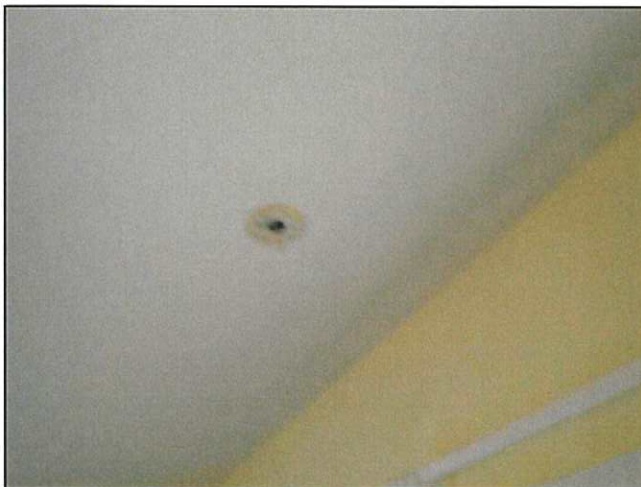
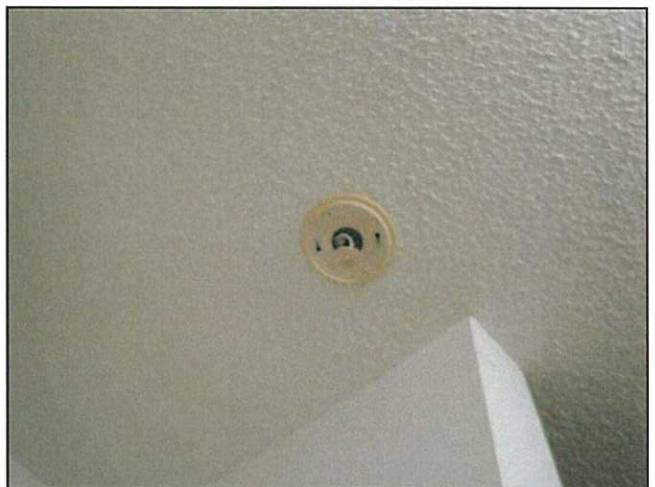
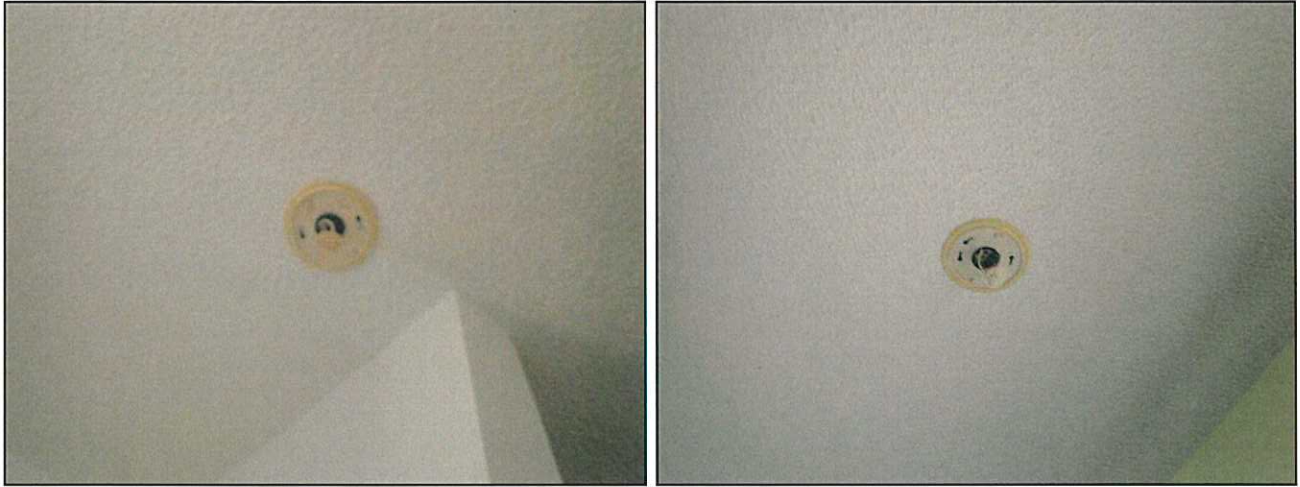
(1) Multiple smoke/carbon monoxide detector(s) was missing at the time of inspection and need installing. Safety hazard. Contact a qualified professional for repair. :

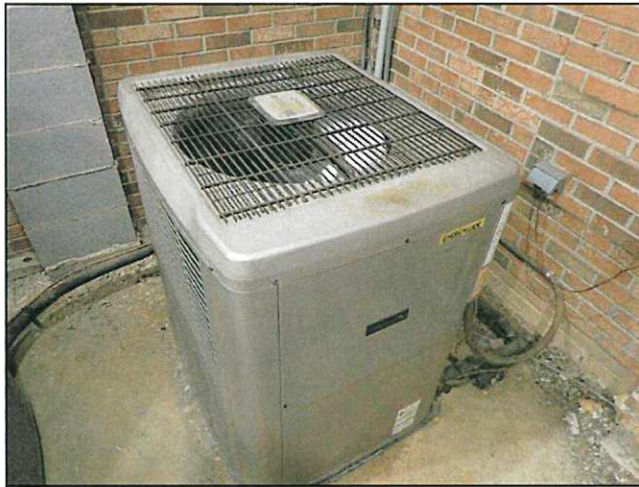
There was a rattling/unusual noise noted at the exterior condensing unit when operating. The inspector was unable to determine the cause of the noise and some disassembling may be required to do so. Contact a qualified HVAC contractor for evaluation/repairs.

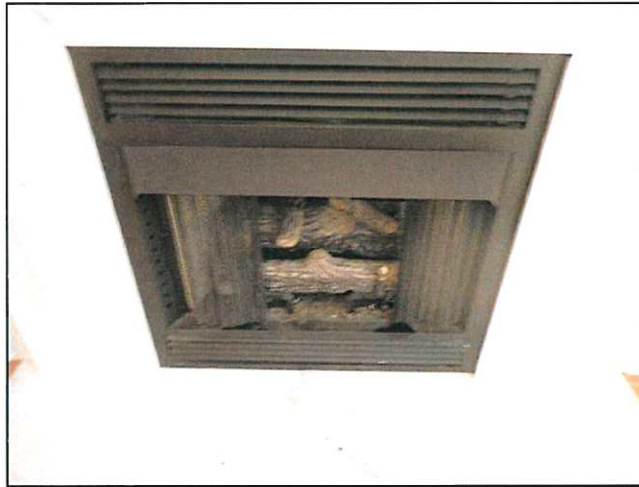
The pilot light was not lit at the time of inspection. Pilot lights must be lit at the time of inspection for the inspector to test the fireplace. If the unit has been off for some it can take a long time to get them to light and/or the air in the lines often need to be bled. The inspector does not carry lighting matches/lighters to lit units that do not have an auto igniter. It is recommended that the pilot be lit and the unit be inspected prior to closing.

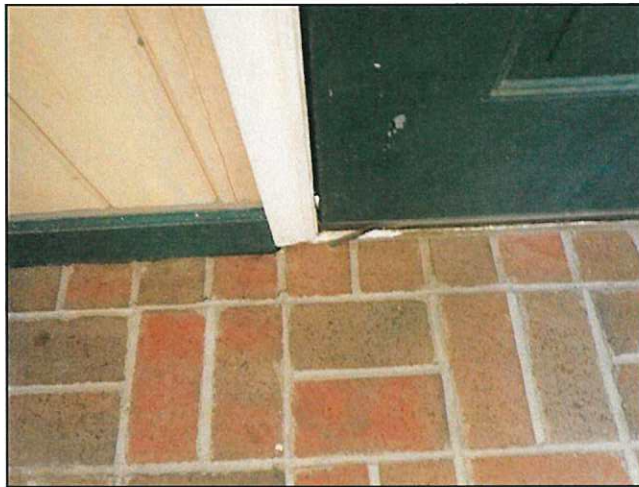
(1) Location: right front door- Daylight can be seen at the bottom left corner of the front door when closed. Additional weather stripping or adjustment is needed. This is needed to prevent water, air, and insect intrusion. Contact a qualified professional.

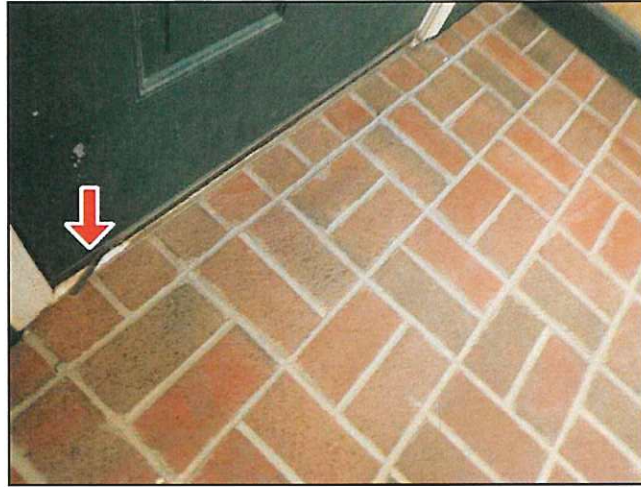
(2) Location: right front door- The weather stripping along the bottom of the front door is torn or deteriorated and needs replacement to prevent water penetration. Contact a qualified professional for repair.

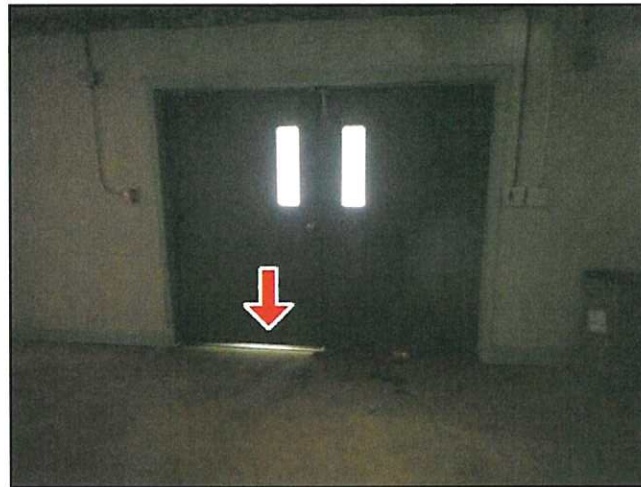
Daylight can be seen along the bottom of the rear house door, basement when closed. Additional weather stripping or adjustment is needed. This is needed to prevent water, air, and insect intrusion. Contact a qualified professional for repair.

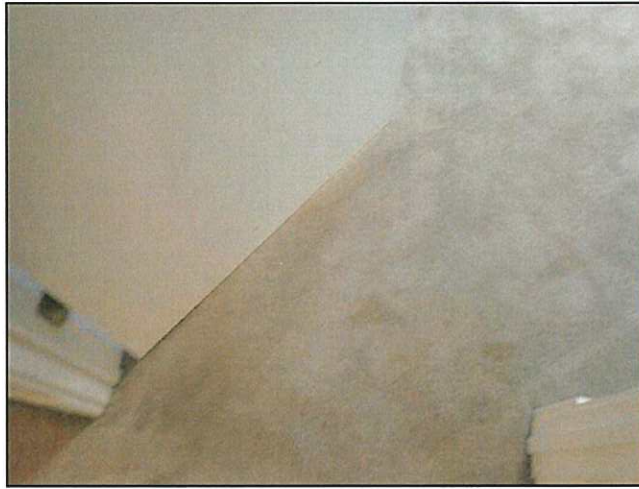
(3) The following door(s) were rubbing the carpet and need to be adjusted. This causes premature wear and tear to the carpeting, makes opening and closing the door difficult, and prevents the HVAC unit from allowing air travel between the rooms adequately. Contact a qualified professional for repair.

1. front left bedroom

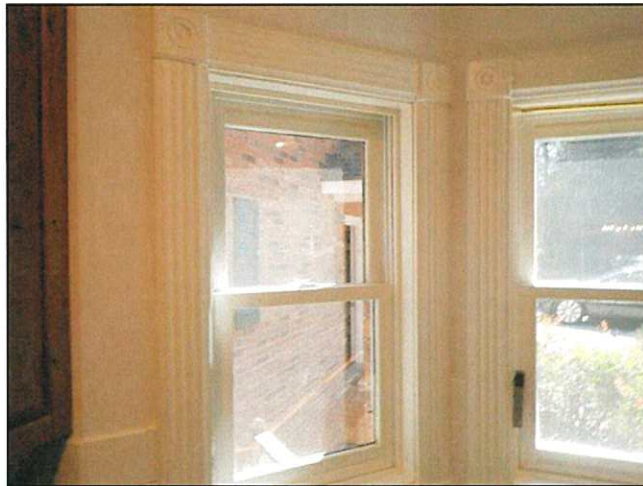
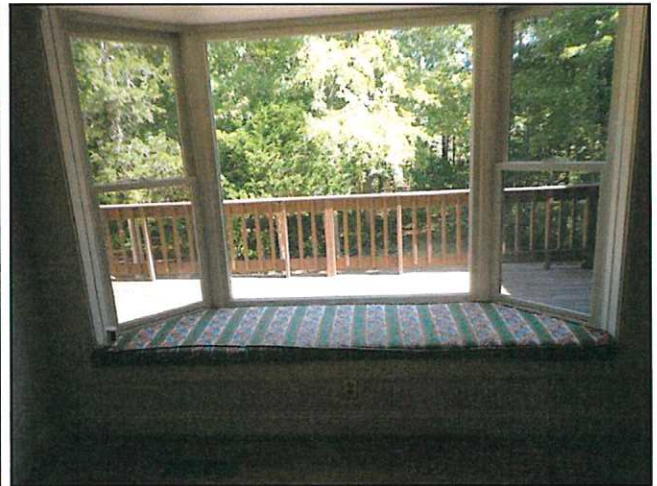
(1) The windows were painted or stuck shut at the time of inspection. When windows are painted or stuck shut they cannot be tested to ensure that the counter weights/springs are functioning properly. Have the windows corrected so that they are not stuck before closing to verify that counter weights/springs function properly in order to provide a means of escape in the event of an emergency. Contact a qualified professional for repair.

1. kitchen- bay window, left window; when facing side yard
2. sitting room- bay window, both windows

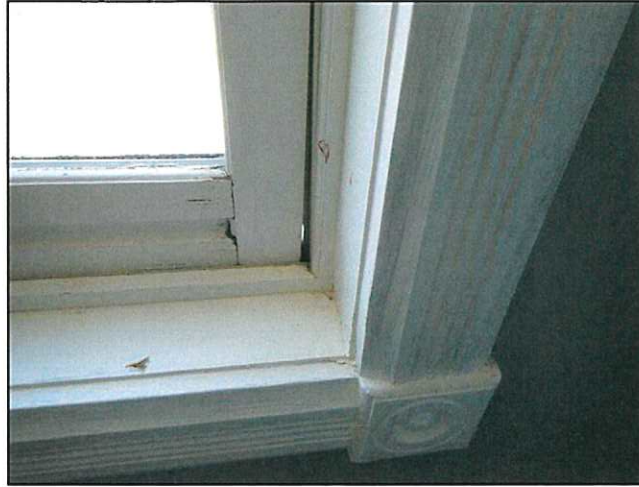
(2) Location: front right bedroom Daylight can be seen at the bottom right corner of the window when closed. Additional weather stripping or adjustment is needed. This is needed to prevent water, air, and insect intrusion. Contact a qualified professional

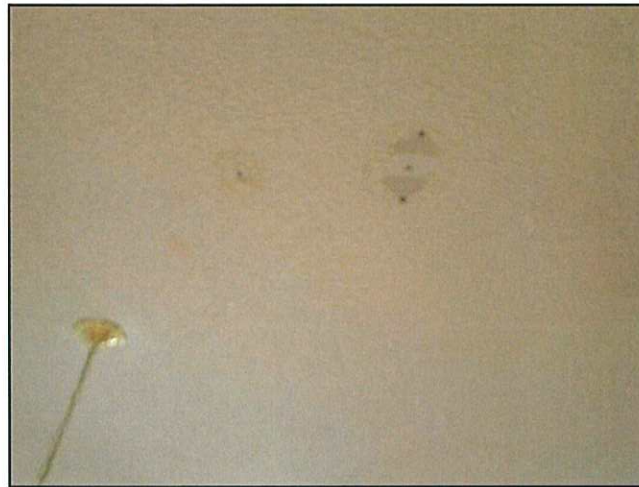
There were stains noted on the ceiling at the following locations. Unable to determine if an active leak existed at the time of inspection. Ask the seller the history of the stains and if repairs have been made to correct any leaks that may have caused the stain. If the sellers are unaware of the stain then the stain should be treated as an active issue and further evaluated by a licensed contractor to make repairs as needed.

1. sitting room off the kitchen

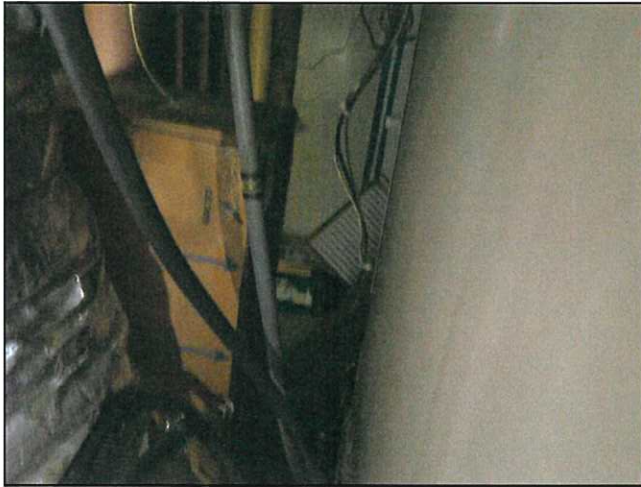
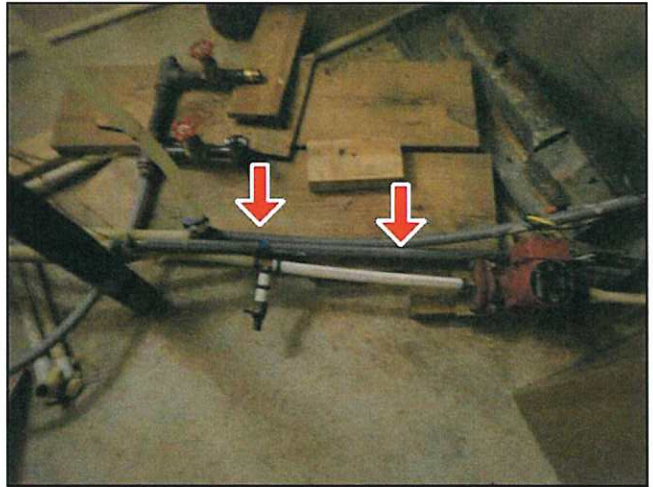
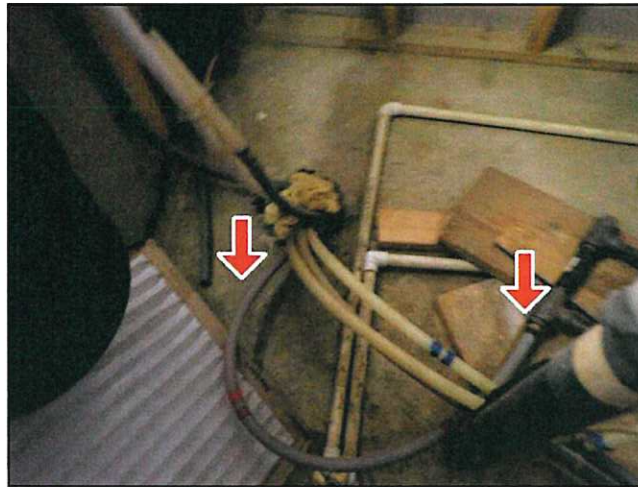
(1) This home has a plumbing supply system that uses polybutylene plastic distribution lines and compression band fittings. Even though this plumbing system was installed in many homes from 1978 until mid-1990's, it is no longer an approved plumbing system due to a history of material failures. The failures were related to improper installation, improper handling, improper storage, and plastic deterioration due to chemical reactions with the water supply. Due to the nature of this latent defect, it was not possible to adequately assess the condition of the plumbing system during the home inspection. A licensed plumbing contractor should be consulted for a complete evaluation of the plumbing system to determine the significance of this concern.

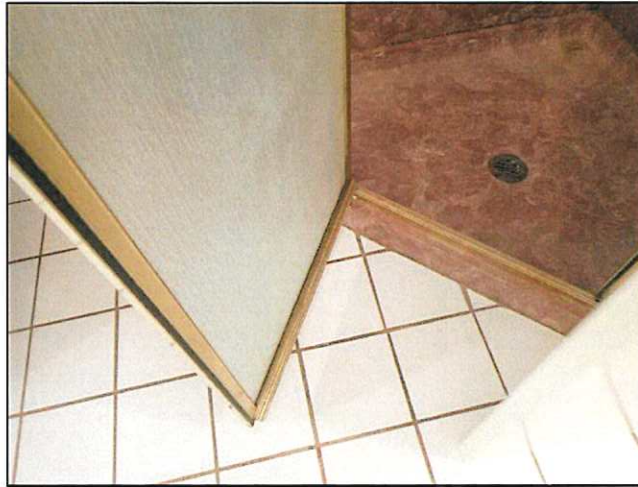
(1) The weather stripping installed at the bottom of the shower door is torn/damaged and/or missing. This is needed to prevent water from leaking out during use. Contact a qualified professional for repair.

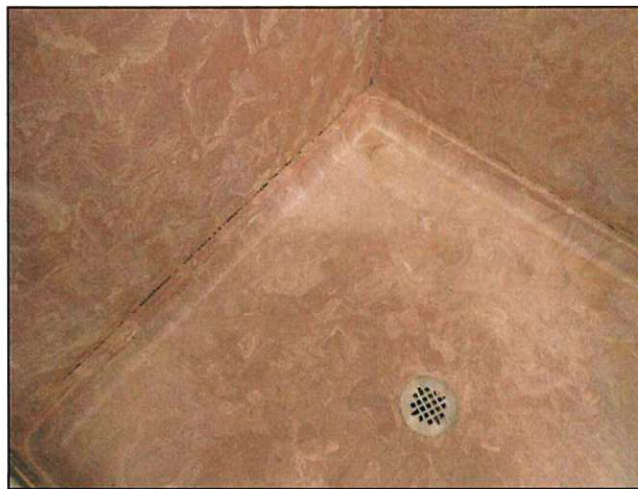
(2) Several areas in the tub/shower surround were noted to be in need of additional sealant to prevent water penetration. Contact a qualified professional for repair.
