Inspection Report

Property Address:
511 Cedar Grove Road
York SC 29745

Carolinas Premier Inspections

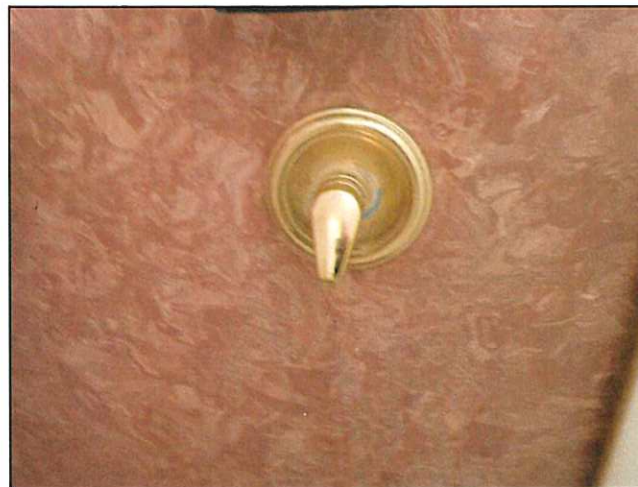
The hot and cold water supply lines are reversed. This is a child safety hazard. The hot should be on the left and the cold on the right. Some fixtures can be replaced from the front and other will require removal of drywall at the rear of the fixture. Contact a licensed plumber for repair.

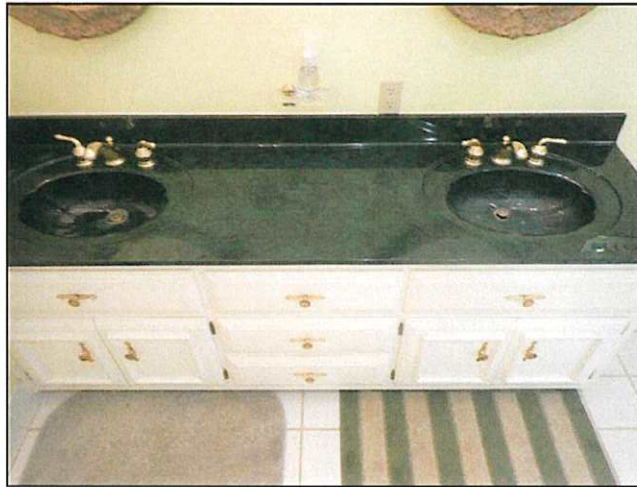
The sink stopper(s) did not function properly at the time of inspection. When pulling the lever the stopper would not respond or function as intended. The root cause was undetermined. Contact a licensed plumber for evaluation and repair.

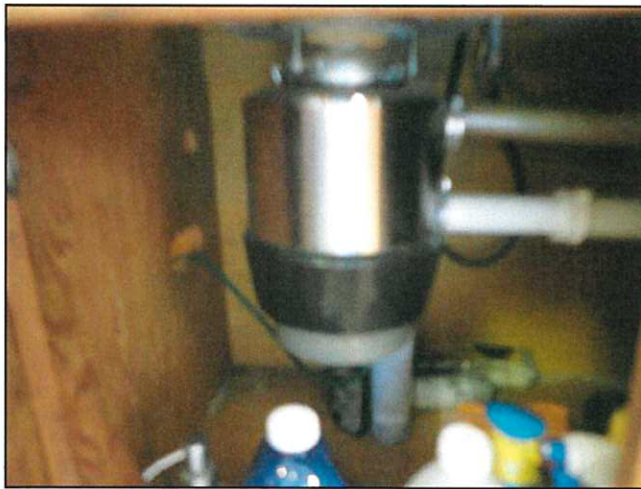
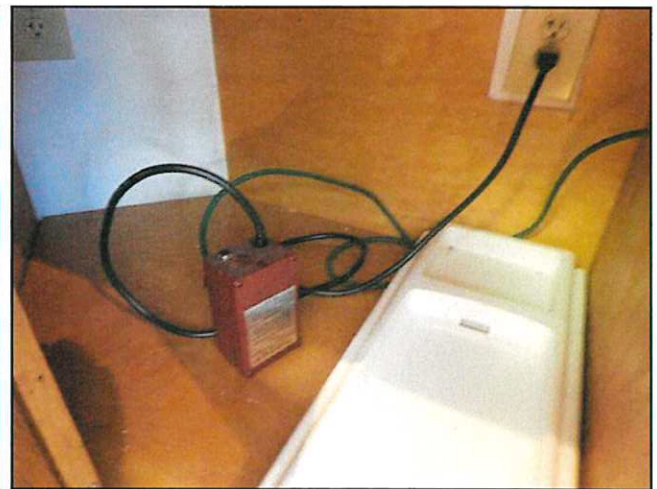
The unit did not respond when tested at the time of inspection. This may be a result of a tripped or bad breaker. The breaker was reset at the time of inspection, however the unit did not function or respond. Contact a qualified professional for repair.

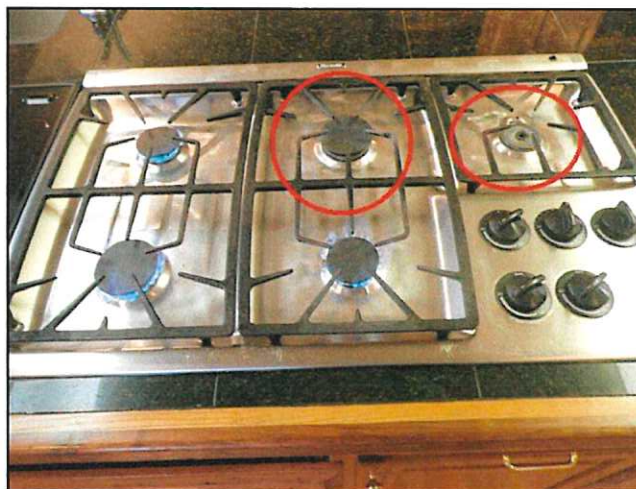
The middle and rear right top burner did not function or respond at the time of inspection. Repair and/or replace as needed for the gas burner to function as intended. Contact a qualified professional for repair.

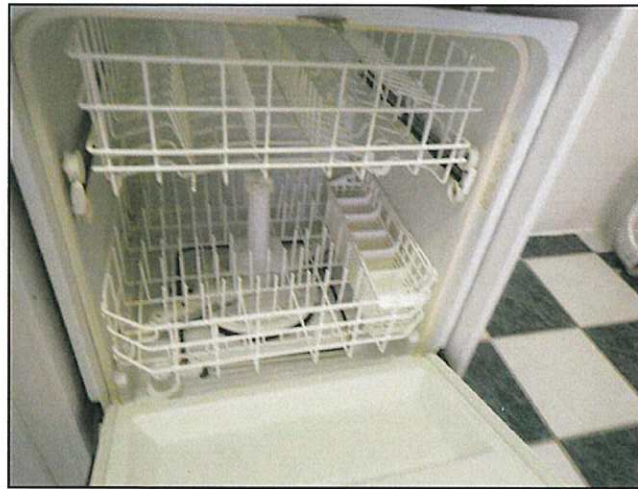
The laundry room dishwasher did not fill with water or operate properly. Repair and/or replace as needed for the dishwasher to function as intended. Contact a qualified professional for repair.
