Inspection Report

Property Address: 203 W Railroad Ave. Hertford Nc 27910

Home Spec of NC, Inc.

Date: 10/12/2022	Time: 01:00 PM	Report ID: 2210122
Property:	Customer:	Real Estate Professional:
203 W Railroad Ave.	Mr. Jake Forbes	Jake Forbes
Hertford Nc 27910		United Country

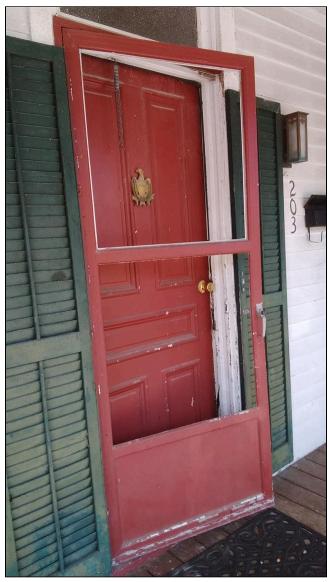
2.1 Item 1(Picture)

2.1 Front storm door needs to be replaced. Item 1(Picture)

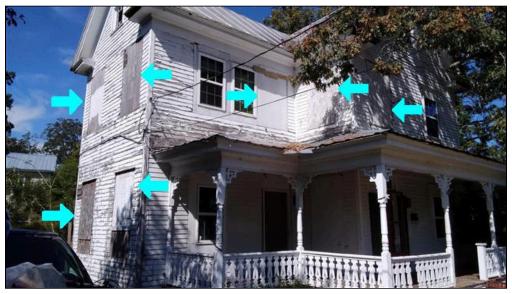
2.2 Item 1(Picture)

2.2 Multiple windows boarded over. It appears, from the inside, that many of these were closed off on the inside also and are intended to have siding applied over the former exterior openings. Item 1(Picture)

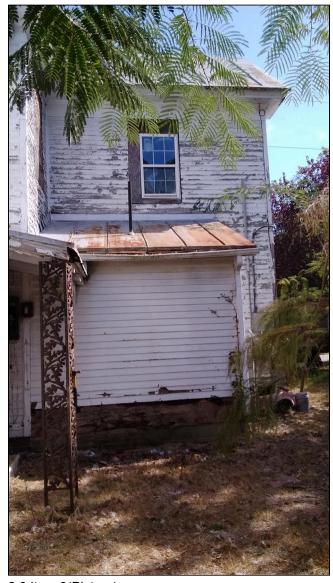
2.6 Item 3(Picture)

2.6 Other elevations. Item 1(Picture) Item 2(Picture) Item 3(Picture) Item 4(Picture) Item 5(Picture) Item 6(Picture) Item 7(Picture)

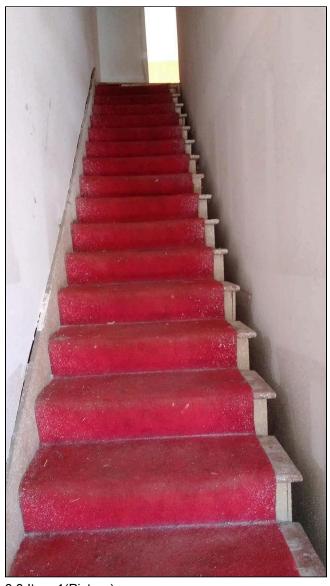
3.3 Item 1(Picture)

3.3 No hand /safety railing installed yet. Item 1(Picture)

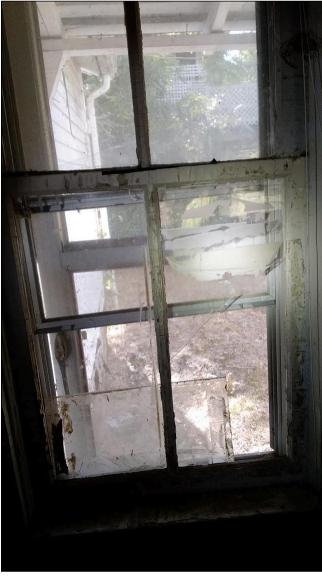
3.6 Item 1(Picture)

3.6 Windows are in poor condition. Examples: Item 1(Picture) Item 2(Picture) Item 3(Picture)

Refer to a contractor who specializes in window replacement.

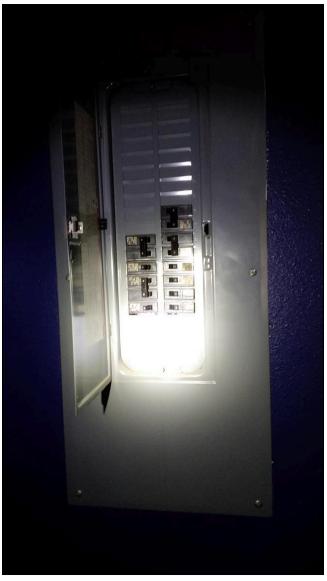
6.1 Item 1(Picture)

6.1 (1) The main panel box for upstairs is located in the top level left front room. Homeline/Square D. Item 1(Picture) Item 2(Picture)

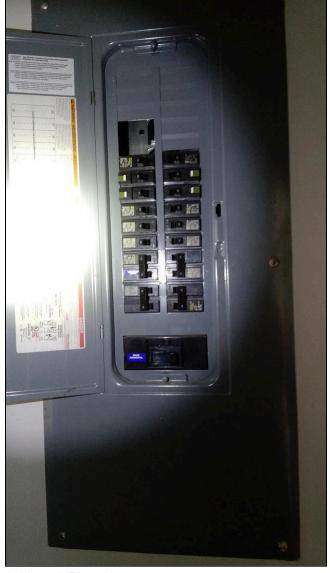
6.1 Item 3(Picture)

First level panel. Item 3(Picture) Item 4(Picture) Homeline/Square D.

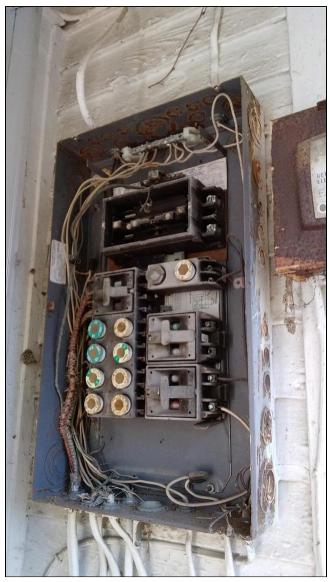
6.1 Item 5(Picture)

(2) There is a fuse panel on the back porch. This appears to have been cut off and no longer functional. Item 5(Picture)

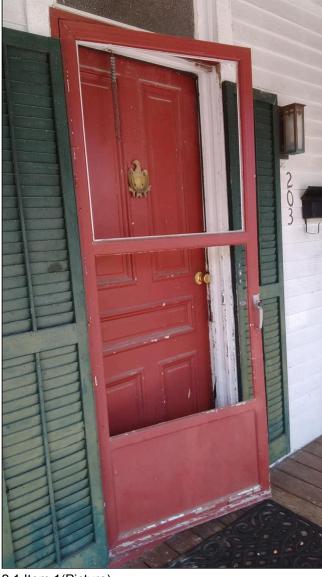
2.1 Item 1(Picture)

Front storm door needs to be replaced. Item 1(Picture)

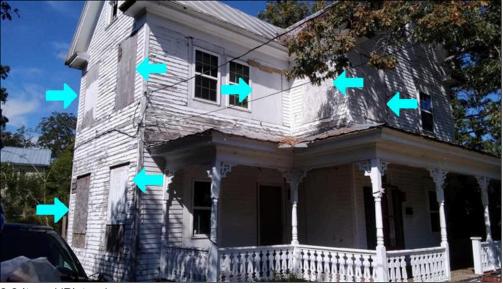
2.2 Item 1(Picture)

Multiple windows boarded over. It appears, from the inside, that many of these were closed off on the inside also and are intended to have siding applied over the former exterior openings. Item 1(Picture)

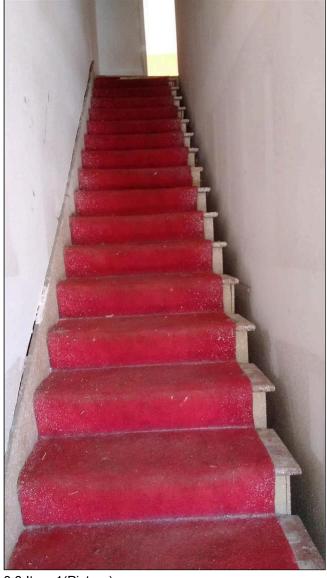
3.3 Item 1(Picture)

No hand /safety railing installed yet. Item 1(Picture)

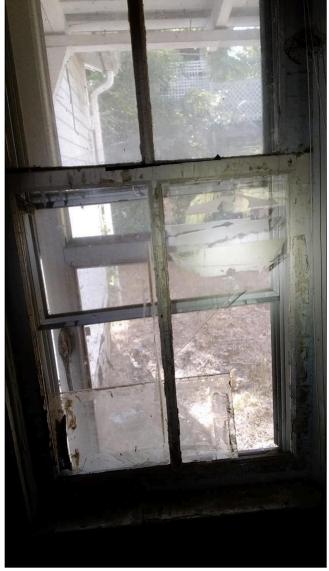
3.6 Item 2(Picture)

4 Windows are in poor condition. Examples: Item 1(Picture) Item 2(Picture) Item 3(Picture)

Refer to a contractor who specializes in window replacement.
