## Summary Only

**Property Address:**  
420 Borderline Rd NW  
Willis VA 24380

**Straight Point Home Inspections LLC**  
**J. Mason Walker 3380001488 NRS exp. 3-31-25**  
**25 S Central Drive**  
**Christiansburg, VA 24073**  
**540-744-6532**

<b>Date:</b> 8/23/2023	<b>Time:</b> 12:00 PM	<b>Report ID:</b> 20230823-420-Borderline-Rd-NW
<b>Property:</b> 420 Borderline Rd NW Willis VA 24380	<b>Customer:</b> Kimberly Quesenberry	<b>Real Estate Professional:</b>

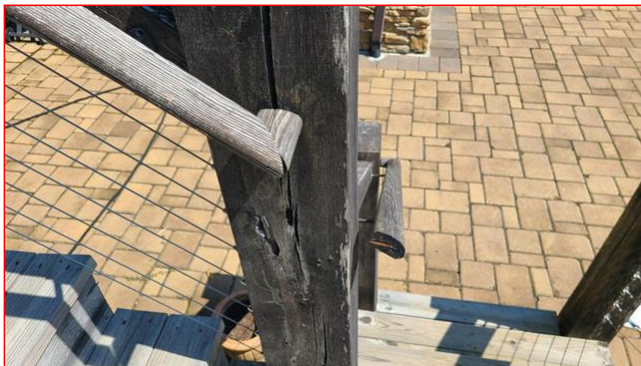
(2) Handrail is loose and deteriorating at the rear right corner exterior stairs.

2.4 Item 3(Picture) exposed screw at edge presents sharps hazard

Recommend further evaluation and repairs as necessary by a licensed general contractor.

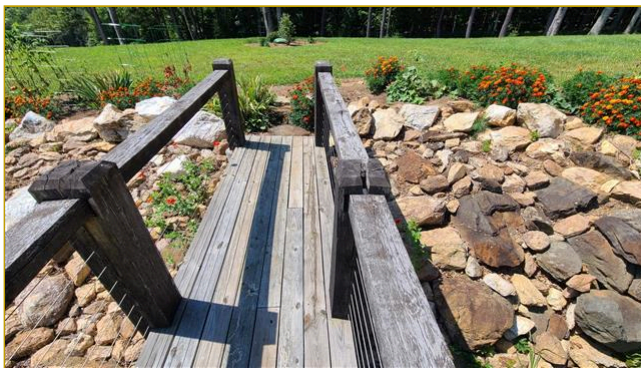
2.4 Item 4(Picture)

(3) Handrail support has split at the top due to natural shrinking. Recommend further evaluation and repairs as necessary by a licensed general contractor.

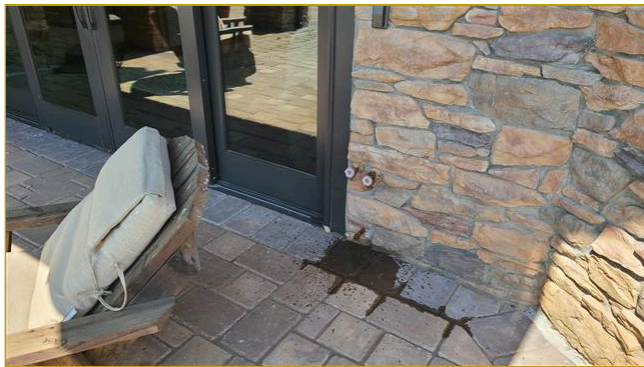
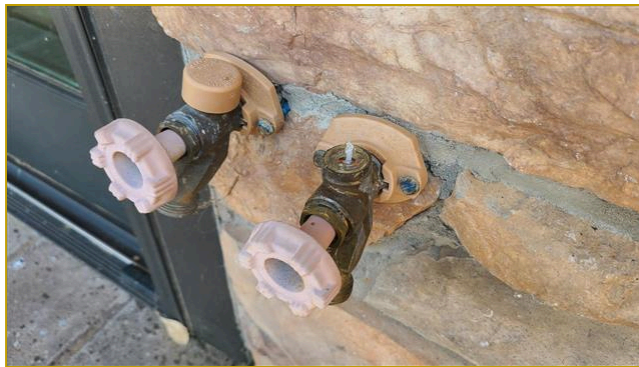
(2) Hose bib vacuum breaker cap is missing. Recommend further evaluation and repairs as necessary by a competent handy person or a licensed general contractor.

2.6 Item 7(Picture) rear left corner of the home

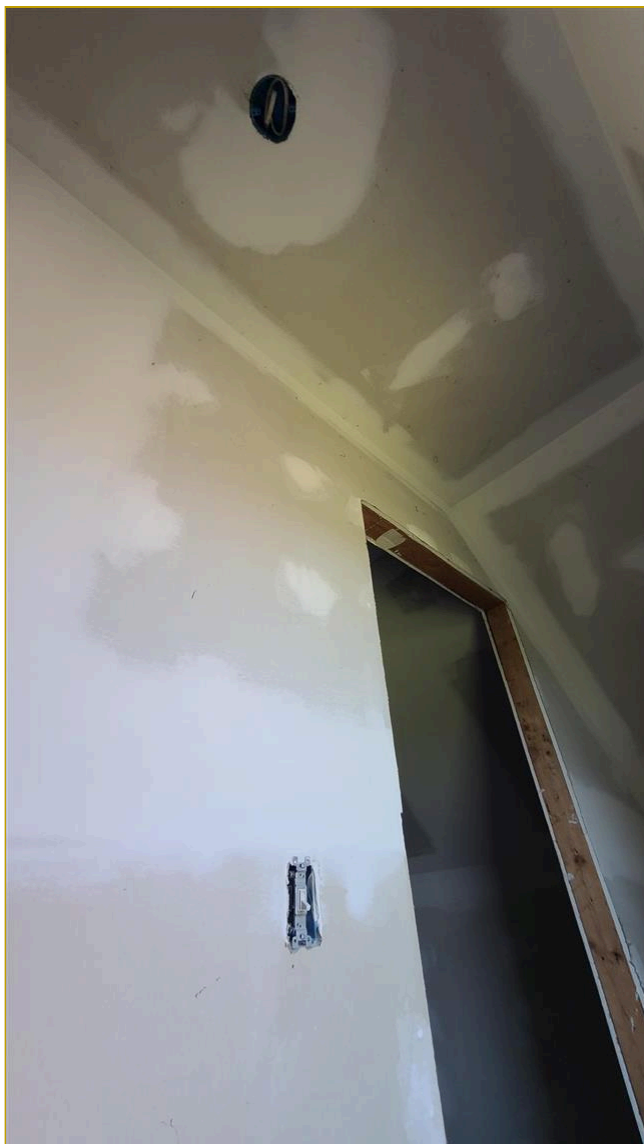
Outlets/Junction boxes/Light Switches with missing or damaged covers can be considered a safety hazard if wires are accessible.

3.2 Item 1(Picture) upper level of garage stairwell - light switch and open junction box for light fixture

Recommend repairs or replacement of covers to keep potential electrical hazards from being present at these locations by a competent handy person or licensed general contractor.

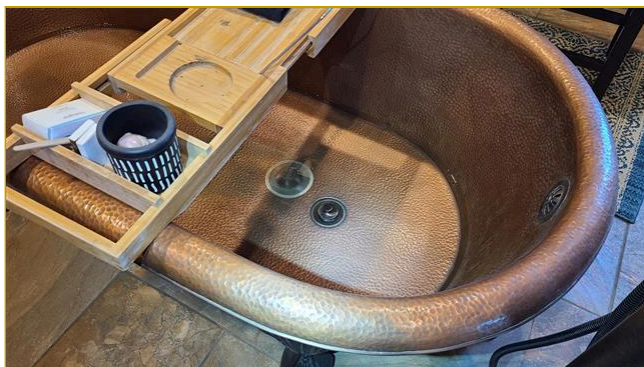
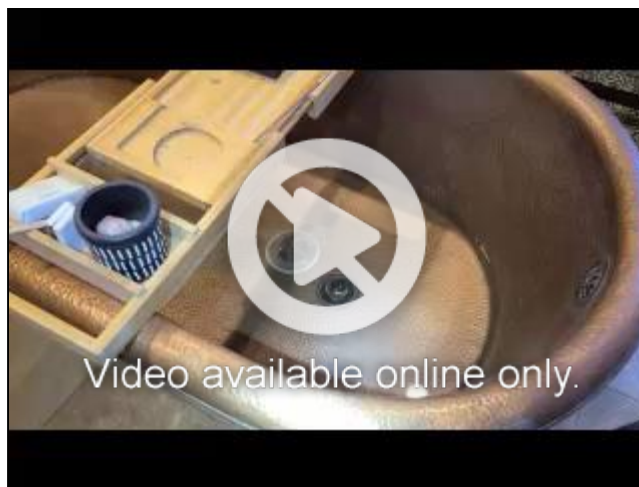
Slow drain during the inspection. Likely due to build up of debris in the drain at the time of inspection as the plumbing system appeared to be in standard condition at the time of inspection. Recommend drain cleaner be applied and tested before final walk through to confirm cleared condition by a competent handy person.

6.10 Item 1(Picture) visible debris in drain

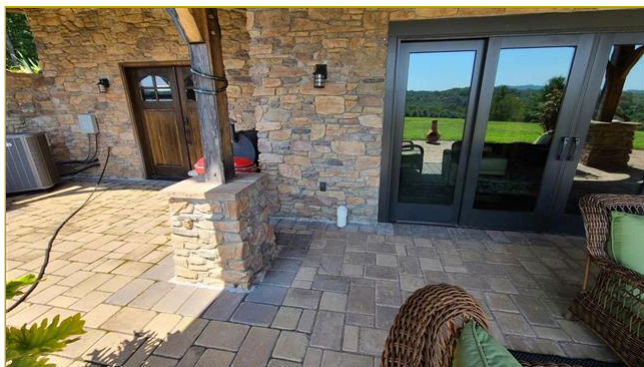
This inspection did not access the tank or determine its location. For a more detailed inspection, I recommend you contact a septic pumping company and have them clean it. At that time the tank could be inspected for proper functioning perhaps by the septic cleaning company.

8.0 Item 1(Picture) clean out for drain located at rear middle right side of home

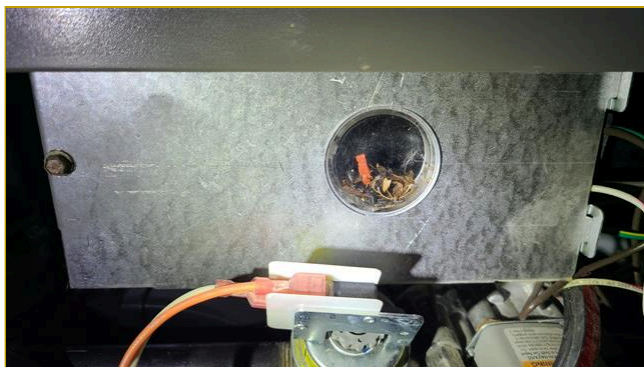
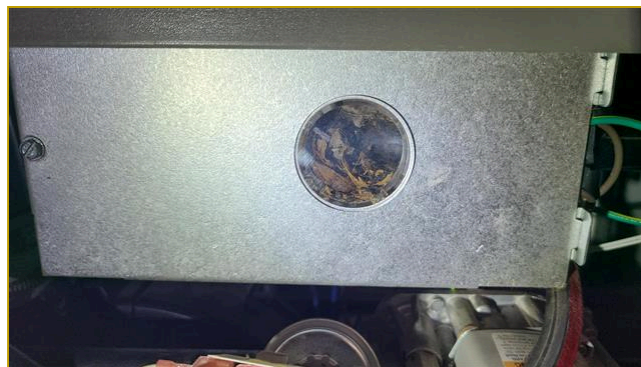
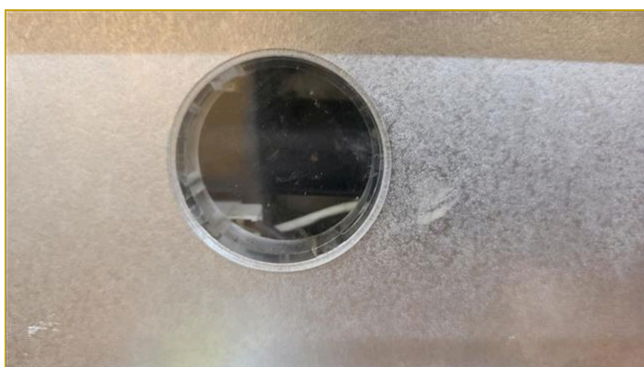
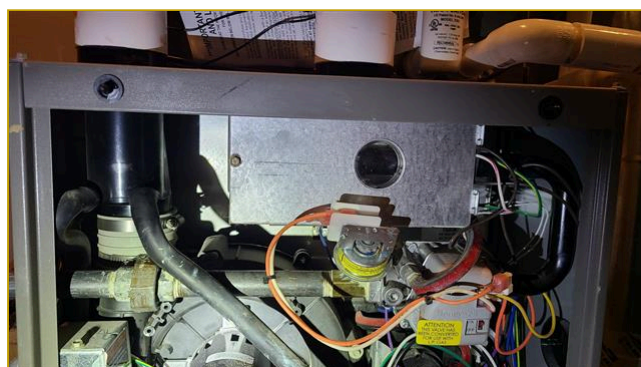
(5) Debris was visible inside the heat exchanger observation glass. This is likely due to mice entering the flue systems. It may be helpful to have a mesh screen installed to help prevent intrusions to the units at the exterior as long as ventilation is still adequate for the units.

Debris was removed during inspection at both units and appear in standard condition at time of inspection.

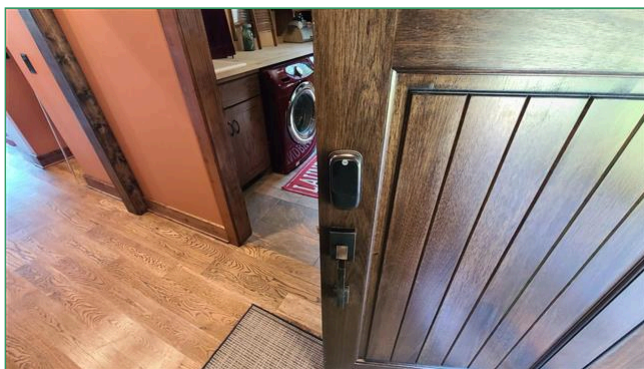
(2) Exterior door(s) has/have an electronic dead bolt lock(s). This should be updated as soon as ownership has transferred. Just a courtesy reminder that a lot of people have had access to the home recently.

2.1 Item 4(Picture) front right side entrance

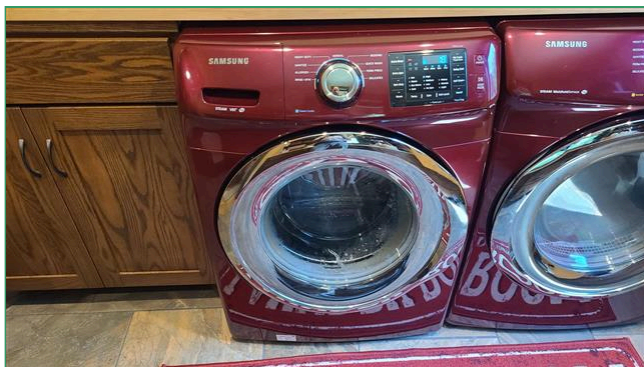
4.14 Item 1(Picture) unable to view supply lines and drain due to countertop configuration

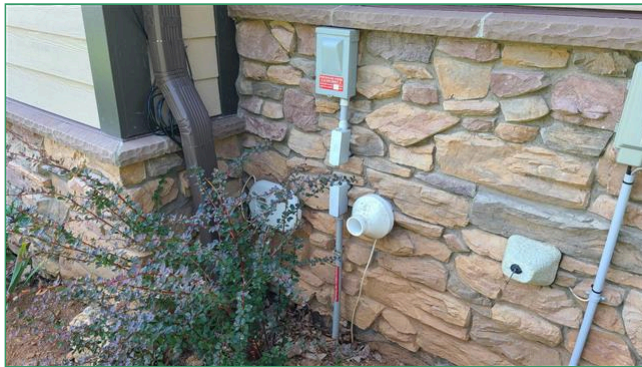
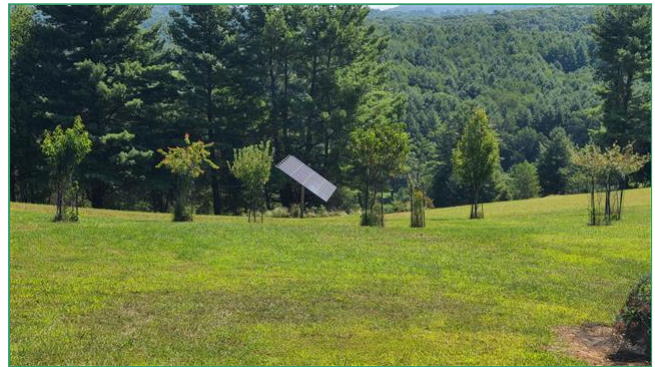
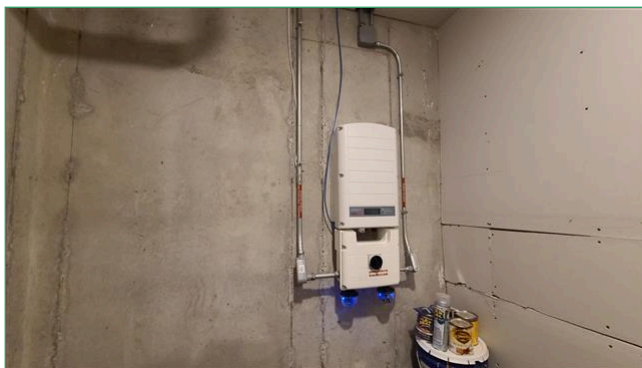
(2) Solar panel system in place to help supply energy for the home. This energy system is outside of the scope of my inspection.

I recommend further evaluation and routine service by a professional solar energy system installer.
