# Inspection Report

**Property Address:**  
420 Borderline Rd NW  
Willis VA 24380

**Straight Point Home Inspections LLC**

| <b>Date:</b> 8/23/2023 | <b>Time:</b> 12:00 PM | <b>Report ID:</b><br>20230823-420-Borderline-Rd-NW |

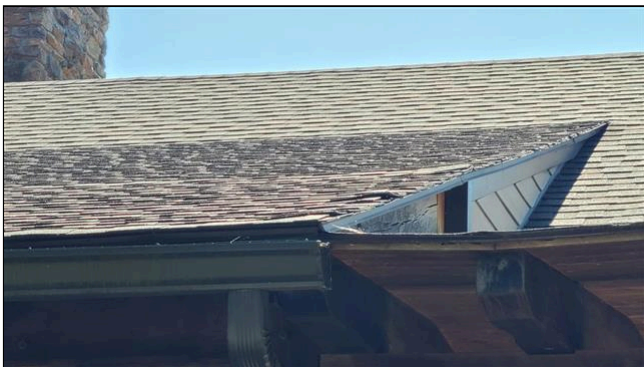
1.0 Item 7(Picture) front right corner by walkway

(2) Nail pop(s) appear to be present on the roof covering. There are many possible causes for nails to uplift on roofs.

Recommend further evaluation and repairs as necessary by a competent handy person or a licensed general contractor.

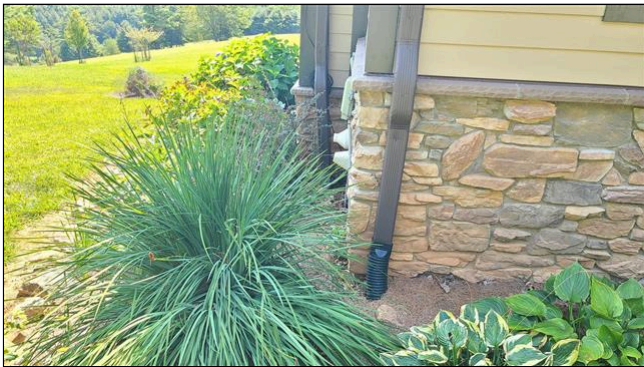
1.4 Item 1(Picture)

(1) Gutter extensions are under landscaping or ground around property. Downspout extensions should carry water at least 5' away from the home to prevent foundation damage. Due to the hidden nature of these extensions it is recommended that you monitor these areas for water spillage during rain to verify if drains are clear and functioning properly.

If water is noted around these connections it is recommended to have extensions cleaned or replaced.

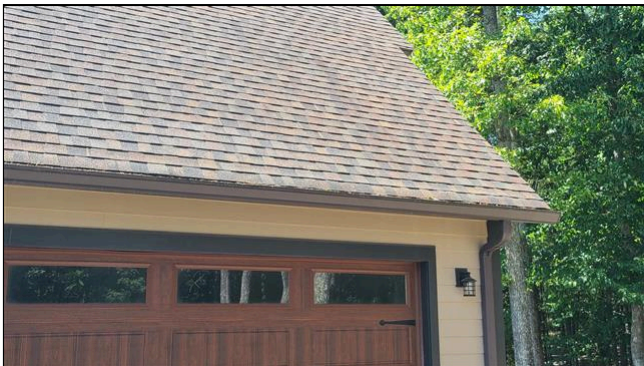
1.4 Item 2(Picture) front gutter for garage

(2) Gutter guards full of debris which may prevent proper function of the system.

Recommend cleaning to allow water to enter system as intended.

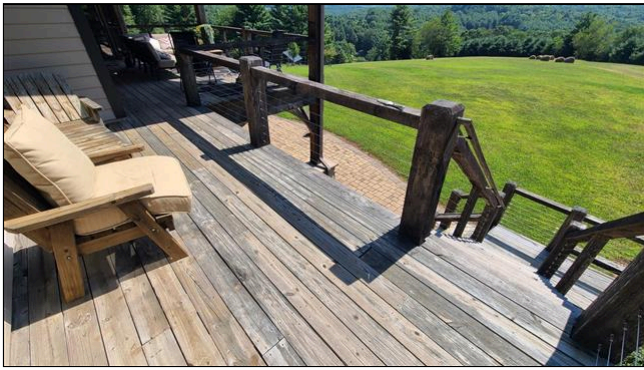
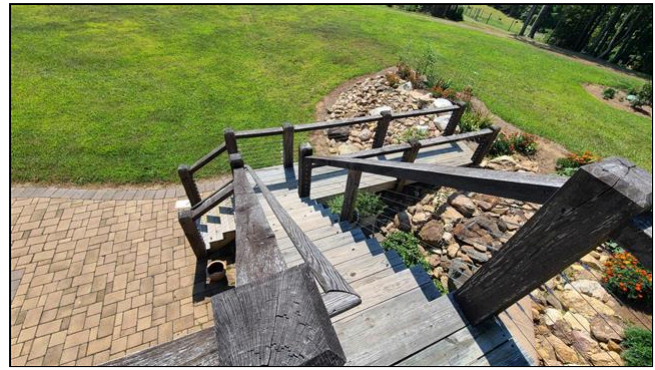
(1) The decking and components needs cleaning with a "Deck wash" and seal with a waterproof sealant. This is considered routine maintenance and will help to prolong the life of the components.

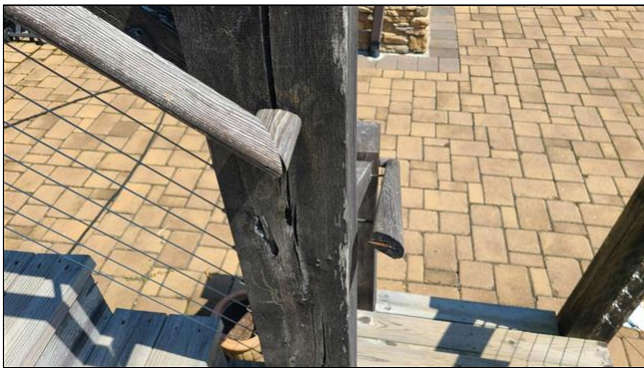
(2) Handrail is loose and deteriorating at the rear right corner exterior stairs.

2.4 Item 3(Picture) exposed screw at edge presents sharps hazard

Recommend further evaluation and repairs as necessary by a licensed general contractor.

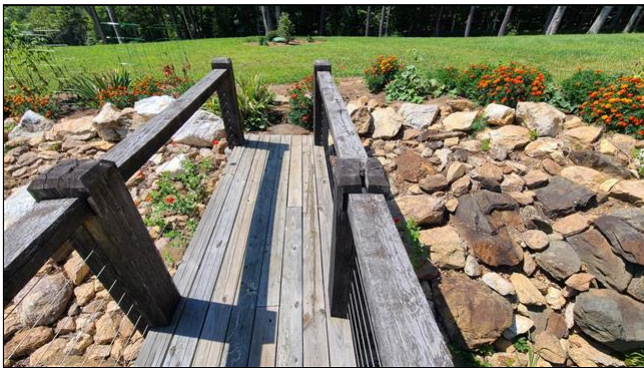
2.4 Item 4(Picture)

(3) Handrail support has split at the top due to natural shrinking. Recommend further evaluation and repairs as necessary by a licensed general contractor.

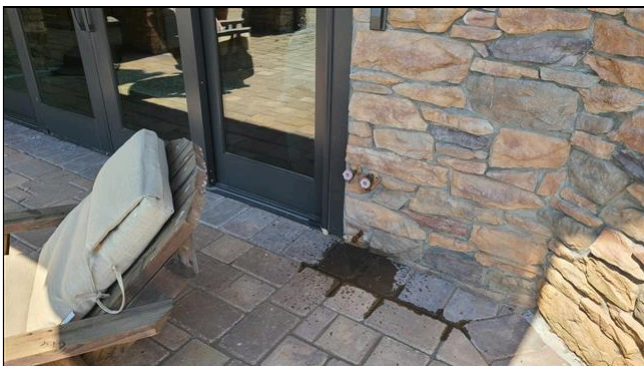
2.6 Item 7(Picture) rear left corner of the home

(2) Hose bib vacuum breaker cap is missing. Recommend further evaluation and repairs as necessary by a competent handy person or a licensed general contractor.

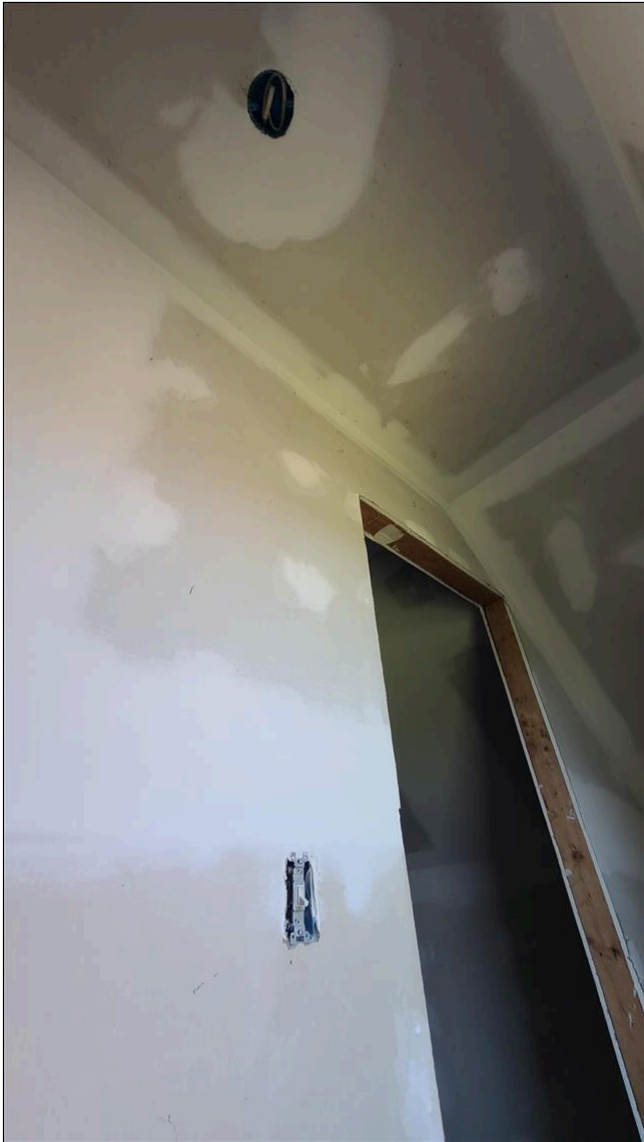
Outlets/Junction boxes/Light Switches with missing or damaged covers can be considered a safety hazard if wires are accessible.

3.2 Item 1(Picture) upper level of garage stairwell - light switch and open junction box for light fixture

Recommend repairs or replacement of covers to keep potential electrical hazards from being present at these locations by a competent handy person or licensed general contractor.

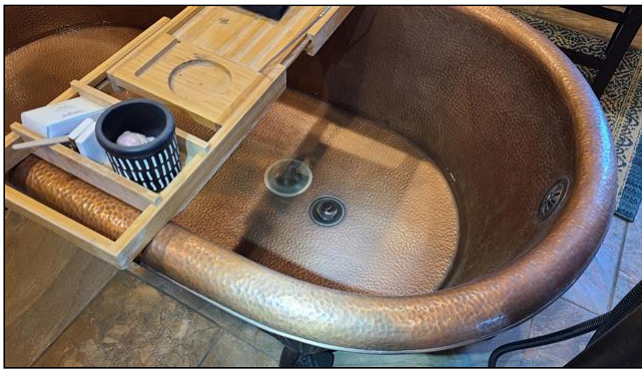
Slow drain during the inspection. Likely due to build up of debris in the drain at the time of inspection as the plumbing system appeared to be in standard condition at the time of inspection. Recommend drain cleaner be applied and tested before final walk through to confirm cleared condition by a competent handy person.

6.10 Item 1(Picture) visible debris in drain

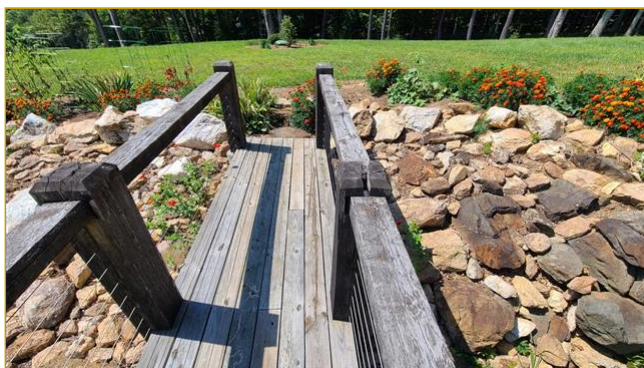
2.4 Item 4(Picture)

(3) Handrail support has split at the top due to natural shrinking. Recommend further evaluation and repairs as necessary by a licensed general contractor.

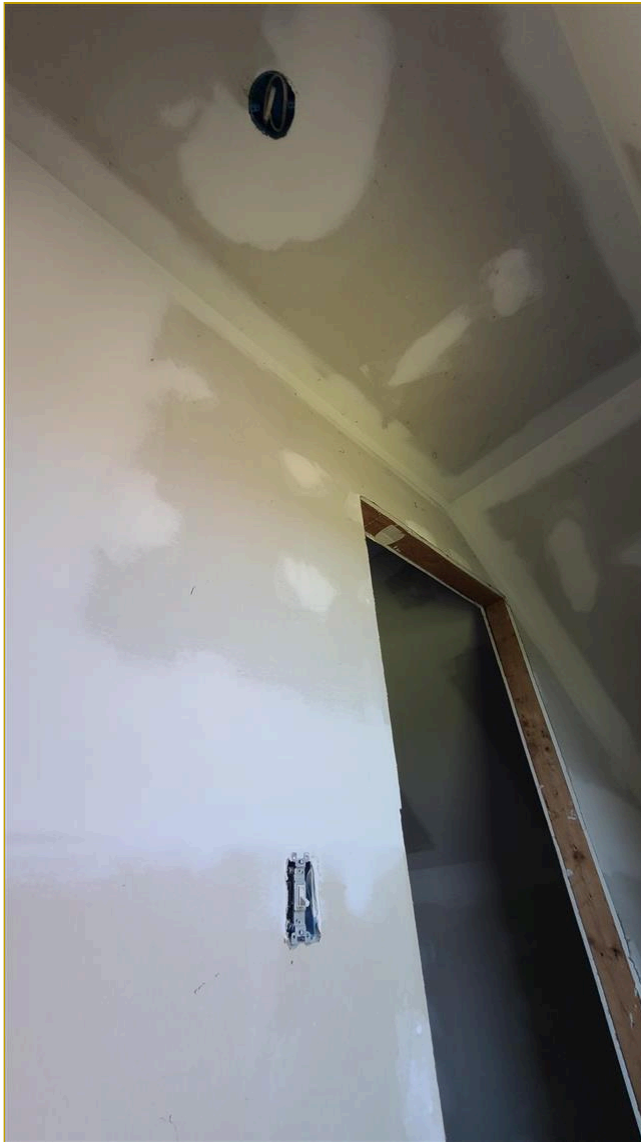
3.2 Item 1(Picture) upper level of garage stairwell - light switch and open junction box for light fixture

Recommend repairs or replacement of covers to keep potential electrical hazards from being present at these locations by a competent handy person or licensed general contractor.

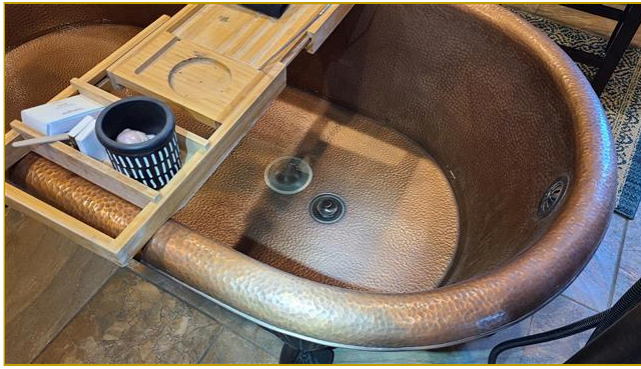
Slow drain during the inspection. Likely due to build up of debris in the drain at the time of inspection as the plumbing system appeared to be in standard condition at the time of inspection. Recommend drain cleaner be applied and tested before final walk through to confirm cleared condition by a competent handy person.

6.10 Item 1(Picture) visible debris in drain
