## Home Inspection Report

PROPERTY INSPECTED:  
5530 South Harmony Road  
Bloomington, IN 47403

Date of Inspection: 09/21/2023

Inspection No. 311577-481

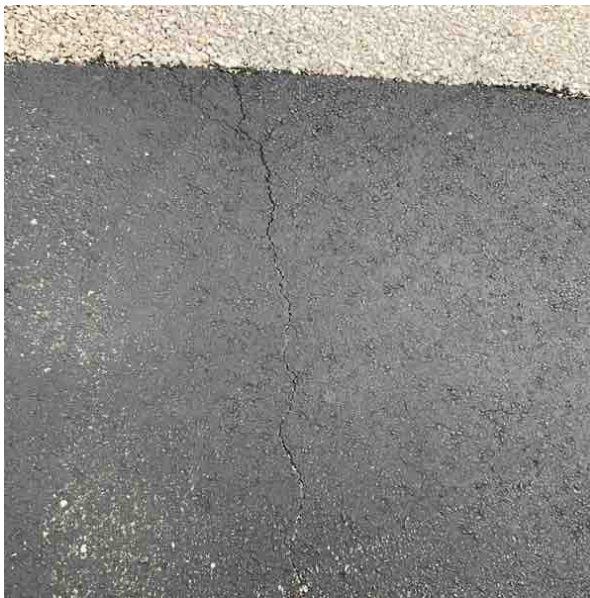
2.2.1 The driveway shows typical and minor surface wear and cracking. Periodic maintenance may prolong the life of the surface.

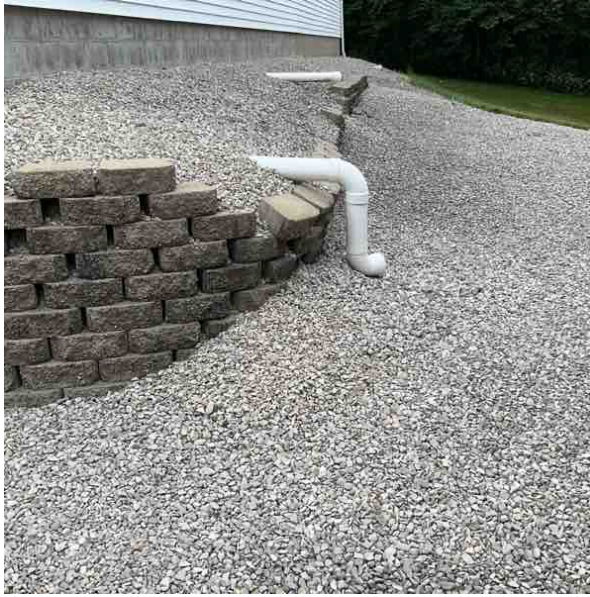
2.3.1 The retaining wall is leaning and damaged. Repair or replace as required to restore functionality, prevent failure, and for safety. **(Exterior Back)**

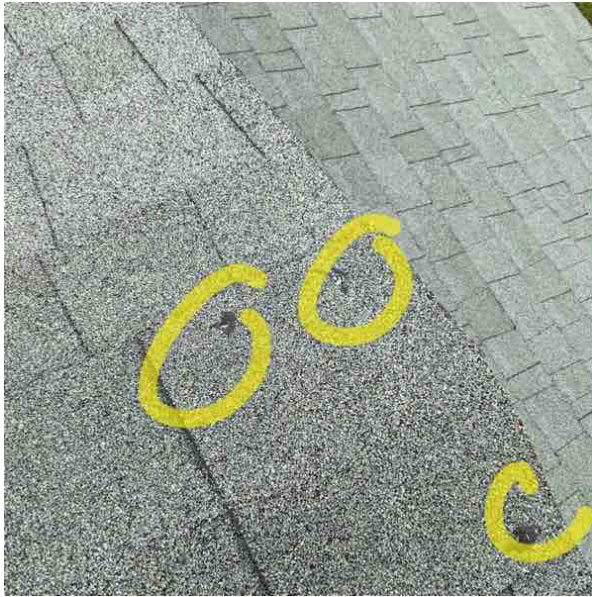
4.2.2 Seal exposed nail heads to maintain water tight integrity for structure. Attached are representative examples. There are similar deficiencies in other locations of the roof.

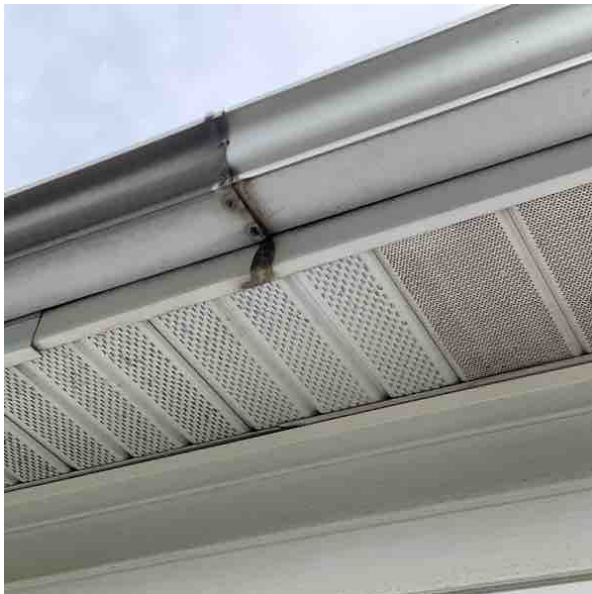
4.4.1 The gutter(s) show signs of leaking. Repair or replace to provide proper controlled drainage off the roof and to prevent water-related damage to structure and interior finishes. **(Detached garage exterior left)**

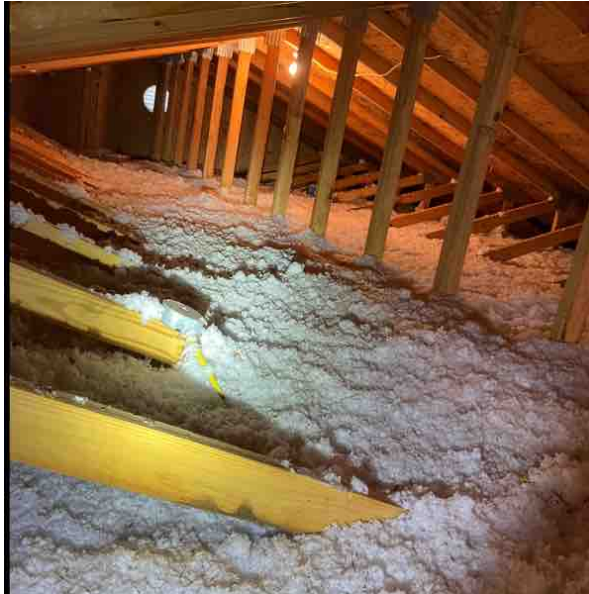
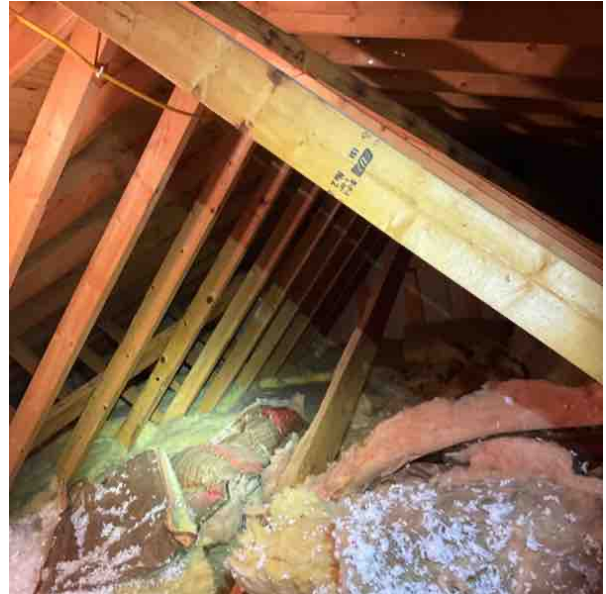
5.2.1 The insulation was inspected and an adequate amount of insulation was observed.

5.2.2 Insulation is at or above today's standards.

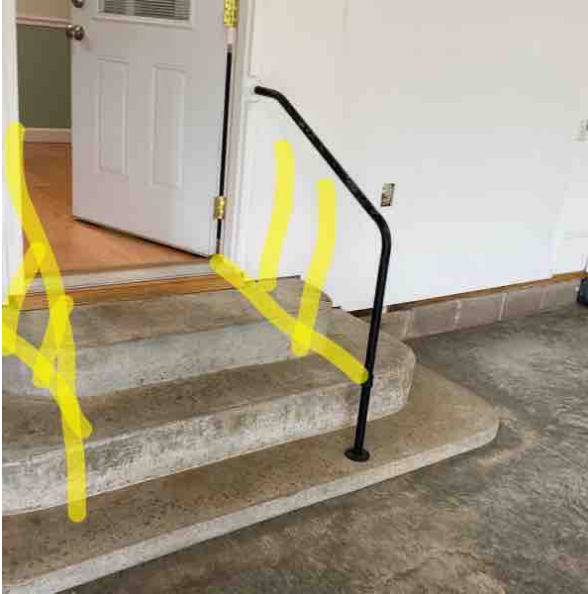
6.3.1 Missing handrail / guardrails with balusters on steps to inside door. Recommend installation of appropriate railing for fall hazard prevention. **(Garage)**

6.3.1 Missing handrail / guardrails with balusters on steps to inside door. Recommend installation of appropriate railing for fall hazard prevention. (Garage)

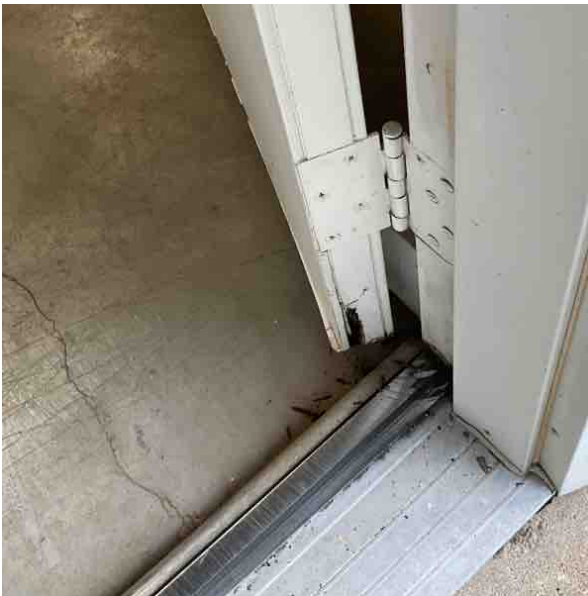
6.4.1 Door is damaged and rotted. Recommend door replacement to prevent water damage and restore proper functionality. (Detached garage)

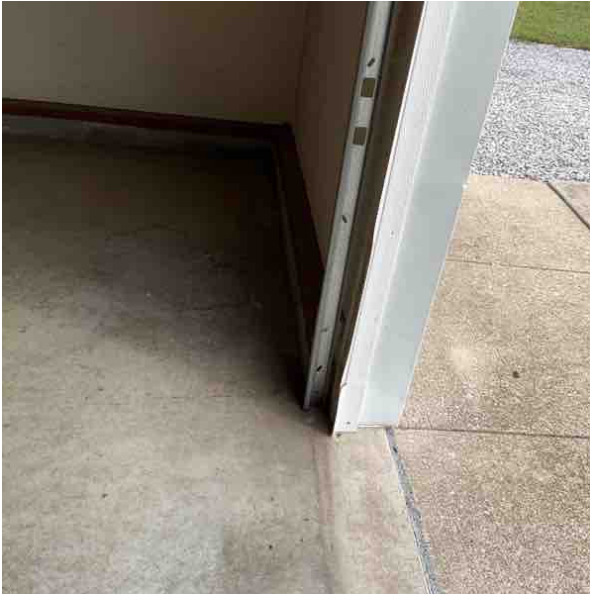
6.7.1 The vehicle door opener is missing photo-eye sensors. Install sensors for improved safety. **(Detached garage)**

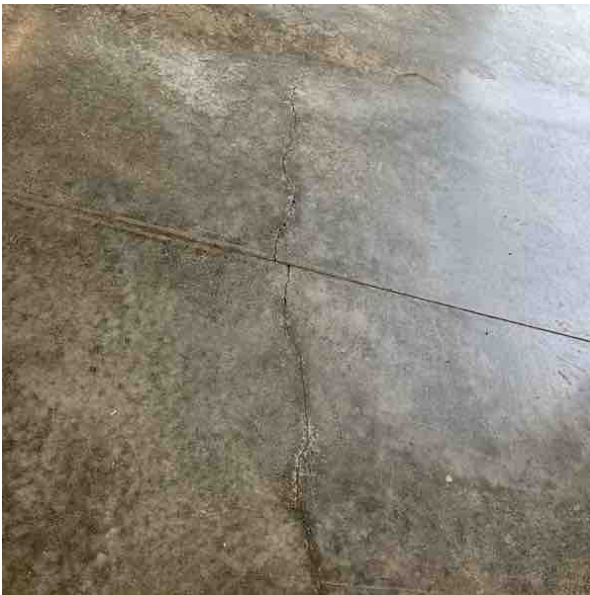
6.8.1 Typical minor floor cracks are present in the garage floor. No improvement is necessary at this time. **(Garage)**

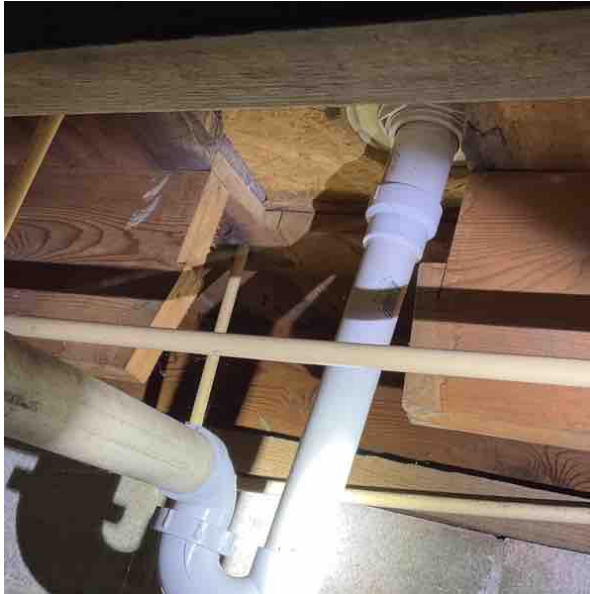
7.3.1 The joist(s) have excessive notches or holes. Have this damage repaired to ensure serviceability. **(Crawlspace)**

7.3.1 **The joist(s) have excessive notches or holes. Have this damage repaired to ensure serviceability. (Crawlspace)**

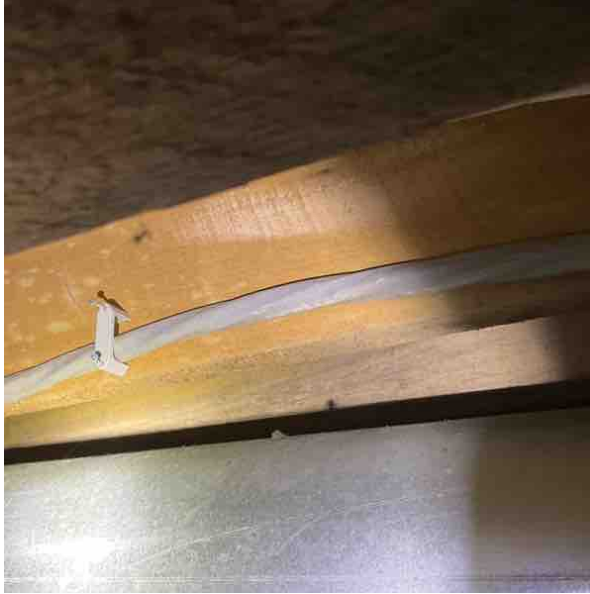
8.1.1 It was noted during the inspection that the crawlspace had an organic growth. The only way to know for sure is to test. If the results come back positive for the present of mold it is advisable to seek a licensed mold remediation specialist to properly remediate all areas with mold.

• attached are representative examples. There are other like conditions in the crawlspace.

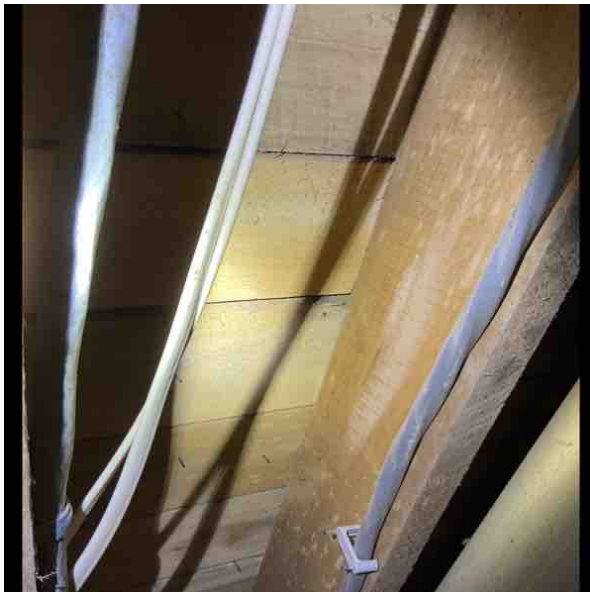
8.4.1 The insulation in the crawlspace is missing. Install insulation, where missing, to prevent excessive heat loss / gain and improve energy efficiency.

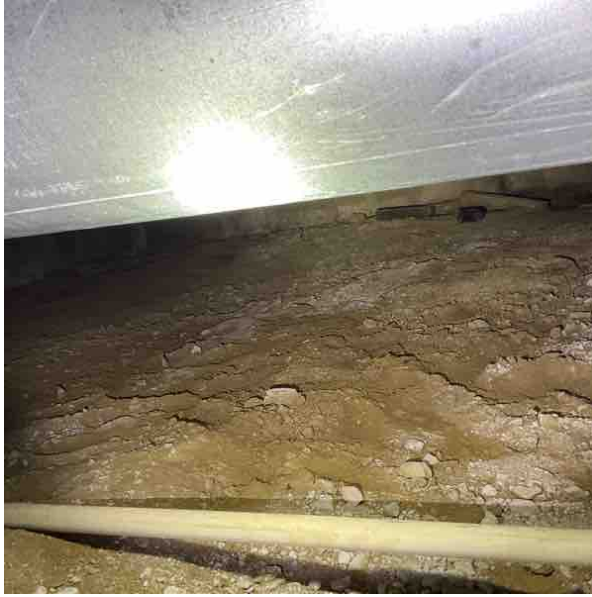
8.5.1 The moisture barrier on the crawlspace floor is missing or has voids. Improve install to prevent condensation and moisture-related damage to the structure.

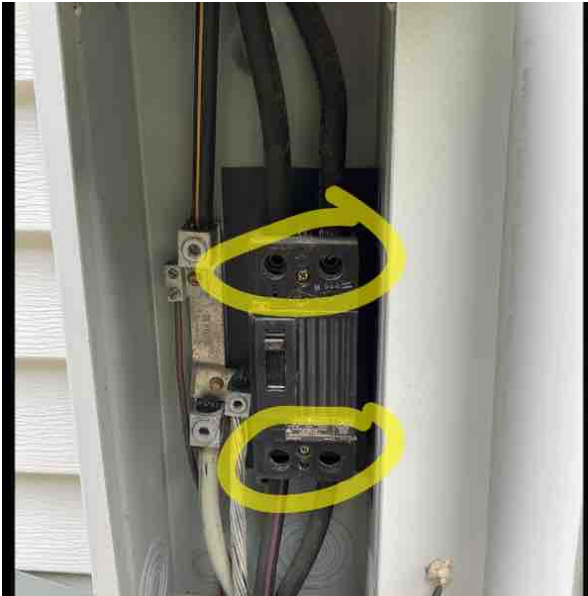
9.5.1 Recommend an electrician add anti-oxidant paste to main feeder wires at lugs to protect the surfaces at the lug connection areas. **(Exterior Left)**

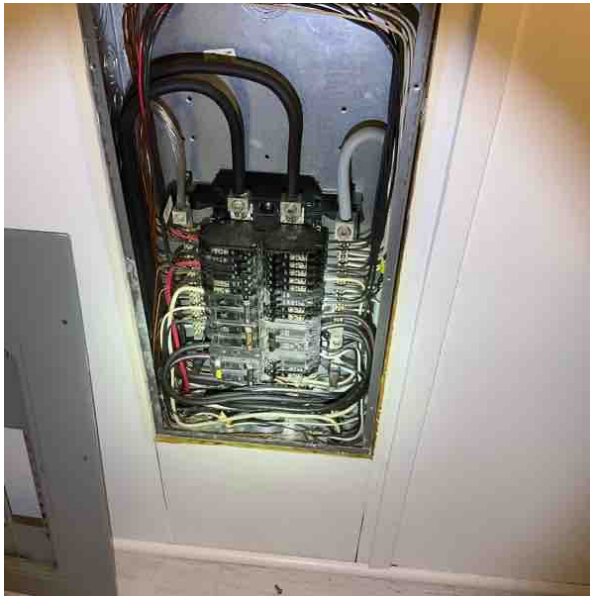
9.6.2 Visual inspection performed inside the distribution panel and no significant deficiencies observed.  
**(Laundry area)**

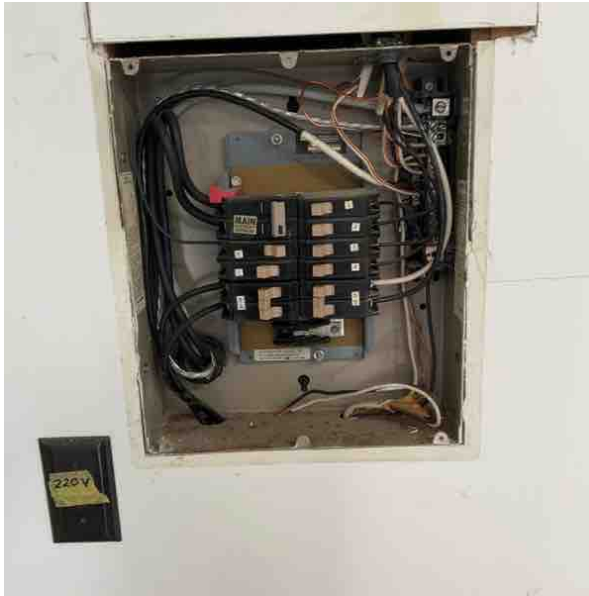
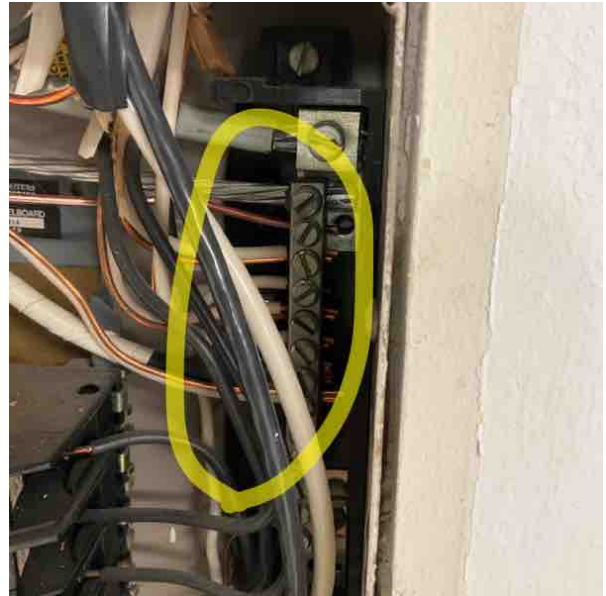
9.7.1 The neutral and ground conductors are connected in the sub-panel. Recommend an electrician further assess and correct as required for electrical safety. **(Detached garage)**

9.7.1 The neutral and ground conductors are connected in the sub-panel. Recommend an electrician further assess and correct as required for electrical safety. (Detached garage)

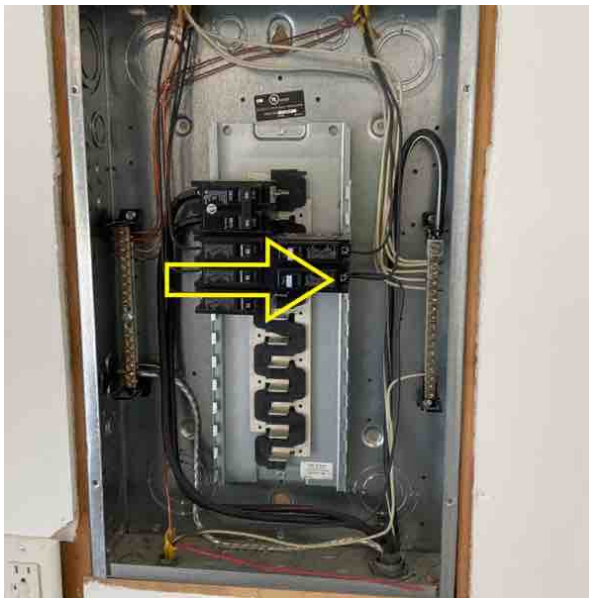
9.7.2 The sub-panel has double-tapped breaker(s). Recommend an electrician assess and correct as required for electrical safety. **(Garage)**

9.7.2 The sub-panel has double-tapped breaker(s). Recommend an electrician assess and correct as required for electrical safety. (Garage)

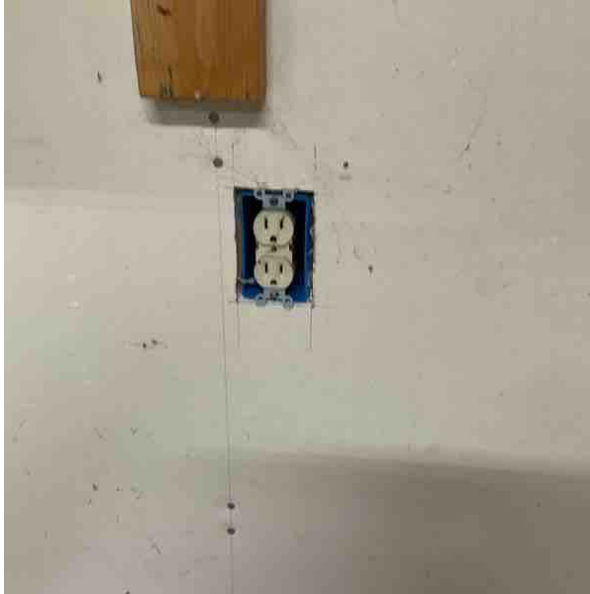
9.10.1 Receptacle covers are missing. Provide these to prevent electric shock injuries. (**Detached garage back bay**)

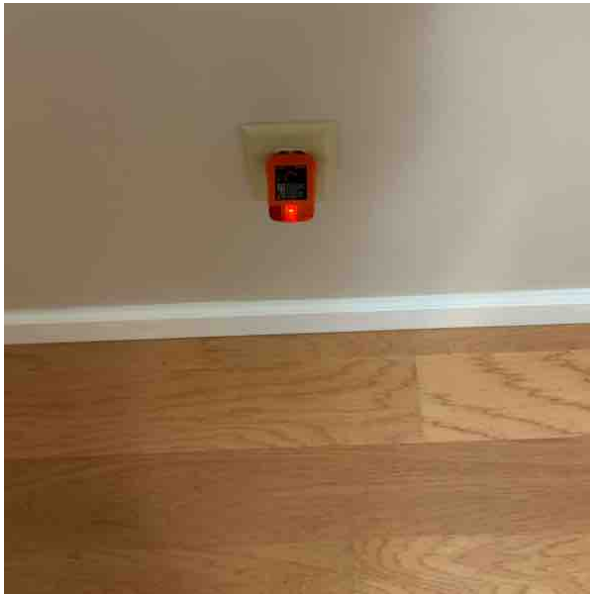
9.10.2 Ungrounded three-prong receptacles were found. This should be corrected to prevent electric shock injuries. (**Front bedroom**)

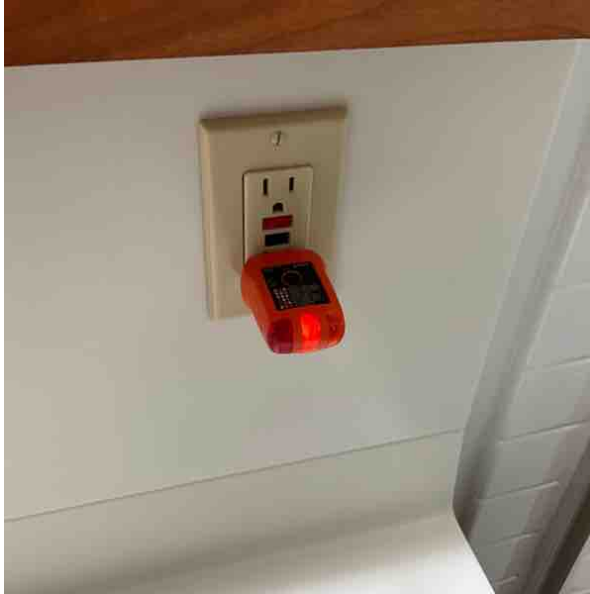
9.13.1 The GFCI(s) did not trip when tested. Recommend an electrician assess and correct as required for electrical safety. **(Bathroom)**

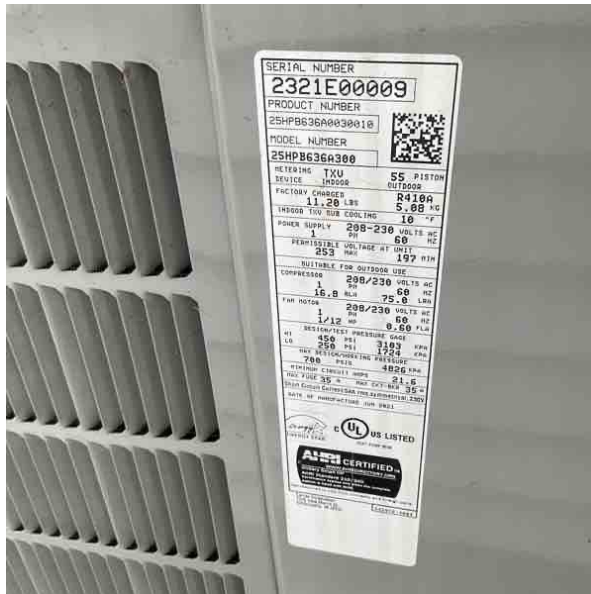
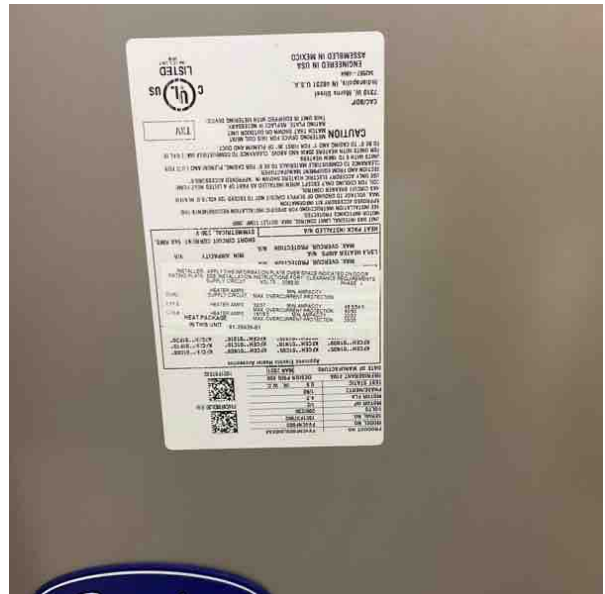
- Exterior Left
- Laundry area

## 10.3.2 Outside unit :

Model: Carrier

Manufacture date: 06/21

Refrigerant: R-410A

Inside unit:

Manufacture date: 03/21

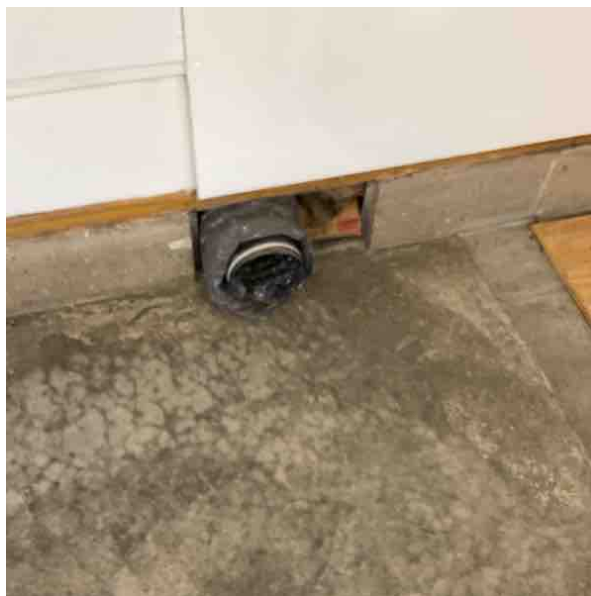
10.5.1 A register diffuser is missing. Recommend installing a diffuser to prevent infestation. **(Garage)**

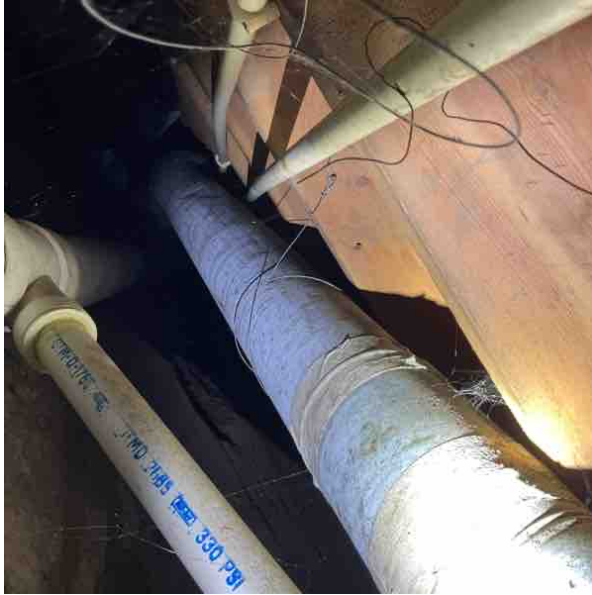
10.5.2 The ductwork is not insulated in the crawlspace. Insulate the ductwork for improved energy efficiency. **(Crawlspace)**

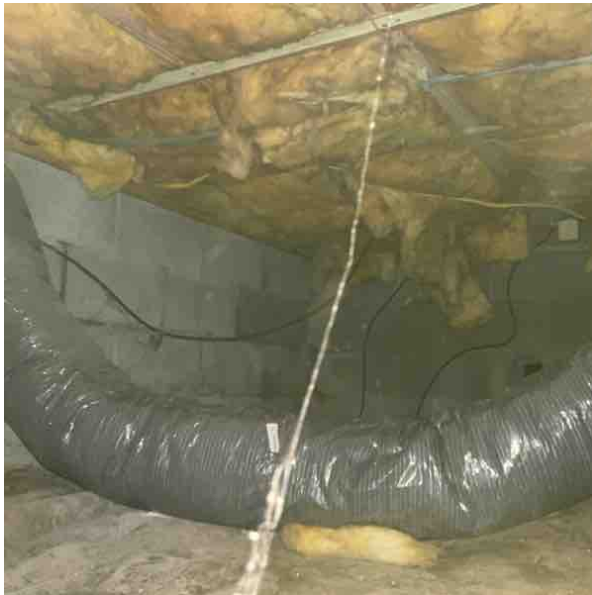
10.5.3 The ductwork is loose / poorly secured. A qualified HVAC contractor should repair as required to restore proper function. **(Crawlspace)**

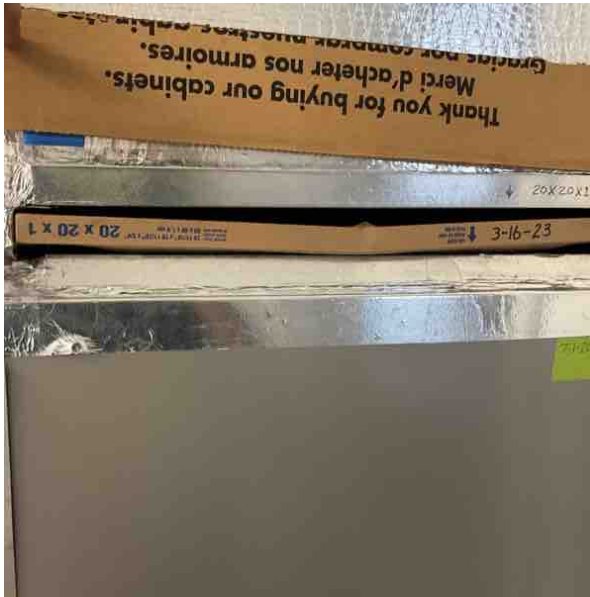
**10.6.3 Size: 20x20x1 (Laundry area)**

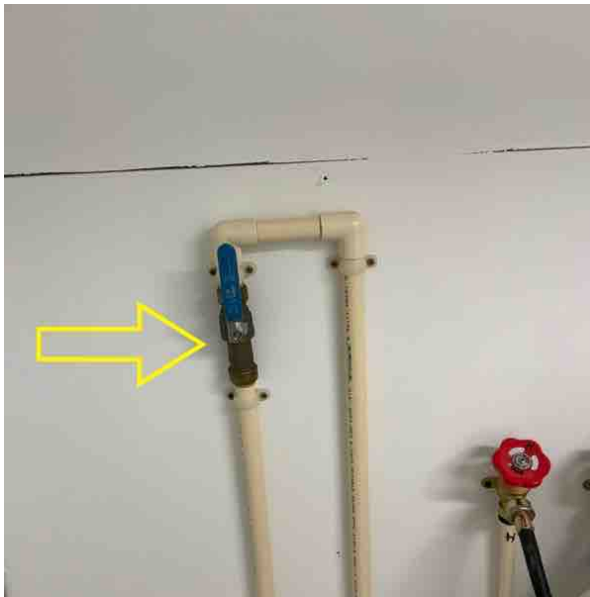
11.2.2 Water main valve. **(Laundry area)**

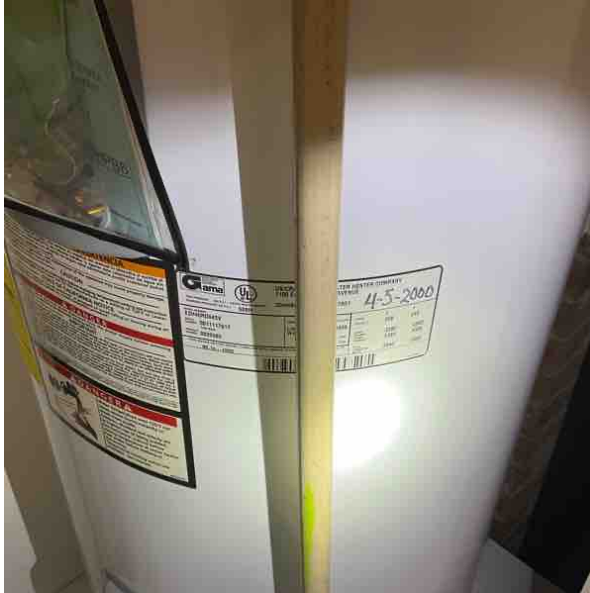
The water heater is past its typical life expectancy. Budget to replace the unit when it fails, when repairs are no longer cost effective, or pro-actively to prevent loss of functionality. **(Laundry area)**

11.5.2 **Model: Us craftsman**

**Manufacture date: 03/00**

**The water heater is past its typical life expectancy. Budget to replace the unit when it fails, when repairs are no longer cost effective, or pro-actively to prevent loss of functionality. (Laundry area)**

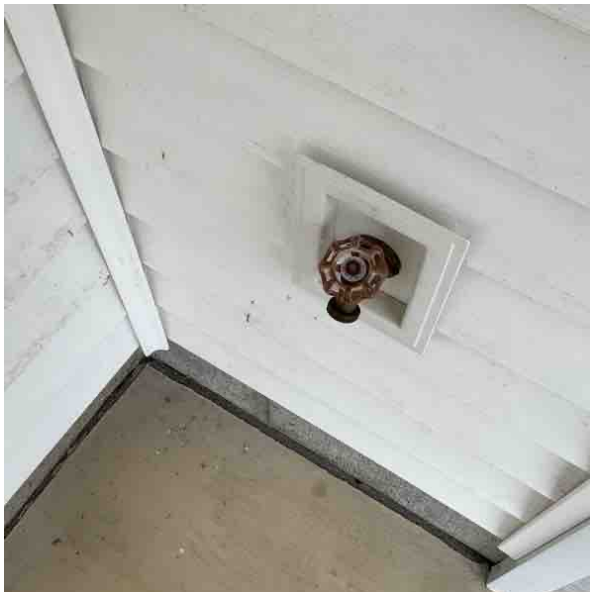
11.6.1 The hose bibb is not a frost-free design. A qualified plumber should upgrade to prevent loss of function and water leakage.

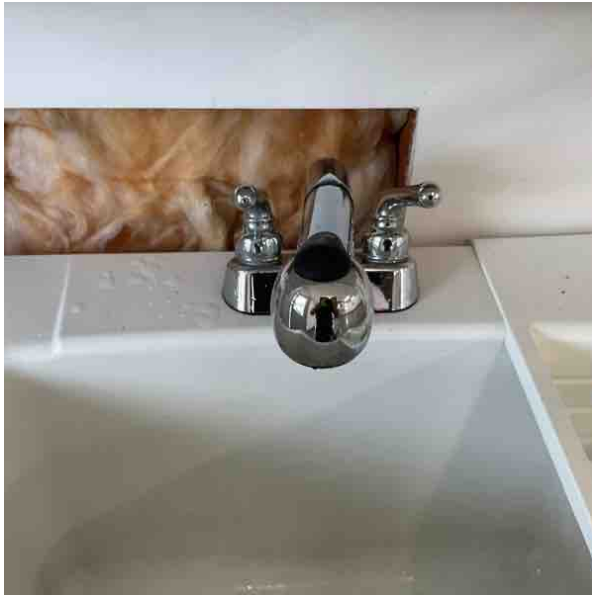
11.7.1 Hand sprayer is not functional. Repair as required to restore functionality. **(Garage)**

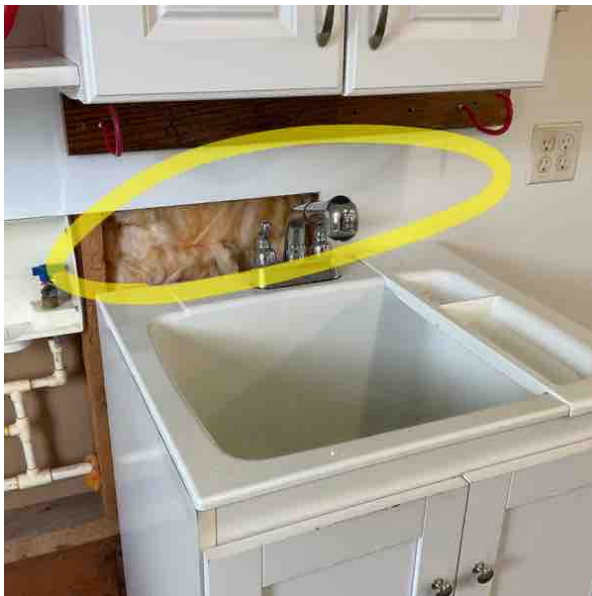
11.8.1 Sink is missing a backsplash. Recommend installing a backsplash to prevent water related damage. **(Garage)**

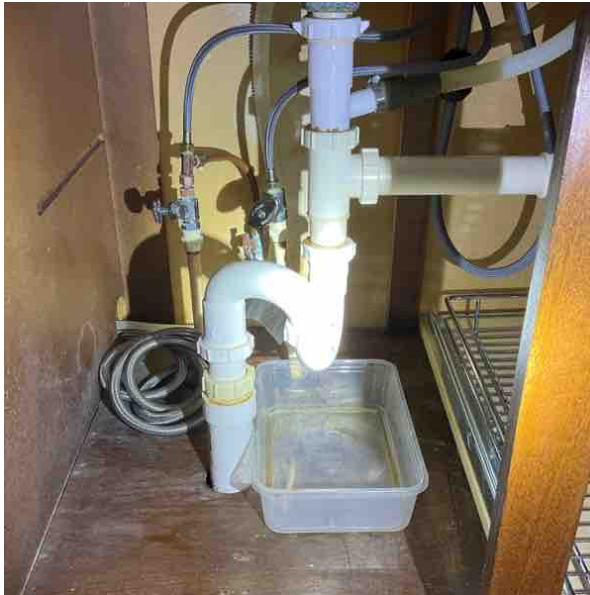
11.8.2 The drain pipe under the sink is leaking. Recommend a plumber assess and repair as required to prevent further water damage. **(Kitchen)**

**11.8.2 The drain pipe under the sink is leaking. Recommend a plumber assess and repair as required to prevent further water damage. (Kitchen)**

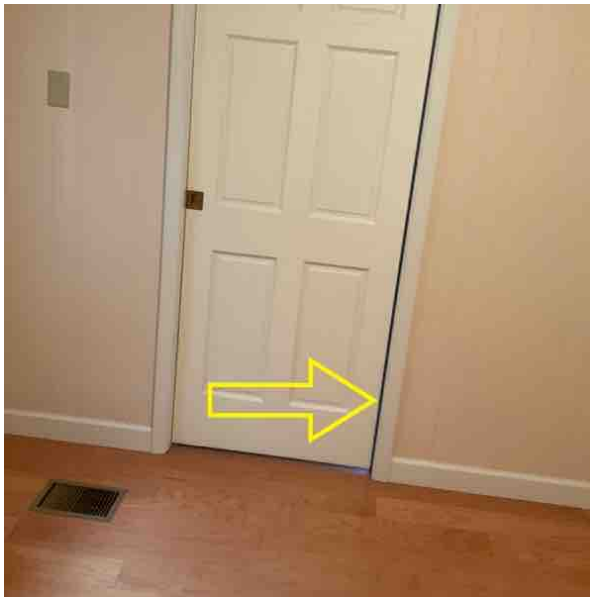
12.4.3 Pocket doors extend past door frame. This makes it cumbersome to open and could damage the finish. Recommend this be repaired for ease of operation. **(Back bedroom)**

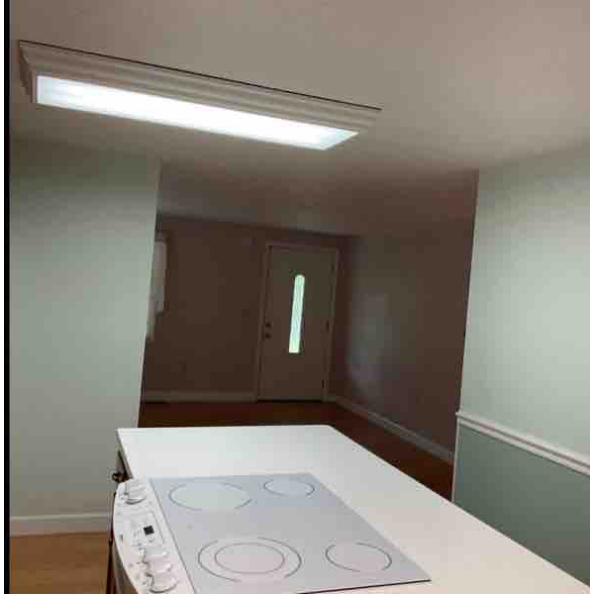
13.3.1 The range hood is missing. Install a range hood to allow for proper venting and grease removal.  
(Kitchen)
