Inspection Report

Property Address:
917 Stoneymead Dr
Kings Mountain NC 28086

Date: 8/8/2024	Time: 08:00:00 AM	Report ID: 080824JK5
Property: 917 Stoneymead Dr Kings Mountain NC 28086	Customer: The McLemore Group	Real Estate Professional: Kevin McLemore kevin@themclemoregroup.com

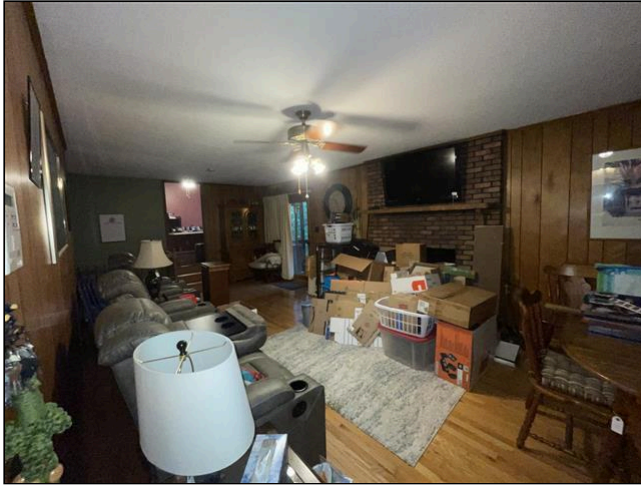
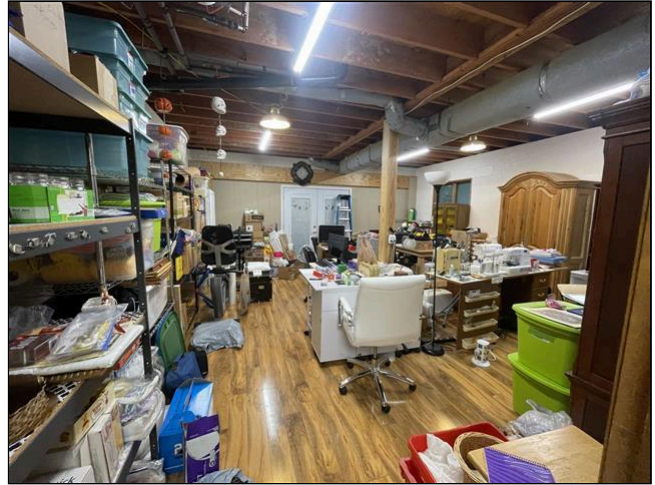
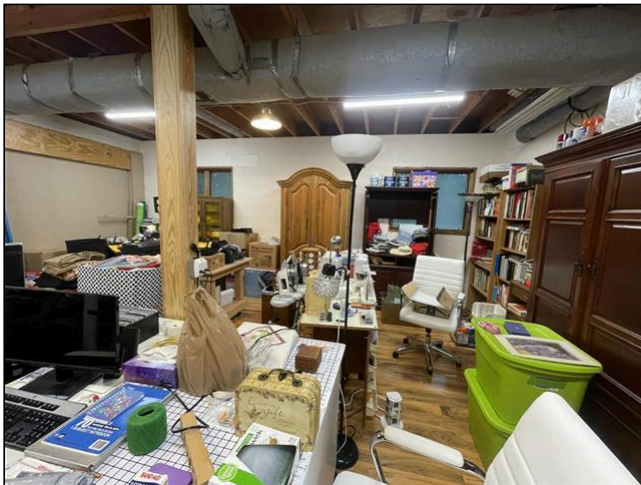
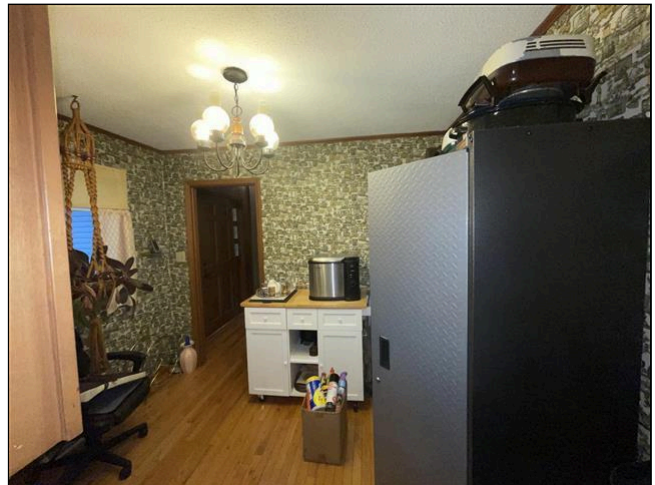
(1) The home is filled with stored items as if it is an estate sale/transaction situation. The home excessive storage limits the inspection as stored items, furniture and personal items are not moved during the inspection.

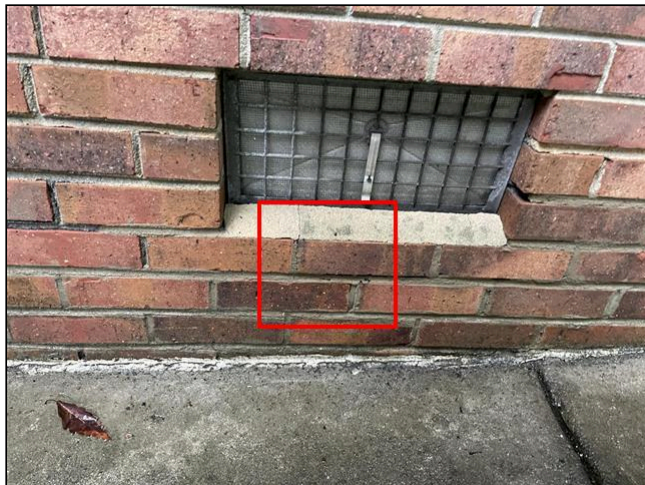
There was/were hairline crack(s) noted in the following locations. Point up and continue to monitor. No corresponding cracks were noted inside the home at these areas and all windows and doors around the area were functioning as intended at the time of inspection. :

1. front side of home
2. rear side of home

Note: Crack monitoring kits can be purchased at Lowe's, Home Depot, and various other locations. They are a slide which is glued to the veneer over the middle of the crack so that one side is attached on either side of the crack. They will crack if there is future movement which would warrant further investigation by a licensed engineer at that time.

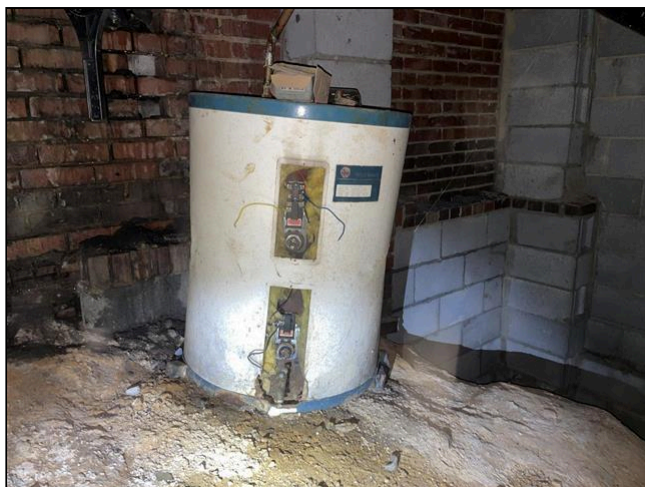
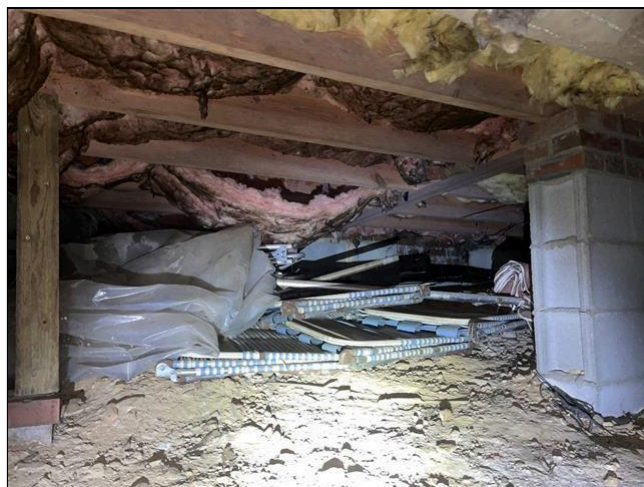
(3) The construction debris/stored items should be removed from the crawl space under home. Stored items/debris give rodents/insects a place to nest and may create undesirable conditions. These items are not moved and prevent full viewing at time of inspection. Remove as needed.

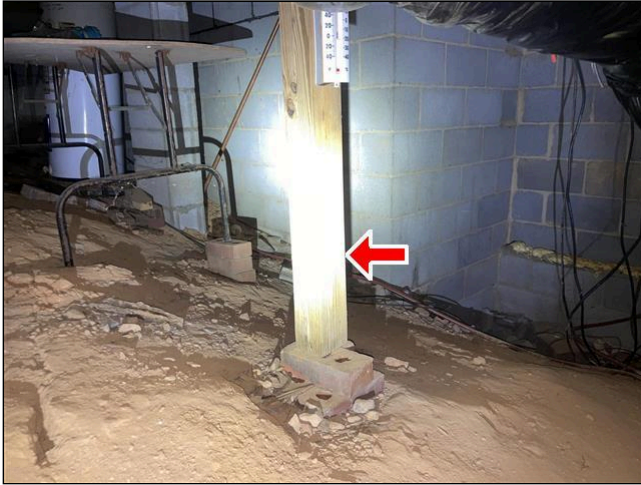
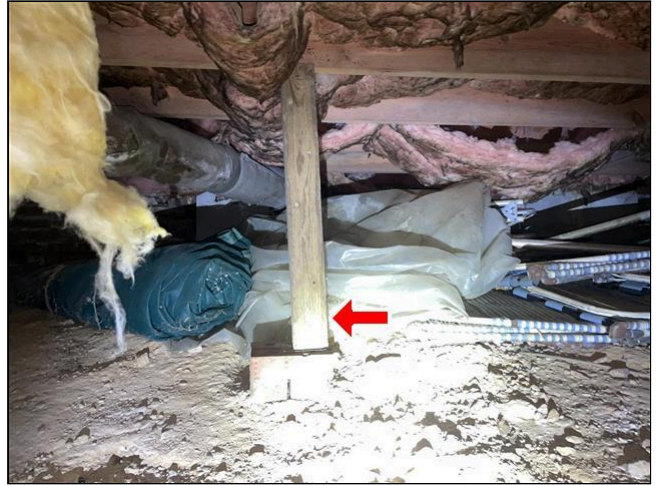
(1) Multiple repairs/added supports have been made to the substructure. The manner in which the repair(s)/modification(s) was made does not conform to standard building practices. All repairs/modifications to a structural member require permits to be pulled. Check to verify that there were pulled. If not, then contact a licensed contractor for repairs.

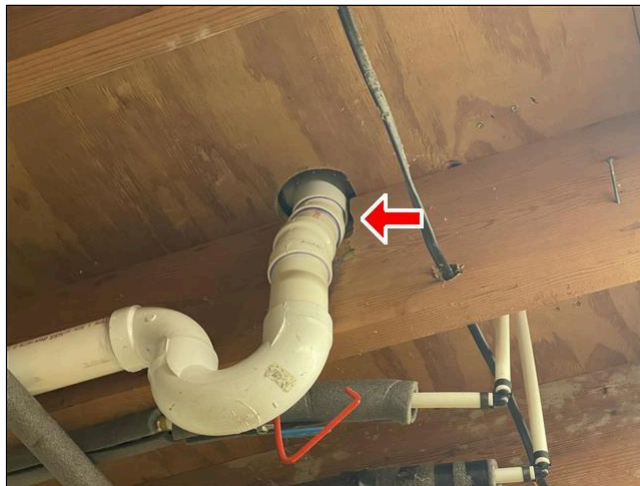
(4) The floor joist has been cut to allow for the plumbing lines under the primary bathroom. This is not typical construction standards. The framing needs to be properly supported. Contact a licensed contractor for review and make repairs as needed.

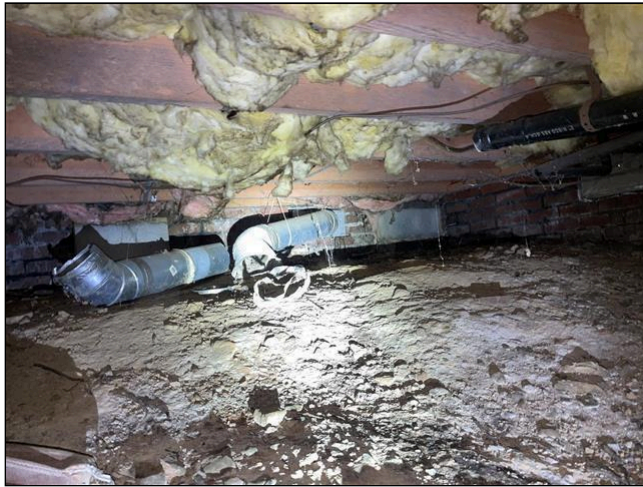
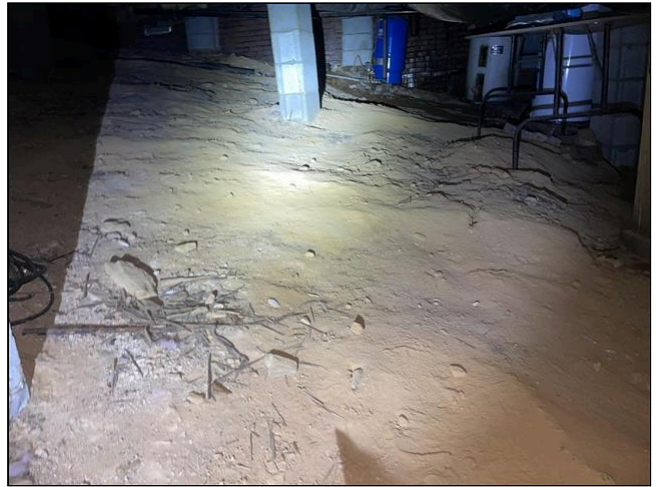
There is not a vapor barrier installed in the crawlspace. Recommend installing a vapor barrier to reduce or keep moisture levels down in the crawlspace area. Contact a qualified professional.

Note: Exposed soils in a crawlspace should be covered with a retardant material to prevent moisture or standing water from deteriorating wood framing above. Approved materials include, but are not limited to: polyethylene sheeting, concrete, or blacktop. If the ground is saturated, wall vapor barriers of like materials are also recommended.

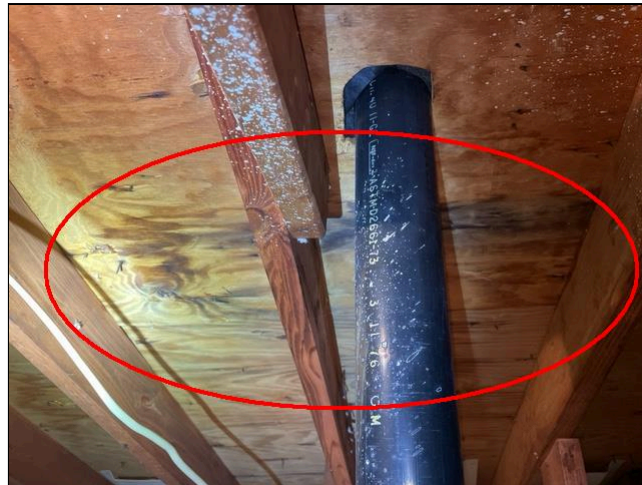
(1) There are stains noted in the attic located at the middle area. Unable to determine if an active leak still existed at the time of inspection. Ask the sellers if a past repair was made. If it is not known then it should be treated as an active issue and further reviewed by a licensed contractor or roofer for evaluation and repair.

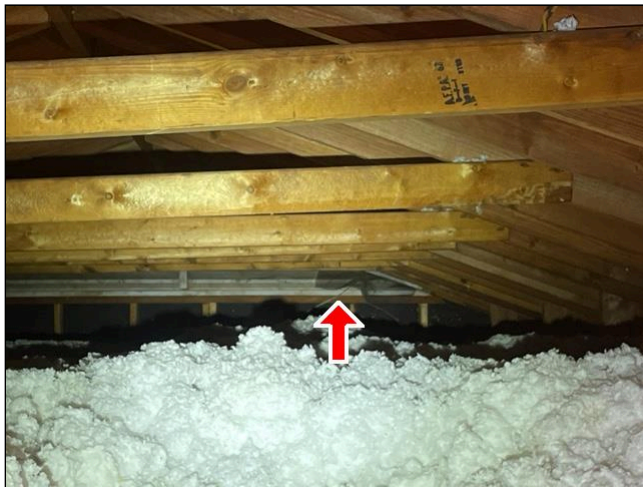
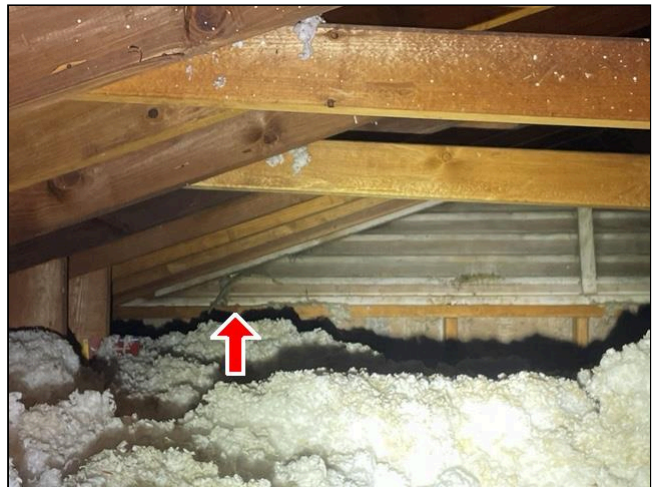
(2) The gable vent screen is loose, damaged, and/or deteriorating at the front and rear of the attic. Repair and/or replacement is needed to prevent pest entry. Contact a qualified professional for repair.

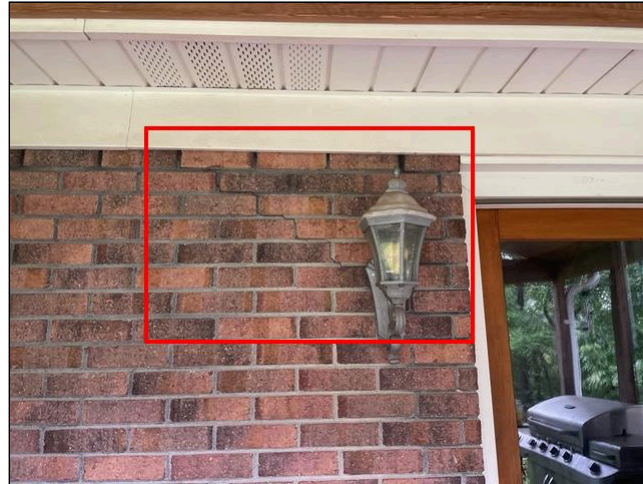
1. rear side of home

(1) There were typical hairline cracks noted in the following locations. These should be pointed-up with mortar to prevent water penetration and expansion. Continue to monitor after the repairs are made. You may wish to install crack monitoring glass to verify that no further settlement is occurring. These devices are inexpensive and consist of a couple pieces of plastic or glass with cross-hairs on them. If the crack returns you should then consult a licensed engineer for further evaluation at that time. :

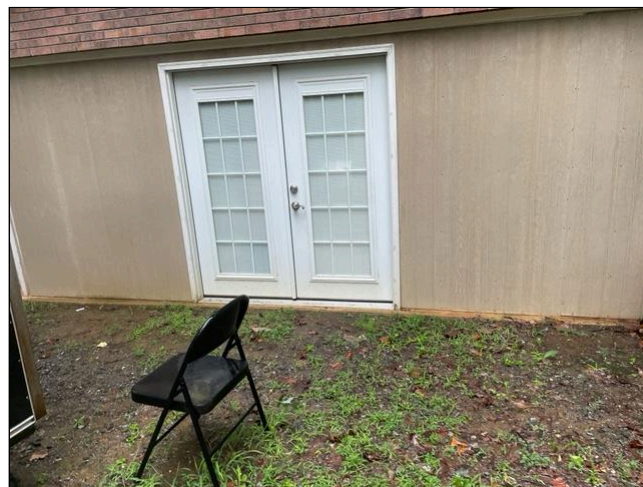
(2) There is siding in close proximity and/or in contact with the ground at the front of the home. This makes easy access for termites and other wood destroying insects, as well as obstructs the viewing of those inspections. The inspector did not inspect behind the siding. A ground clearance of six to eight inches where possible is recommended. Contact a qualified professional for repairs.

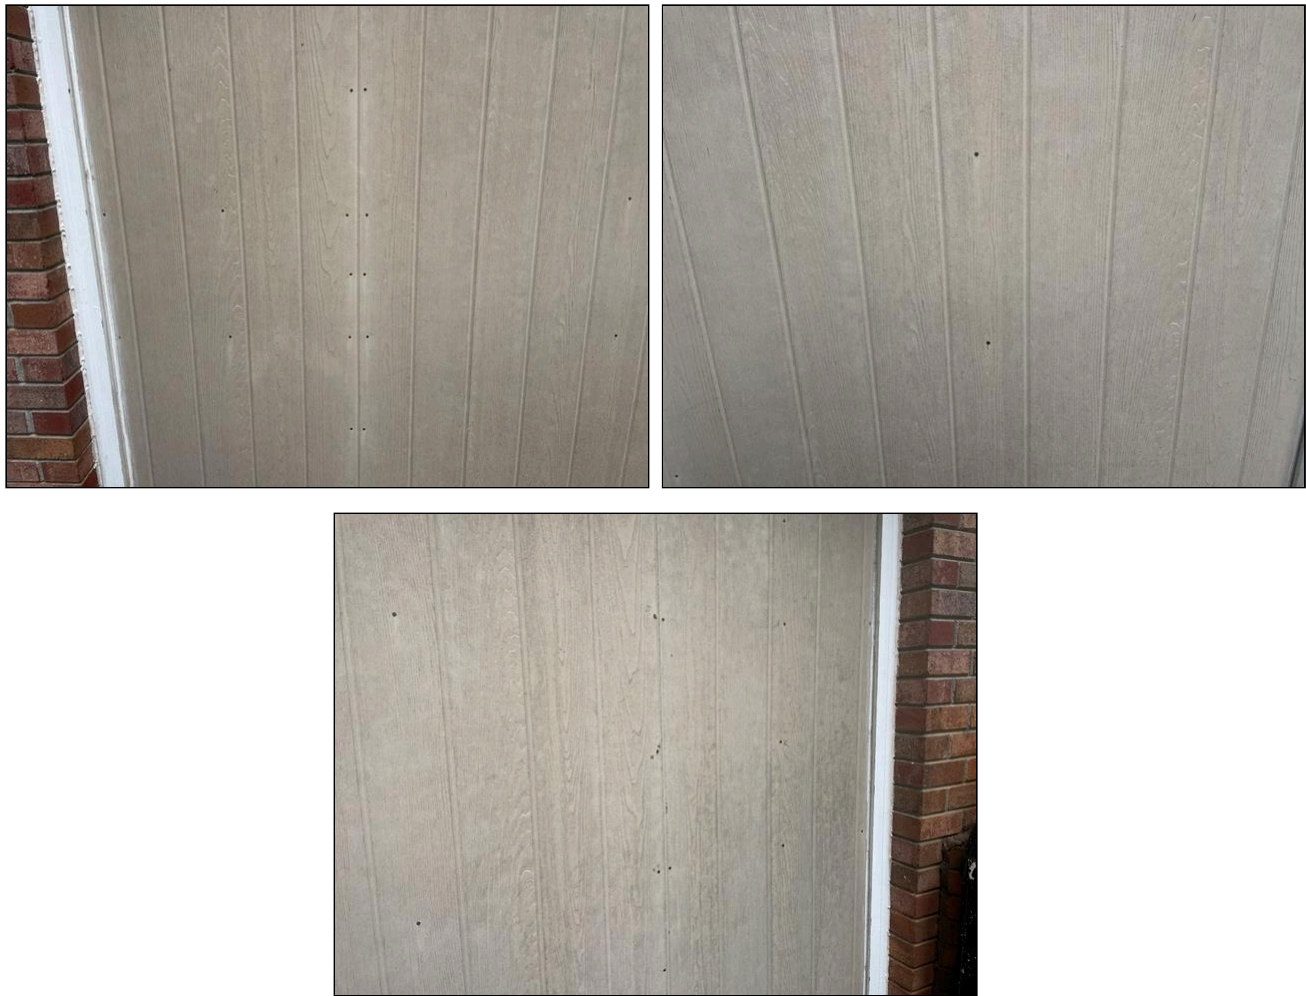
(3) There were multiple areas at the front of the home where the nail heads have been recessed into the siding. This allows for moisture to enter behind the siding and causes damage to the material. All nail heads need sealing and any rotted/decayed sections of the siding should be replaced. Contact a qualified professional for repairs.

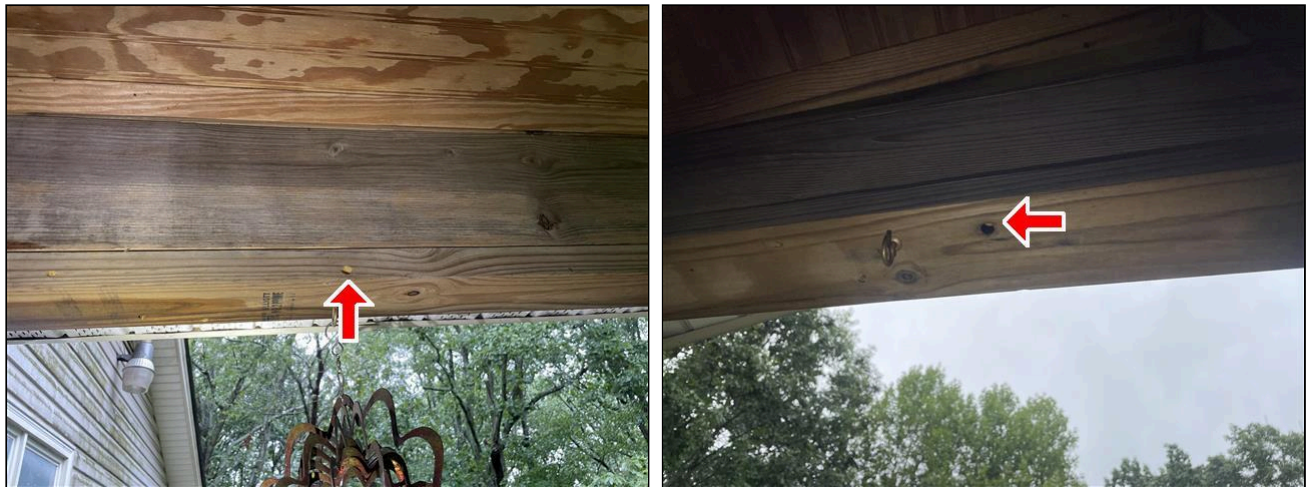
- 1. rear decking

There is a carpenter bee hole(s) found in the trim at the following locations. Have an exterminator further evaluate and treat as needed. Contact a licensed contractor to repair the trim as needed.

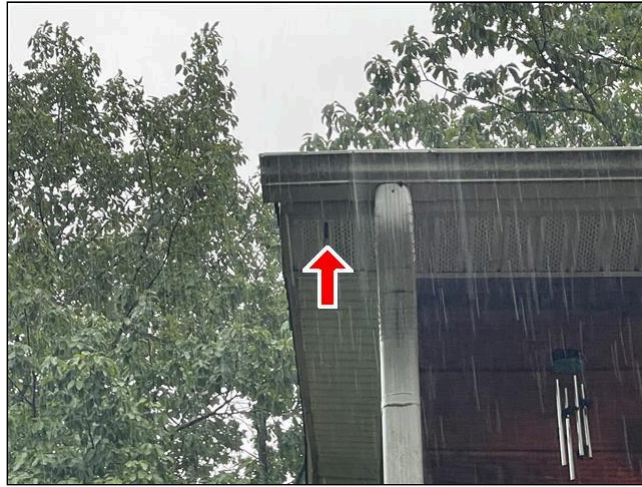
- 1. rear side of home

Damaged or disconnected soffit venting was noted in the following locations. This is needed to prevent pest entry into the attic cavity. Contact a qualified professional for repairs. :

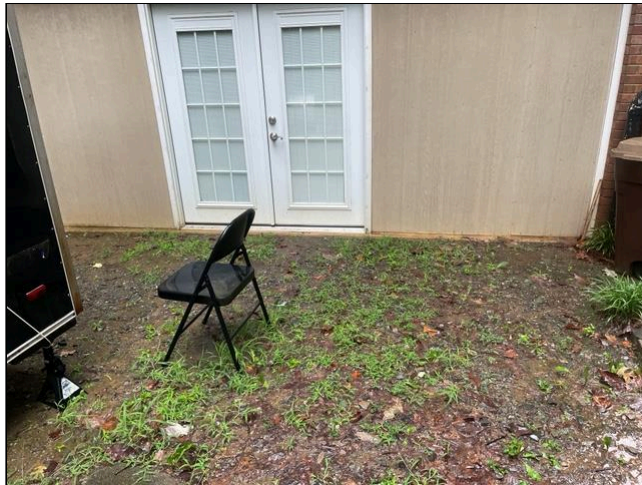
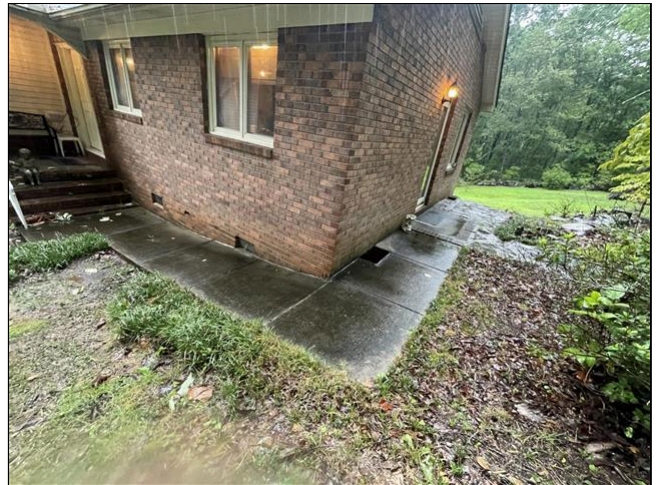
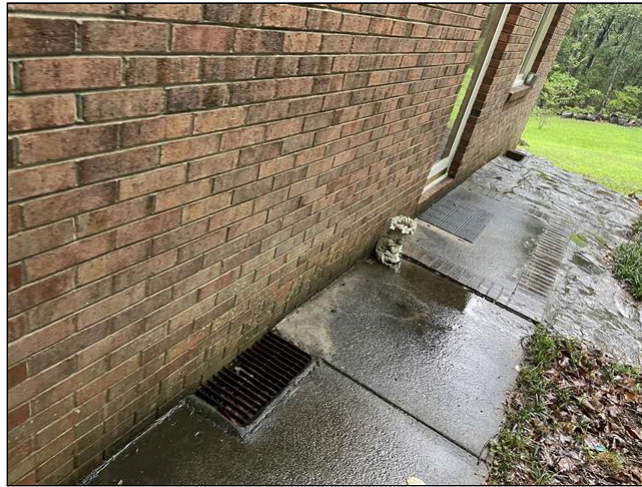
(1) The grade at foundation needs correction at the front and right sides of the home. The grade slopes toward the home and proper drainage needs to be installed to direct water away from the foundation. Contact a qualified professional /landscaper for repairs.

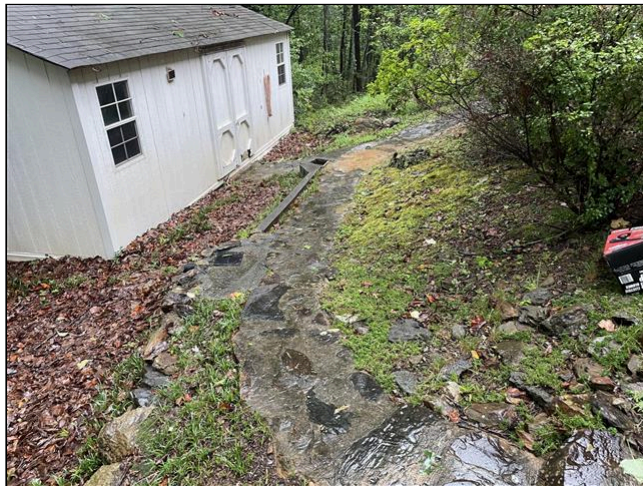
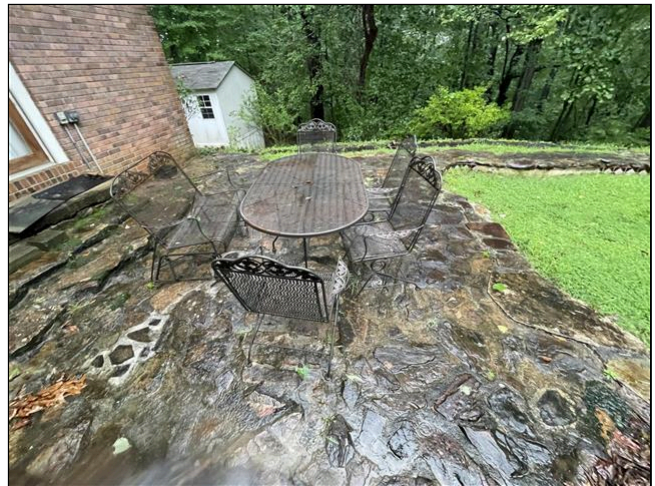
(2) Evidence of poor drainage at the following location(s). This was noted by staining or muddy soil indicating standing water at times or by physically standing water at the time of inspection. This can lead to foundation issues and/or organic growth if standing longer than 48 hours. Contact a qualified professional/landscaper for repairs. :

1. left side of home
2. rear patio
3. right side of home

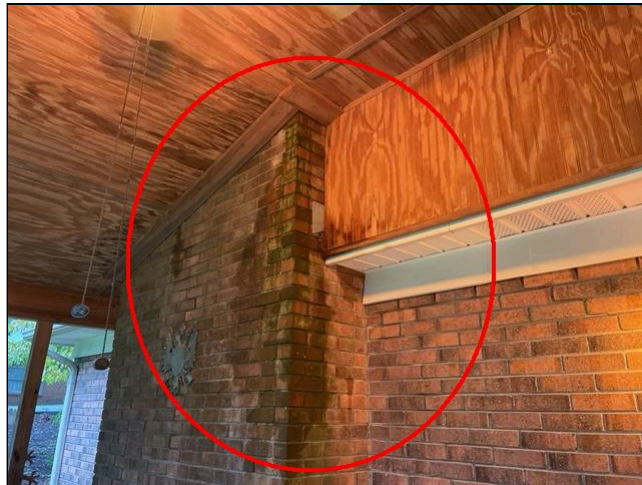
There was an active moisture leaks noted at the rear deck/porch. Contact a licensed contractor for review, determine the source/cause and make any additional repairs as needed.

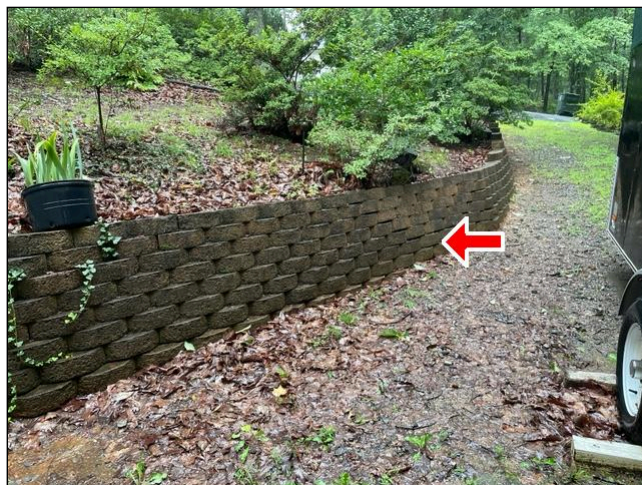
The retaining wall at the front yard was noted to be leaning, bowing, or sagging at the time of the inspection. This is an indication that the wall has moved and is in need of repair. Contact a licensed contractor for review, determine the extent of the damages and make repairs as needed.

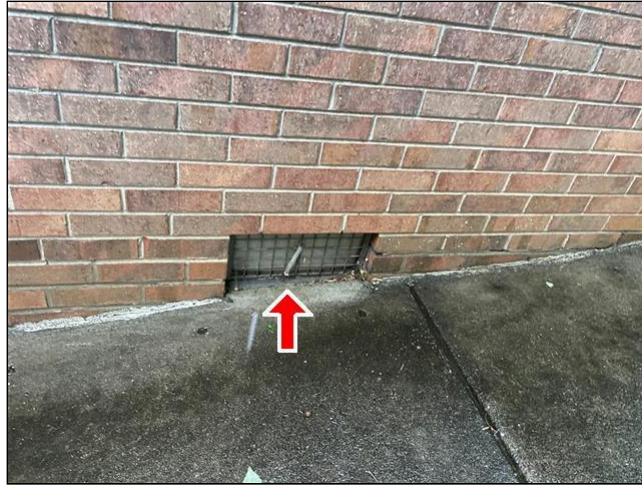
1. front of home

The crawl space vent(s) were at or below grade in the following locations. Water entry and/or poor ventilation into the crawl space is of concern. Contact a qualified professional for full evaluation to determine any repairs or replacements necessary. :

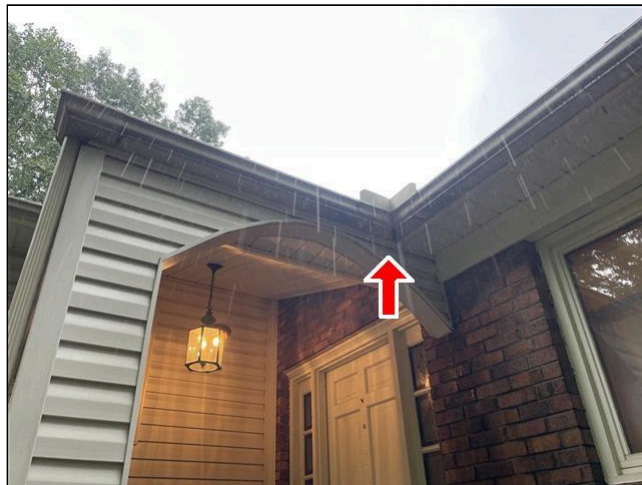
The gutter system on the roof edge at the front side of the home appears to be leaking or inadequately sloped to carry the water to the downspouts. Corrections/repairs are needed to properly direct water away from the home. Contact a qualified professional for repairs.

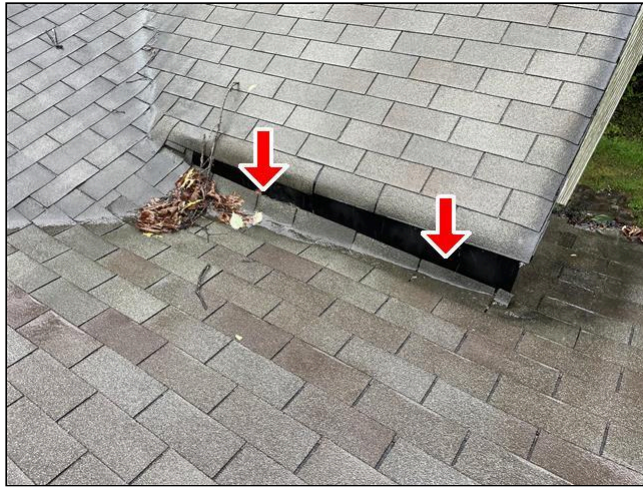
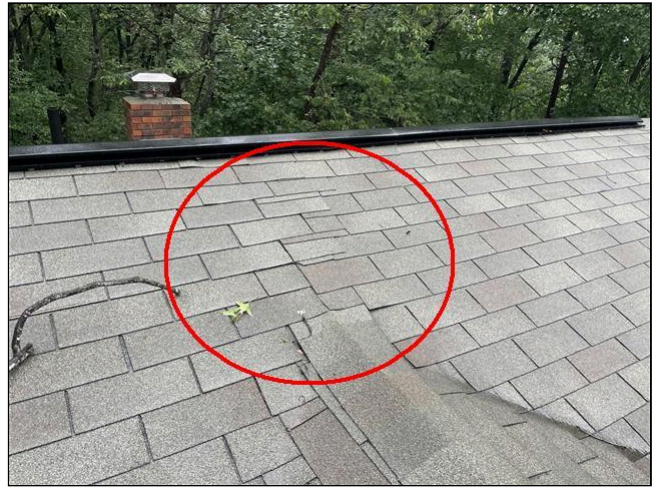
The following area(s) were found to not be flashed and/or installed properly. This can allow water penetration and needs to be repaired. Contact a licensed roofer for repair. :

1. rear side valley
2. upper middle, above right side ridge

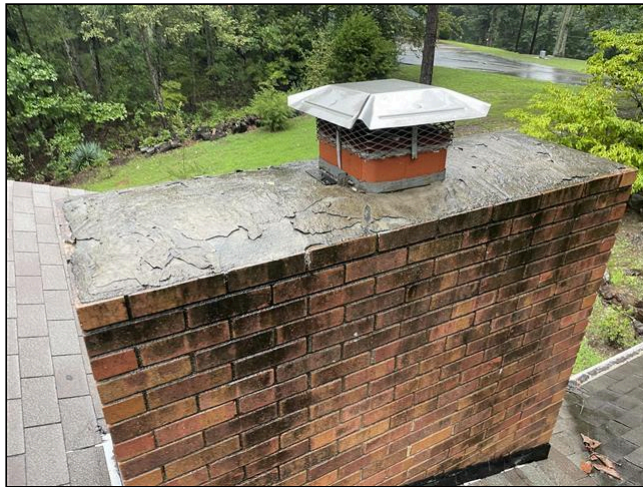
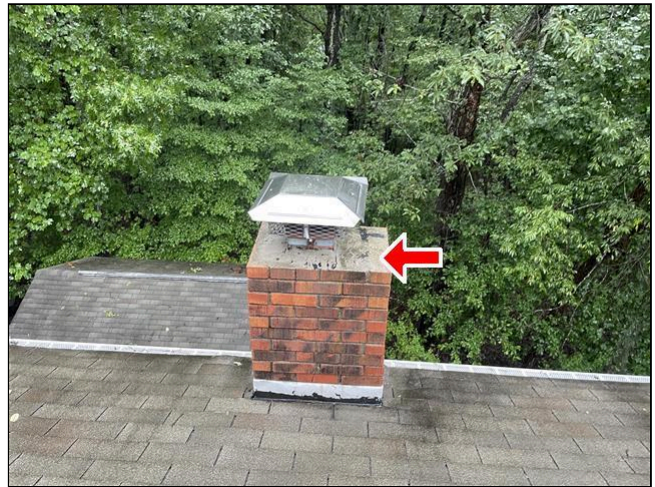
(2) The mortar has cracks and is deteriorating at the top of the chimney caps/crowns. The mortar needs repair to prevent water penetration. This usually consists of pointing up (adding more mortar). The chimney cap/crowns function is to keep water from entering the masonry brick joints that can cause deterioration. Contact a licensed chimney company for repair.

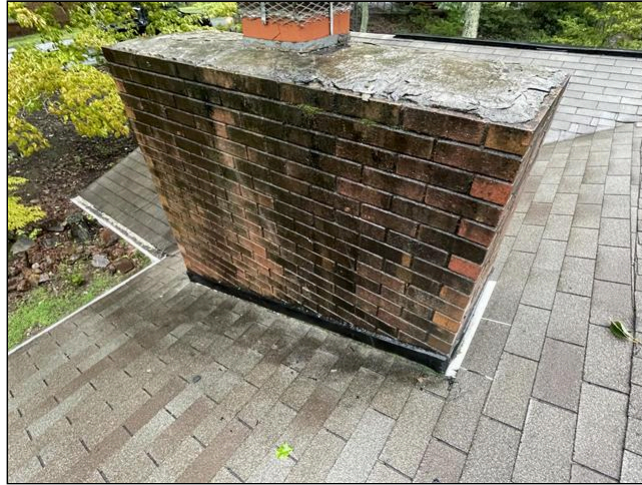
(3) There was lichen growth noted around the main/rear chimney cap and/or top sides of the chimney. This is an indication of a moisture problem which needs to be corrected to prevent further damage/deterioration. Contact a licensed chimney company for repair.

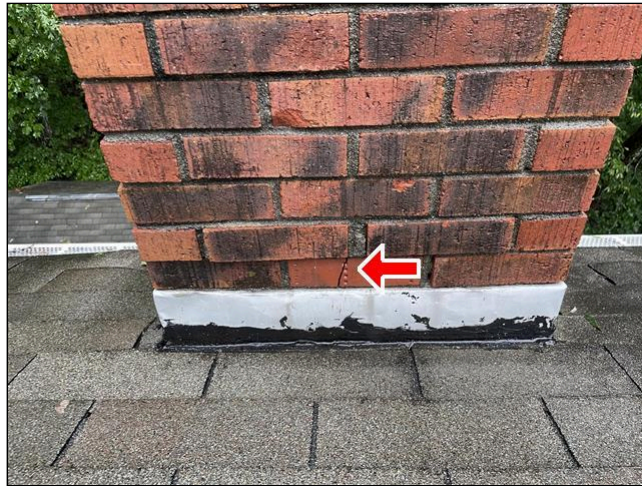
(4) Cracks noted in the exterior of the left side chimney/flue indicate some movement or a possible cracked flue liner. Contact a licensed chimney company for repair.

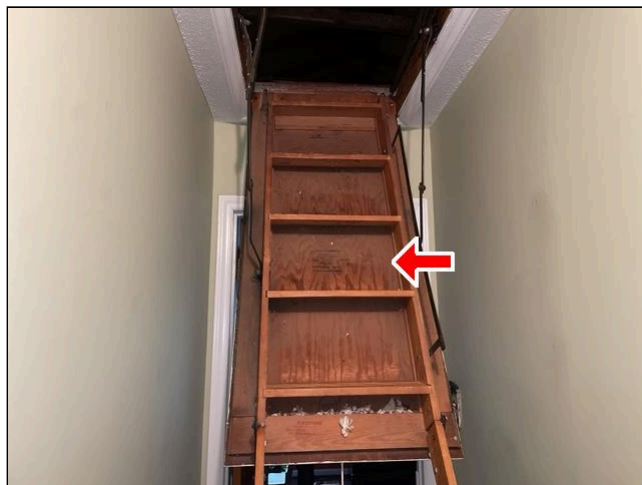
(1) There is no insulation installed on the back of the pull down attic stairs. This provides little to no R-value protection and can be a large source of heat loss. Installation of insulation or an "attic tent" is recommended. Contact a qualified professional for repair.

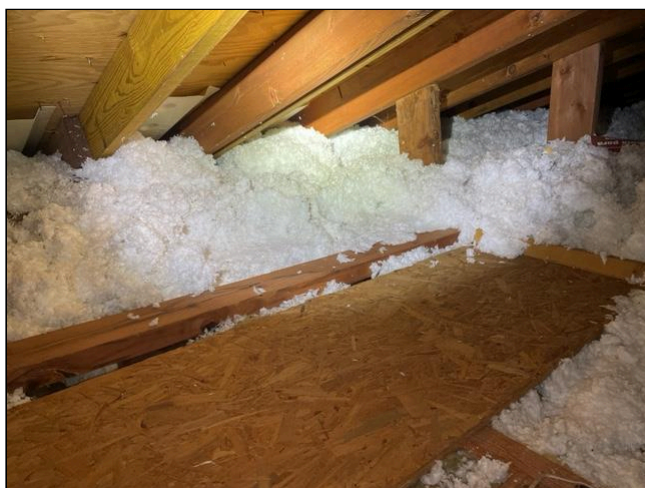
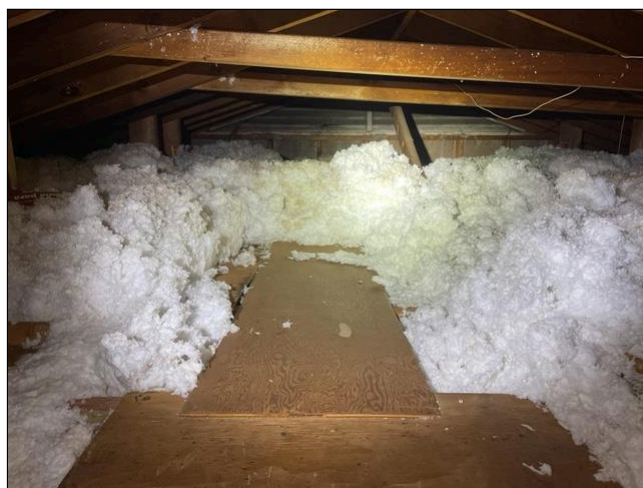
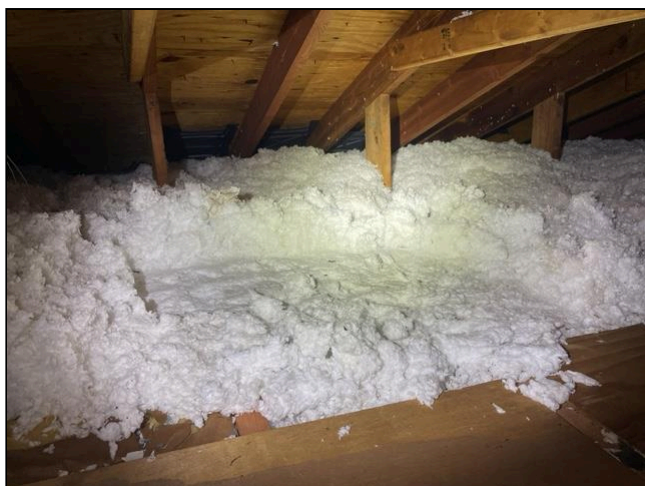
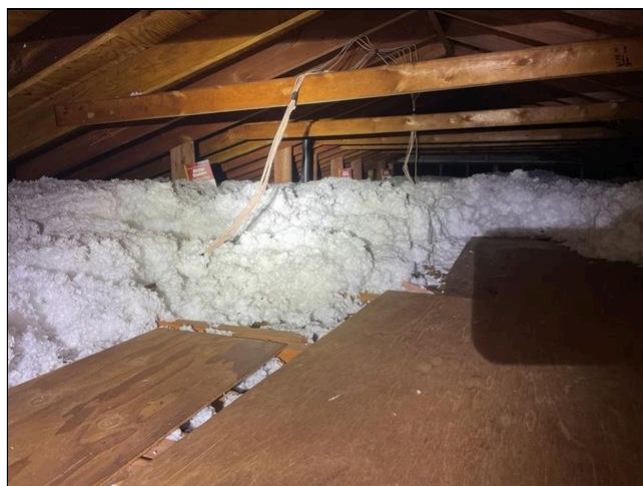
(2) The insulation is compacted in several areas throughout the attic and the true R-factor at this point in time may be substantially less than when originally installed. Installation of additional insulation is needed. Contact a qualified professional for repair.

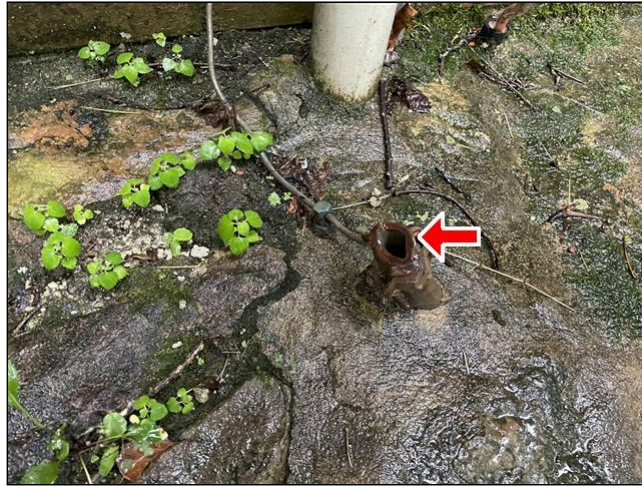
(1) The ground rod is hollow core galvanized piping. This generally rusted out in a period of 10 to 15 years. The age of the ground rod is over this limit. It is recommended an update be done by a licensed electrician to assure the home is grounded properly.

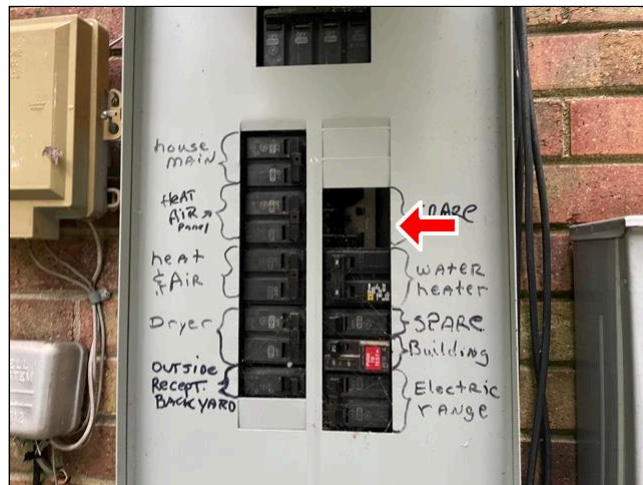
(2) Missing breakers/spacing was noted at the electric panel. This is a safety hazard. Contact a licensed electrician for repair.

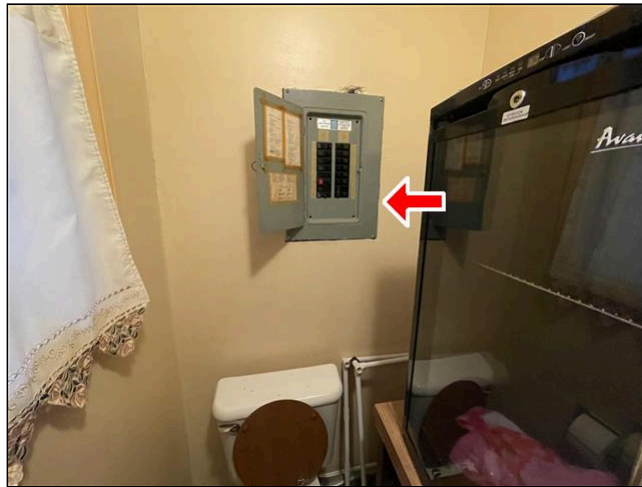
(4) The electrical sub-panel is installed in the downstairs bathroom. This is not typical and generally not allowed for electric panels to be installed in bathrooms. Safety concern. Contact a licensed electrician to

further evaluate the entire electrical system and make any additional repairs as needed.

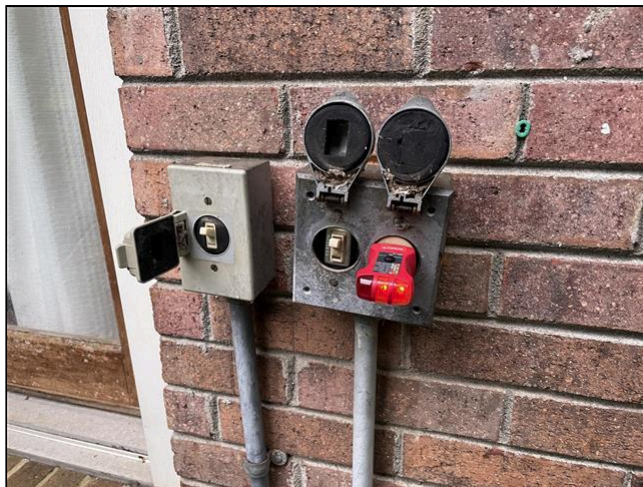
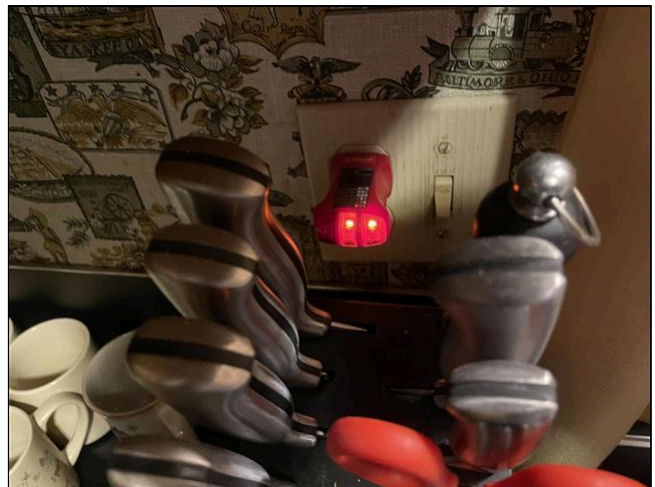
The following outlet(s) are not protected by a GFCI. These are needed in "wet" locations to allow the circuit to turn off in case of an emergency. Contact a licensed electrician for repair. :

1. exterior outlets
2. kitchen outlets
3. bathroom/laundry room outlets

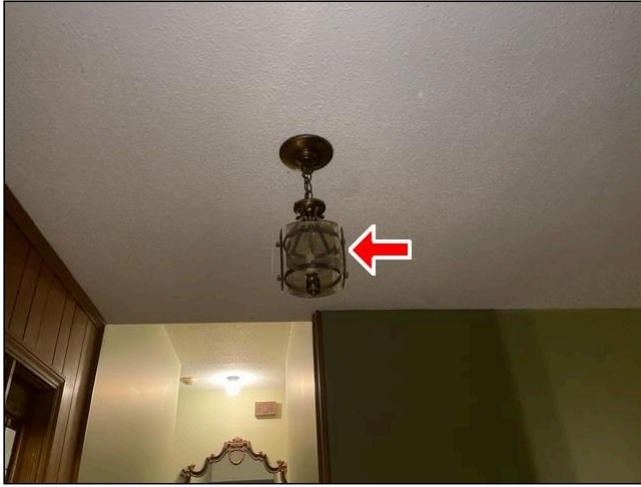
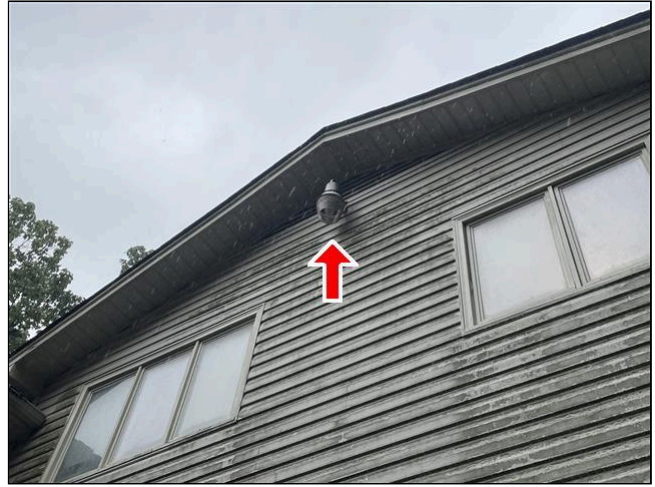
(1) The following lights had a bulb that did not function when tested. Replace the bulb and re-test to be sure it functions and is not an electrical issue prior to closing. Contact a licensed electrician if replacing the bulb does not correct the issue. :

1. foyer
2. exterior light(s)

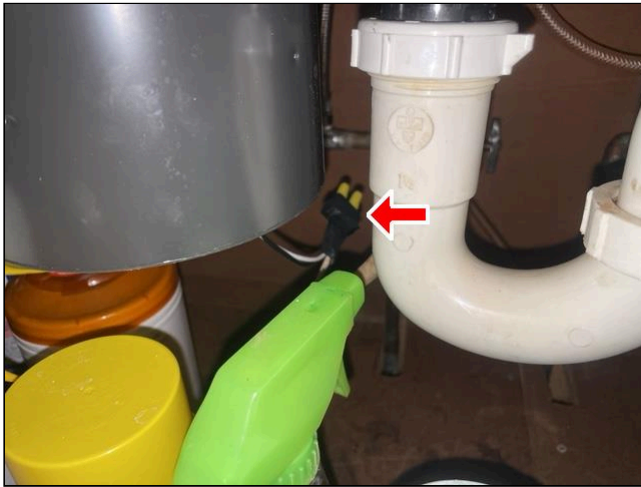
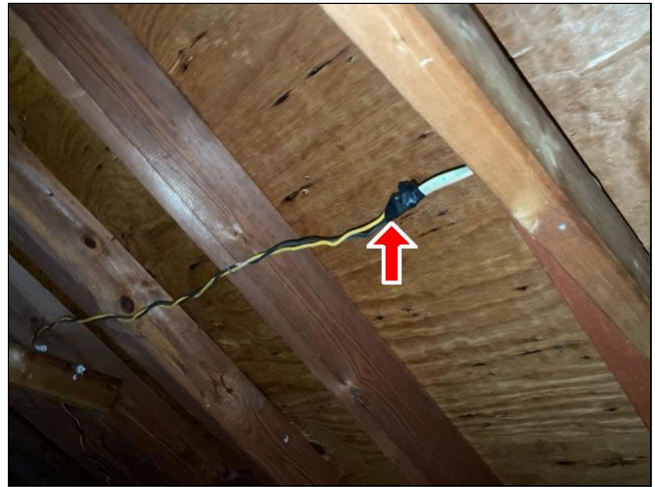
(2) There are wires wrapped in electrical tape at the following locations that need to be installed into a junction box. This is a safety hazard. Contact a licensed electrician for repair. :

1. disposal under the kitchen sink
2. attic area

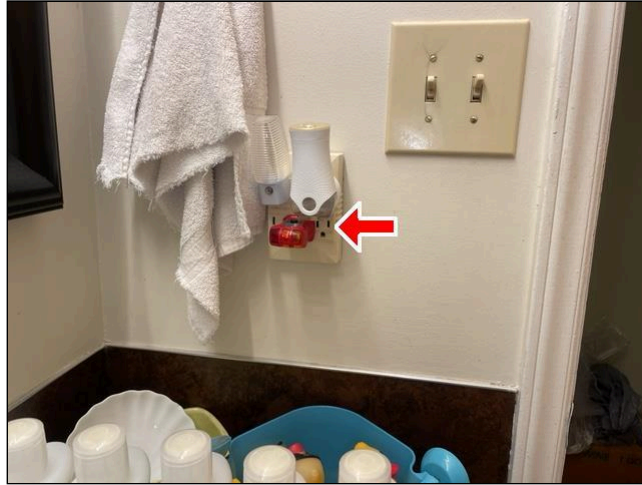
1. hall bathroom outlet

(3) The following outlet(s) were found to have an open ground and need correction. Electrical hazard. Contact a licensed electrician for repair. :

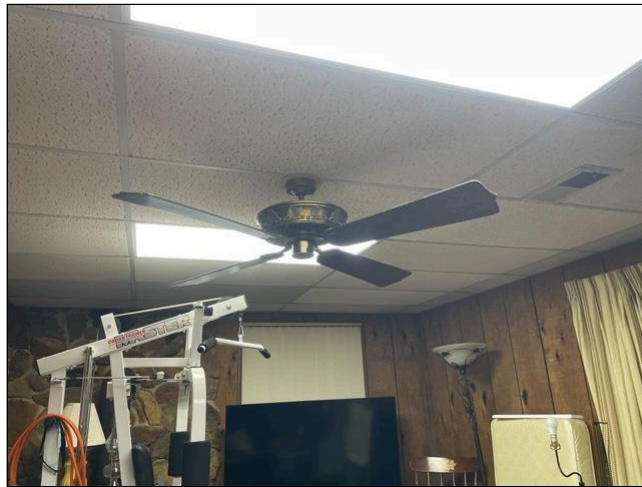
(4) The ceiling fan in the basement family room did not respond when tested. The ceiling fan may be controlled by a remote that was not present at the time of inspection. Ask the sellers if the ceiling fan is controlled by a remote and the location of the remote control. If the ceiling fan is not controlled by a remote then repairs are needed. Contact a licensed electrician for evaluation and repair.

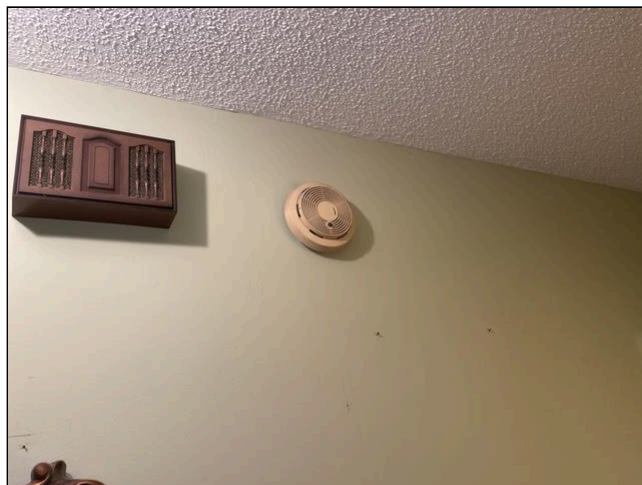
1. upper hallway

(2) The following smoke detector(s) did not respond when tested and need to be repaired/replaced. Safety hazard. If the units are designed to be tied together then one that also ties in is what should replace it. Contact a qualified professional for repair.

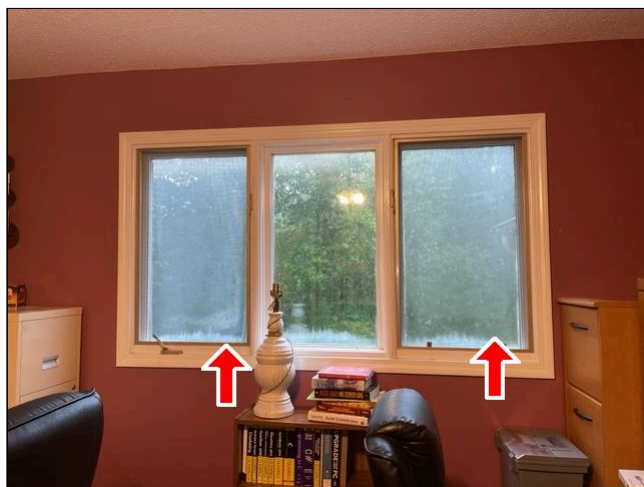
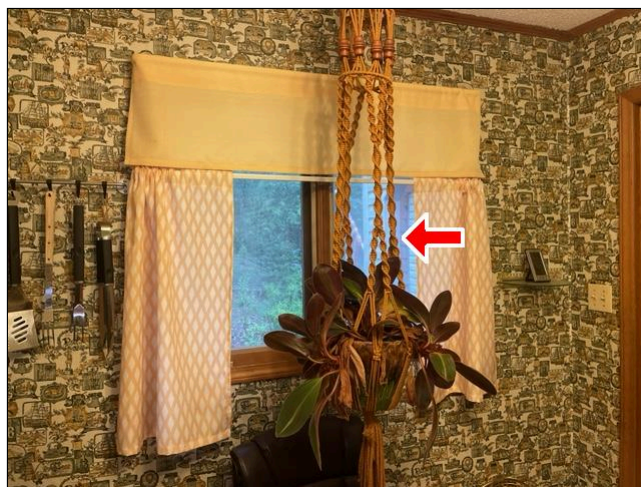
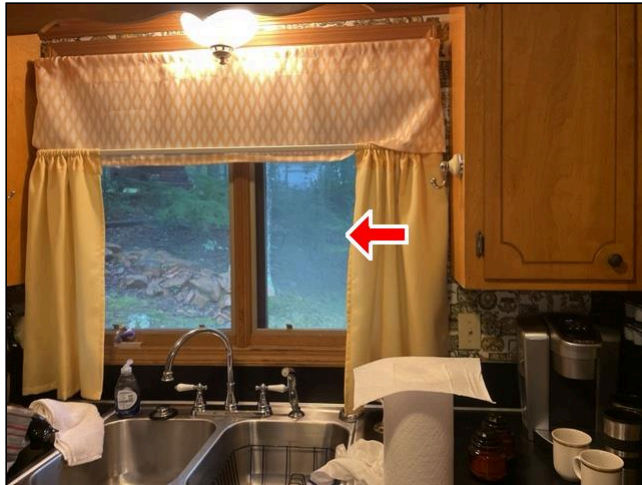
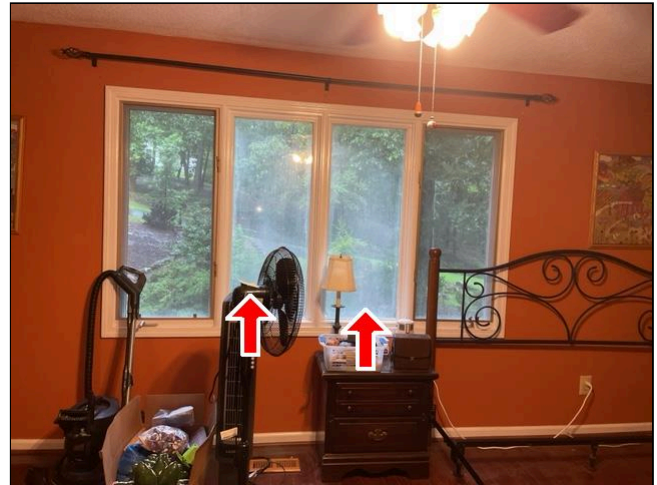
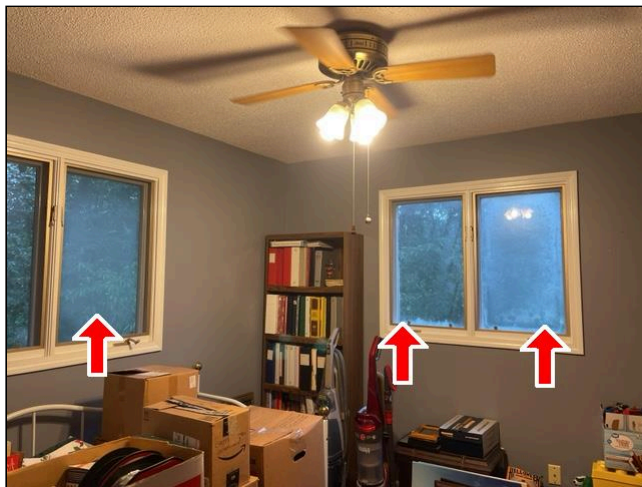
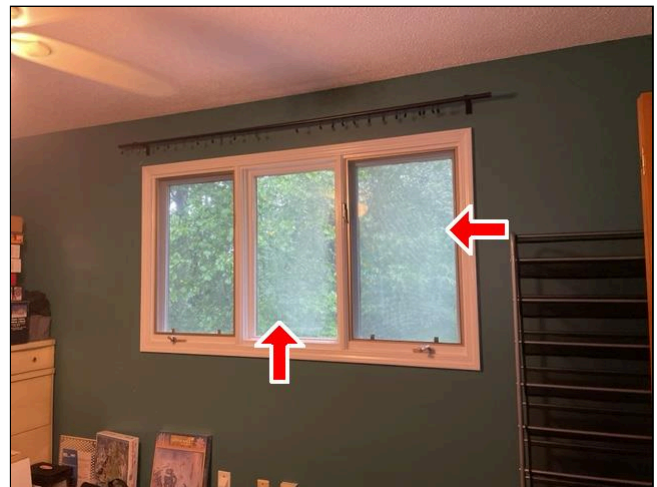
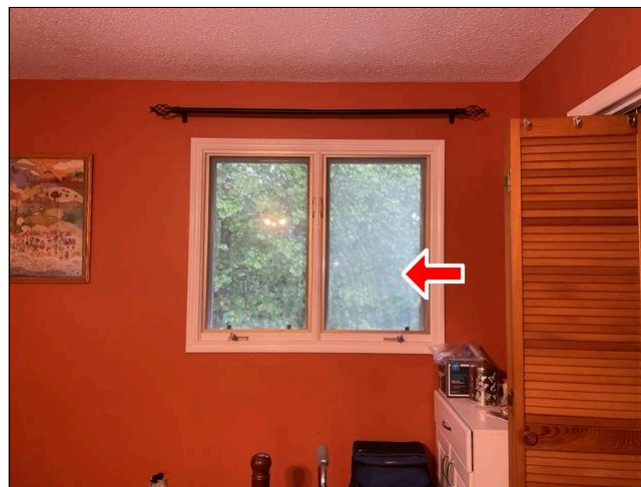
(1) Various windows and/or sashes (but not limited to) were found to have a bad or broken thermal window seal. The thermal window seal is the gasket that prevents moisture from entering in between the interior of the window panes and causing them to fog. The window at this point has lost its gas thus reduces the original r-value of the window. Contact a qualified professional for repair.
