Inspection Report

Property Address:
917 Stoneymead Dr
Kings Mountain NC 28086

Date: 8/8/2024	Time: 08:00:00 AM	Report ID: 080824JK5
Property: 917 Stoneymead Dr Kings Mountain NC 28086	Customer: The McLemore Group	Real Estate Professional: Kevin McLemore kevin@themclemoregroup.com

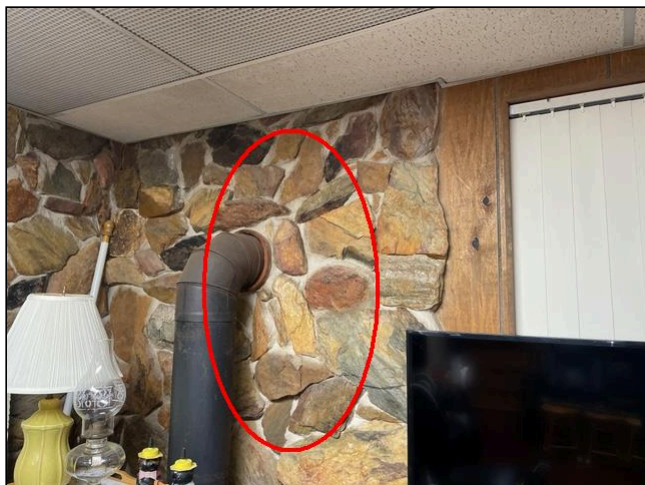
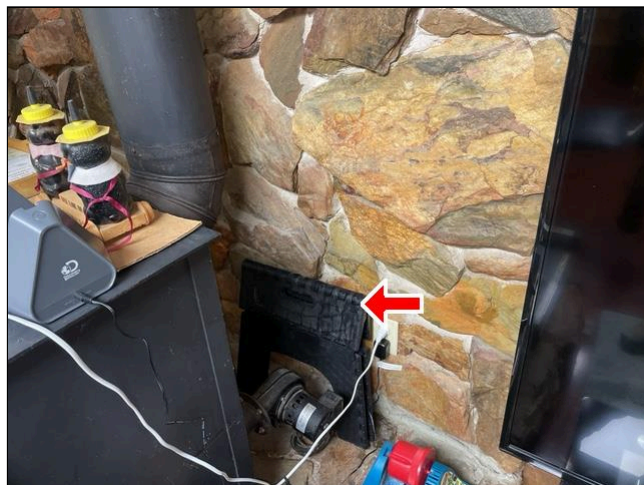
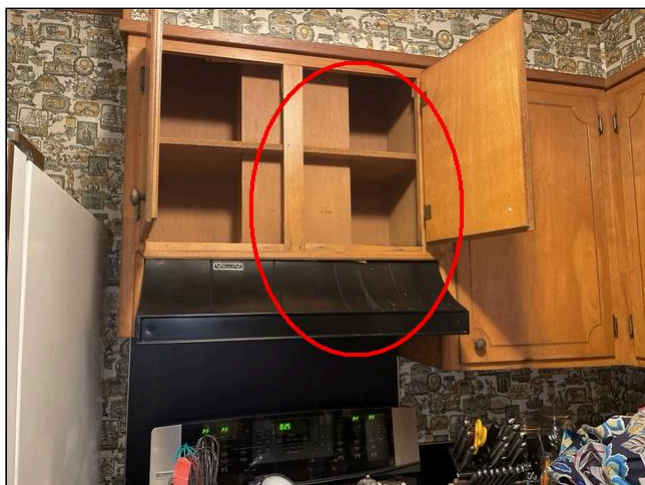
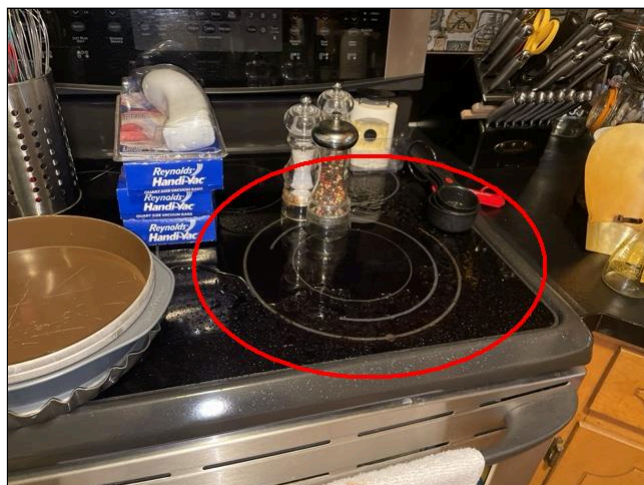
(1) There was an active moisture leaks noted at the following locations. Contact a licensed contractor for review, determine the source/cause and make any additional repairs as needed. : basement family room- left wall, above fireplace kitchen- at exhaust location

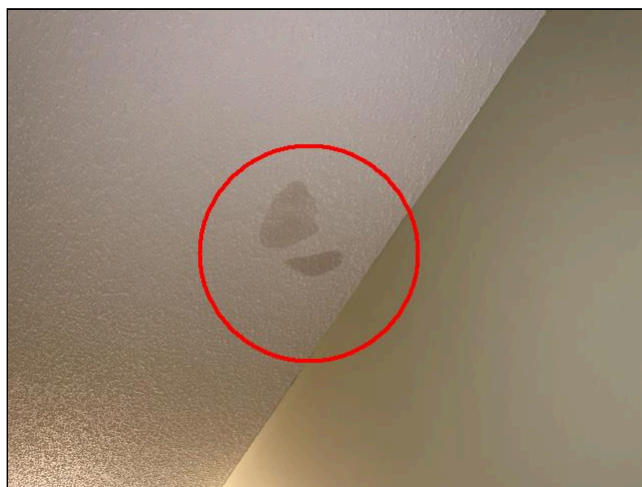
(2) There was a moisture stain noted at the upper hallway ceiling. The reading was inactive at the time of inspection; however the home was vacant at that time. Due to the constraints of time during an inspection, fixtures are only tested for a short period of time. This does not allow time to fully operate the fixtures to simulate normal volume of an occupied home. Ask the seller if a past repair was made. If they do not know then it should be considered an active issue and be further evaluated by a licensed contractor to make repairs as needed.

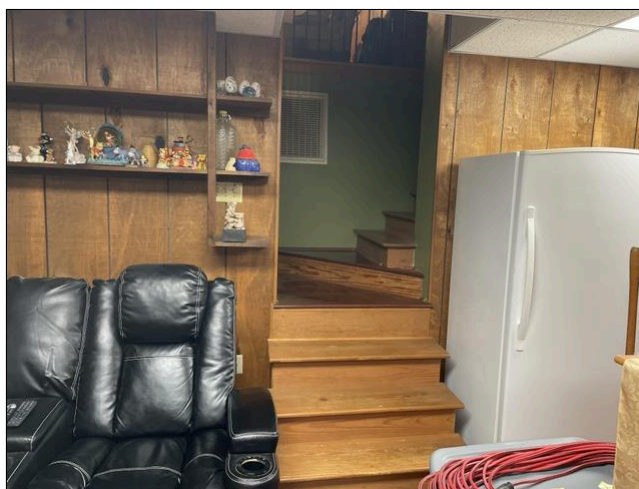
There were 3 or more steps without a handrail installed at the basement staircase. Stairs with 3 or more steps are in need of a handrail or railing. Installation and/or corrections needed to prevent personal harm. Contact a licensed contractor for repair.

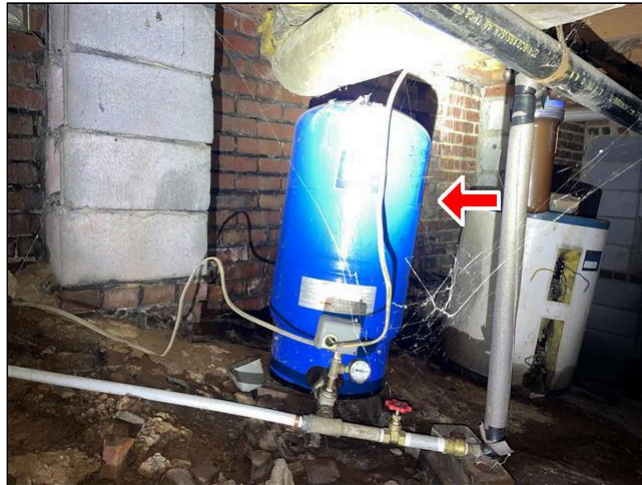
- (1) There was a heavy sulfur smell noted when testing the well. This can sometimes be an issue with the anode rod in the water heater, but can also be from the well. This is not a standard test performed during an inspection, but you may wish to contact a well company to review and determine the cause to be sure it isn't the well itself.
- (2) The bladder tank was not level at the time of inspection. This can cause the tank to not operate properly. Contact a licensed plumber or contractor for repair.

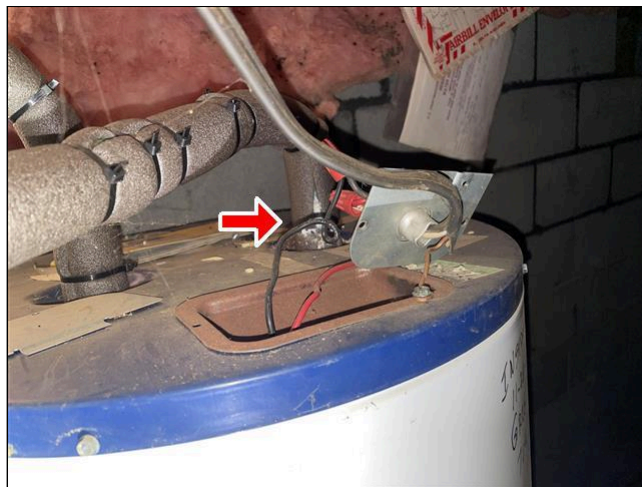
(1) The electrical wiring at the top of the tank is exposed and needs to be secured/terminated properly. This is needed to prevent someone from grabbing the line and being shocked or for the line to arc to the tank. Contact a qualified professional for repairs.

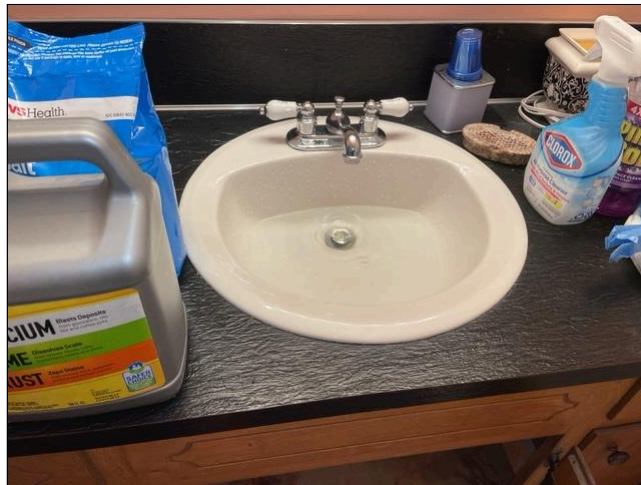
The sink is slow to drain. Corrections needed for the sink to drain properly. Clean the drain and re-inspect. If the sink is still slow to drain it could possibly be a venting issue. Contact a licensed plumber for evaluation and repair.

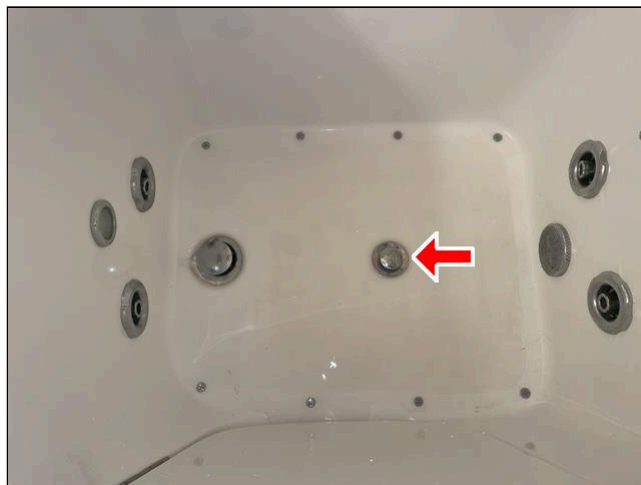
The drain stopper was not functioning properly at the time of inspection. Repair/replacement is needed so the tub can hold water properly when bathing. Due to this, the tub was not fully filled and the jets were not tested. Contact a licensed plumber for repair.

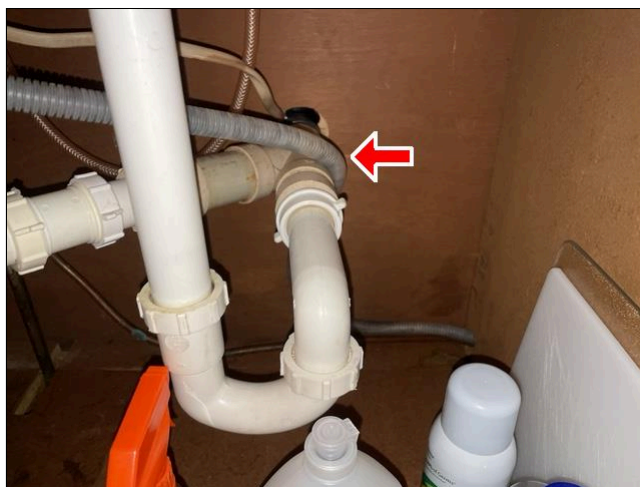
There was no high loop installed for the dishwasher drain. The drain line should go up as soon as it enters the cabinet, attach to the bottom of the countertop and then slope back down to the waste line/ disposal connection. This is needed to prevent water from flowing back into the dishwasher after the pump cuts off. Contact a qualified professional for repair.
