Wolverine Home & Property Inspections, LLC
6201 N. Viewpoint Dr.
Prescott Valley,, Arizona, 86314

Property Inspection Report

3375 N. Meadowlark Dr
Prescott Valley , Arizona 86314

Inspector Name Bill Srock
Company Name Wolverine Home & Property Inspections, LLC
Address 6201 N. Viewpoint Dr.
City Prescott Valley, State Arizona, Zip 86314
Phone 928-308-4630
E-Mail Wolverineinspection@hotmail.com
File Number WS1381PZ

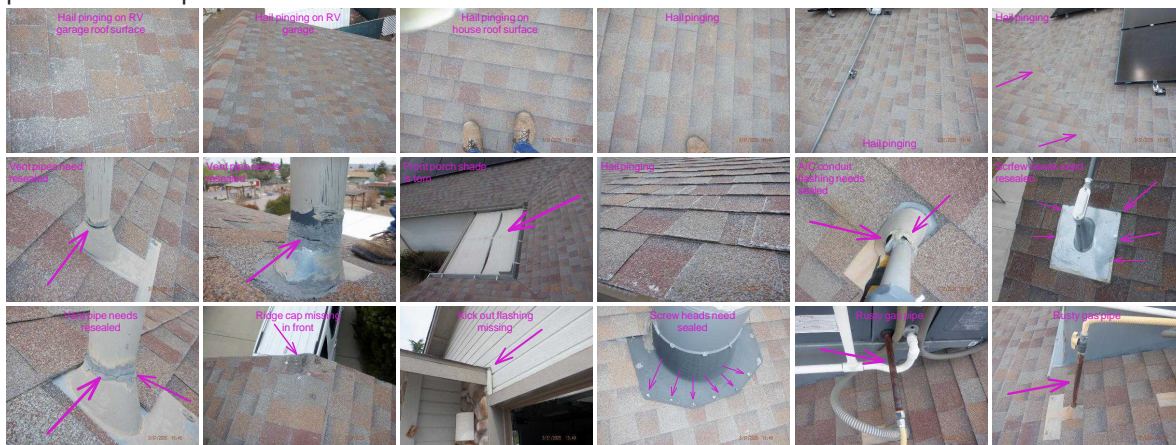
3. Marginal Material: Asphalt shingle - Hail pinging noted mostly on the south sides of roof surface on the house and RV garage, screw heads and vent pipes need sealed on house, A/C electrical conduit flashing needs sealed, kick out flashing missing in front of garage, ridge cap shingle missing in front of garage, shade screen in front of house is ripped. Recommend a qualified roofing company to evaluate and give estimate to repair all issues. Also gas lines going to gas pack on roof should be painted to stop rust.

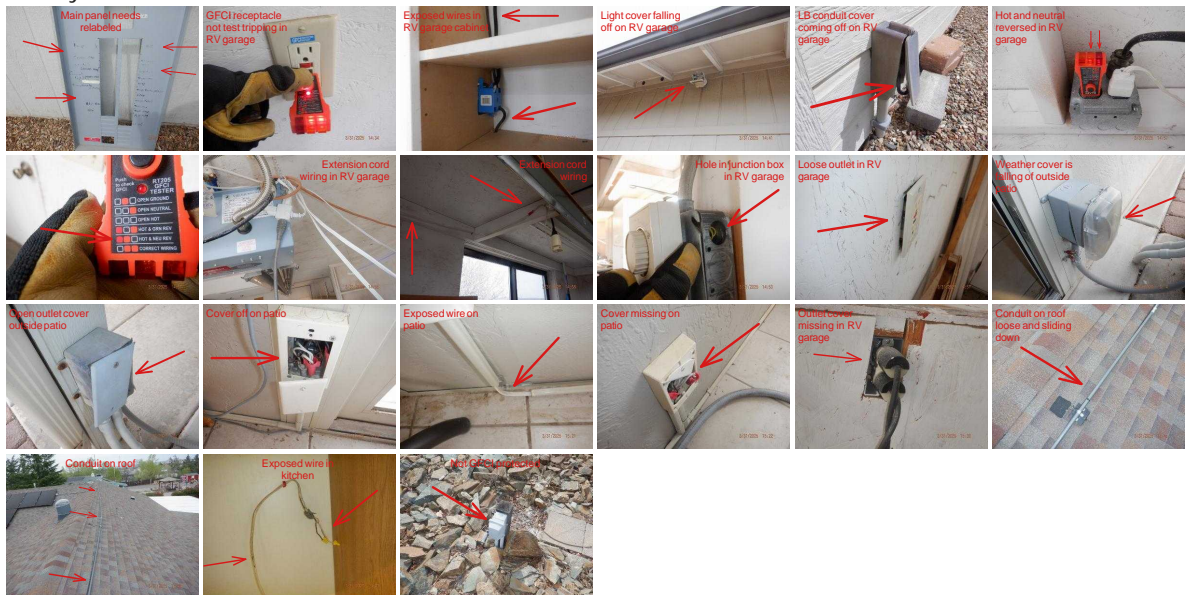
2. Defective Service: Copper and aluminum - Attached garage and RV garage have no GFCI protection, most all of the outdoor outlets around house and RV garage are not GFCI protected, main panel needs relabeled, hot and neutral are reversed in outlet in RV garage above sub panel, open weather tight conduit elbow in front of RV garage, exposed wires inside cabinet in RV garage, hole in junction box in RV garage, extension cord wiring in RV garage, outlet covers missing in RV garage, outside light cover coming off on the south side of RV garage. Patio behind house has junction box covers missing, outside weather cover is falling off outside patio, exposed wires on patio, exposed wires in kitchen where dishwasher used to go, conduit on roof is coming loose and sliding down roof. Recommend a qualified electrical company to evaluate these issues and repair as needed. This is a safety issue.

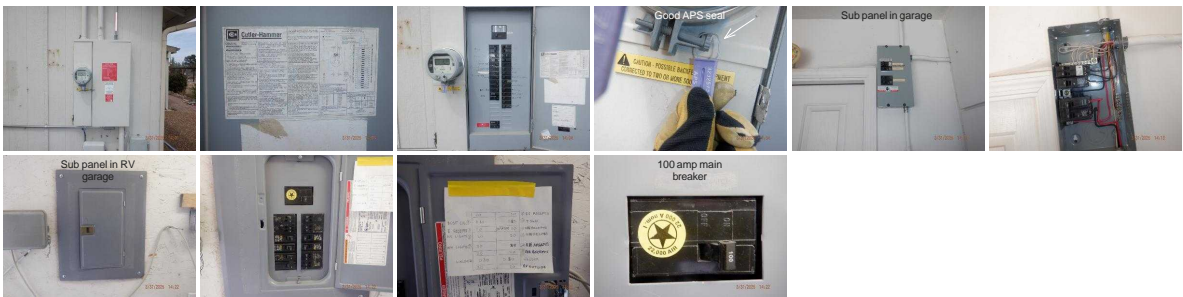
10. Acceptable Manufacturer: Cutler-Hammer

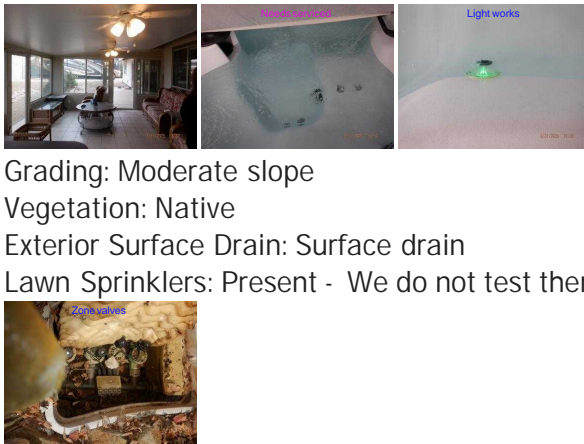
1. Acceptable Fences: Chain link
2. Acceptable Driveway: Concrete
3. Acceptable Walks: Concrete
4. Acceptable Porch: Concrete
5. Marginal Patio: Concrete - Hot tub needs serviced
6. Acceptable Grading: Moderate slope
7. Acceptable Vegetation: Native
8. Acceptable Exterior Surface Drain: Surface drain
9. Acceptable Lawn Sprinklers: Present - We do not test them

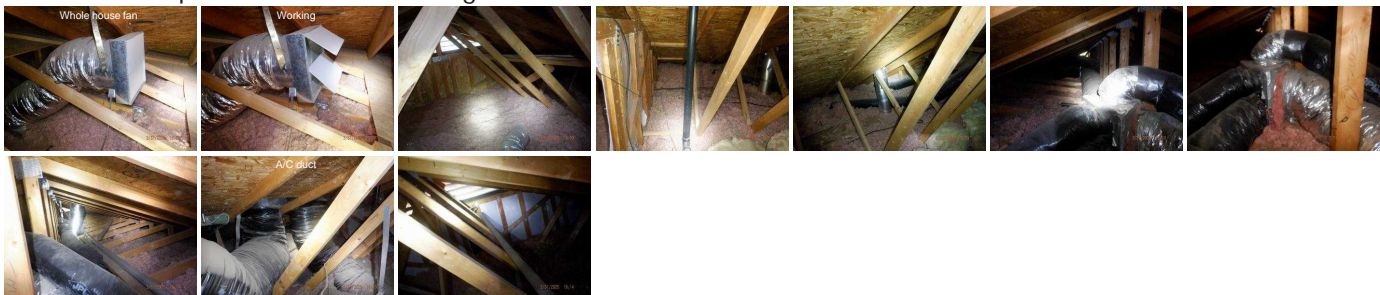
1. Method of Inspection: Crawled through attic

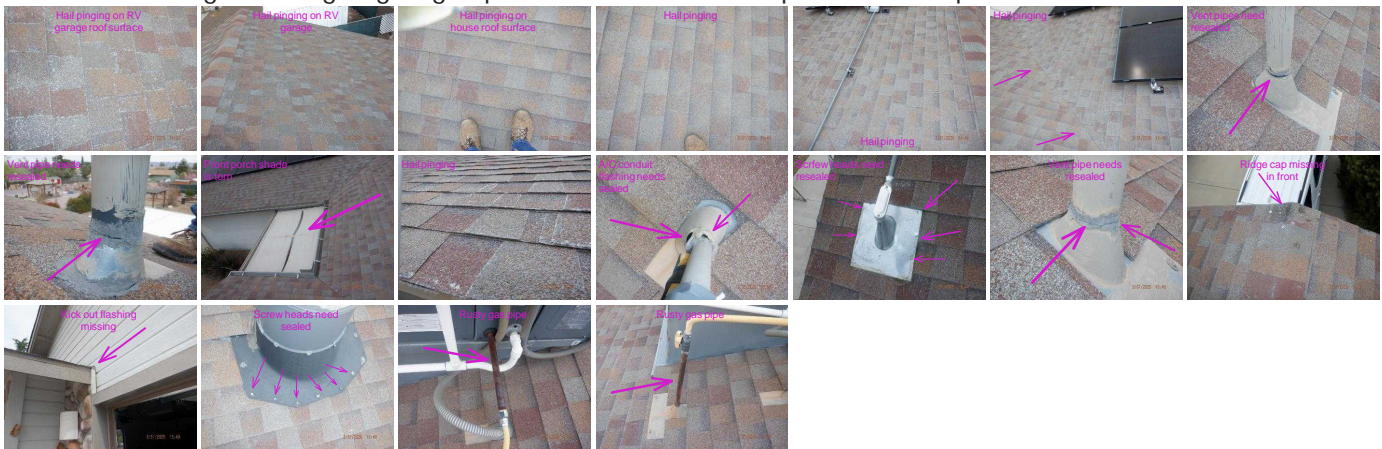
1. Whole house Roof Surface Material: Asphalt shingle - Hail pinging noted mostly on the south sides of roof surface on the house and RV garage, screw heads and vent pipes need sealed on house, A/C electrical conduit flashing needs sealed, kick out flashing missing in front of garage, ridge cap shingle missing in front of garage, shade screen in front of house is ripped. Recommend a qualified roofing company to evaluate and give estimate to repair all issues. Also gas lines going to gas pack on roof should be painted to stop rust.

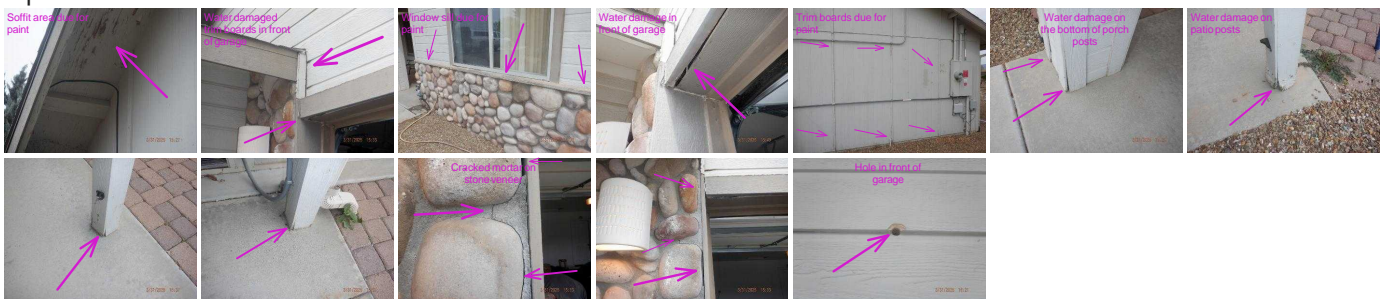
3. Trim: Composite material, Wood - Some of the trim boards and window sills are due for paint, soffit areas around house are due for paint, front and back porch wood posts have water damage on the bottoms, hole in siding in front of garage, trim damaged in front of garage due to no kick out flashing. Stone veneer is due for mortar touch up between the stones.

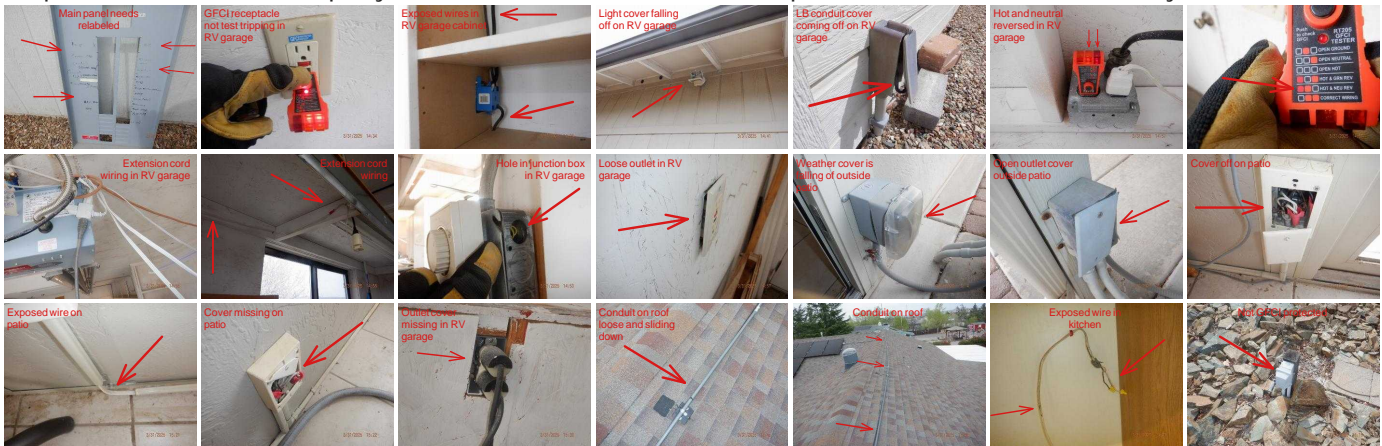
2. Service: Copper and aluminum - Attached garage and RV garage have no GFCI protection, most all of the outdoor outlets around house and RV garage are not GFCI protected, main panel needs relabeled, hot and neutral are reversed in outlet in RV garage above sub panel, open weather tight conduit elbow in front of RV garage, exposed wires inside cabinet in RV garage, hole in junction box in RV garage, extension cord wiring in RV garage, outlet covers missing in RV garage, outside light cover coming off on the south side of RV garage. Patio behind house has junction box covers missing, outside weather cover is falling off outside patio, exposed wires on patio, exposed wires in kitchen where dishwasher used to go, conduit on roof is coming loose and sliding down roof. Recommend a qualified electrical company to evaluate these issues and repair as needed. This is a safety issue.
