Inspection Report

**963 Beaver Creek Road
Bluff City, TN 37618**

1.1 Client Name: Lois Wells.
 1.2 Inspection Number: 042125-02.
 1.3 Inspection Date: April 21, 2025.
 1.4 Inspection Address: 963 Beaver Creek Road, Bluff City, TN 37618.
 1.5 Inspector: Ron Ladd, TNHIL #0000033, VAHIL #3380000585, ASHI #245442.
 1.6 Parties Present: Seller, Sellers Agent.
 1.7 Clients Agent: N/A.
 1.8 Weather: The weather conditions at time of inspection: Sunny, The temperature at time of inspection: 70 - 80 degrees fahrenheit.

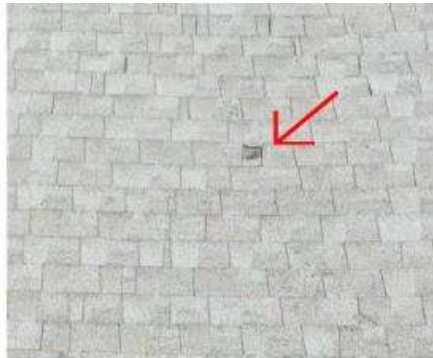
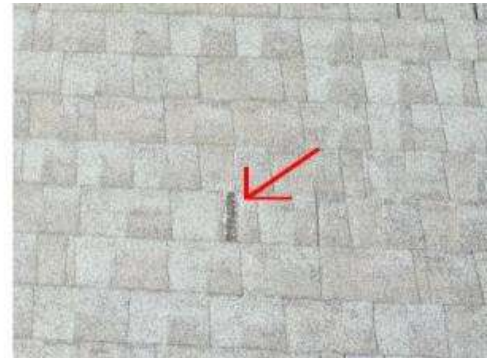
Maintenance: Several small damaged shingles noted causing / leaving fiberglass material to be exposed. Due to the number of layers of shingle materials this does **NOT** appear to be a significant issue.

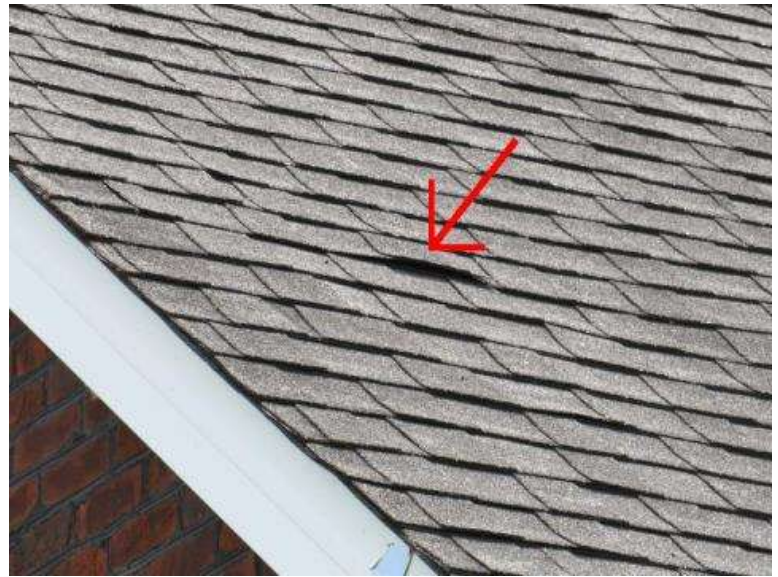
Maintenance: Nails Protruding: This condition can lead to damage to existing shingles and moisture penetration over time. Suggest securing, caulking, sealing nails, nail holes to prevent water entry.

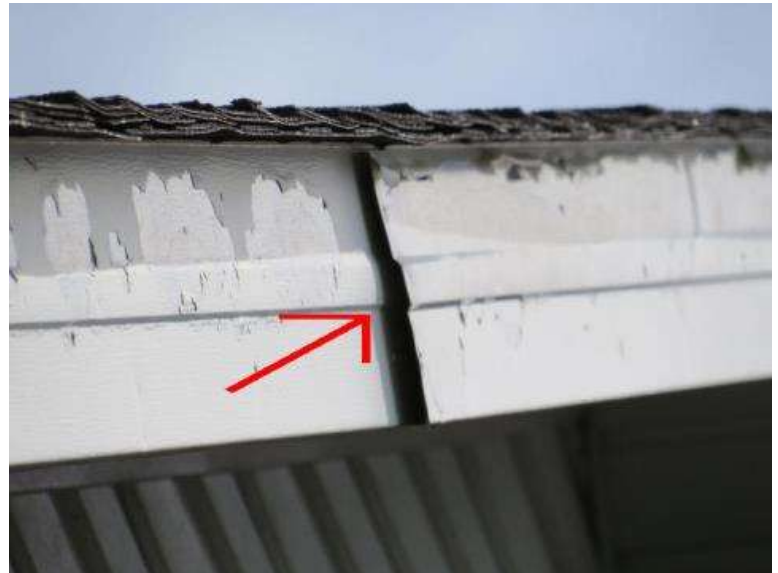
Maintenance: The roof ridge boards at the sides of the roof have loose or protruding metal trim noted. Suggest securing to prevent damage or loss.

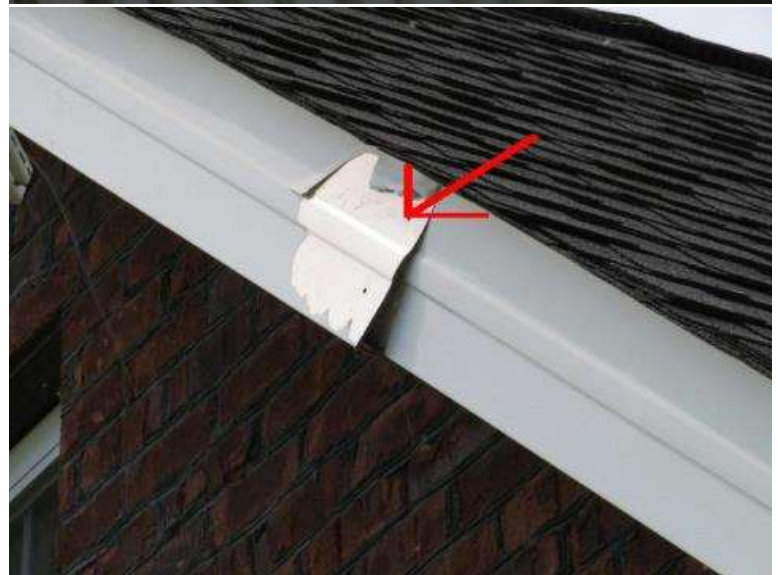
Maintenance: The roof ridge boards metal trim at the rear bonus room roof line is damaged / bent and in need of repair or replacement to prevent further damage or loss.

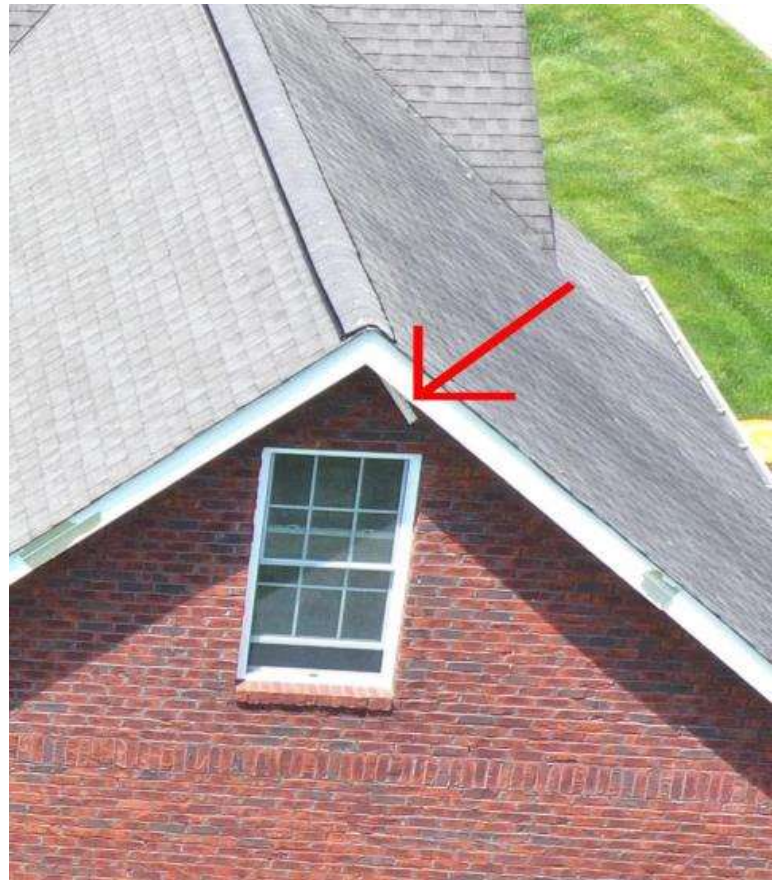
Maintenance: Soffit trim noted as loose and hanging in several locations around the structure at time of inspection. Suggest securing.

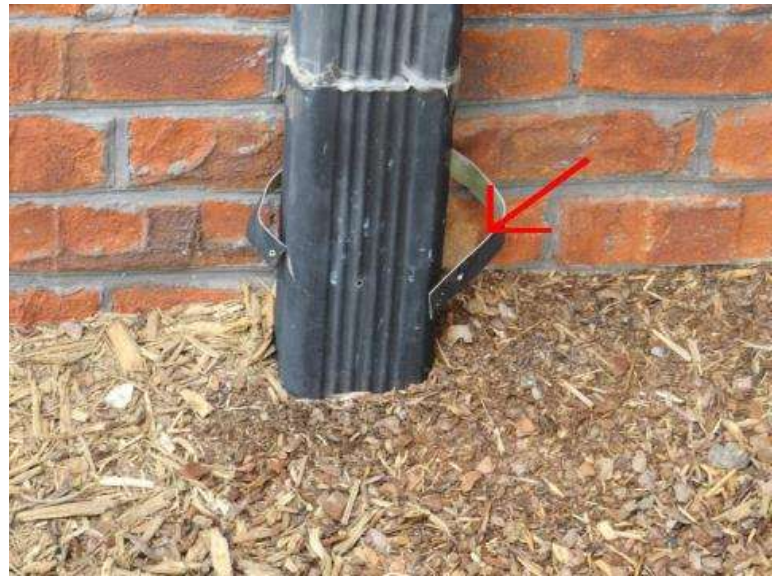
Maintenance: Gutter and downspout securing straps noted as loose or disconnected. Suggests securing to prevent damage or loss.

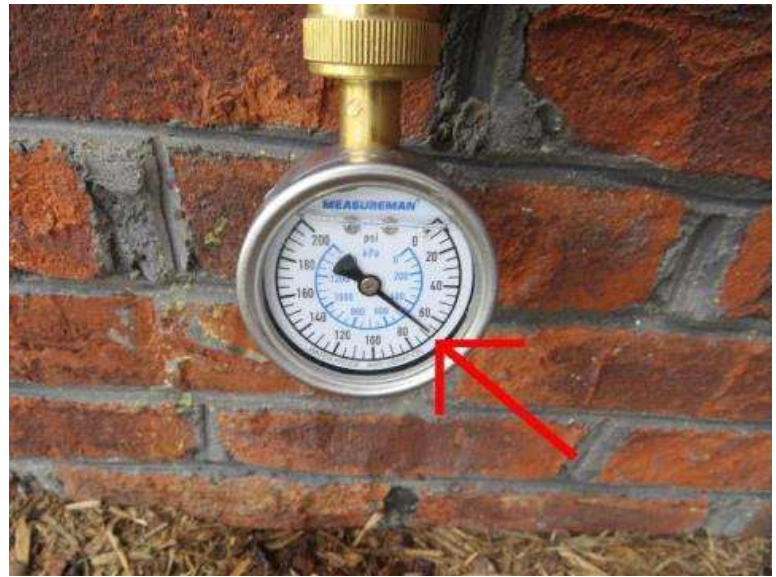
8.3

Comments: Water pressure at time of inspection was **68** psi. This is within the normal recommended limits of 40 - 80 psi.

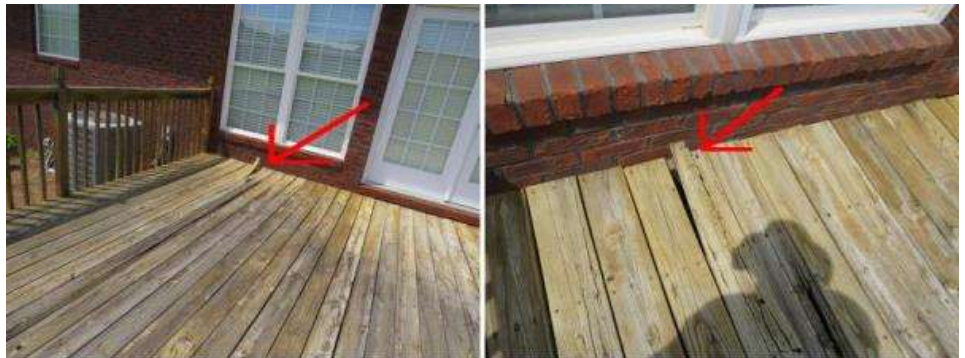
- 10.1 Description: The deck is located at the rear of the house and is constructed of wood. This deck has an open cover design.
- 10.2 Condition: **Maintenance:** Deterioration noted to deck surface, suggest sealing / caulking / staining to prevent further damage/deterioration.

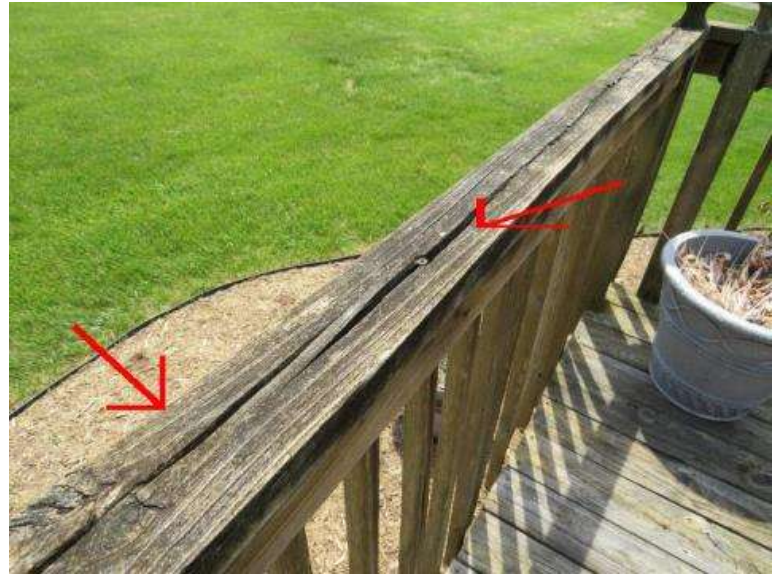
10.3

Maintenance: Deck guardrail / handrail material is noted as splitting, cracking and beginning to deteriorate. Suggest repair or replacement.

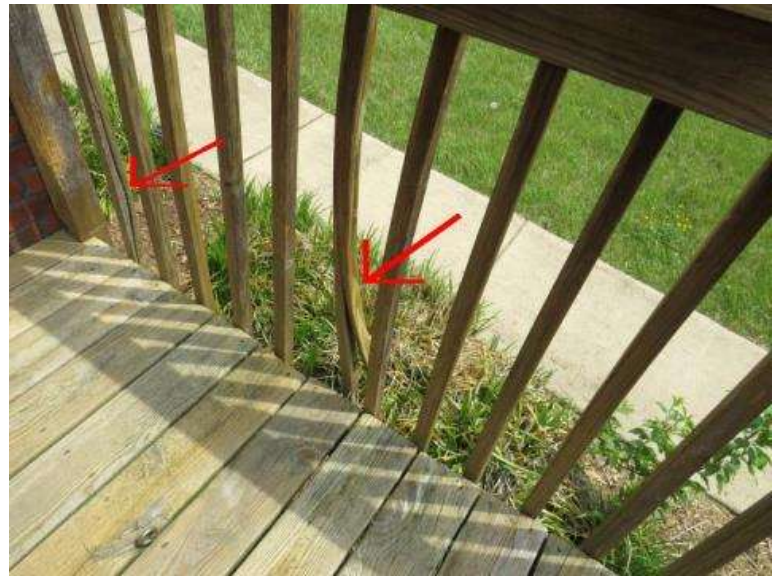
10.5

Maintenance: Deck guardrail spindles noted as loose, damage, deteriorating, warping and in need of repair or replacement.

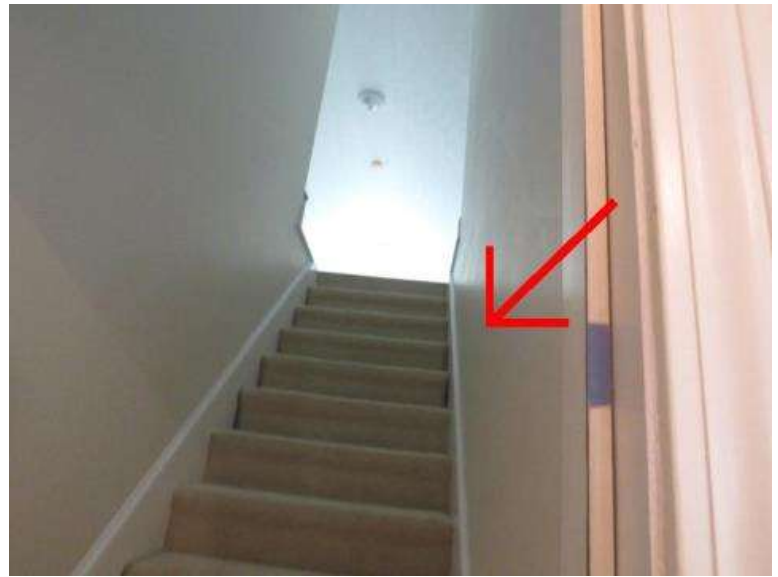
12.45 Conditions:

Safety: No hand railing is installed at the rear hallway to bonus room landing.. Installing to enhance safety is recommended.

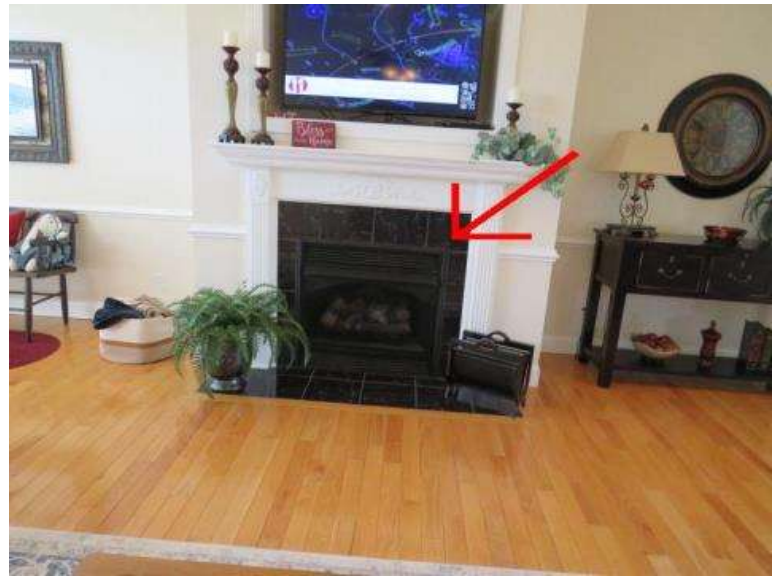
13.26 Type:

Prefabricated metal. Gas logs / inserts noted at time of inspection. **NOTE:** Inspector could not verify gas logs installed are "VENTLESS DESIGN", suggest verifying with seller gas logs are designed so a flue is not required when in use.

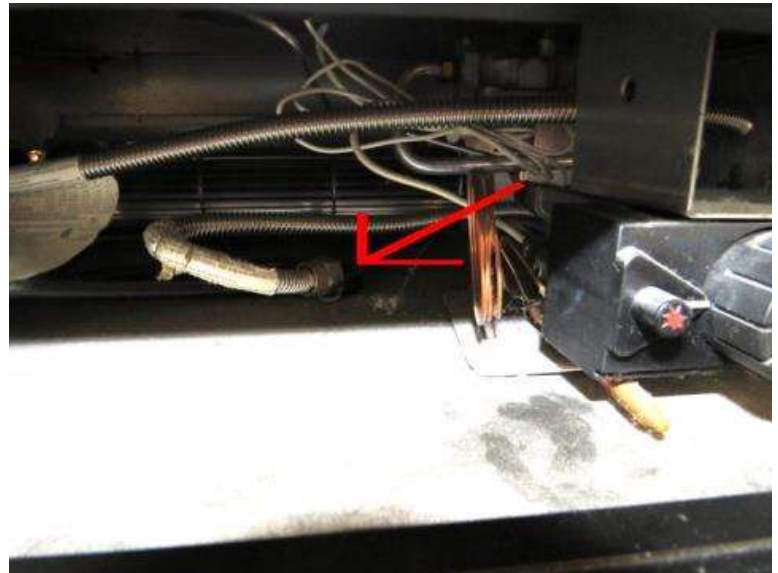
13.27 Condition:

Safety: The gas line was NOT connected at time of inspection and was open at the end of the line. This condition could allow gas to leak out of the line is connected at the other end.

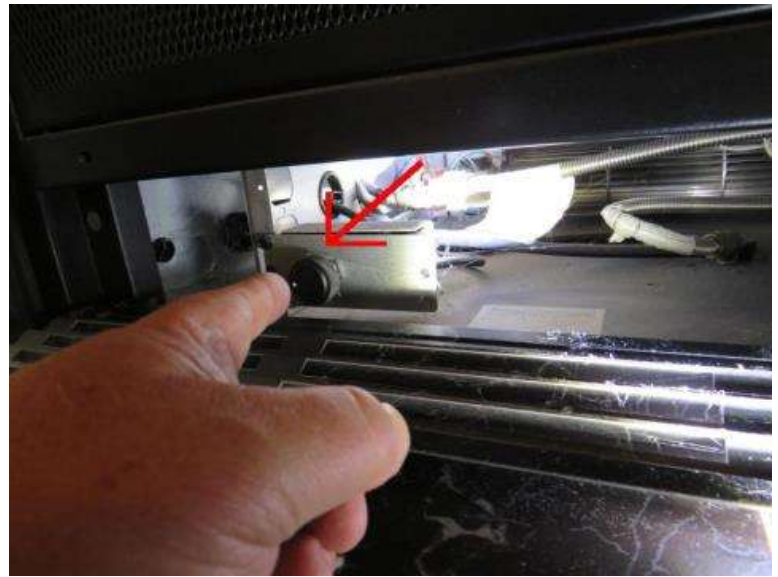
13.28

Safety: The gas fireplace does NOT have a manual gas shutoff valve installed. A manual gas shutoff valve is required within 6 feet of a gas appliance and must be located in the same room as the gas appliance.

Maintenance: The blower fan for the gas fireplace did not work on day of inspection.

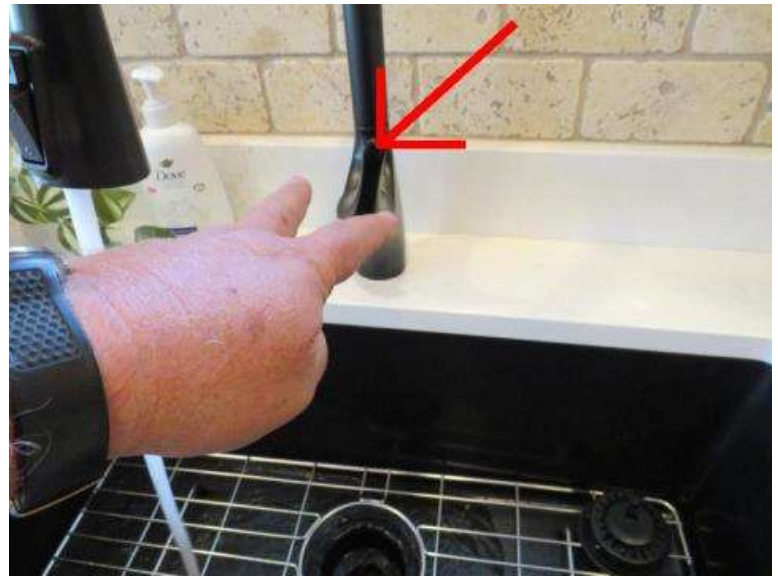
15.27 Conditions:

Maintenance: The HOT and COLD water supply lines are reversed. **NOTE:** HOT should be to the left of the faucet.

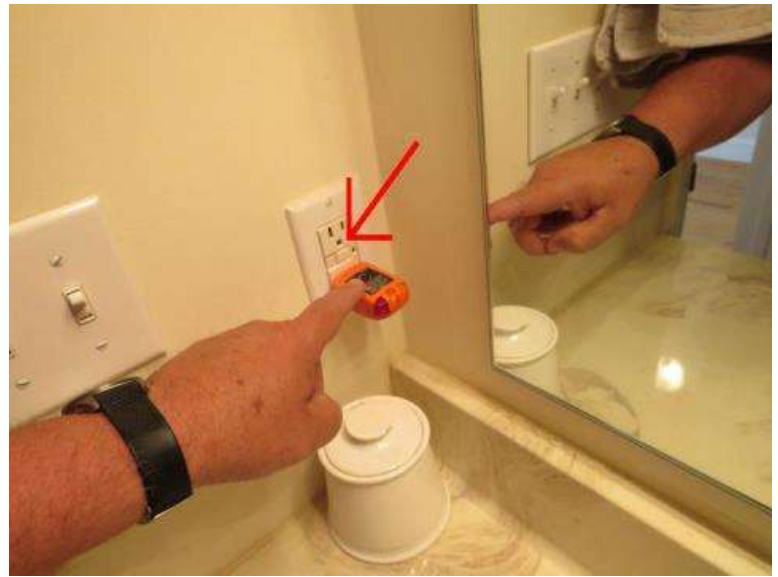
17.15 Condition: **Deficient:** The GFCI outlet had power on day of inspection but would not trip when tested.

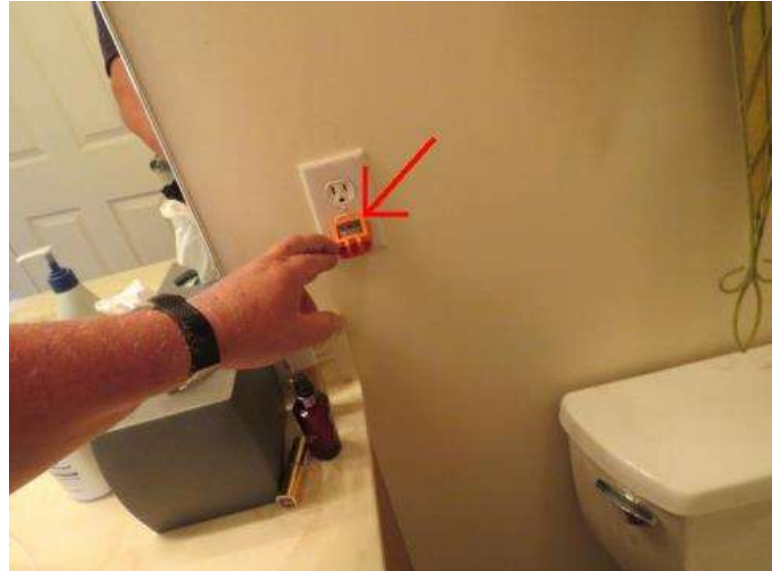
17.16 **Safety:** Outlet did **NOT** have power on day of inspection and **NO GFCI** was protection was noted..

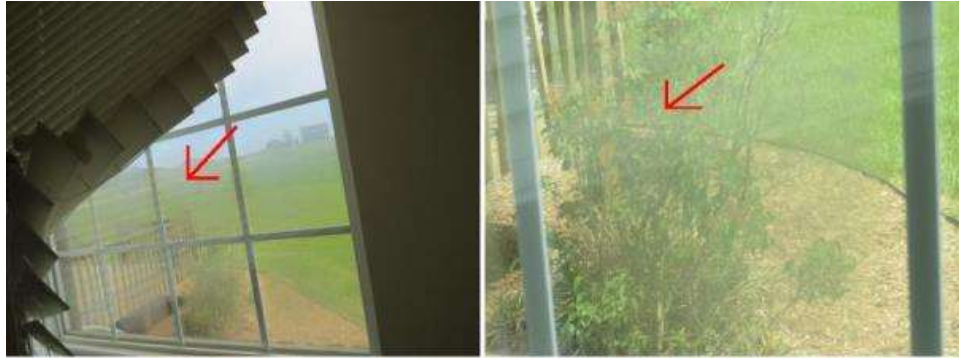
17.50 Condition: **Maintenance:** Fog and condensation was noted in the double glazed insulated window panes at . This indicates a broken seal which will reduce visibility and the insulating capability of this window. To restore visibility and regain the insulating capability, replacement of this window pane is required.

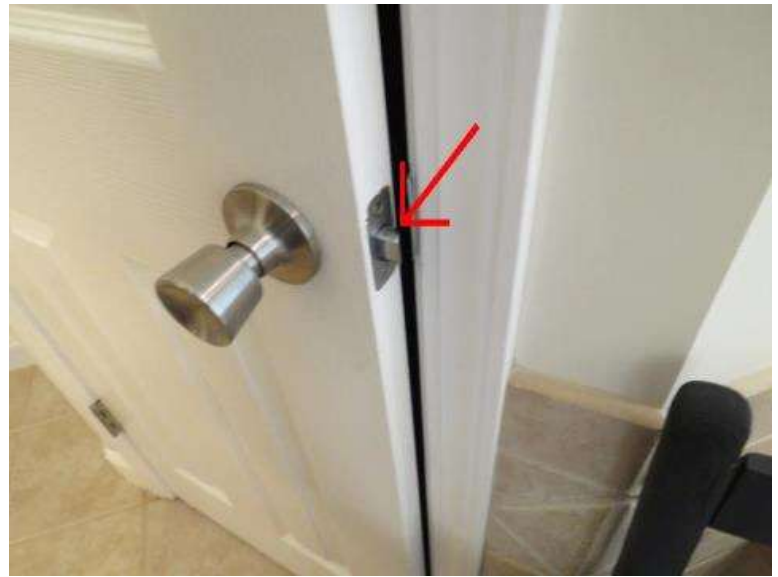
- 17.58 **Maintenance:** Door does not properly lock, latch and remain closed when shut.

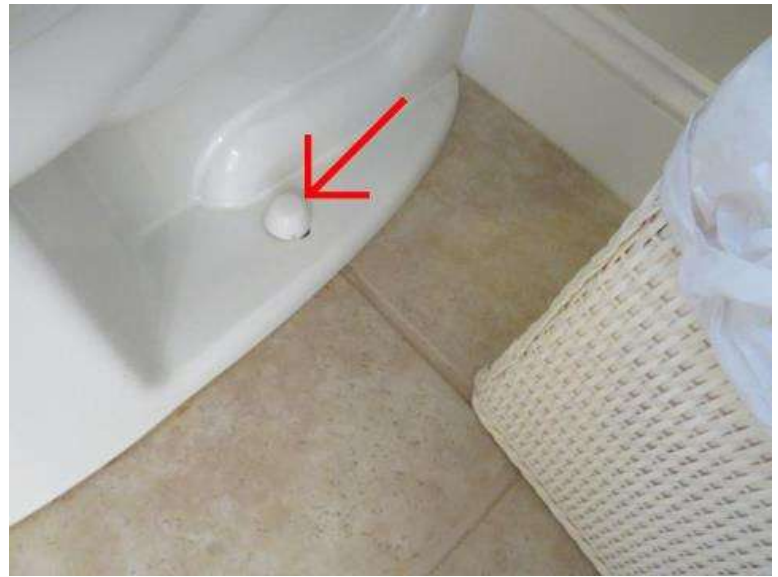
17.76 Toilet:

Maintenance: The toilet bowl is loose at floor anchor bolts. The wax ring inside the unit must have a snug, secure fit in order to keep from leaking. Re-sealing and re-securing of this unit is recommended to prevent water leakage and damage.

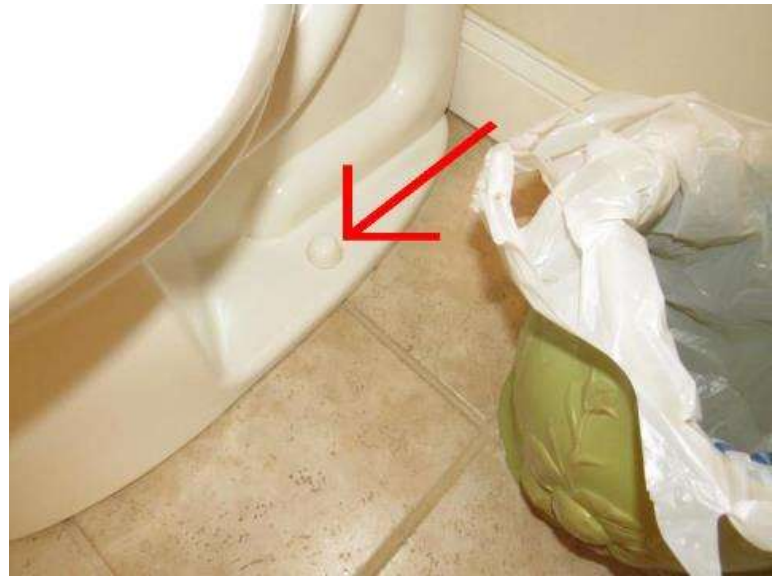
17.92 Toilet:

Maintenance: The toilet bowl is loose at floor anchor bolts. The wax ring inside the unit must have a snug, secure fit in order to keep from leaking. Re-sealing and re-securing of this unit is recommended to prevent water leakage and damage.

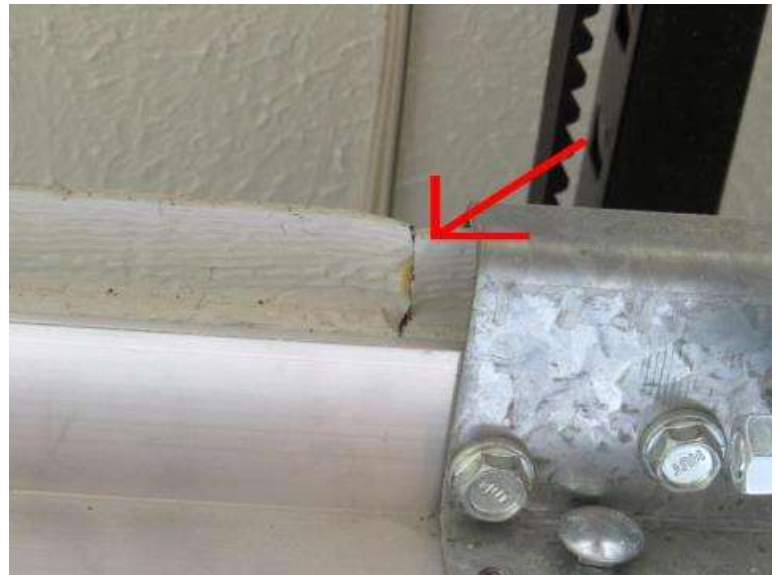
- 20.12 Material: Metal.
- 20.13 Condition: **Maintenance:** The forward vehicle garage door upper door panel is damaged / cracked. This condition weakens the door and it will eventually cause it the break. Suggest installing a 6 to 8 foot piece of angle iron across the top of the door to help extend the useful life of the door.

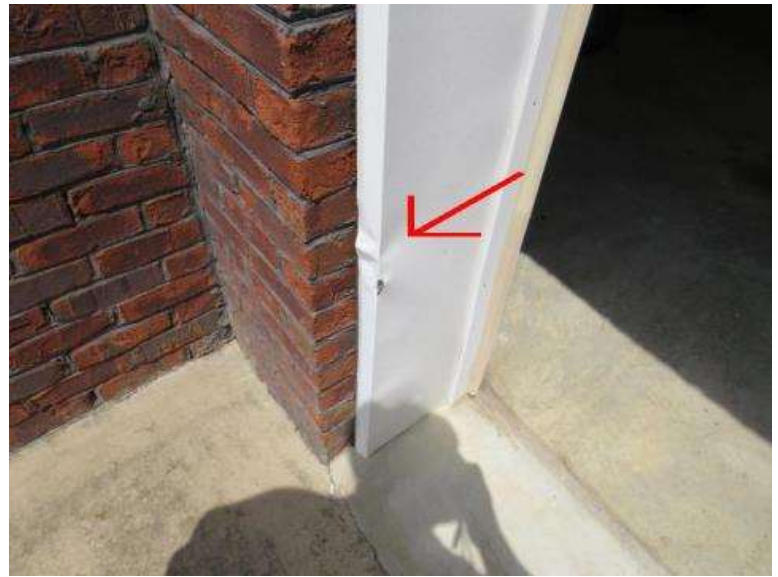
20.39

Maintenance: Minor damage is noted to door frame hardware, suggest repair / replacement to damaged / defective materials for serviceability.

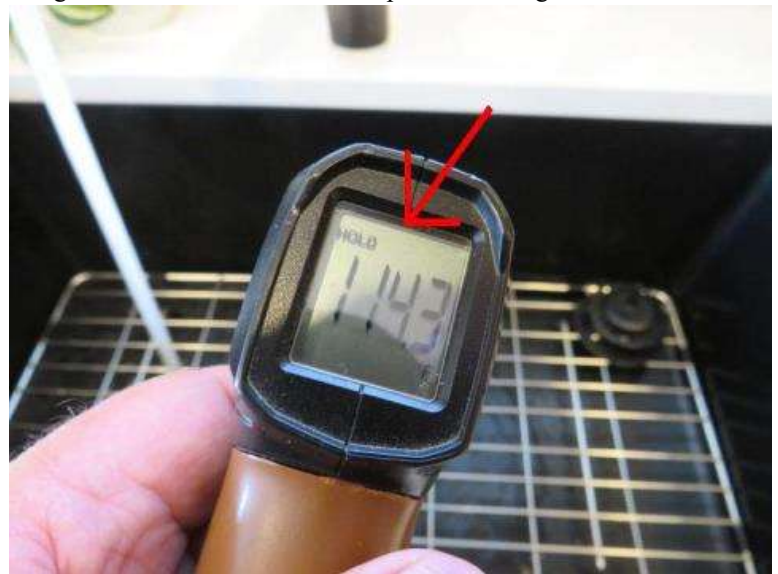
21.14

Comments: Water temperature at time of inspection was **114** degrees, this is just outside the normal limits of 120 - 140 degrees.

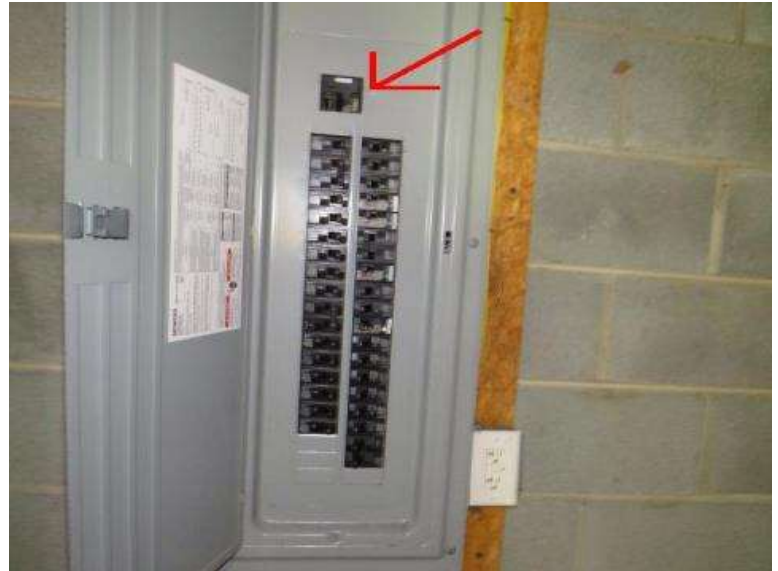
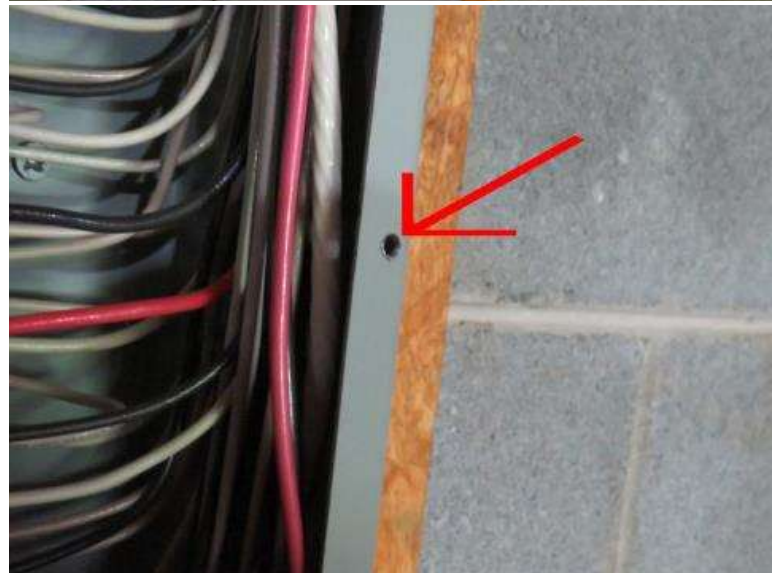
- 22.4 Condition: **Safety:** The mounting screws for the electrical panel cover plate is noted coming into contact with the high voltage wiring inside the electrical panel cabinet. Suggest moving all internal wires to allow for the proper insertion of the panel cover screws.

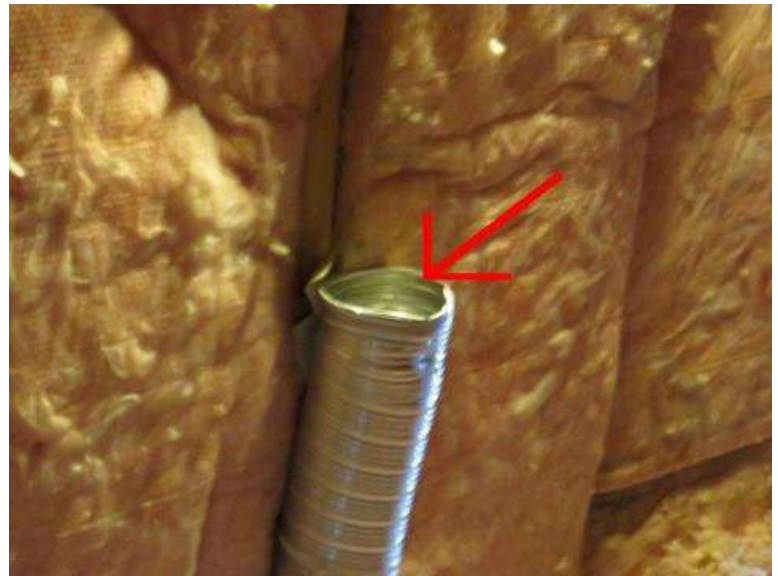
- 25.4 **Maintenance:** Bathroom exhaust vents exiting into attic. This condition allows warm moist air from bathroom to exit into the attic. This condition can lead to condensation forming on roof sheeting and the development of mold growth in the attic.
