Perfection Home Inspections
Mesa, AZ 85203
602-524-2916
perfectionhomeinspections.com

Inspected By:
Greg Oswalt Arizona Lic. 38752

Auction, United Country Excelled
2002 N 25th Street
Phoenix, AZ 85008
480-422-6800

Inspected 5/31/25 8:00 AM
Built 1951
1090sf

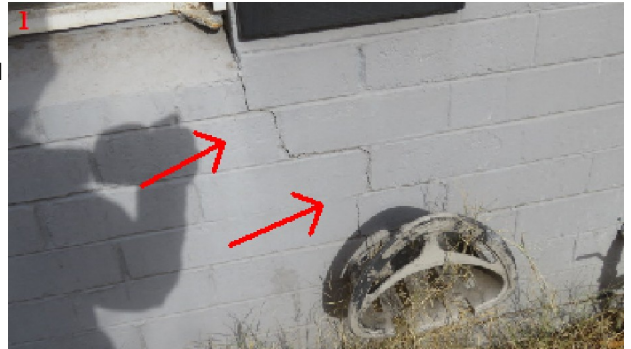
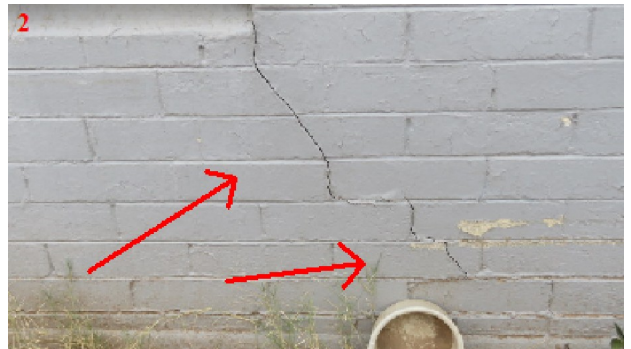
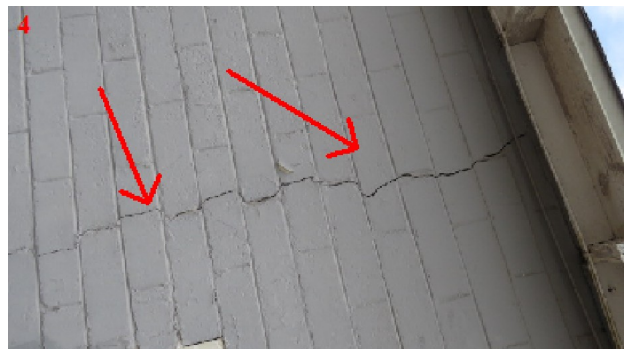
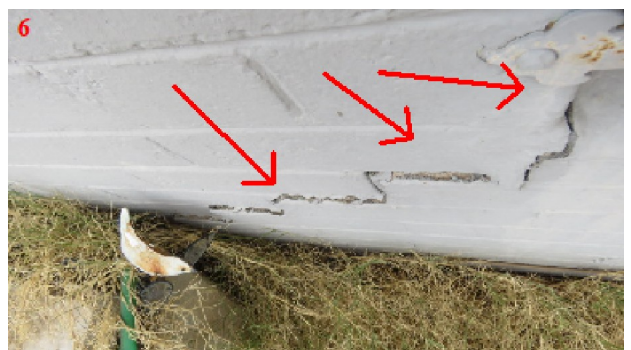
Cracks in the exterior wall structure. Racked wall outside of the back bedroom. aka Bedroom 2. There is a sheet of drywall used to patch a hole in an exterior wall outside the master bedroom. Drywall is not water proof. Recommend a qualified contractor evaluate and take all necessary steps to solve this problem.

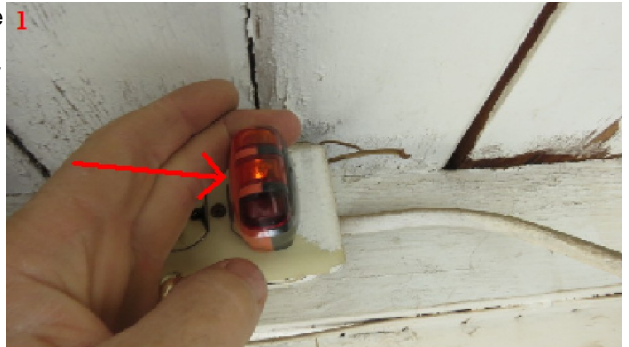
The polarity and the grounding of all accessible exterior outlets were tested. The front porch outlet has an open ground. Recommend a qualified contractor evaluate and make all necessary repairs.

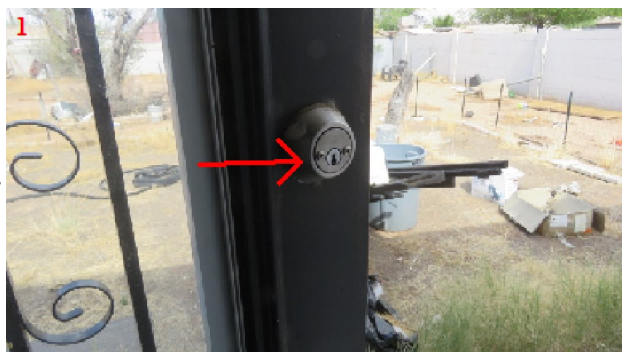
Double sided dead bolt locks used on exterior patio door. These type of locks require the use of a key to exit so they are a fire escape hazard. Recommend replacing all double dead bolts with standard dead bolt locks.

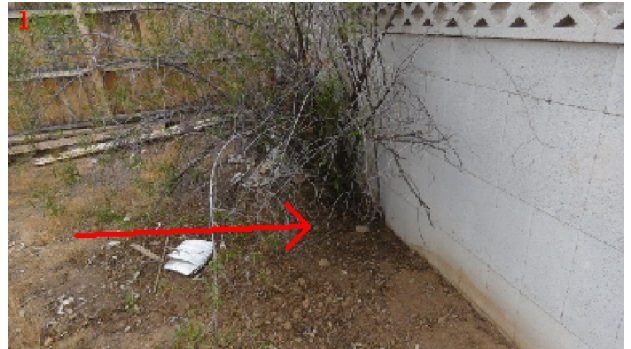
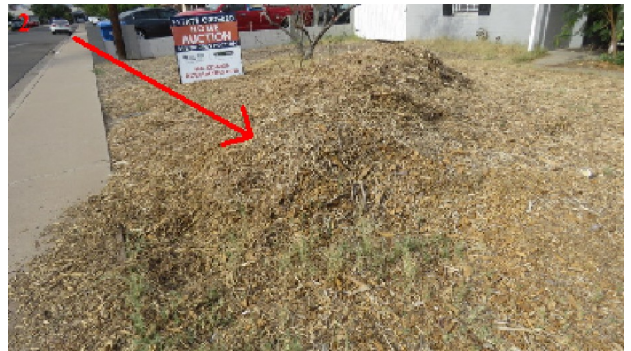
Trees located too close to the house foundation, block walls, sidewalks, and or concrete slabs, can crack and or heave the concrete. Recommend removing trees too close to the concrete structures, foundations and or sidewalks.
Large pile of debris in the front yard. Recommend removing the debris.

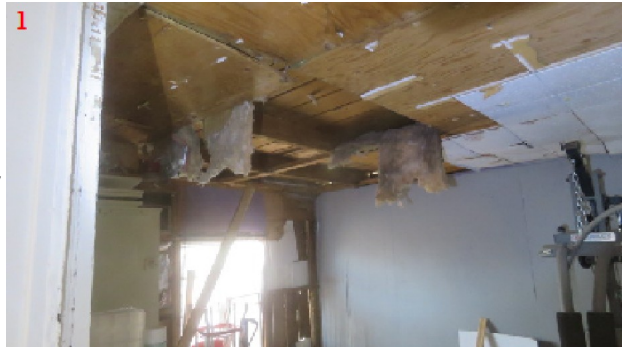
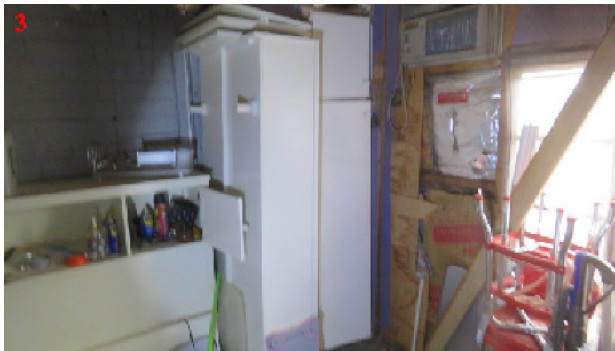
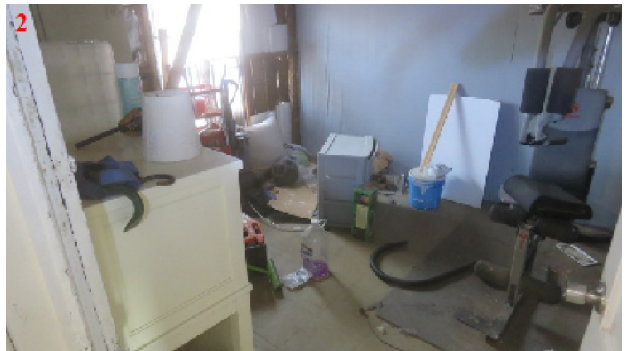
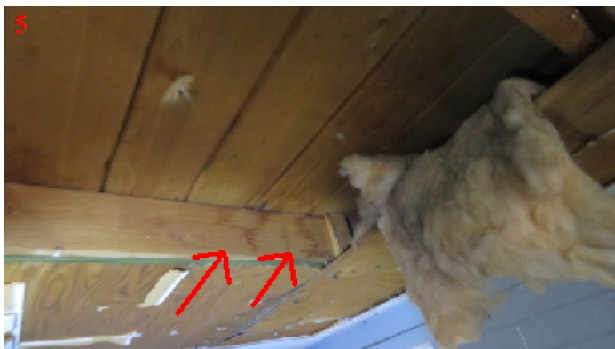
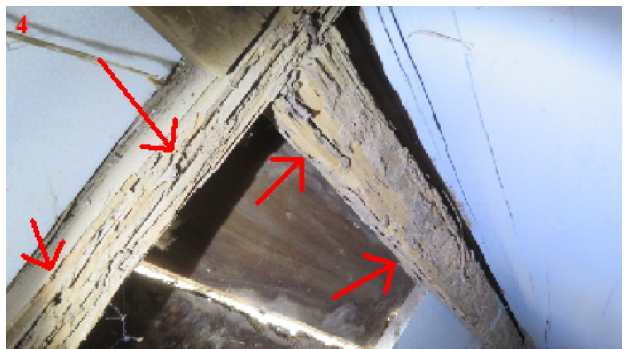
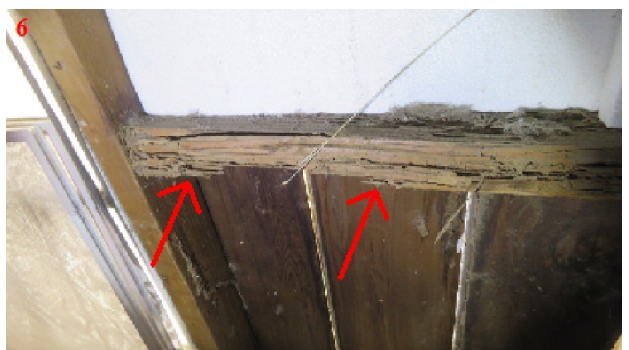
Massive termite damage to visible section of the wall in the storage room addition. This looks like an enclosed section of a past carport.. Due to lack of access no outlets or switches were tested in this addition. No HVAC in this shed. Lots of water stain on the ceiling in this room. Ceiling covering caved in. Ceiling insulation missing and out of place. Recommend a qualified contractor evaluate and make all necessary repairs.

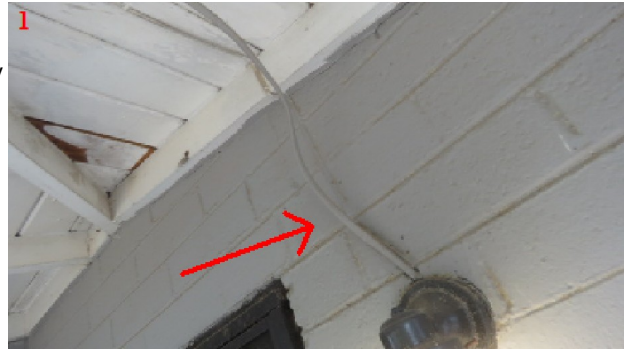
Exposed romex type wire within 7 feet of the ground found on the exterior of the home at the front porch. This is a shock hazard. Recommend a qualified contractor evaluate and make all necessary repairs.

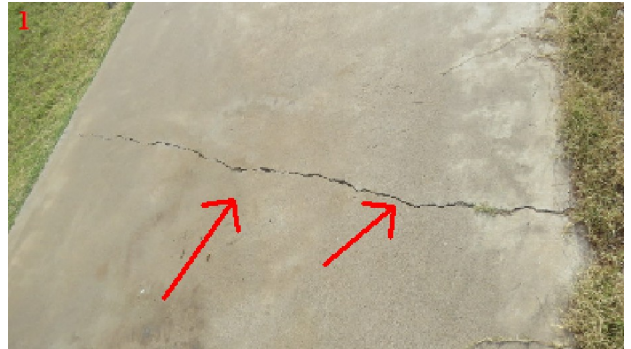
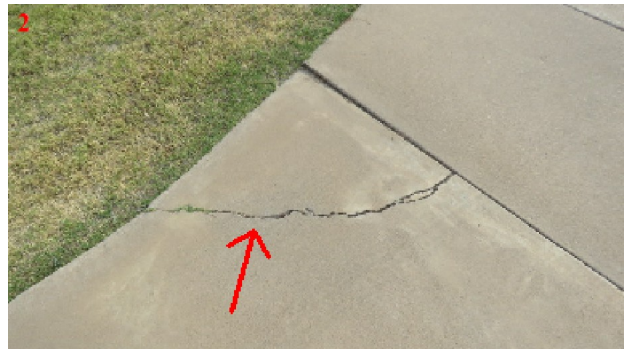
Cracks in driveway. Recommend sealing cracks to keep moisture out and to keep the cracks from spreading. See sample picture

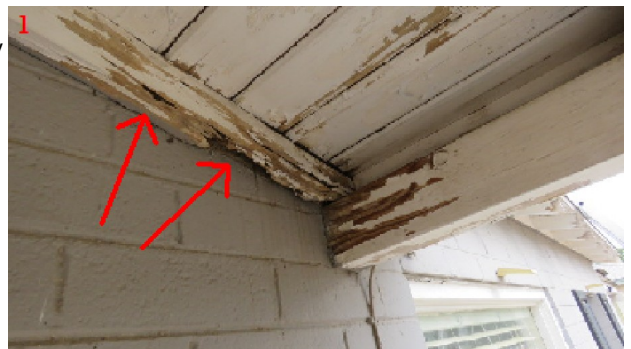
Termite damage and or wood rot in a rafter at the front porch. Recommend a qualified contractor evaluate and make all necessary repairs.

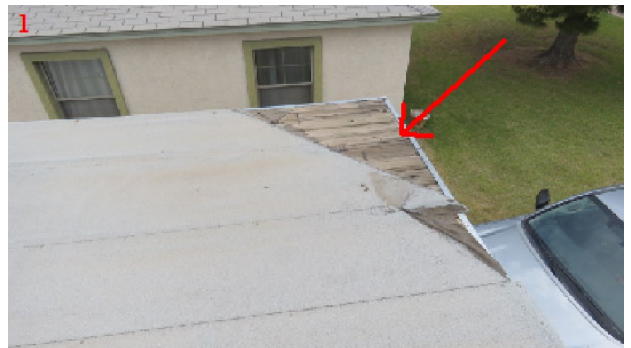
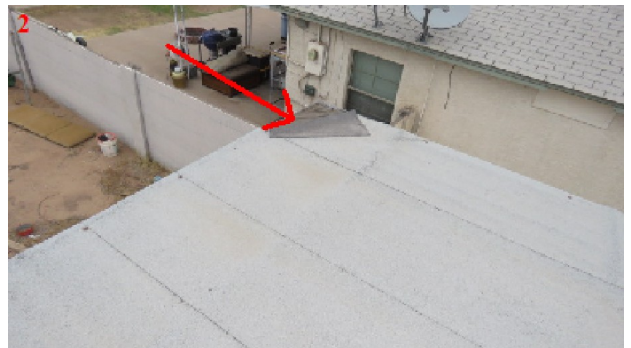
The carport and storage room roof is a rolled material in poor condition lifting in the front and in the back. Recommend a qualified roofing contractor evaluate and make all necessary repairs.

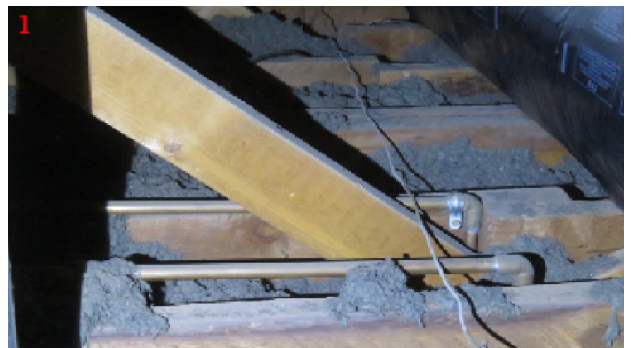
The attic floor insulation is 2 to 3 inches thick. Recommend adding more attic insulation to meet current standards.

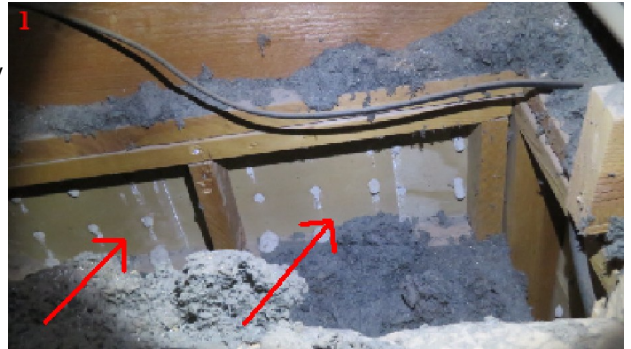
Some insulation in the attic is missing from the wall to livable space. Recommend all walls to living space be insulated from the exterior. Recommend a qualified contractor evaluate and make all necessary repairs.

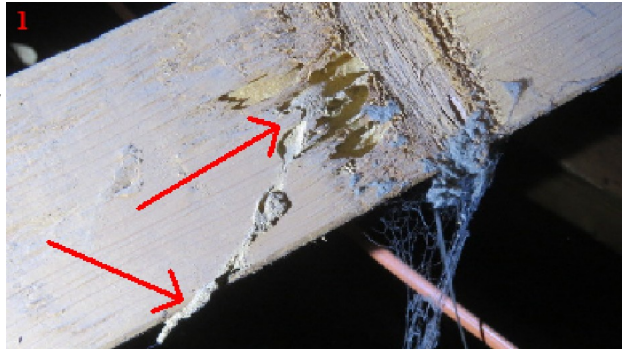
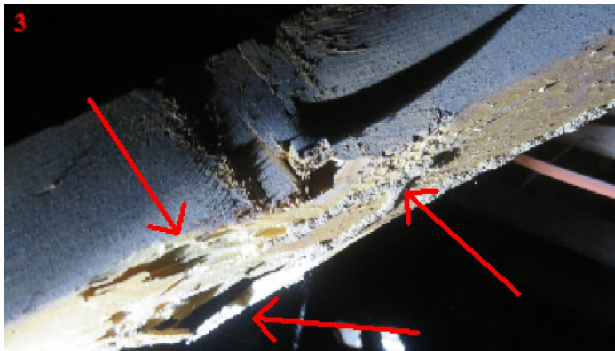
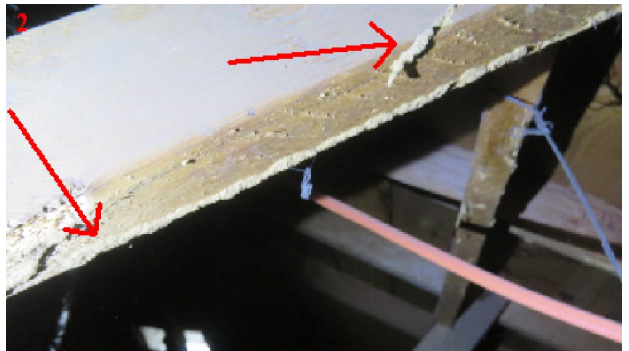
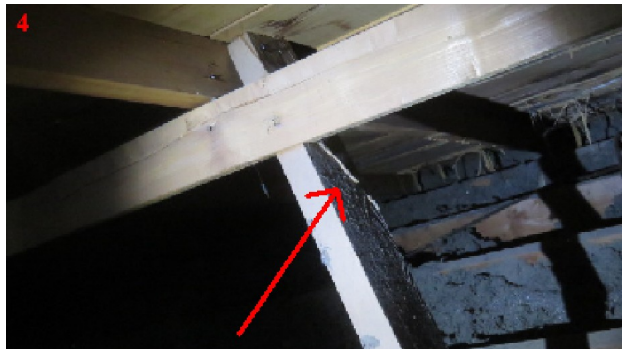
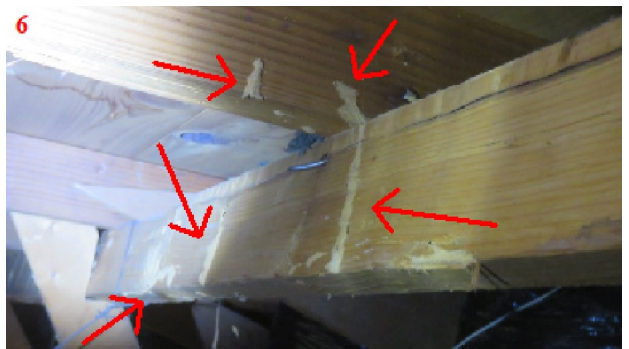
Structural damage to attic members from termite damage. Ceiling joist and other structural wood with termite damage. See sample pictures. Recommend a qualified contractor evaluate and make all necessary repairs.

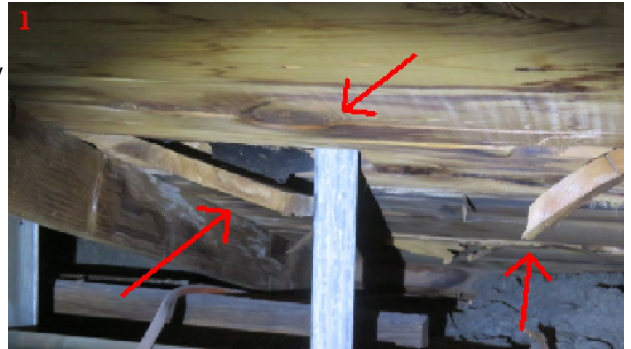
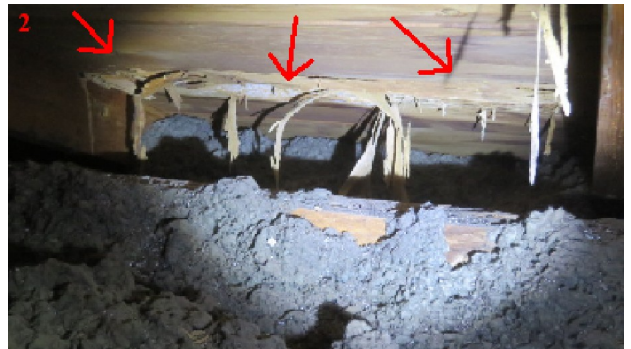
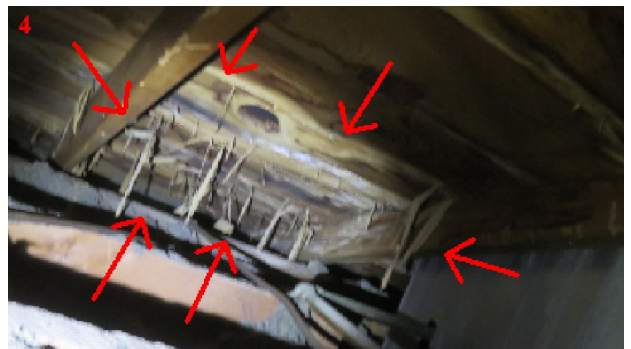
Water damage and termite damage to roof sheathing. Broken sheathing board at a vent pipe. Recommend a qualified contractor evaluate and make all necessary repairs.

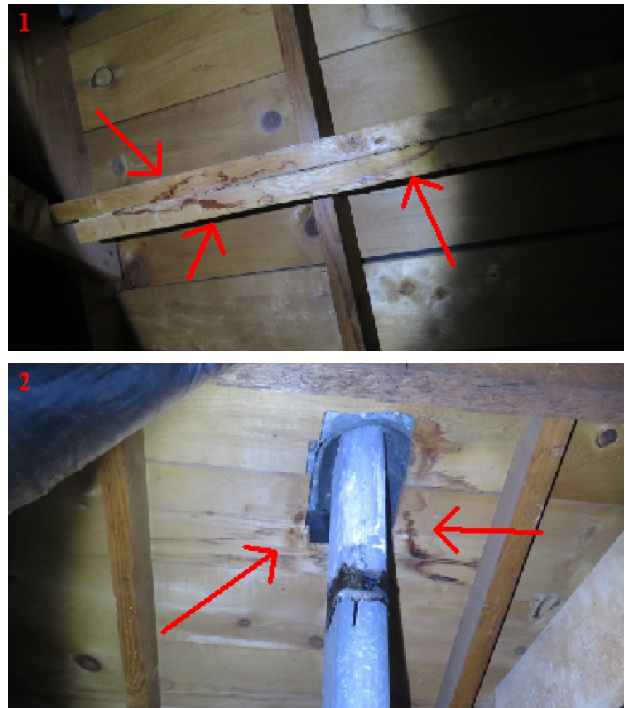
Signs of prior roof leaks in attic. Sheathing has water stains in several areas. Recommend asking seller if this problem has been solved and if not recommend a qualified roofing contractor evaluate and make all necessary repairs. See pictures

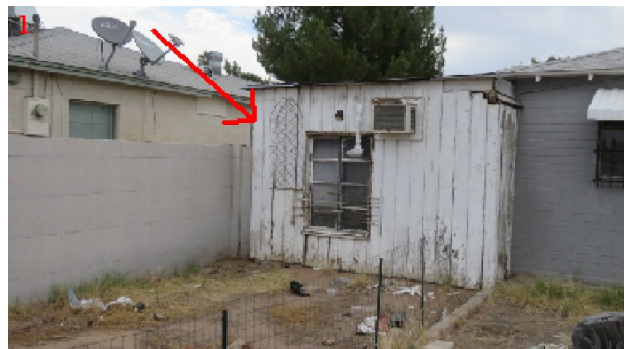
The garage is a carport, and it and the storage shed may be too close to the property line for current city codes. This is not a code inspection. Recommend checking with the city. This shed was poorly inspected due to lack of access. Recommend further inspecting after all the stuff is removed from this room.

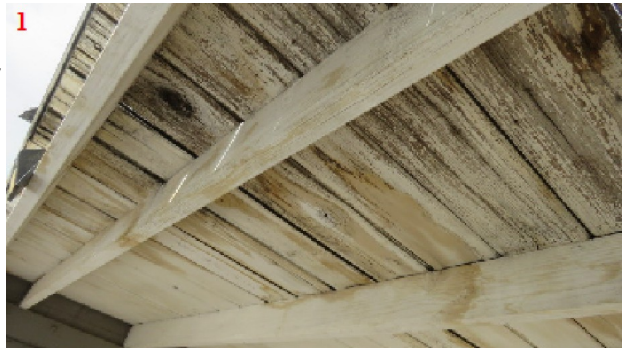
Lots of water stains in the carport roof sheathing and some wood rot.
Recommend a qualified contractor evaluate and make all necessary repairs.

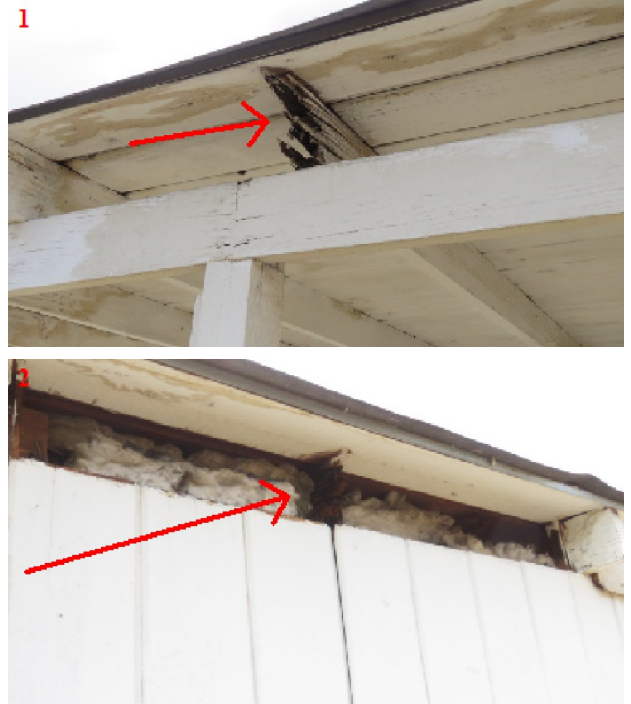
Wood rot in carport/storage room ceiling rafters.
No signs of structural defect from the garage area but I recommend providing attic access.

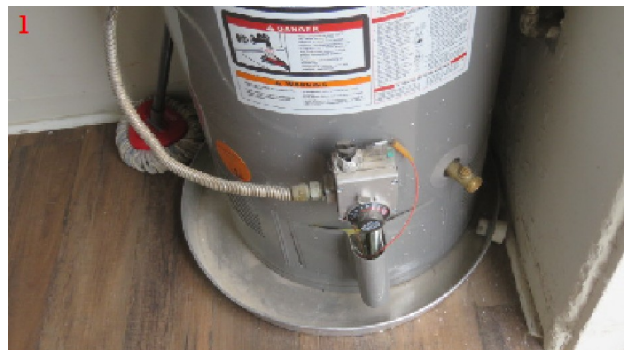
Water heater installed directly on the floor in the laundry. This may cause an explosion from flammable vapors. Recommend raising the water heater a minimum of 18 inches above the garage floor for both gas and electric water heaters.

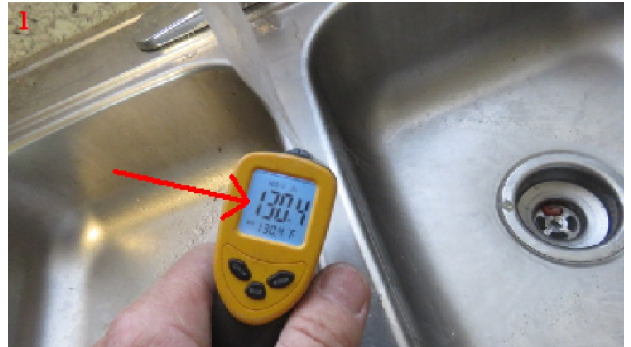
Water temperature of 130 degrees. See picture. Water temperatures set too high can cause severe burns. Recommend lowering water temperature setting to 120 degrees on water heater.

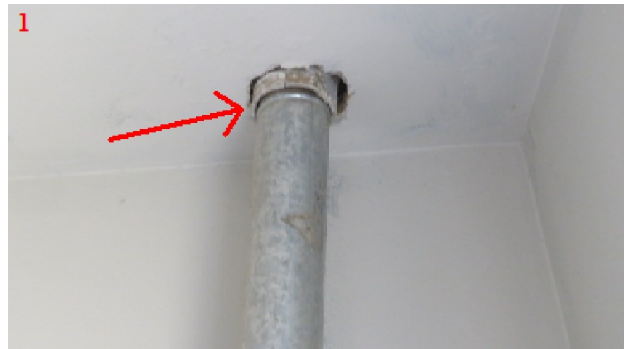
The water heater single walled vent pipe is attached to the transite vent pipe at the ceiling. Attaching metal vent pipes to transite vent pipes is not recommend. See picture
Recommend a qualified mechanical contractor evaluate and make all necessary repairs.

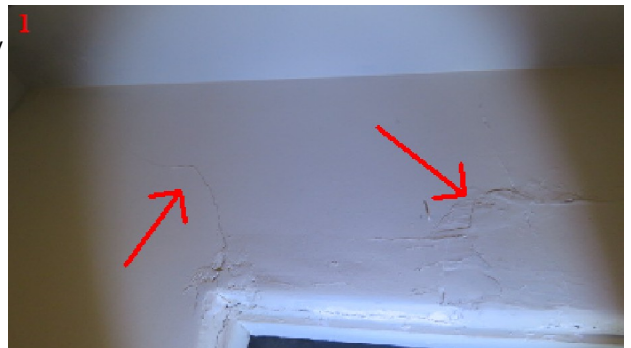
Minor cracking in the laundry room wall plaster.
Recommend a qualified contractor evaluate and make all necessary repairs. see sample picture.

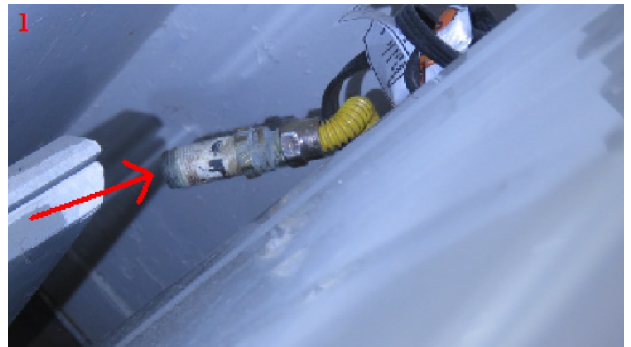
The gas valve is not capped off and not attached to a dryer. If something hits the gas valve it could leak gas into the home. Recommend capping all gas valves when not attached to a gas appliance.

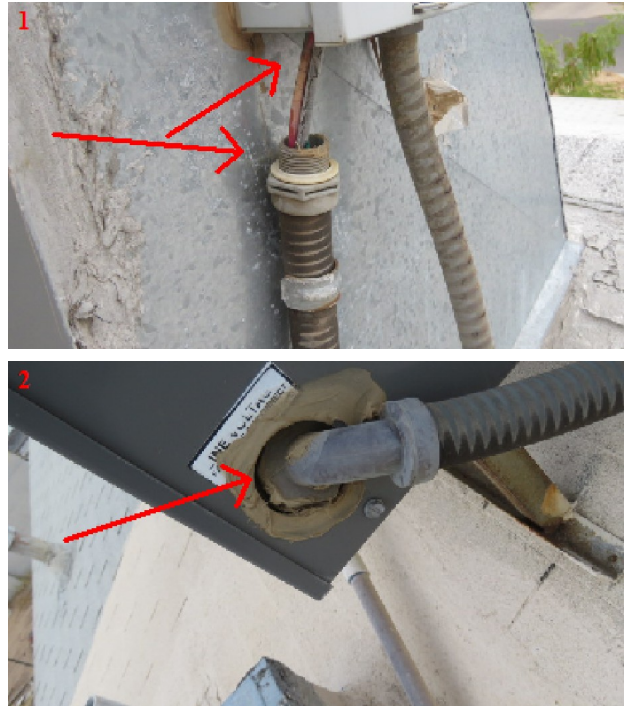
Electrical conduit supplying power to the AC unit is not properly attached at either end. This could short out the wire. Recommend a qualified electrical contractor evaluate and make all necessary repairs. See picture

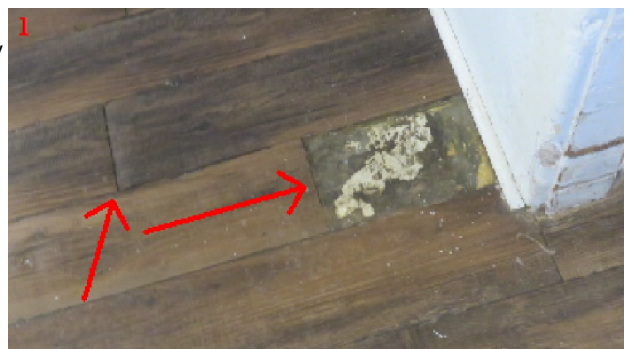
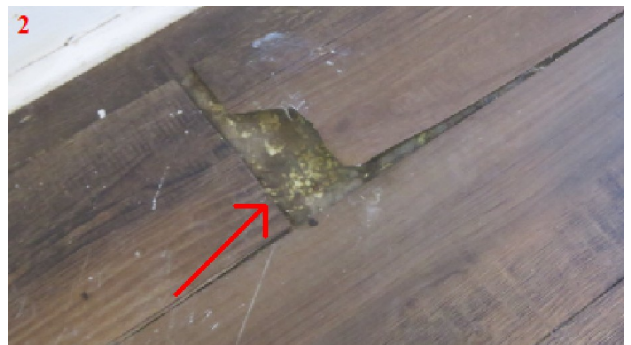
Damage to vinyl floor planks in the kitchen and the flooring is lifting. Recommend a qualified contractor evaluate and make all necessary repairs.

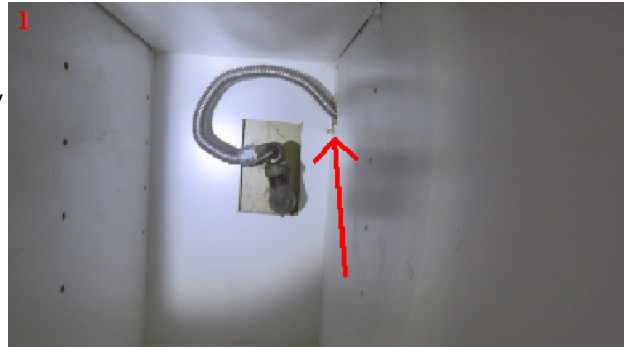
The gas supply pipe for the stove/cook top is a flex gas line run through a cabinet wall. Flex gas lines are not designed to be run through walls
Recommend a qualified contractor evaluate and make all necessary repairs.

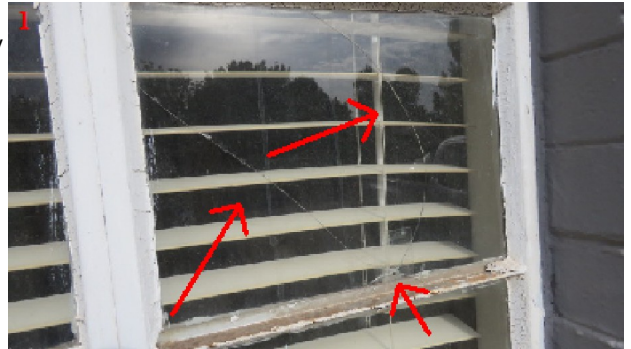
Living room window pane cracked.
Recommend a qualified contractor evaluate and make all necessary repairs.

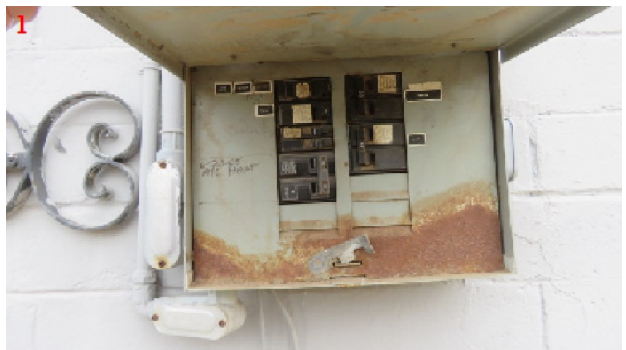
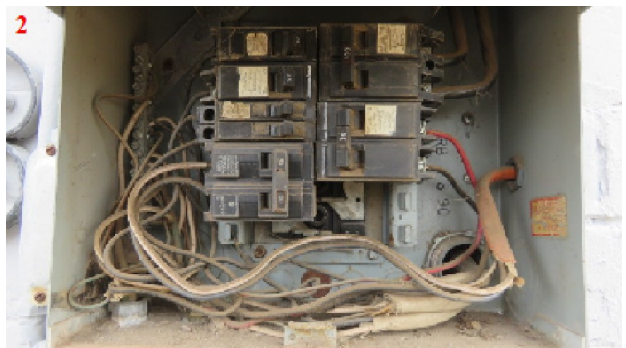
Wires attached to the main electric panel in the back are missing a grommet needed to keep the wires off the sharp metal box and the wires may short out on the sharp metal panel. This is a shock hazard and a fire hazard. Recommend a qualified electrical contractor evaluate and make all necessary repairs. See Picture

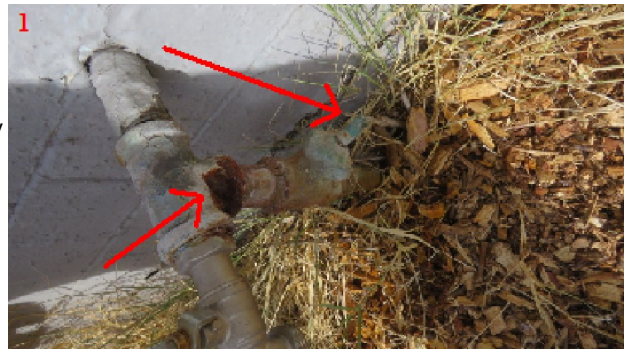
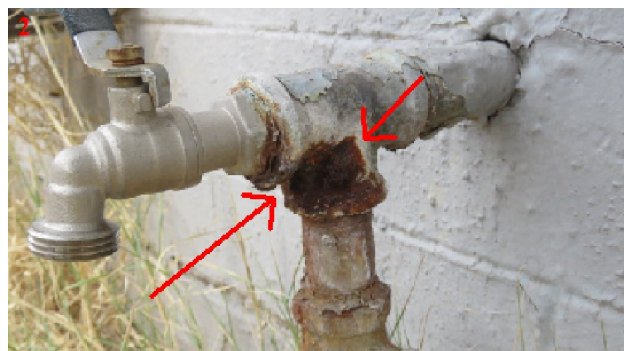
The gate valve for the water main is defective and missing a handle to operate it. There is a galvanized pipe fitting at the water main connected to copper pipes and the two metals are not compatible. Recommend a qualified contractor evaluate and make all necessary repairs.

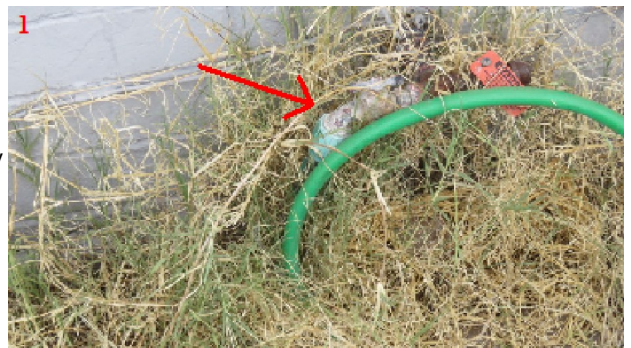
The hose bibb on the back of the house is stuck in the closed position.
Recommend a qualified contractor evaluate and make all necessary repairs.

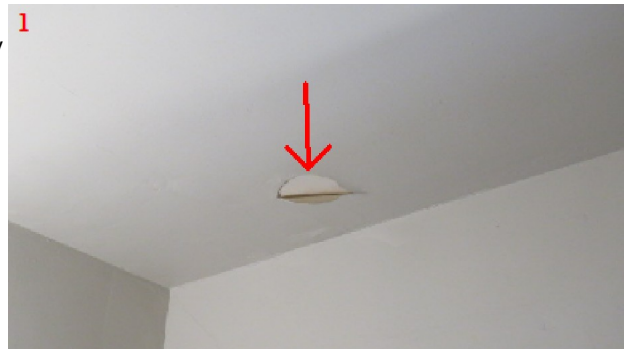
Peeling paint on the ceiling in the bathroom.
Recommend a qualified contractor evaluate and make all necessary repairs.

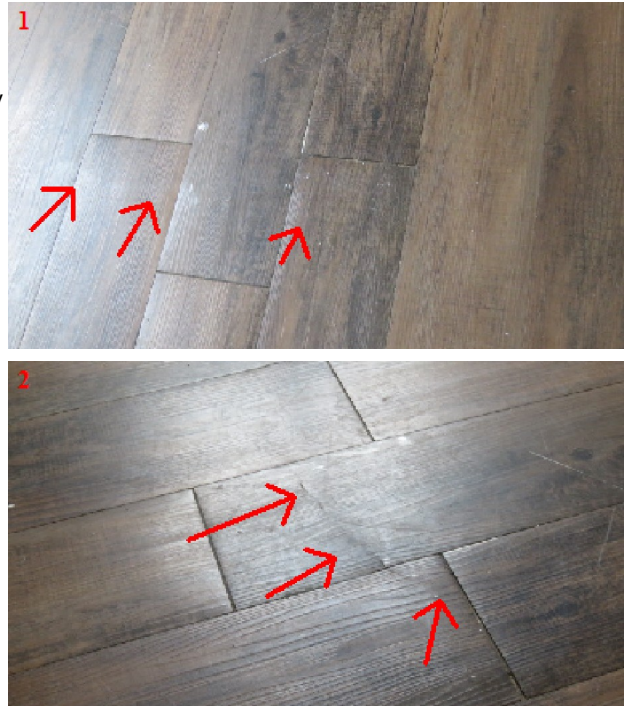
Vinyl flooring lifting up in the master bedroom.
There is a crack in the master bedroom floor as seen through the vinyl flooring.
Recommend a qualified contractor evaluate and make all necessary repairs.

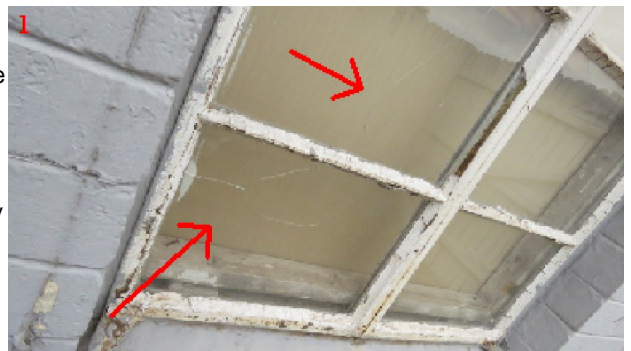
Bars permanently installed on window with or without a quick release are a fire escape hazard. Recommend removing bars from window before sleeping in room. Bars on windows are a fire escape hazard even if they have a quick disconnect. How can a fireman enter if no one opens the bars?
The window cranks do not operate the windows properly. Cracked window pane.
Recommend a qualified contractor evaluate and make all necessary repairs.

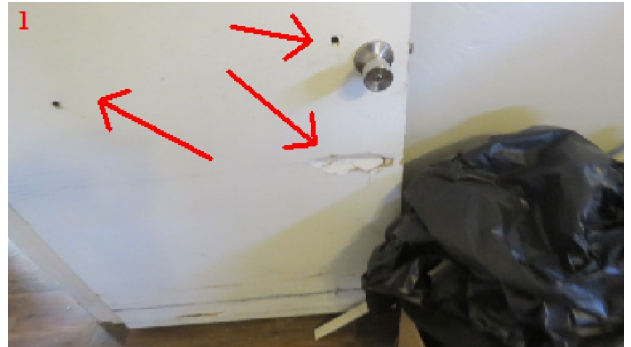
This bedroom door and door jamb are damaged. Recommend replacing this door.

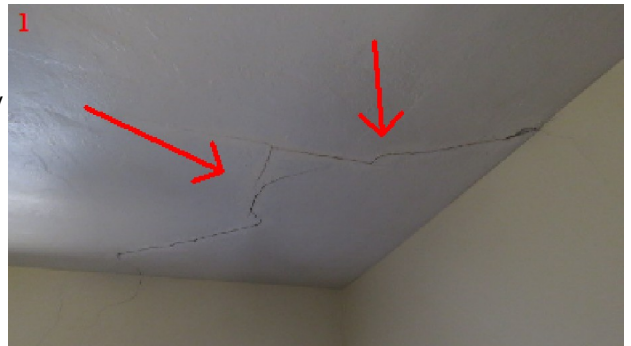
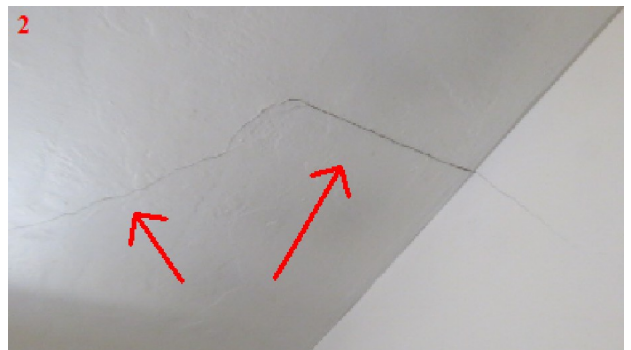
There is a hole in the wall next to the door and the back wall is racked from the moving block wall and the ceiling has a zagged crack. Recommend a qualified contractor evaluate and make all necessary repairs.

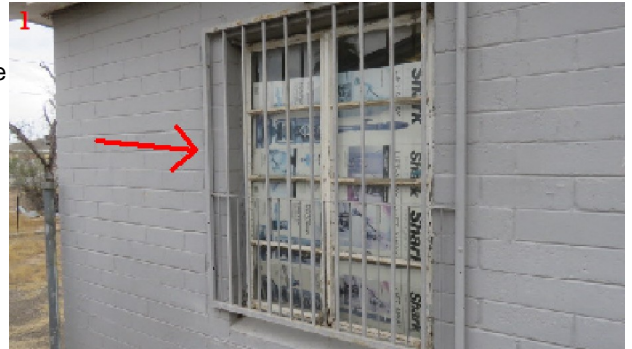
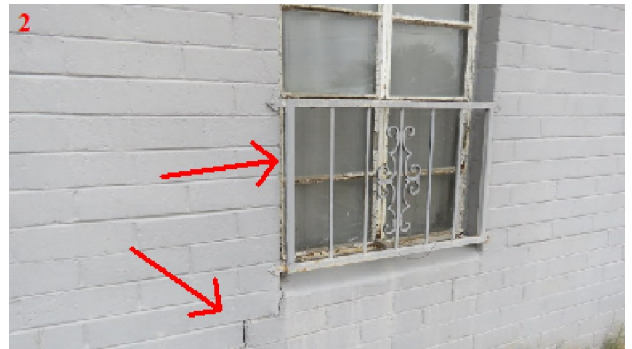
Bars permanently installed on window with or without a quick release are a fire escape hazard. Recommend removing bars from window before sleeping in room. Bars on windows are a fire escape hazard even if they have a quick disconnect. How can a fireman enter if no one opens the bars? The window cracks are missing on one window and and not operating property on the other.. Cracked window panes. Recommend a qualified contractor evaluate and make all needed repairs.

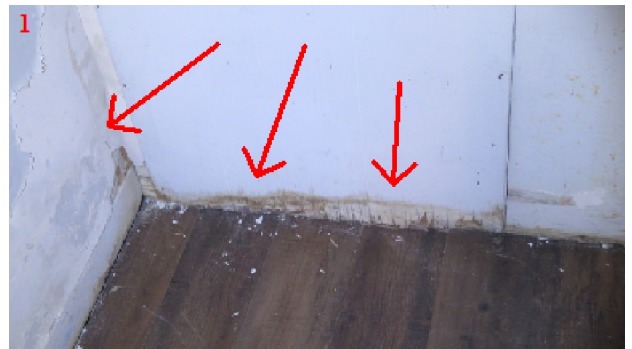
Closet door lock does not latch. There is a wood patch on the back wall of the closet and water stains on the wood and peeling paint on the wall.. Recommend a qualified contractor evaluate and make all needed repairs.
