## ***WHAT REALLY MATTERS IN A HOME INSPECTION***

Saturday, May 31, 2025

Inspection Site

2716 Peaks Mountain Road  
Galax VA

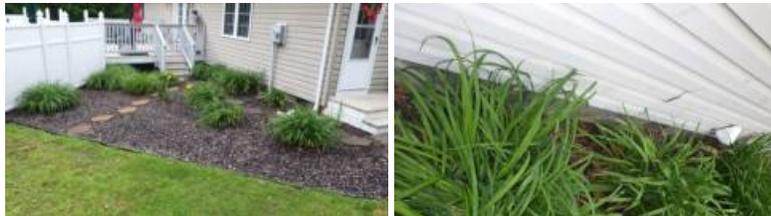
A flower bed, mulch, rock landscaping or soil was observed to be in contact or close proximity to the home. This can lead to moisture intrusion of the home. Recommend ensuring a barrier is in place to prevent moisture damage against the home or removing or addressing this landscaping feature to reduce the probability of moisture intrusion on the home and its components.

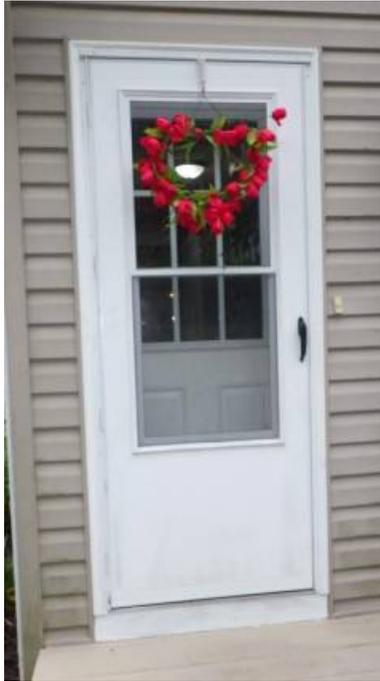
- Door closure allows Door to slam, recommend adjustments or replacement of closure to allow for proper operation.

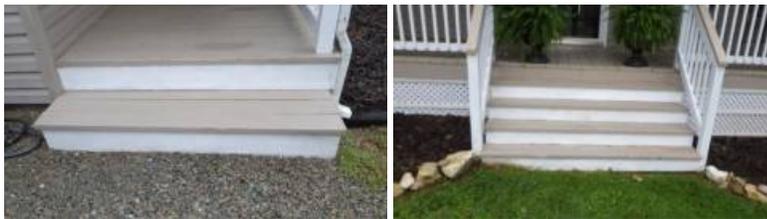
A graspable handrail is recommended where noted. In the event of a fall, handrails should be easy to grab to hopefully be able to catch yourself. Graspable handrails are generally rounded in shape. Other shapes may be difficult to grab and hold on to. This is considered a current safety concern.

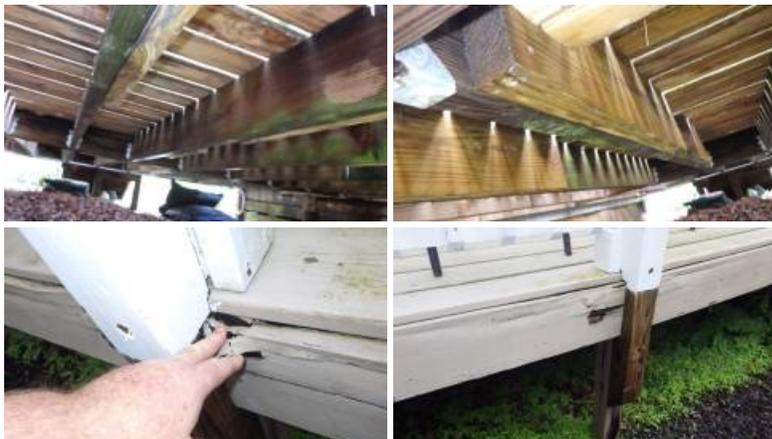
Deck is weathered and in marginal condition at this time. Observed was significant deterioration, sagging bowed cupped joists, bowed & out of plumb posts, sagging beams, corroded hardware. Recommend further evaluation and repair/replace as needed by a qualified contractor.

Structure appears over spanned/sagging/damaged

wood rot and deterioration in areas noted- at minimum affected areas of wood rot and deterioration should be replaced

The wood decking needs significant maintenance-type service, such as replacing damaged planks, securing loose or offset planks, replacing or resetting nails or screws, sanding, painting or sealing, all of which will prolong the life of the deck.

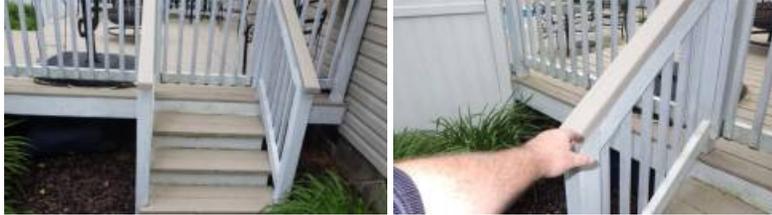
Handrail in place is considered as a non-graspable handrail and is a safety hazard. Recommend having a qualified contractor add a graspable handrail to prevent injury.

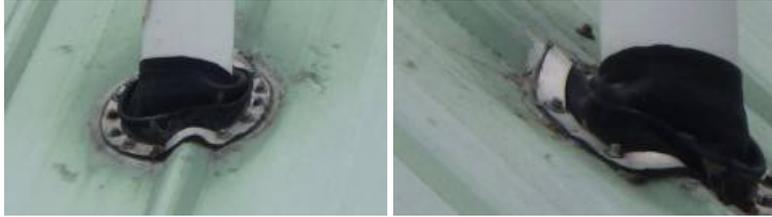
- Types Noted: Metal, Rubber boot flashing.
- NOTE: The roof flashing and boot flashing should be inspected annually as part of a routine maintenance plan
- One or more rain collars on the plumbing vent stacks are buckled. This condition can allow for water to pond next to the pipe and eventually leak via capillary action into the roof structure. Recommend having a qualified roofing contractor repair so rain collars will shed water off and away from pipe.

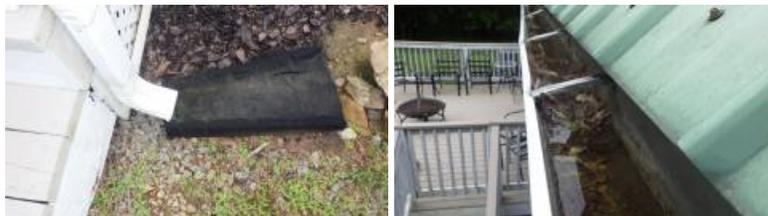
Guttering holding water - recommend removing blockage for proper drainage of the Guttering system

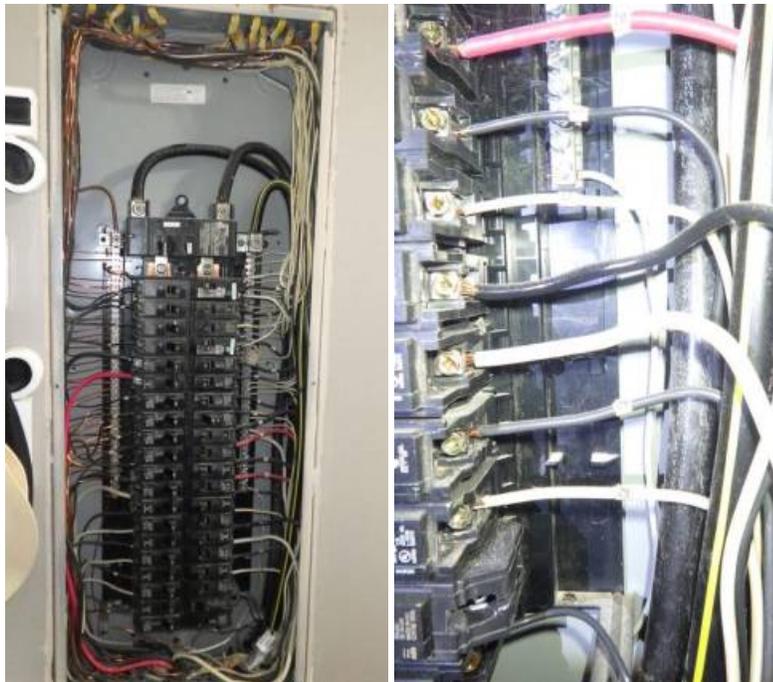
The electrical panel was equipped with breaker(s) manufactured by a company other than the panel manufacturer. Some circuit breaker models from different manufacturers may be substituted for each other, but confirmation of what models are acceptable is beyond the scope of a home inspection. An evaluation of the breaker(s) to determine their acceptability is recommended to be performed by a licensed electrical contractor, with replacement of breakers made as needed, if needed.

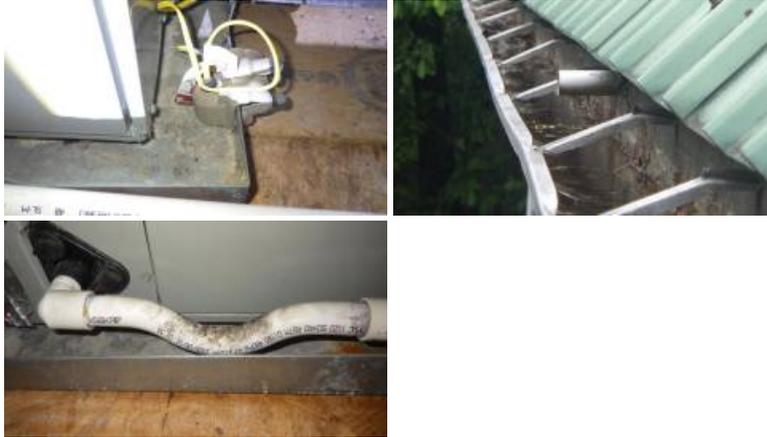
No auxiliary drain line. Recommend adding a shut off switch or directing the condensate to the outside or pan below the unit. If the primary is plugged up then the condensate will run out of the sides of the unit and can damage the flooring or if on the second floor or attic, then damage to the ceiling and possibly furniture and flooring.

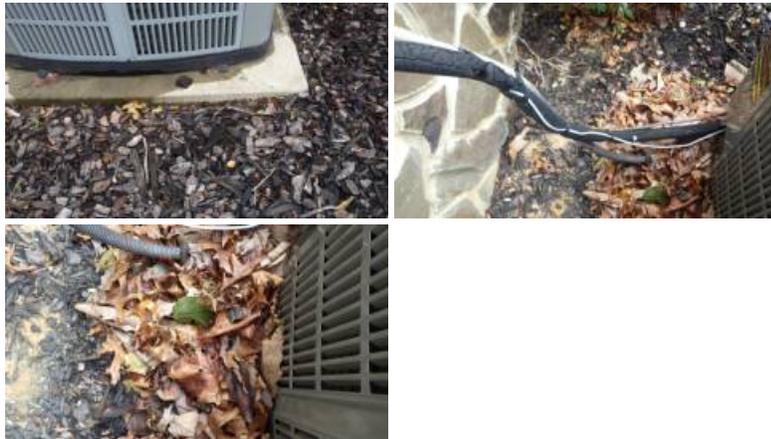
Recommend keeping leaves and debris from accumulating behind the unit

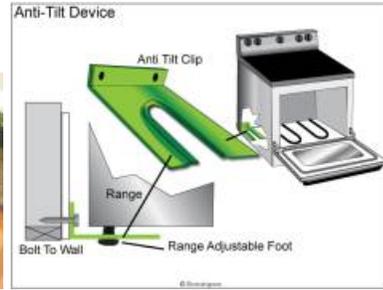
The range could tip forward. An anti-tip bracket may not be installed. This is a potential safety hazard since the range can tip forward when weight is applied to the open door, such as when a small child climbs on it or if heavy objects are dropped on it. Anti-tip brackets have been sold with all free-standing ranges since 1985. Recommend installing an anti-tip bracket to eliminate this safety hazard.

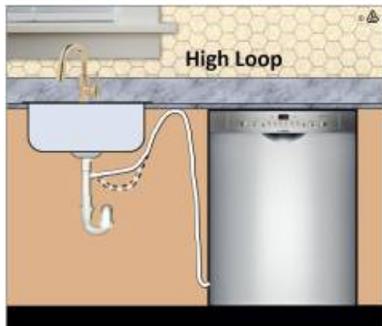
The dishwasher drain line is not secured in a high loop configuration. This is a potential safety hazard because waste water can backflow into the dishwasher, and can also siphon into the fresh water supply. Recommend attachment of drain line to underside of kitchen counter in a high loop to prevent backflow of drain water into dishwasher.

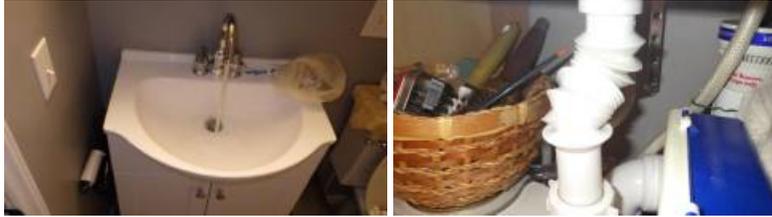
A flex drain pipe was present. Flex drain pipes are not recommended as they may clog more often and affect water drain flow. Current standards call for smooth walled drain pipes only. Replacement of the flex pipe(s) is recommended to be conducted by a licensed plumber.

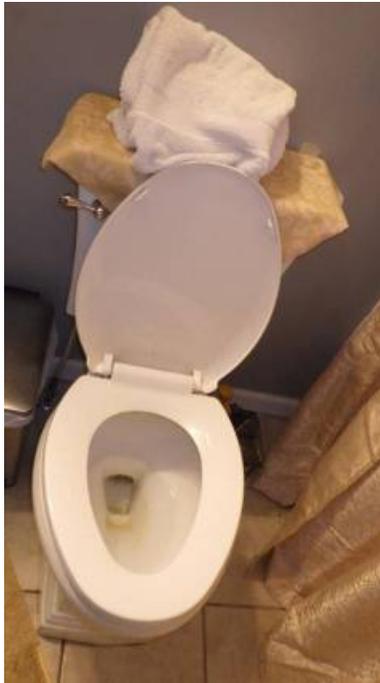
- Recommend caulking around toilet base leaving a gap of about an inch to 1 1/2 inches to allow for visual when leakage is occurring

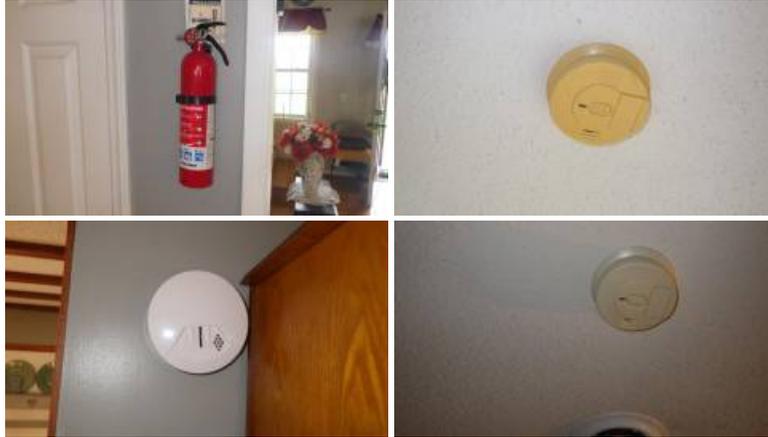
There were smoke detector(s) present that were "yellowed" in color. This is typically an indicator that the detector(s) are past 10 years of age. Multiple sources recommend replacing smoke detectors every five to ten years.

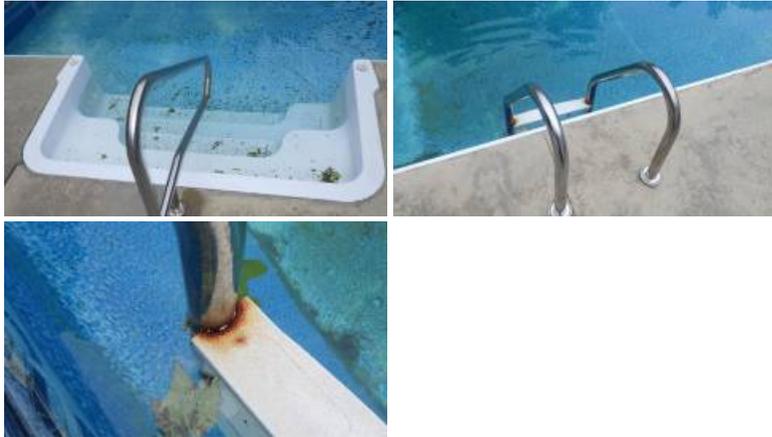
some rusting noted on ladder.
