Perfection Home Inspections
Mesa, AZ 85203
602-524-2916
perfectionhomeinspections.com

Inspected By:
Greg Oswalt Arizona Lic. 38752

Auction, United Country Excelled
18212 N 43rd Place
Phoenix, AZ 85032
480-422-6800

Inspected 6/19/25 8:00 AM
Built 1962
2071 sf

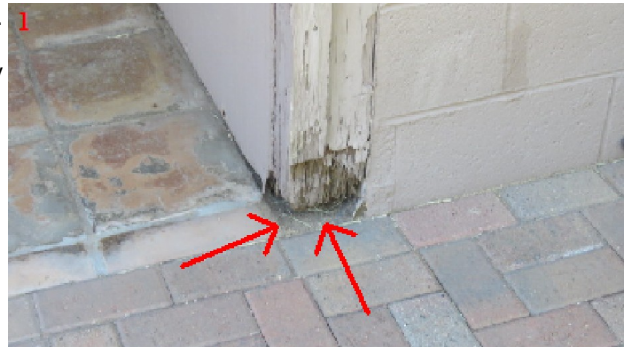
Damage to the bottom of a column on the back patio at the addition. The bottom has rotted away. Recommend a qualified contractor evaluate and make all necessary repairs.

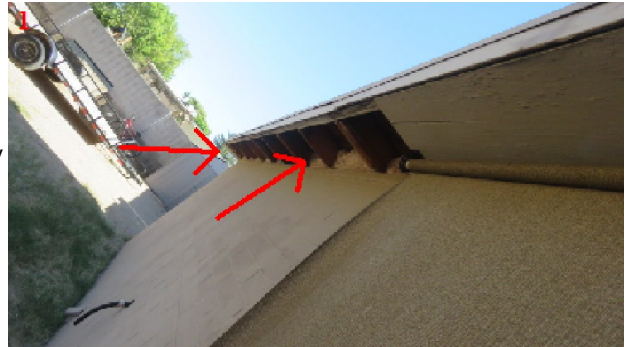
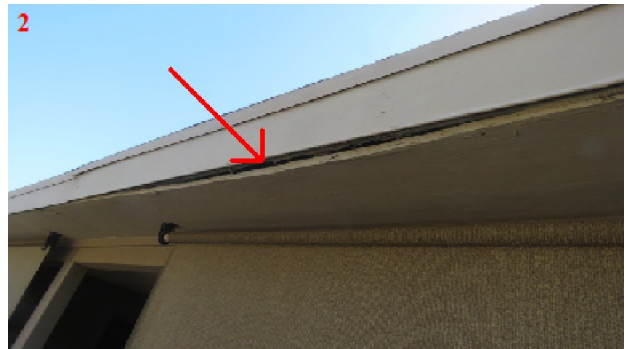
The house soffit area is covered with wood except the area behind the laundry all the soffit covering wood has been removed. The soffit covering is bowed down in the back. Recommend replacing the soffit covering or installing bird blocking at all the areas between the rafters to keep pests out of the attic. Recommend a qualified contractor evaluate and make all necessary repairs.

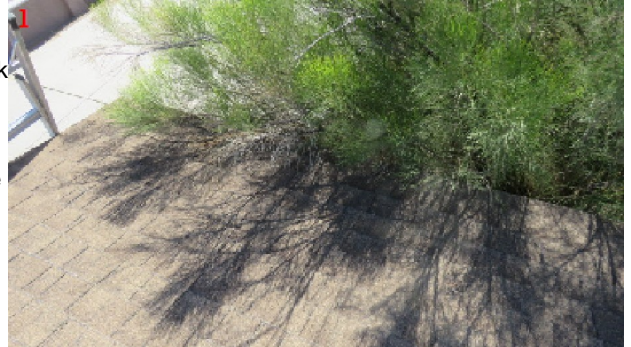
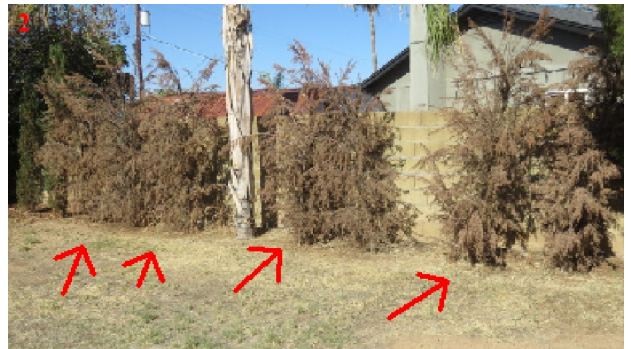
Trees or bushes over hanging the roof cause debris to build up on the roof and also damages the roof when the wind blows the branches across the roof. Recommend cutting trees or bushes back to protect the roof and removing all debris on the roof. See picture

The plants and grass are too dry. Recommend watering the plants and trees during the escrow period so all the plants do not die in the heat.

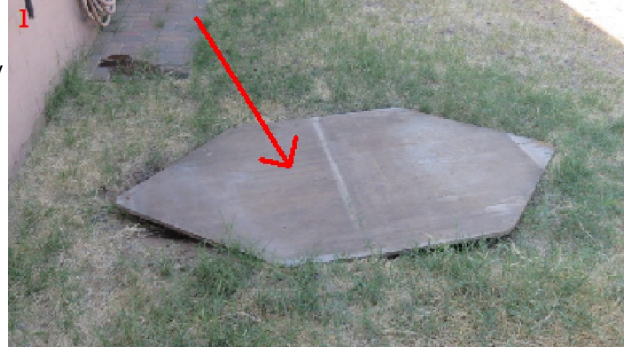
There is a sheet of plywood partly covering a hole in the back yard.
This is a trip hazard.
Recommend a qualified contractor evaluate and make all necessary repairs.

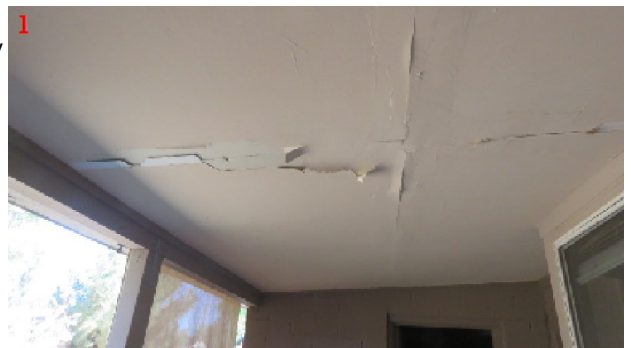
Paint and plaster peeling off the patio ceiling.
Recommend a qualified contractor evaluate and make all necessary repairs.

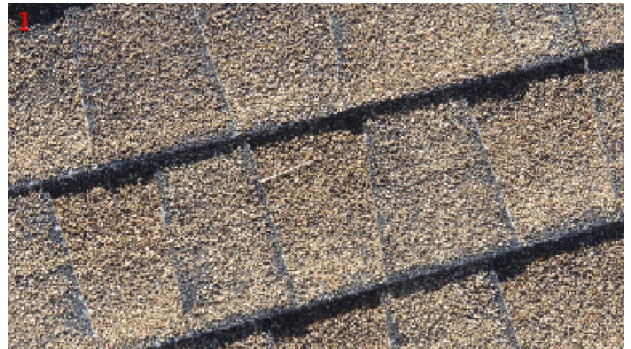
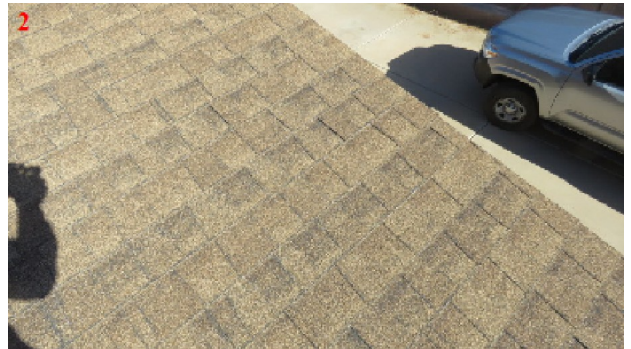
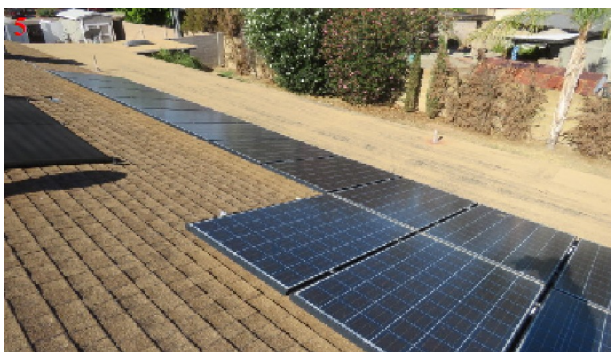
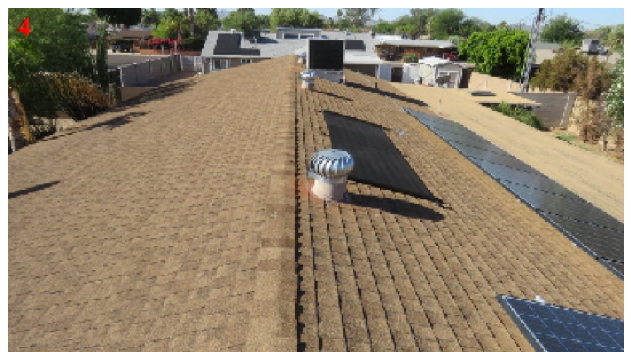
The asphalt shingles are a multilayer or multidimensional and are showing sign of wear with loss of rock cover on the edge and bottoms of shingles. Recommend a qualified roofing contractor evaluate and make all necessary repairs.

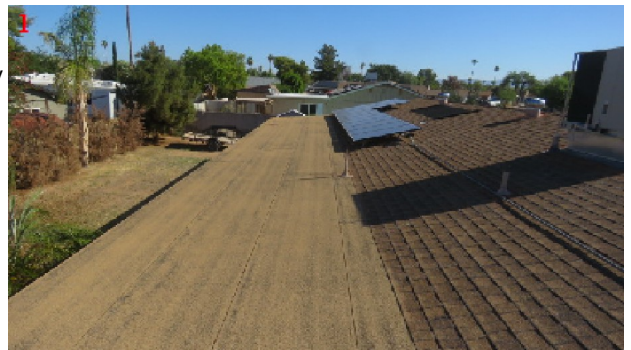
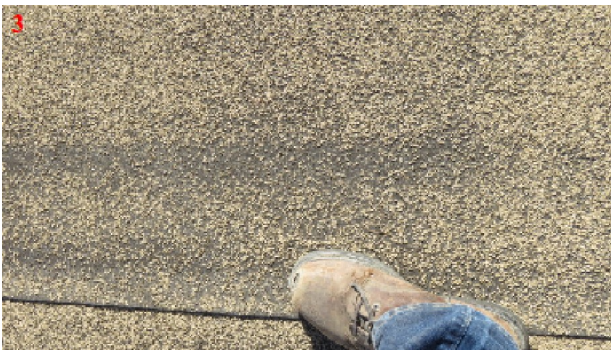
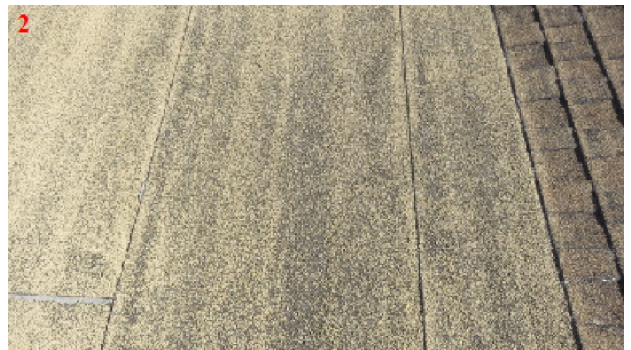
Lots of lost rock cover on the rolled roofing in the back. This rolled roofing is near the end of its useful life. Recommend a qualified contractor evaluate and make all necessary repairs.

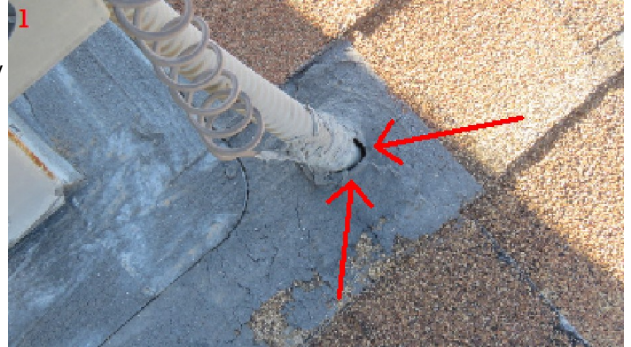
There is a gap at the electrical conduit from the heat pump to the attic.
Recommend a qualified contractor evaluate and make all necessary corrections.

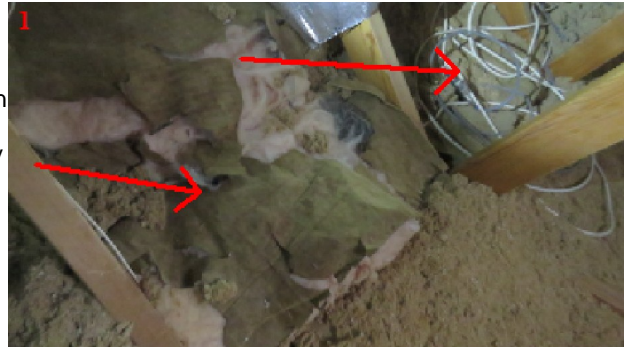
Attic insulation vapor retarder on the back of batt insulation is left exposed in the attic. Most of the batt insulation is covered with blown in insulation. Exposed vapor paper retarder is a fire hazard. Recommend following manufacturers recommendations stamped on the insulation to help avoid a fire hazard. Recommend a qualified contractor evaluate and make all necessary repairs. See picture

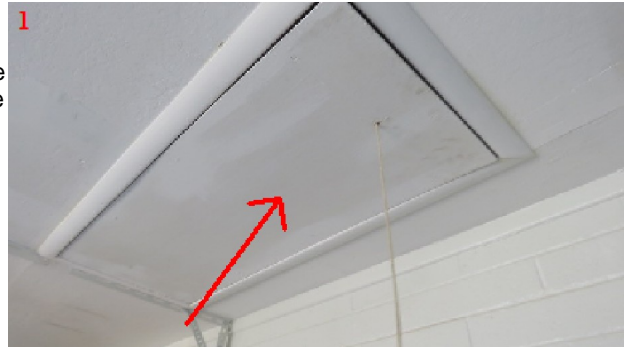
Attic hatch in garage is not properly fire rated. Recommend installing fire resistant hatch as needed. Recommend a 5/8 inch thick type x drywall be used as an attic hatch cover and making sure the cover closes all the way. Some area no longer require this to be fire rated if there is no habitable space above the garage.

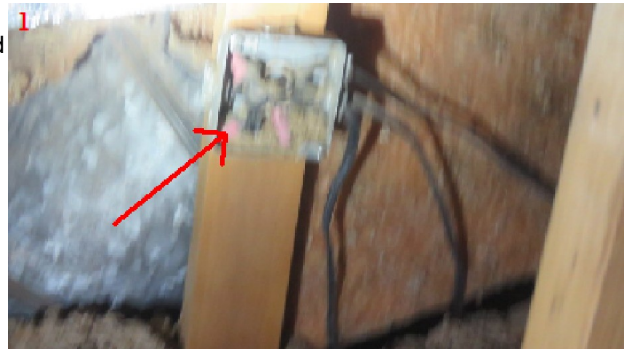
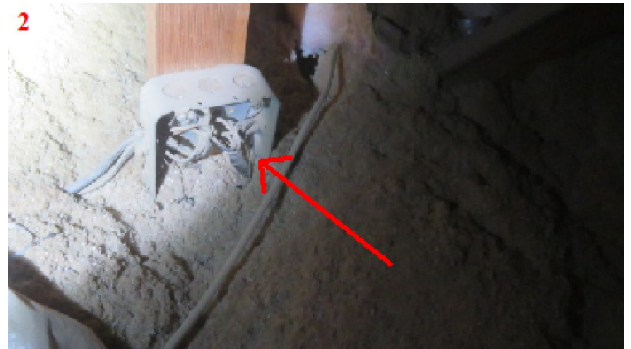
Missing junction box cover plates in the attic create a shock hazard. Recommend installing a cover plate on all junctions boxes that need them.

Spliced wires in attic not properly installed in electrical junction box. This is a shock hazard. Recommend placing all spliced wires in an electrical junction box. Recommend a qualified electrical contractor make all necessary repairs. See Picture

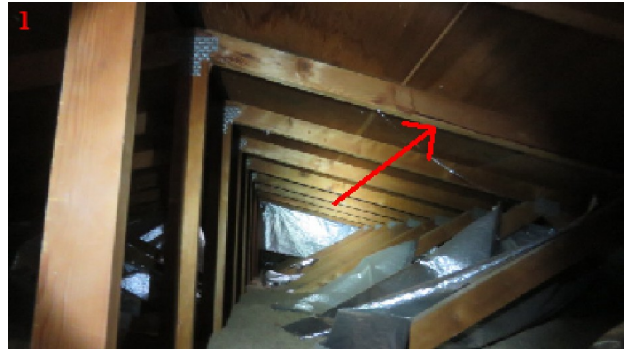
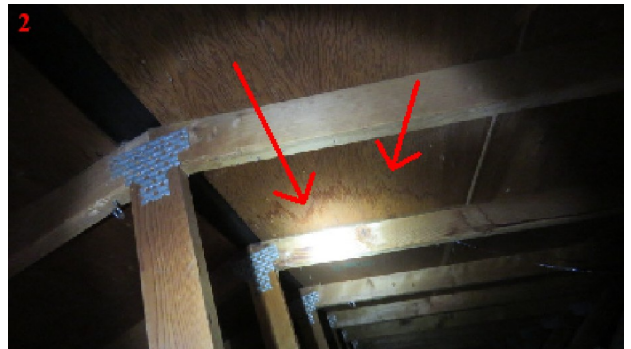
Signs of prior roof leaks in attic. Sheathing has water stains in several areas. Recommend asking seller if this problem has been solved and if not recommend a qualified roofing contractor evaluate and make all necessary repairs. See picture

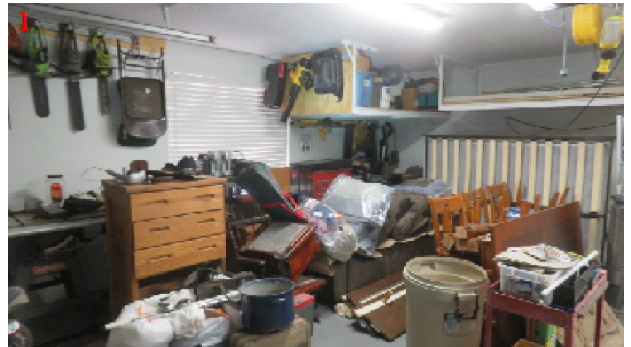
Stuff in the garage blocks view of the interior of the garage. Recommend inspecting garage area after the stuff is removed.

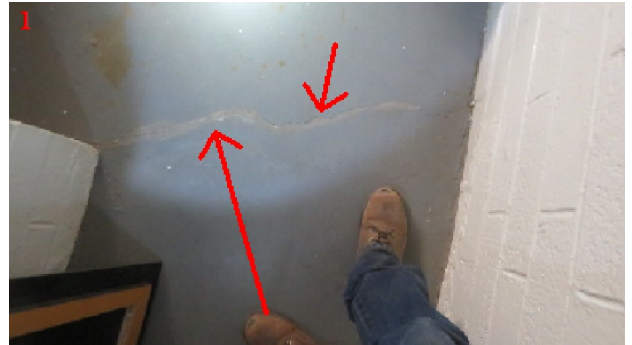
A crack in the garage slab has been patched.

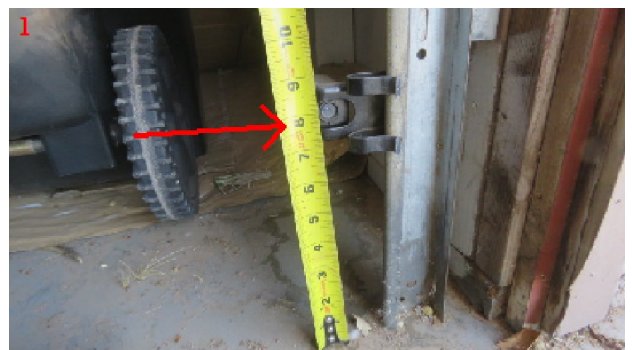
The electronic eye sensor beam used to stop the automatic garage door from closing if something is in its path is more than the recommended height of 6 inches above the garage floor. This is a safety hazard. Recommend installing this sensor eye beam 4 to 6 inches above the garage floor.

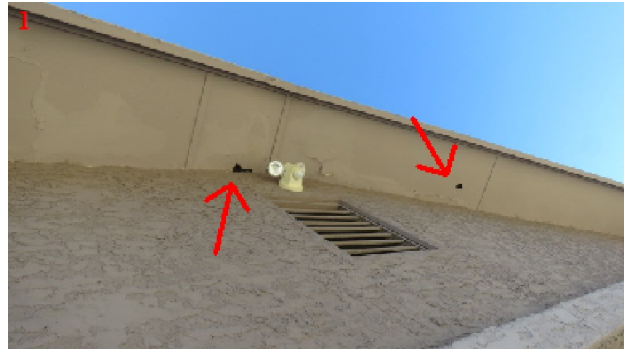
There are holes in the soffit area covering.
Peeling paint in the soffit area. This is a cosmetic item.
Recommend painting when convenient.

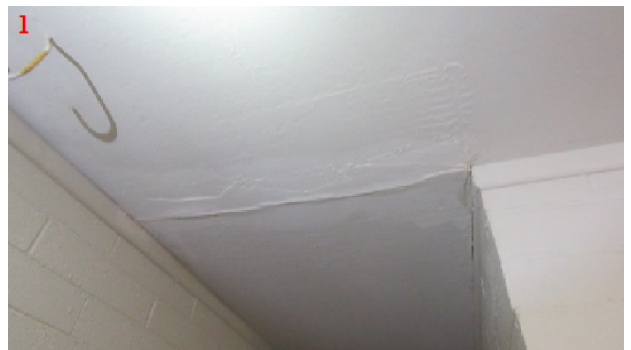
Settling crack(s) found in garage ceiling drywall. Recommend patching and painting to match existing.

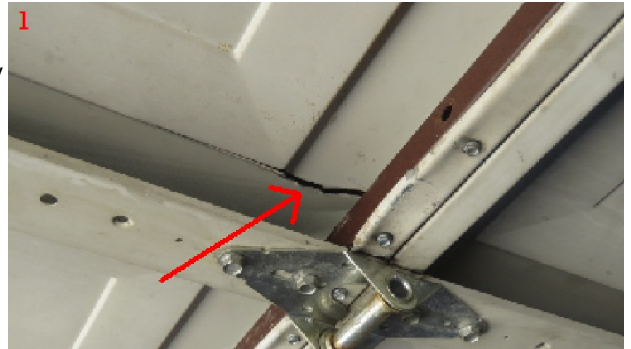
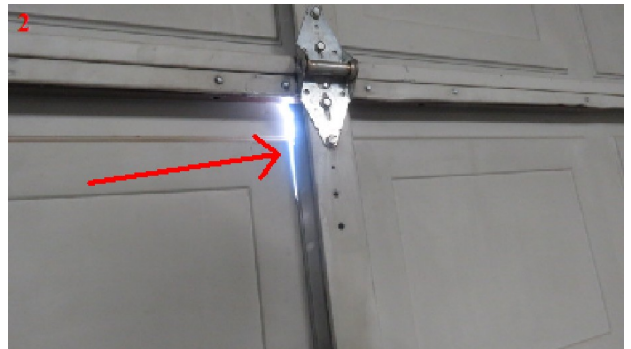
The 2nd from the top over head garage door panel is ripped or cracked open.
Recommend a qualified contractor evaluate and make all necessary repairs.

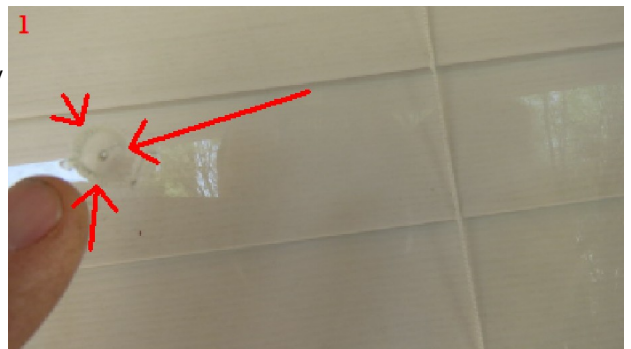
No access to the window in the garage so it was not operated.
There is a crack or a BB hole in one window pane.
Recommend a qualified contractor evaluate and make all necessary repairs.

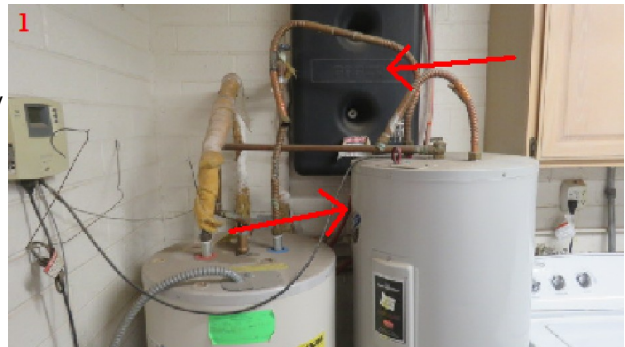
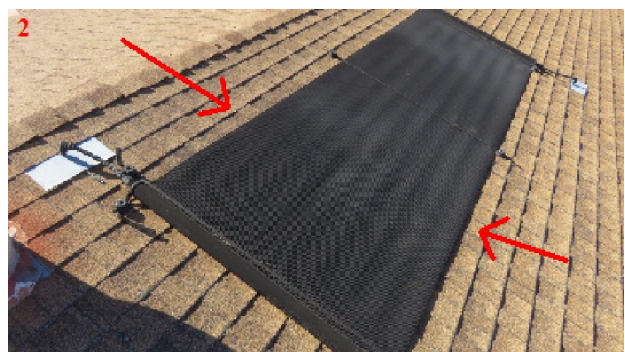
Two water heaters one is not hooked up and the roof water heating panel system looks it is attached to the nonfunctional water heater. The solar water heater panel is still on the roof. Recommend a qualified contractor evaluate and make all necessary repairs.

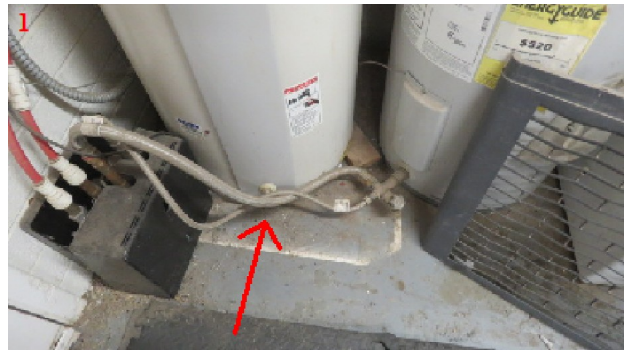
No pan installed under the water heater.
Recommend installing an overflow pan under the water heater and installing a drain line from this pan if possible to the exterior. This is normally best done when changing water heaters.

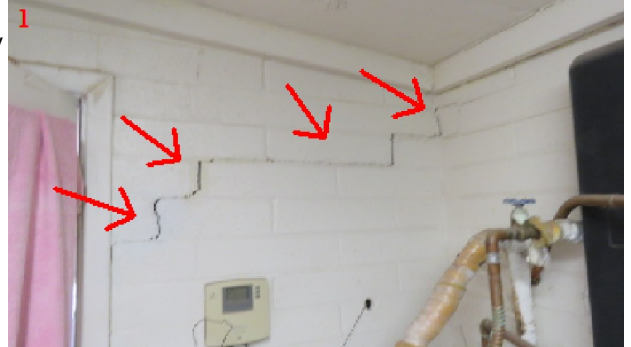
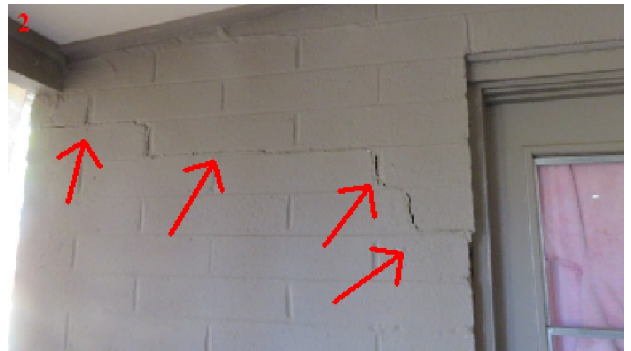
The laundry room block wall is racked on the interior and exterior. Recommend a qualified contractor evaluate and make all necessary repairs.

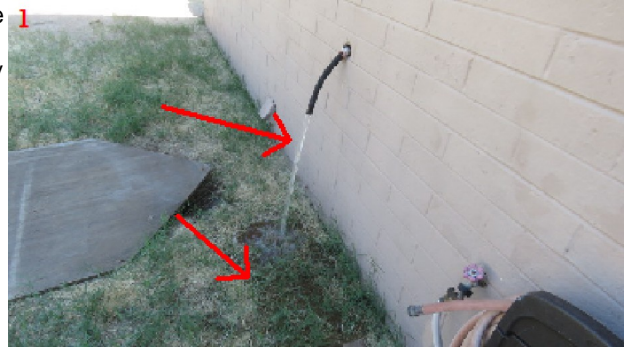
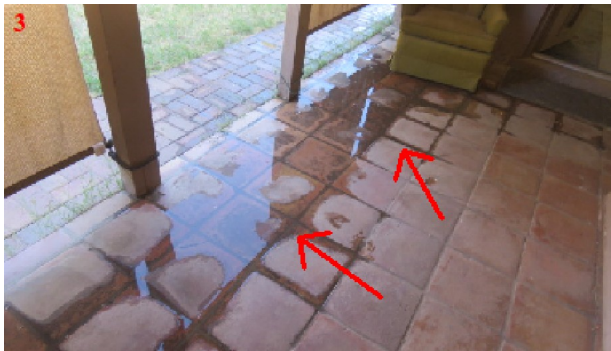
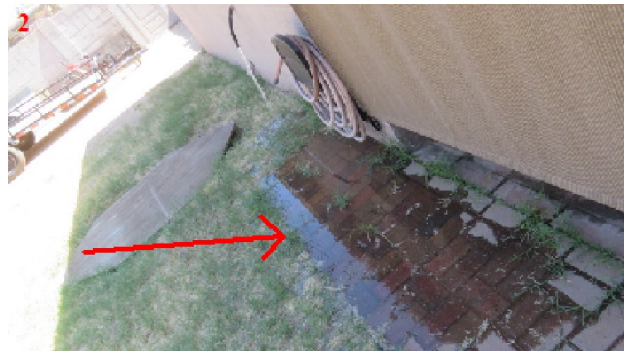
The washing machine drains to the back yard and water flows to the patio.
Recommend a qualified contractor evaluate and make all necessary repairs.

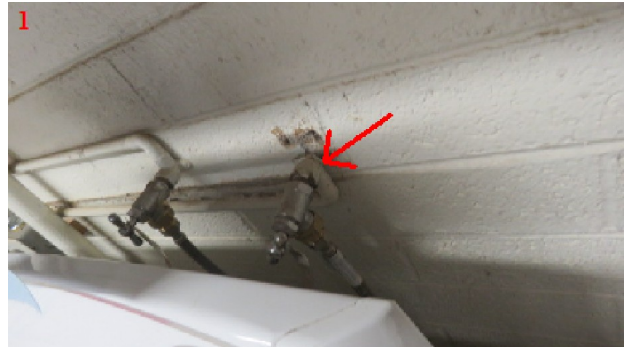
One or more of the supply pipes to laundry room faucets are loose in the wall. Loose pipe can make noises in the wall and lead to leaks. Recommend a licensed plumbing contractor evaluate and make all needed repairs.

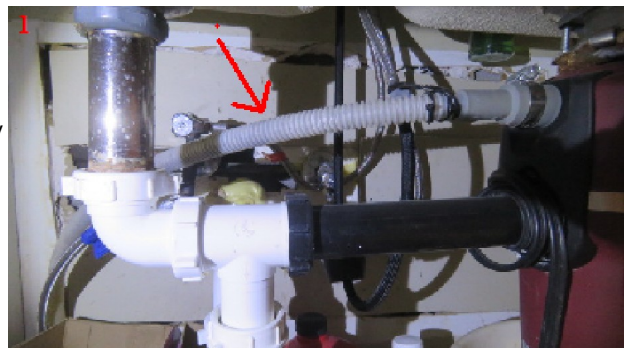
Dishwasher - Drain Hose

The drain hose from the dishwasher to the disposal needs a loop above the disposal drain and most of the sink or a sink air gap to prevent sink drain water from flowing into the dishwasher. See picture
Recommend a qualified contractor evaluate and make all necessary repairs.

Recommend a qualified contractor evaluate and make all necessary repairs.

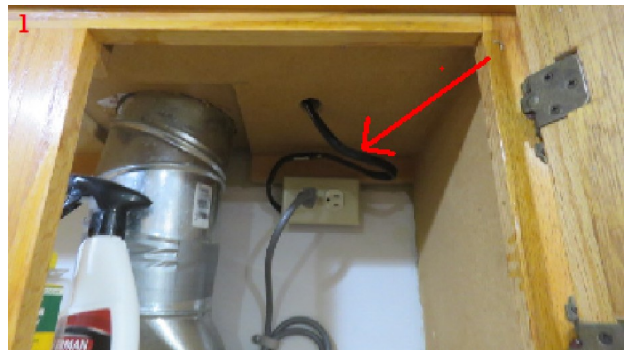
Exposed romex type wire found in a kitchen cabinet. Recommend all exposed romex type wire less than seven feet above the floor be installed in conduit or properly protected.

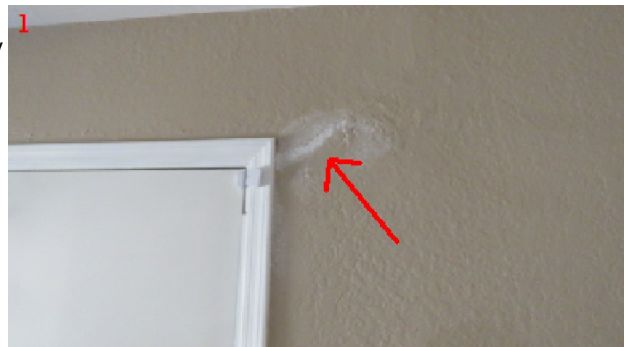
There is a sloppy patch on the wall by the door to the garage. Recommend a qualified contractor evaluate and make all necessary repairs.

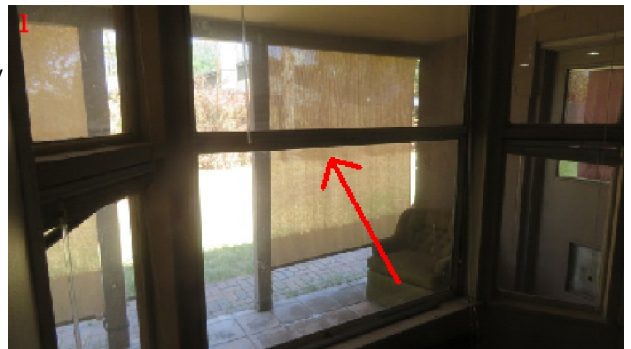
The dining area window lock is stuck in the locked position so this window was not tested.
Recommend a qualified contractor evaluate and make all necessary repairs.

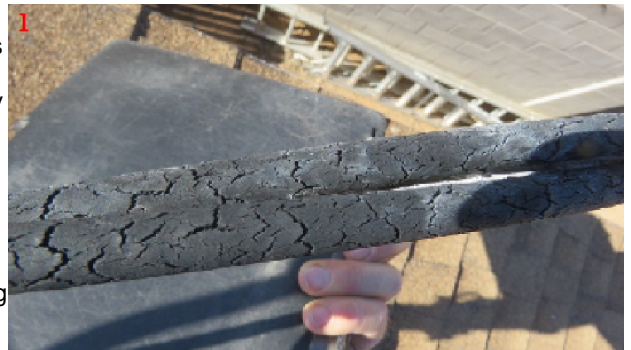
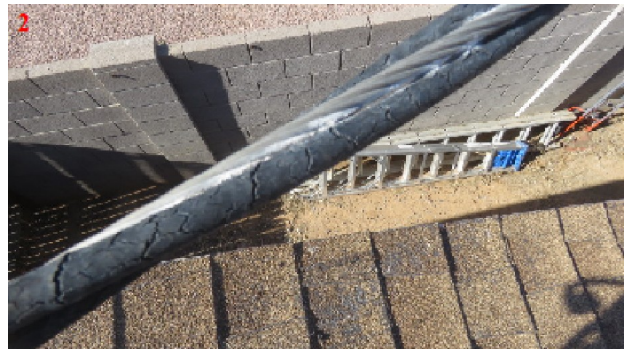
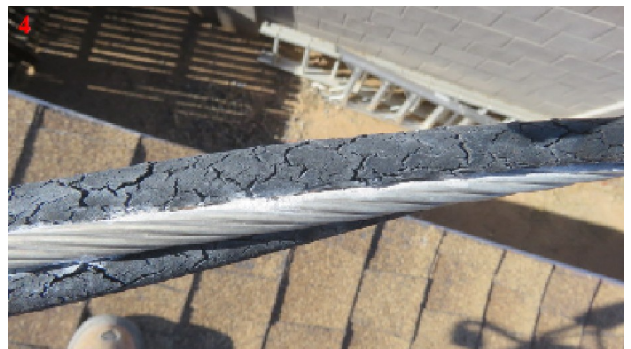
Solar energy cells installed to assist in electric power for this home. Recommend inspection solar panel leased carefully before buying. Solar energy systems are observed for obvious signs of defects but not operated or tested by the home inspector.

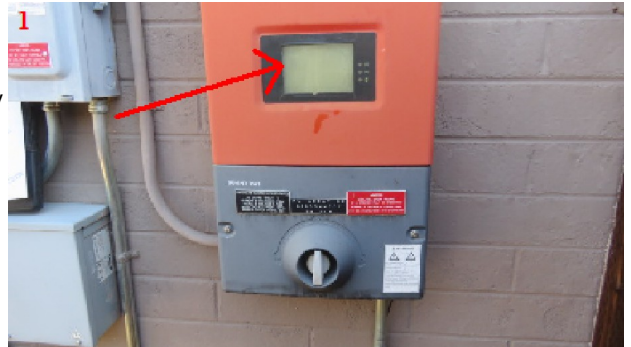
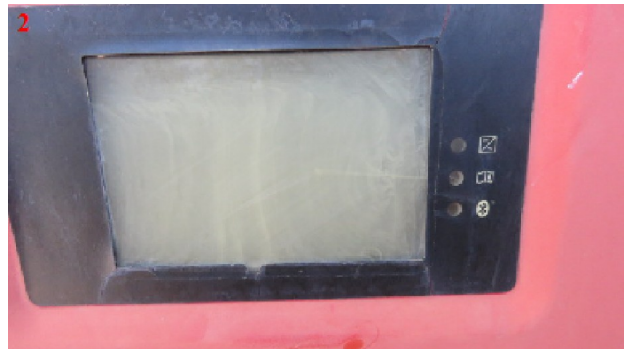
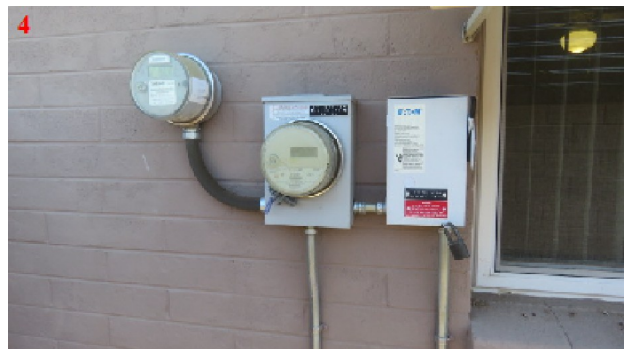
The solar panel control panel is blank. No visible data. This is a defect. The solar panels on the roof are not providing any usable electricity. Zero volts recorded. Recommend a qualified contractor evaluate and make all necessary repairs.

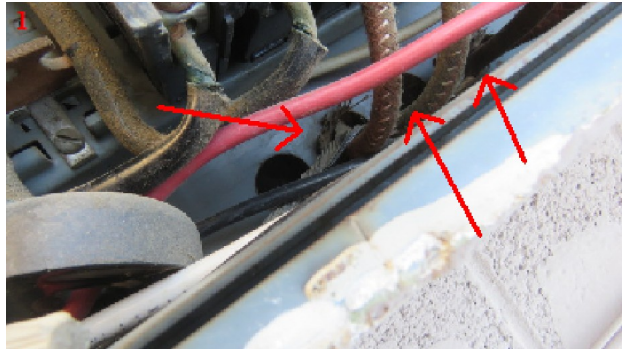
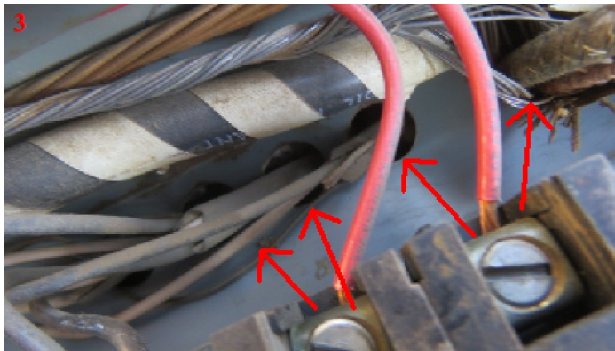
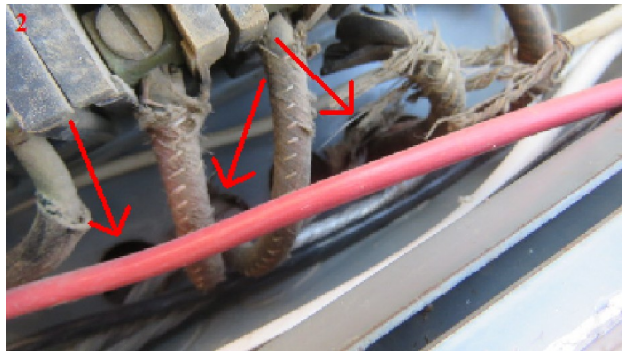
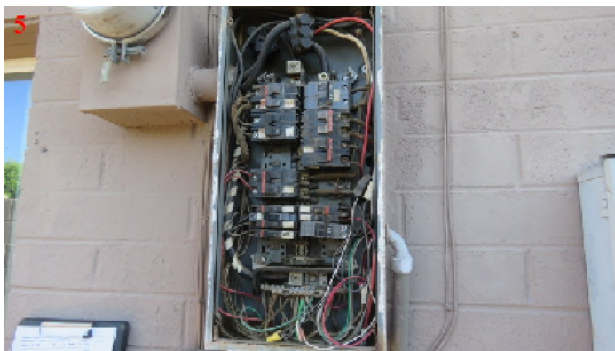
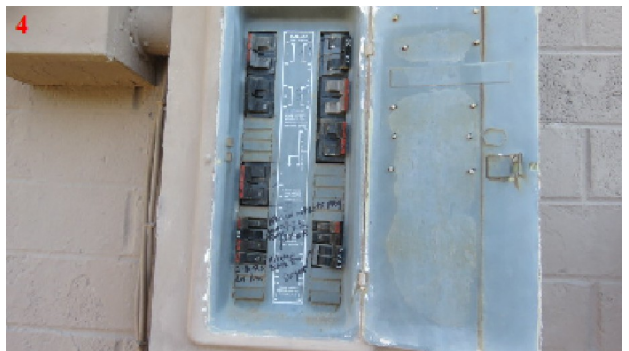
Wires attached to the main electric panel in the back are missing grommets needed to keep the wires off the sharp metal box and the wires may short out on the sharp metal panel. This is a shock hazard and a fire hazard. Recommend a qualified electrical contractor evaluate and make all necessary repairs. See Picture

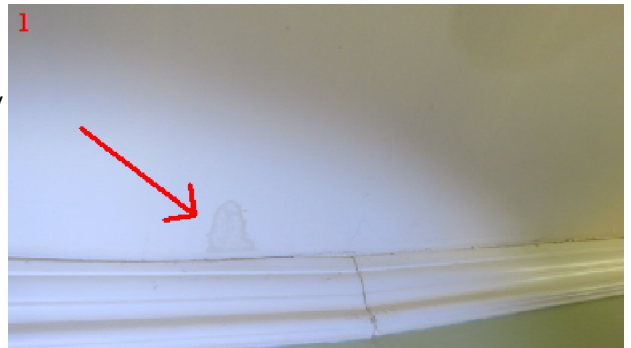
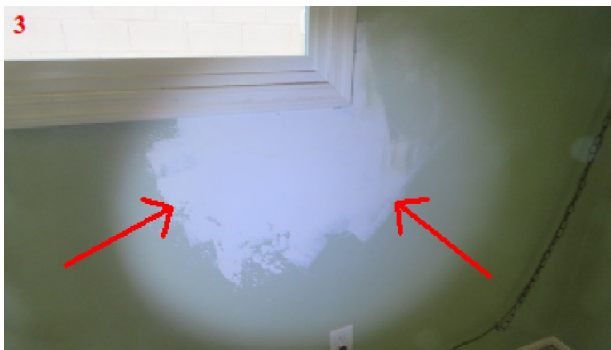
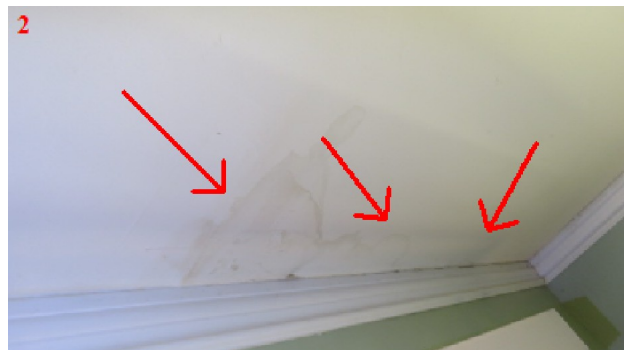
Water stains on the ceiling in the addition to the master bedroom. There is a patch on the wall in the master bedroom below a window and there is a water stain at the patch area. Recommend a qualified contractor evaluate and make all necessary repairs.

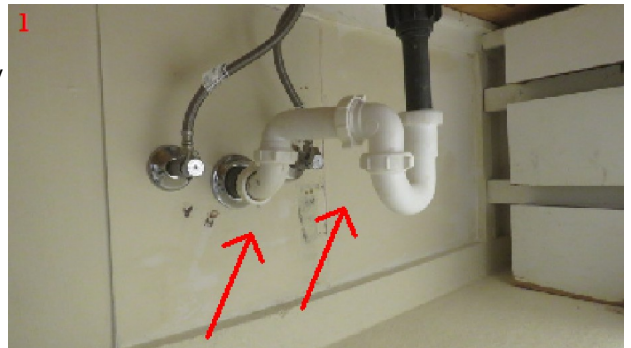
This hall bathroom sink has a S shaped drain and this can drain the water out of the p-trap.
Recommend a qualified contractor evaluate and make all necessary repairs.

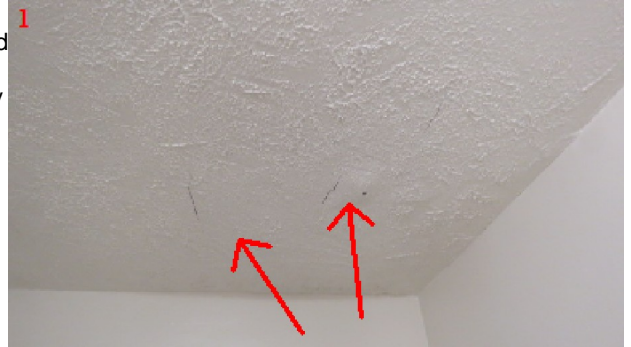
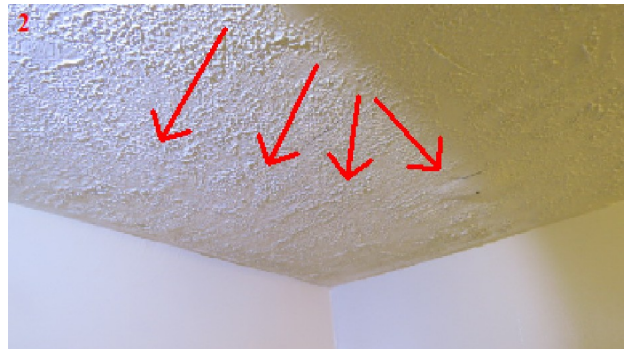
The hall bathroom ceiling above the toilet area in the hall bathroom is bowed down from water damage and the ceiling paint is loose and puffy from water damage. Recommend a qualified contractor evaluate and make all necessary repairs.

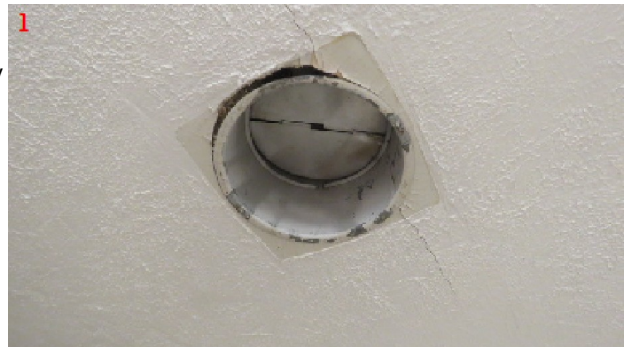
There is a vent hole in the hall bathroom ceiling but no vent fan or fan cover. Recommend a qualified contractor evaluate and make all necessary repairs.
