# Home Inspection

**Property Address:**  
11021 McArthur Rd  
Atlanta MI 49709

**Hawkeye Home Inspection Co**

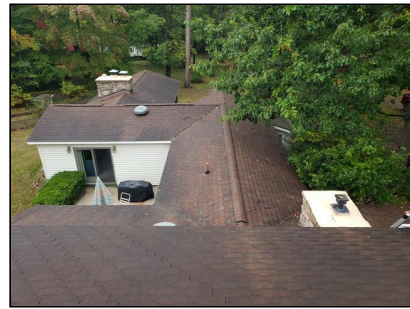
1.0 Item 20(Picture)

**1.0** The roof covering is old, and the life of covering has almost expired. The covering does need to be replaced within the next 3 years. While it could last a couple years or so, some areas may need patching with tar as leaks develop. NOTE: All areas of shingle tabs missing should be sealed with a roofing tar to help prevent water leaks until new roofing is installed.

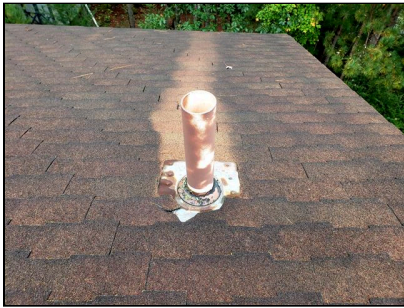
1.2 Item 1(Picture)

**1.2** (1) PVC vent pipe was in satisfactory condition when inspected. The rubber boot flashing was damaged/ cracked and needs to be repaired. The cracks can allow water to seep into the attic space and deterioration and mildew can accrue. Recommend a contractor to replace the rubber boot flashings as needed.

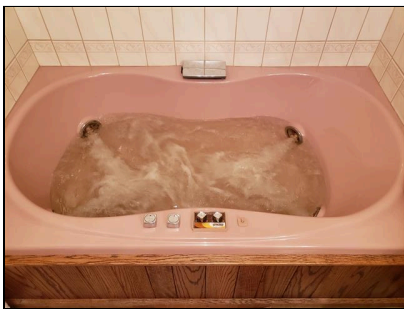
5.1 Item 14(Picture)

(2) The jet powered bath tub worked properly at time of inspection. The power source, GFCI breaker or outlet for a power supply to the bathtub was not found or was not installed. Recommend a contractor to further investigate and to install a GFCI as required when using a jet tub pump. NOTE: There was a small water leak under the bath tub. Recommend a contractor to repair as needed.

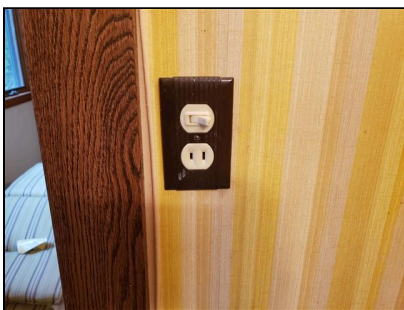
5.3 Item 1(Picture)

**5.3** The bathroom outlets were not on a GFCI system at the older area of the home. New construction would require all outlets within 6' of water to be a GFCI installment. Recommend a contractor to update the outlets as needed.

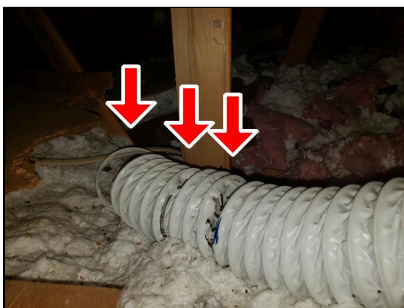
5.4 Item 8(Picture)

(2) There was a flexible vent tube installed to the bathroom vent fan. The flexible vent was damaged and needs to be replaced. Recommend a contractor to replace the vent tube as needed.

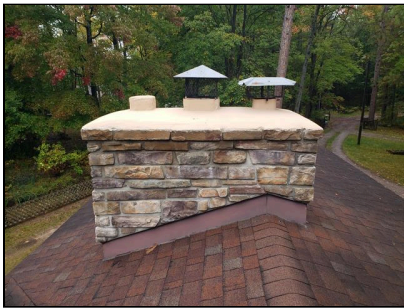
9.0 Item 4(Picture)

(2) The liners were mainly visible and appears good except for creosote dust that may conceal a hairline crack until cleaned and inspected by a licensed chimney sweep. For a detailed inspection of liners, I recommend a qualified chimney sweep inspect for safety. The liners were not inspected by our company. I recommend a qualified chimney sweep inspect for safety.

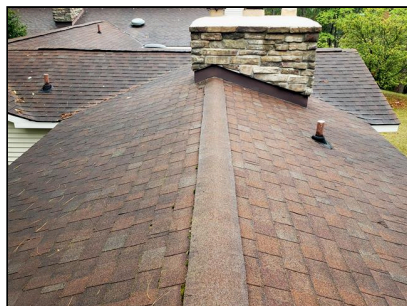
1.0 Item 1(Picture)

The roof covering is old, and the life of covering has almost expired. The covering does need to be replaced within the next 3 years. While it could last a couple years or so, some areas may need patching with tar as leaks develop. NOTE: All areas of shingle tabs missing should be sealed with a roofing tar to help prevent water leaks until new roofing is installed.

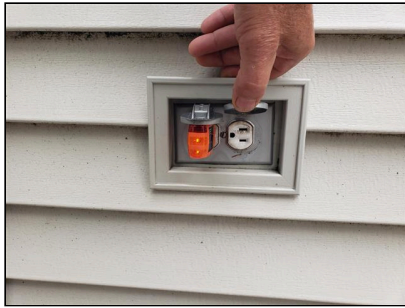
2.7 Item 1(Picture)

The exterior outlets were not GFCI outlets (Ground Fault Circuit Breakers), but were grounded when tested. Recommend replacement of outlets. NOTE: All exterior outlets would be required to be on a GFCI system with new construction. This is for your information. Recommend a contractor to repair as needed.

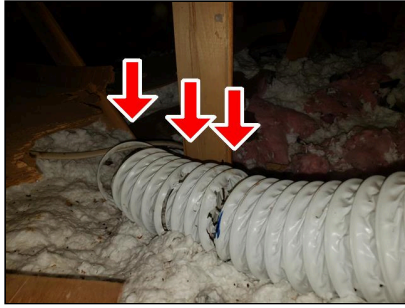
5.4 Item 8(Picture)

(2) There was a flexible vent tube installed to the bathroom vent fan. The flexible vent was damaged and needs to be replaced. Recommend a contractor to replace the vent tube as needed.

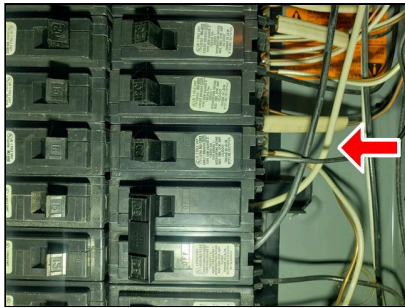
8.2 Item 1(Picture)

(2) At the time of inspection there was one 14 gauge wire in the electric panel that was installed to a 20 amp breaker. 14 gauge wires are not to be installed to any breaker larger than a 15 amp breaker. Recommend a contractor to repair as needed.

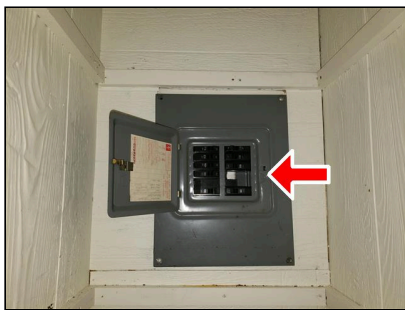
8.2 Item 2(Picture)

(3) There were open knockouts in the sub panel at the hallway closet. Recommend a qualified person to install knockout clips where needed.

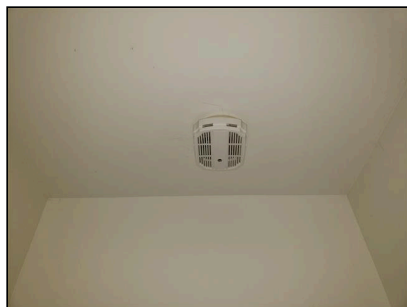
8.5 Item 1(Picture)

The smoke detector should be tested at common hallway to bedrooms upon moving in to home. Additional smoke detectors should be added at each bedroom in the home. Recommend installing smoke detectors in each bedroom as required with new construction.

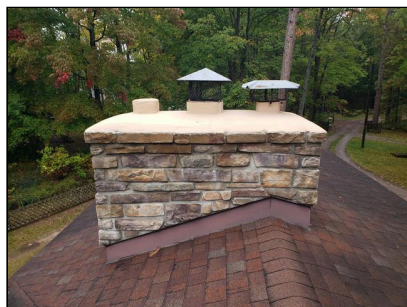
9.0 Item 4(Picture)

(2) The liners were mainly visible and appears good except for creosote dust that may conceal a hairline crack until cleaned and inspected by a licensed chimney sweep. For a detailed inspection of liners, I recommend a qualified chimney sweep inspect for safety. The liners were not inspected by our company. I recommend a qualified chimney sweep inspect for safety.

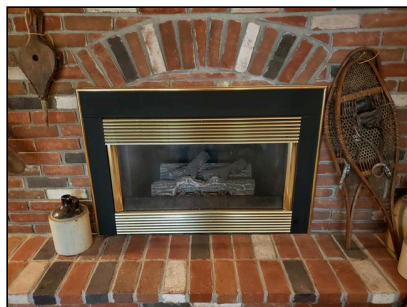
9.7 Item 1(Picture)

Gas log fireplace appeared to be in satisfactory working condition and vented properly. Control panel for operation of the fireplace was found on the left wall of fireplace. Recommend a contractor to clean and further evaluate the gas log fireplace as needed. It has not been in operation for a few years.
