# GUARDIAN REAL ESTATE INSPECTIONS

## PUNCHLIST INSPECTION

380 Fort Island Rd  
Eure, NC 27935

Jake Forbes  
05/22/2026

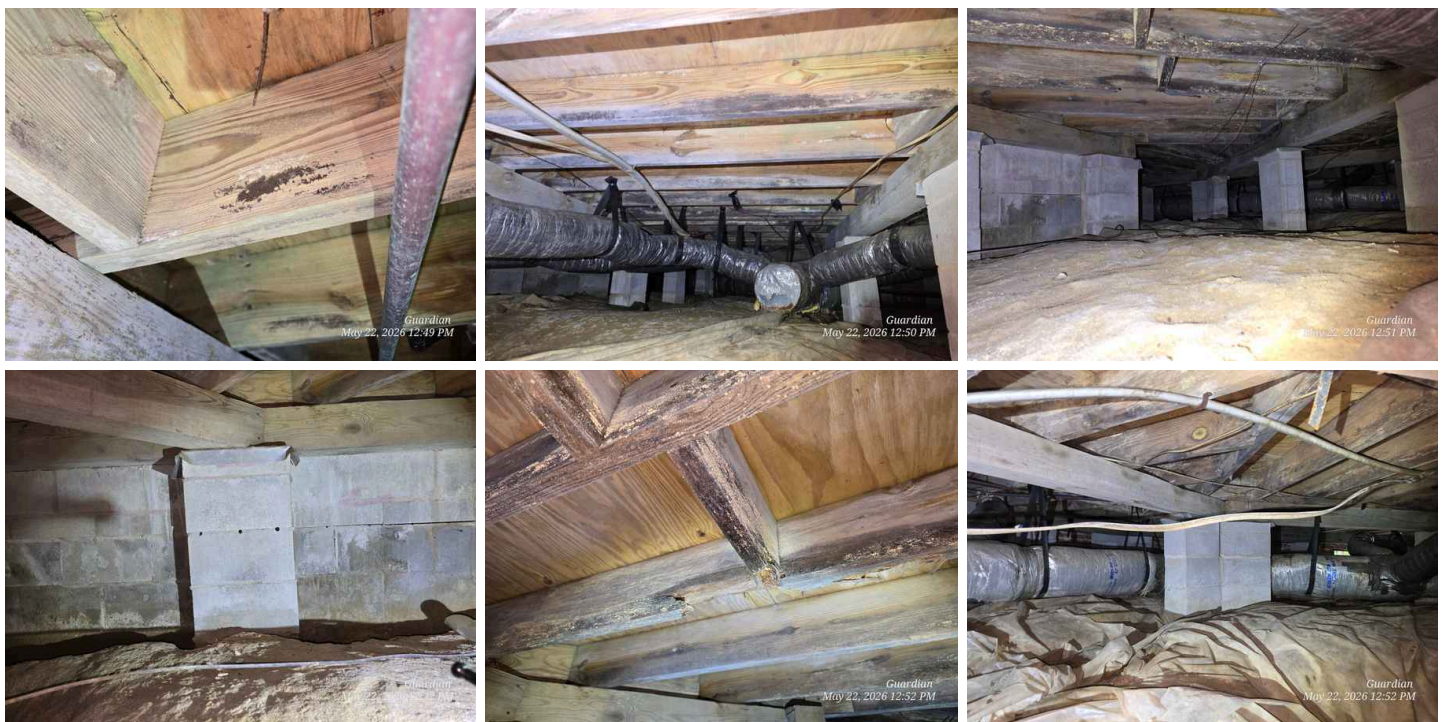
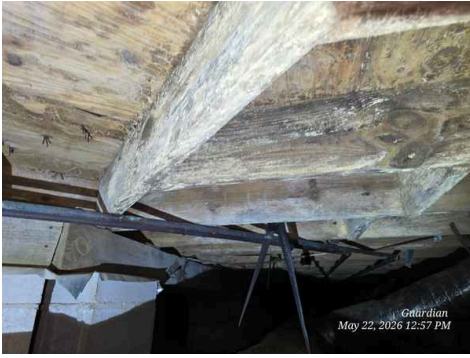
Organic growth was observed on the floor joists and subfloor throughout the crawlspace at the time of this inspection. The levels noted were not unusual for a vented crawlspace in North Carolina.

Growth was visible on multiple framing members, consistent with elevated humidity and periodic moisture exposure. The property owner reported that river water levels have risen to the foundation, and the foundation vents were covered, limiting ventilation. Only visible and accessible areas of the crawlspace were evaluated; no destructive testing or microbial identification was performed.

Organic growth in a vented crawlspace is common in humid regions; however, the reported river-level rise to the foundation and blocked vents indicate conditions that may be contributing to persistent moisture retention. Prolonged elevated moisture can lead to:

- Continued or worsening organic growth
- Elevated wood moisture content
- Deterioration of framing components
- Potential structural concerns if moisture levels remain high

Given the environmental conditions and the extent of visible growth, further assessment is warranted.

Recommend a full evaluation of the floor structure and wood moisture levels by a qualified foundation contractor. Based on findings, appropriate moisture-mitigation protocols—such as drainage improvements, ventilation correction, vapor-barrier installation, or encapsulation—should be outlined and performed by a licensed contractor to reduce moisture levels and prevent recurrence.

Contact a foundation contractor.

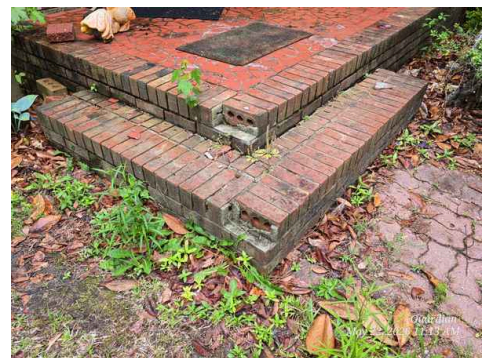
### 3.4.1 Decks, Balconies, Porches & Steps

#### BRICKS: LOOSE/MISSING

A brick was missing from the front entryway steps at the time of this inspection.

The missing brick created an irregular surface at the step assembly. No loose bricks were observed in the immediate area, but the gap exposes underlying mortar and may allow further deterioration from weather and foot traffic. Only visible and accessible portions of the steps were evaluated.

A missing brick can compromise the structural integrity of the step assembly and may create a tripping hazard for occupants or visitors. Open gaps also allow moisture intrusion, which can accelerate mortar deterioration and lead to additional brick displacement over time.

Recommend repair by a qualified masonry contractor to replace the missing brick and restore the stability and safety of the entryway steps.

Contact a qualified masonry professional.

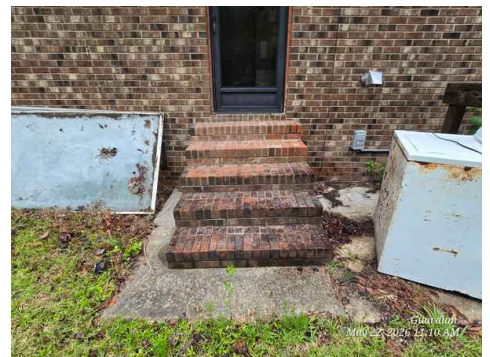
### 3.4.2 Decks, Balconies, Porches & Steps

#### HANDRAIL: MISSING

There were no handrails at the exterior utility room entryway. Handrails are required when the distance between the surface and the ground is 30" or more to prevent personal injury. A licensed general contractor should be consulted to install to prevent a falling hazard.

Contact a qualified licensed general contractor

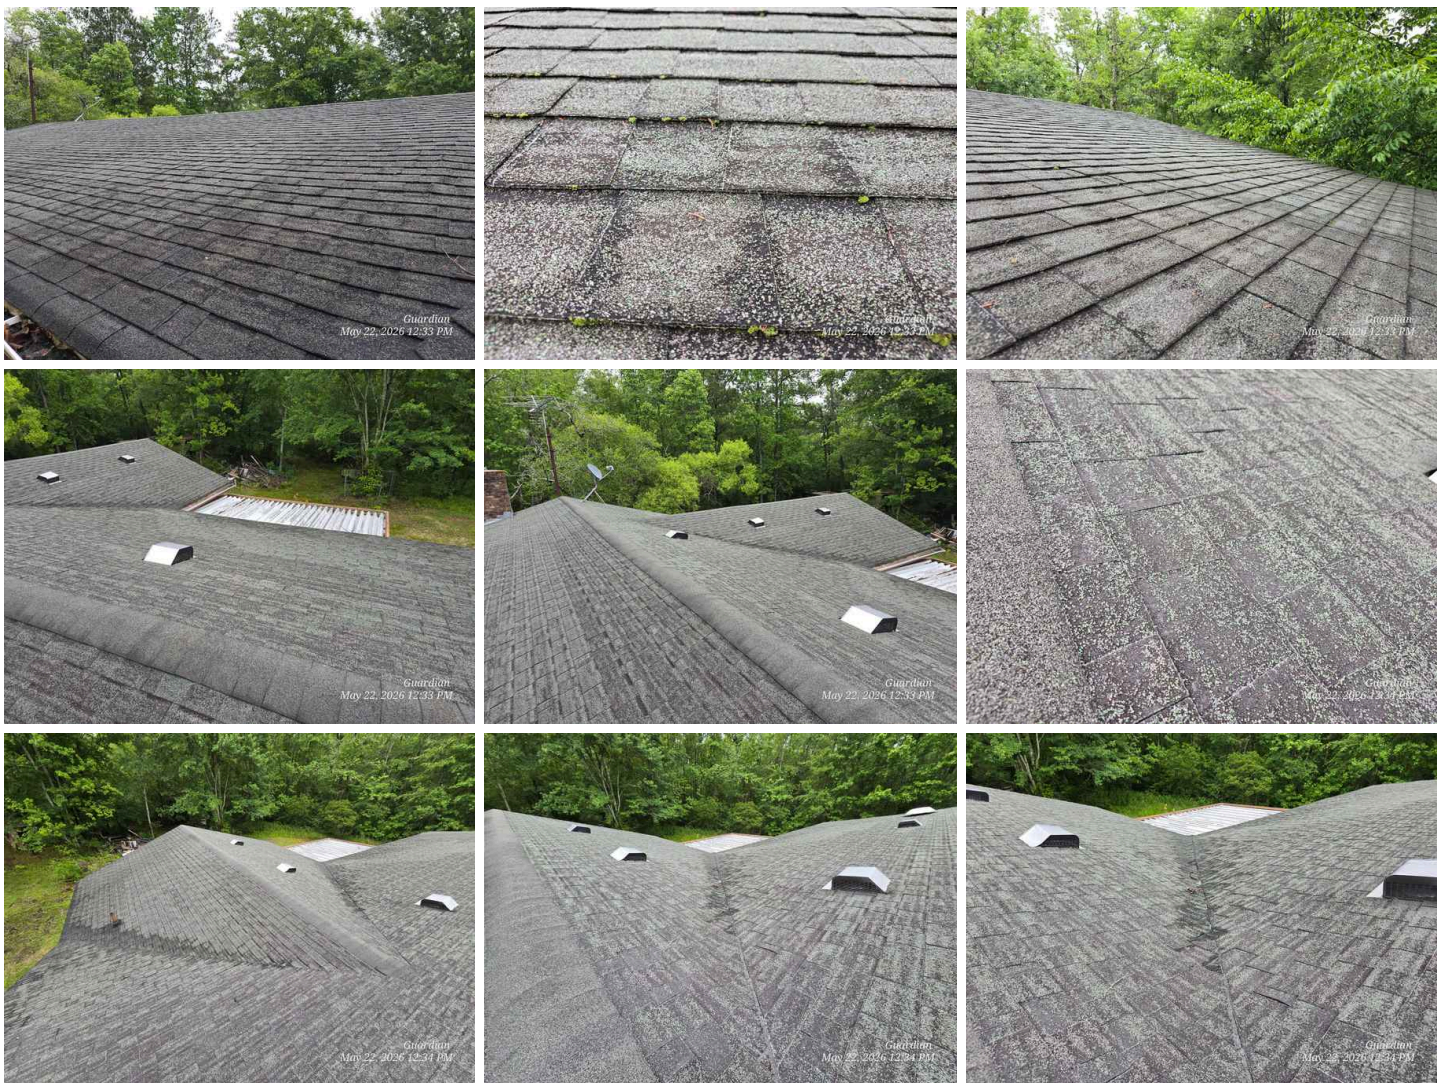
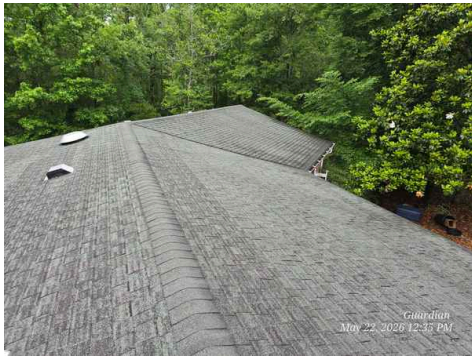
**BUDGET TO REPLACE**

The roof covering was observed to be beyond its typical life expectancy based on its overall condition at the time of this inspection.

Most shingles exhibited significant granule loss, with large areas showing exposed substrate across the roof surface. Evidence of roof leaks was visible from the interior of the structure, specifically at the rear valley, indicating active or past moisture intrusion. Only visible and accessible areas were evaluated during this inspection.

Extensive granule loss exposes the underlying shingle material to UV degradation and accelerates deterioration, reducing the roof's ability to shed water. Interior leak evidence at the rear valley suggests that the roof system is no longer performing as intended and may have compromised underlayment or flashing. A roof in this condition is at high risk for ongoing moisture intrusion, structural damage, and interior finish deterioration.

Recommend evaluation and replacement of the roof covering by a licensed roofing contractor. Repairs should include assessment of the rear valley and any associated structural or moisture-related damage.

Contact a qualified certified roofing contractor

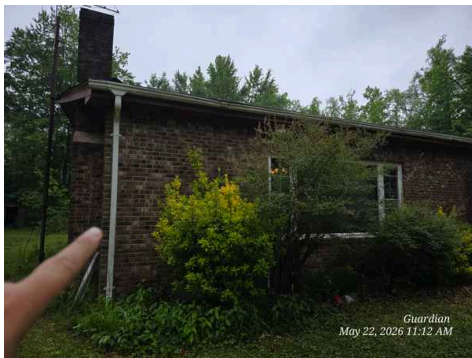
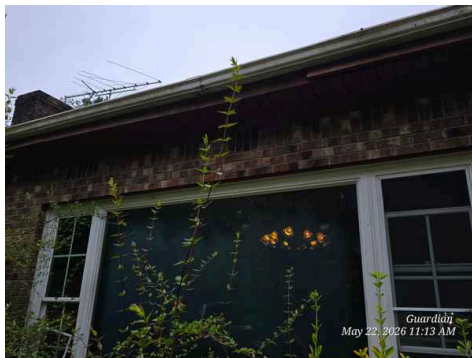
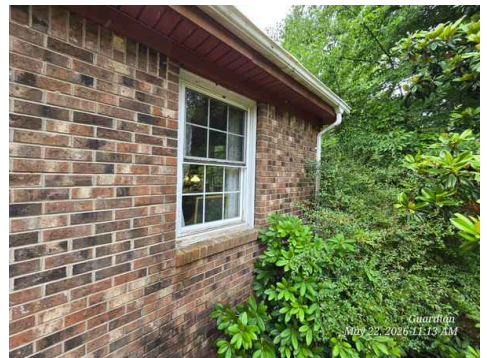
### 4.3.1 Roof Drainage Systems

## GUTTER OBSERVATIONS AND RECOMMENDATIONS

The installed gutters were observed to be aged and filled with organic debris at the time of inspection.

Debris accumulation was present throughout the gutter system, and the gutters were draining directly at the foundation. Moisture intrusion was noted in the basement, and soil washout was visible at the front wall of the crawlspace. Damage to the fascia appeared consistent with gutter backup and prolonged moisture exposure. Only visible and accessible components were evaluated during this inspection.

Aged gutters that are clogged or draining improperly can cause water to overflow or discharge against the structure, contributing to foundation moisture intrusion, soil erosion, and deterioration of adjacent building materials such as fascia boards. These conditions indicate that the gutter system is no longer functioning as intended and may be contributing to the moisture-related issues observed at the foundation and crawlspace.

Recommend replacement of the gutter system by a certified roofing or gutter contractor. The contractor should ensure proper installation, slope, and discharge away from the foundation to reduce future moisture concerns.

Contact a qualified certified roofing contractor

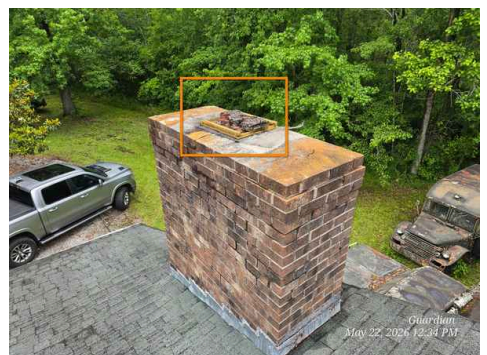
### 4.5.1 Skylights, Chimneys & Roof Penetrations

## CHIMNEY CAP NOT PERMANENTLY INSTALLED

The chimney cap was observed to be not permanently installed at the time of this inspection.

The cap appeared loosely set in place rather than mechanically fastened or properly secured to the chimney structure. A non-secured cap can shift or detach due to wind, weather, or animal activity. Only visible and accessible chimney components were evaluated.

A chimney cap is an important protective component that helps prevent moisture intrusion, animal entry, and debris accumulation within the flue. A cap that is not permanently installed cannot reliably perform these functions and may allow water penetration that can damage masonry, flue liners, or fireplace components. A loose cap may also become a falling hazard if dislodged.

Recommend proper installation or replacement of the chimney cap by a qualified roofing or chimney contractor to ensure secure attachment and adequate protection of the chimney system.

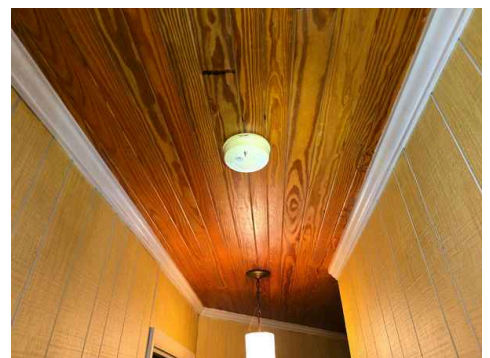
#### **RECOMMEND REPLACING ALL INSTALLED DETECTORS WITH COMBINATION DETECTORS**

Observed the installed detectors to be beyond the manufacturer's recommended service life.

This condition presents a carbon monoxide/fire safety hazard as the installed detectors do not function as intended and are beyond the serviceable life.

Recommend replacement of all installed detectors by a licensed electrical contractor.

Contact a qualified licensed electrical contractor

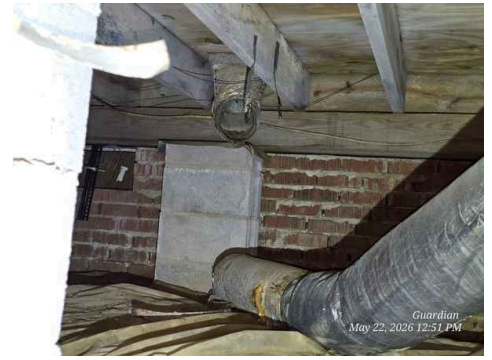
### 7.2.1 Distribution System: Heating and Cooling

A section of HVAC ducting in the crawl space was observed to be disconnected at the time of this inspection.

The separation was visible at the duct joint, allowing conditioned air to escape directly into the crawl space. Only visible and accessible portions of the duct system were evaluated during this inspection.

A disconnected duct results in loss of conditioned air, reducing system efficiency and increasing energy costs. It can also contribute to humidity imbalance, uneven heating or cooling, and unnecessary strain on the HVAC system. In a crawl space, escaping conditioned air may also elevate moisture levels, potentially affecting structural components.

Recommend evaluation and repair by a licensed HVAC contractor to properly reattach and seal the duct to prevent further air loss and ensure efficient system operation.

Contact a qualified licensed mechanical contractor

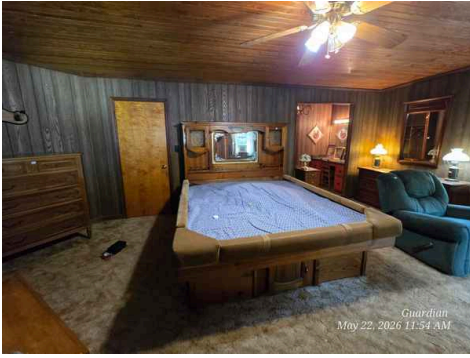
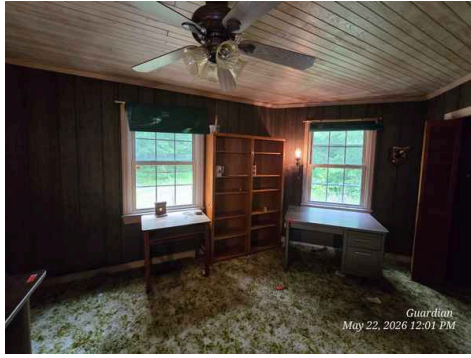
#### RECOMMEND FLOOR COVERING REFINISHING/REPLACEMENT

The installed flooring was observed to be worn at the time of this inspection.

Visible wear was present across the flooring surface, consistent with age, use, and normal traffic patterns. Only visible and accessible flooring areas were evaluated.

Worn flooring can detract from appearance, reduce durability, and may continue to deteriorate with ongoing use. Depending on the material and extent of wear, cleaning alone may not restore the finish, and replacement may be necessary to achieve proper performance and appearance.

Recommend cleaning and/or replacement of the worn flooring by a qualified flooring contractor.

Contact a qualified flooring contractor

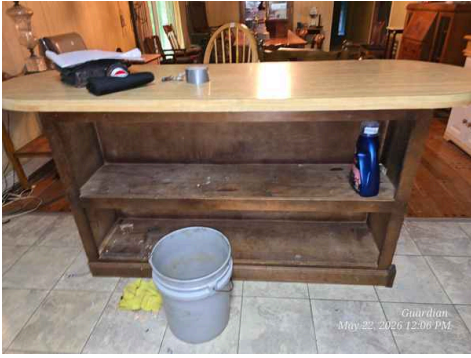
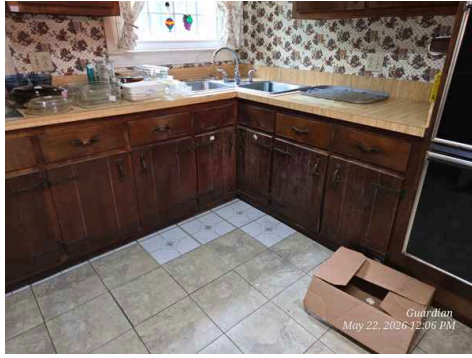
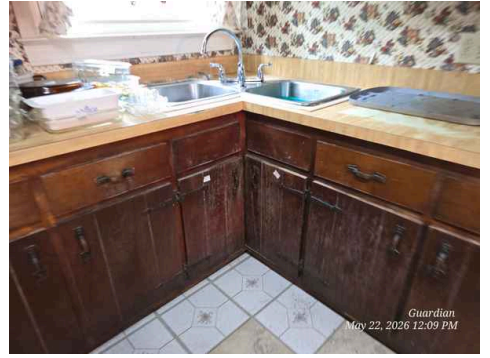
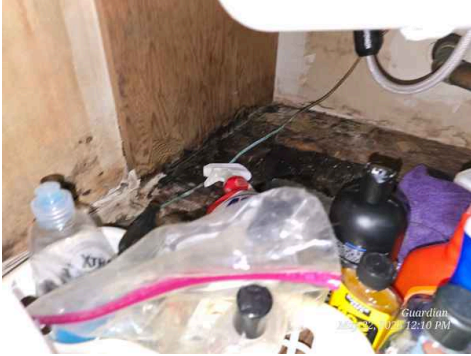
9.5.1 Countertops & Cabinets

**CABINETS - FUNGAL GROWTH AND MOISTURE DAMAGE**

The installed and onsite cabinetry throughout the home was observed to have organic growth on exterior surfaces and interior cabinet faces at the time of this inspection.

Organic growth consistent with mildew was present on cabinet facings and within bathroom closets. The pattern and distribution of the growth are indicative of elevated indoor humidity and limited air circulation. Only visible and accessible cabinetry surfaces were evaluated; no destructive testing or microbial identification was performed.

The condition suggests a broader humidity-control deficiency within the home.

Recommend evaluation and remediation by a qualified contractor or indoor-air specialist. Actions may include:

- Cleaning and treating affected cabinetry
- Improving ventilation and airflow in closets and enclosed spaces
- Assessing and correcting sources of elevated humidity within the home

Contact a qualified cabinet contractor.

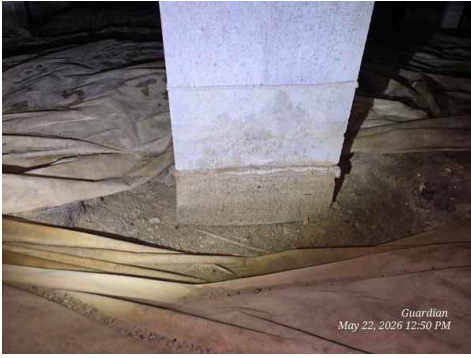
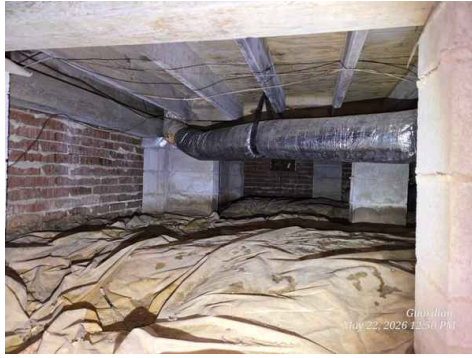
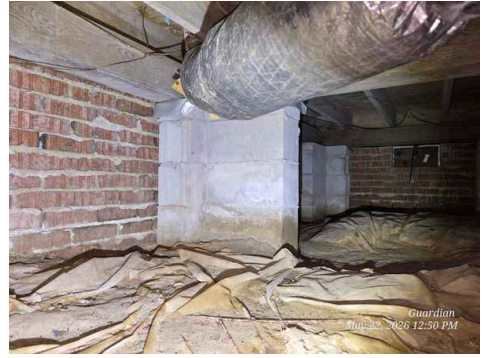
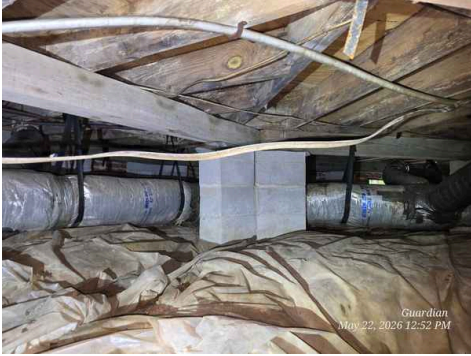
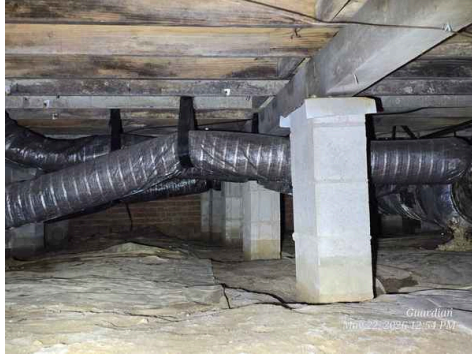
#### **PARTIAL VAPOR BARRIER COVERAGE OBSERVED**

Observed the installed vapor barrier to provide only partial coverage of the crawlspace floor at the time of this inspection.

Partial coverage allows the ground vapor to enter the crawlspace and cause organic growth and insulation damage.

Recommend a full vapor barrier to be installed in the crawlspace as part of the moisture mitigation system to prevent further organic growth.

Contact a foundation contractor.
