# GUARDIAN REAL ESTATE INSPECTIONS

## PUNCHLIST INSPECTION

887 Snug Harbor Rd  
Hertford, NC 27944

08/03/2026

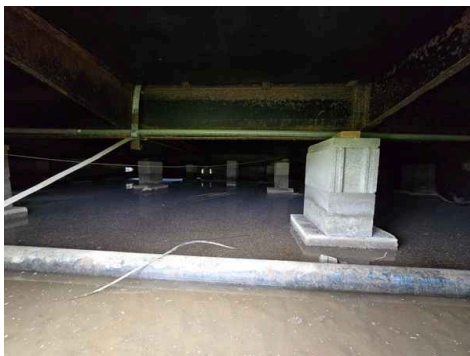
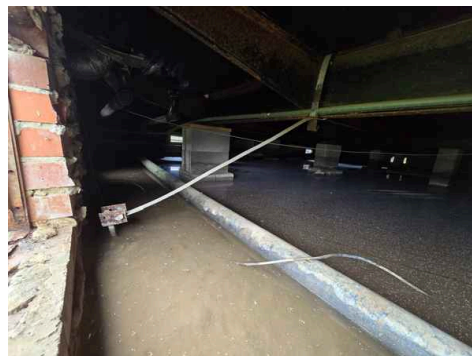
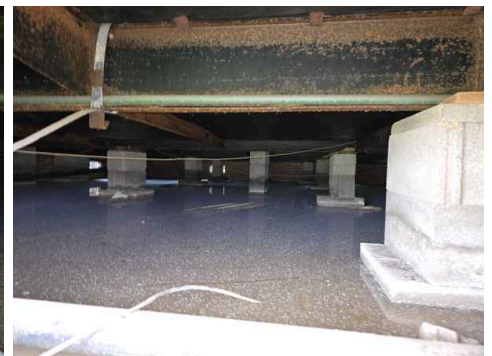
1.1.1 General

At the time of this inspection, approximately 2 inches of standing water was present throughout the crawlspace. Due to the health and safety hazards associated with standing water in a confined area—including electrical risk, biological contaminants, and limited visibility—the crawlspace was not inspected beyond the entry point. Only visible and safely accessible areas were evaluated.

Because the water prevented safe access, the full condition of the crawlspace, foundation, mechanical systems, and structural components could not be evaluated.

Recommend immediate evaluation by a licensed general contractor or crawlspace specialist to:

- Identify the source of the standing water
- Correct drainage, plumbing, or moisture-control issues
- Remove standing water and dry the crawlspace
- Restore safe access for a complete inspection once conditions allow

Contact a foundation contractor.

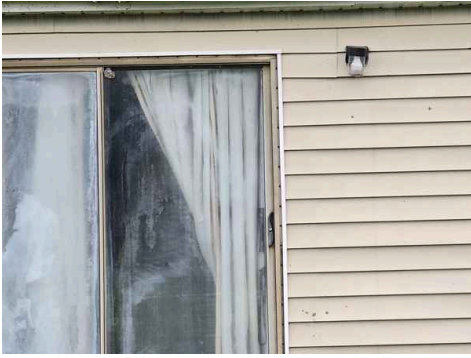
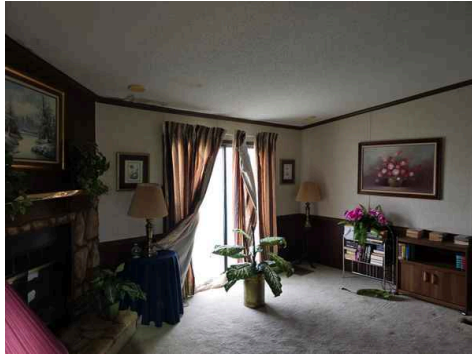
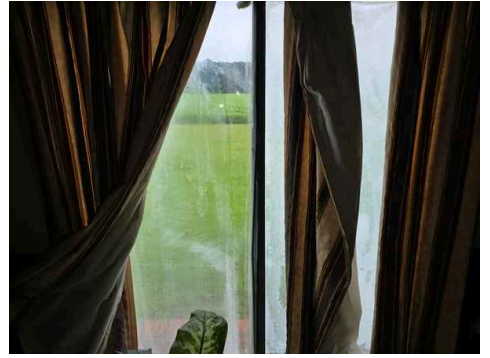
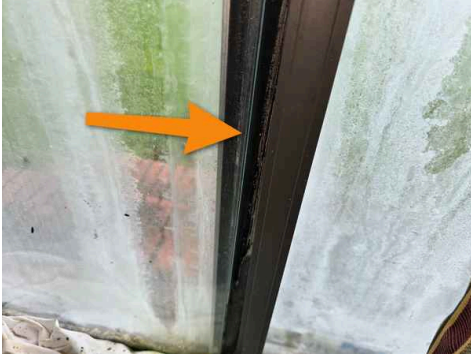
**SLIDING GLASS DOOR - DAMAGED**

At the time of this inspection, the sliding glass door was missing portions of its frame. This condition has allowed water intrusion into the interior of the structure, and organic growth was observed at interior surfaces surrounding the door. Only visible and accessible components were evaluated.

Because the frame is incomplete, concealed damage behind the door assembly is likely and cannot be fully assessed without invasive inspection.

Recommend evaluation and repair by a licensed general contractor, including:

- Removal of damaged door components
- Assessment of surrounding wall and floor framing for moisture-related deterioration
- Remediation of organic growth
- Installation of a properly flashed and sealed door assembly to prevent future intrusion

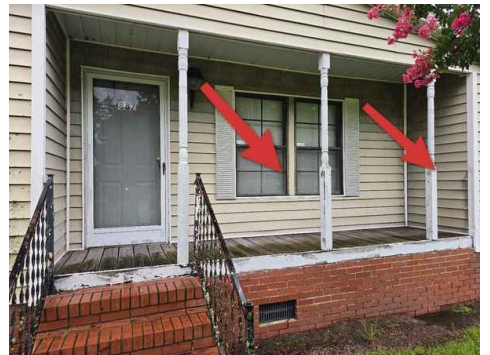
### 3.4.1 Decks, Balconies, Porches & Steps

#### **GUARDRAIL: MISSING**

There are no guardrails installed at the front porch. Guardrails are required when the distance between the surface and the ground is 30" or more to prevent personal injury. A licensed general contractor should be consulted to install to prevent a falling hazard.

Contact a qualified licensed general contractor

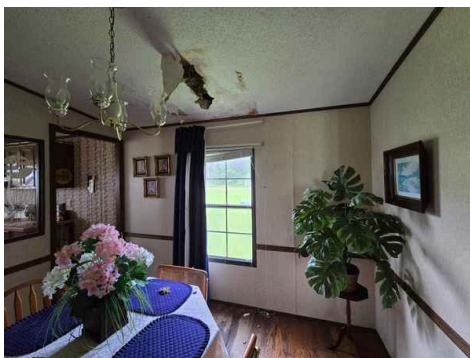
Dining Room

- Lifted shingles across both the front and rear roof fields
- Substandard repairs at roof penetrations, including multiple layers of roof sealant applied in lieu of proper flashing repair
- A sunken plumbing vent at the rear center roof field, indicating possible sheathing deterioration beneath the vent
- The aluminum chimney missing its cap, with significant corrosion visible at the exhaust flue
- Damaged gable-end shingles at multiple locations
- Damaged front fascia at the right valley
- A vinyl gutter pulling away from the fascia
- A wavy roof surface, suggesting underlying roof-sheathing damage or failure

Interior inspection revealed multiple roof leaks, accompanied by:

Recommend immediate evaluation by a certified roofing contractor to:

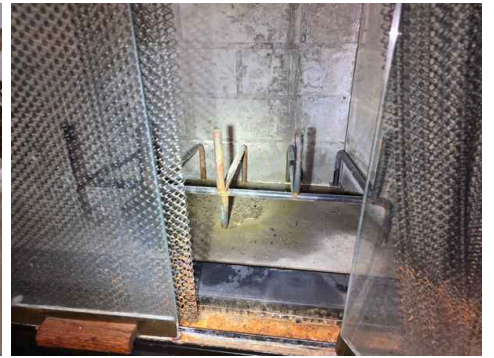
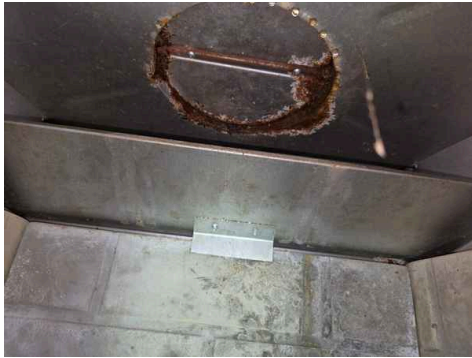
Fireplace

Missing chimney cap and corrosion at the flue create moisture and safety hazards.

Correct all defective penetrations, including plumbing vents and chimney components

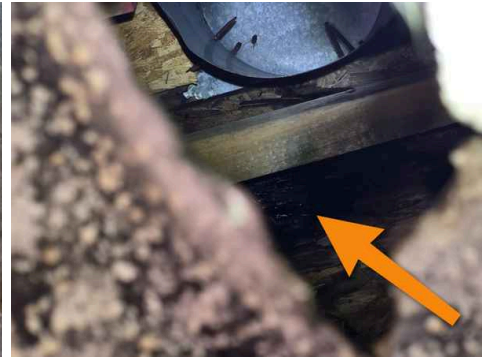
Wet Sheathing - Long term water damage

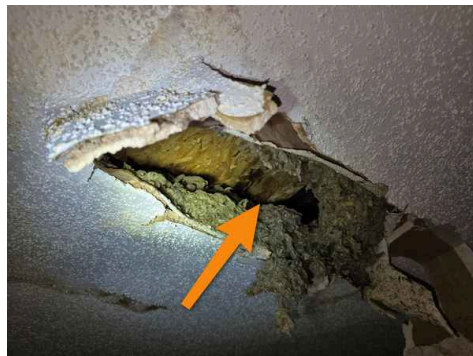
Roof sheathing wet

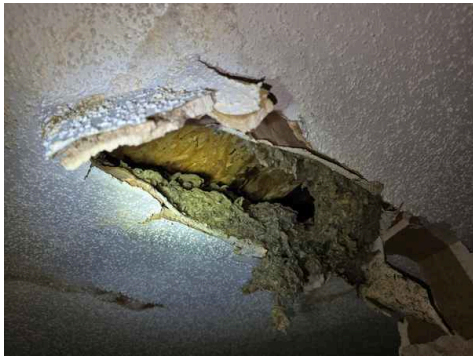
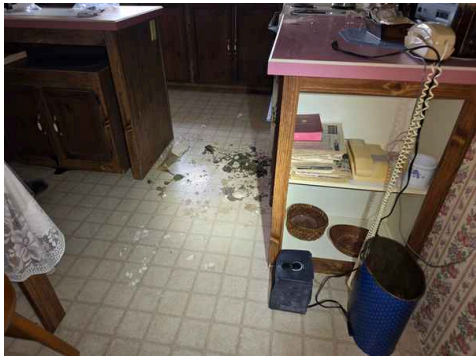
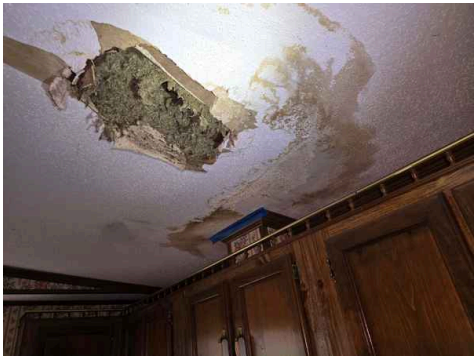
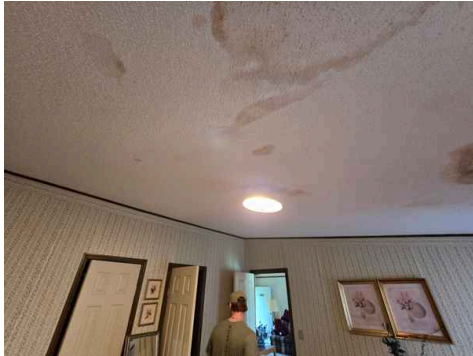
The exterior wall and floor at the dining room window were soft, indicating long-term moisture damage. This condition correlates with the active roof leak present at the time of inspection.

Multiple ceiling areas were either fallen or showed moisture damage, including visible organic growth.

Standing water was present on the linoleum flooring in both the kitchen and bathroom, directly resulting from roof leaks.

It is strongly recommended that a licensed general contractor perform a destructive inspection to:

- Assess the condition of wall framing, roof structure, and floor systems
- Identify and remediate hidden organic growth
- Determine the full extent of moisture-related deterioration
- Develop a comprehensive repair plan addressing both structural and moisture-control needs
