**Perfection Home Inspections**  
**Mesa, AZ 85203**  
**602-524-2916**  
**perfectionhomeinspections.com**

Client Information: Record Number 8613

**Sturgeon, Melanie**  
**1211 S. Barkley**  
**Mesa, AZ 85204**  
**480-881-6717**

Inspected 7/24/21 8:00 AM  
Built 1980  
1688 sf

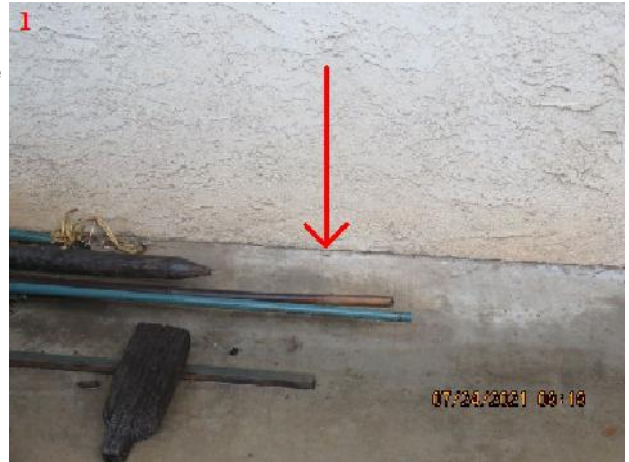
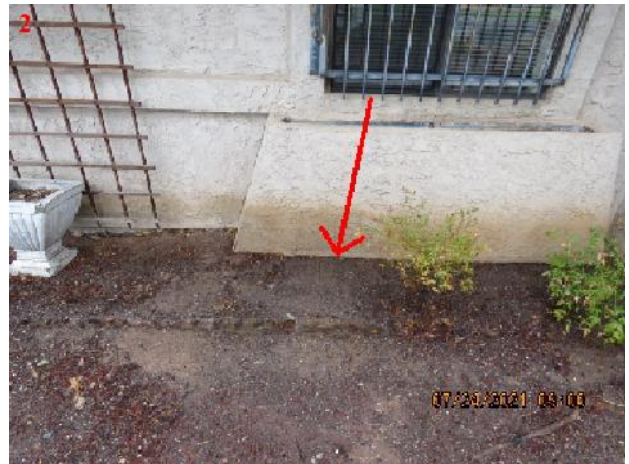
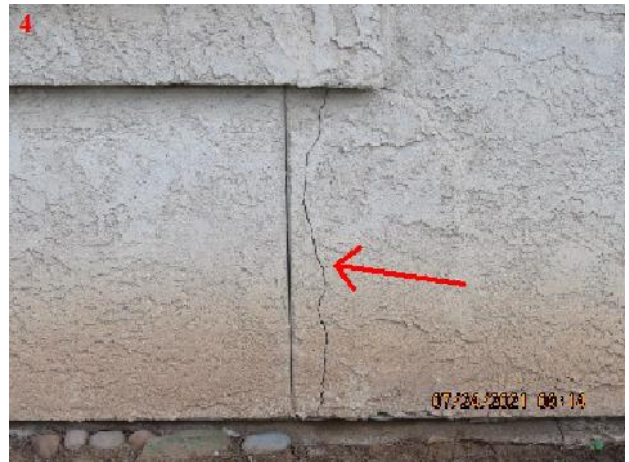
Crack in the stucco. Recommend repair.

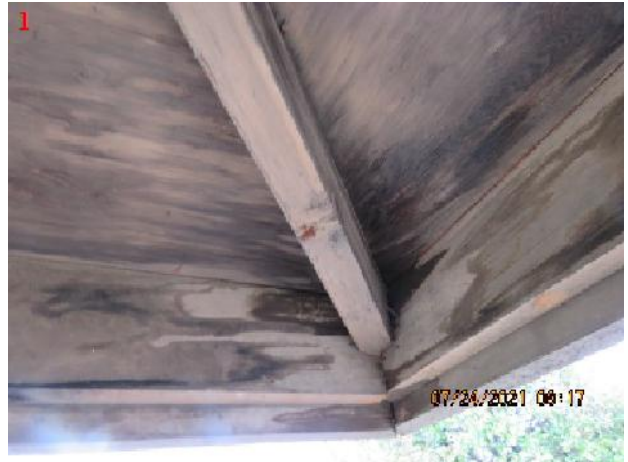
Lots of water stains in the soffit area around the home but no signs of an active leak at this time.

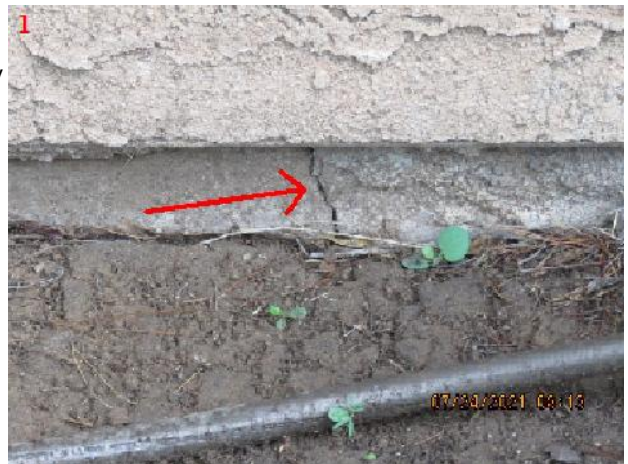
There is a crack in the house foundation on the side of bedroom three.

There is a crack in the house foundation on the side of bedroom three.  
Recommend a qualified contractor evaluate and make all necessary repairs.

Recommend a qualified contractor evaluate and make all necessary repairs.

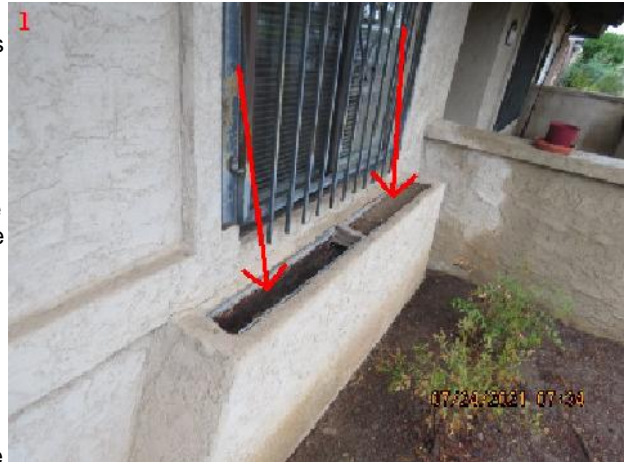
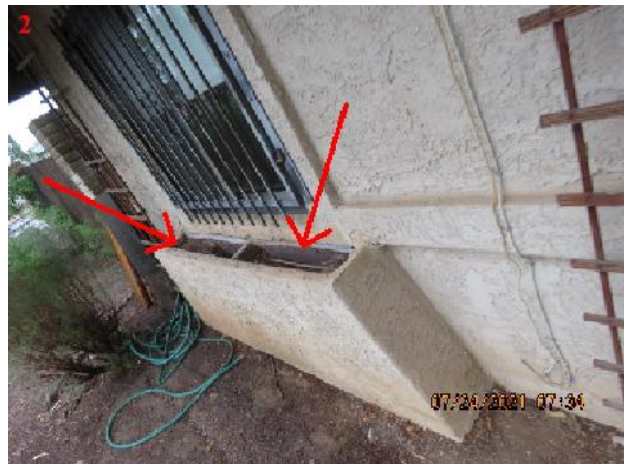
Planters installed next to the house hold water against the house foundation and sometimes raise the soil level above the house slab level. Recommend finding a way to drain water from this area to help protect the house foundation. When soil is against the house and above the house slab water and pests like termites may enter the home undetected. Recommend keeping planters away from the house foundation.

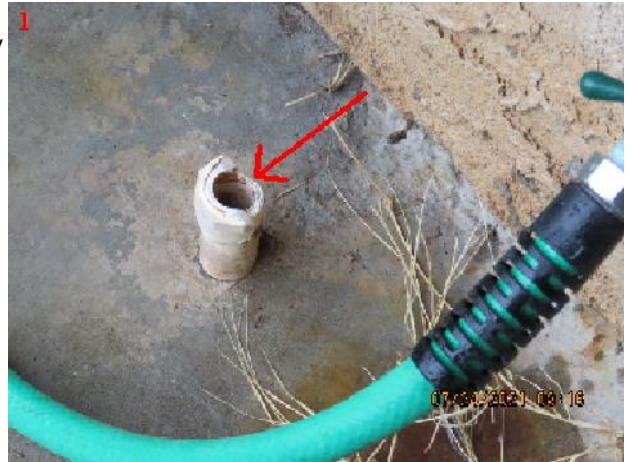
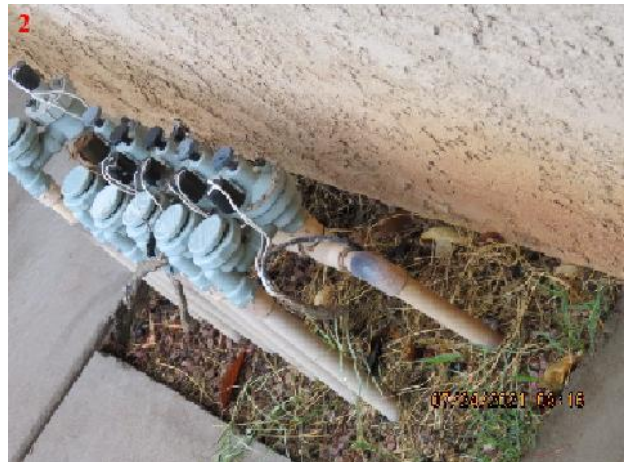
The water line to the sprinkler system in the back has been cut. Recommend a qualified contractor evaluate and make all necessary repairs.

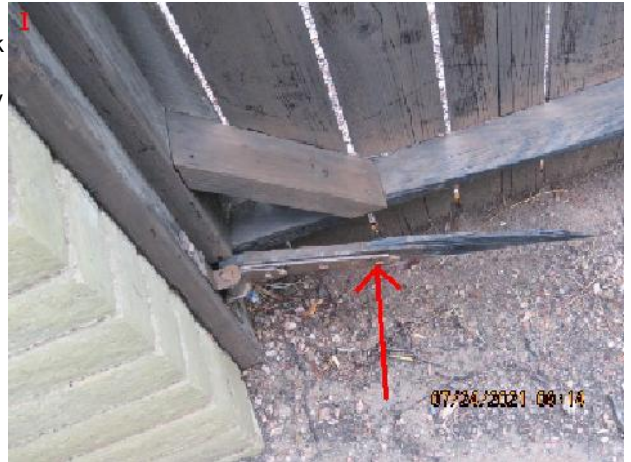
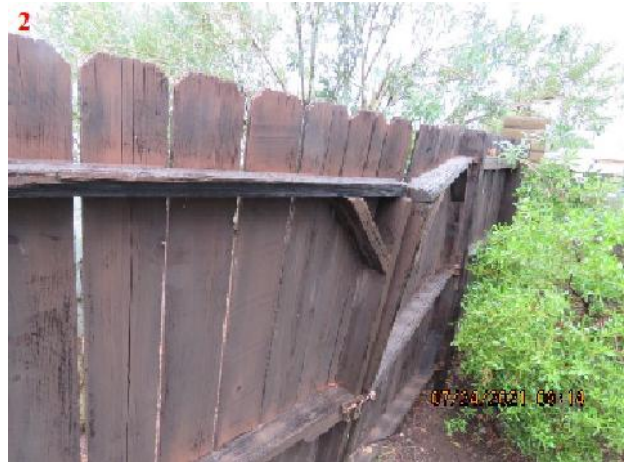
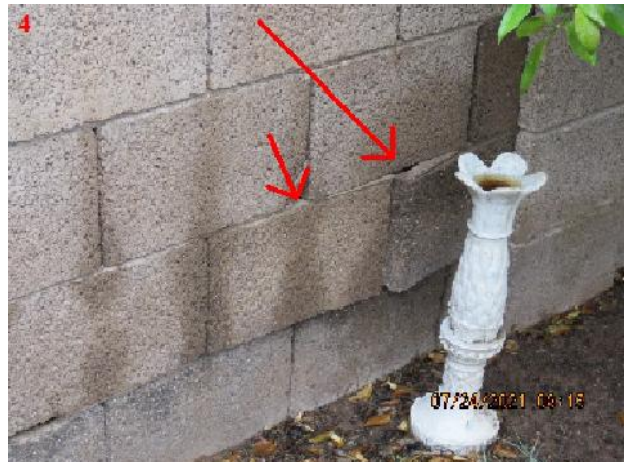
The fence gate in the front is falling over. There is a fence gate in the side yard to the neighbors back yard. Damage block in the back fence wall.

The fence gate in the front is falling over. There is a fence gate in the side yard to the neighbors back yard. Damage block in the back fence wall. Recommend a qualified contractor evaluate and make all necessary repairs.

Recommend a qualified contractor evaluate and make all necessary repairs.

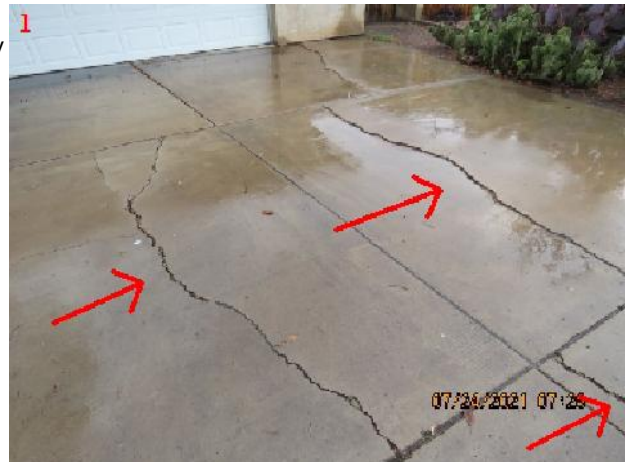
Lots of large cracks in driveway.

Lots of large cracks in driveway.  
Recommend a qualified contractor evaluate and make all necessary repairs.

Recommend a qualified contractor evaluate and make all necessary repairs.

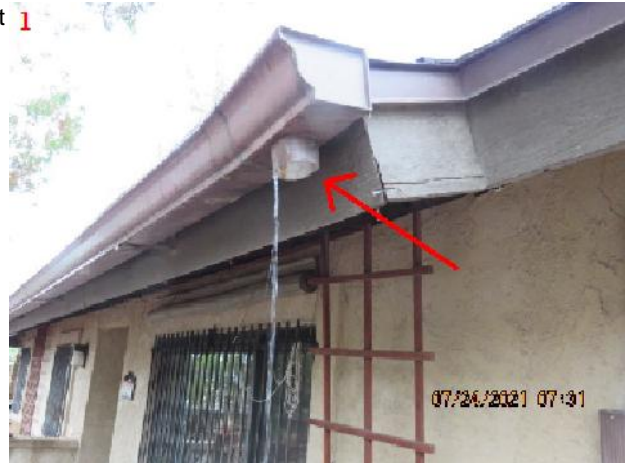
Gutter down spouts are missing. Recommend installing down spout and directing all roof water away from the house foundation.

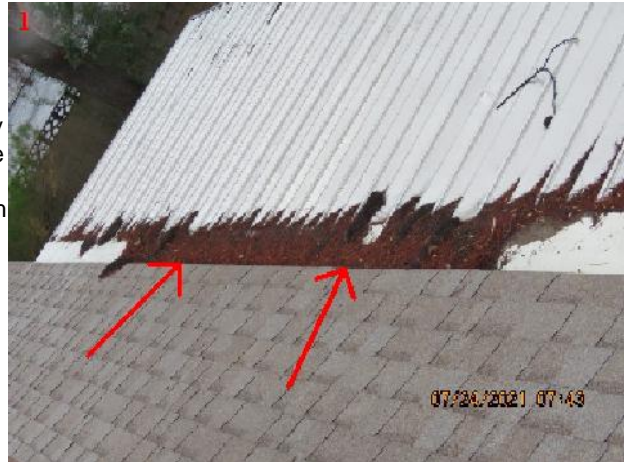
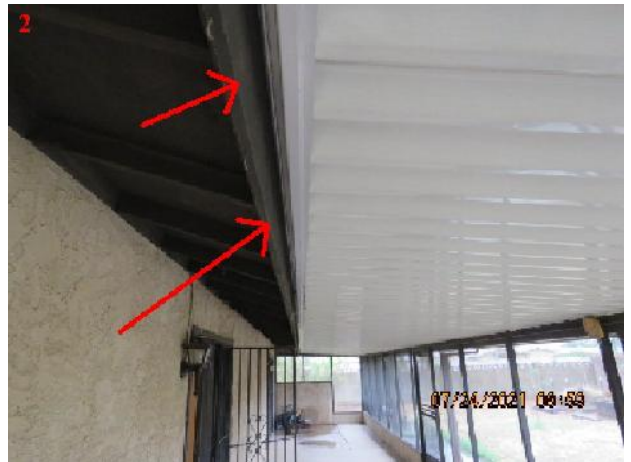
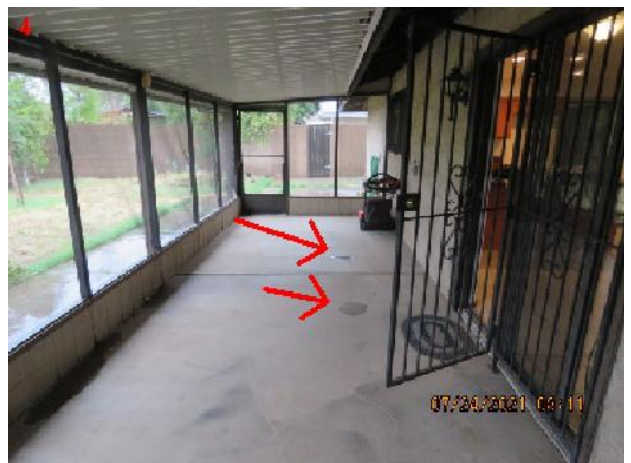
The back patio roof has been attached to the fascia wood. This is a good indication the patio addition was installed without a permit. Water leaking between the patio roof and the house room in the patio area.

Debris on the back patio roof. Recommend removing all debris from the roof.

The back patio roof has been attached to the fascia wood. This is a good indication the patio addition was installed without a permit. Water leaking between the patio roof and the house room in the patio area. Recommend a qualified contractor evaluate and make all necessary repairs. Recommend asking the seller for permits obtained from the city to install the patio roof. Debris on the back patio roof. Recommend removing all debris from the roof.

Recommend a qualified contractor evaluate and make all necessary repairs. Recommend asking the seller for permits obtained from the city to install the patio roof.

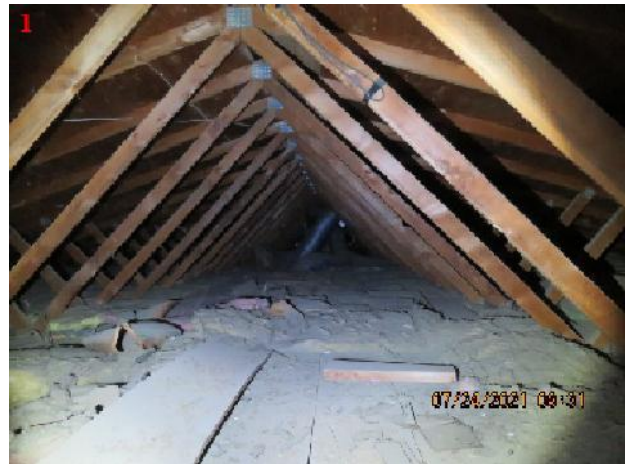
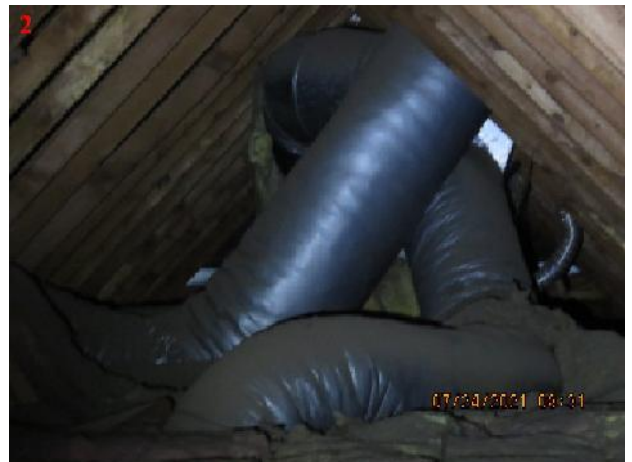
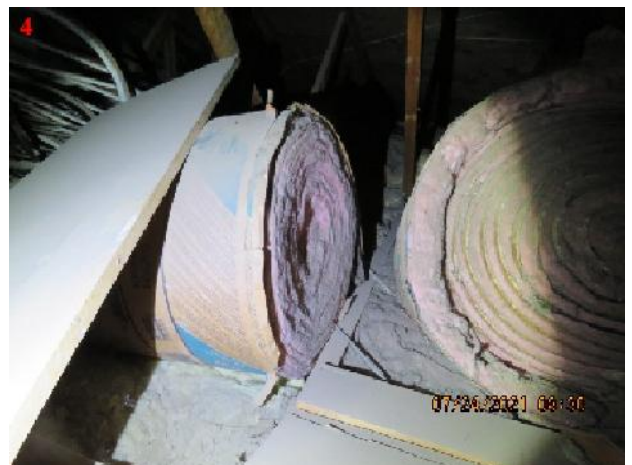
Sample attic picture. Stuff stored in the attic. Recommend removing the stuff.

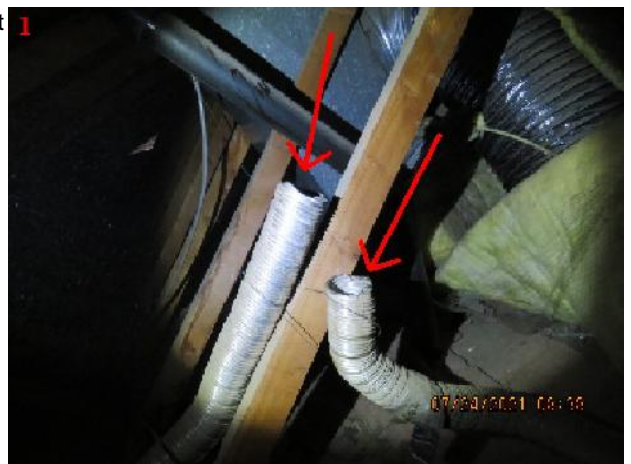
Vent pipes not properly connected to roof vent. Recommend all vent pipes be directed outside, however in the dry climate of southern Arizona venting into attics may not cause a moisture problem. See picture

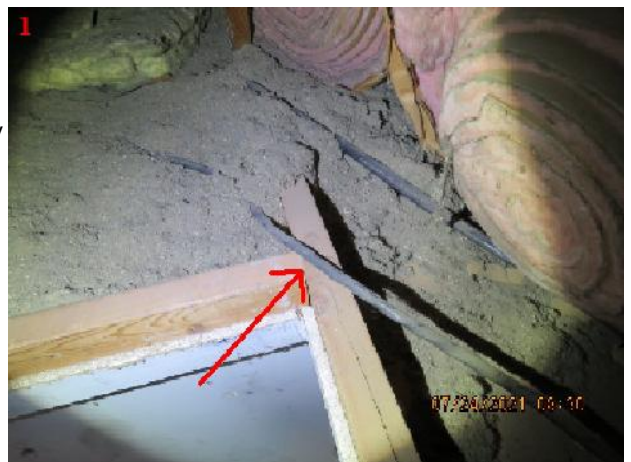
Romex type wires installed too close to the attic hatch are not properly protected.  
Romex type wires should not be installed within 6 feet of an attic hatch without being properly protected.  
Recommend a qualified contractor evaluate and make all necessary repairs.

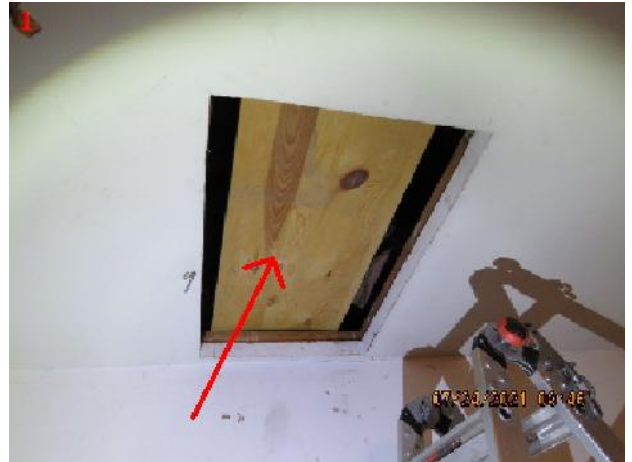
Attic hatch in garage is not properly fire rated. Recommend installing fire resistant hatch as needed. Recommend a 5/8 inch thick type X drywall be used as an attic hatch cover. Some areas no longer require this to be fire rated if there is no habitable space above the garage.

Attic hatch in garage is not properly fire rated. Recommend installing fire resistant hatch as needed. Recommend a 5/8 inch thick type x drywall be used as an attic hatch cover. Some area no longer require this to be fire rated if there is no habitable space above the garage.

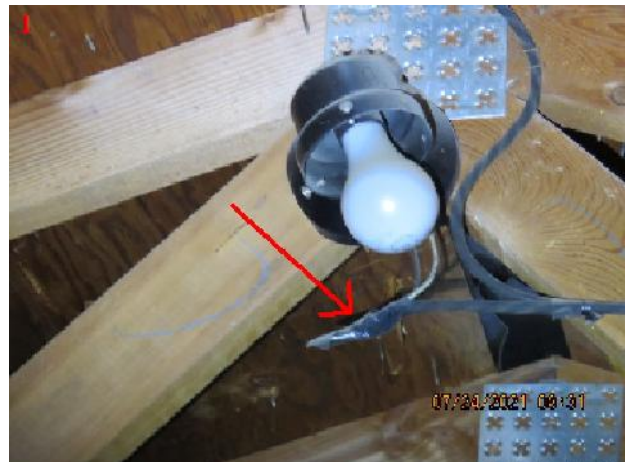
Spliced wires in attic not properly installed in electrical junction box. This is a shock hazard. Recommend placing all spliced wires in an electrical junction box. Recommend a qualified electrical contractor make all necessary repairs.

Spliced wires in attic not properly installed in electrical junction box. This is a shock hazard. Recommend placing all spliced wires in an electrical junction box. Recommend a qualified electrical contractor make all necessary repairs. See Picture

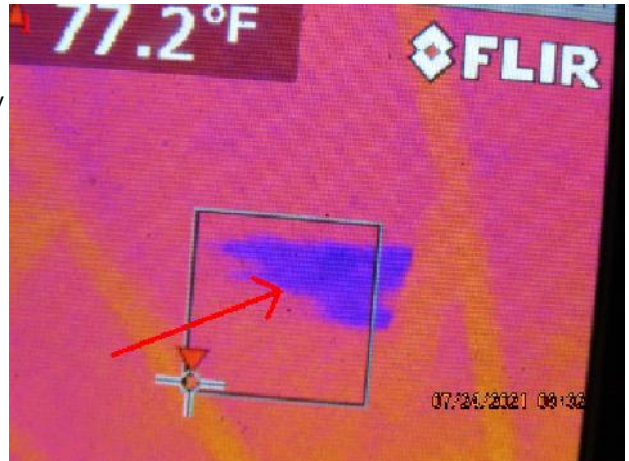
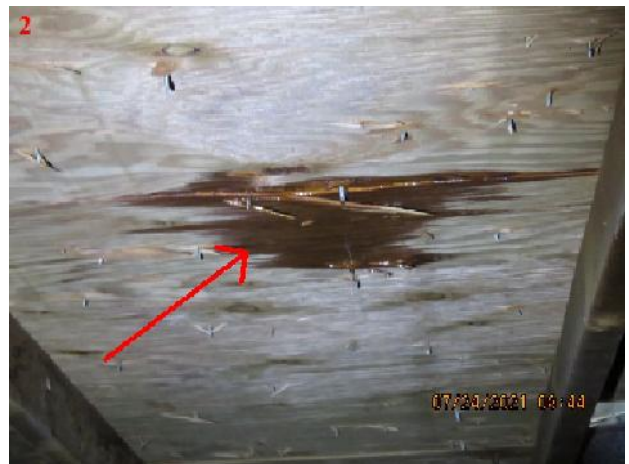
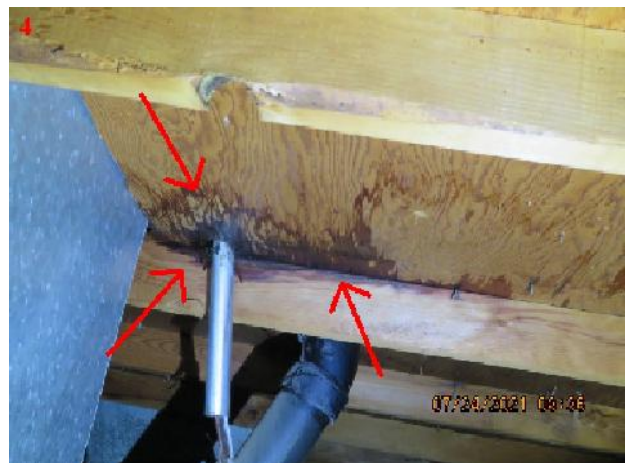
Roof leak in the attic at the AC electric line and on the sheathing near the attic hatch above the kitchen area. Sheathing has water stains in several areas. Recommend a qualified contractor evaluate and make all necessary repairs.

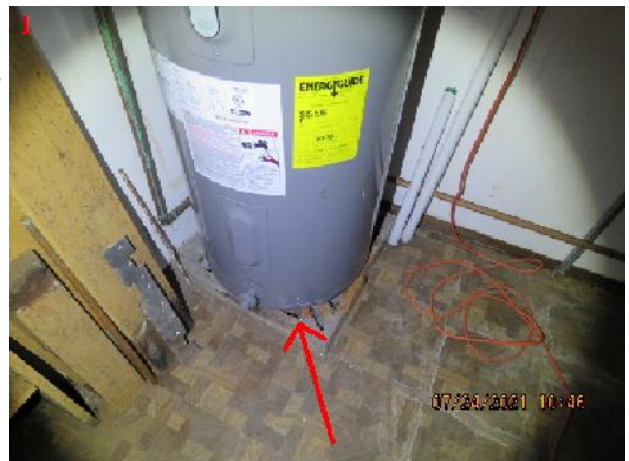
No pan installed under the water heater.  
Recommend installing an overflow pan under the water heater and installing a drain line from this pan if possible to the exterior. This is normally best done when changing water heaters.

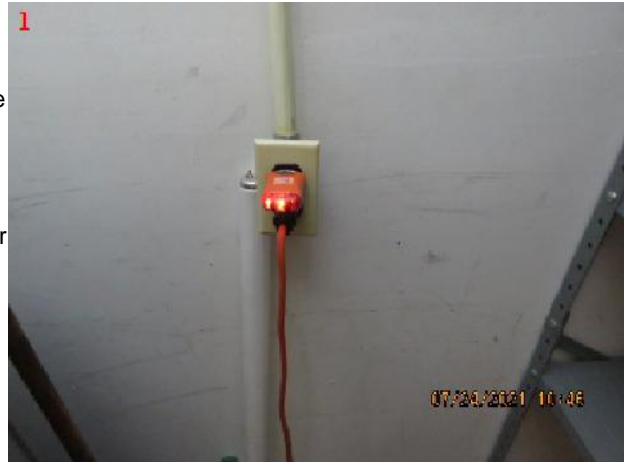
Hot and neutral wires reversed on two outlets near water heater. This outlet is also not GFCI protected. Recommend GFCI protection for all outlets in the garage.

This is a shock hazard. Recommend a qualified electrical contractor evaluate and make all necessary repairs. See picture

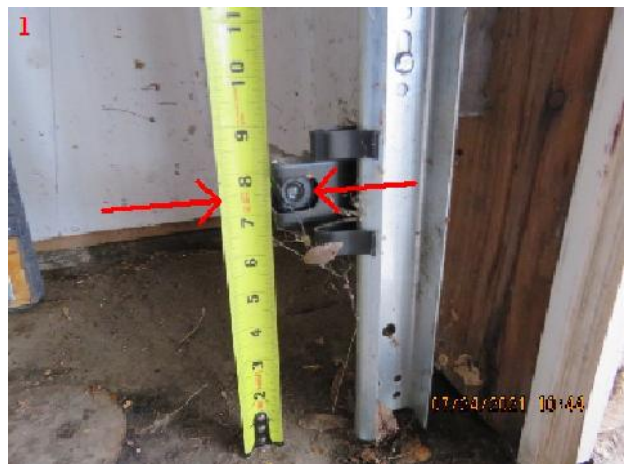
The electronic eye sensor beam used to stop the automatic garage door from closing if something is in its path is more than the recommended height of 6 inches above the garage floor. This is a safety hazard. Recommend installing this sensor eye beam 4 to 6 inches above the garage floor.

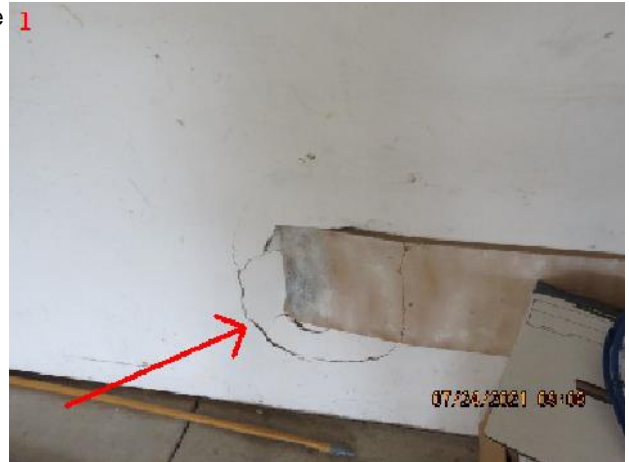
Hole or holes in the drywall on the wall or ceiling between the house and the garage. This drywall is a fire stop and a carbon monoxide stop between the house and the garage. Recommend patching all holes in the wall between the garage and the house. See picture

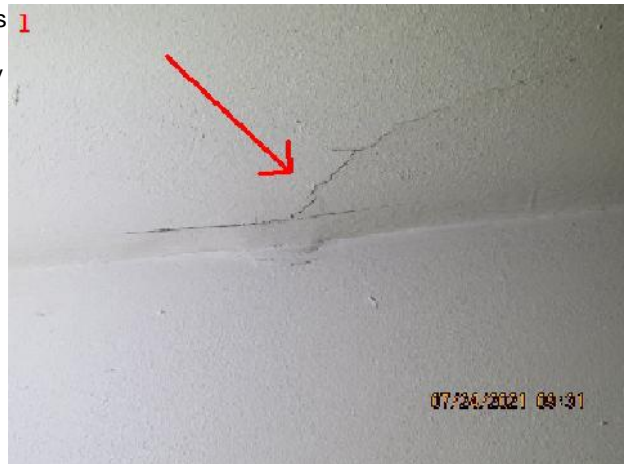
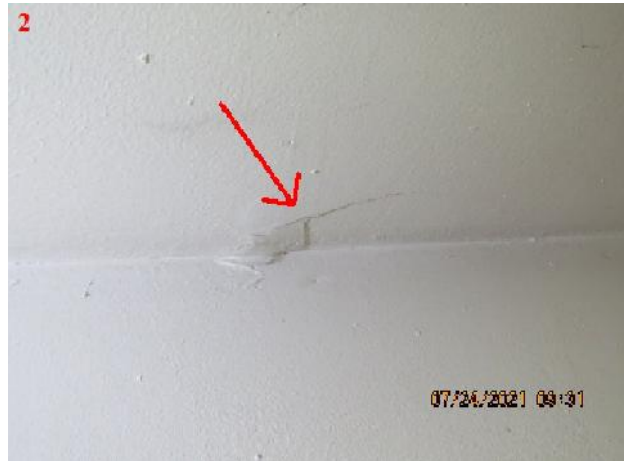
Water stains on the laundry wall at the washer hookup area. Cracks on the ceiling.  
Recommend a qualified contractor evaluate and make all necessary repairs.

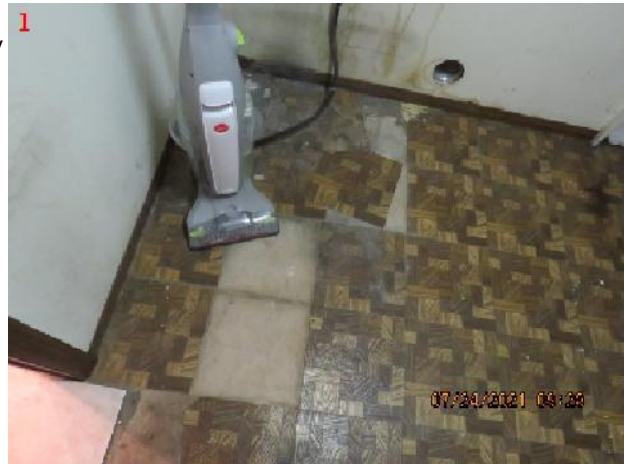
Laundry flooring loose with parts missing.  
Recommend a qualified contractor evaluate and make all necessary repairs.

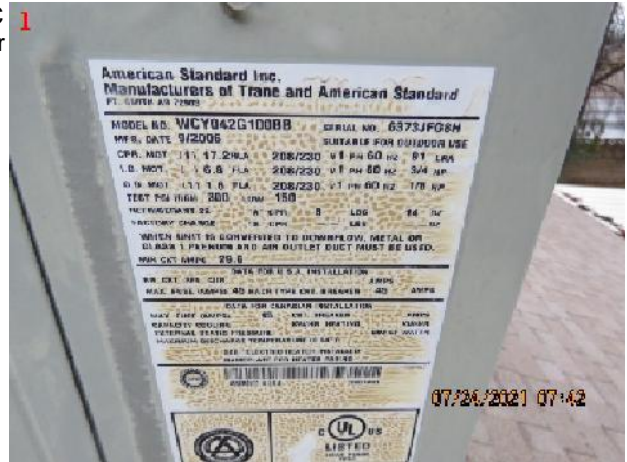
This unit looks like it is over 15 years old. The average life of an AC system in the Phoenix area is 12 to 15 years. This unit may be near the end of its useful life. Typical AC has only 50% of its initial efficiency after 20 years. So a 12 SEER would have a 6 SEER rating.

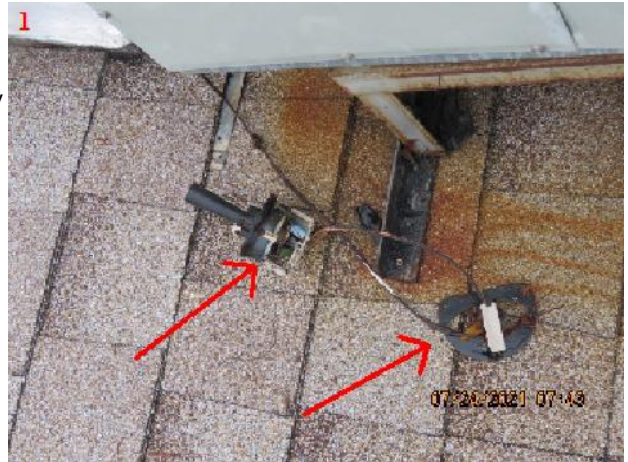
Cooling coil(s) made by Trane.  
There is some electrical debris on the roof at the heat pump. Not sure what is is but is it damaged.  
Recommend a qualified contractor evaluate and make all necessary repairs.

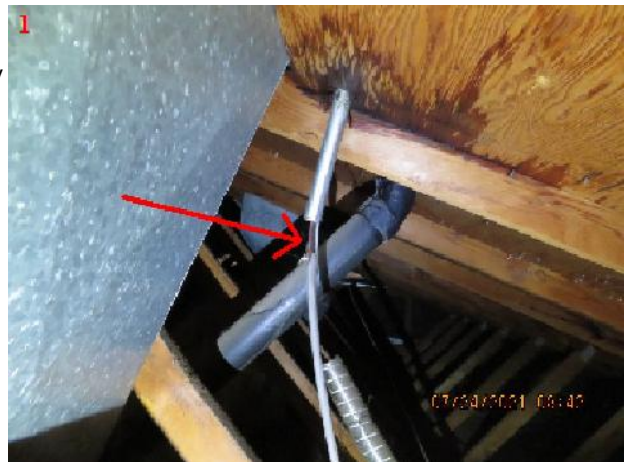
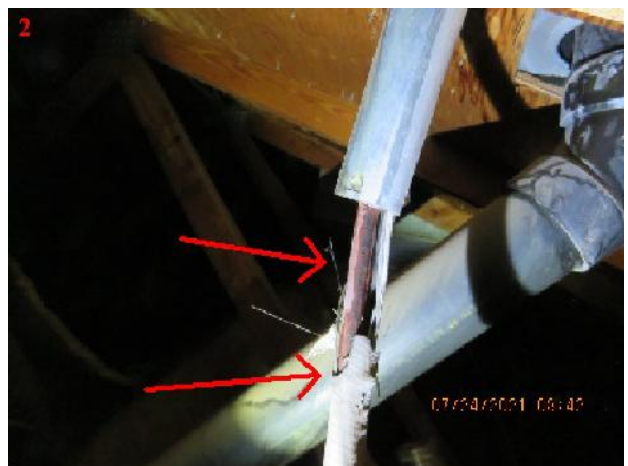
The heat pump electrical line outer layer of insulation is damaged in the attic. Recommend a qualified contractor evaluate and make all necessary repairs.

The heat pump electrical line outer layer of insulation is damaged in the attic.  
Recommend a qualified contractor evaluate and make all necessary repairs.

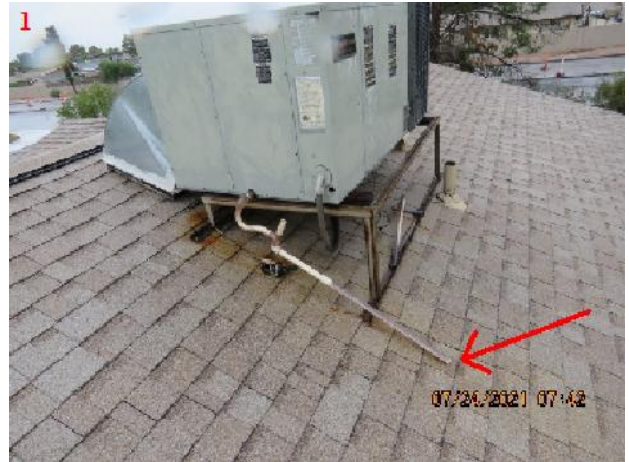
Condensate lines clogged, not properly attached or not properly extended off the roof will allow condensate water to leak onto the roof and this will cause a roof leak. Recommend properly attaching condensate line and extending off roof.

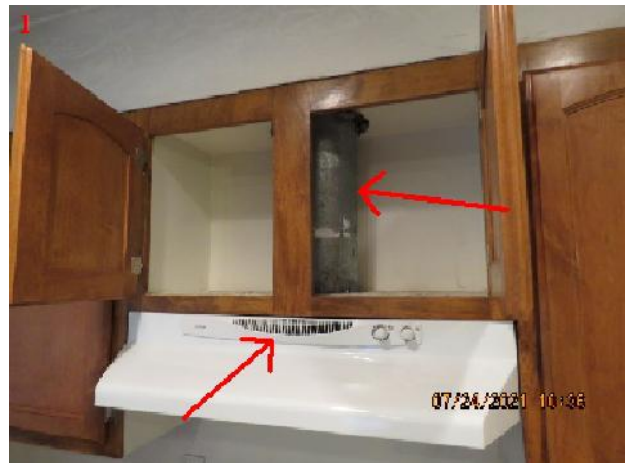
The exhaust hood has a vent pipe but it vents the air back into the kitchen through slits in the top or front of the hood. This is a ductless type hood installed with a duct. Recommend a qualified contractor evaluate and make all needed repairs.

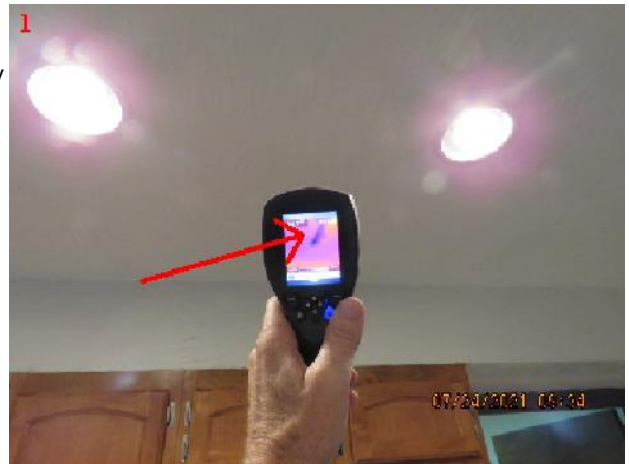
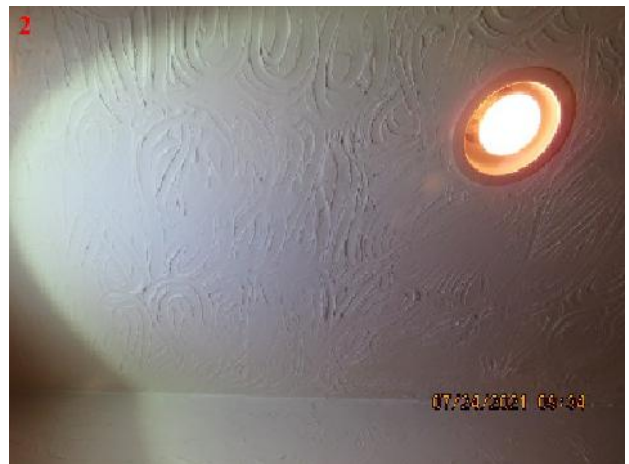
Active water leak on the kitchen ceiling in front of the refrigerator area. See Infrared picture. See attic leak near attic hatch. Recommend a qualified contractor evaluate and make all necessary repairs.

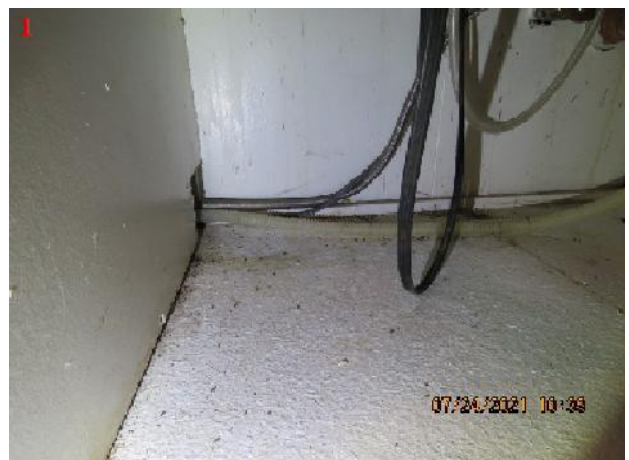
The base of the kitchen sink cabinet has bowed down from water leaking under the sink. Recommend a qualified contractor evaluate and make all necessary repairs. See picture

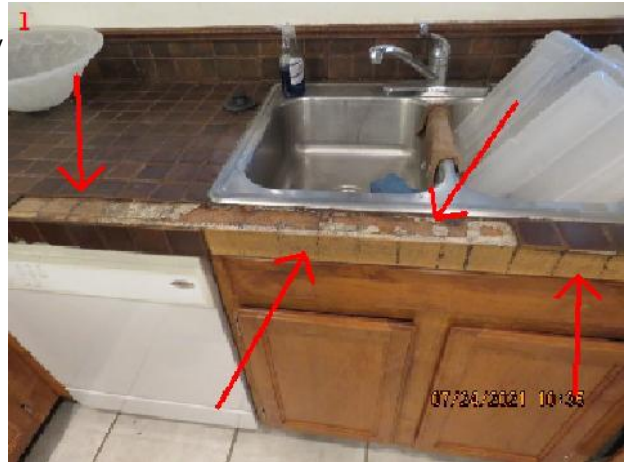
Lots of missing counter top tiles in the kitchen.  
Recommend a qualified contractor evaluate and make all necessary repairs.

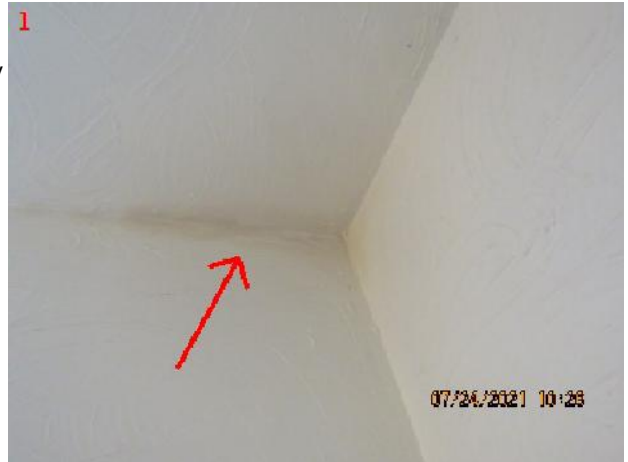
Cracks in the living room walls and water stain on the family room ceiling in the corner.  
Recommend a qualified contractor evaluate and make all necessary repairs.

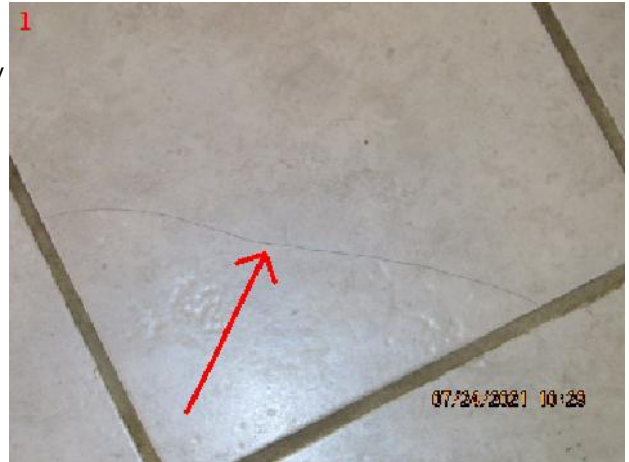
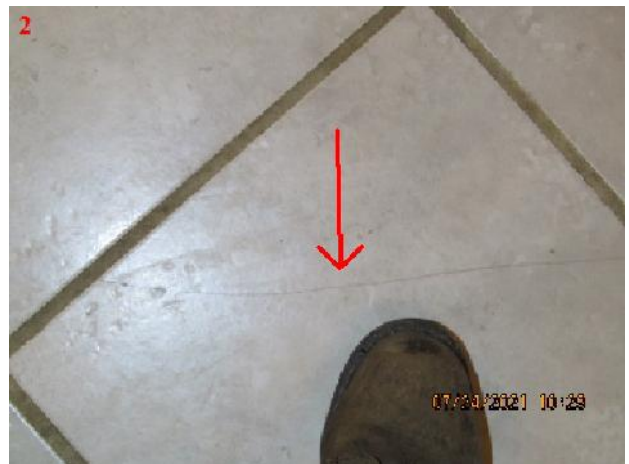
Crack floor tiles in the family room and no floor covering in the living room.  
Recommend a qualified contractor evaluate and make all necessary repairs.

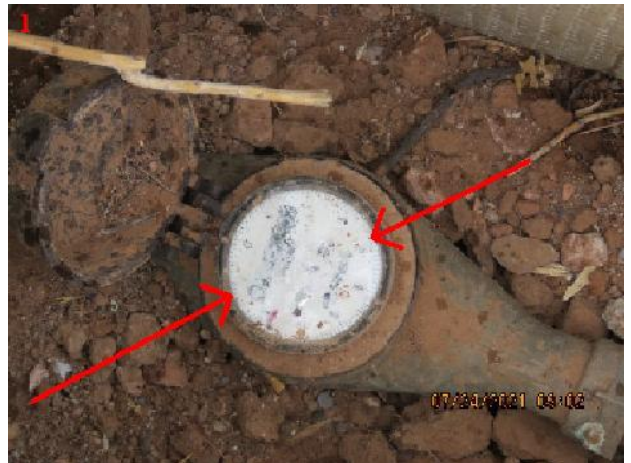
Water inside the glass cover of the water meter. This water meter by the street may be defective and I cannot read it. Recommend calling the water company and having it replaced or repaired.

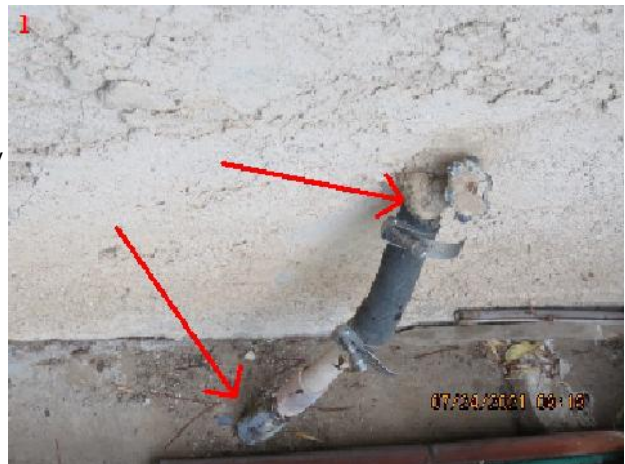
Tested all accessible exterior hose bibbs for water flow and leaks. Interior bibbs such as in a garage are not tested. There is a hose bibb on the south side of the house that is hooked to a pipe running into the ground. This hose bibb valve handle is stuck and I do not know where this pipe is going to. Recommend a qualified contractor evaluate and make all necessary repairs.

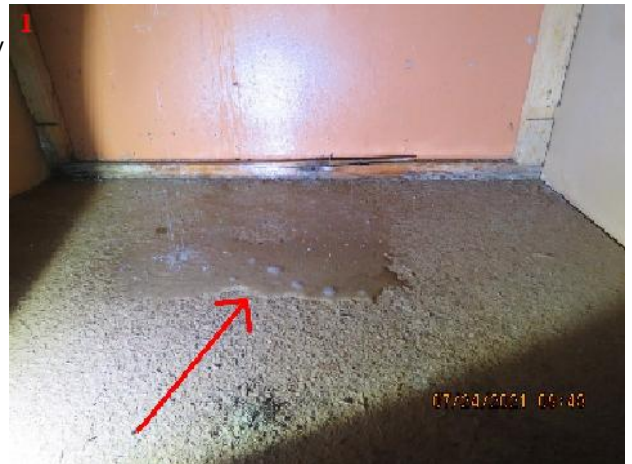
Water damage to the base of the master bathroom sink cabinet. Recommend a qualified contractor evaluate and make all necessary repairs.

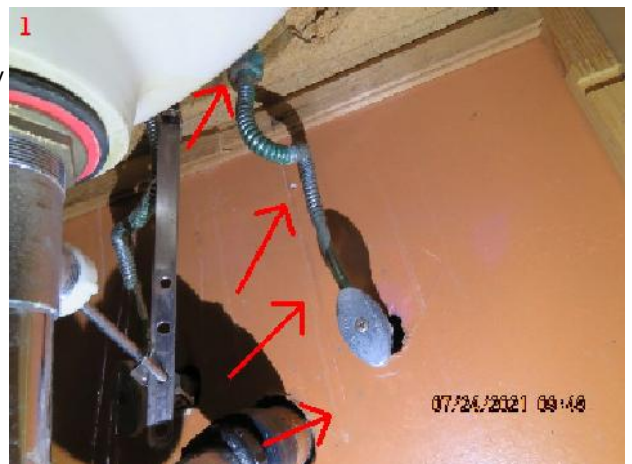
When the master bathroom sink faucet is running water leaks to the base of the sink cabinet below. Recommend a qualified contractor evaluate and make all necessary repairs.

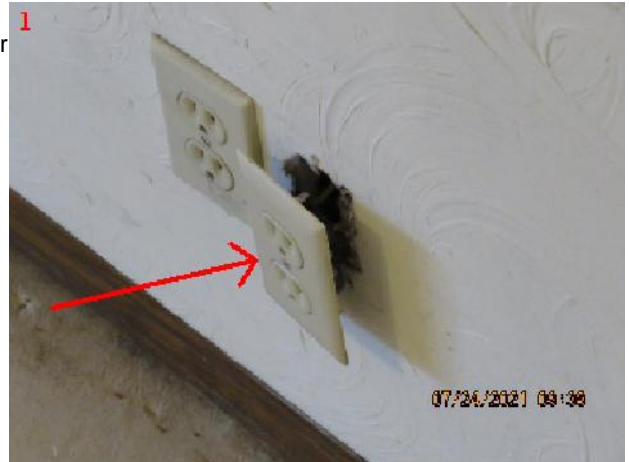
One outlet in the master bedroom is hanging out of the wall.  
This is a shock hazard. Recommend a qualified electrical contractor evaluate and make all necessary repairs.

One outlet in the master bedroom is hanging out of the wall. This is a shock hazard. Recommend a qualified electrical contractor evaluate and make all necessary repairs.

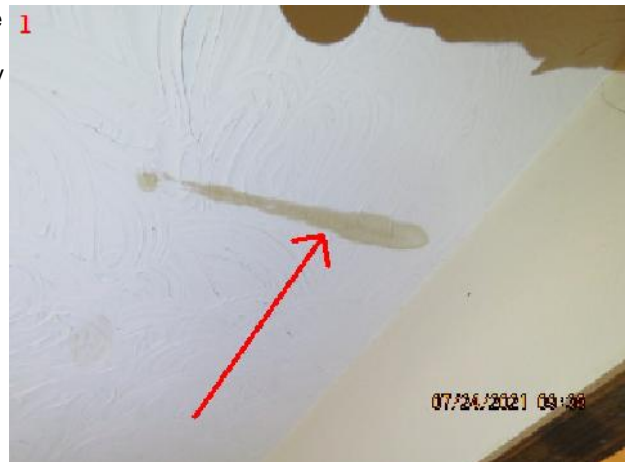
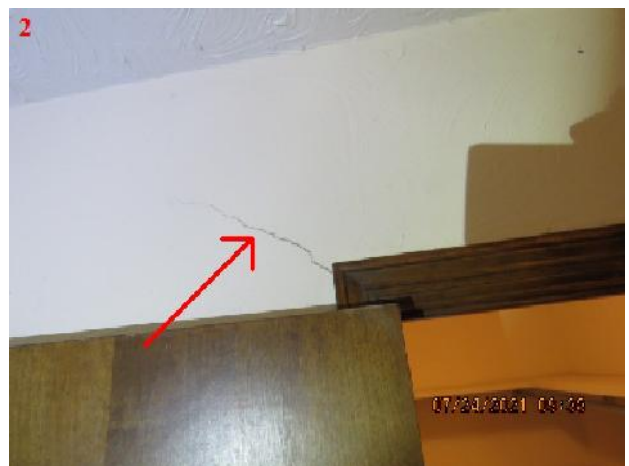
Stains on the ceiling look like water stains. There is a crack on the wall in the master bedroom. Recommend a qualified contractor evaluate and make all necessary repairs.

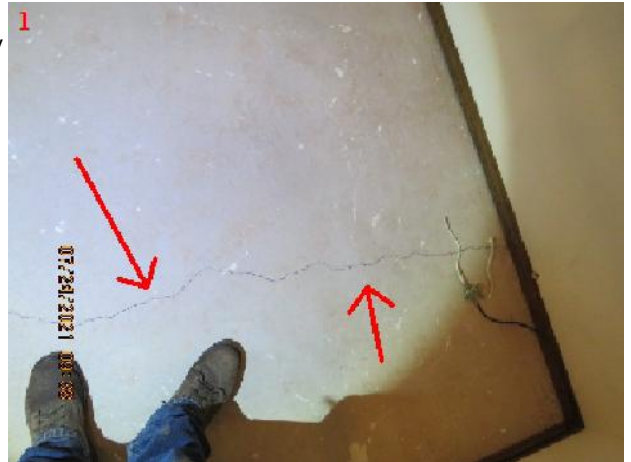
There is a small crack in the concrete slab in this bedroom.  
Recommend a qualified contractor evaluate and make all necessary repairs.

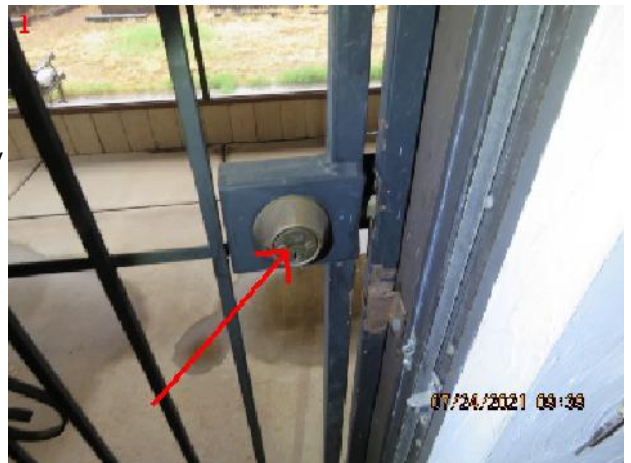
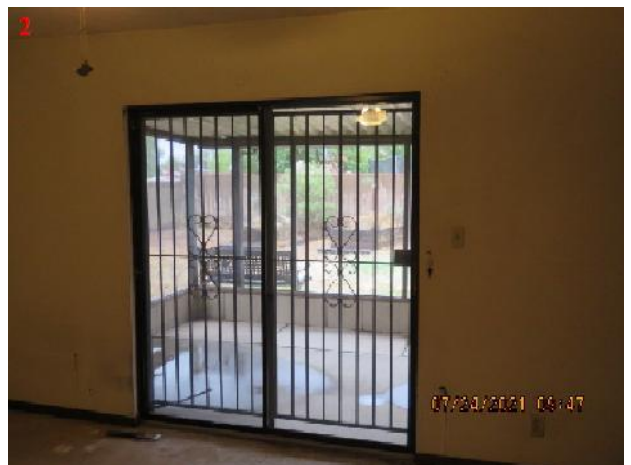
No window or door leading directly to the exterior from this master bedroom.  
All residential bedroom are required to have a door or window directly to the exterior allow egress to and from the bedroom for a fire escape.  
Recommend a qualified contractor evaluate and make all necessary repairs.  
Double cylinder dead bolt used on door to the enclosed patio. Recommend using standard dead bolts type of lock on exterior doors because double dead bolt locks block fire escapes.

No window or door leading directly to the exterior from this master bedroom.  
All residential bedroom are required to have a door or window directly to the exterior allow egress to and from the bedroom for a fire escape.  
Recommend a qualified contractor evaluate and make all necessary repairs.  
Double cylinder dead bolt used on door to the enclosed patio.  
Recommend using standard dead bolts type of lock on exterior doors because double dead bolt locks block fire escapes.

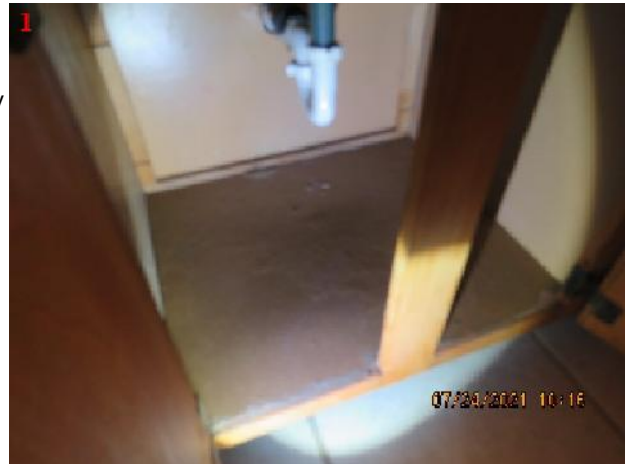
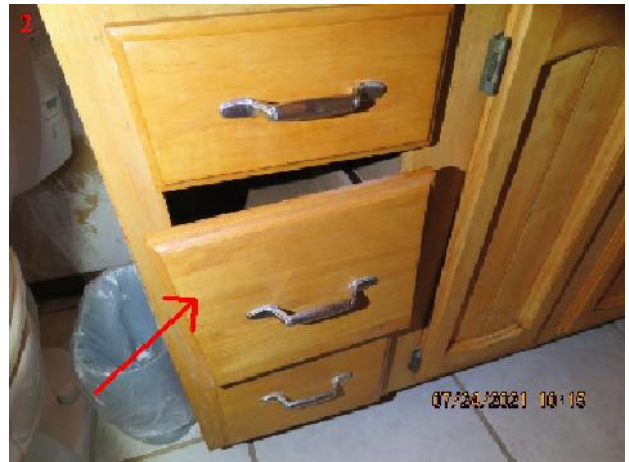
Some water damage to this bathroom sink cabinet from prior water leaks. A drawer in the hall bathroom sink cabinet is not properly attached. Recommend a qualified contractor evaluate and make all necessary repairs.

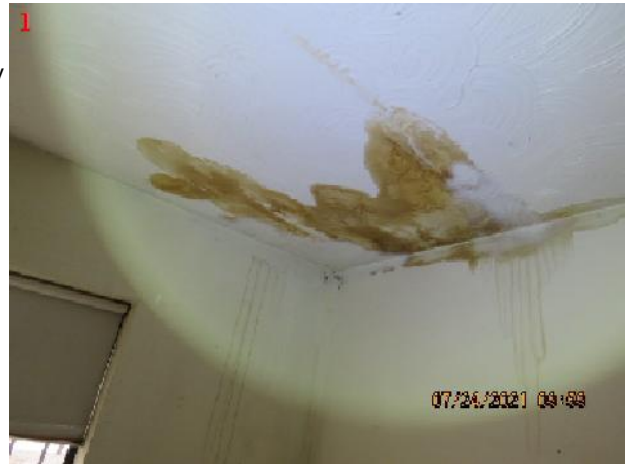
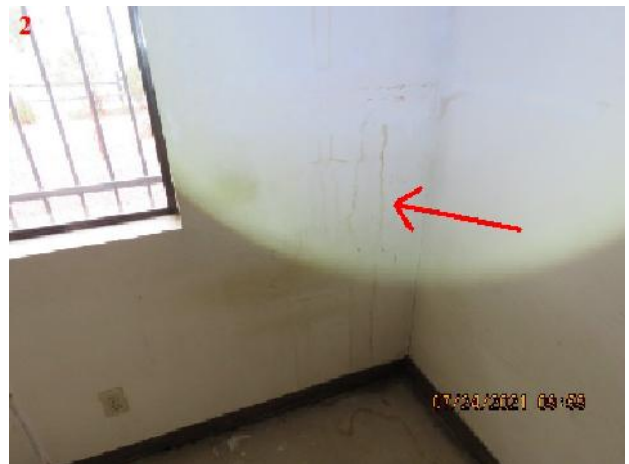
Massive water strains on the ceiling and walls in this bedroom. Not wet at this time and it is raining outside. Recommend a qualified contractor evaluate and make all necessary repairs.

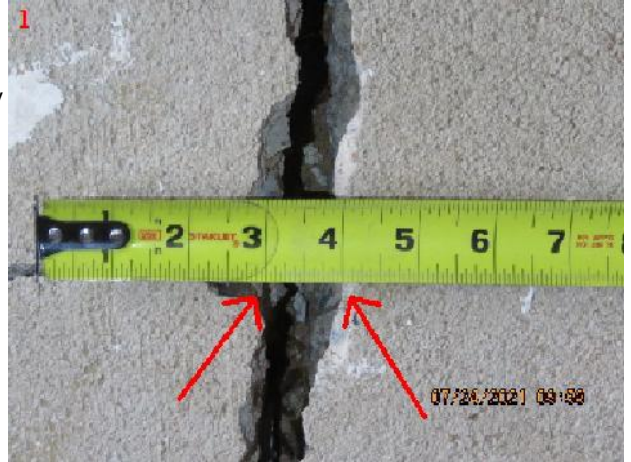
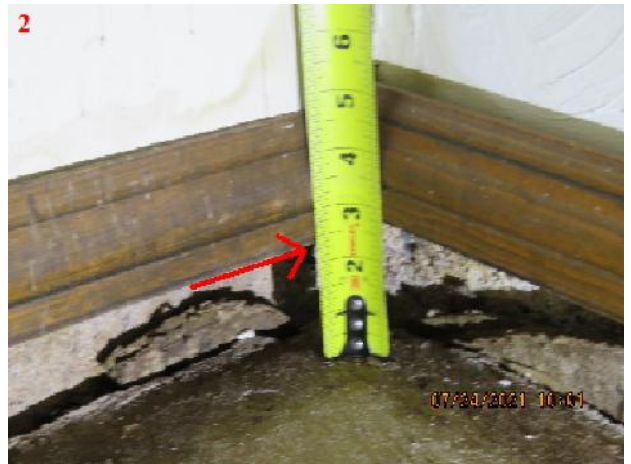
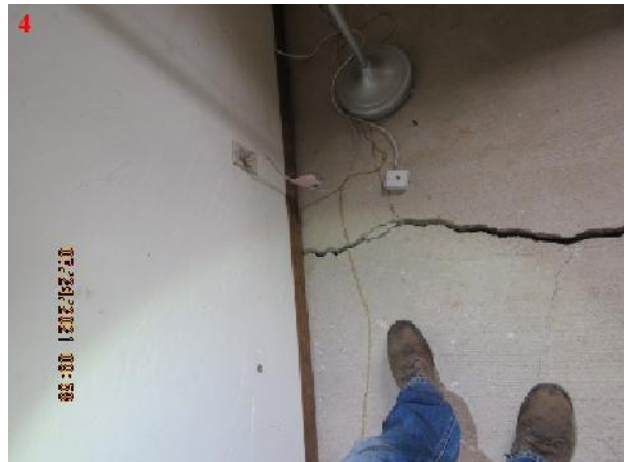
Large crack running across the center of the floor in this bedroom is up to 1 inch wide and a section of the slab has dropped over 2 inches in 5 feet.

Large crack running across the center of the floor in this bedroom is up to 1 inch wide and a section of the slab has dropped over 2 inches in 5 feet.  
Recommend a qualified contractor evaluate and make all necessary repairs.

Recommend a qualified contractor evaluate and make all necessary repairs.

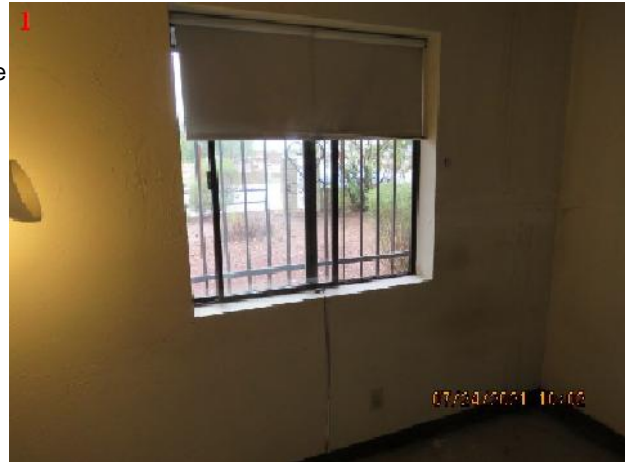
Bars permanently installed outside of window without a quick release are a fire escape hazard. Recommend removing bars from window before sleeping in room. Bars on windows are a fire escape hazard even if they have a quick disconnect. How can a fireman enter if no one opens the bars??

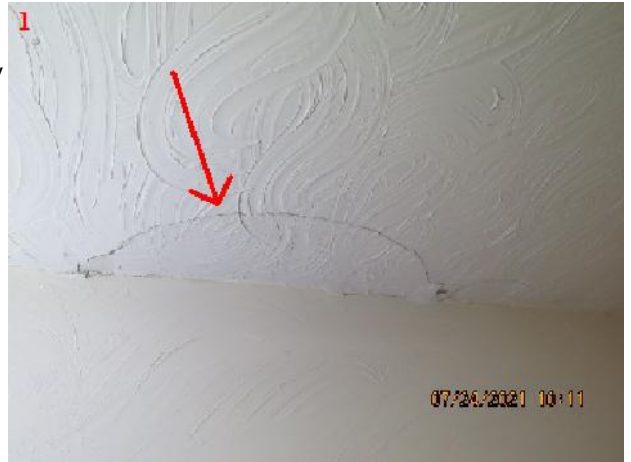
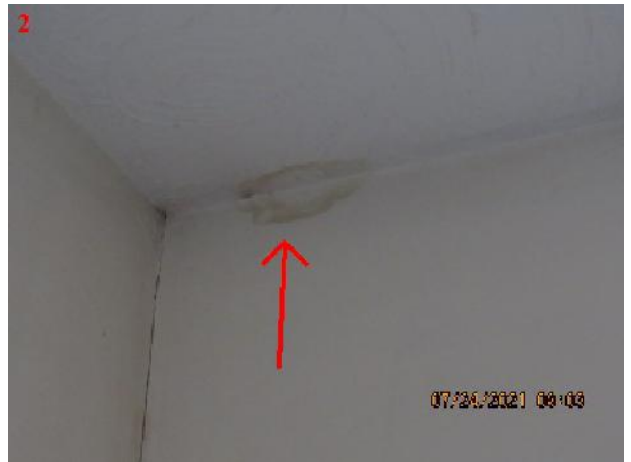
Cracks on the ceiling and wall in this room and water stains on the ceiling and wall but on wet at this time.  
Recommend a qualified contractor evaluate and make all necessary repairs.
