**Perfection Home Inspections**  
**Mesa, AZ 85203**  
**602-524-2916**  
**perfectionhomeinspections.com**

Client Information: Record Number 8613

**Sturgeon, Melanie**  
**1211 S. Barkley**  
**Mesa, AZ 85204**  
**480-881-6717**

Inspected 7/24/21 8:00 AM  
Built 1980  
1688 sf

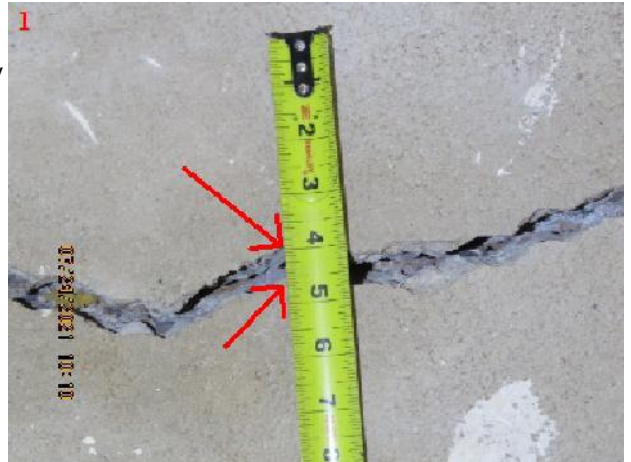
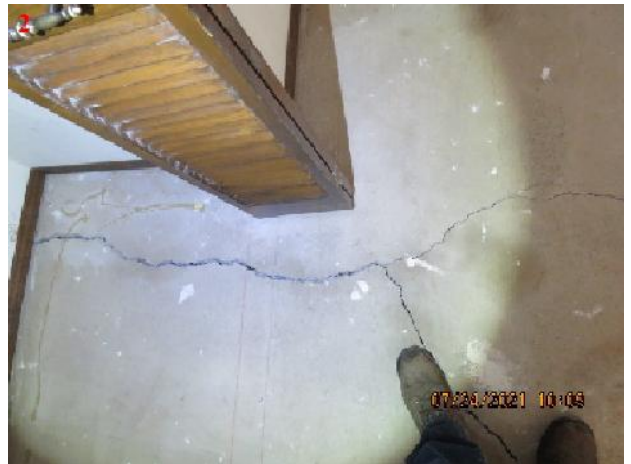
There is a large crack running through the closet and most of the bedroom and it is up to 1/2 of an inch wide.

There is a large crack running through the closet and most of the bedroom and it is up to 1/2 of an inch wide. Recommend a qualified contractor evaluate and make all necessary repairs.

Recommend a qualified contractor evaluate and make all necessary repairs.

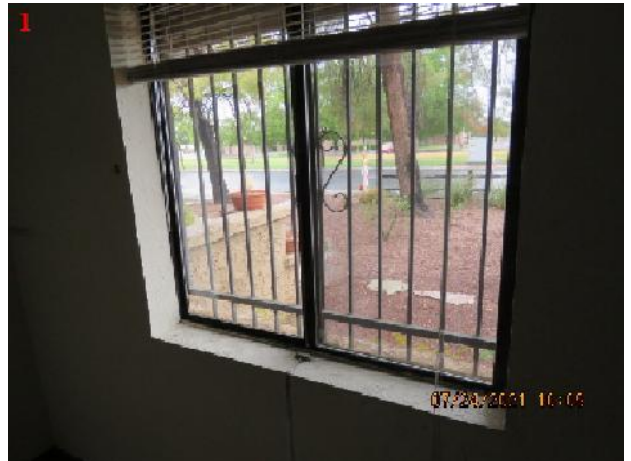
Bars permanently installed on window without a quick release are a fire escape hazard. Recommend removing bars from window before sleeping in room. Bars on windows are a fire escape hazard even if they have a quick disconnect. How can a fireman enter if no one opens the bars??
