DONAN[®]

MS. MELANIE STURGEON
1211 SOUTH BARKLEY
MESA, ARIZONA 85204-5912
CLAIM NUMBER: 046096968-01
DONAN PROJECT NUMBER: 55-21070005-0

RE: **Ms. Melanie Sturgeon**
1211 South Barkley
Mesa, Arizona 85204-5912
Claim Number: 046096968-01
Donan Project Number: 55-21070005-0

At your request, on July 12, 2021, a study was made on the house at the above-referenced address. The purpose of the study was to determine the cause of the displaced floor. Ms. Melanie Sturgeon was present to point out areas of concern and to provide firsthand information. This letter, with the enclosed photographs, is the report of my findings and conclusions.

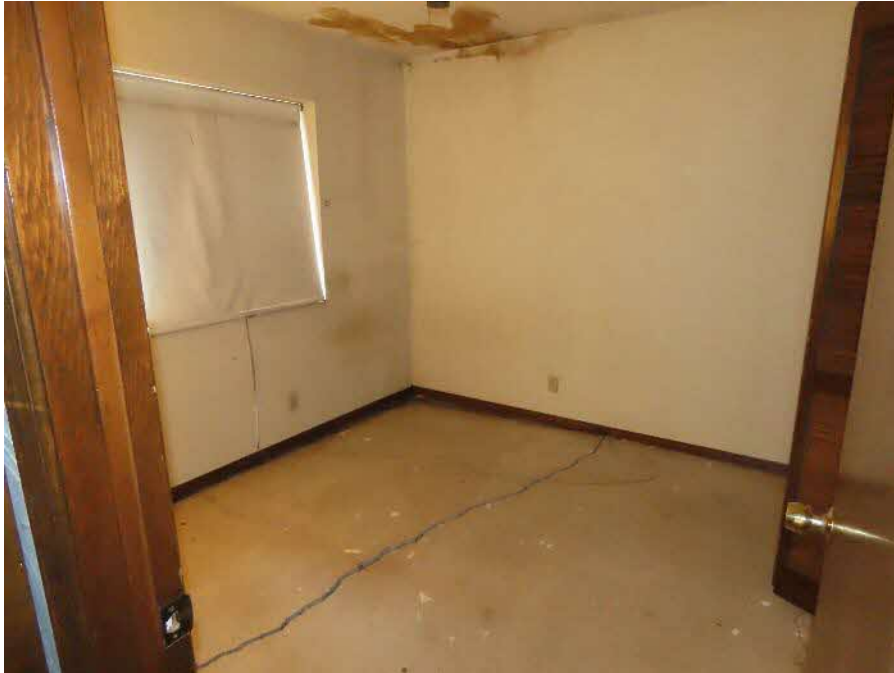
A crack in the concrete slab is up to 1-inch wide with sharp, bright edges and spans north-south approximately 4 feet east of the west wall of the northwest bedroom (Photographs 5 through 7). The crack extends into a bedroom to the south and turns toward the west edge of the house. The crack intersects the west edge of the foundation approximately 12 feet south of the northwest corner (Photographs 8 and 9).

Photograph 5: The northwest bedroom.

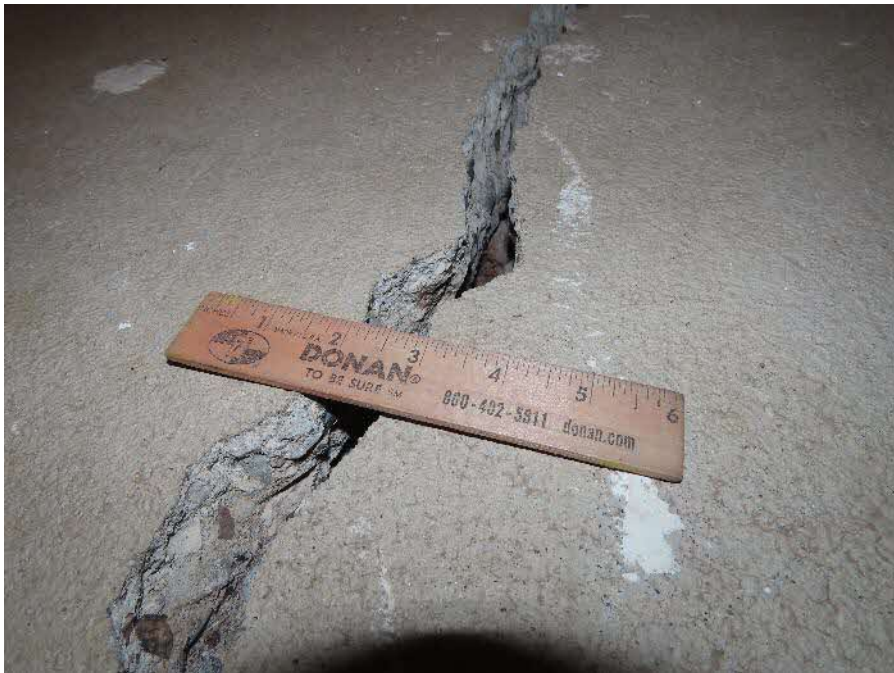
Concrete slab cracks greater than ½ inch wide and that are vertically offset on opposing edges, unlevel floors, and diagonal cracks in wall finish surfaces are caused by differential movement of the supporting soil. Soil that is exposed to excessive moisture has an increased potential to settle differentially when compared to soil that is exposed to excessive moisture. Moisture content readings on the ceiling, and leak detection testing results, indicate that excessive moisture from a roof or plumbing leak do not contribute to differential settlement. The absence of gutters near the northwest corner and grade slope readings are evidence that inadequate drainage in the area worsens differential settlement. The displaced

Photograph 6: The crack in the northwest bedroom floor slab.

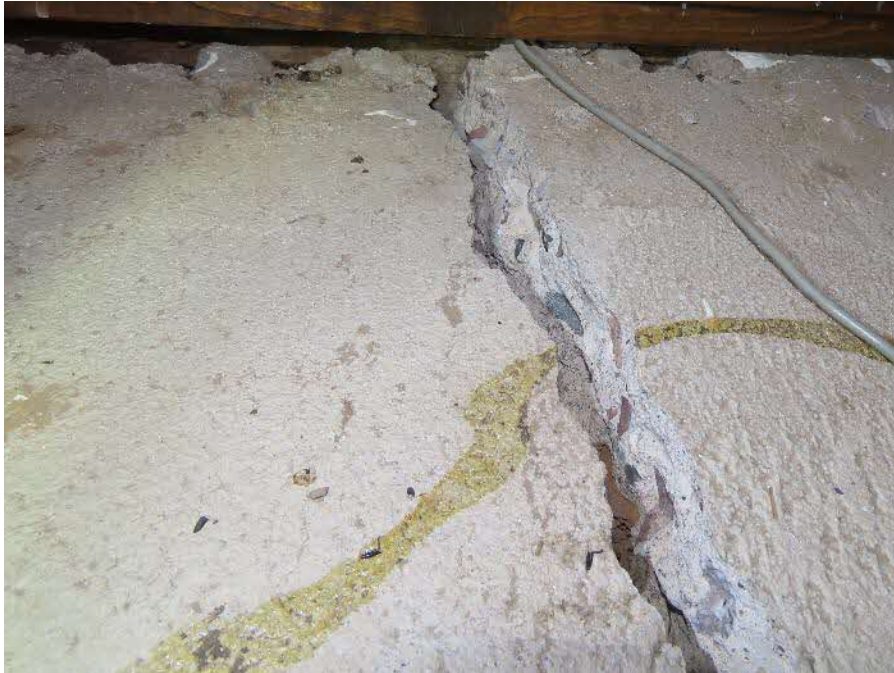
Photograph 7: The cracks has sharp, bright edges.

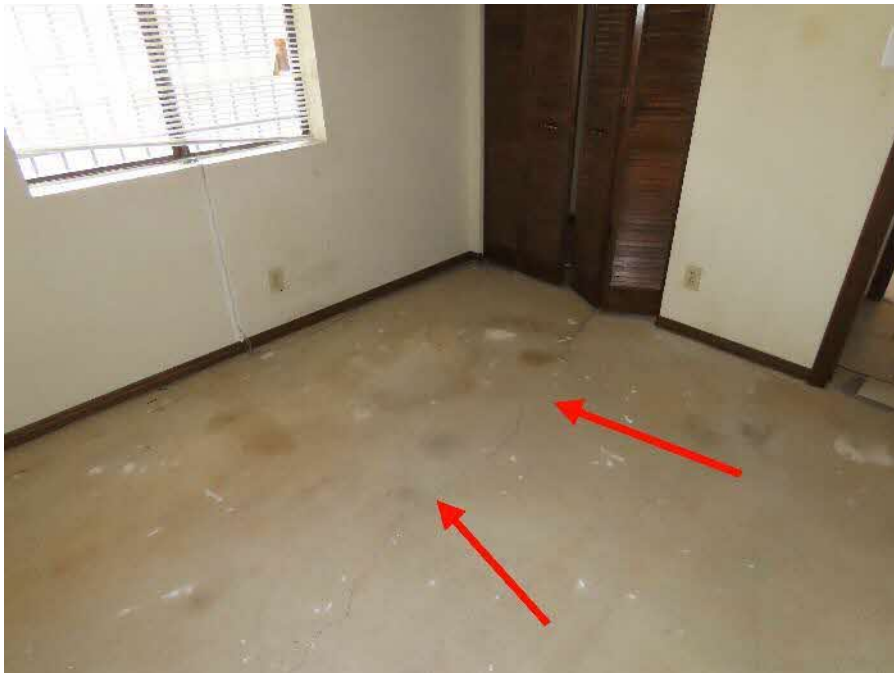
Photograph 8: The crack in the bedroom south of the northwest bedroom.

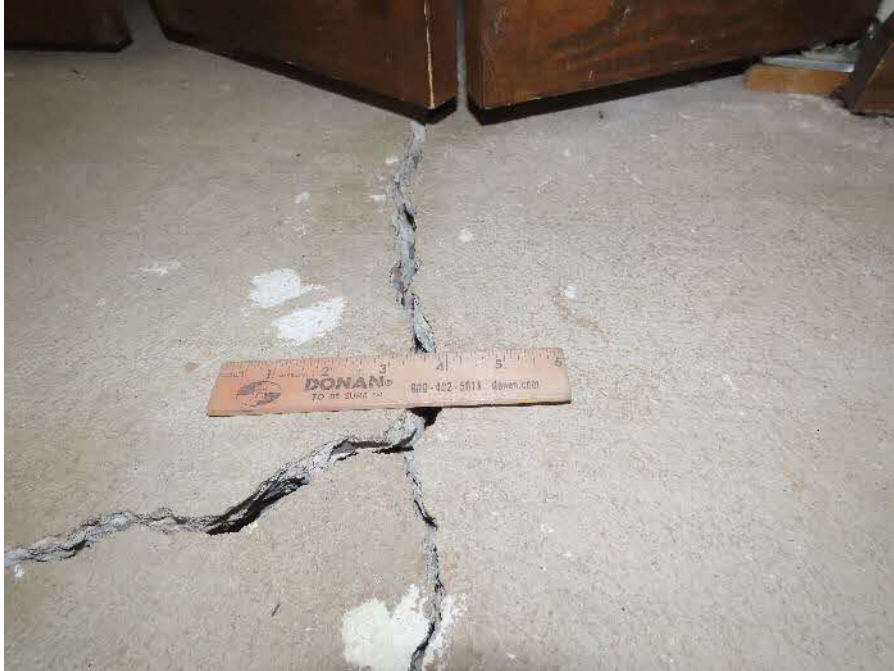
Photograph 9: The crack in the bedroom south of the northwest bedroom.

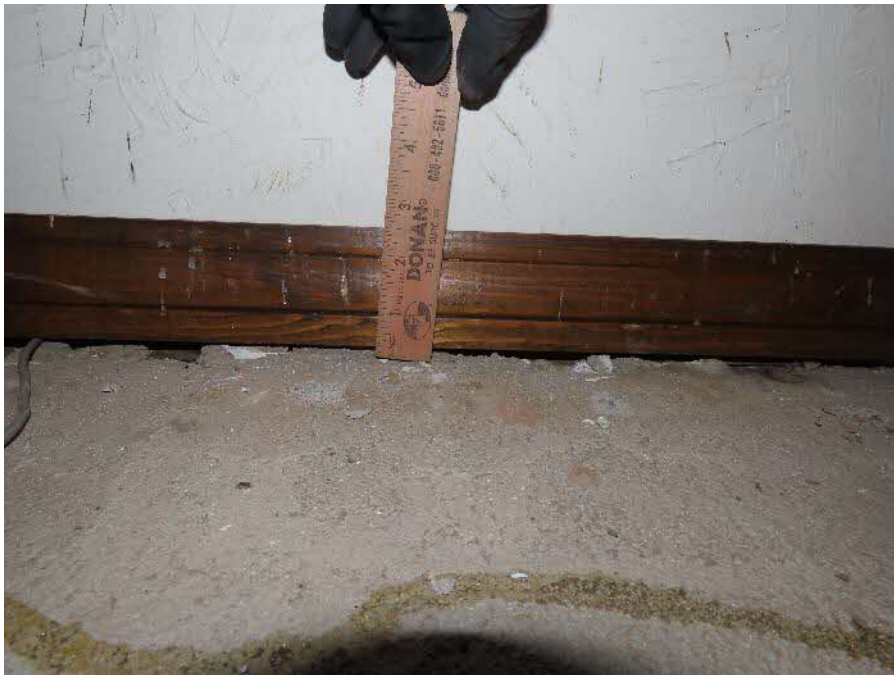
In the northwest bedroom, the baseboard trim is tight to the top of the slab on the east side of the crack (Photograph 10). At the northwest corner, a 3 inch gap is between the bottom of baseboard trim and the top of the slab (Photograph 11).

Photograph 10: The baseboard on the east side of the crack.

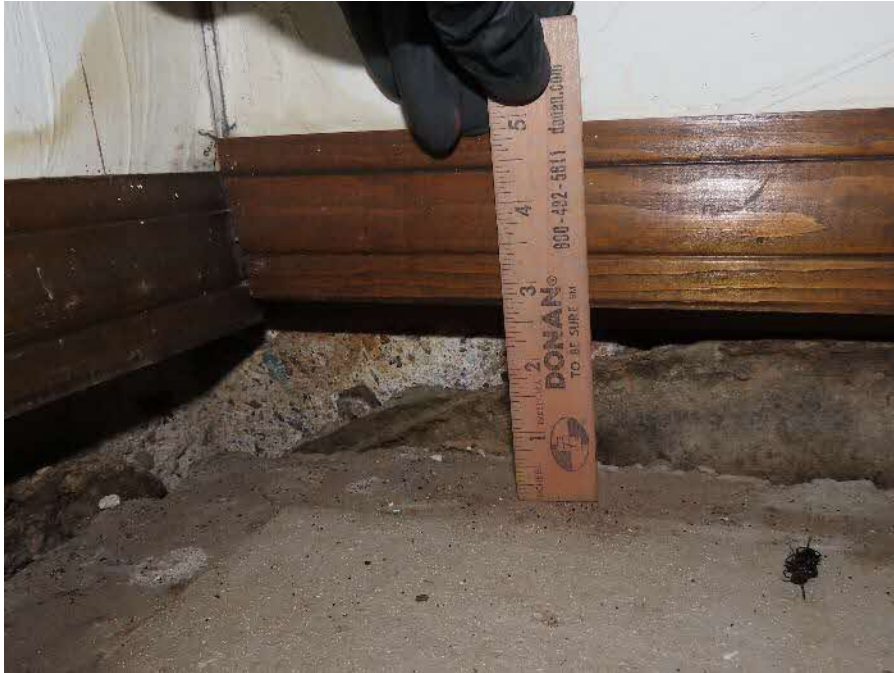
Photograph 11: The baseboard at the northwest corner.

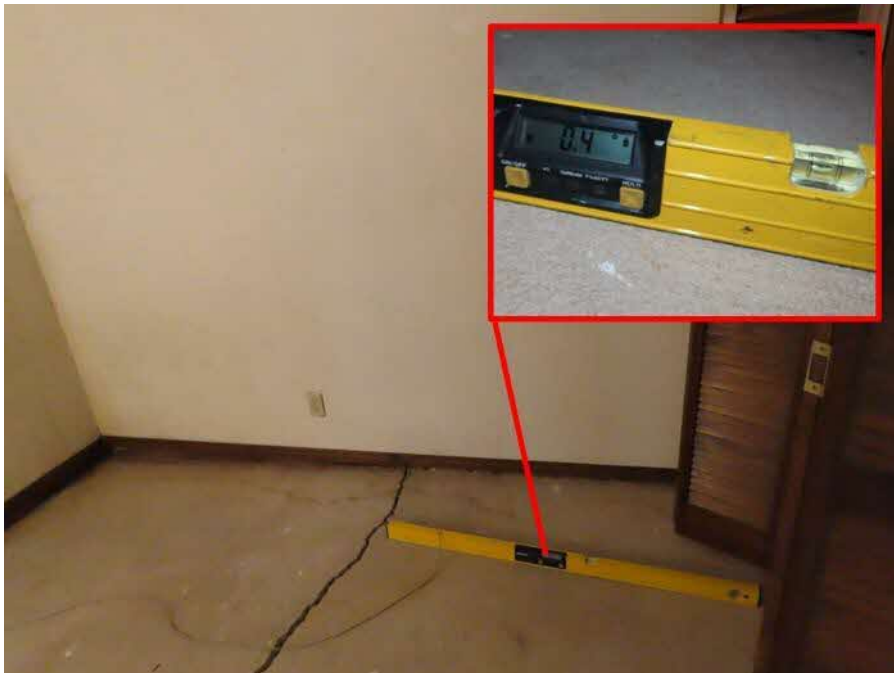
East of the crack, the floor slab is level and free of cracks (Photograph 12).¹ West of the crack the floor slab slopes down 2.0 and 1.3 degrees toward the west and north, respectively (Photographs 13 and 14).

Photograph 12: A slope reading on the east side of the crack.

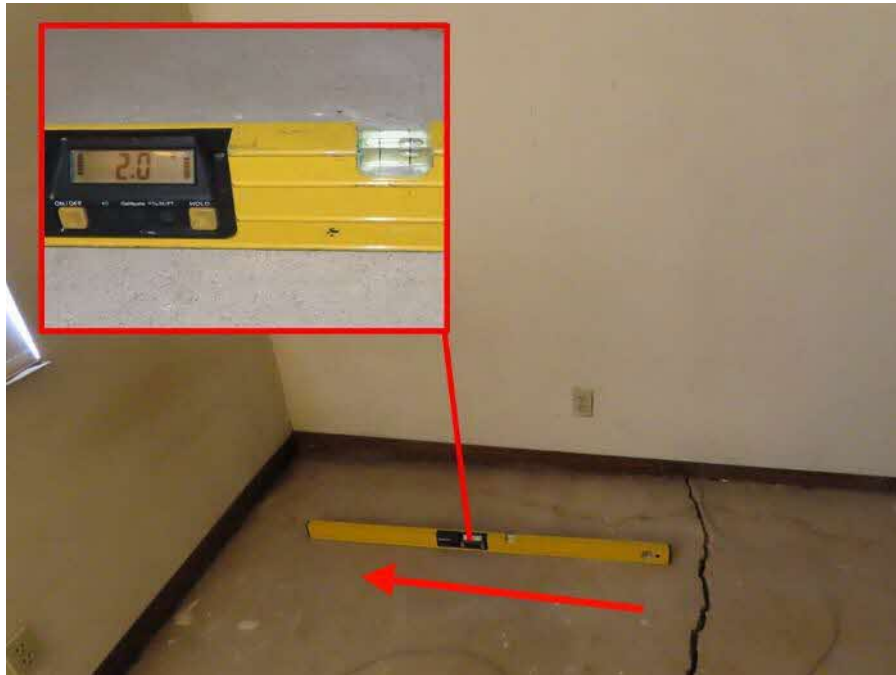
Photograph 13: A slope reading on the west side of the crack.

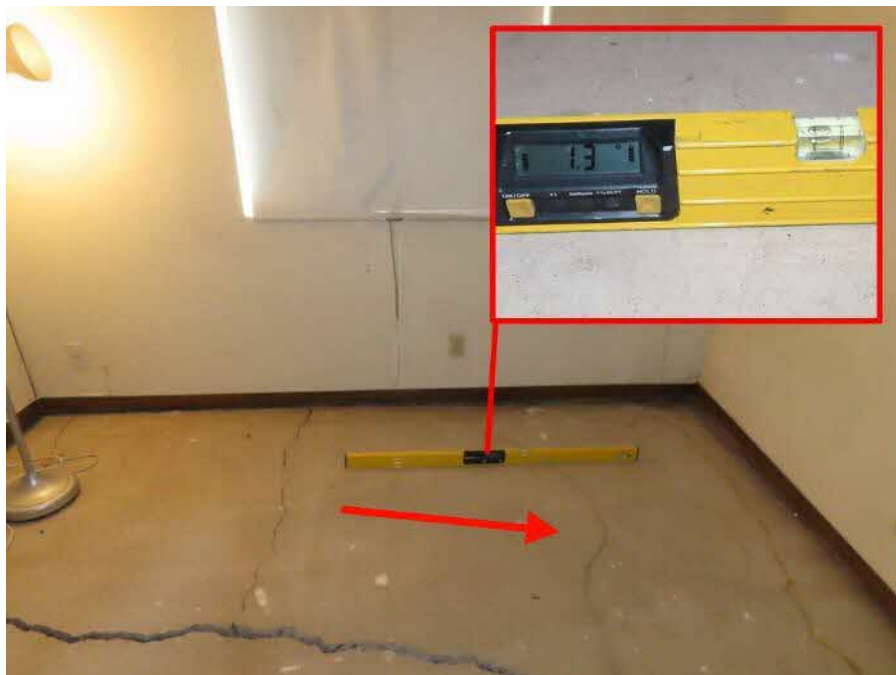
Photograph 14: A slope reading on the west side of the crack.

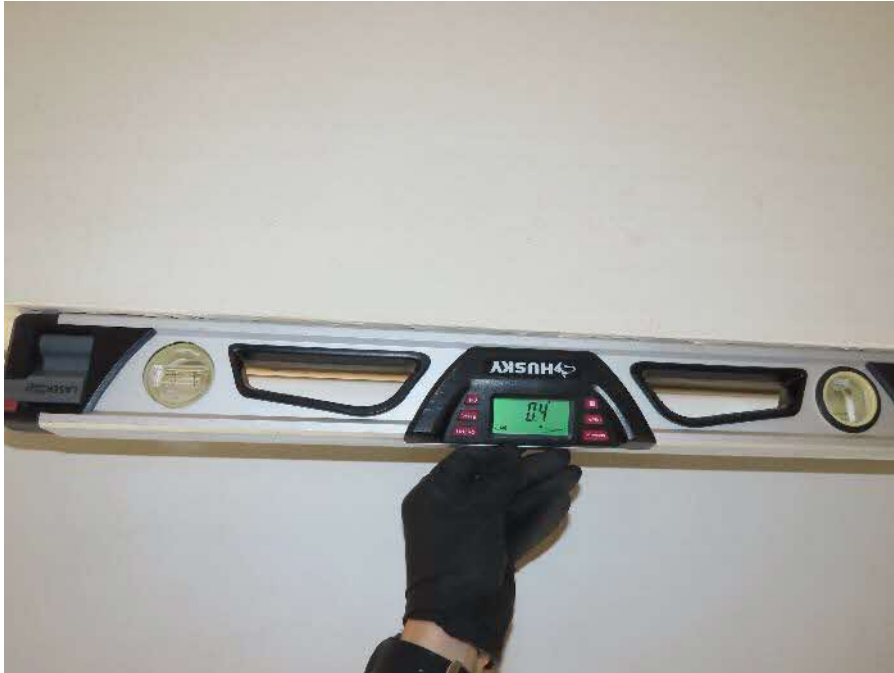
The top of a window opening on the west wall of the northwest bedroom is level (Photograph 15). Comparative moisture readings of the ceiling at brown stains at the northwest corner and the ceiling away from brown stains are zero (Photographs 16 and 17).²

Photograph 15: A slope reading at the top of the window on the west wall.

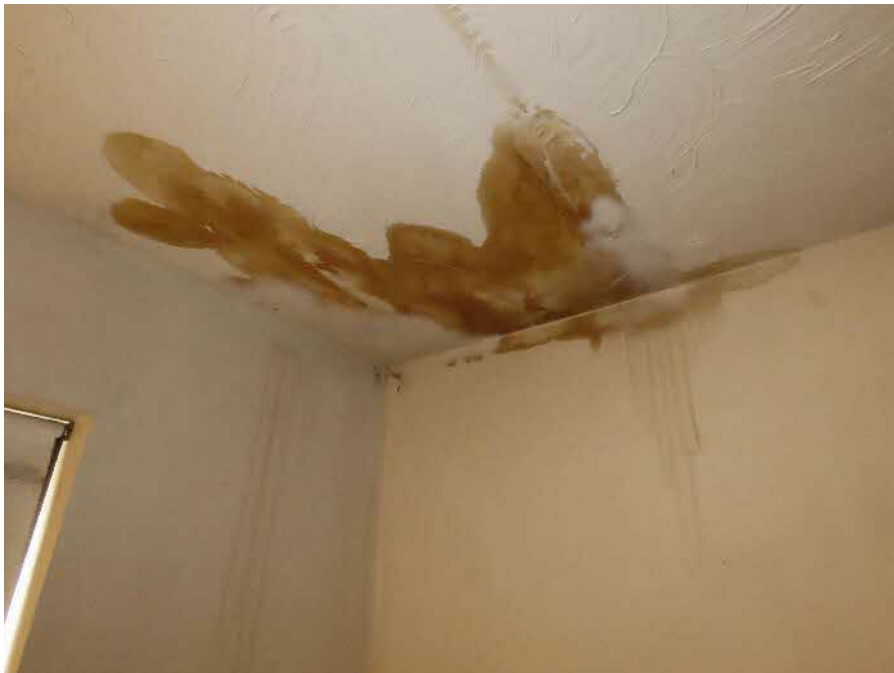
Photograph 16: A stain on the ceiling at the northwest corner.

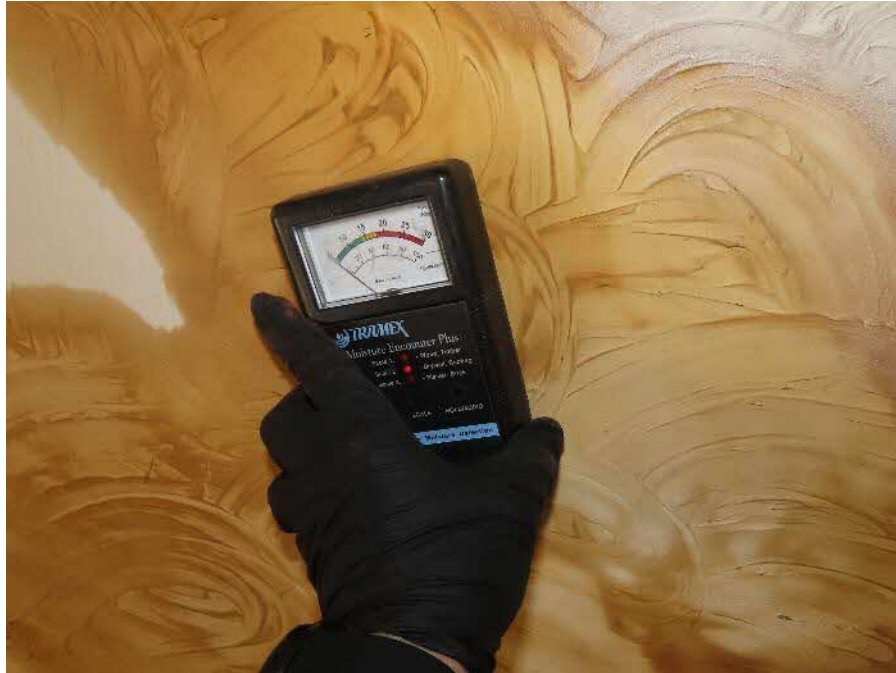
Photograph 17: A comparative moisture reading on the stain.

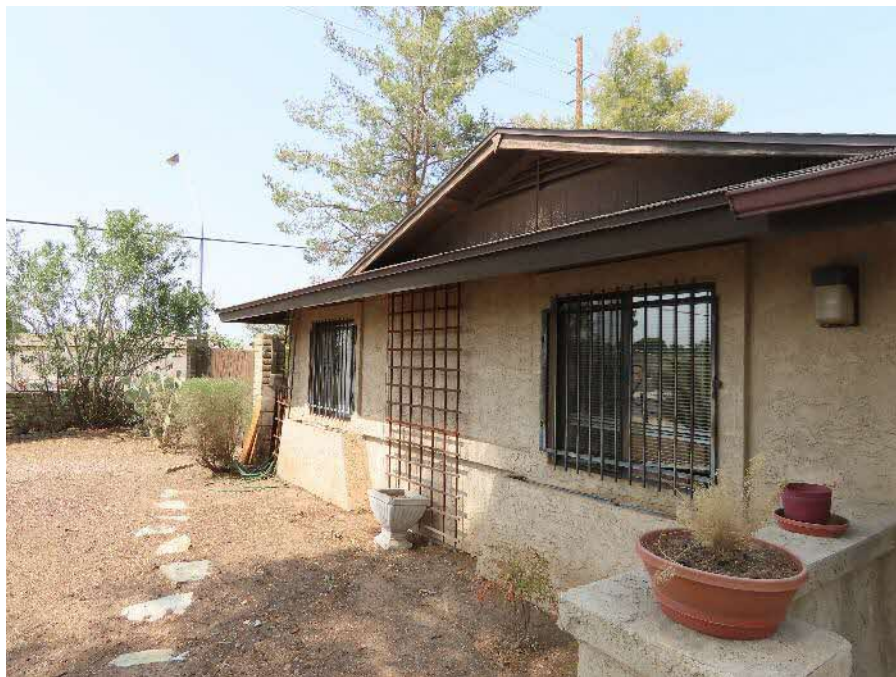
Gutters are not on the house near the northwest corner (Photograph 18). Grade slope readings near the north end of the west side are 1.4 percent down, toward the foundation (Photograph 19). Cracks in stucco with rounded edges and that are not offset horizontally on opposing edges extend from the corners of window openings (Photograph 20).

Photograph 18: The north end of the west side.

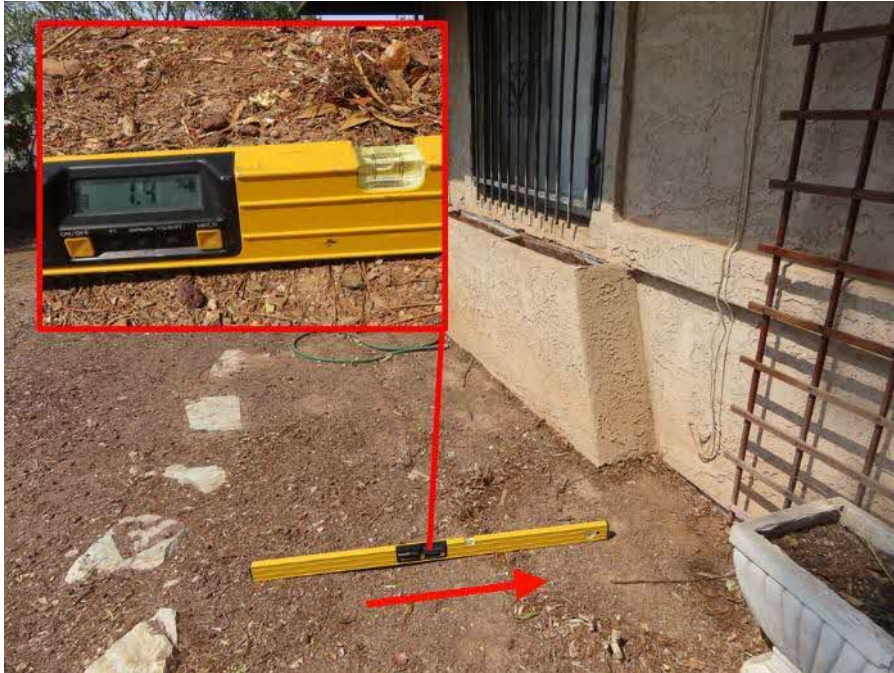
In order to prevent water from damaging the foundation system or entering a building, the ground surface adjacent to a building should slope away from the building. The *International Residential Code* (IRC) and good construction practices require a minimum of a 6-inch vertical drop in 10 feet of horizontal length around building foundations.³ This equates to a 5-percent slope away from the structure. Good construction practices also dictate that impervious surfaces within 10 feet of the building foundation slope away at a minimum of 2 percent.

Photograph 19: A grade slope reading near the north end of the west side.

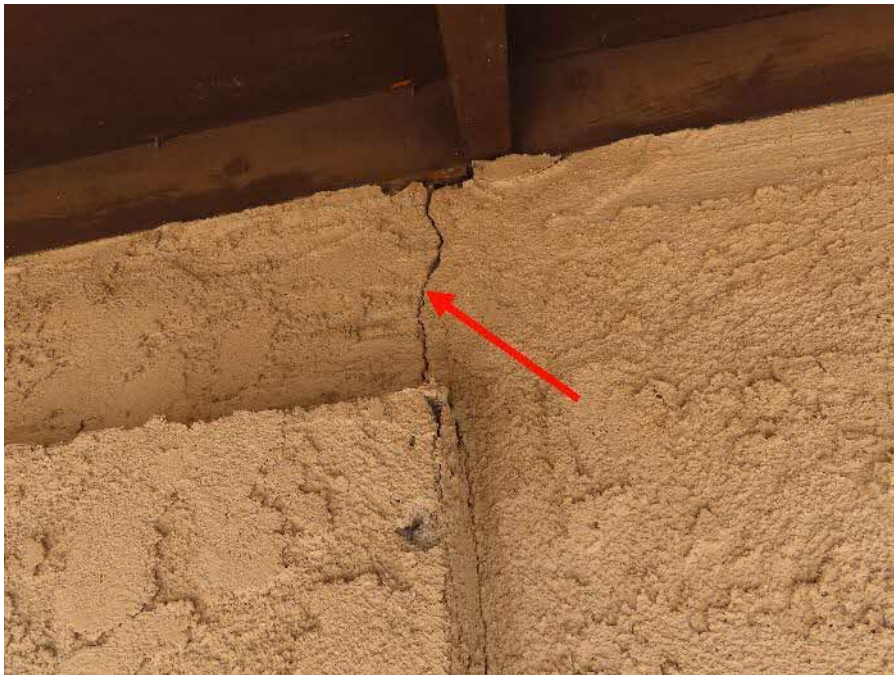
Photograph 20: A crack in stucco that extends from the corner of a window opening.

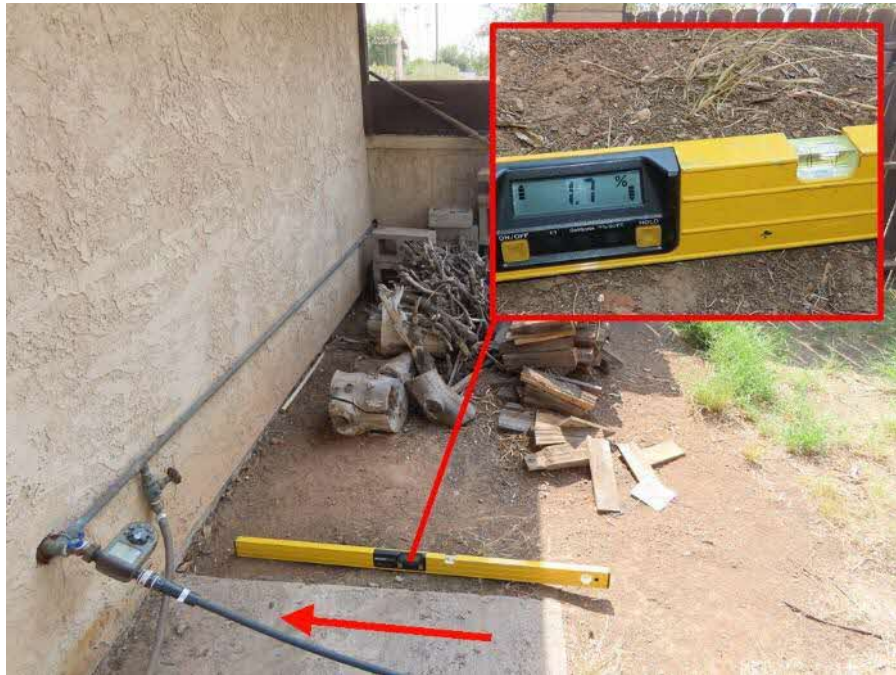
Near the west end of the north wall, grade slope readings are 1.7 percent down, toward the foundation (Photograph 21). Cracks with rounded edges, that are not offset on opposing edges, and that are surrounded by paint that does not match the prevailing wall color extend from windows (Photographs 22 and 23).

Photograph 21: A grade slope reading near the west end of the north side.

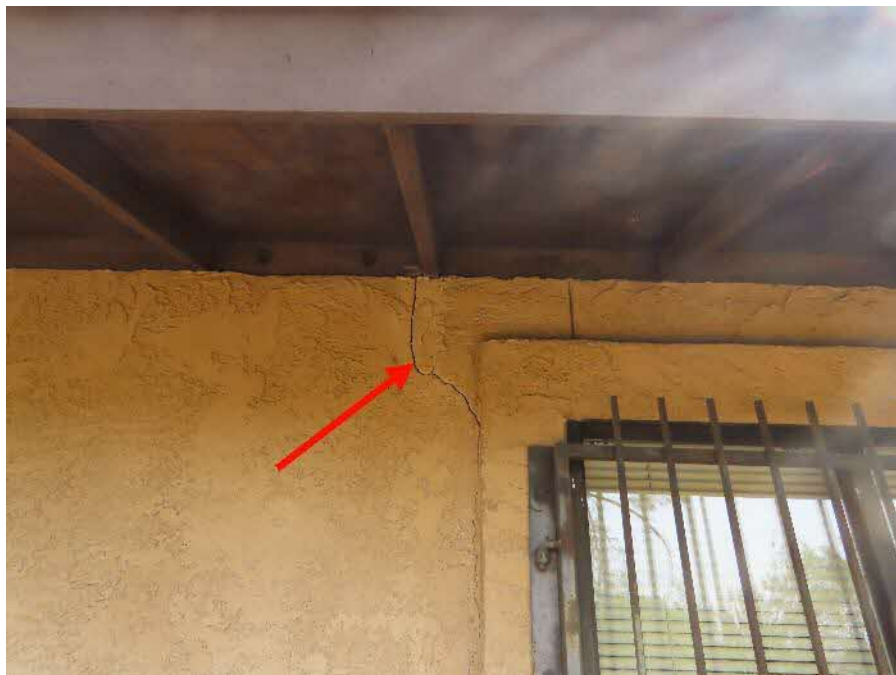
Photograph 22: A diagonal crack extends from the corner of a window opening.

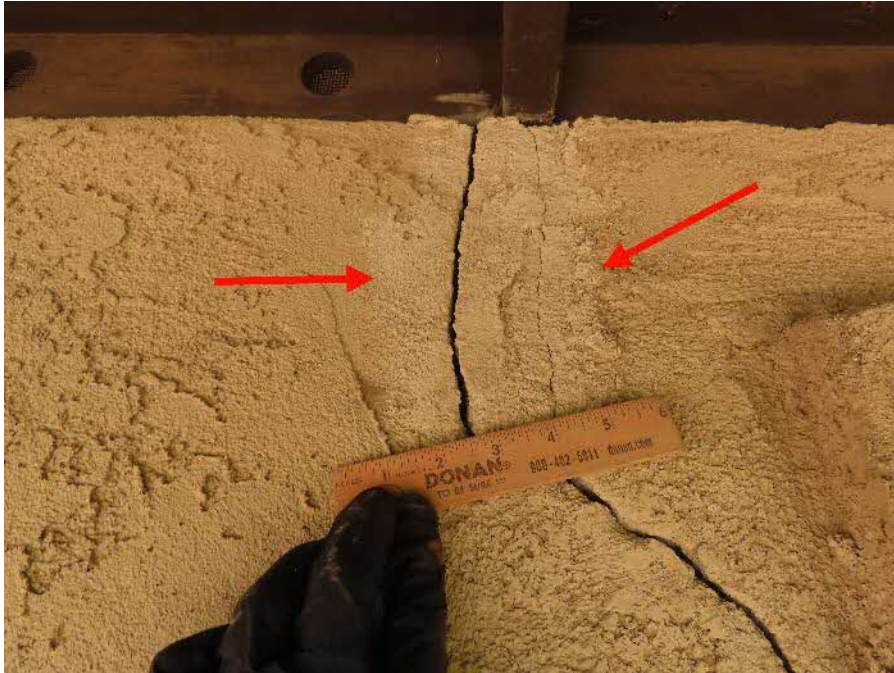
Photograph 23: The crack has rounded edges and is surrounded by paint that does not match the prevailing surface.

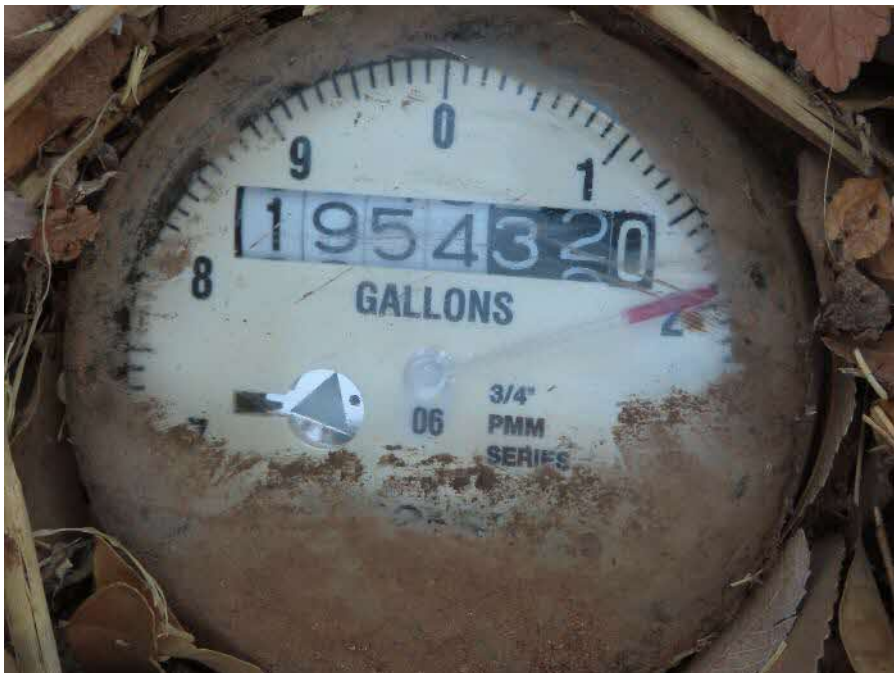
All water outlets inside and outside the house were turned off so that a leak detection test of the domestic supply plumbing could be performed. The water meter was monitored for 28 minutes and did not change during the test (Photographs 24 and 25).

Photograph 24: The water meter at the beginning of the leak test.

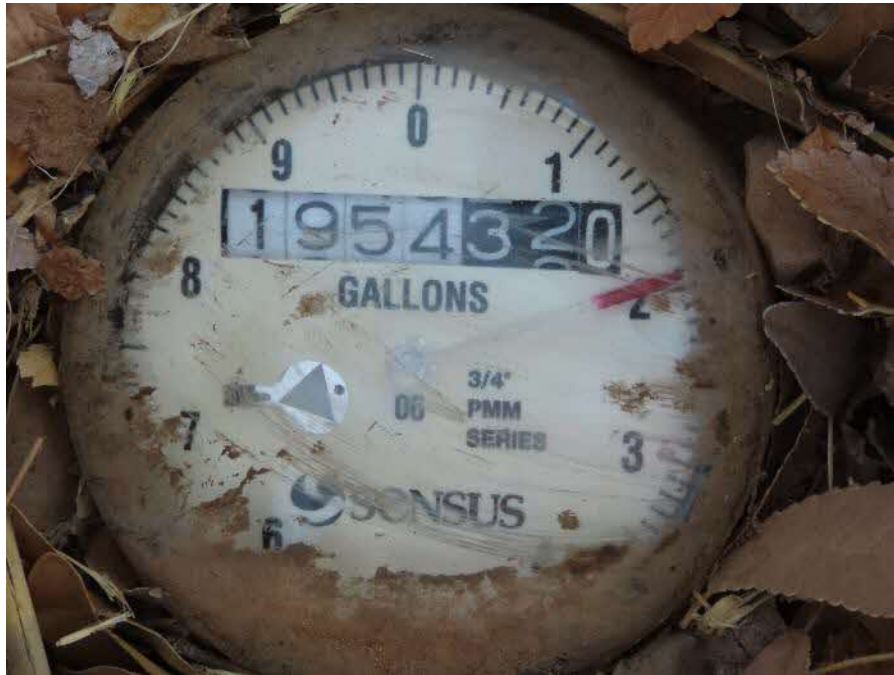
Photograph 25: The water meter at the end of the 28 minute leak test.
