Phillip A. DeLoatch
12175 US158 HWY
Conway, North Carolina 27820
Commercial Building Inspection
October 26, 2021

SUBJECT PROPERTY:
2100 Old US Hwy 64
Jamesville, North Carolina 27846

Summary of Deficiencies

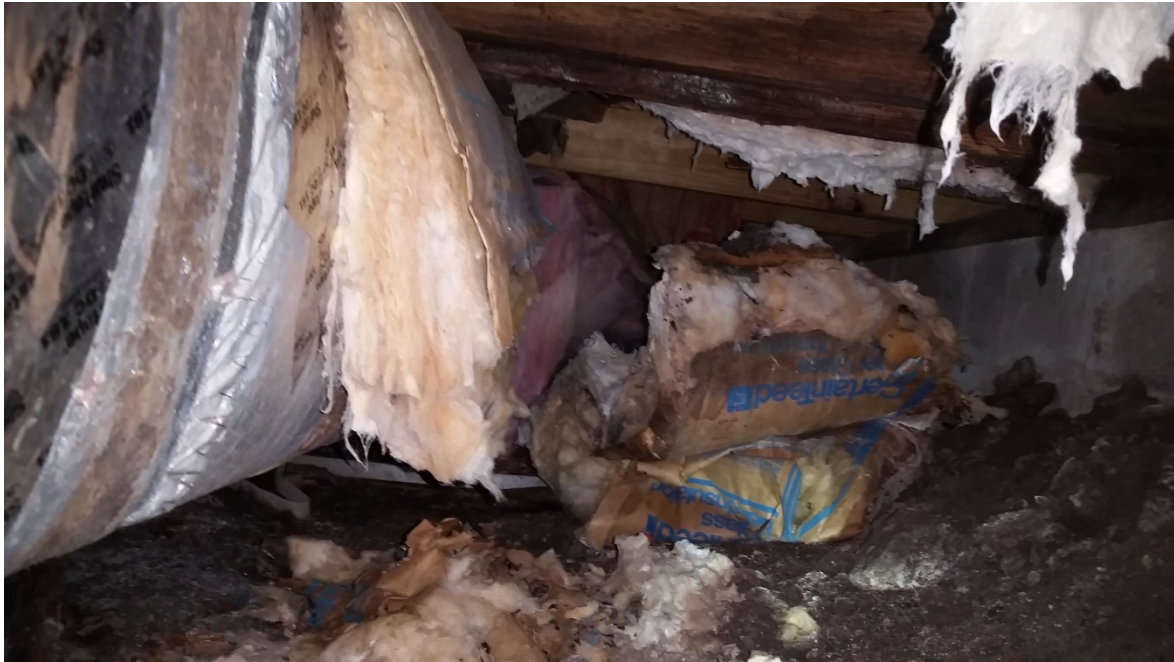
Insulation has fallen from below the floor of the pulpit area. This condition reduces the operating efficiency of the heating and cooling equipment of the building. Reduced operating efficiency increases operating cost. A licensed insulating contractor should be consulted to correct this concern.

Fallen Insulation in Crawlspace

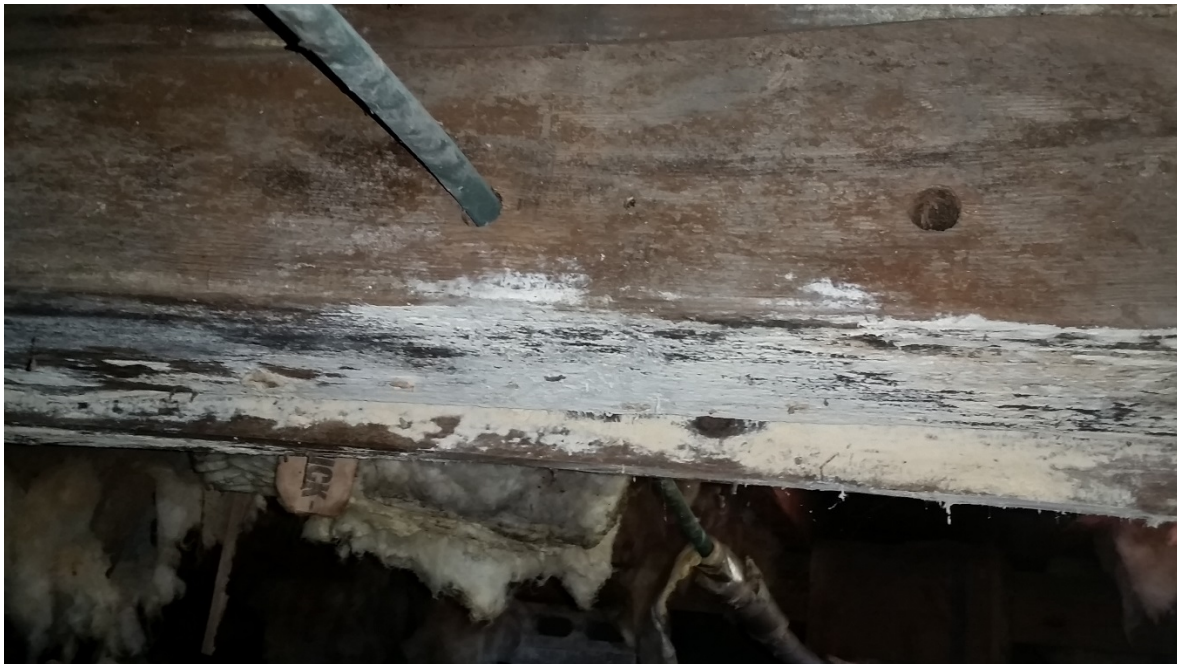
There are dark stains and mildew on the floor framing and subflooring throughout the crawlspace of the restrooms and office. These stains and mildew are an indication of elevated moisture levels and limited ventilation here in the past. This issue can be further evaluated and corrected by a controlled crawlspace specialist.

Dark Stains and Mildew on Floor Framing

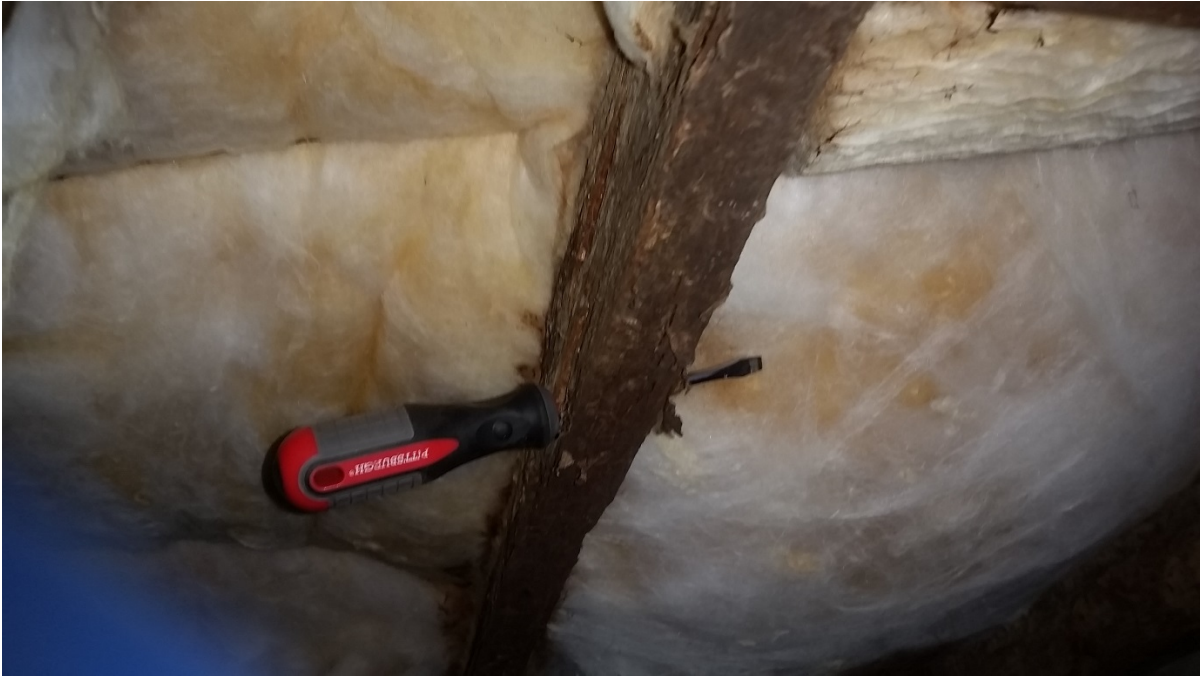
There are dark stains and deteriorated floor joists and girders below the floor of the sanctuary. The structural integrity of these floor joists has been compromised. This condition is a potential collapse concern of this floor framing system. A licensed general contract should be consulted to correct this issue.

Deteriorated Floor Joist

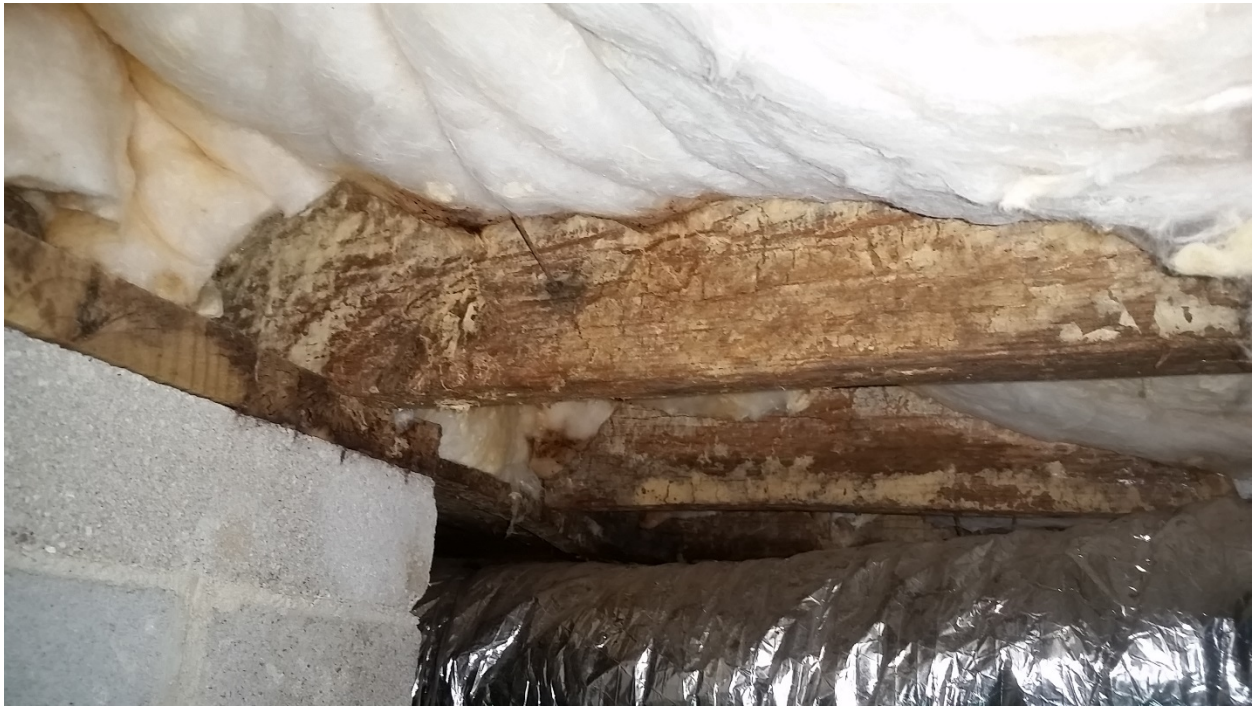
Darks Stained Deteriorated Floor Framing
