Inspection Report

703 Washington Street Plymouth NC 27962

Home Spec of NC, Inc.

Date: 4/6/2022	Time: 09:30 AM	Report ID: 2204061
Property:	Customer:	Real Estate Professional:
703 Washington Street	Ms. Sandy Tenney	Jake Forbes
Plymouth NC 27962		United Country

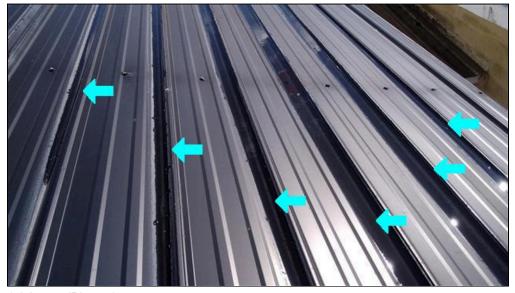
1.0 Item 4(Picture)

(2) Very low pitch for running these roof panel horizontally. Water is being trapped at the ribs. Item 4(Picture)

Some of the puddles are directly over screws that penetrate the metal to secure it to the substrate. This is a potential for corrosion issues.

I recommend having this condition evaluated by a metal roofing contractor.

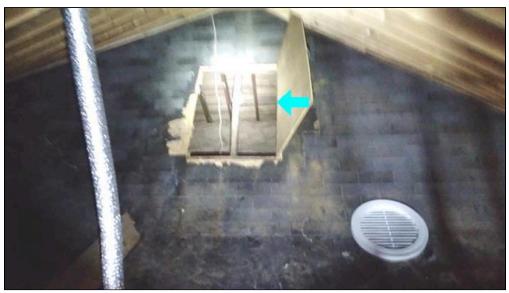
4.4 Item 1(Picture)

- **4.0** Most of the building is on a cement slab. The original section has a crawl space. This inspector did not find an access for the crawl space.
- **4.4** Original attic section was viewed through its opening from the new attic space. Item 1(Picture)

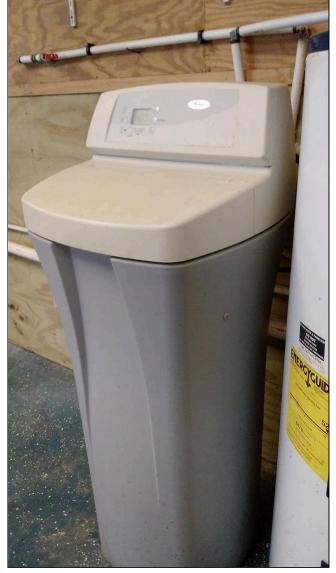
5.1 Item 2(Picture)

- (2) PVC material has been used for the drain and waste piping.
- **5.1** (1) A water filter and softener system were observed. We do not test these for adequate function as a part of a home inspection. Item 1(Picture) Item 2(Picture)

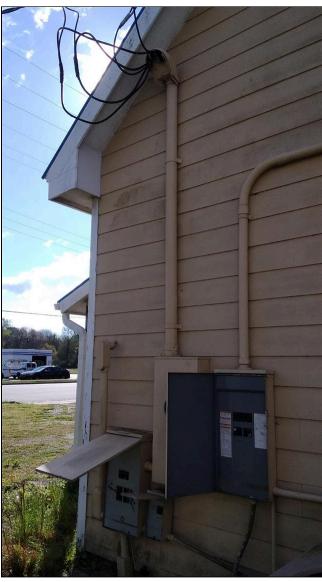
6.0 Item 1(Picture)

6.0 Electrical entrance conductors are overhead and located on the right side of the house with the meter base. Item 1(Picture) Item 2(Picture) Item 3(Picture)

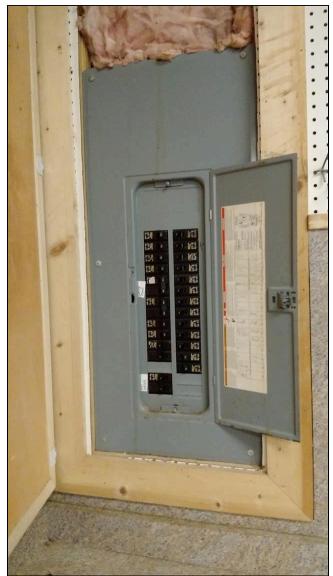
6.1 Item 8(Picture)

(3) Not opened due to enclosure. Item 8(Picture) Item 9(Picture)

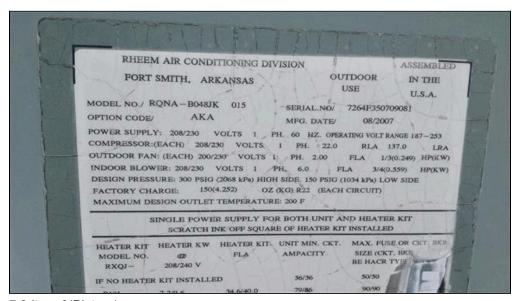
7.0 Item 6(Picture)

(3) Rheem, 2007, 4 ton capacity, packaged heat pump. Not functioning as intended.

Refer to a licensed HVAC technician for repair or replacement as needed.

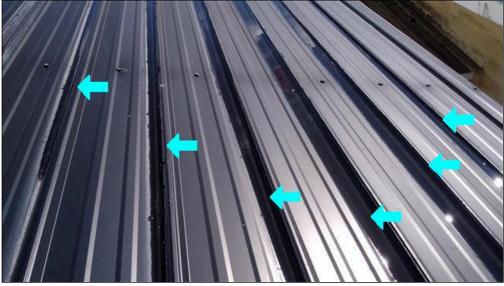
1.0 Item 4(Picture)

Some of the puddles are directly over screws that penetrate the metal to secure it to the substrate. This is a potential for corrosion issues.

I recommend having this condition evaluated by a metal roofing contractor.

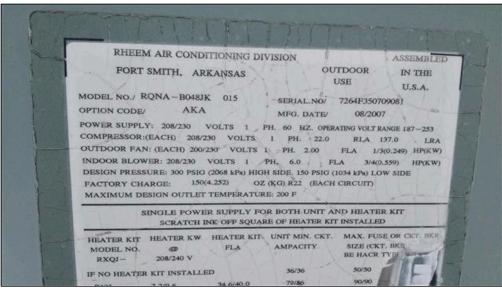
7.0 Item 6(Picture)

(3) Rheem, 2007, 4 ton capacity, packaged heat pump. Not functioning as intended.

Refer to a licensed HVAC technician for repair or replacement as needed.
