## Home Inspection Report

PROPERTY INSPECTED:  
**4216 South Darrell Drive  
Bloomington, IN 47403**

**Date of Inspection: 10/02/2023**

Inspection No. 311577-480

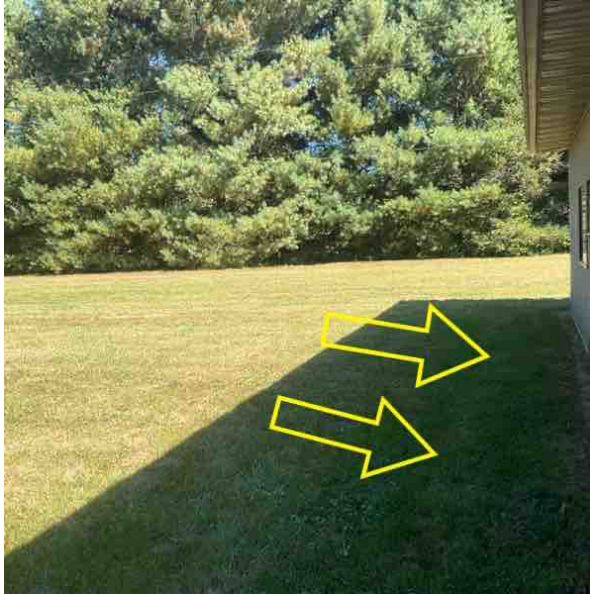
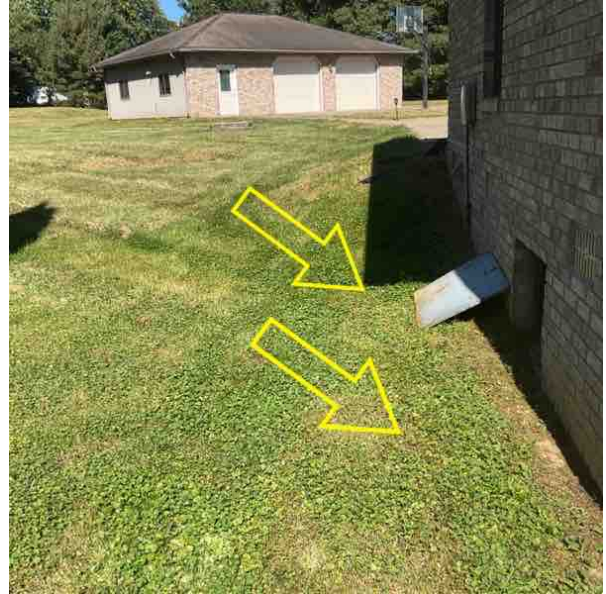
2.1.1 The landscape does not have a slope that will allow for water drain away from the structure. It is recommended that the slope be modified so that the ground irrigates away from the foundation to prevent water build-up near the foundation.

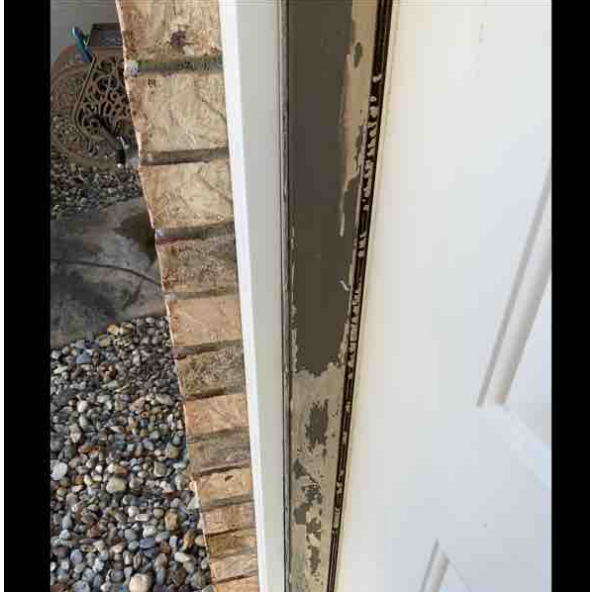
3.4.1 The paint on the trim is peeling, faded or deteriorated. Repaint to maintain a weather-resistant coating and prevent water damage. **(Exterior Front)**

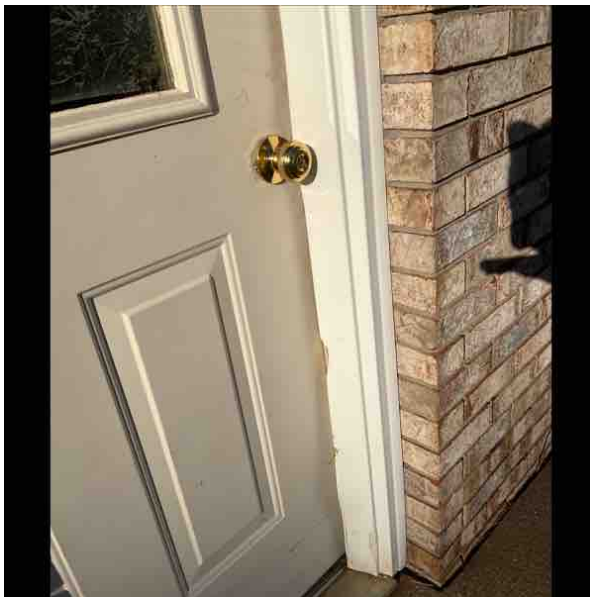
3.4.2 Door flashing is loose. Seal to protect from water related damage. **(Detached garage exterior front )**

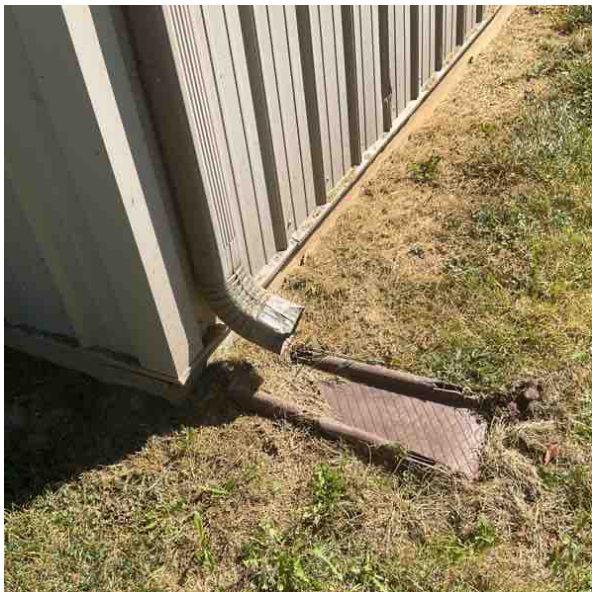
4.4.1 Downspouts discharging water close to foundation. Redirect and extend all downspouts 4-6 feet away from foundation to help prevent water damage to structure. **(Various)**

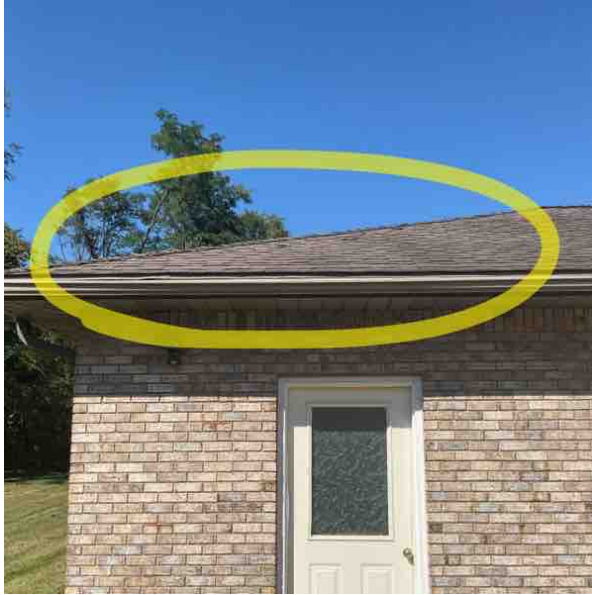
4.4.2 The gutter(s) are loose and sagging. Repair to provide proper controlled drainage off the roof and to prevent water-related damage to structure and interior finishes. **(Detached garage exterior front )**

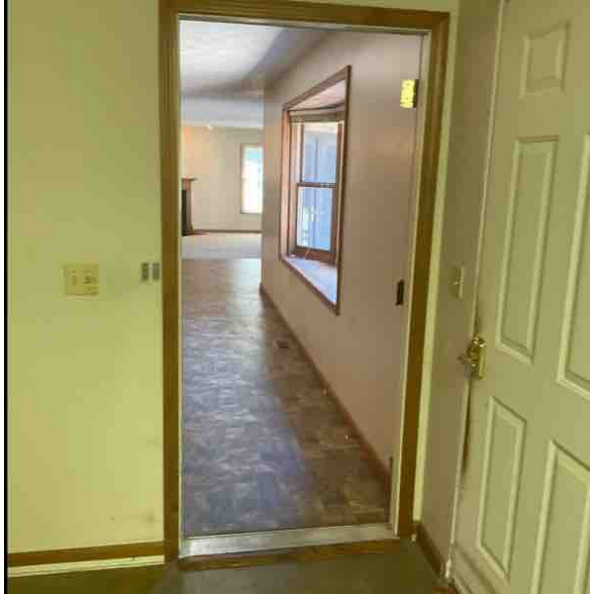
6.3.1 The interior access door is missing. Install a door to provide intended fire / gas barrier safety. **(Garage)**

6.3.1 The interior access door is missing. Install a door to provide intended fire / gas barrier safety. (Garage)

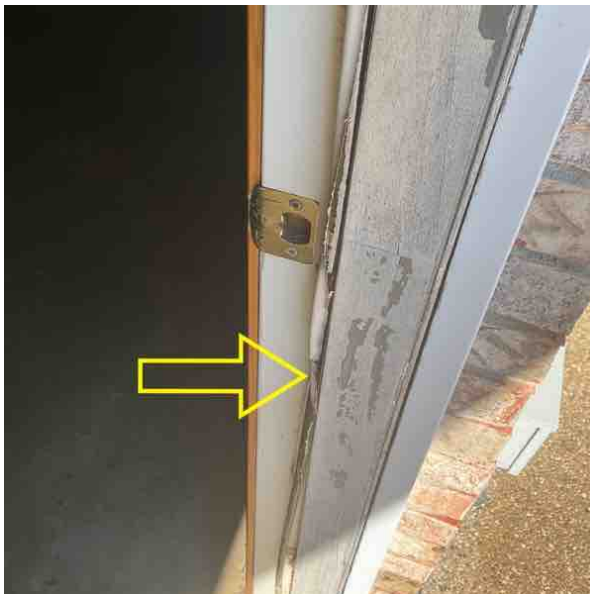
6.4.1 The exterior access door has damaged weatherstripping. Recommend to replace weatherstripping to prevent water leakage and pest entry. (Exterior Front)

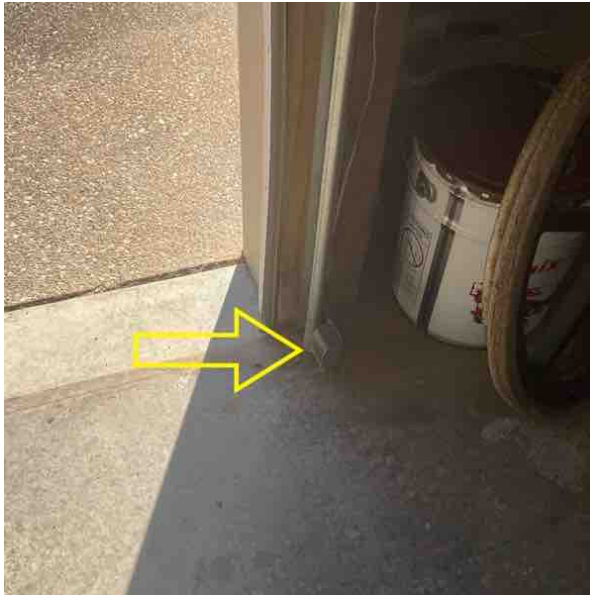
6.6.2 The vehicle door opener photo-eye sensors are installed very low. Raise to 4-6 inches for improved safety. **(Detached garage)**

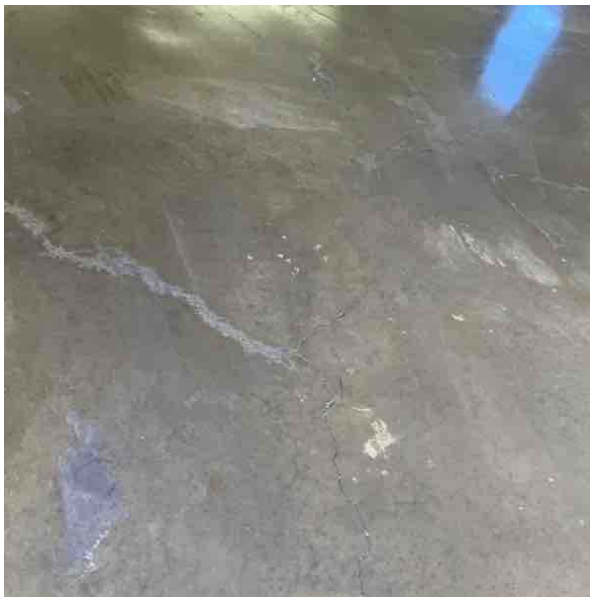
6.7.1 Typical minor floor cracks are present in the garage floor. No improvement is necessary at this time.

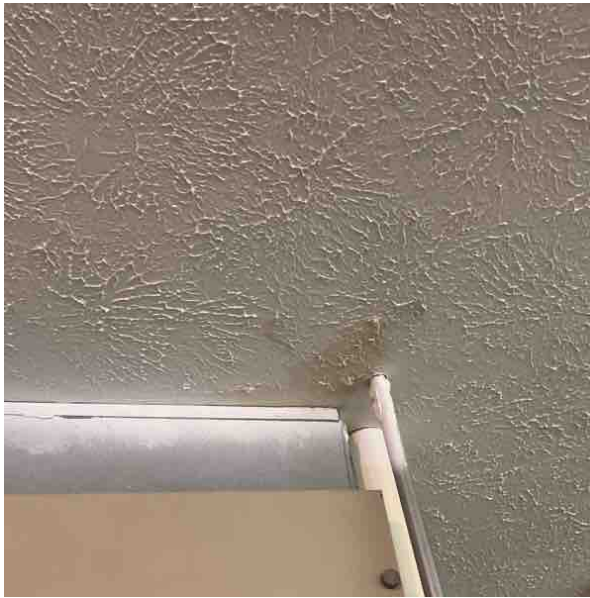
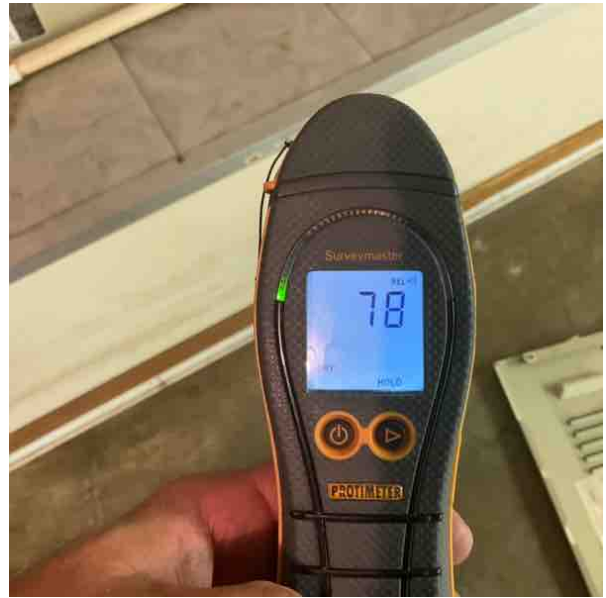
6.9.1 Evidence of past moisture, not active at the time of inspection. Recommend asking seller if any repairs have been made to alleviate leak.

- Monitor on a regular basis and repair if leak returns. **(Garage)**

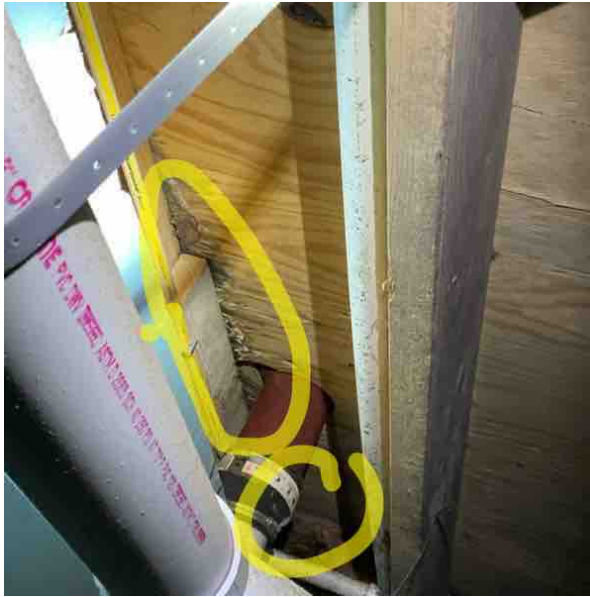
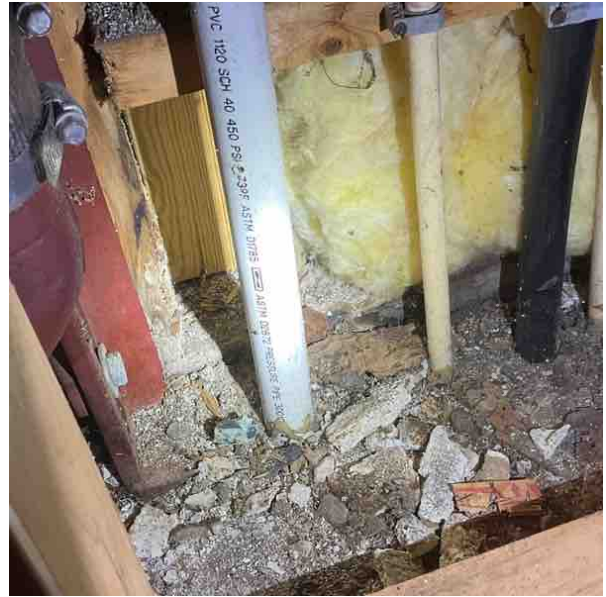
7.4.1 The joist(s) and subfloor show evidence of a leak directly below the master bathroom. Area tested dry at the time of inspection. Recommend a general contractor assess and repair as required.

7.4.1 **The joist(s) and subfloor show evidence of a leak directly below the master bathroom. Area tested dry at the time of inspection. Recommend a general contractor assess and repair as required.**

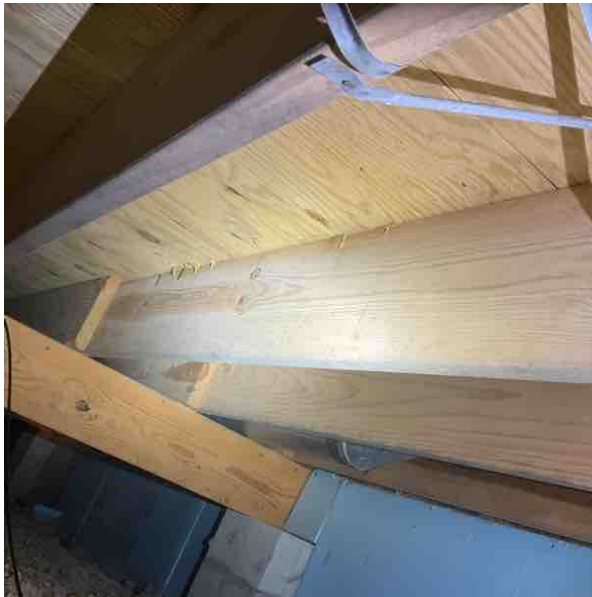
8.1.1 It was noted during the inspection that the crawlspace had an organic growth. The only way to know for sure is to test at a licensed laboratory facility. If the results come back positive for the present of mold it is advisable to seek a licensed mold remediation specialist to properly reinspect and remediate all areas with mold. **(Crawlspace)**

8.1.1 It was noted during the inspection that the crawlspace had an organic growth. The only way to know for sure is to test at a licensed laboratory facility. If the results come back positive for the present of mold it is advisable to seek a licensed mold remediation specialist to properly reinspect and remediate all areas with mold. (Crawlspace)

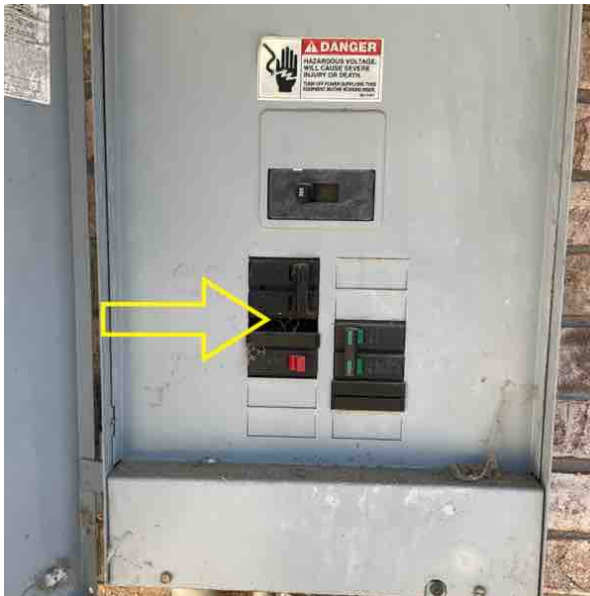
9.5.1 Openings in the panel should be filled to prevent electric shock. **(Exterior Back)**

9.5.1 Openings in the panel should be filled to prevent electric shock. (Exterior Back)

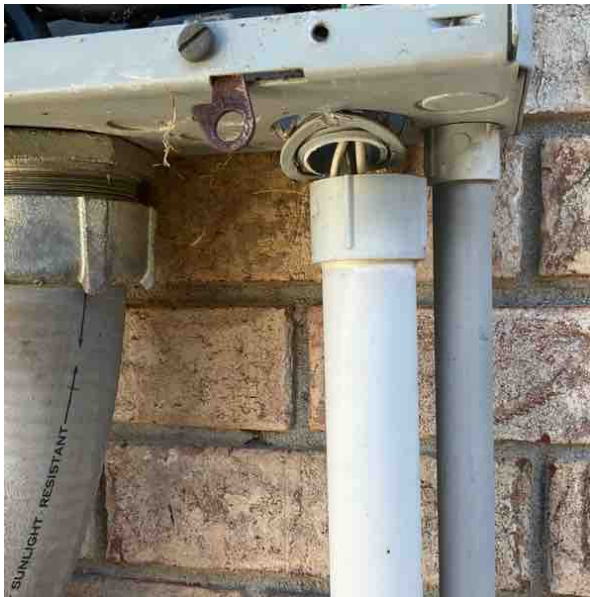
9.5.4 The service conduit is not sealed and damaged. Recommend an electrician further assess and repair as required for to prevent water entry for electrical safety. **(Exterior Back)**

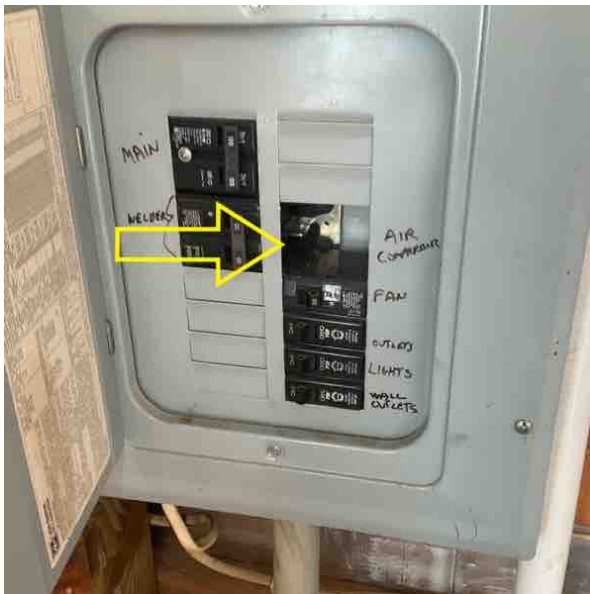
9.7.1 Openings in the panel should be filled to prevent electric shock. **(Detached garage)**

9.7.1 Openings in the panel should be filled to prevent electric shock. (Detached garage)

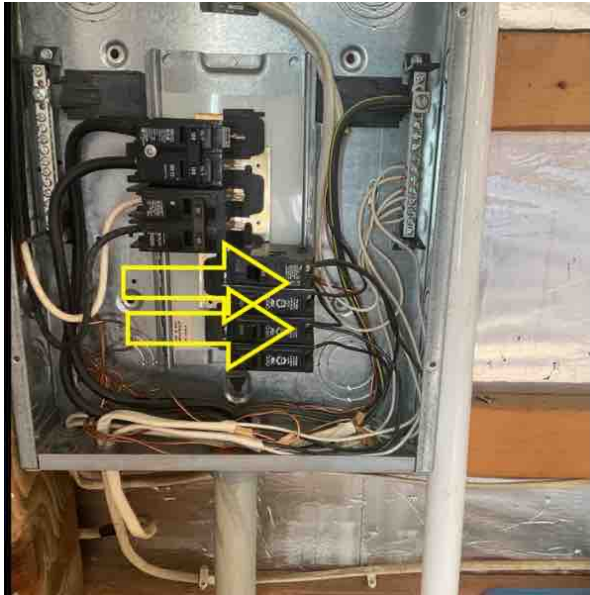
9.7.2 The sub-panel has double-tapped breaker(s). Recommend an electrician further assess and correct as required for electrical safety. **(Detached garage)**

9.7.2 The sub-panel has double-tapped breaker(s). Recommend an electrician further assess and correct as required for electrical safety. (Detached garage)

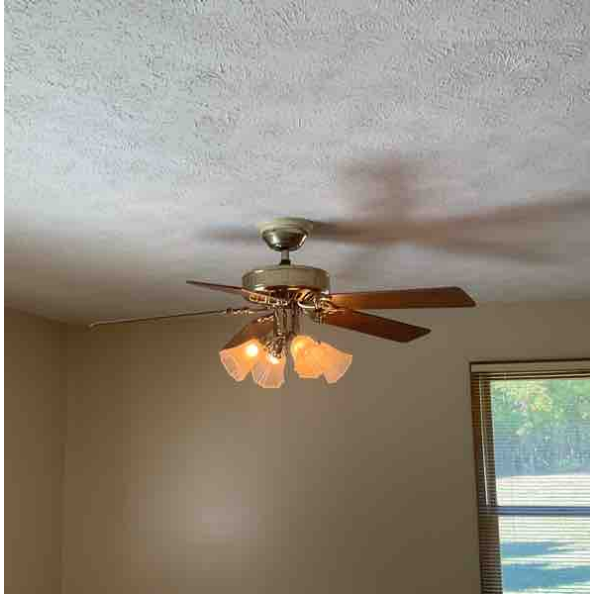
9.10.2 The ceiling fans(s) are inoperative. Recommend an electrician further assess and repair as required to regain proper function. **(Family Room)**

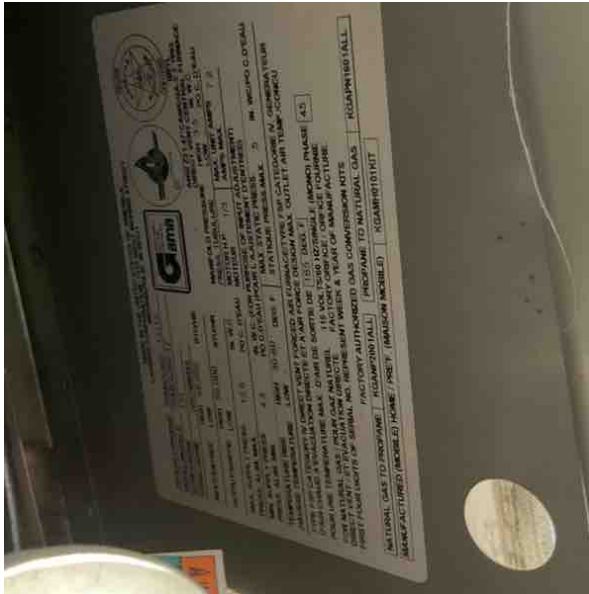
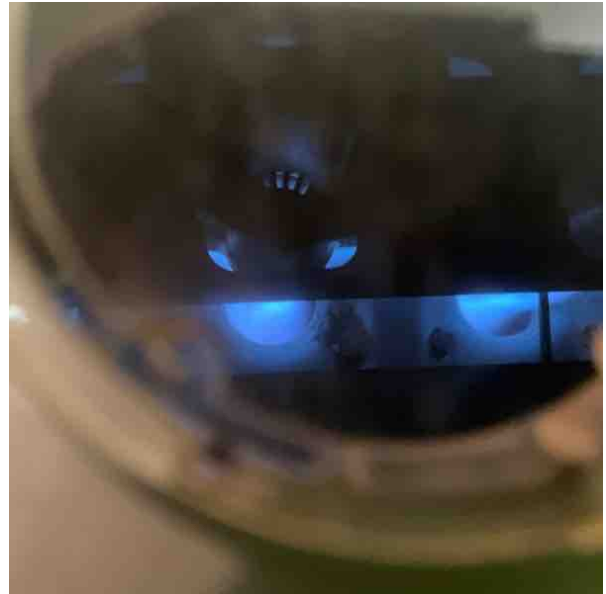
10.6.2 Main house

Model: Carrier

Manufacture date: 03/97

10.6.4 Both the forced air furnace are past the typical life expectancy. Replace the system when it fails, when repairs are no longer cost effective, or pro-actively to prevent loss of functionality.

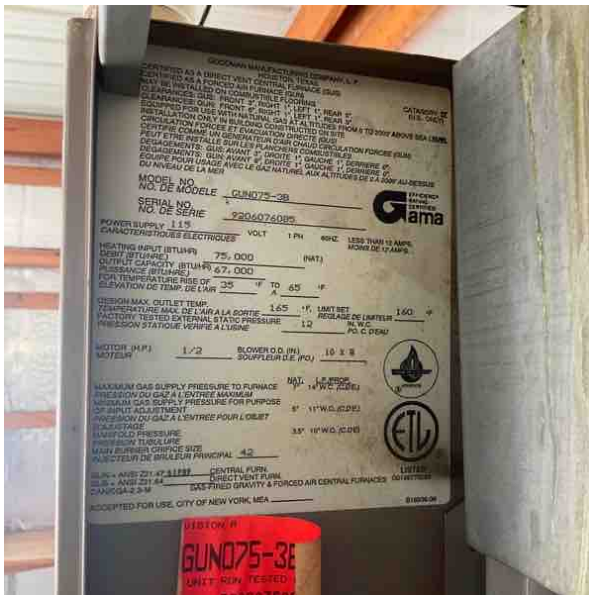
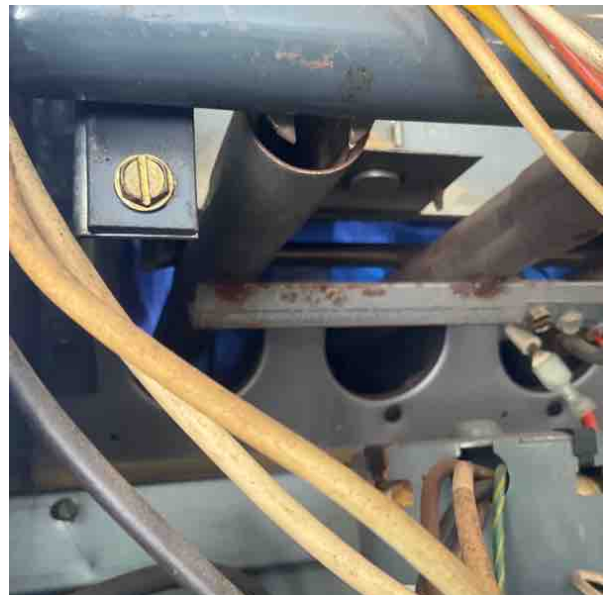
10.6.3 Detached garage

Model: Janitrol

Manufacture date: 06/92

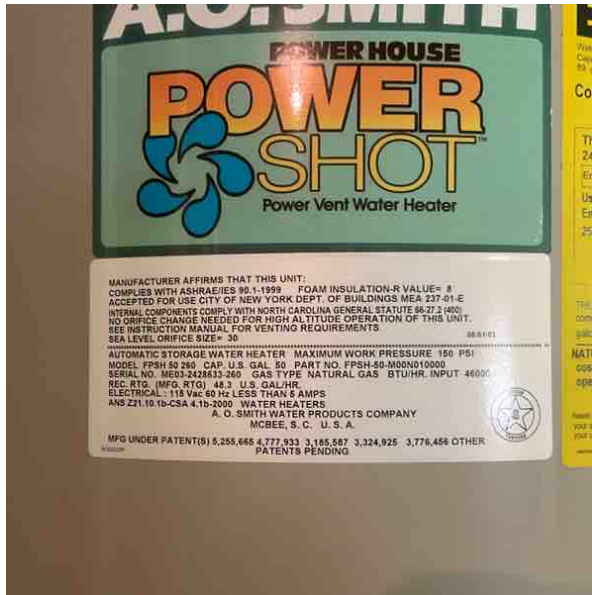
The water heater is past its typical life expectancy. Replace the unit when it fails, when repairs are no longer cost effective, or pro-actively to prevent loss of functionality. **(Garage)**

11.4.2 **Model: AO Smith**

**Manufacture date: 05/03**

**The water heater is past its typical life expectancy. Replace the unit when it fails, when repairs are no longer cost effective, or pro-actively to prevent loss of functionality. (Garage)**

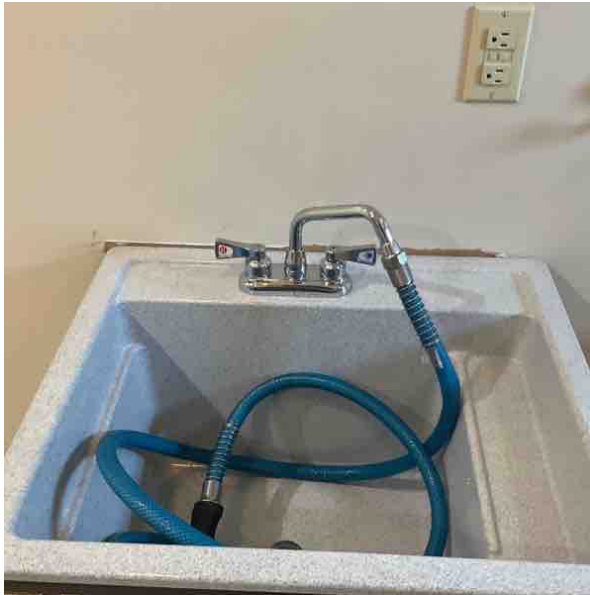
11.7.2 The hot and cold faucets are reversed at the deep sink. Correct this for proper operation. **(Laundry area)**

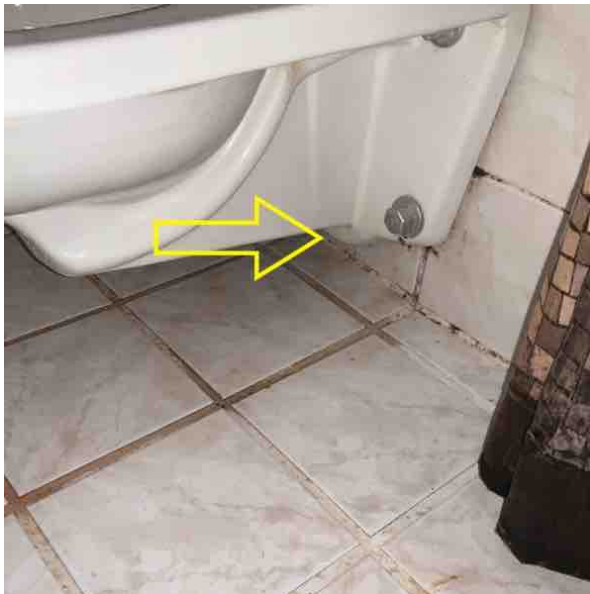
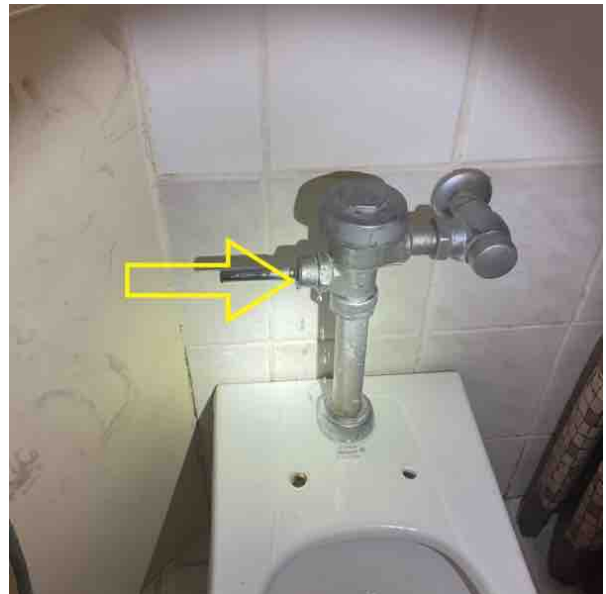
11.9.1 The toilet is leaking. Repair or replace as required it to prevent water damage. **(Master Bathroom)**

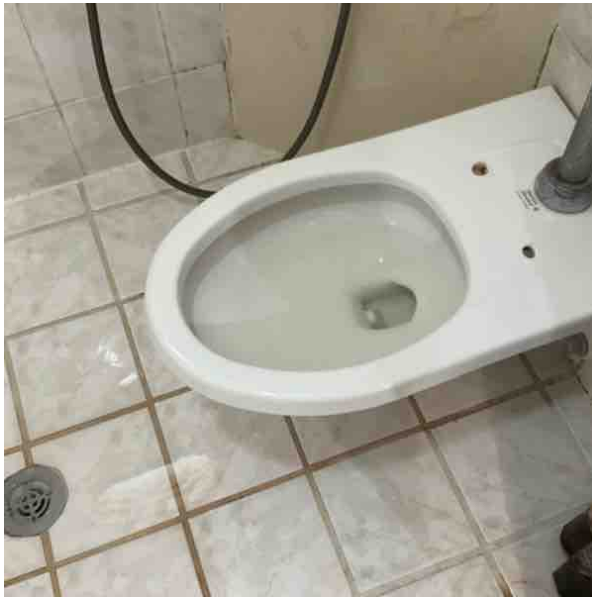
11.9.2 Toilet seat / lids are missing. Install seats / lids to restore proper function. **(Master Bathroom)**

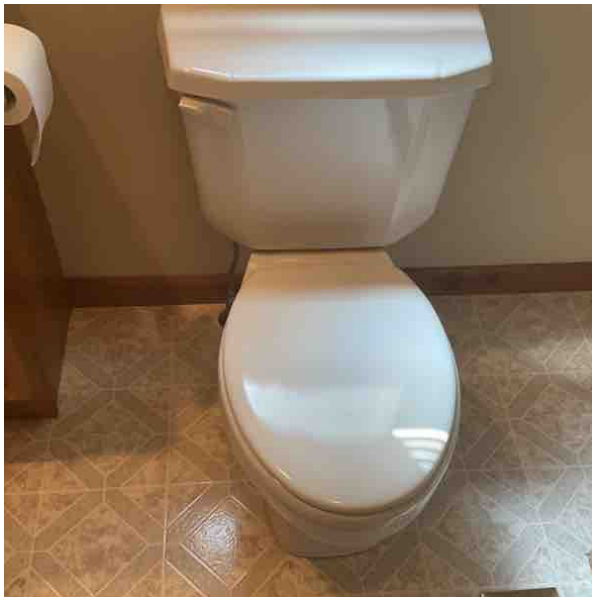
11.9.3 The toilet is loose. Repair as required to prevent water damage. **(Bathroom)**

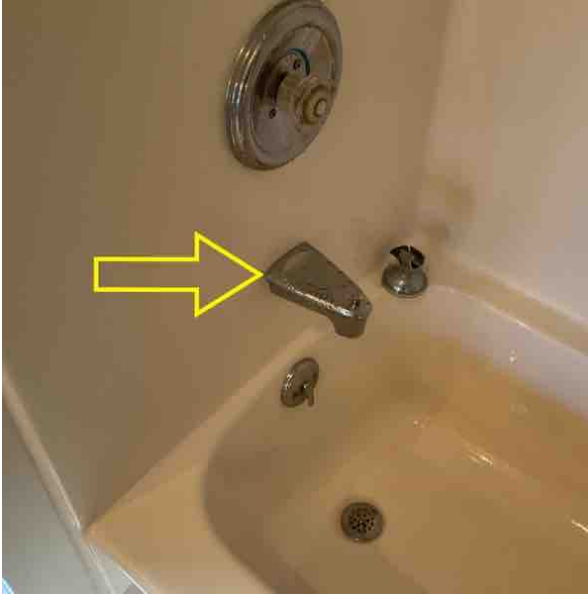
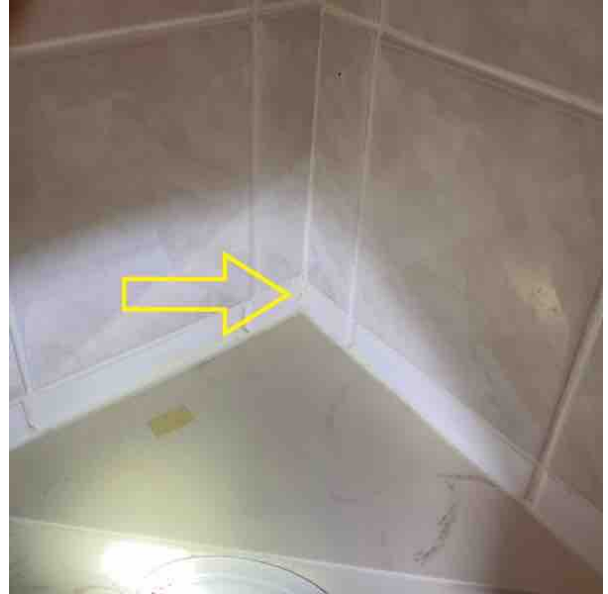
11.10.1 General grout and caulking repairs are required. This should be done soon to minimize leakage and further damage. **(Bathroom)**

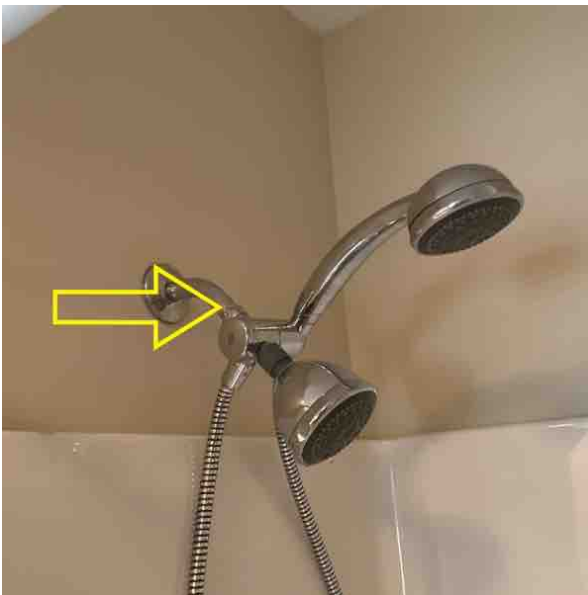
11.10.2 The shower head is loose. Repair as required to prevent water leaks. **(Bathroom)**

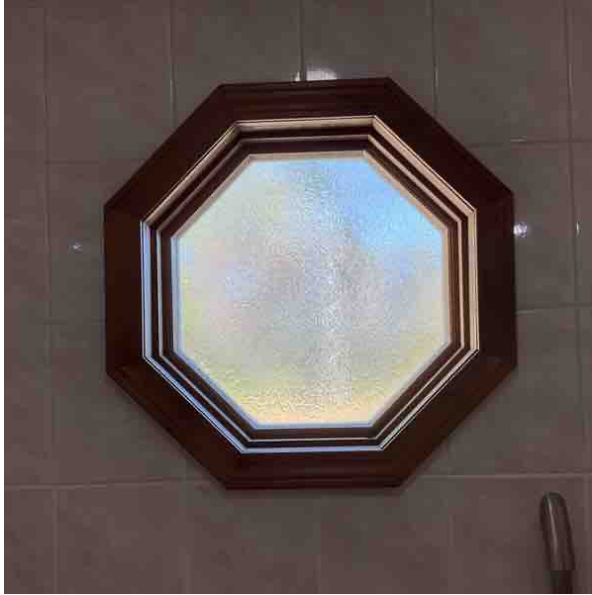
11.10.3 The window / trim in the shower enclosure is not a water-resistant material. Replace the window / trim with appropriate materials to prevent water damage. **(Master Bathroom)**

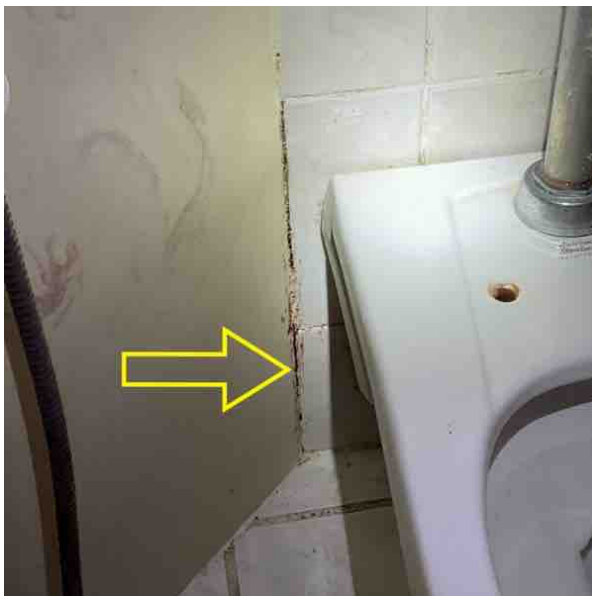
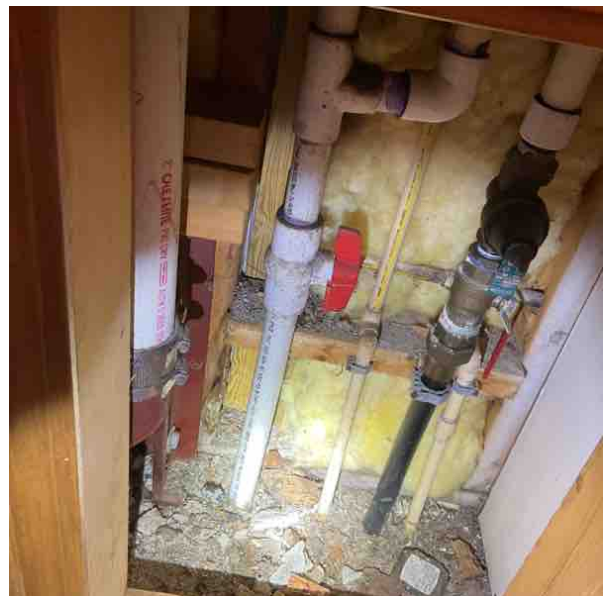
12.3.1 It was noted during the inspection that the wall had an organic growth. Recommend having this tested and remediated as required by a certified remediation company.

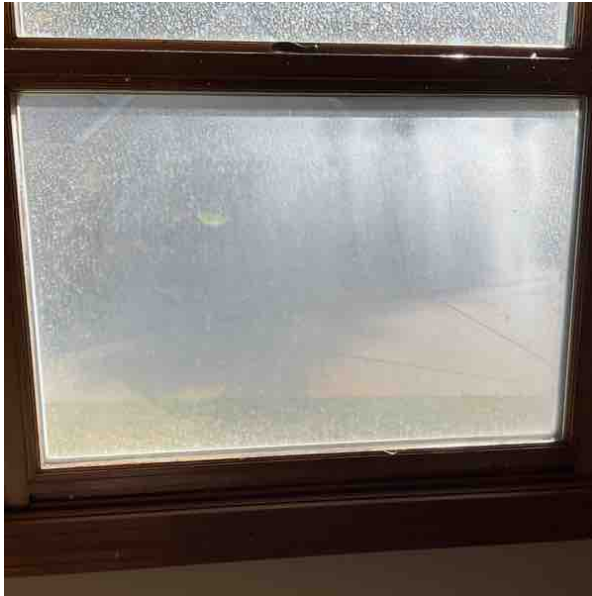
12.4.1 The window(s) have failed thermal seals. Replace for improved energy efficiency and, as desired for aesthetics.

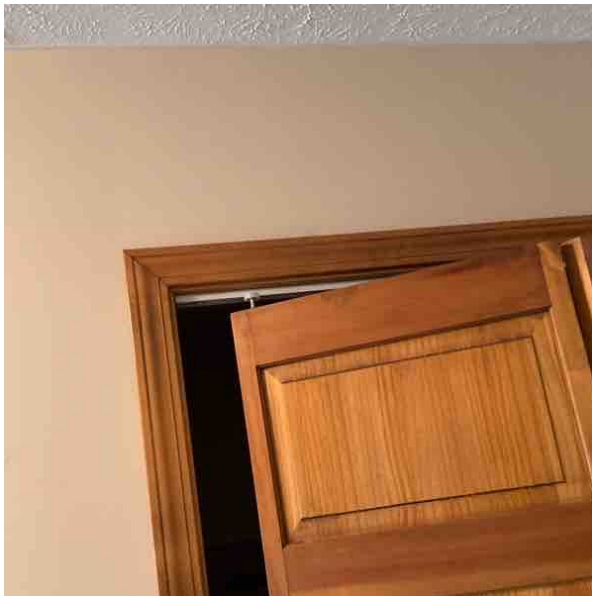
12.5.1 The door(s) have loose and misaligned hardware. Replace as required to restore proper functionality.

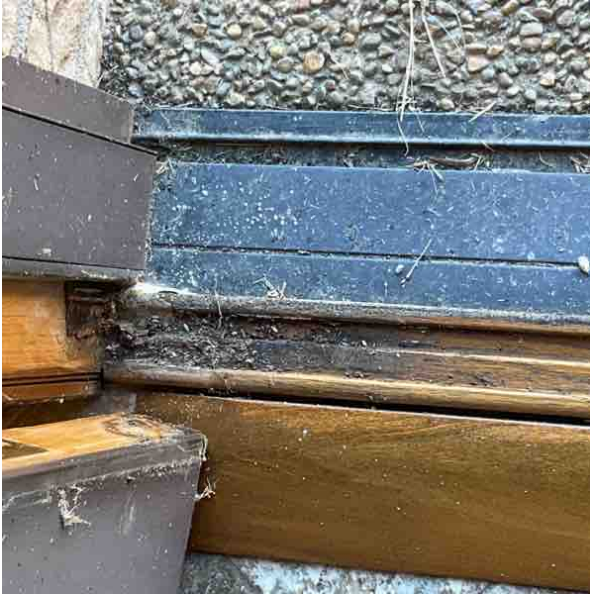
12.6.1 Door thresholds have rotting wood. Repair or replace as needed to prevent water damage and restore proper functionality. **(Dining room)**

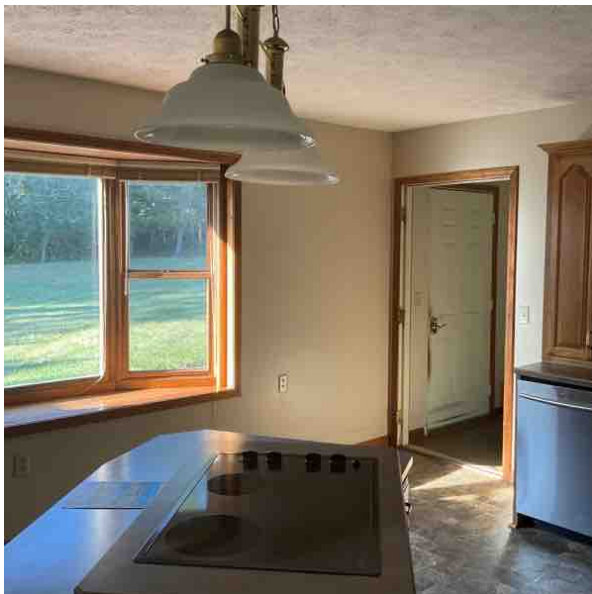
14.3.1 The range hood is missing. Install for proper venting. **(Kitchen)**

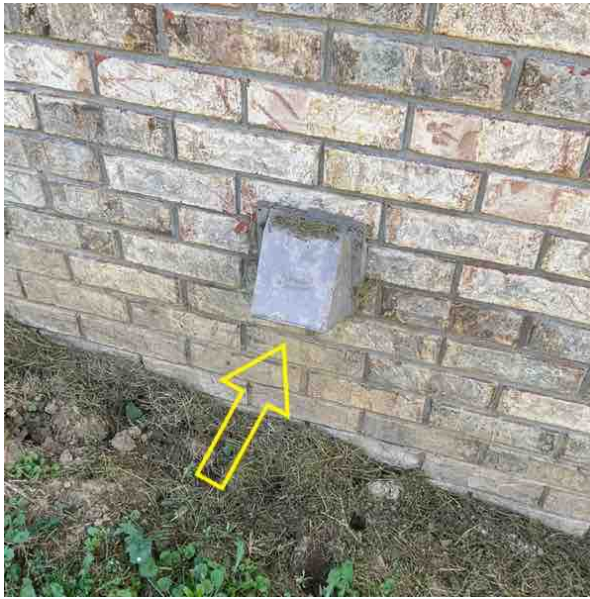
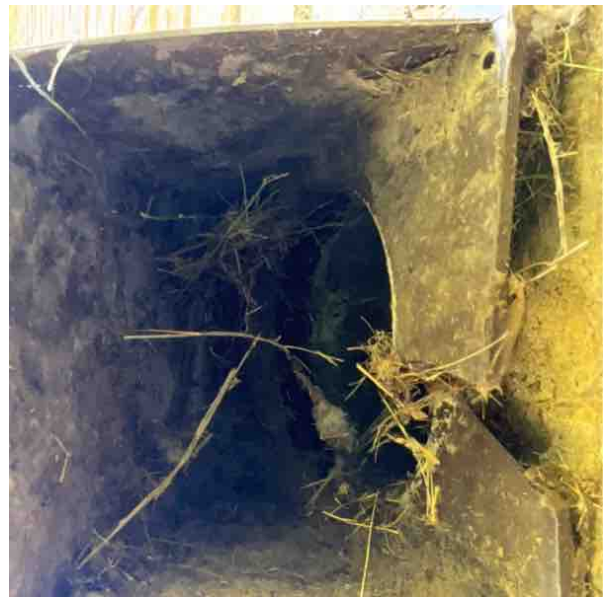
14.7.1 Exterior vent covers damaged. Repair or replace to maintain water integrity and to prevent rodent and insect infestation. **(Exterior Back)**
