# Inspection Report

119 Currituck Drive  
Hertford NC 27944

**Home Spec of NC, Inc.**

<b>Date:</b> 4/10/2024	<b>Time:</b> 09:30 AM	<b>Report ID:</b> 2404101
<b>Property:</b> 119 Currituck Drive Hertford NC 27944	<b>Customer:</b> Mr. Arie van der Meulen	<b>Real Estate Professional:</b> Jake Forbes United Country

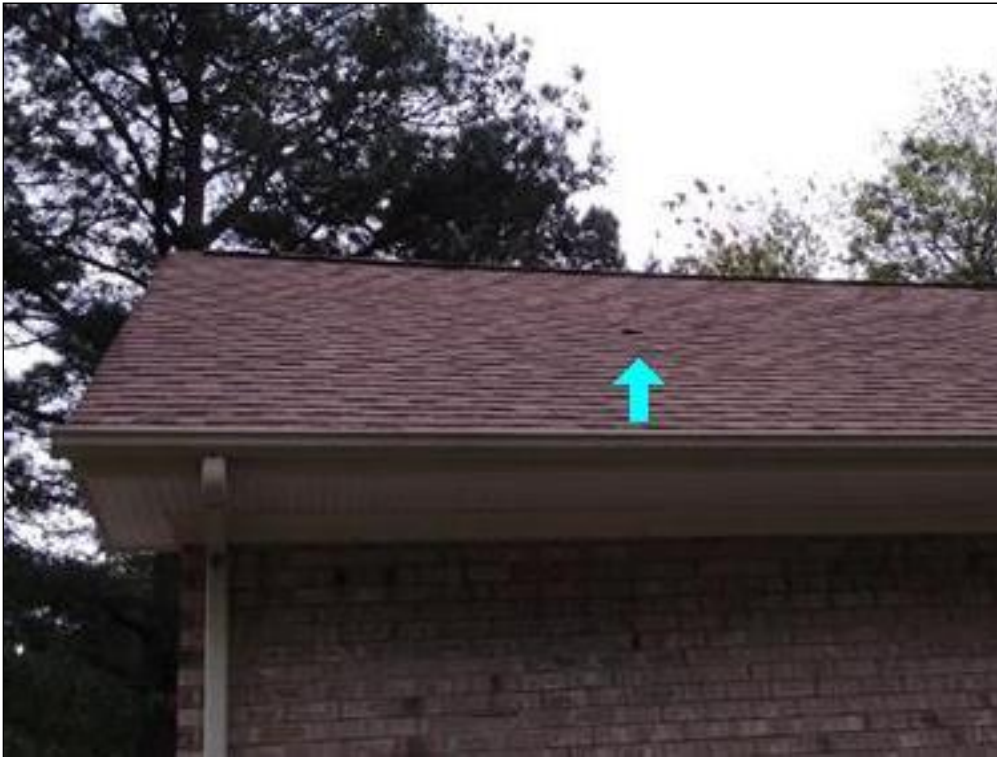
1.0 Item 1(Picture)

There are two apparent nail pops that were noted. One on each side of the garage gable end. Example: Item 1(Picture) Very minor cosmetic and not leaking.

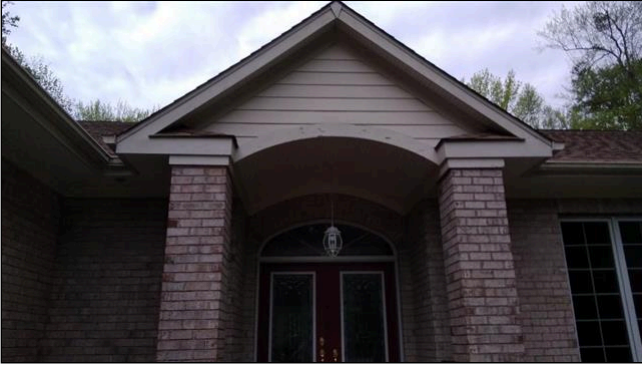
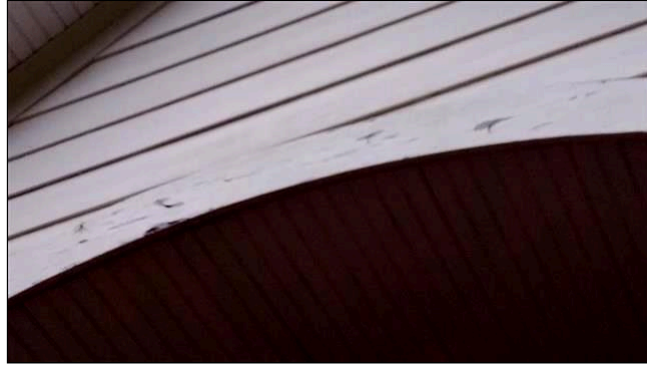
🏠 2.0 (1) Siding and trim above front entry needs to be painted. Item 1(Picture) Item 2(Picture)

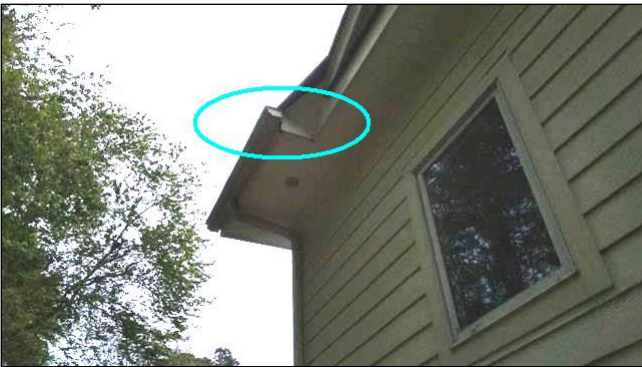
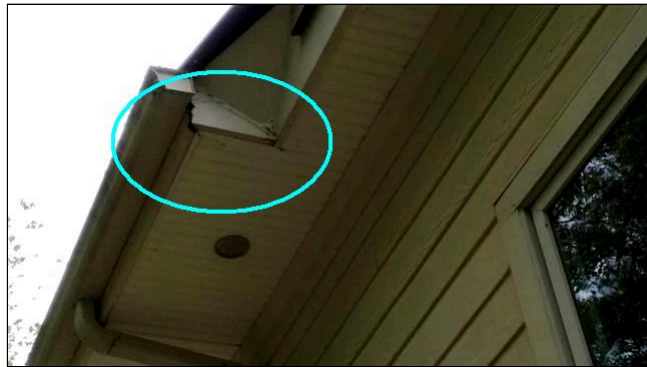
🏠 (2) Right corner trim shows moisture damage behind gutter. Item 3(Picture) Item 4(Picture)

(2) Right corner trim shows moisture damage behind gutter. Item 3(Picture) Item 4(Picture)

Refer to a siding contractor for repair or replacement

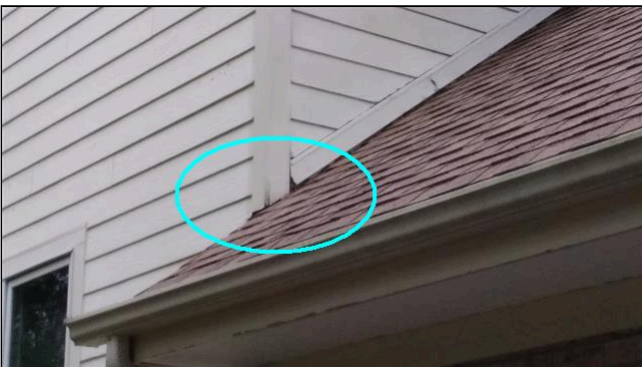
2.0 Item 5(Picture)

Left side trim above smaller garage door. Item 5(Picture)

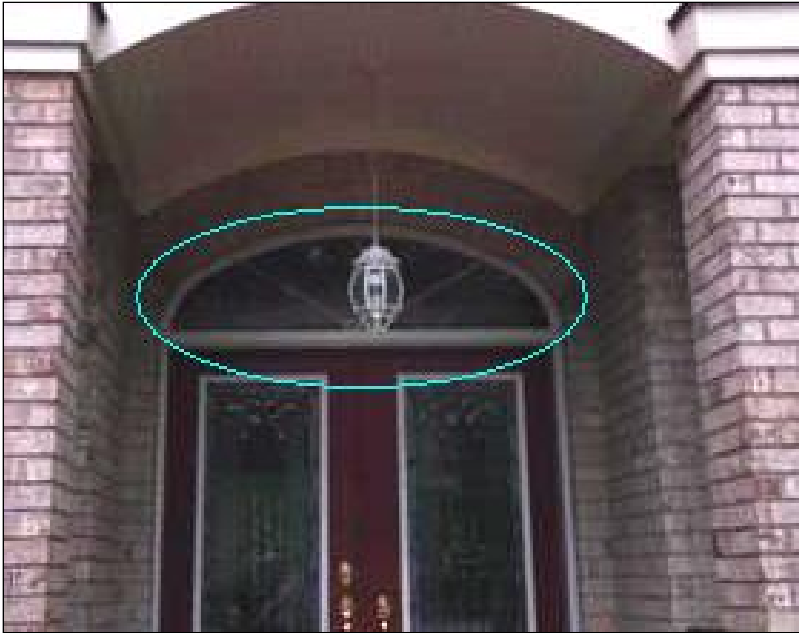
2.2 Item 1(Picture)

🏠 **2.2** Fogged glass panel above front entry. Item 1(Picture) The thermo-seal has failed and moisture has condensed on the inside of this glass panel.

Fogged glass panel above front entry. Item 1(Picture) The thermo-seal has failed and moisture has condensed on the inside of this glass panel.

Refer to a glass specialty contractor for evaluation.

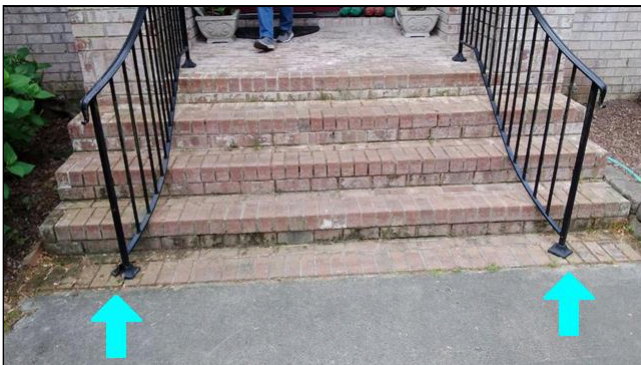
2.3 Item 1(Picture)

🏠 **2.3** (1) Front metal railings are loose at their attachment to the masonry. Item 1(Picture) Item 2(Picture) Item 3(Picture)

(1) Front metal railings are loose at their attachment to the masonry. Item 1(Picture) Item 2(Picture) Item 3(Picture)

REfer to a technician who is familiar with how to improve these fittings.

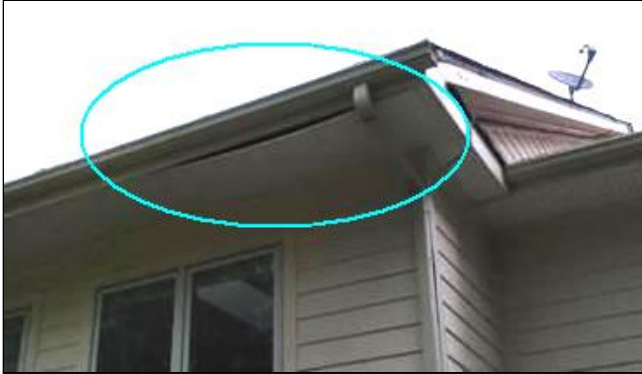
2.5 Item 1(Picture)

**2.5** Rear soffit has a loose panel. Item 1(Picture)

Rear soffit has a loose panel. Item 1(Picture)

Refer to a siding contractor for full evaluation and all necessary repairs or replacement.

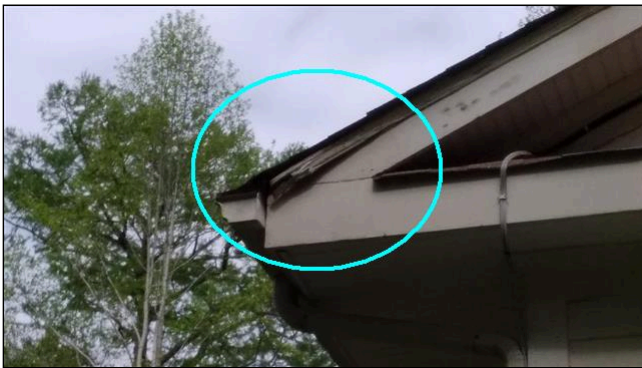
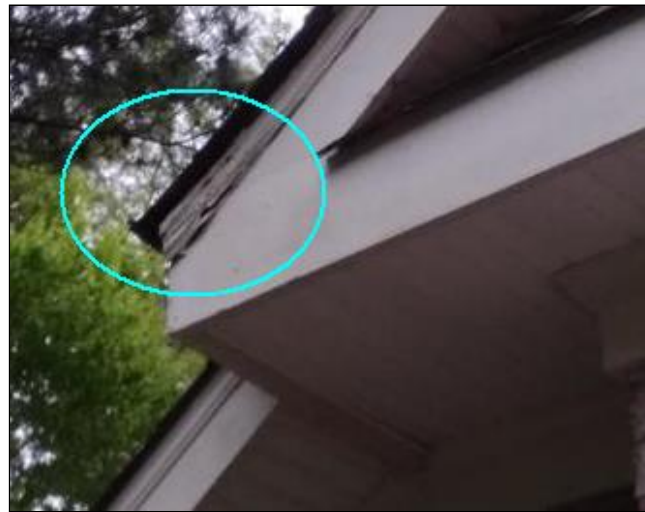
Front rake trim shows moisture damage .Item 3(Picture) Item 4(Picture)

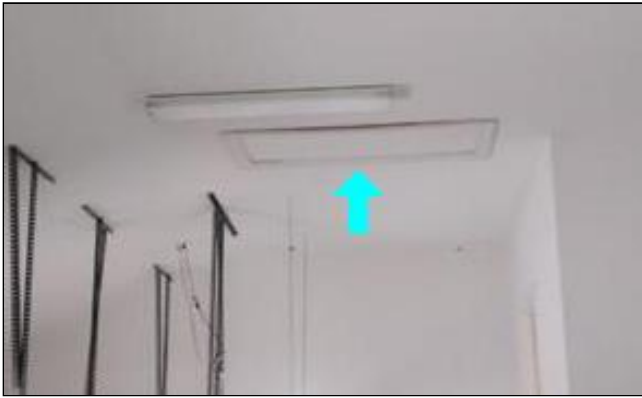
3.7 Item 1(Picture)

3.7 Unable to access the attic garage space. Item 1(Picture) Above this inspectors ladder capacity.

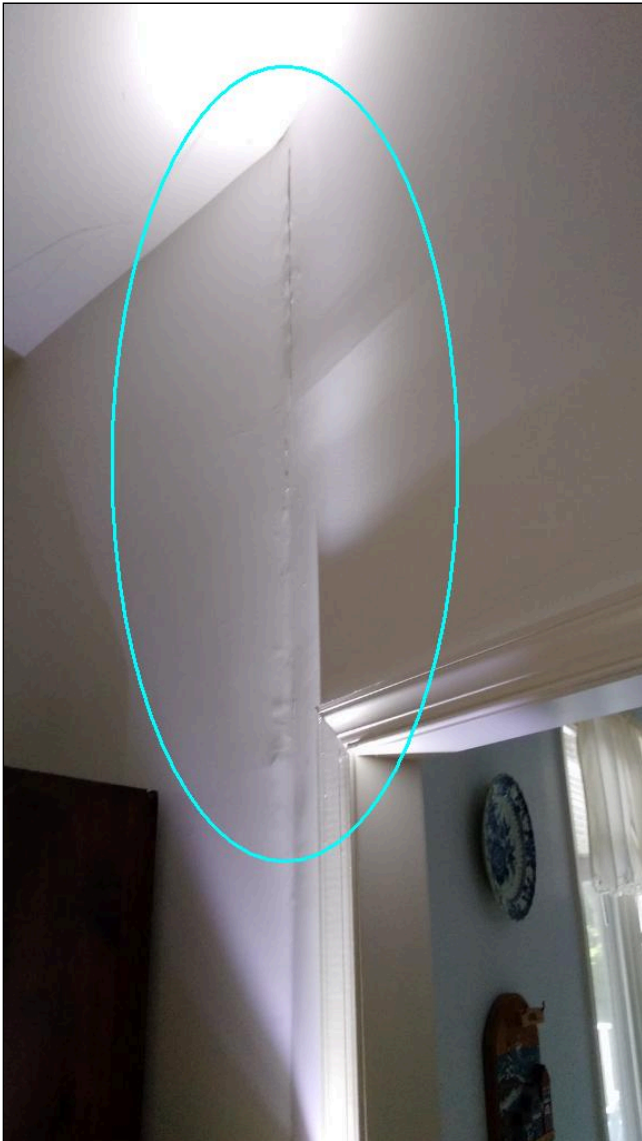
4.1 Item 1(Picture)

**4.1** Kitchen to living room doorway. Very irregular and uneven drywall finish. Item 1(Picture)

Refer to a drywall finishing contractor for evaluation and repair.

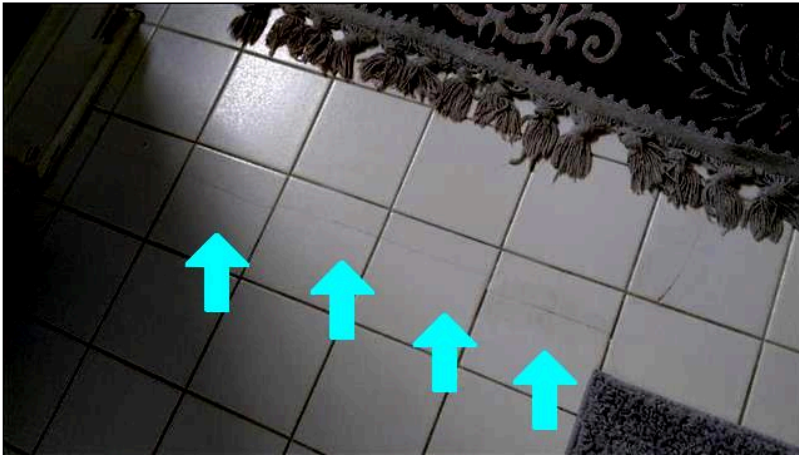
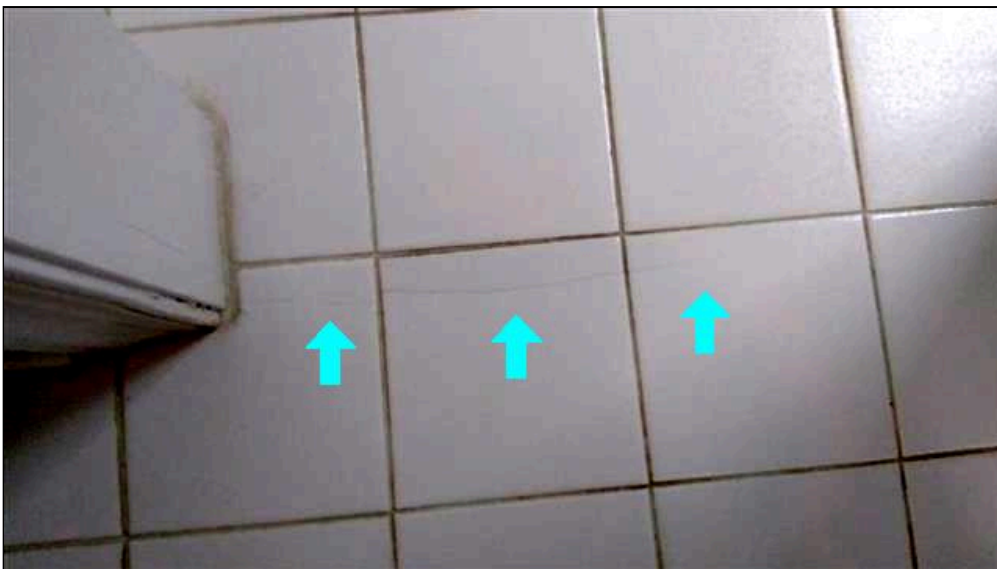
🏠 4.2 Primary bathroom tiled floor shows cracks in the tiles. Examples: Item 1(Picture) Item 2(Picture)

Primary bathroom tiled floor shows cracks in the tiles. Examples: Item 1(Picture) Item 2(Picture)

Refer to a tile specialty contractor for a full evaluation and all necessary repairs or replacement.

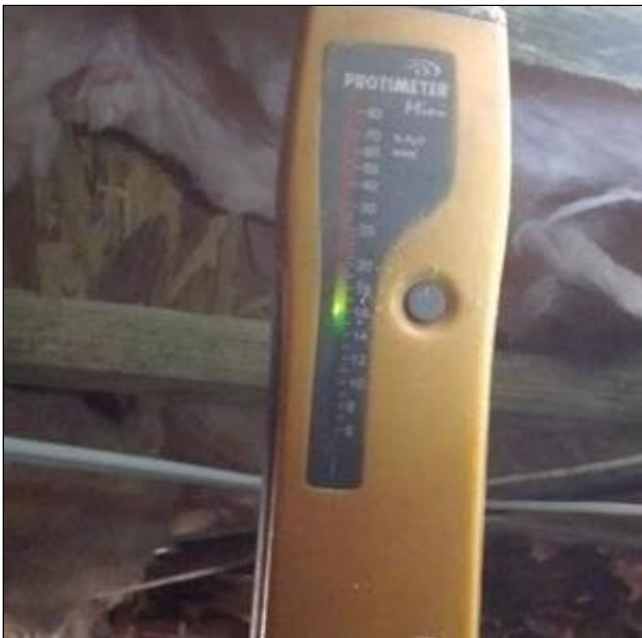
5.0 Item 1(Picture)

**5.0** Moisture readings taken from the crawl space structural framing members ranged from 16% to 20% and are in a marginal range. Fungal growth can be sustained at 20% or higher levels of moisture content. Item 1(Picture)

Moisture readings taken from the crawl space structural framing members ranged from 16% to 20% and are in a marginal range. Fungal growth can be sustained at 20% or higher levels of moisture content. Item 1(Picture)

I believe that a new vapor retarding plastic sheeting is all that is needed. Refer to a pest company for this installation.

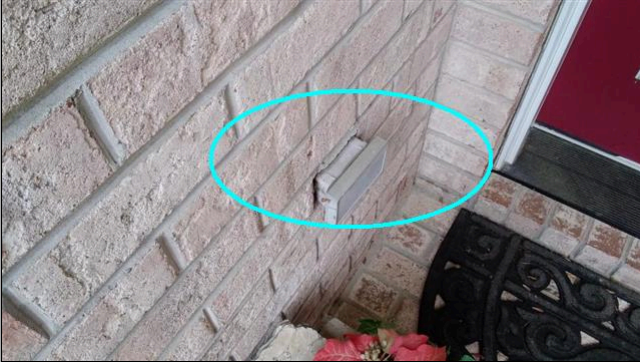
7.5 Item 1(Picture)

(2) Loose receptacle at front entry. Item 1(Picture)

Refer to an electrician for repair.

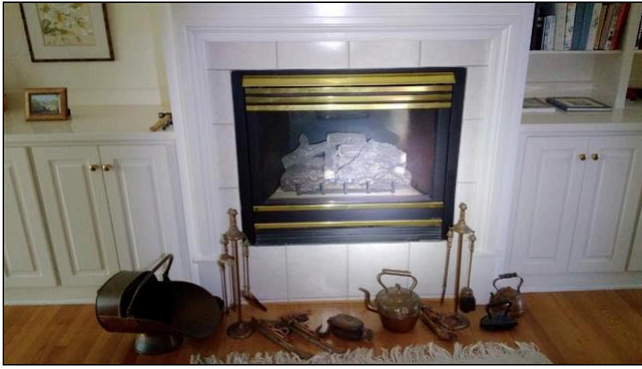
8.7 Item 1(Picture)

8.7 No gas leak testing or combustion testing or CO testing was accomplished for this unit. Refer to a qualified technician who will perform these functions at start-up/ move-in. Item 1(Picture)

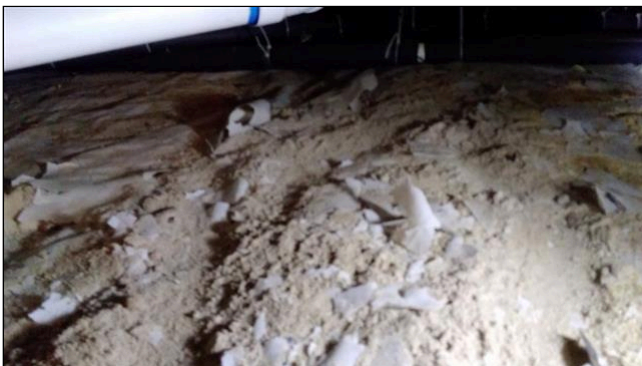
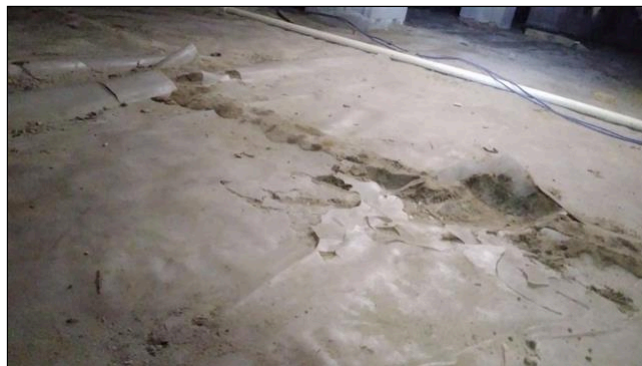
**Vapor Retarder:**  
6 mil poly sheeting present  
Current vapor retarding sheeting is aged, damaged, and ineffective.  
A 100% coverage 6 mil poly vapor retarder is highly recommended.

9.2 A 6mil poly vapor retarding sheeting has been installed over the dirt floor of the crawl space. This sheeting has deteriorated over time and is no longer functioning as intended. Item 1(Picture) Item 2(Picture)

Refer to a qualified contractor for replacement of this 100% coverage 6 mil sheeting.

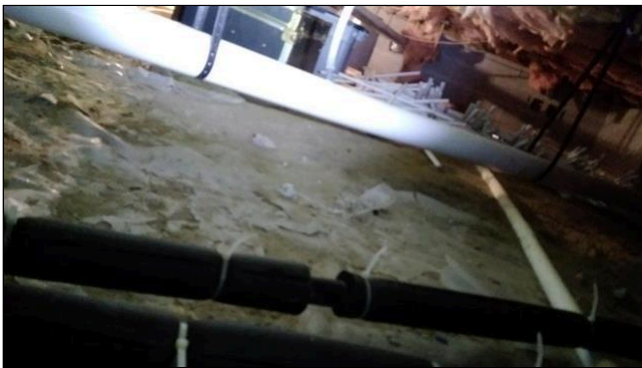
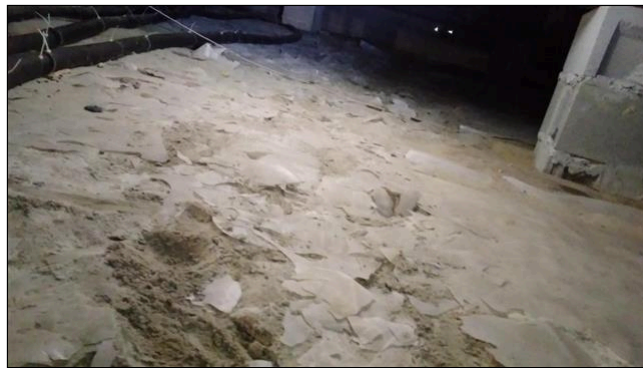
**11.3** A partial 6 mil poly vapor retarder is installed. This sheeting is totally ineffective at controlling ground moisture. A 100% coverage 6 mil poly sheeting is needed. Item 1(Picture) Item 2(Picture)
