E2335 Barnhart Dr. Waupaca , WI 54981

6/5/2024 4:09:14 PM

Inspection Company

Inspector Name Frank Freiburger Company Name Top Notch Home and Foundation Inspections E-Mail ffrei@hotmail.com Amount Received 0

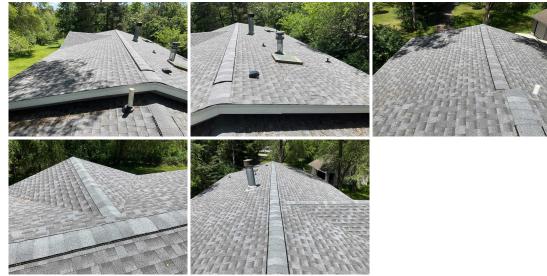
1. Method of Inspection: On roof

Unable to Inspect: 0% Material: Asphalt shingle

Acceptable
 Type: Gable

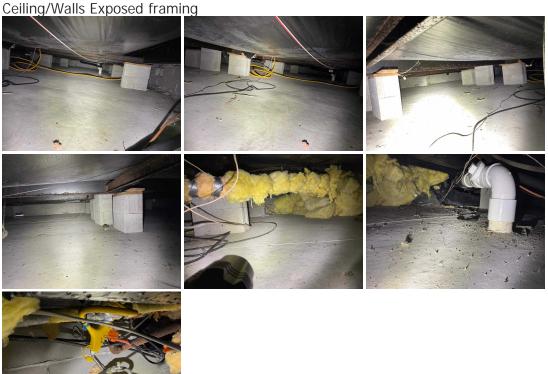
- 1. Acceptable, Not Inspected Unable to Inspect: 30% Limited visibility, access
- 2. Acceptable Ceiling/V

Floor: Poured

Moisture Location: No water was present at the time of the inspection. All grading on the exterior of the house should have a minimum slope of one inch per foot for the first four feet away from the foundation. A 5-10 mil plastic should then be installed on top covered with stones or mulch for aesthetics. This will help direct water away from the house to help lower the chance of water from entering the basement and reduce hydrostatic pressure on the foundation walls the future. Lack of maintenance on the exterior grading and gutters is the number one cause of foundation problems.
