Service: Pre-Listing Inspection

Inspection Information

Site Address: 47 Curly Horse Ranch Rd, Sonoita, AZ 85637

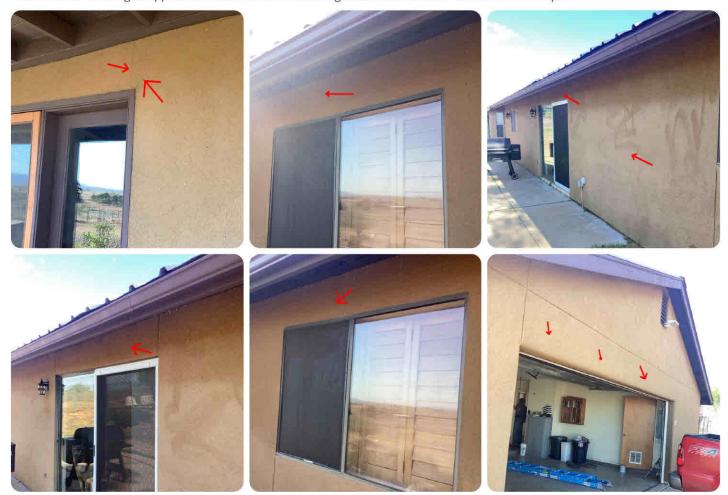
Minor Stucco Cracks

The siding is in functional condition; however, there are some cracks in the stucco. These types of cracks are common due to movement and curing at application. Recommend contacting a stucco contractor to evaluate and repair.

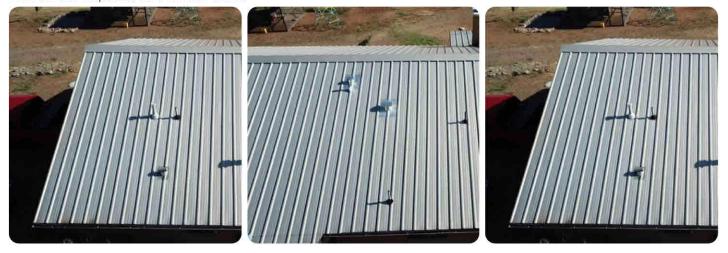
The roof was inspected via overhead drone.
