# Inspection Report

**Property Address:**  
917 Stoneymead Dr  
Kings Mountain NC 28086

| <b>Date:</b> 8/8/2024 | <b>Time:</b> 08:00:00 AM | <b>Report ID:</b> 080824JK5 |

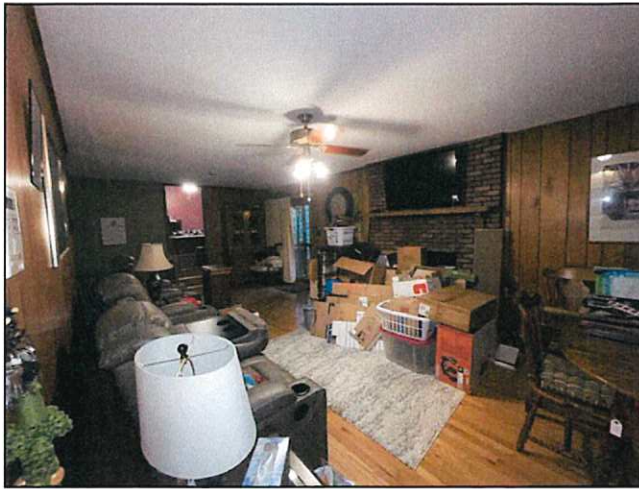
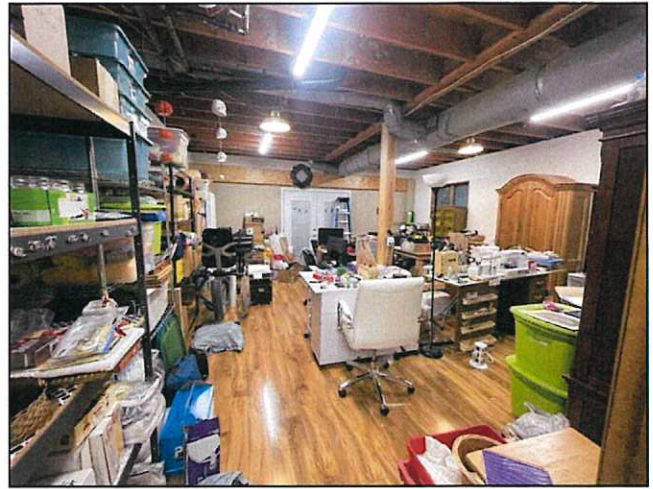
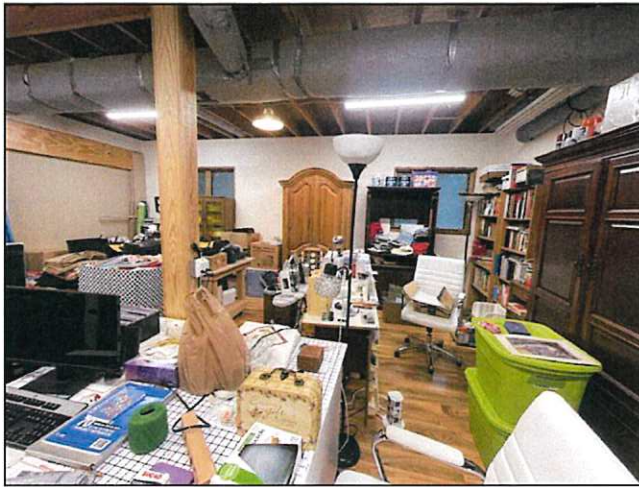
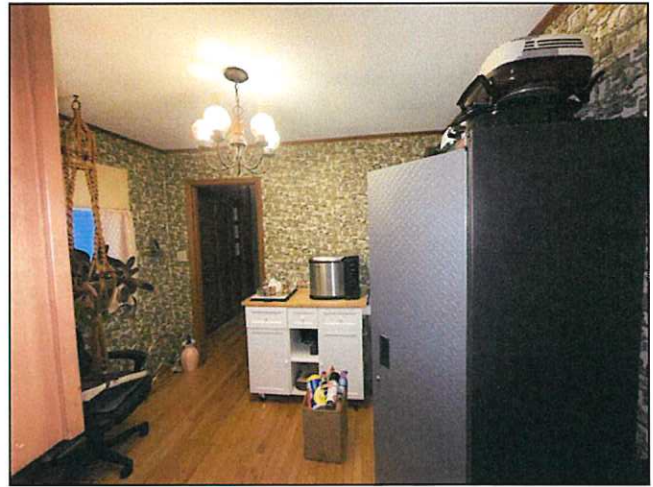
(1) The home is filled with stored items as if it is an estate sale/transaction situation. The home excessive storage limits the inspection as stored items, furniture and personal items are not moved during the inspection.

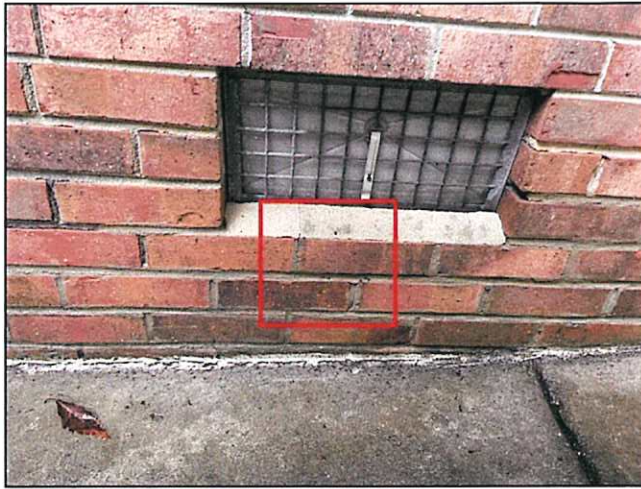
There was/were hairline crack(s) noted in the following locations. Point up and continue to monitor. No corresponding cracks were noted inside the home at these areas and all windows and doors around the area were functioning as intended at the time of inspection. :

1. front side of home
2. rear side of home

Note: Crack monitoring kits can be purchased at Lowe's, Home Depot, and various other locations. They are a slide which is glued to the veneer over the middle of the crack so that one side is attached on either side of the crack. They will crack if there is future movement which would warrant further investigation by a licensed engineer at that time.

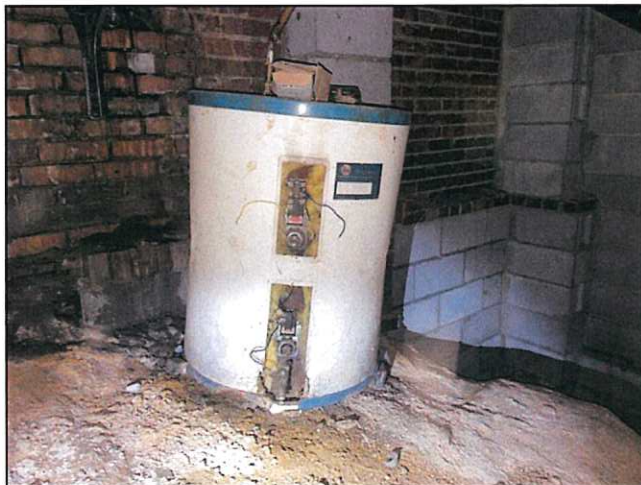
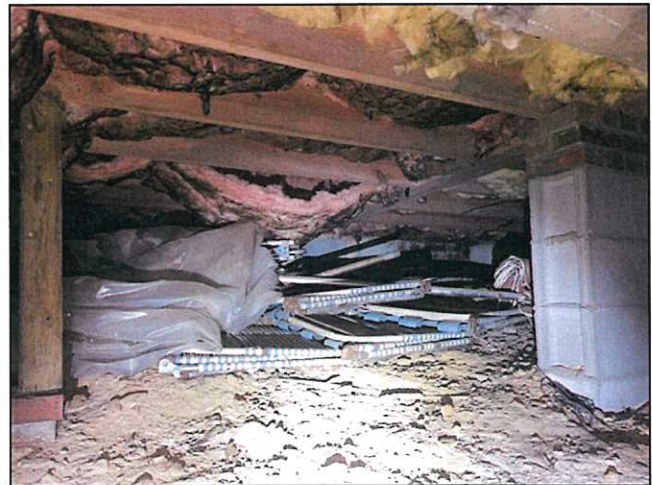
(3) The construction debris/stored items should be removed from the crawl space under home. Stored items/debris give rodents/insects a place to nest and may create undesirable conditions. These items are not moved and prevent full viewing at time of inspection. Remove as needed.

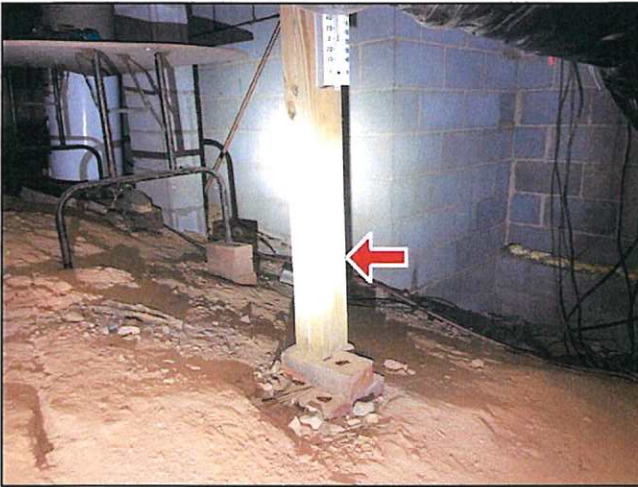
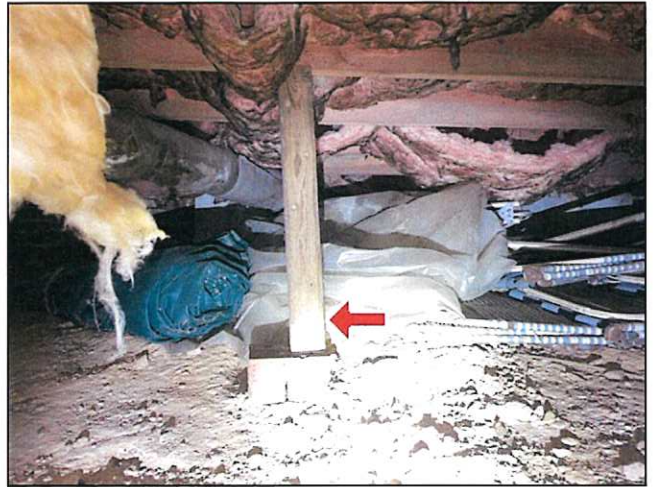
(1) Multiple repairs/added supports have been made to the substructure. The manner in which the repair(s)/modification(s) was made does not conform to standard building practices. All repairs/modifications to a structural member require permits to be pulled. Check to verify that there were pulled. If not, then contact a licensed contractor for repairs.

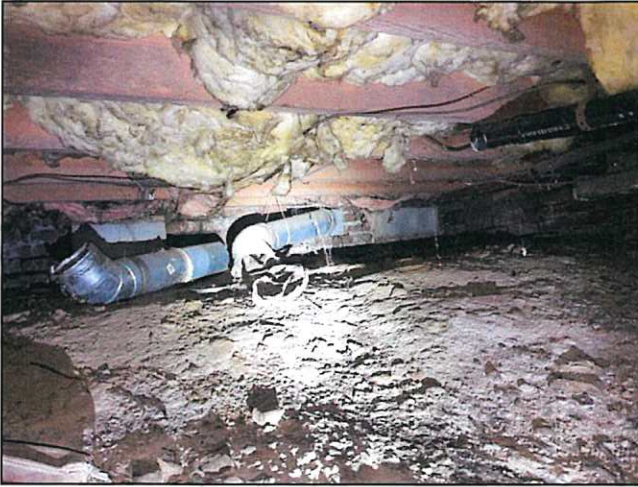
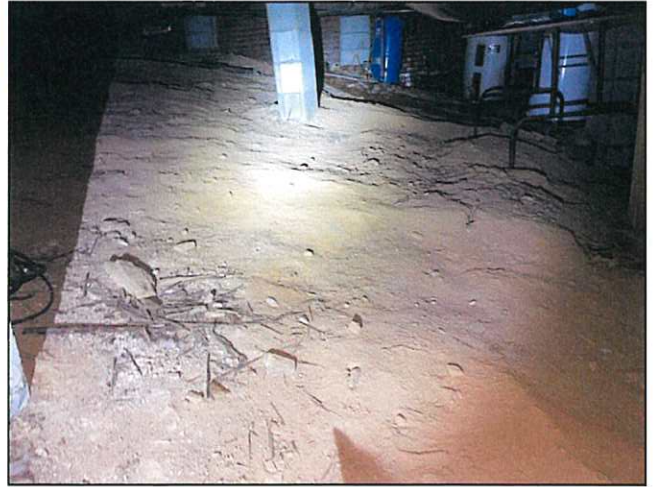
There is not a vapor barrier installed in the crawlspace. Recommend installing a vapor barrier to reduce or keep moisture levels down in the crawlspace area. Contact a qualified professional.

Note: Exposed soils in a crawlspace should be covered with a retardant material to prevent moisture or standing water from deteriorating wood framing above. Approved materials include, but are not limited to: polyethylene sheeting, concrete, or blacktop. If the ground is saturated, wall vapor barriers of like materials are also recommended.

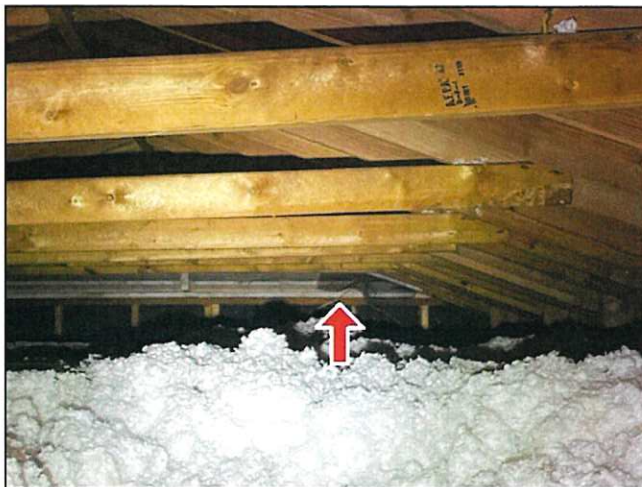
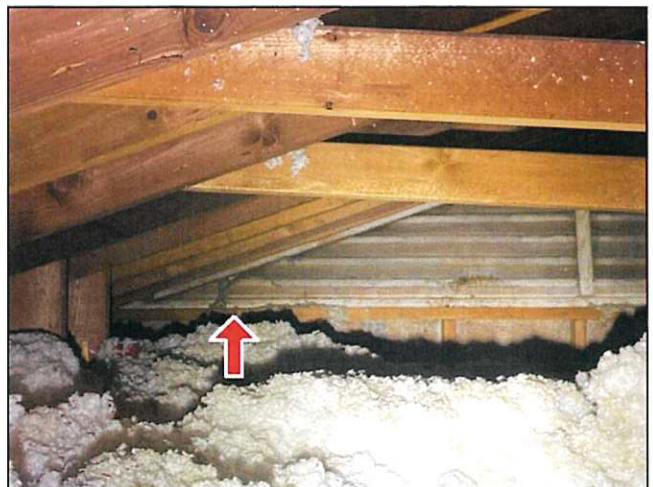
(2) The gable vent screen is loose, damaged, and/or deteriorating at the front and rear of the attic. Repair and/or replacement is needed to prevent pest entry. Contact a qualified professional for repair.

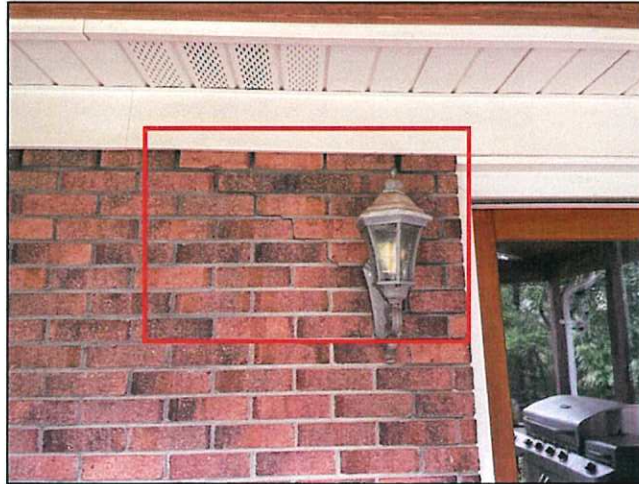
(1) There were typical hairline cracks noted in the following locations. These should be pointed-up with mortar to prevent water penetration and expansion. Continue to monitor after the repairs are made. You may wish to install crack monitoring glass to verify that no further settlement is occurring. These devices are inexpensive and consist of a couple pieces of plastic or glass with cross-hairs on them. If the crack returns you should then consult a licensed engineer for further evaluation at that time. :

1. rear side of home

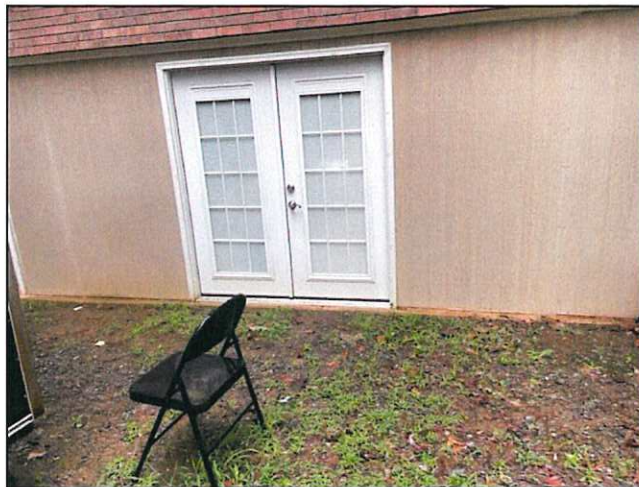
(2) There is siding in close proximity and/or in contact with the ground at the front of the home. This makes easy access for termites and other wood destroying insects, as well as obstructs the viewing of those inspections. The inspector did not inspect behind the siding. A ground clearance of six to eight inches where possible is recommended. Contact a qualified professional for repairs.

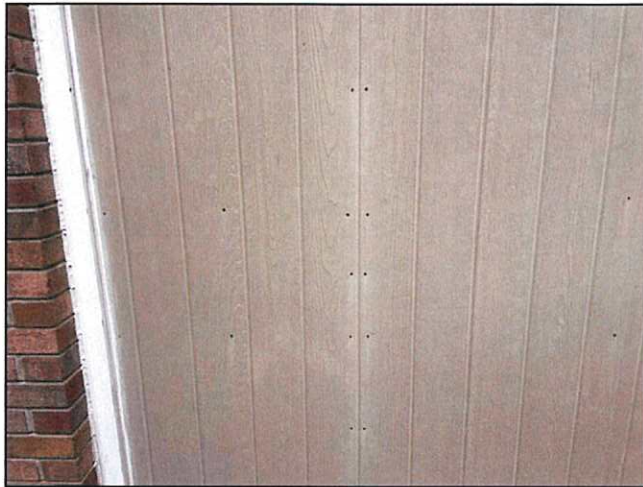
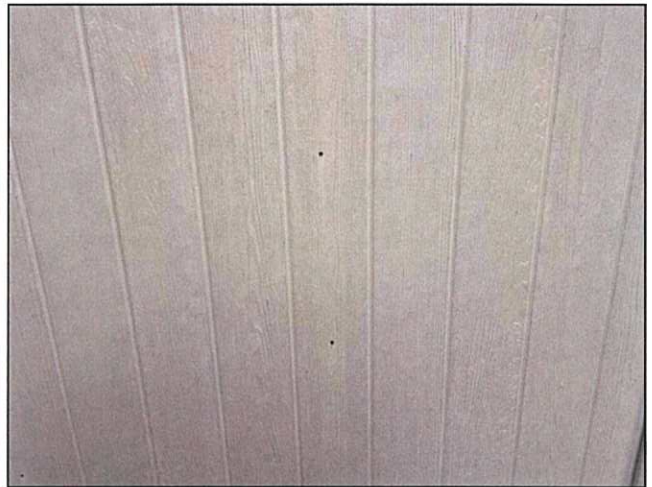
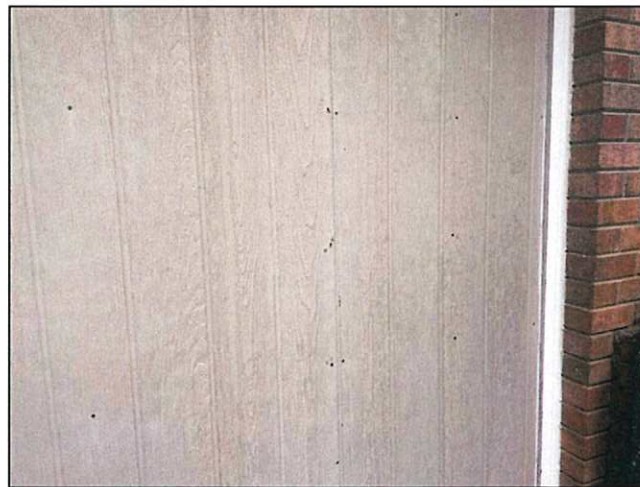
(3) There were multiple areas at the front of the home where the nail heads have been recessed into the siding. This allows for moisture to enter behind the siding and causes damage to the material. All nail heads need sealing and any rotted/decayed sections of the siding should be replaced. Contact a qualified professional for repairs.

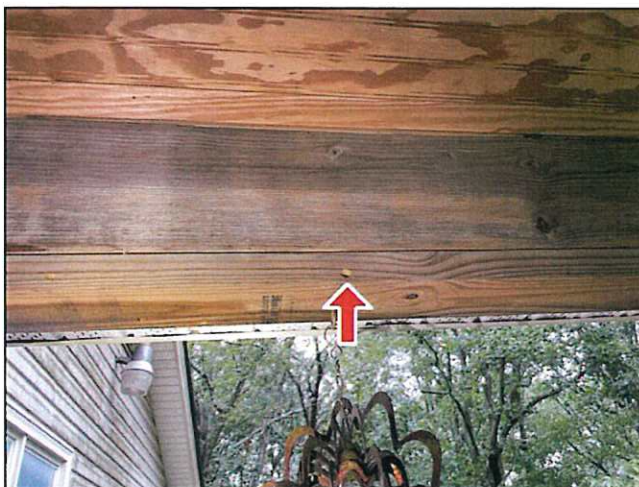
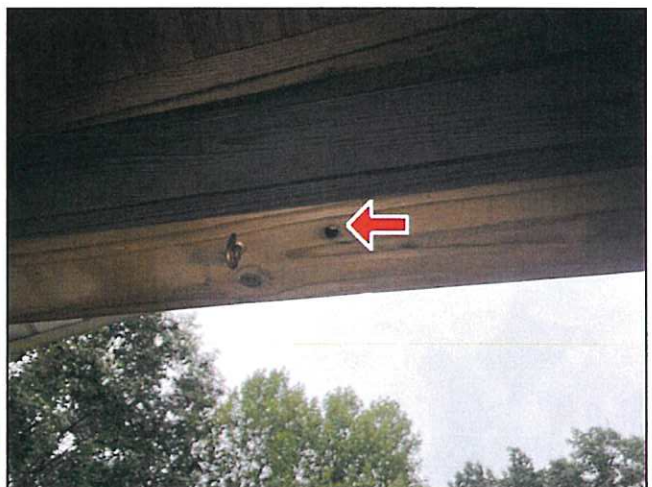
There is a carpenter bee hole(s) found in the trim at the following locations. Have an exterminator further evaluate and treat as needed. Contact a licensed contractor to repair the trim as needed.

1. rear decking

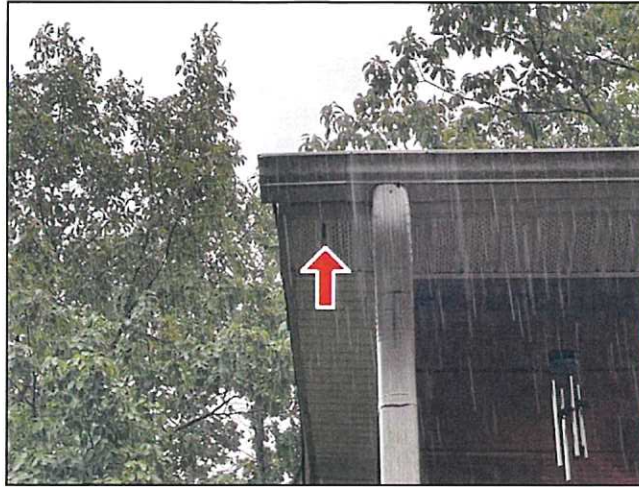
Damaged or disconnected soffit venting was noted in the following locations. This is needed to prevent pest entry into the attic cavity. Contact a qualified professional for repairs. :

1. rear side of home

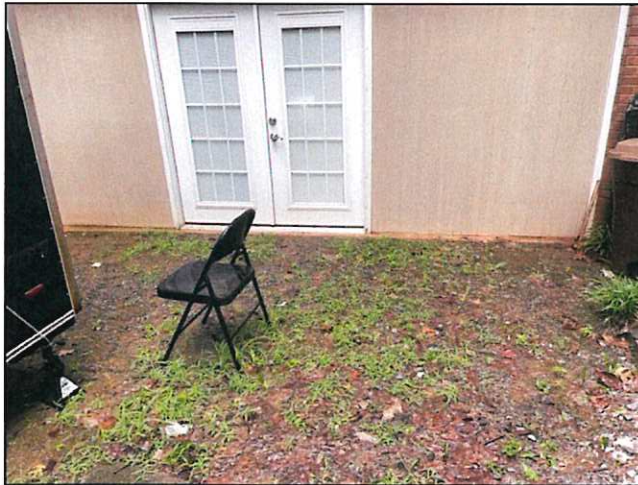
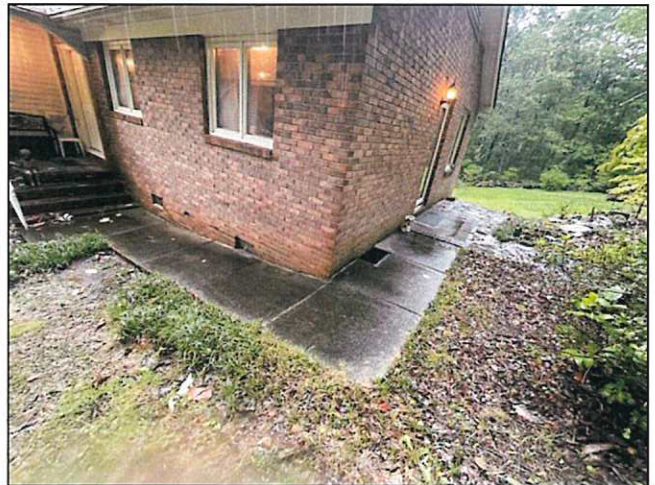
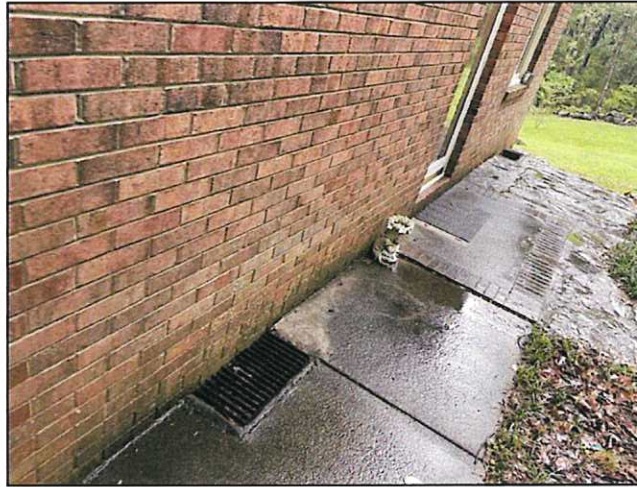
(1) The grade at foundation needs correction at the front and right sides of the home. The grade slopes toward the home and proper drainage needs to be installed to direct water away from the foundation. Contact a qualified professional /landscaper for repairs.

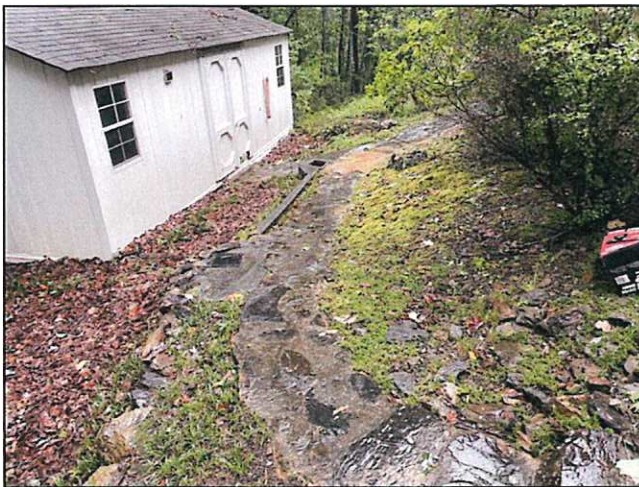
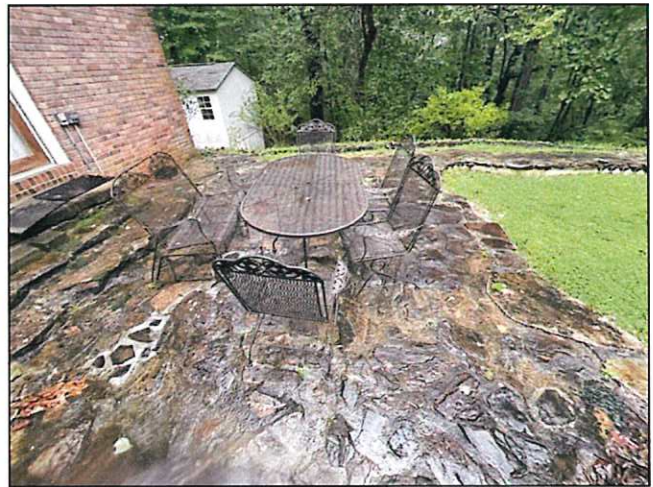
(2) Evidence of poor drainage at the following location(s). This was noted by staining or muddy soil indicating standing water at times or by physically standing water at the time of inspection. This can lead to foundation issues and/or organic growth if standing longer than 48 hours. Contact a qualified professional/landscaper for repairs. :

1. left side of home
2. rear patio
3. right side of home

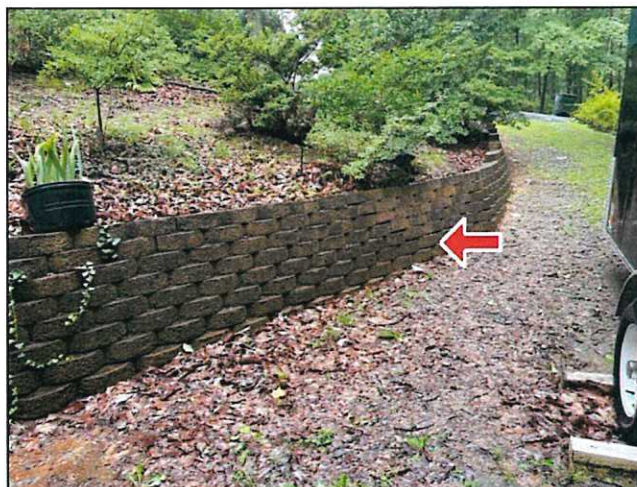
The retaining wall at the front yard was noted to be leaning, bowing, or sagging at the time of the inspection. This is an indication that the wall has moved and is in need of repair. Contact a licensed contractor for review, determine the extent of the damages and make repairs as needed.

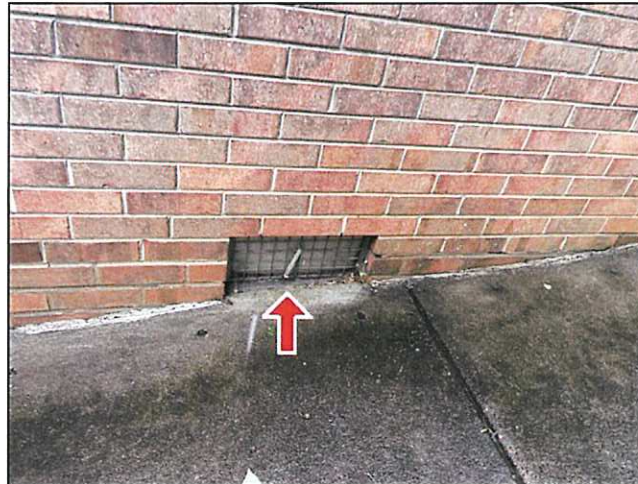
The crawl space vent(s) were at or below grade in the following locations. Water entry and/or poor ventilation into the crawl space is of concern. Contact a qualified professional for full evaluation to determine any repairs or replacements necessary. :

1. front of home

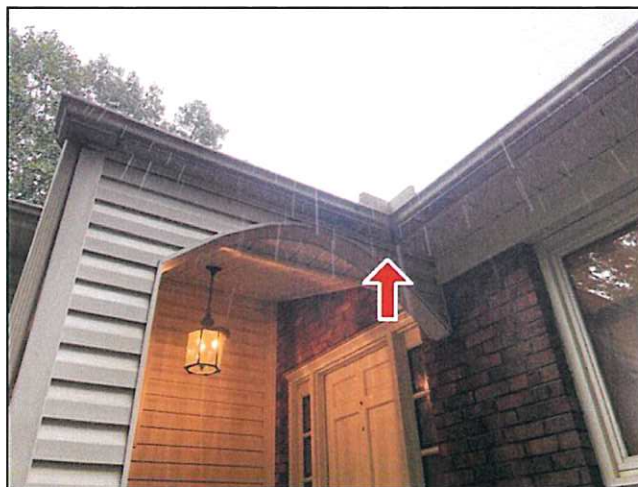
The gutter system on the roof edge at the front side of the home appears to be leaking or inadequately sloped to carry the water to the downspouts. Corrections/repairs are needed to properly direct water away from the home. Contact a qualified professional for repairs.

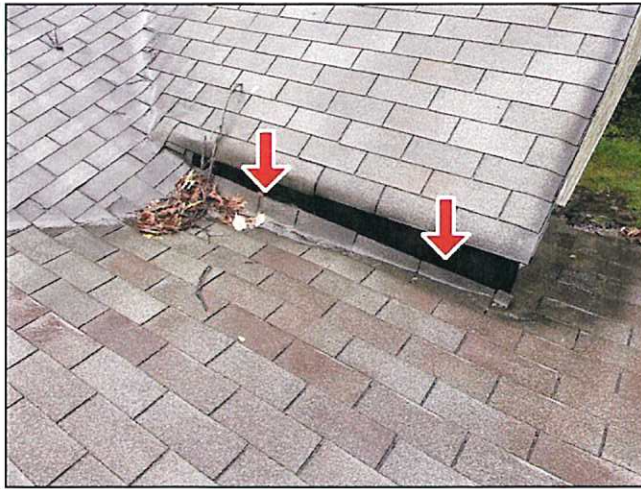
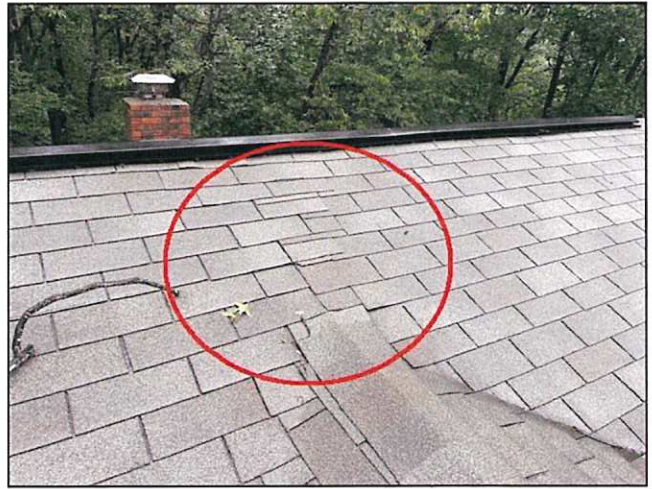
The following area(s) were found to not be flashed and/or installed properly. This can allow water penetration and needs to be repaired. Contact a licensed roofer for repair. :

1. rear side valley
2. upper middle, above right side ridge

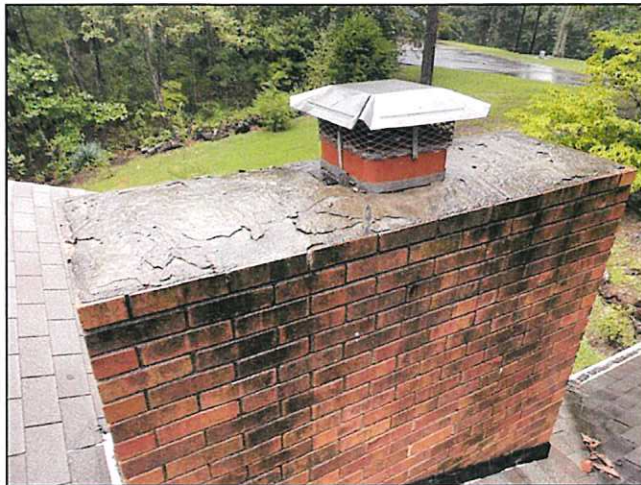
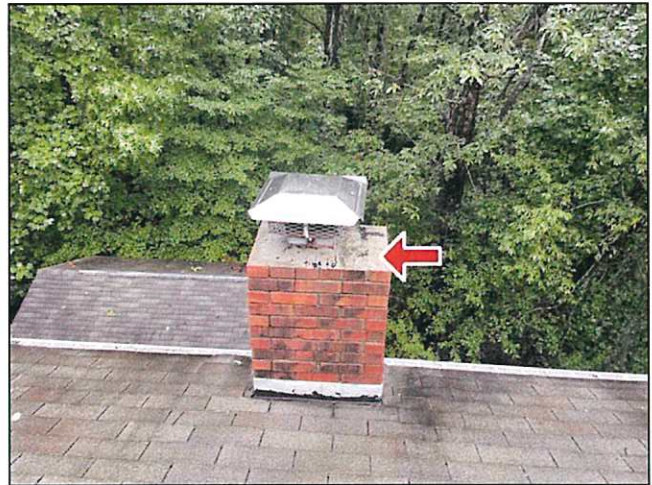
(2) The mortar has cracks and is deteriorating at the top of the chimney caps/crowns. The mortar needs repair to prevent water penetration. This usually consists of pointing up (adding more mortar). The chimney cap/crowns function is to keep water from entering the masonry brick joints that can cause deterioration. Contact a licensed chimney company for repair.

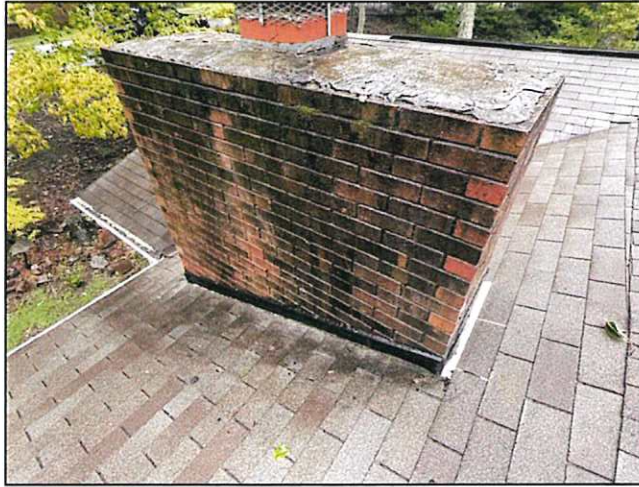
(3) There was lichen growth noted around the main/rear chimney cap and/or top sides of the chimney. This is an indication of a moisture problem which needs to be corrected to prevent further damage/deterioration. Contact a licensed chimney company for repair.

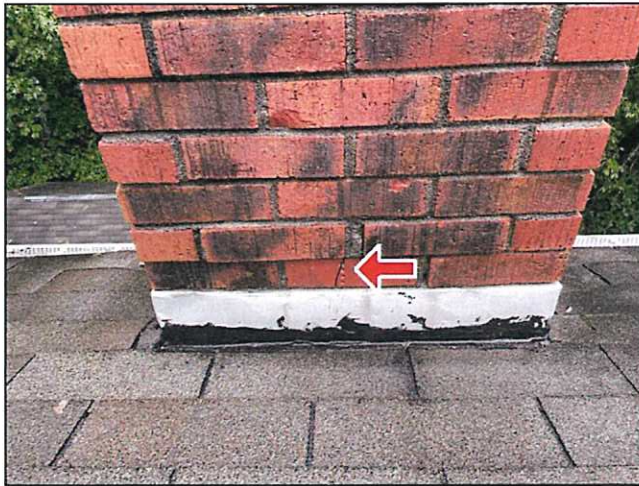
(4) Cracks noted in the exterior of the left side chimney/flue indicate some movement or a possible cracked flue liner. Contact a licensed chimney company for repair.

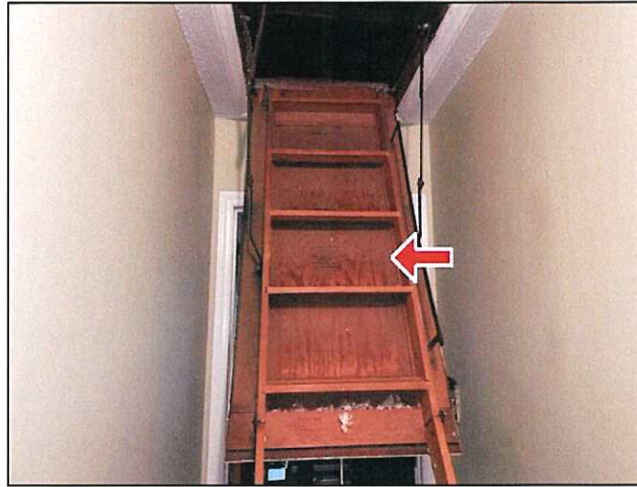
(1) There is no insulation installed on the back of the pull down attic stairs. This provides little to no R-value protection and can be a large source of heat loss. Installation of insulation or an "attic tent" is recommended. Contact a qualified professional for repair.

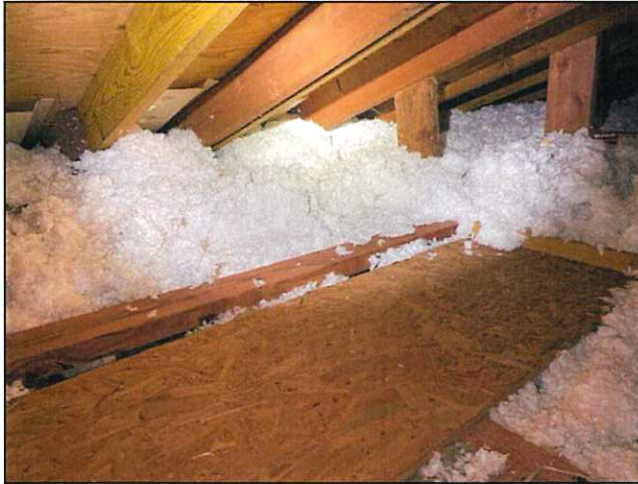
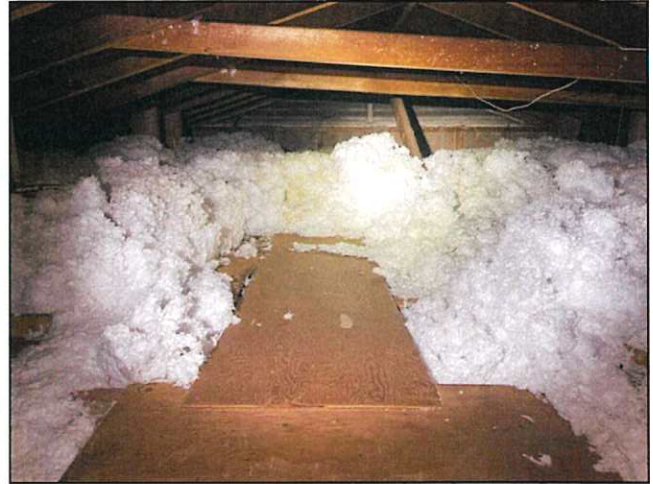
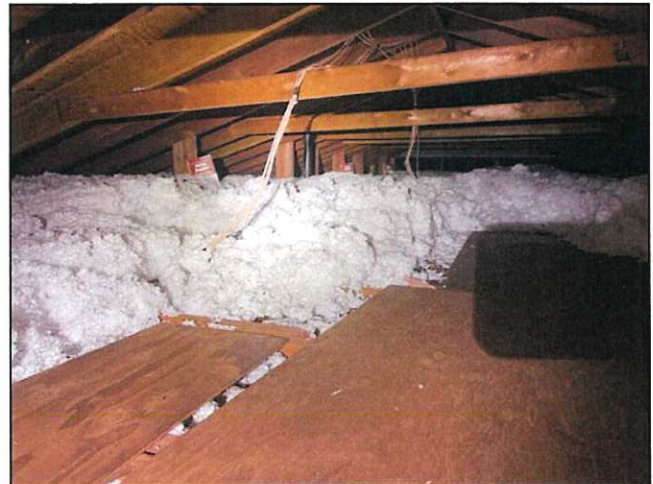
(2) The insulation is compacted in several areas throughout the attic and the true R-factor at this point in time may be substantially less than when originally installed. Installation of additional insulation is needed. Contact a qualified professional for repair.

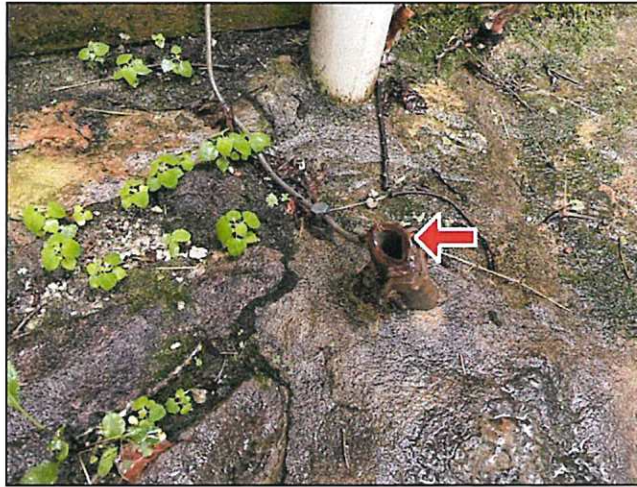
(1) The ground rod is hollow core galvanized piping. This generally rusted out in a period of 10 to 15 years. The age of the ground rod is over this limit. It is recommended an update be done by a licensed electrician to assure the home is grounded properly.

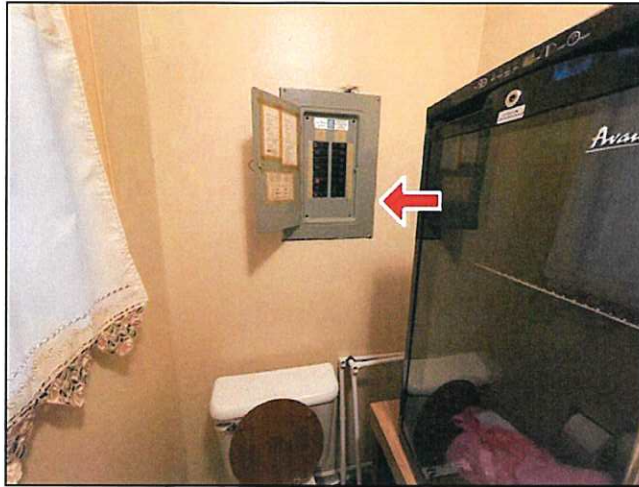
(4) The electrical sub-panel is installed in the downstairs bathroom. This is not typical and generally not allowed for electric panels to be installed in bathrooms. Safety concern. Contact a licensed electrician to

further evaluate the entire electrical system and make any additional repairs as needed.

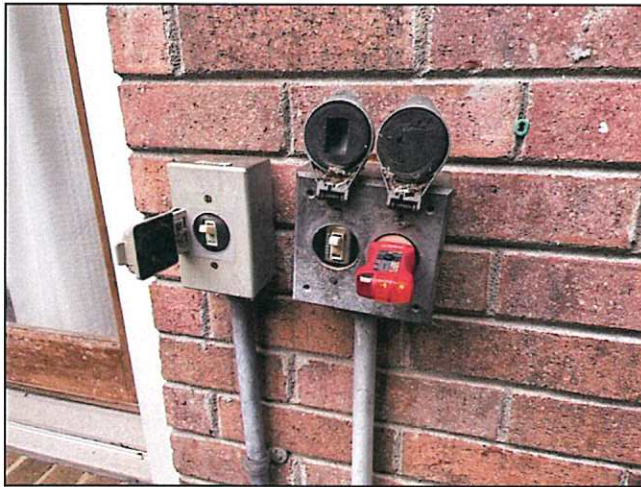
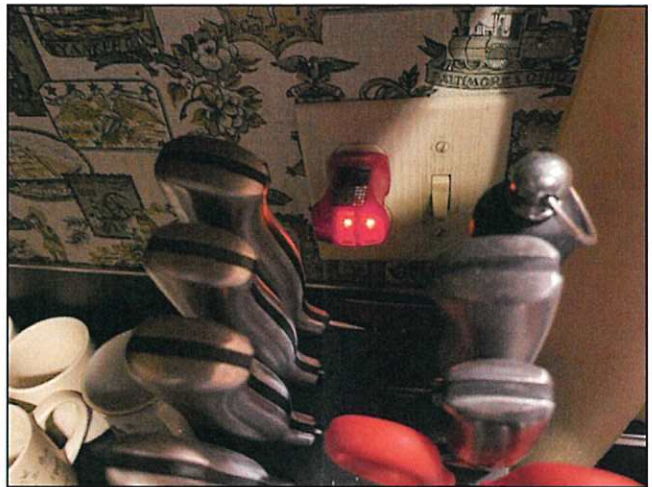
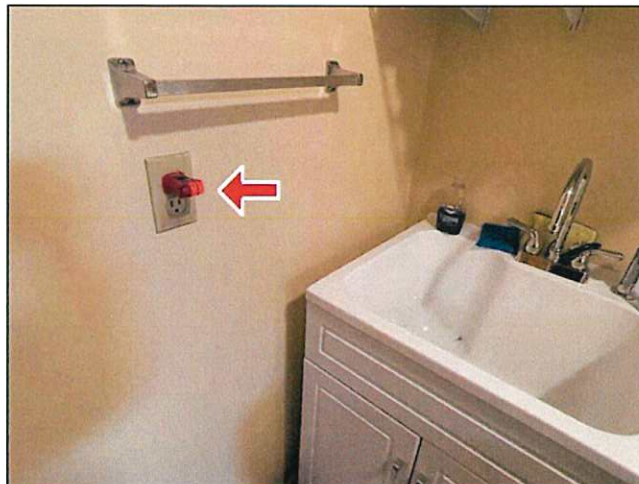
The following outlet(s) are not protected by a GFCI. These are needed in "wet" locations to allow the circuit to turn off in case of an emergency. Contact a licensed electrician for repair. :

1. exterior outlets
2. kitchen outlets
3. bathroom/laundry room outlets

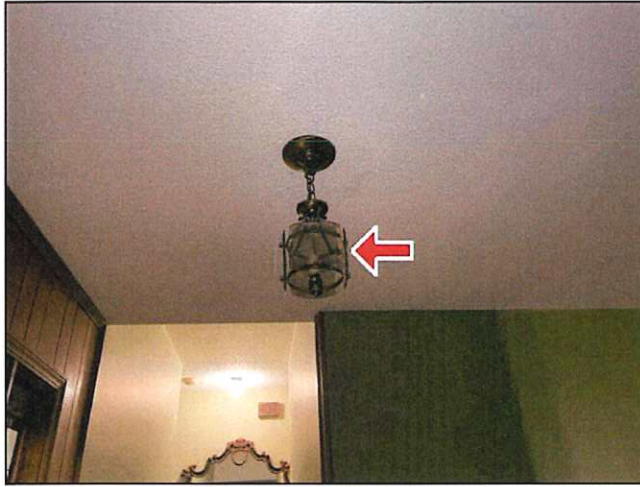
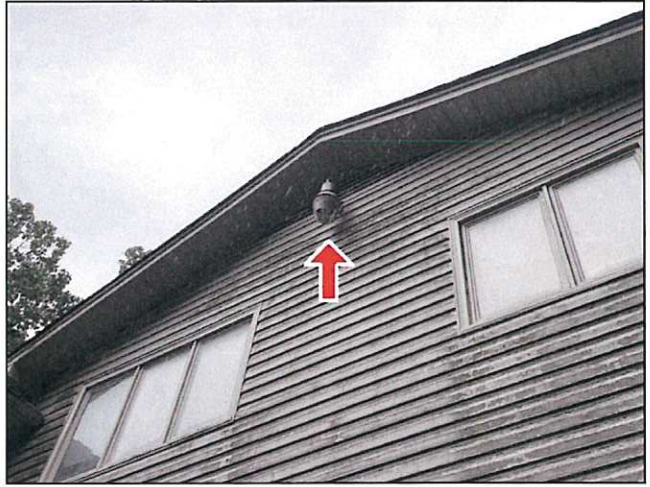
(1) The following lights had a bulb that did not function when tested. Replace the bulb and re-test to be sure it functions and is not an electrical issue prior to closing. Contact a licensed electrician if replacing the bulb does not correct the issue. :

1. foyer
2. exterior light(s)

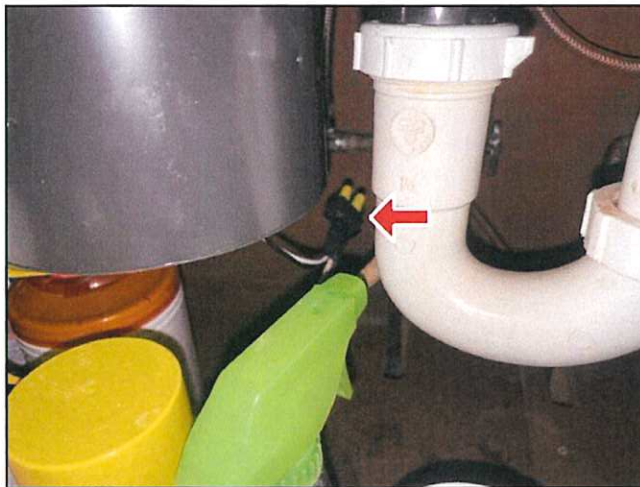
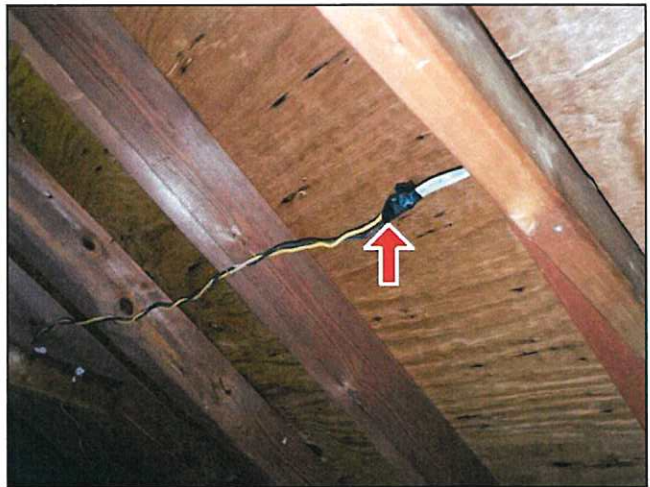
(2) There are wires wrapped in electrical tape at the following locations that need to be installed into a junction box. This is a safety hazard. Contact a licensed electrician for repair. :

1. disposal under the kitchen sink
2. attic area

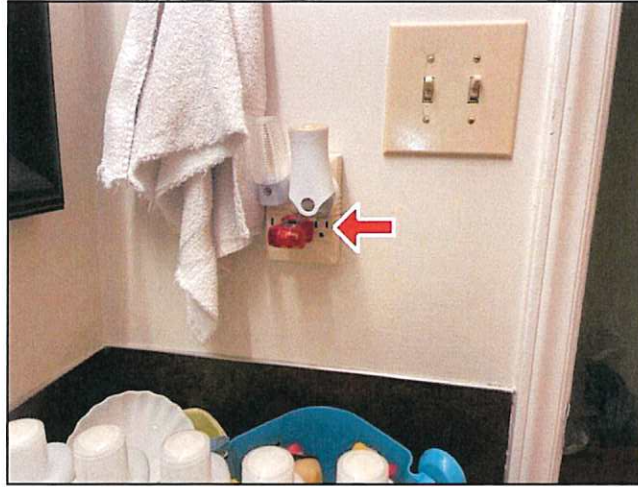
(3) The following outlet(s) were found to have an open ground and need correction. Electrical hazard. Contact a licensed electrician for repair. :

1. hall bathroom outlet

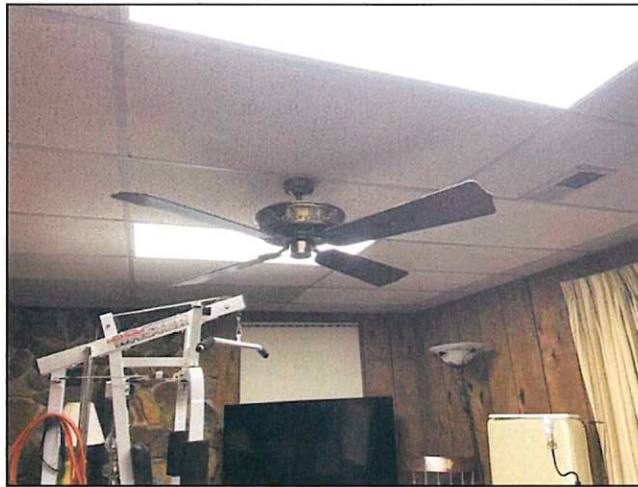
(4) The ceiling fan in the basement family room did not respond when tested. The ceiling fan may be controlled by a remote that was not present at the time of inspection. Ask the sellers if the ceiling fan is controlled by a remote and the location of the remote control. If the ceiling fan is not controlled by a remote then repairs are needed. Contact a licensed electrician for evaluation and repair.

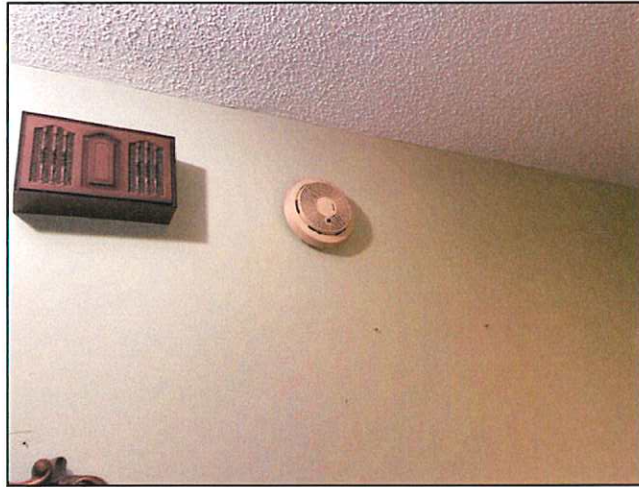
(2) The following smoke detector(s) did not respond when tested and need to be repaired/replaced. Safety hazard. If the units are designed to be tied together then one that also ties in is what should replace it. Contact a qualified professional for repair.

1. upper hallway

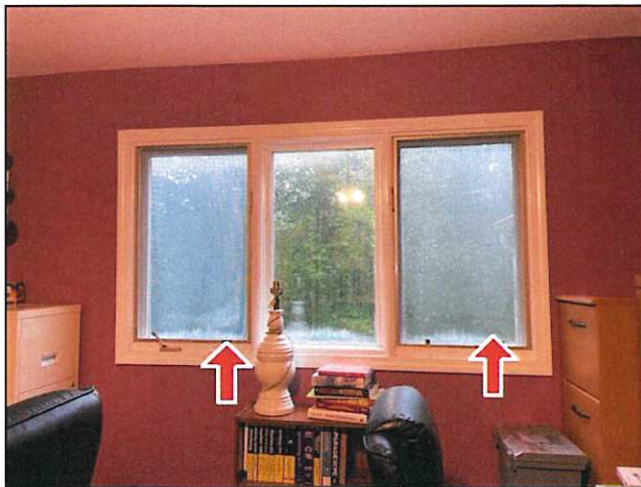
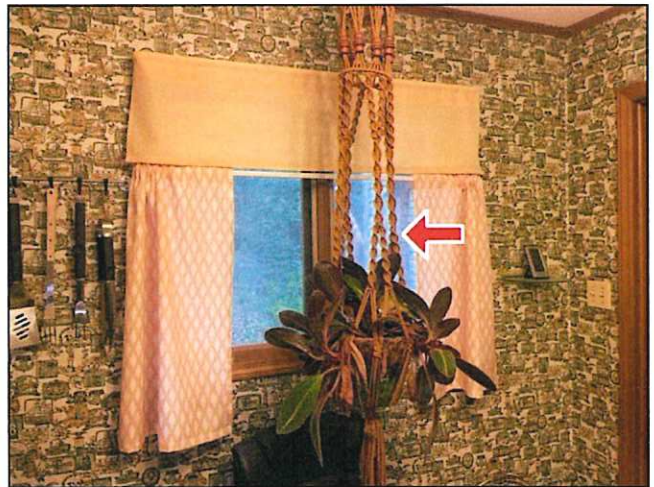
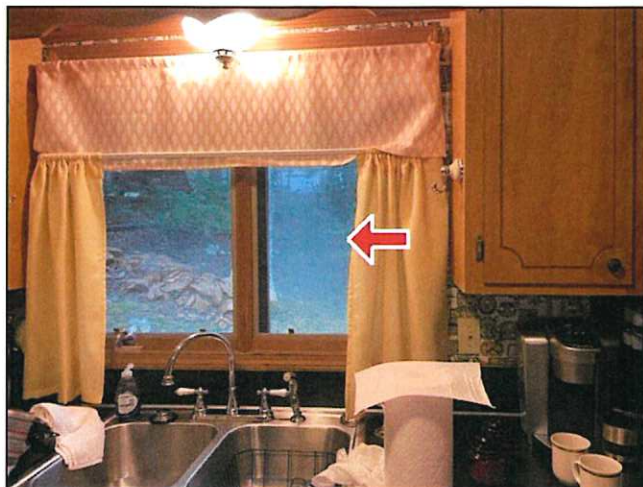
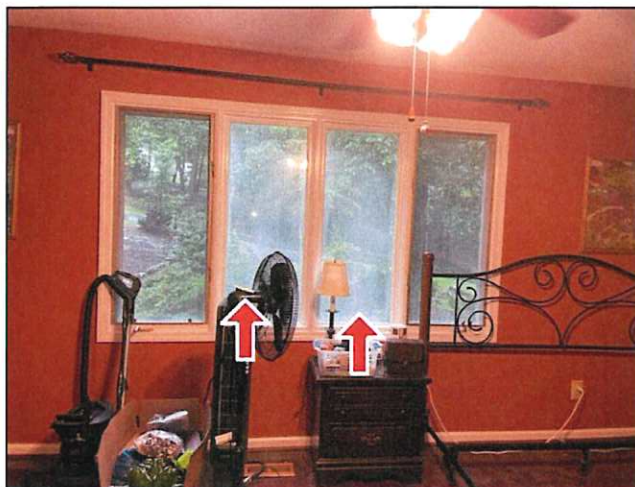
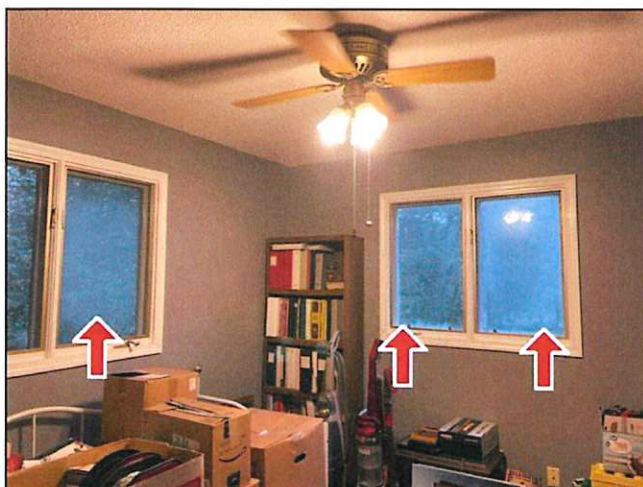
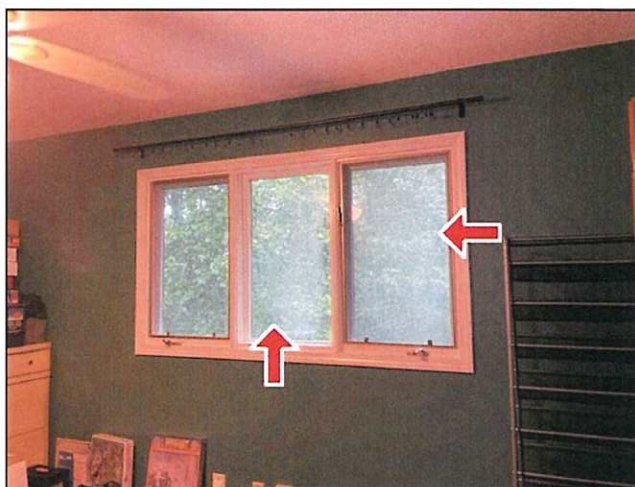
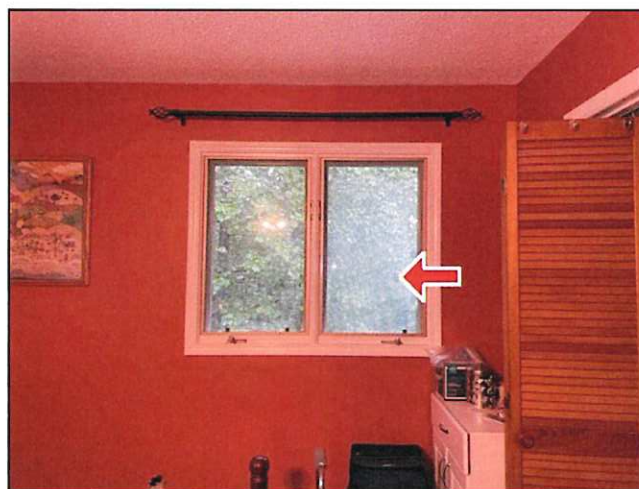
(1) Various windows and/or sashes (but not limited to) were found to have a bad or broken thermal window seal. The thermal window seal is the gasket that prevents moisture from entering in between the interior of the window panes and causing them to fog. The window at this point has lost its gas thus reduces the original r-value of the window. Contact a qualified professional for repair.

Note: Overcast days, dirty windows, and or rain can obstruct the view of the window or make it difficult to identify a bad thermal seal. Because of this it is recommend that all windows be cleaned and further evaluated by the licensed or qualified professional making the repairs. Any additional windows that are found to have bad thermal seals at that time should also be repaired/replaced.

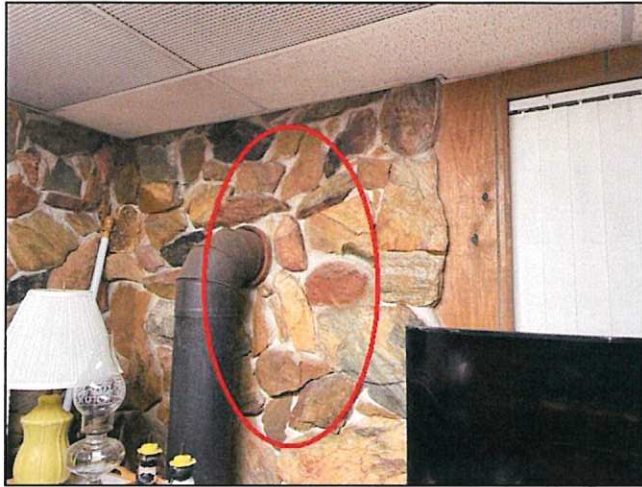
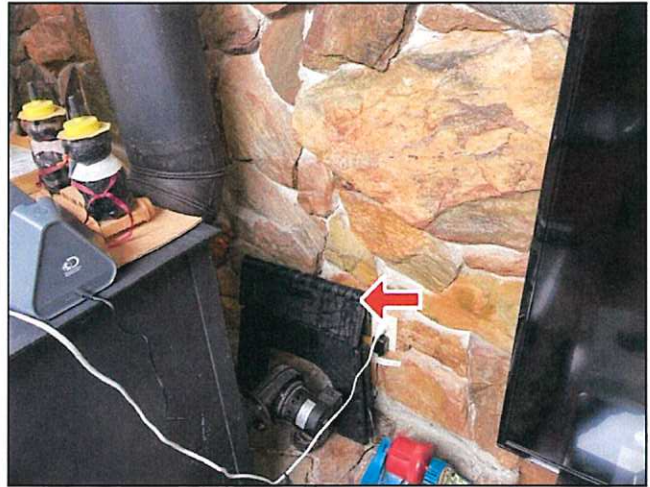
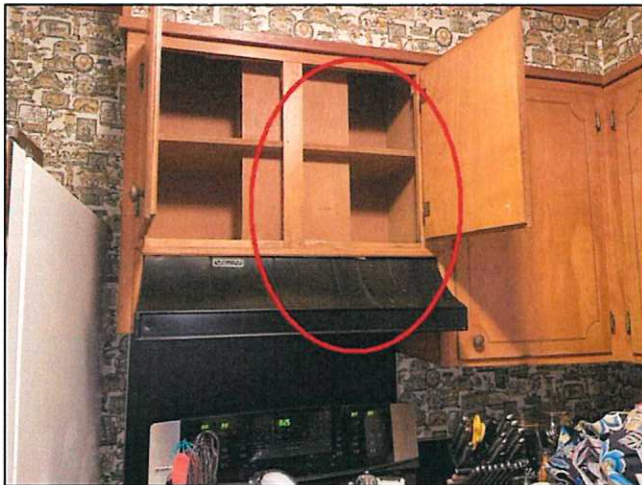
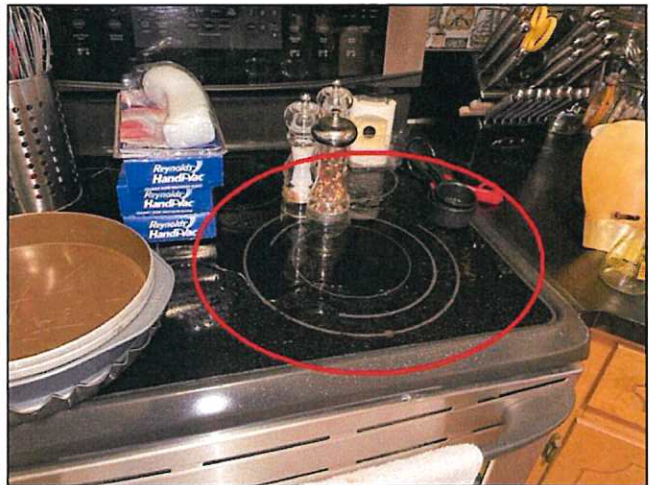
(1) There was an active moisture leaks noted at the following locations. Contact a licensed contractor for review, determine the source/cause and make any additional repairs as needed. : basement family room- left wall, above fireplace kitchen- at exhaust location

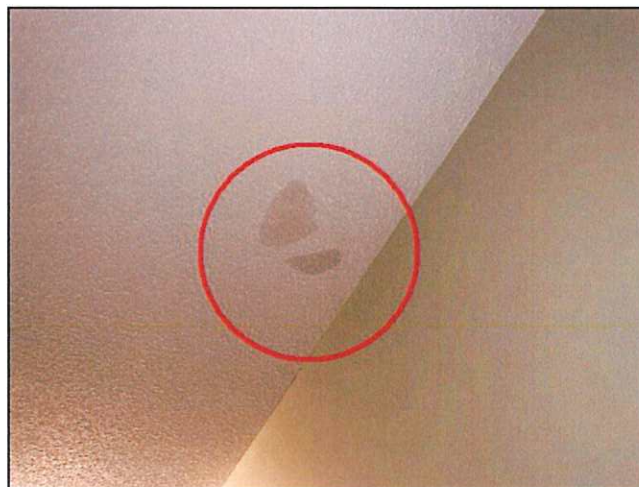
(2) There was a moisture stain noted at the upper hallway ceiling. The reading was inactive at the time of inspection; however the home was vacant at that time. Due to the constraints of time during an inspection, fixtures are only tested for a short period of time. This does not allow time to fully operate the fixtures to simulate normal volume of an occupied home. Ask the seller if a past repair was made. If they do not know then it should be considered an active issue and be further evaluated by a licensed contractor to make repairs as needed.
