# Inspection Report

**Property Address:**  
917 Stoneymead Dr  
Kings Mountain NC 28086

| <b>Date:</b> 8/8/2024 | <b>Time:</b> 08:00:00 AM | <b>Report ID:</b> 080824JK5 |

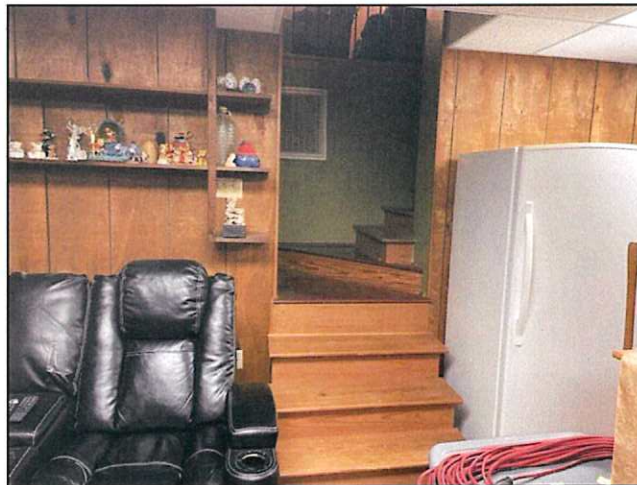
There were 3 or more steps without a handrail installed at the basement staircase. Stairs with 3 or more steps are in need of a handrail or railing. Installation and/or corrections needed to prevent personal harm. Contact a licensed contractor for repair.

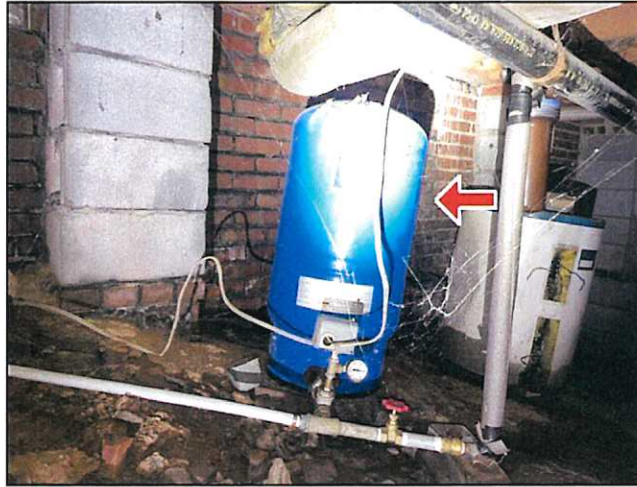
- (1) There was a heavy sulfur smell noted when testing the well. This can sometimes be an issue with the anode rod in the water heater, but can also be from the well. This is not a standard test performed during an inspection, but you may wish to contact a well company to review and determine the cause to be sure it isn't the well itself.
- (2) The bladder tank was not level at the time of inspection. This can cause the tank to not operate properly. Contact a licensed plumber or contractor for repair.

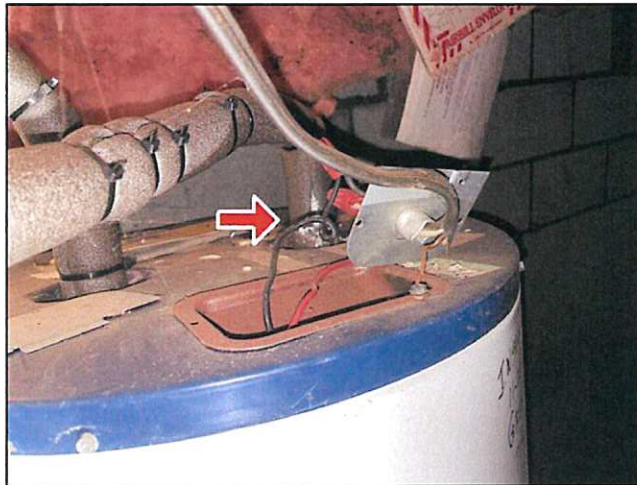
(1) The electrical wiring at the top of the tank is exposed and needs to be secured/terminated properly. This is needed to prevent someone from grabbing the line and being shocked or for the line to arc to the tank. Contact a qualified professional for repairs.

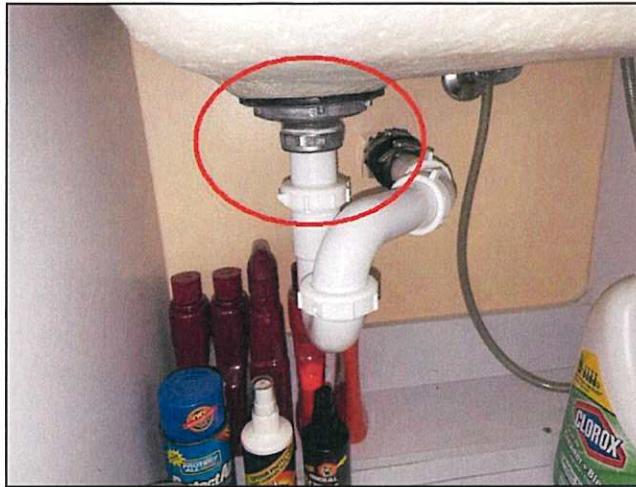
There was an active leak noted under the sink at the waste pipe where it connects to the bottom of the sink at the time of inspection. Corrections are needed to prevent water damage. Contact a licensed plumber for repair.

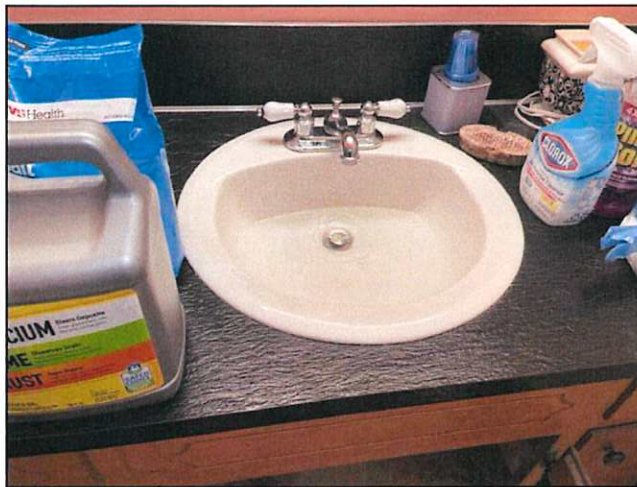
The sink is slow to drain. Corrections needed for the sink to drain properly. Clean the drain and re-inspect. If the sink is still slow to drain it could possibly be a venting issue. Contact a licensed plumber for evaluation and repair.

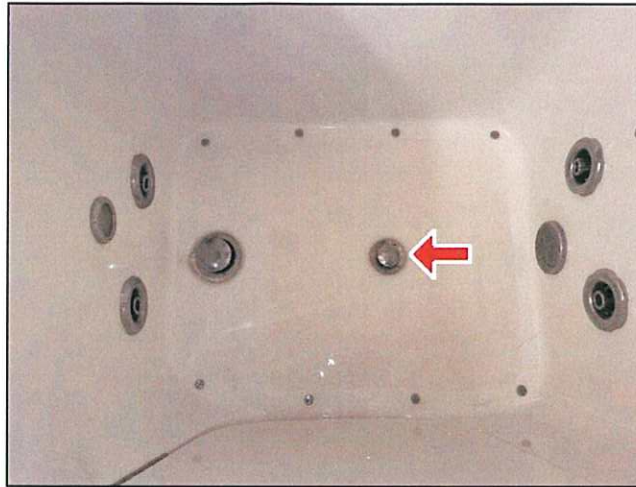
The drain stopper was not functioning properly at the time of inspection. Repair/replacement is needed so the tub can hold water properly when bathing. Due to this, the tub was not fully filled and the jets were not tested. Contact a licensed plumber for repair.

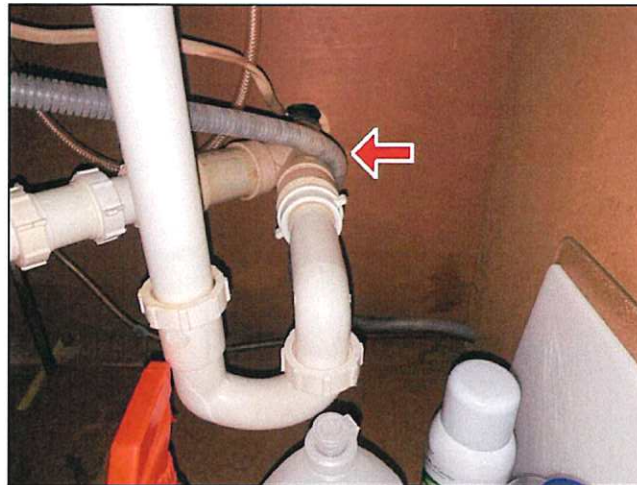
There was no high loop installed for the dishwasher drain. The drain line should go up as soon as it enters the cabinet, attach to the bottom of the countertop and then slope back down to the waste line/ disposal connection. This is needed to prevent water from flowing back into the dishwasher after the pump cuts off. Contact a qualified professional for repair.
