BENFIELD OUTDOOR SERVICES & SOLUTIONS

December 14, 2023,

RE: Septic System Inspection 158 Cove View Dr, Mooresville, NC BOSS Project #: 2584

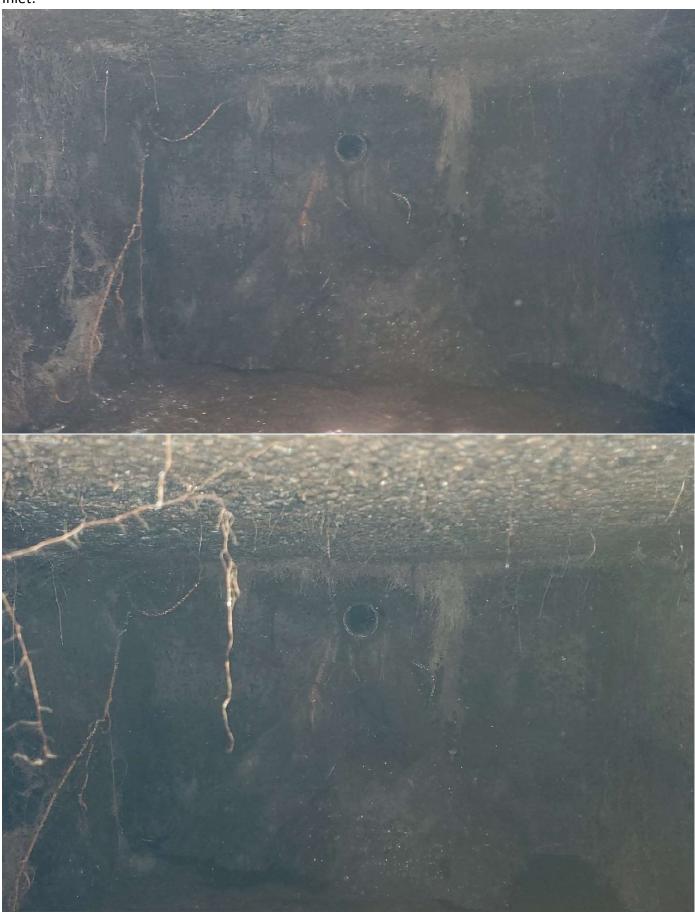
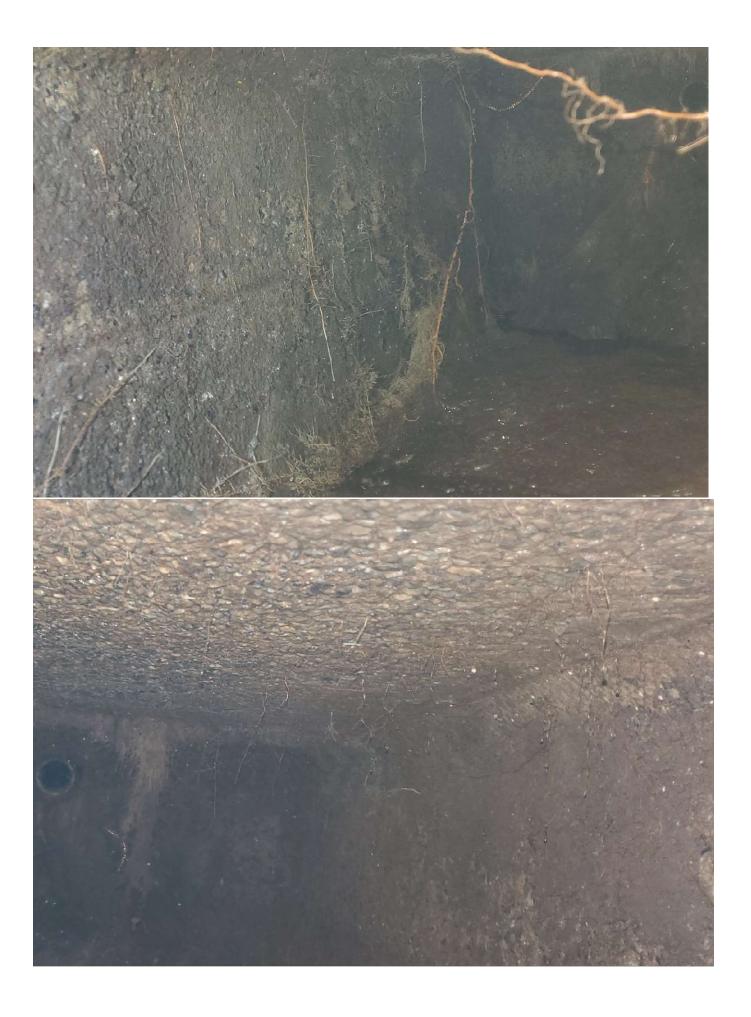
Inlet:

During the inspection BOSS personnel located, uncovered, and inspected the septic tank. The inlet and outlet appeared to function. However, the tank showed signs of age/decay, moderate to heavy root infiltration, the water level was low, and there was a tree beside the tank. We determined the tank had roughly 25-30% solids. For future reference, tanks are recommended to be pumped every 3-5 years or when the tank has reached around 25-35% solid build up.

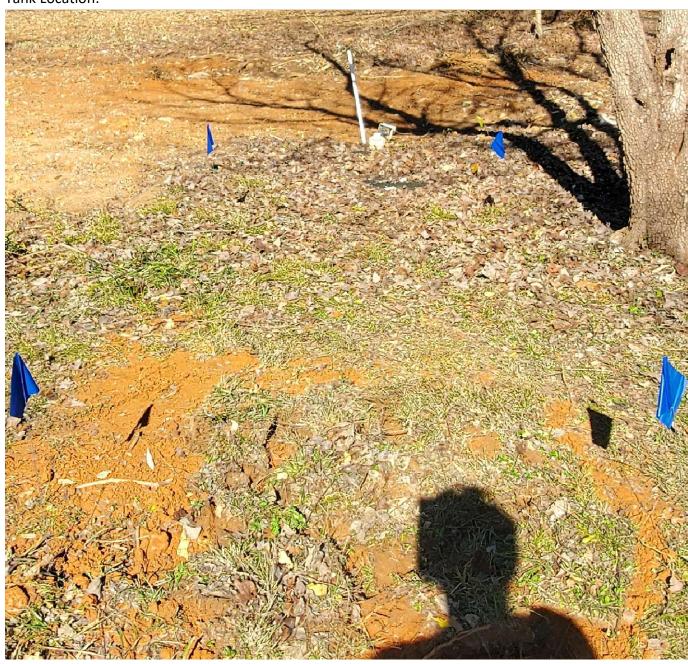
Tank Location:

The system consisted of an estimated 1000-gallon septic tank that fed to a conventional drainfield. The septic tank was located by a tree with a visible cleanout. The drainfield was located 4-5 ft from the septic tank and ran from the tank towards the front of the property.

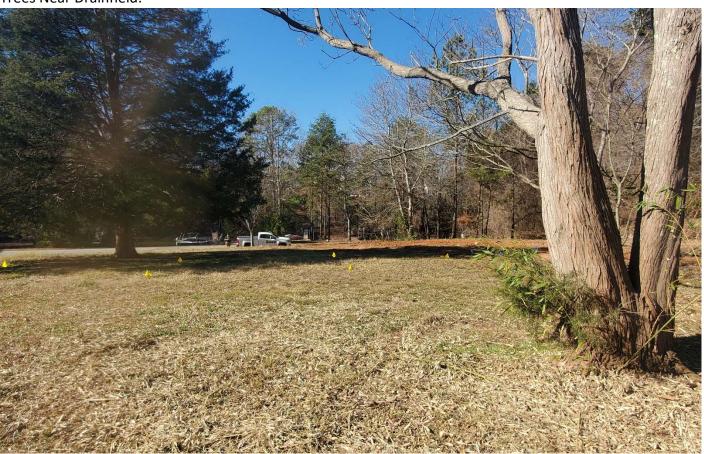
Trees Near Drainfield:

The drainfield was located and inspected. It consisted of a gravel bed roughly measuring 10 ft x 53 ft. During the inspection we did not observe any signs of surfacing or damage. However, there were two old growth trees near the drainfield.
