Inspection Report

**963 Beaver Creek Road
Bluff City, TN 37618**

1.1 Client Name: Lois Wells.
 1.2 Inspection Number: 042125-02.
 1.3 Inspection Date: April 21, 2025.
 1.4 Inspection Address: 963 Beaver Creek Road, Bluff City, TN 37618.
 1.5 Inspector: Ron Ladd, TNHIL #0000033, VAHIL #3380000585, ASHI #245442.
 1.6 Parties Present: Seller, Sellers Agent.
 1.7 Clients Agent: N/A.
 1.8 Weather: The weather conditions at time of inspection: Sunny, The temperature at time of inspection: 70 - 80 degrees fahrenheit.

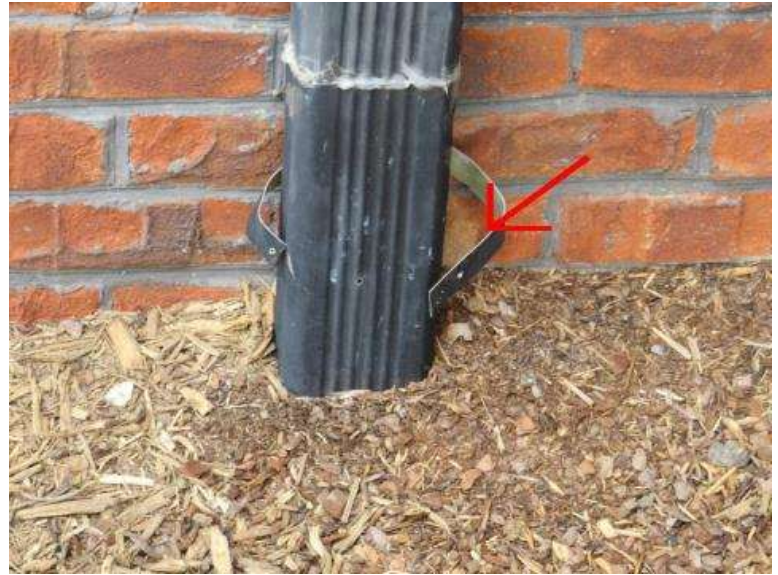
Maintenance: Gutter and downspout securing straps noted as loose or disconnected. Suggests securing to prevent damage or loss.

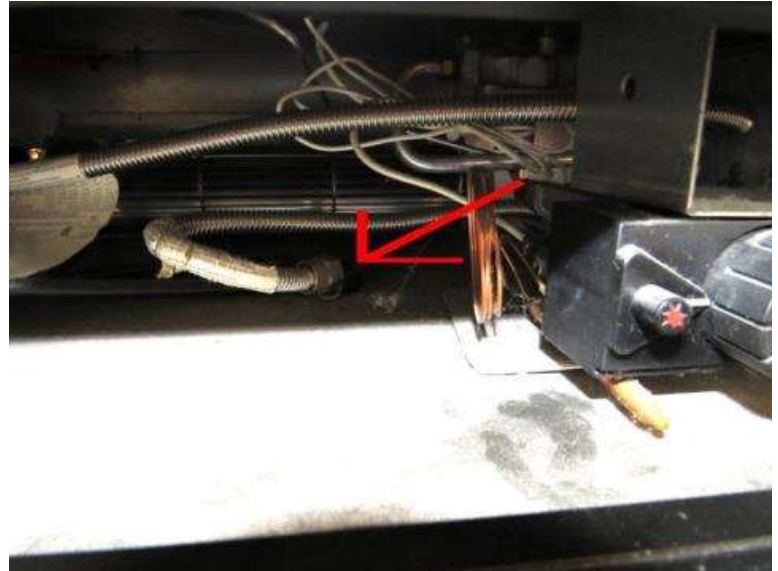
13.27 Condition:

Safety: The gas line was NOT connected at time of inspection and was open at the end of the line. This condition could allow gas to leak out of the line is connected at the other end.

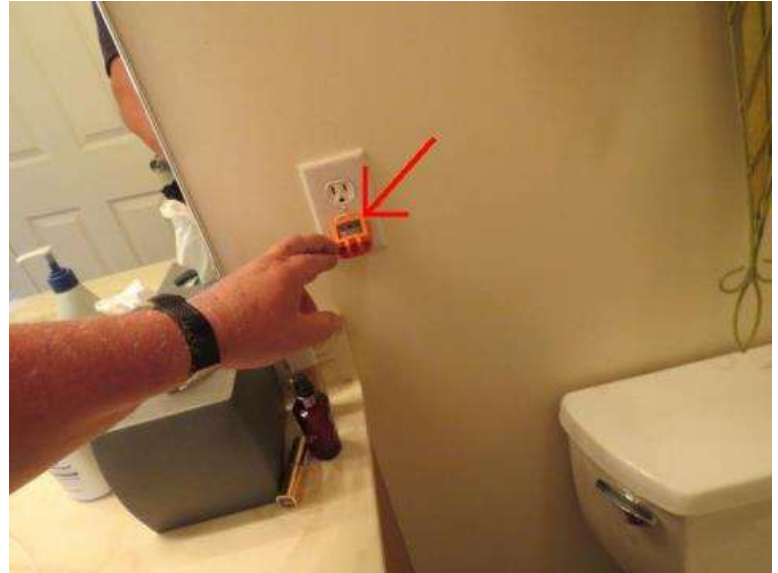
17.16 **Safety:** Outlet did **NOT** have power on day of inspection and **NO GFCI** was protection was noted..

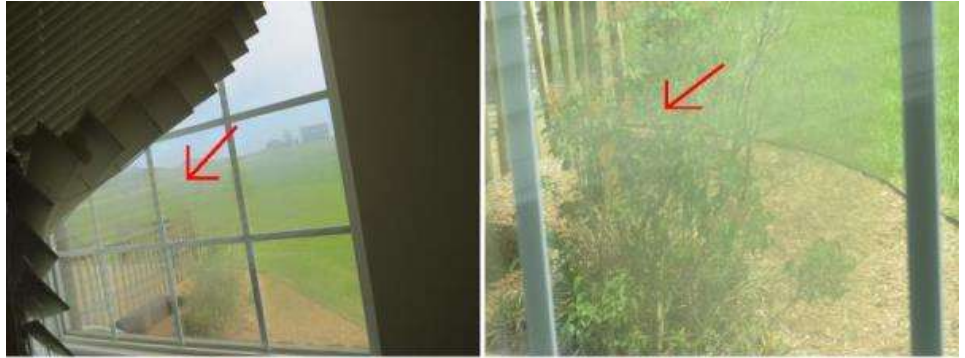
17.50 Condition: **Maintenance:** Fog and condensation was noted in the double glazed insulated window panes at . This indicates a broken seal which will reduce visibility and the insulating capability of this window. To restore visibility and regain the insulating capability, replacement of this window pane is required.

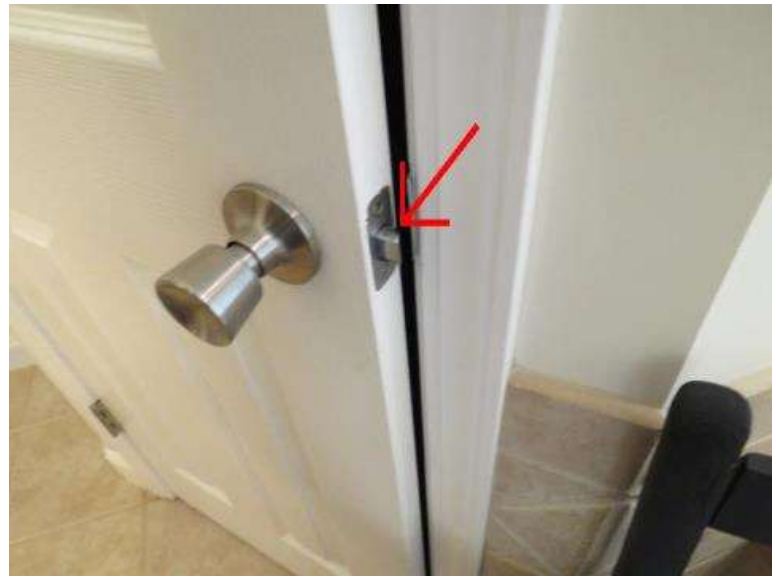
- 17.58 **Maintenance:** Door does not properly lock, latch and remain closed when shut.

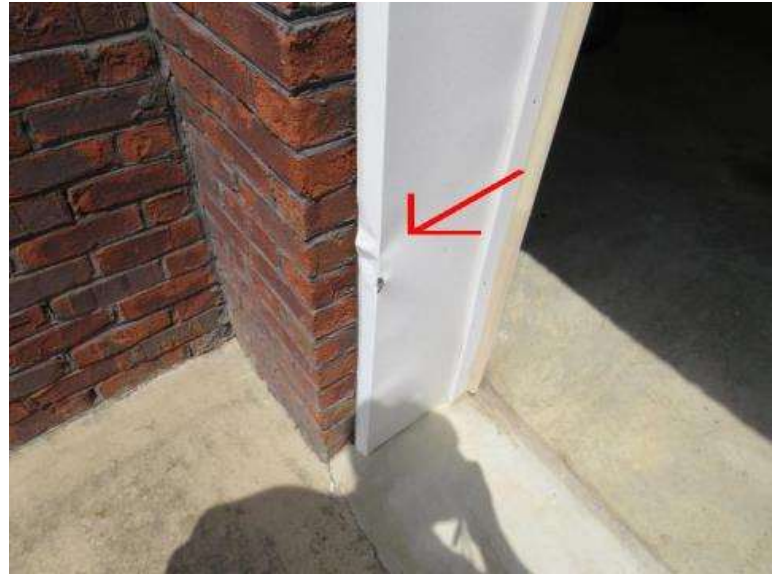
20.39

Maintenance: Minor damage is noted to door frame hardware, suggest repair / replacement to damaged / defective materials for serviceability.
