PROPERTY INSPECTION REPORT

1303 Coggin Ave, Brownwood, TX 76801

Date of Inspection: 11/6/2025 Time: 1:00 PM Size: 1684

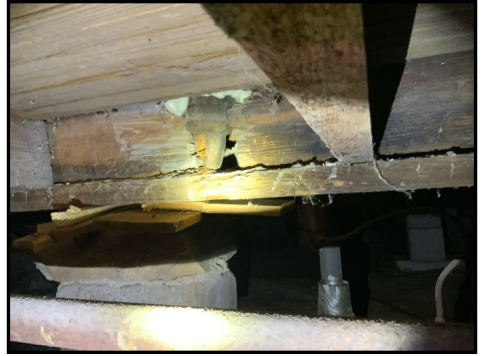
Older damage was observed in the rim joist below the kitchen window and in a beam where an old bathroom was located.

Older damage

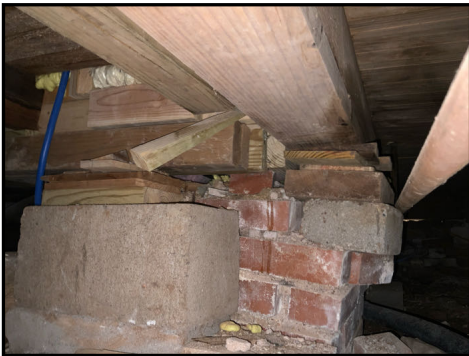
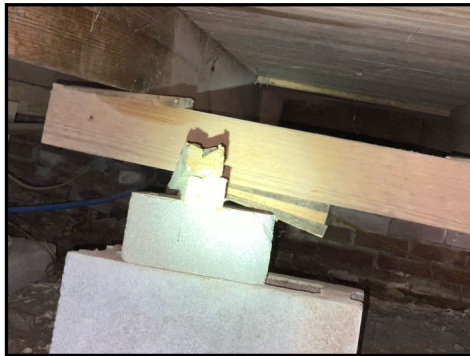
Quite a few shims were used on several supports. While it is supporting the structure, these may need to be adjusted as the seasons change the house shifts. If there are concerns, I would recommend consulting with a foundation company.

Multiple shims

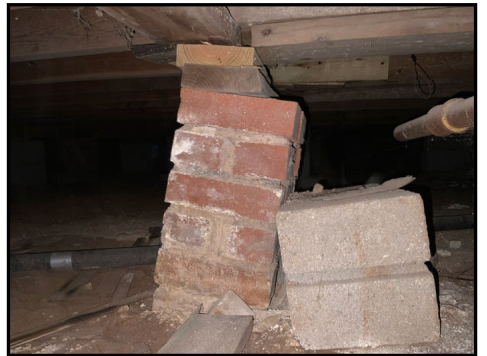
One of the supports are leaning. This is one of the original supports. New supports have been added nearby.

Leaning

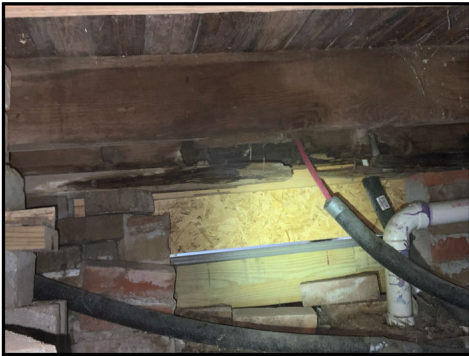
Older damage

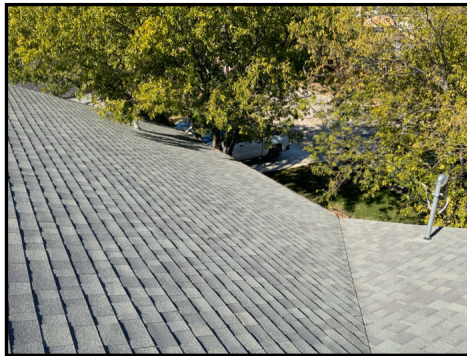
Limbs close

Tree limbs are close to touching the roof in several locations. Recommend trimming these back to prevent damage to the roof.

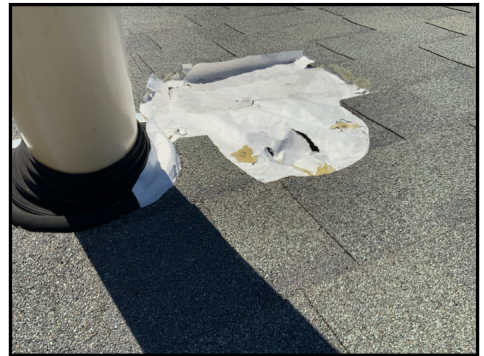
There is a hole in the roof where a previous vent was located. The hole has been covered with underlayment. Repairs are recommended to prevent leaks.

Hole in roof

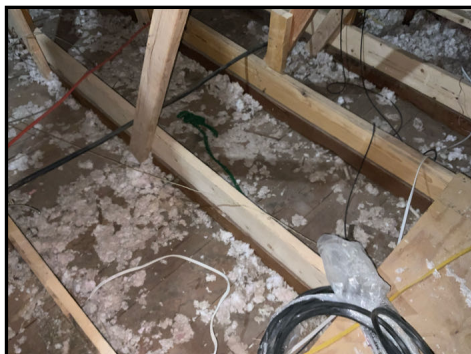
No insulation

No insulation was installed in parts of the attic. It is recommended that a minimum R-30 value be added to meet current energy standards.

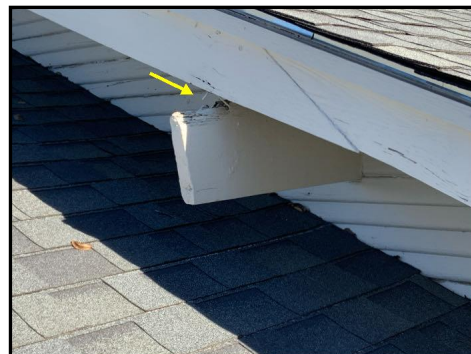
Older damage was present in the faux beams on the back side of the house.

Older damage

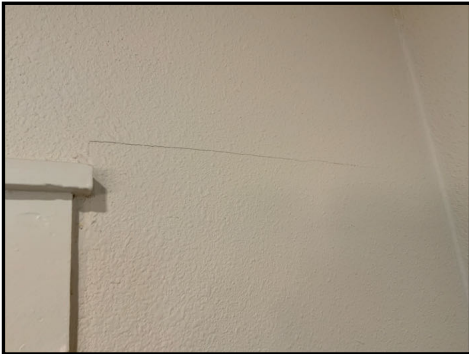
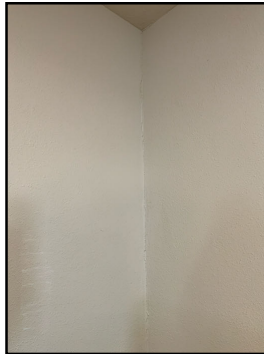
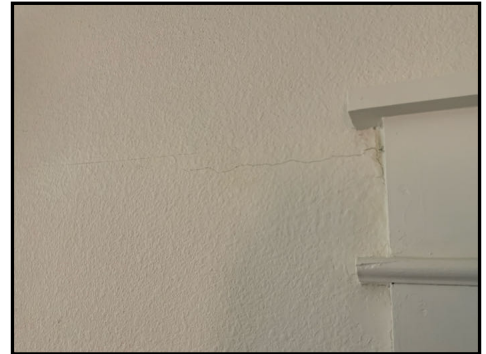
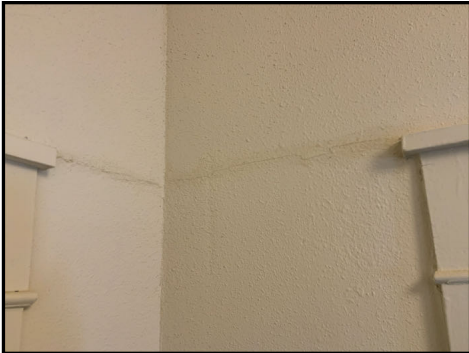
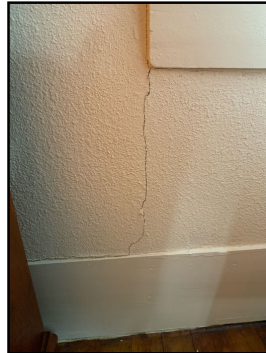
*Small crack
Dining room*

*Crack in
dining room*

*Crack by
front door*

Cracks in hallway

Crack in front bedroom

Typical interior wall cracks were noted in several areas of the house. I would recommend the client monitor these cracks and patch them as needed.

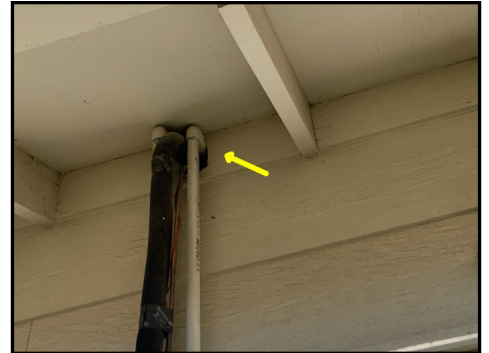
The hole where the AC lines enter the structure needs to be sealed.

Hole needs sealed up

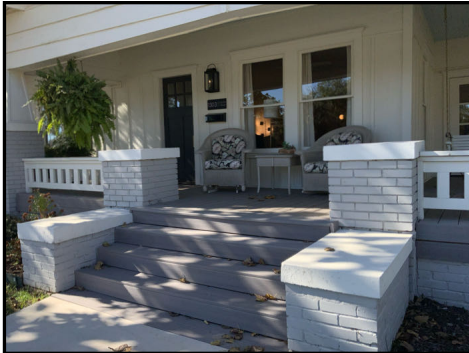
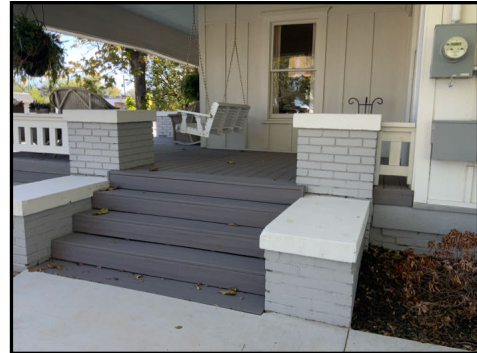
Handrail is missing

No handrail

There was not a handrail in place at the time of the inspection for the front porch. It is recommended that a graspable handrail be installed to ensure the safety of the occupants.

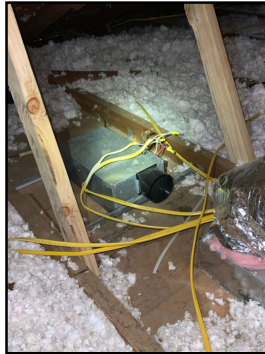
Spliced and taped wires or exposed connections were observed in the attic. These connections should be installed with a covered junction box with approved connectors.

Spliced wires

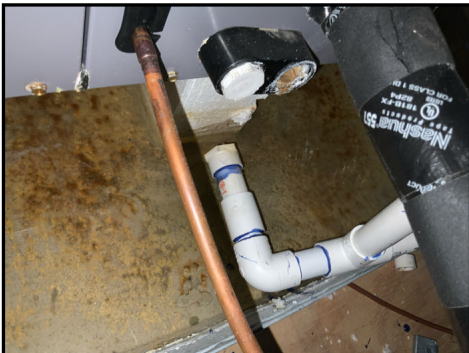
The condensate drain has come loose in the attic, at the unit. This is causing it to drip into the pan and out through the secondary drain. Repairs are recommended.

Disconnected

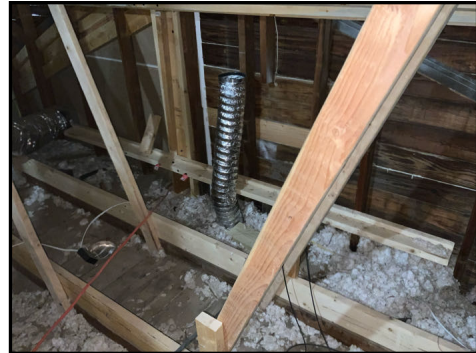
Vents to attic

Page 21 Item: C	Range Hood and Exhaust Systems	The vent was terminated in the attic and should extend to the exterior
Page 23 Item: F	Mechanical Exhaust Vents and Bathroom Heaters	The bath fan(s) terminated in the attic space and should be vented to the exterior to prevent moisture build up in the attic.

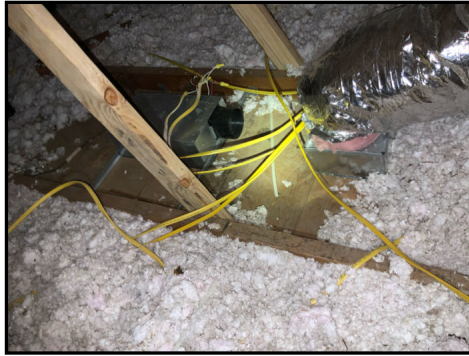
The bath fan(s) terminated in the attic space and should be vented to the exterior to prevent moisture build up in the attic.

Vents to attic
