**192 Flower House Loop Troutman, NC 28166**

## **Inspection Prepared For Ryan Wright**

Date: 8/5/2026 Time: 9:30 AM

Year Built: 1946 | Size: 1330 sq.ft.

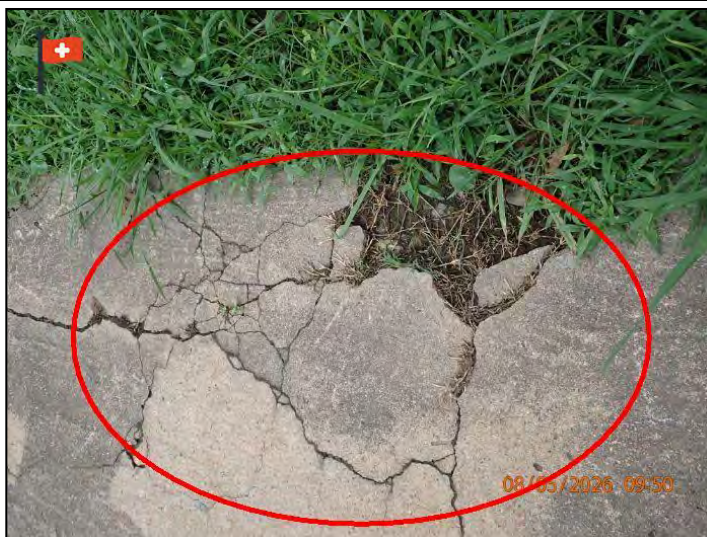
• **SAFETY CONCERN:** Portions of the concrete walkway had heavy cracking and/or displacement (over 1/4-inch differential) at the time of inspection. These conditions present a trip hazard and may worsen if not addressed. Recommend a qualified concrete contractor further evaluate and repair or replace the affected sections to reduce the risk of injury.

Walkway Has Cracking With Over 1/4" Differential (Tripping Hazard) (Multiple Locations)

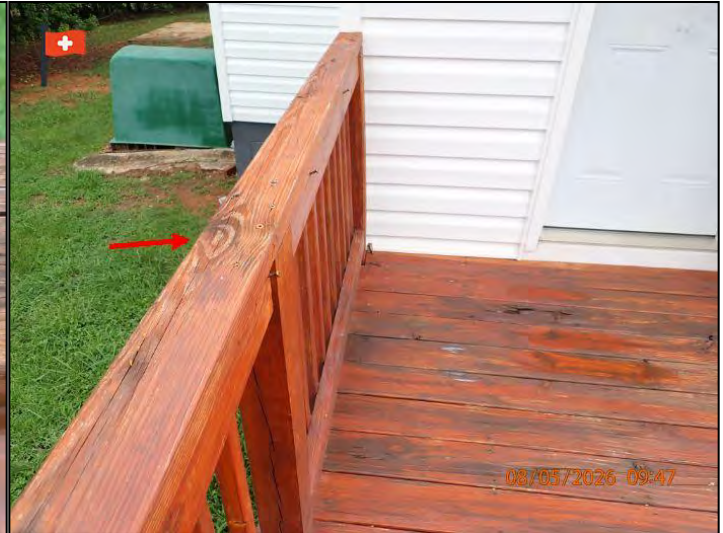
Loose Guardrail(s) (Left Of Structure)

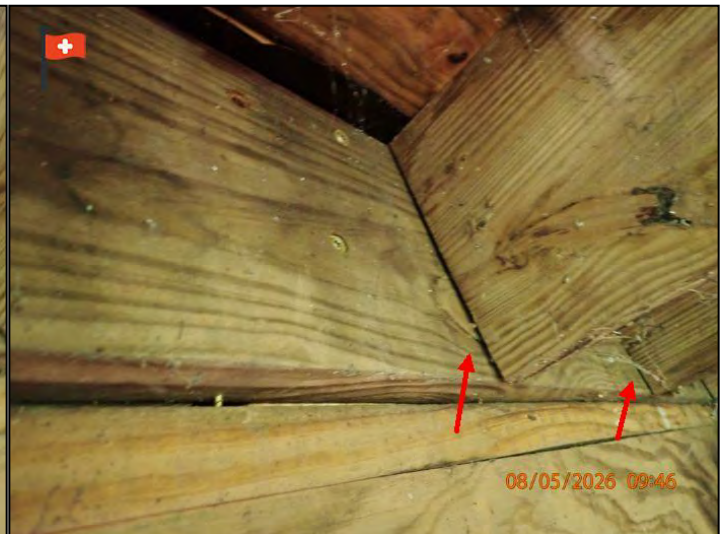
Missing Joist Hangers (Left Of Structure)

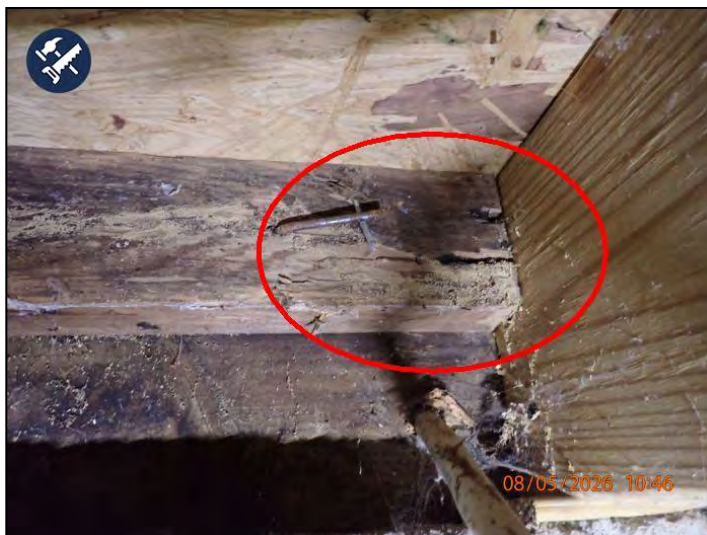
- **REPAIR:** Damage and/or deterioration to the band sill was observed at the time of inspection. A compromised band sill can lead to settlement and reduced support. Recommend a qualified contractor further evaluate and repair or replace the band sill to prevent further deterioration of the building materials.

Damage/Deterioration To Band Sill (Beneath Refrigerator, Tested Dry)

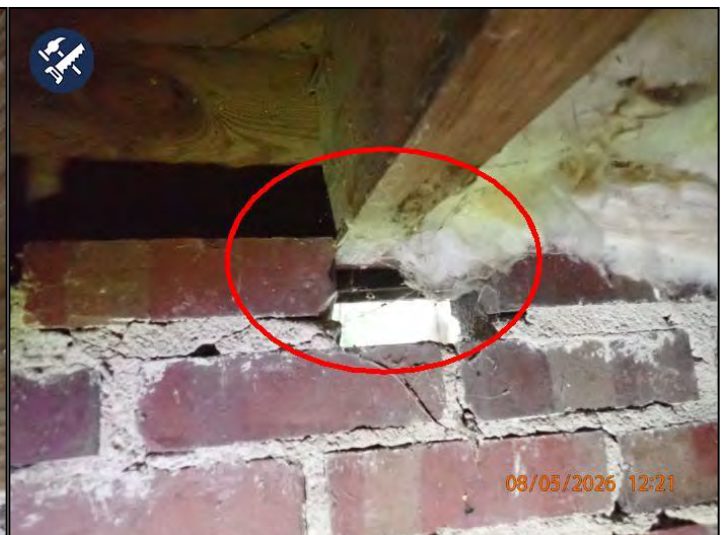
- **REPAIR:** Improper construction practices were observed at one or more floor joists at the time of inspection. The floor joist(s) were not properly supported. Improper construction can weaken support and reduce long-term performance. Recommend a qualified general contractor further evaluate and repair or replace the materials as necessary to restore proper structural support.

Floor Joist Not Supported (Rear Right Of Structure)

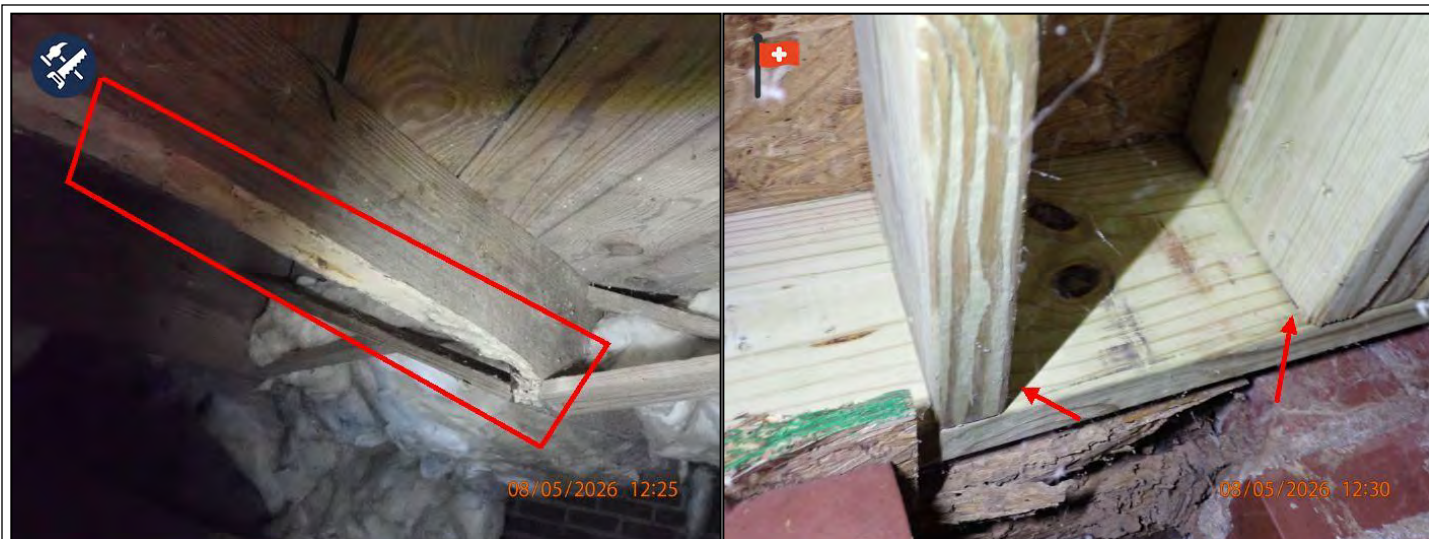
- **REPAIR:** Deterioration and/or damage to one or more floor joists and/or sub flooring was observed at the time of inspection. Compromised components can weaken structural support. Recommend a qualified contractor further evaluate and repair or replace the affected materials to prevent further deterioration of the building materials.

Deterioration To Sub Floor (Multiple Locations)

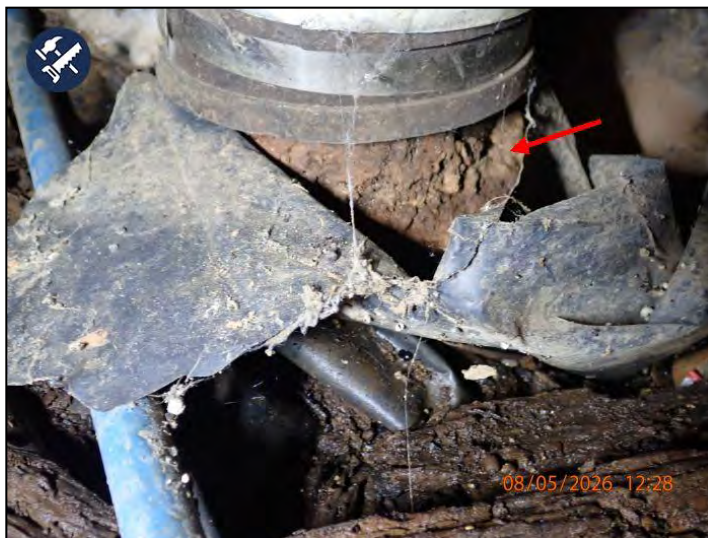
- REPAIR: Cast iron plumbing was observed at the time of inspection. Cast iron pipes have an expected lifespan of about 30–50 years and may corrode or crack as they age, which can lead to leaks and water damage. Recommend a qualified plumbing contractor further evaluate the system and replace or update it as necessary to prevent leaks and water damage.
- REPAIR: Polybutylene plastic (PB) supply piping was present at the time of inspection. PB distribution systems and compression-band fittings have a documented history of premature failure at joints, which can lead to sudden leaks and significant water damage; concealed portions cannot be fully evaluated during a visual home inspection. Recommend a qualified plumbing contractor replace the entire PB supply piping and associated fittings to reduce leak risk and avoid costly damage.

Cast Iron

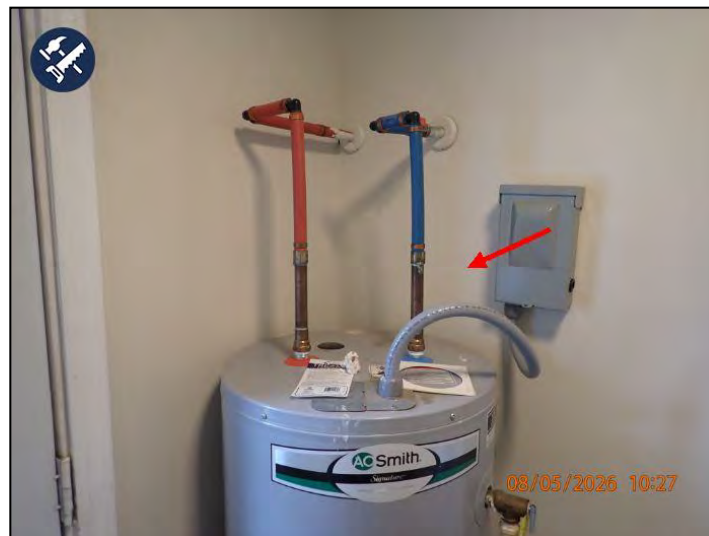
• **REPAIR:** An **expansion tank** was not installed at the time of inspection. Lack of an expansion tank can create trapped, high-pressure spikes every time the water heater runs. This, in turn, strains pipe joints, wears out internal tank linings, and can ruin heating elements. Recommend a qualified plumbing contractor install the expansion tank to ensure optimal function and prolong the service life of the water heater.

Expansion Tank Missing

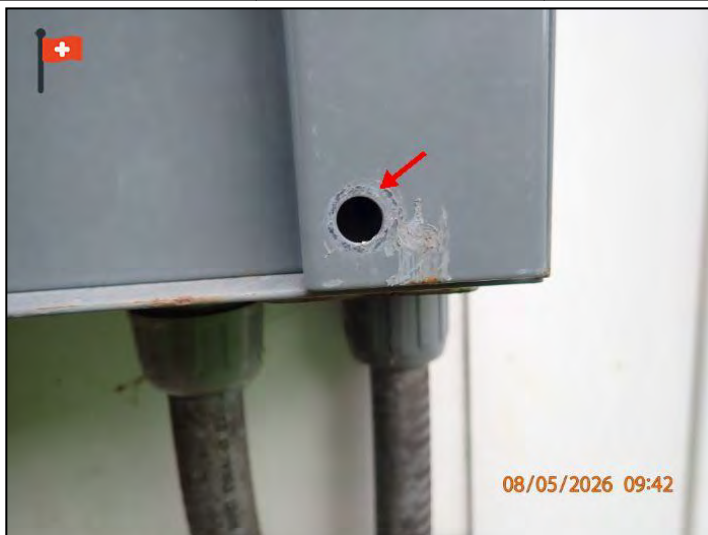
- **SAFETY CONCERN:** Electrical panel cover screw(s) were missing from the panel at the time of inspection. Missing screws compromise the integrity of the panel cover, increasing the risk of accidental contact with energized components. Recommend a qualified electrical contractor install the missing screw(s) to restore safe conditions and reduce the risk of injury.
- **SAFETY CONCERN:** Wrong fastener(s) were used in the electrical panel at the time of inspection. Improper fasteners can compromise the panel integrity and safety. Recommend a qualified electrical contractor install correct fastener(s) to restore safe conditions and reduce the risk of injury.

Missing Screw(s) (Main Panel)

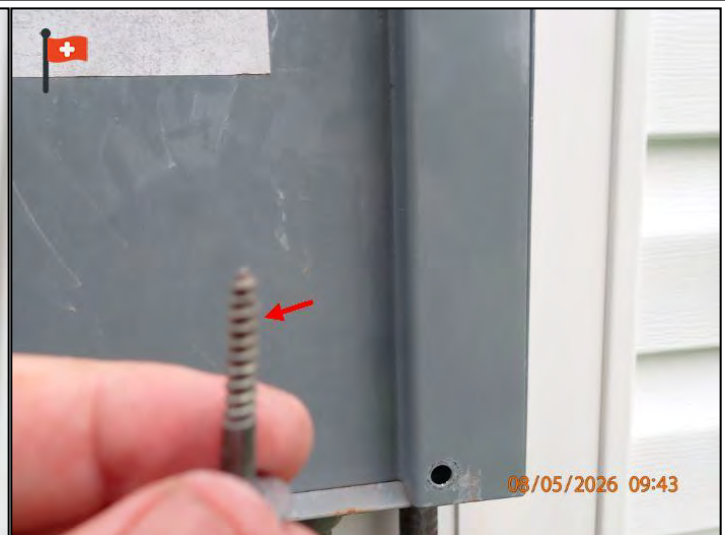
Wrong Fastener(s) (Main Panel)

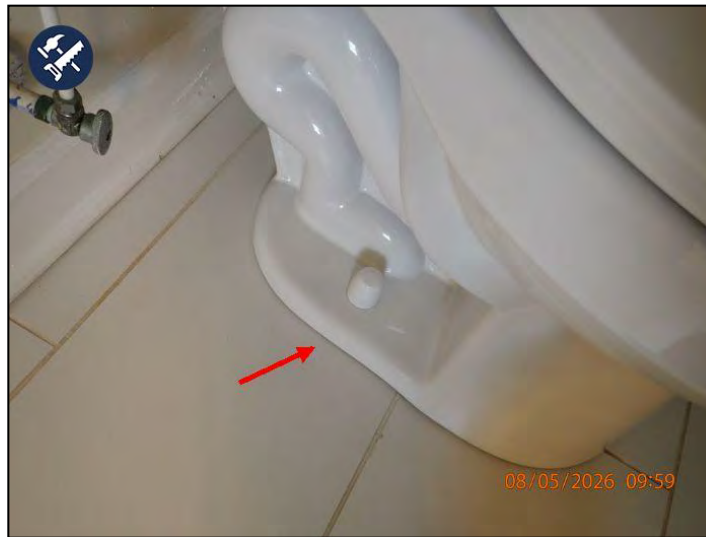
- **REPAIR:** A toilet bowl was loose at the floor anchor bolts at the time of inspection. A loose toilet can compromise the wax ring seal, leading to water leakage and damage to the sub floor area, though the extent of damage may not be visible. Recommend a qualified plumbing contractor repair or secure the toilet and replace the wax ring as needed to prevent unwanted issues.
- **REPAIR:** A loose toilet and/or loose or soft sub flooring was observed at the time of inspection. This condition can indicate damage to the sub flooring beneath the fixture, which is not fully visible without destructive investigation. Recommend a qualified plumbing contractor further evaluate and repair the area to prevent unwanted issues.

Loose (Primary Bathroom)

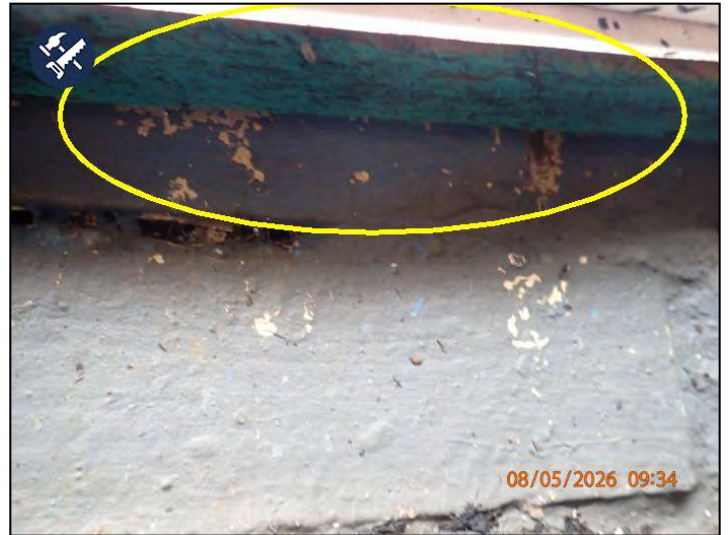
- **IMPROVE:** Exposed wooden sheathing was observed in multiple locations at the time of inspection. Exposed wood can absorb moisture and deteriorate more quickly. Recommend a qualified painting contractor prep, prime, and paint the affected area(s) to protect the building materials and prevent further deterioration.

Exposed Wooden Sheathing (Multiple Locations)    Exposed Wooden Sheathing (Multiple Locations)

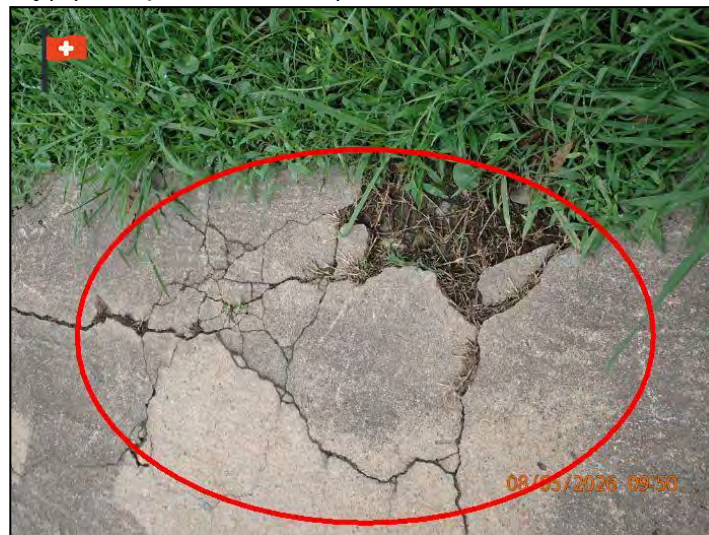
Walkway Has Cracking With Over 1/4" Differential (Tripping Hazard) (Multiple Locations)

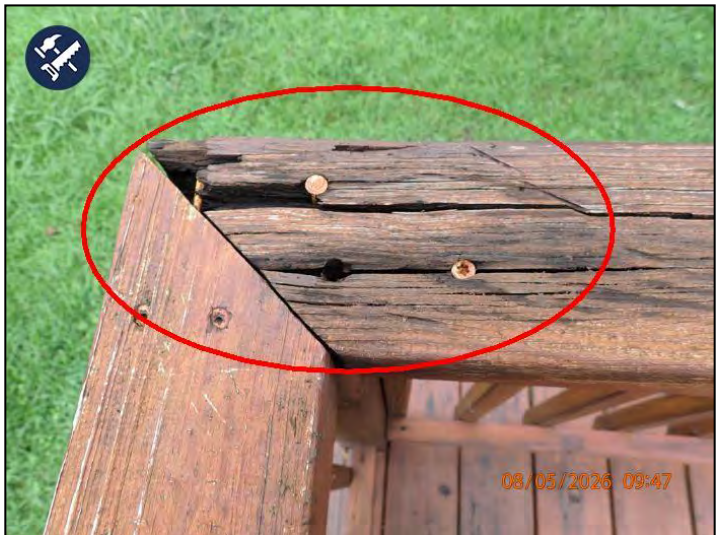
Significant Deterioration/Exposed Nails (Left Of Structure)

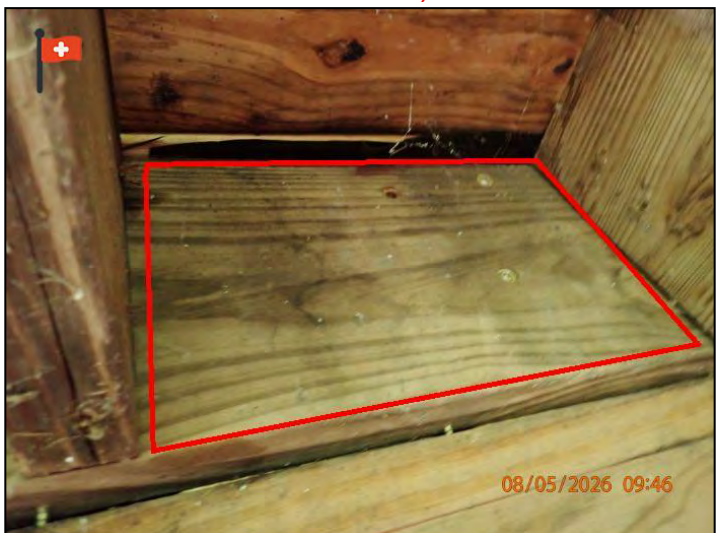
Inadequate Hardware Used In Ledger Board (Left Of Structure)

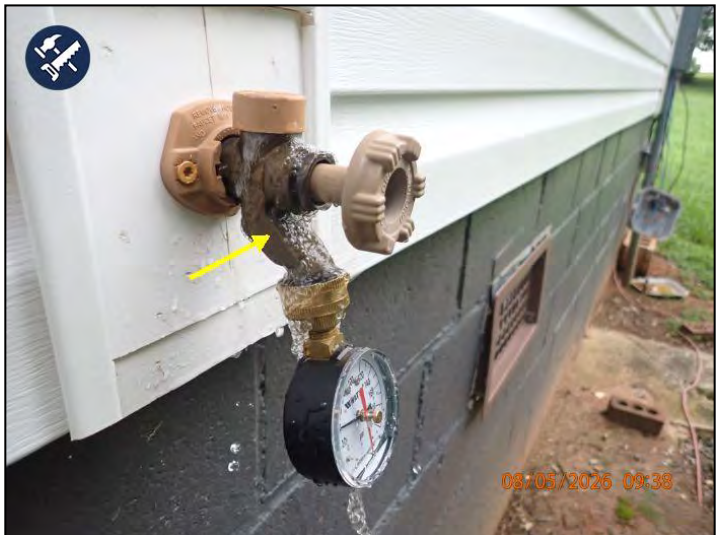
Leak At Valve

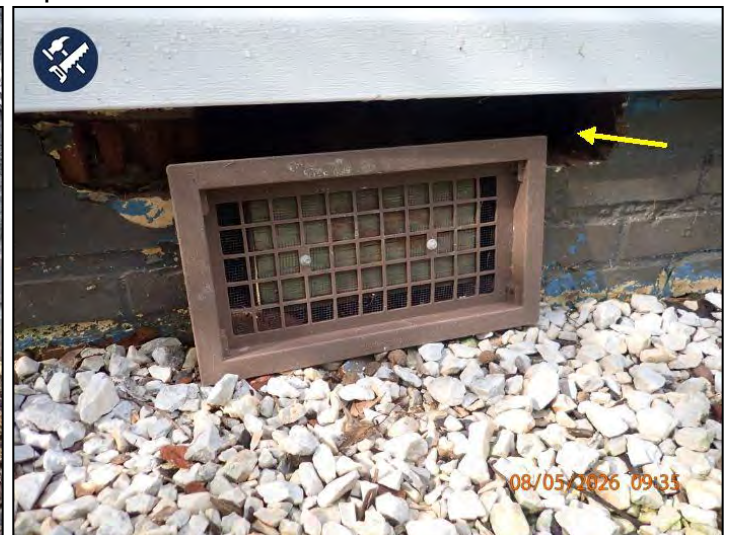
Unsealed Penetration(s) (Multiple Locations)

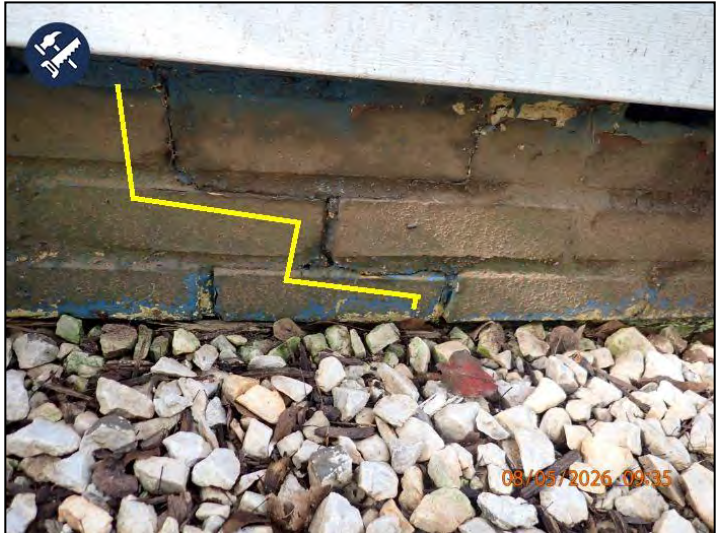
Step Crack(s) (Multiple Locations)

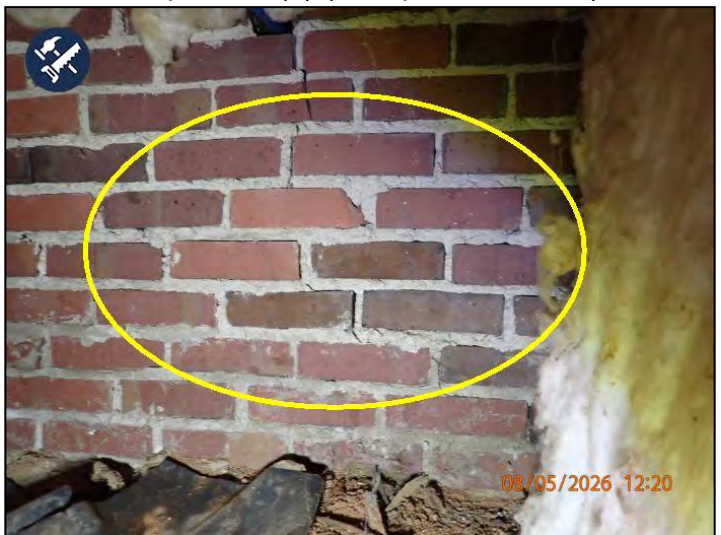
Settlement Crack(s) (Original Foundation Wall Between Kitchen/Dining Room)

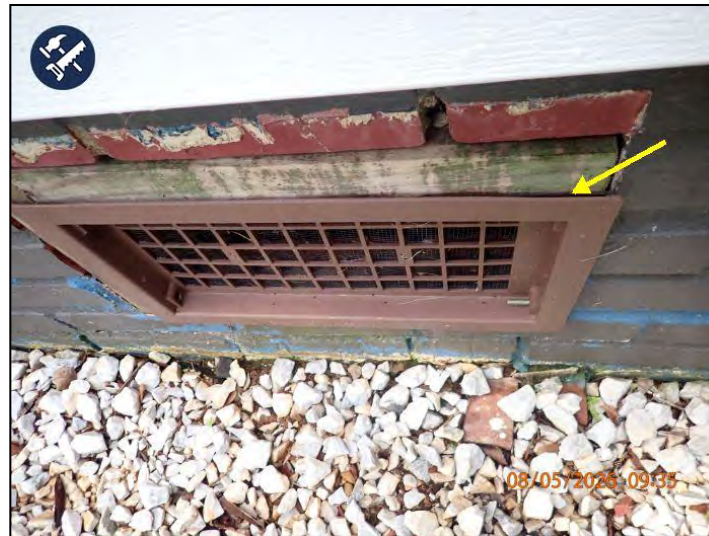
- **NOTE:** Screened openings observed at the time of inspection.
- **IMPROVE:** Vent(s) were loose to the structure at the time of inspection. Loose vents may allow gaps that reduce ventilation performance and permit insect and/or pest intrusion. Recommend a qualified contractor secure all vents to restore proper function and to prevent insect and/or pest intrusion.

Not Secure To Structure (Multiple Locations)

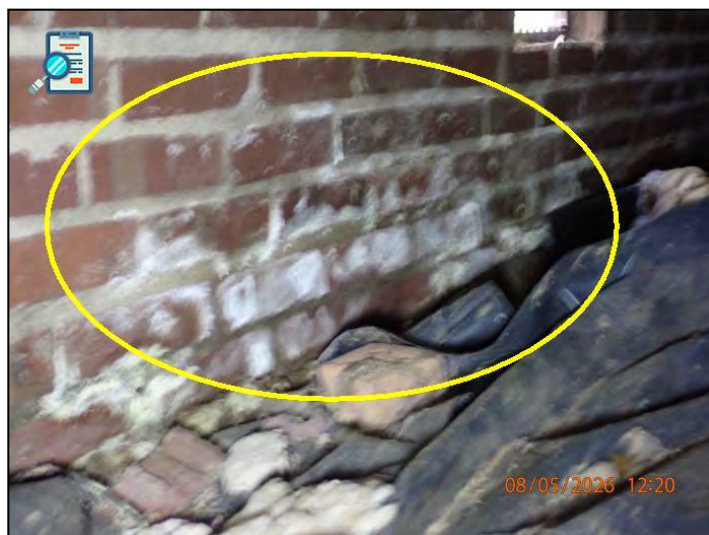
- **MONITOR:** Efflorescence was observed on the foundation walls at the time of inspection. Efflorescence indicates that moisture has moved through the wall materials in the past, leaving mineral deposits behind. Recommend monitoring the affected areas, as continued moisture intrusion may deteriorate building materials.

Efflorescence

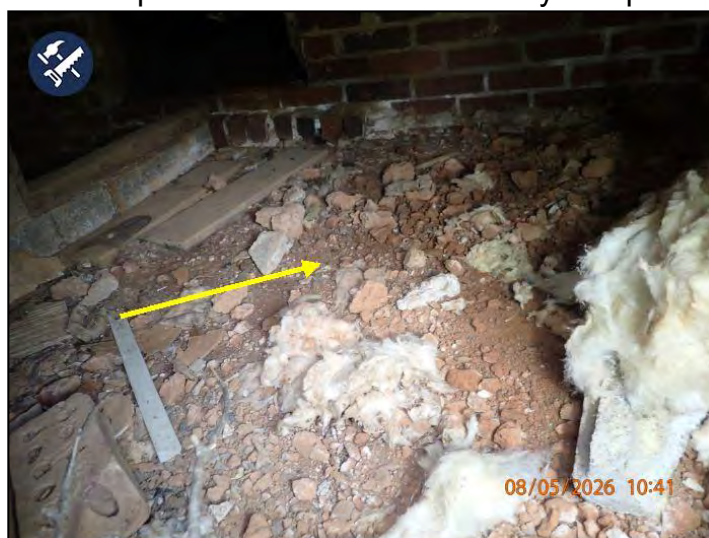
- **IMPROVE:** A partially installed vapor barrier was observed at the time of inspection. Partial coverage reduces effectiveness and can allow elevated humidity. Recommend a qualified crawl space specialist fully install the vapor barrier to reduce humidity and protect the building materials.

Partially Installed Vapor Barrier

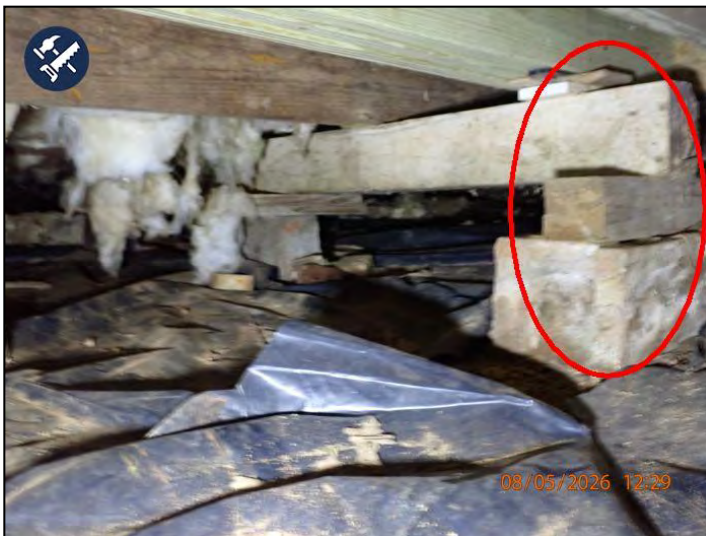
- **REPAIR:** Free-floating support(s) were observed in multiple locations at the time of inspection. Supports not properly anchored or bearing load can fail to provide adequate stability. Recommend a qualified contractor or structural engineer further evaluate and repair or replace as necessary to restore proper structural support.

Free Floating Support(s) (Multiple Locations)

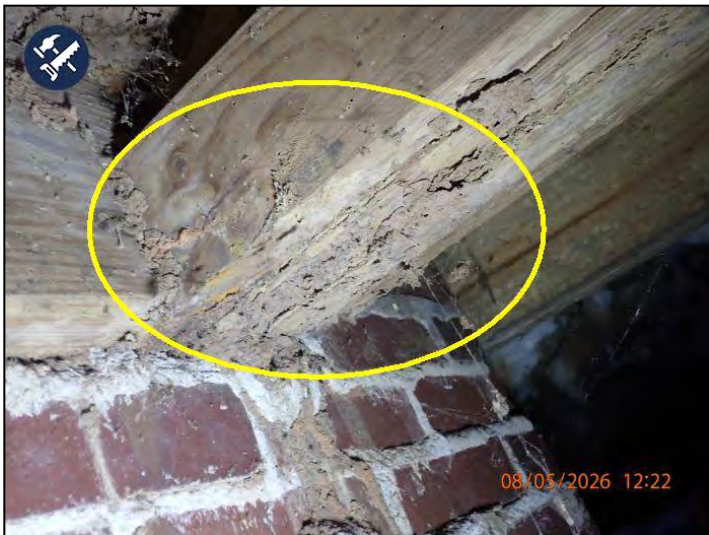
Evidence Of (WDI) Wood Destroying Insects/Organisms (Abandoned Chimney)

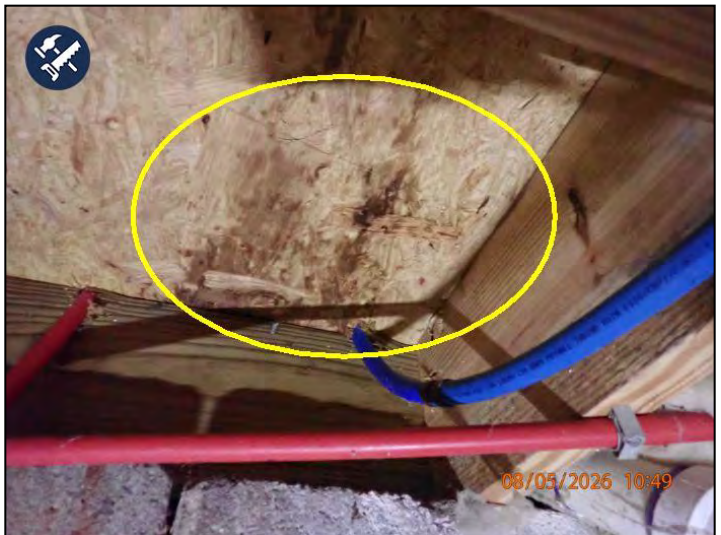
Moisture Intrusion/Damage (Under Kitchen Sink, Tested Dry)

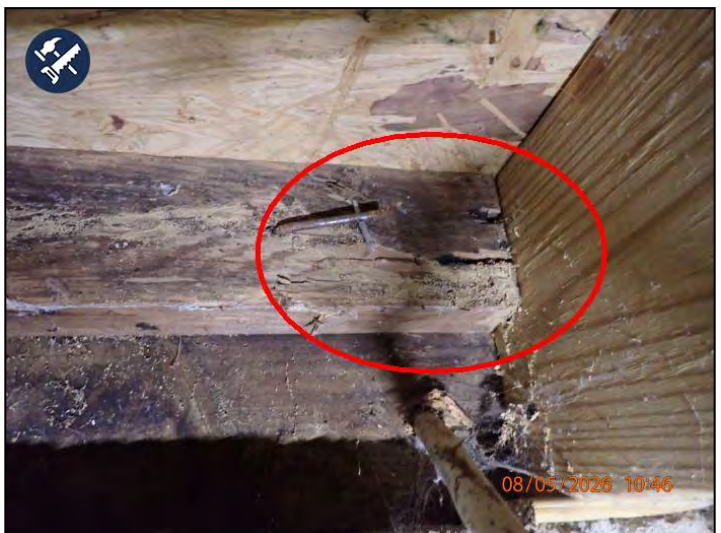
Damage/Deterioration To Band Sill (Beneath Refrigerator, Tested Dry)

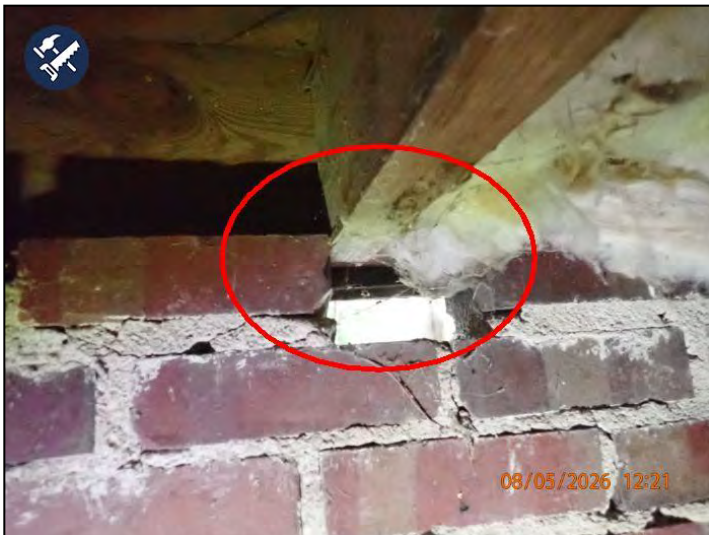
Floor Joist Not Supported (Rear Right Of Structure)

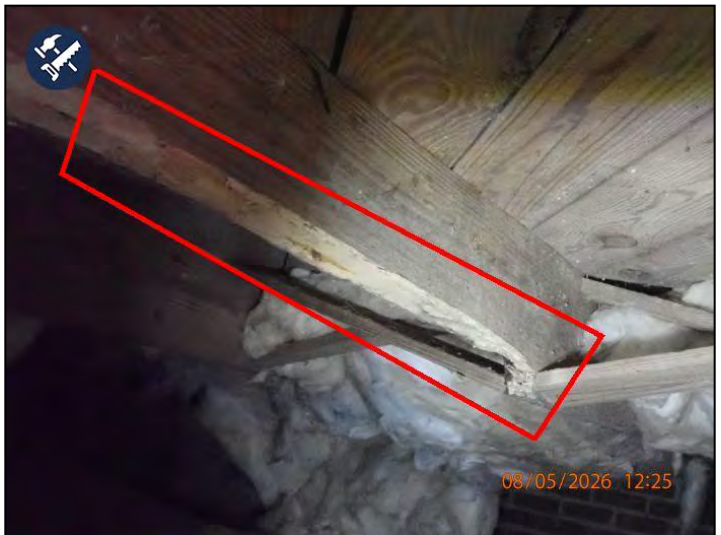
Deterioration To Sub Floor (Multiple Locations)

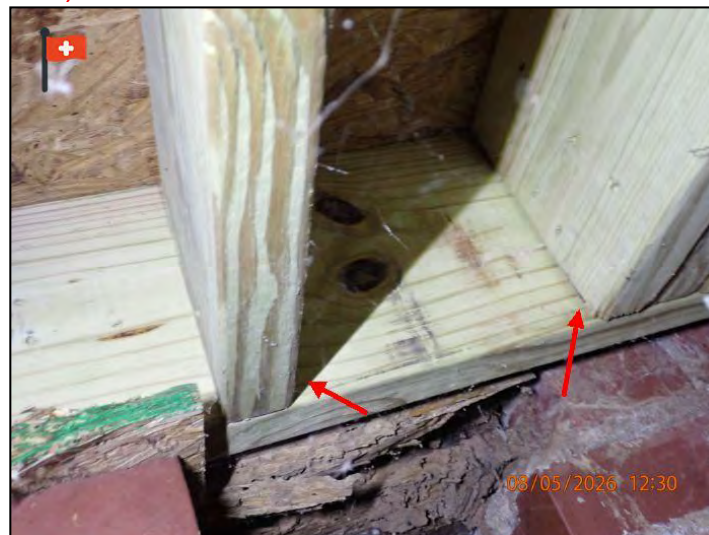
- **SAFETY CONCERN:** Joist hangers were missing from one or more floor joists at the time of inspection. Missing connectors can reduce load transfer and create a safety hazard. Recommend a qualified contractor or carpenter install appropriate joist hangers to reduce the risk of injury.

Missing Joist Hangers

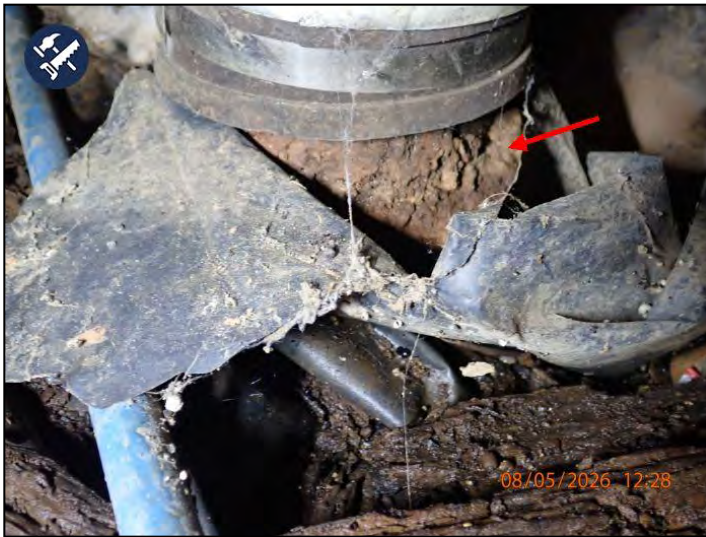
Cast Iron

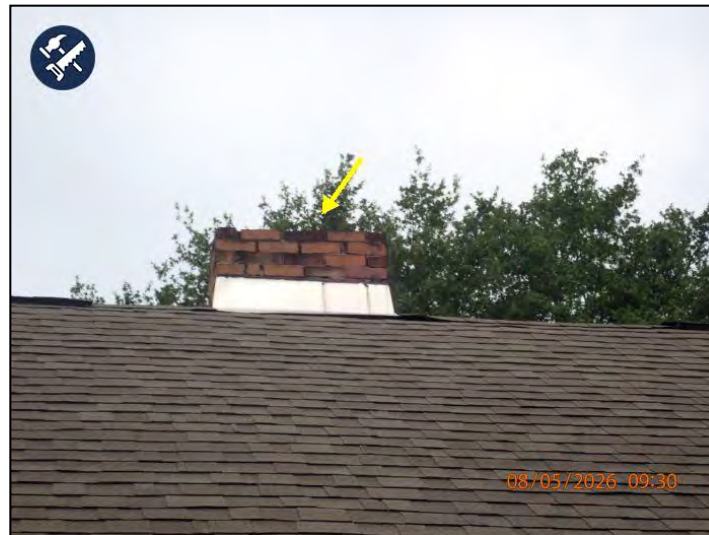
- IMPROVE: No chimney rain caps and/or spark arrestors were in place at the time of inspection. Missing caps can allow moisture and/or pest intrusion into the chimney structure, which may deteriorate surrounding building materials. Recommend a qualified contractor install appropriate rain caps and/or spark arrestors to prevent moisture and/or pest intrusion and protect the building materials.

Missing Spark Arrestor/Rain Cap

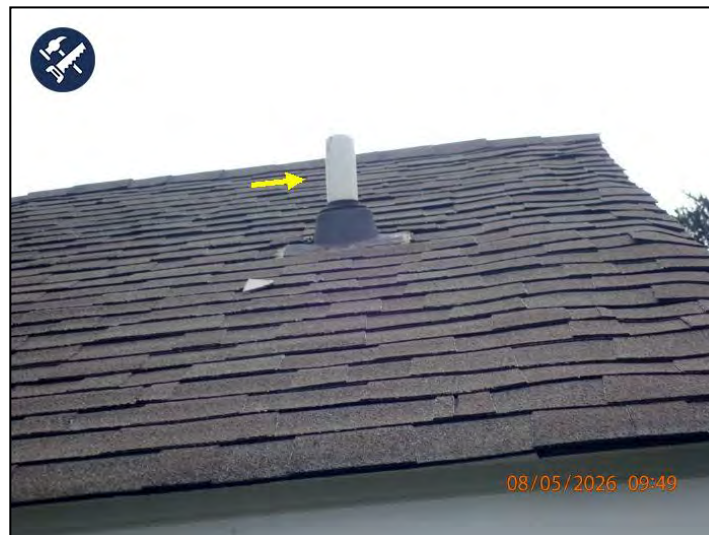
- **IMPROVE:** The roof-level plumbing vent stack(s) were not painted at the time of inspection. Unpainted vent stacks are susceptible to UV deterioration, which may shorten the service life of the material. Recommend a qualified plumbing contractor paint the vent stack(s) to protect the materials and prolong their service life.

Not Painted

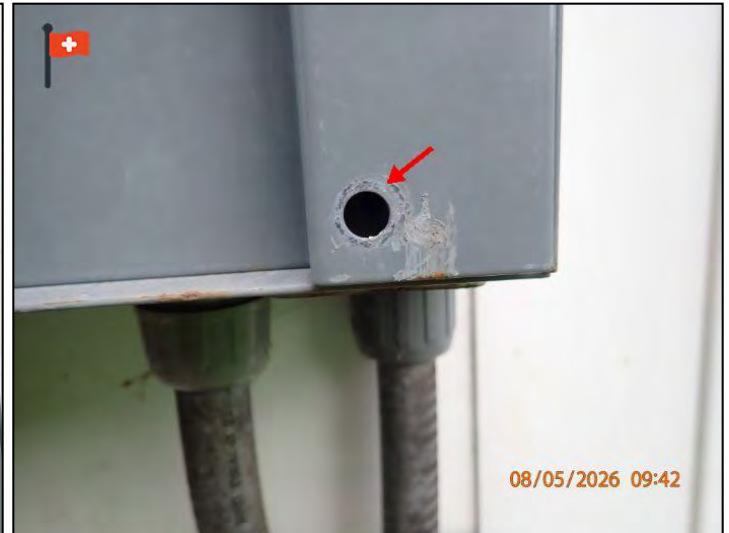
Missing Screw(s) (Main Panel)

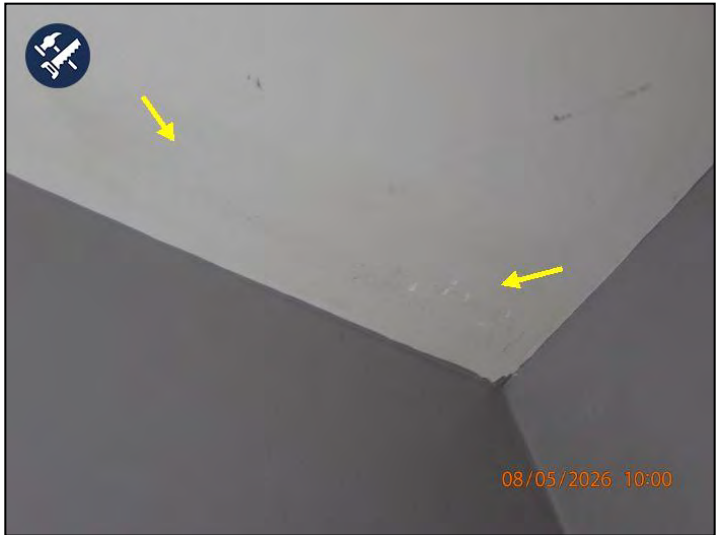
Past Repairs (Unable To Determine If Professional) (Multiple Locations)

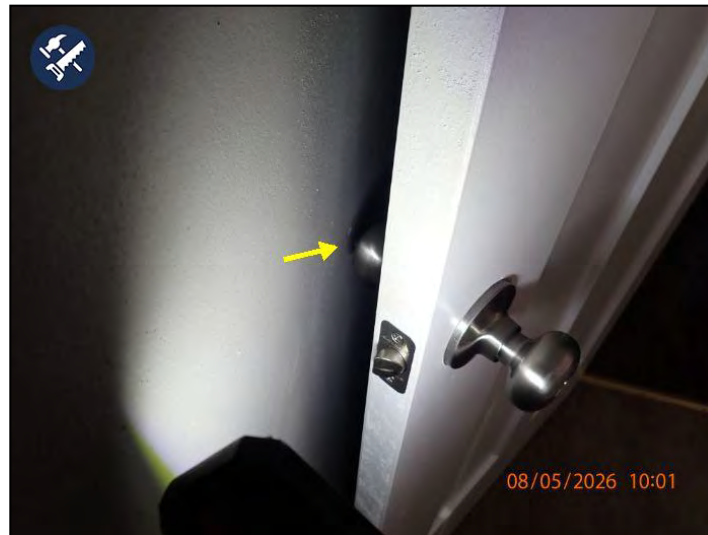
- IMPROVE: Door stop(s) were missing at the time of inspection. Missing stops allow doors to strike walls, which can damage walls or hardware. Recommend a qualified contractor install door stop(s) to protect the walls and hardware.

Missing Door Stop(s) (Multiple Locations)

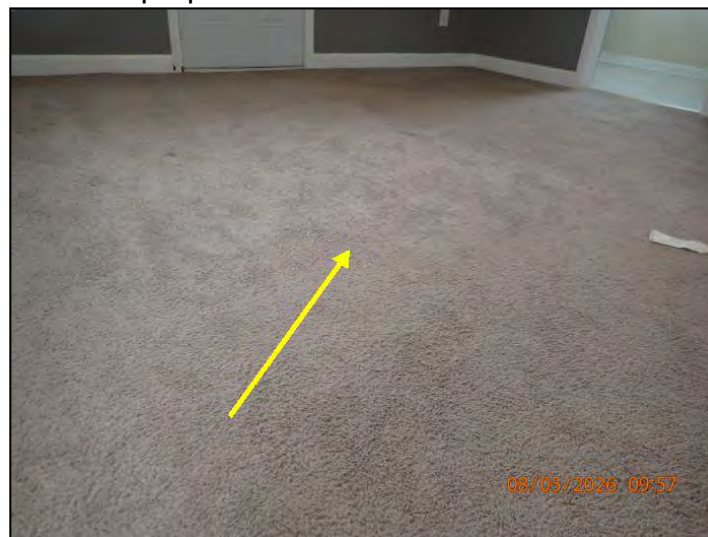
- **IMPROVE:** The bedroom floor(s) were not level and/or soft sub flooring was observed at the time of inspection. Uneven or soft flooring can indicate underlying structural deterioration or damage. Recommend a qualified flooring contractor further evaluate and repair or replace all compromised materials as necessary to restore proper function.

Not Level/Soft Sub Flooring (Multiple Locations) (Primary Bedroom)

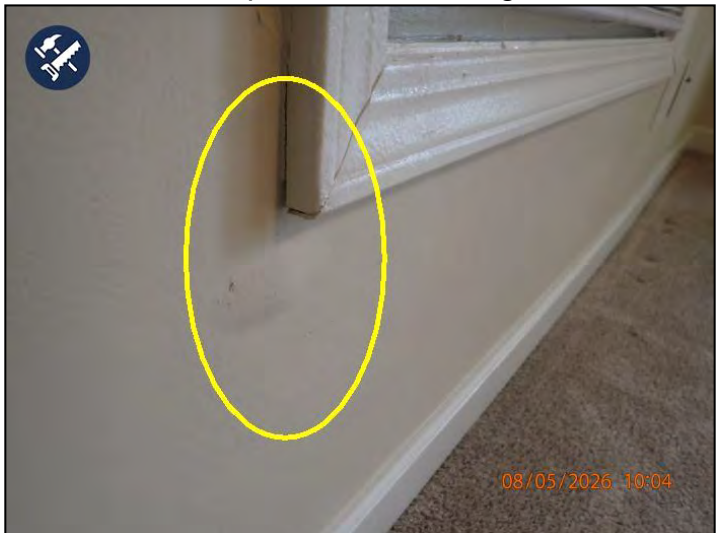
Past/Present Moisture Intrusion (Multiple Locations)

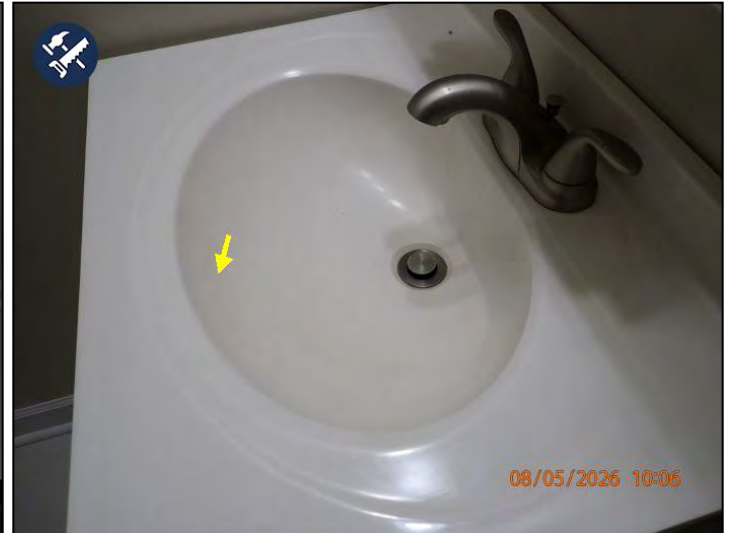
Missing Overflow Drain (Guest Bathroom)

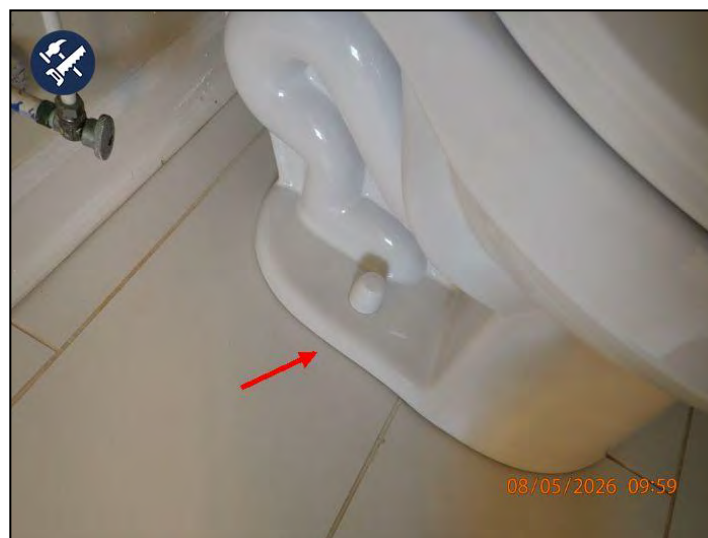
- **REPAIR:** A toilet bowl was loose at the floor anchor bolts at the time of inspection. A loose toilet can compromise the wax ring seal, leading to water leakage and damage to the sub floor area, though the extent of damage may not be visible. Recommend a qualified plumbing contractor repair or secure the toilet and replace the wax ring as needed to prevent unwanted issues.
- **REPAIR:** A loose toilet and/or loose or soft sub flooring was observed at the time of inspection. This condition can indicate damage to the sub flooring beneath the fixture, which is not fully visible without destructive investigation. Recommend a qualified plumbing contractor further evaluate and repair the area to prevent unwanted issues.

Loose (Primary Bathroom)

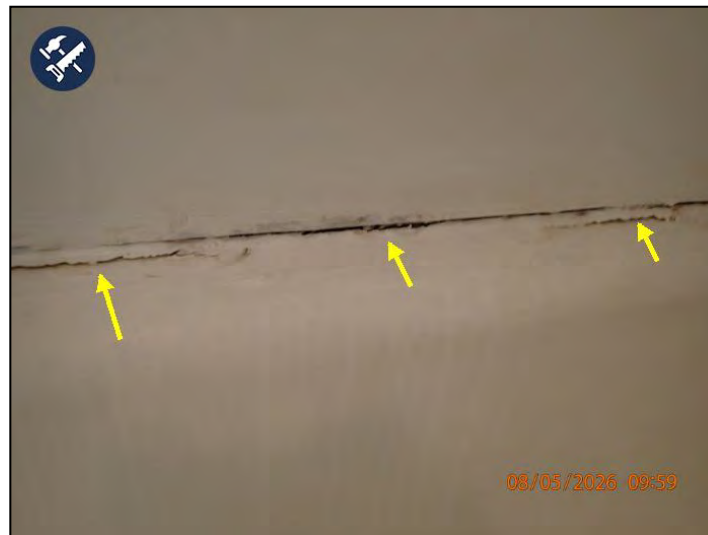
Failing Sealant/Caulk (Multiple Locations)

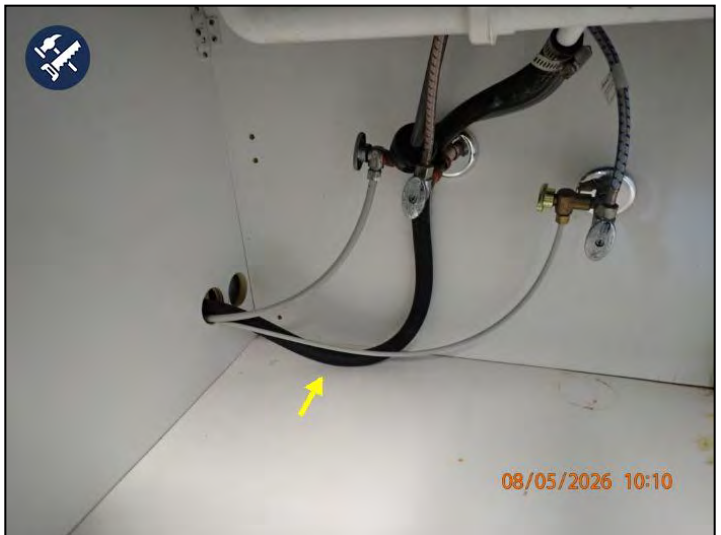
Missing High Loop

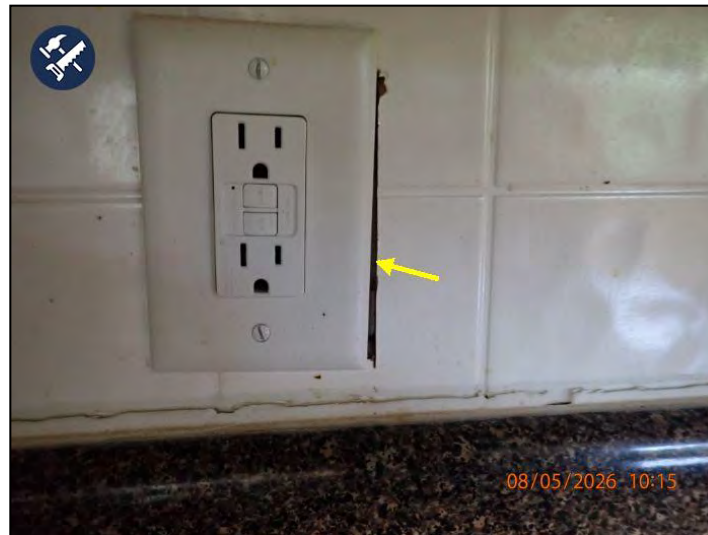
- **IMPROVE:** Loose or improperly installed outlet(s) were observed at the time of inspection. Loose or incorrectly mounted outlets can create poor connections, which may cause arcing, heat buildup, or electrical hazards. Recommend a qualified electrical contractor repair or replace the outlet(s) to restore proper and safe function.

Loose/Improperly Installed Outlet(s)

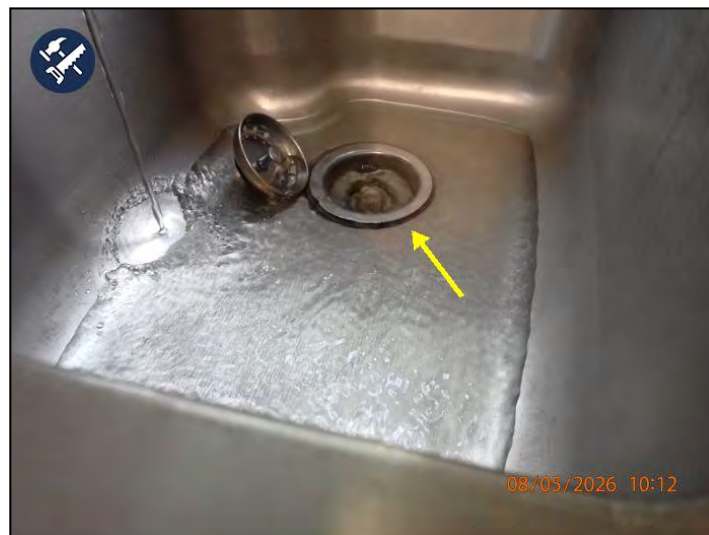
- **IMPROVE:** A slow drain was observed in the kitchen sink(s) at the time of inspection. Slow drainage indicates a partial blockage that may worsen and lead to backups. Recommend a qualified plumbing contractor clear the blockage(s) and/or further evaluate and repair as necessary to restore optimal function.

Slow Drain/Clogged (Both Sinks)

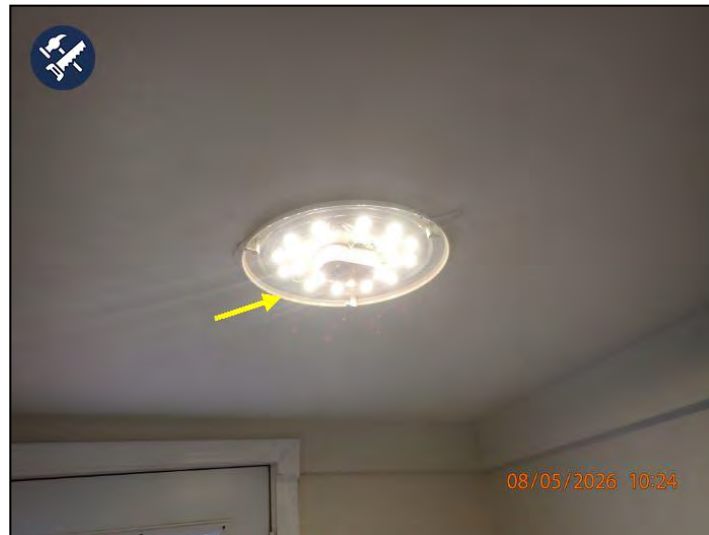
- **IMPROVE:** Globe(s) were missing from light fixture(s) at the time of inspection. Missing globes leave bulbs exposed to potential damage. Recommend a qualified contractor install globes to protect the light bulbs.

Missing Globe

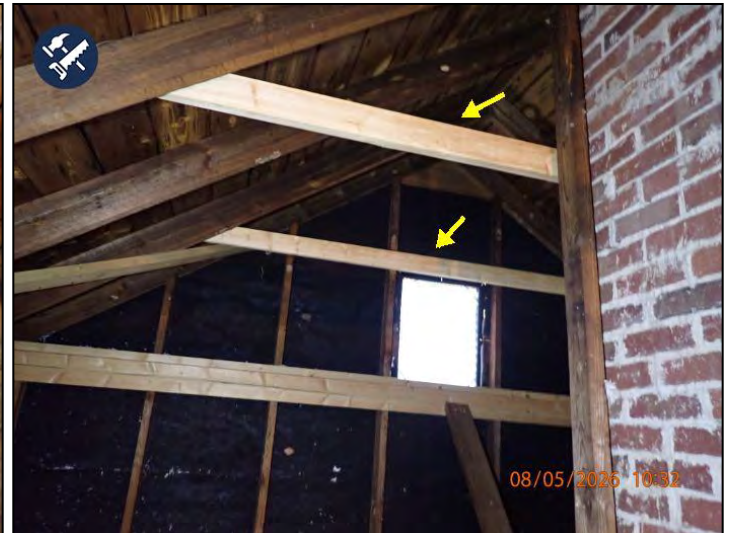
Past Repairs (Unable To Determine If Professional)

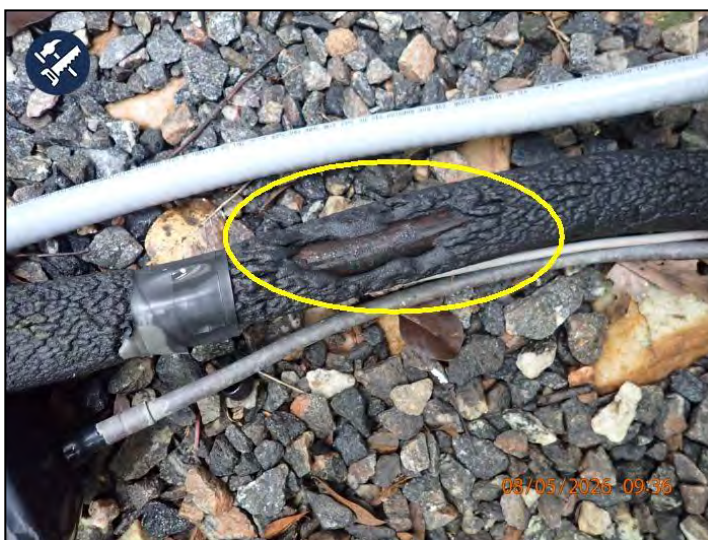
- **IMPROVE:** Refrigerant line insulation was damaged and/or worn at the time of inspection. Compromised insulation can reduce efficiency and lead to condensation, which may promote microbial growth and damage surrounding materials. Recommend a qualified HVAC technician repair or replace the insulation and perform annual maintenance to prevent condensation and protect the materials.

Damaged/Worn (Multiple Locations)

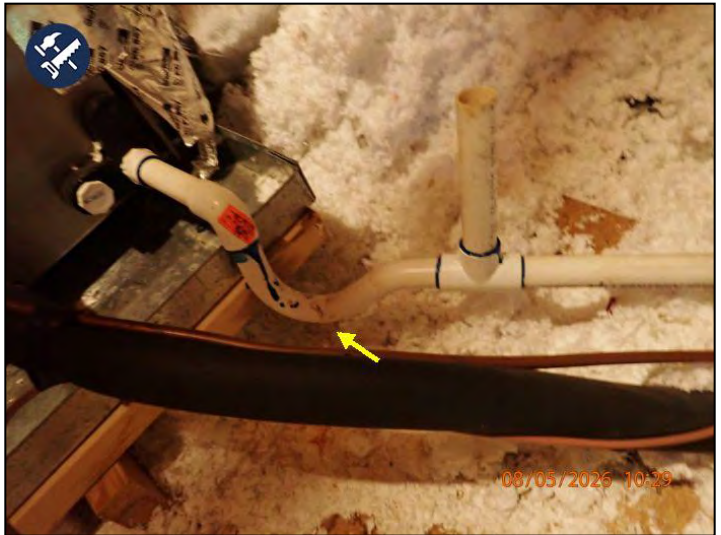
Trap Missing Insulation

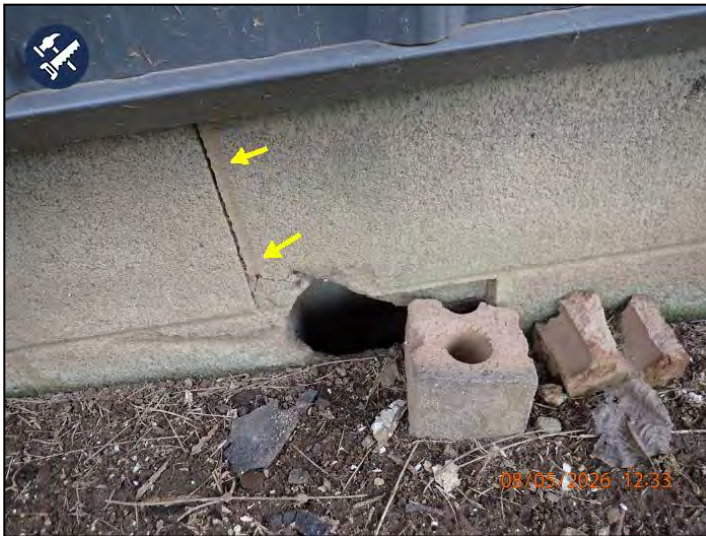
Vertical Crack(s) (Multiple Locations)

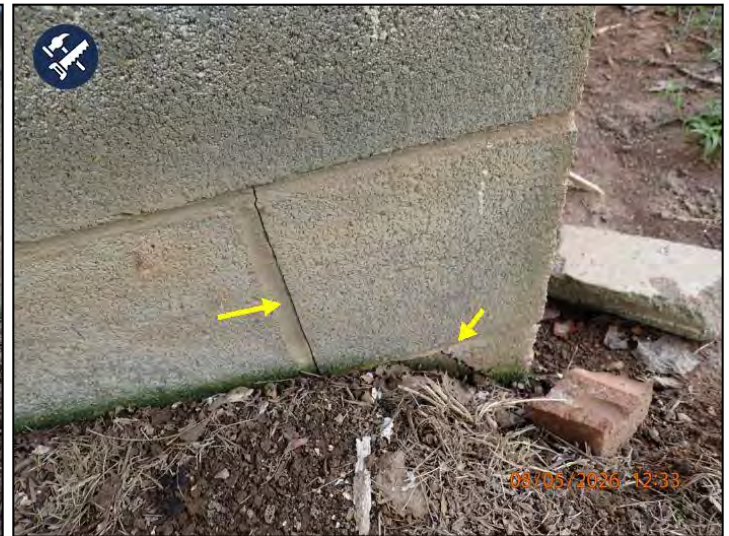
- **IMPROVE:** Step cracking was observed in the foundation perimeter at the time of inspection. This pattern can signify movement or settlement that may progress and affect surrounding building materials. Recommend a qualified masonry contractor point up the affected mortar joints and for the owner to monitor the area(s) periodically. If the condition worsens, contact a qualified structural engineer for further evaluation to prevent further deterioration.

Step Crack(s) (Right Of Structure)

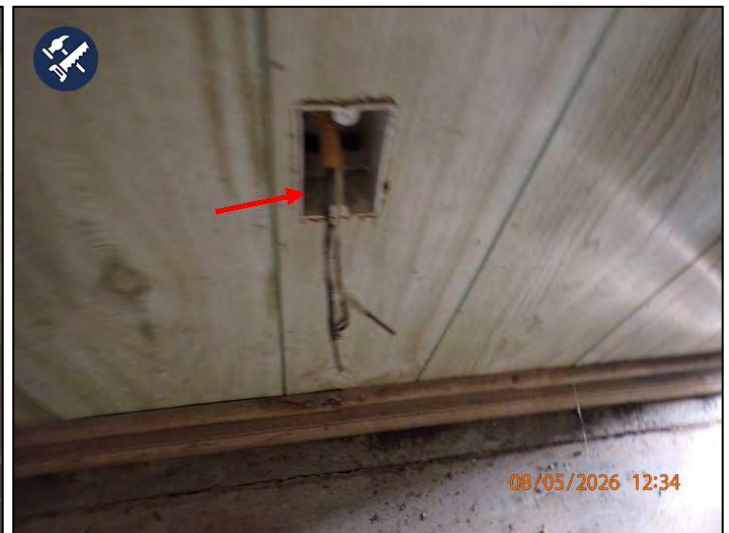
• **REPAIR:** Open junction box(es) were observed at the time of inspection. Open boxes leave splices exposed to separation, arcing, or shock. Recommend a qualified electrical contractor install proper covers to restore safe conditions and reduce the risk of fire.

Open Junction Boxes (Multiple Locations)
