# Home Inspection Report

Prepared for: Cadence Richeson

903 B Street  
Arapaho, OK 73620

Inspected by:  
Johnny Red  
Red Property Services, LLC

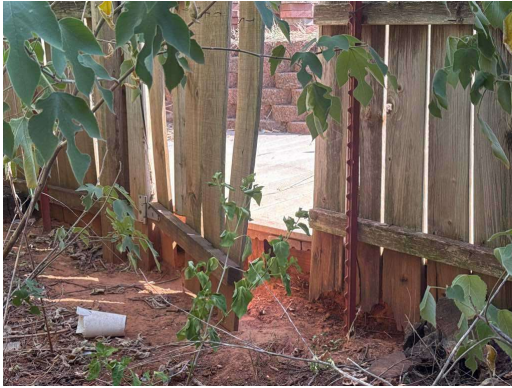
11. Marginal

Fences: Chain link, Wood - Areas of repair needed

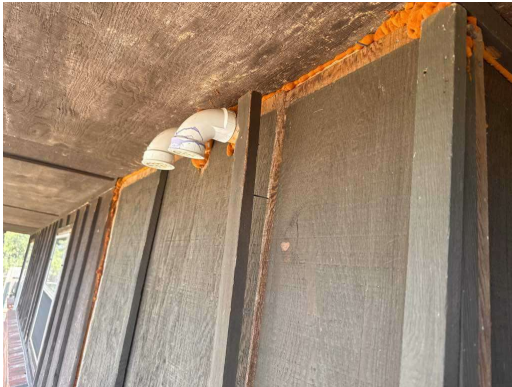
2. Marginal

Siding: Wood - Repairs needed

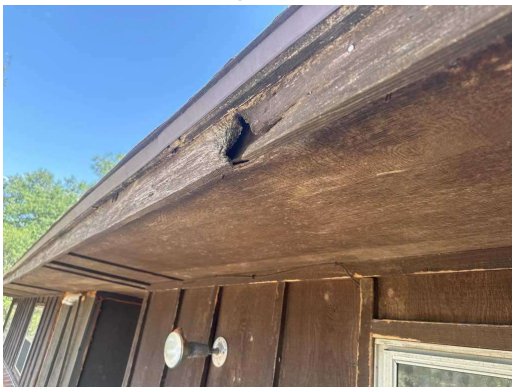
3. Marginal

Fascia: Wood - Repairs needed

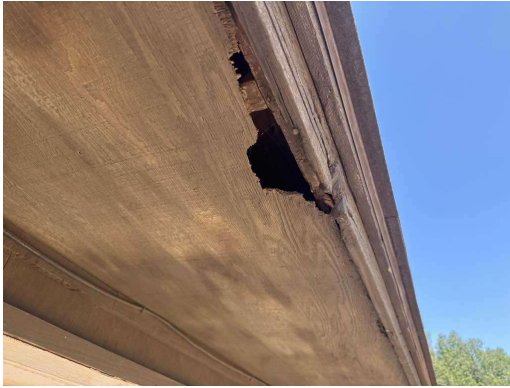
4. Marginal

Soffits: Plywood - Repairs needed

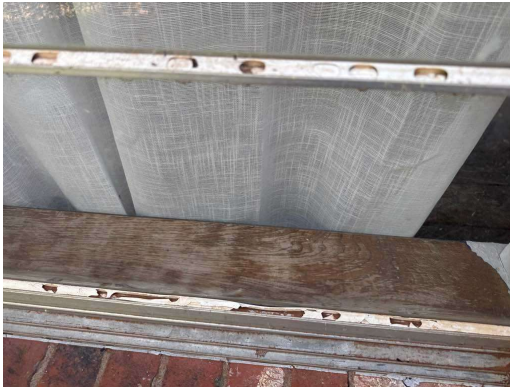
7. Marginal

Windows: Aluminum single hung - Glazing needs repair

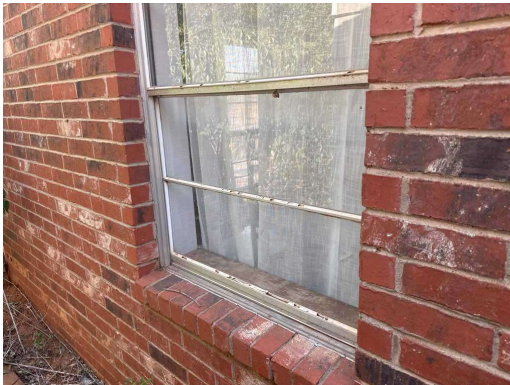
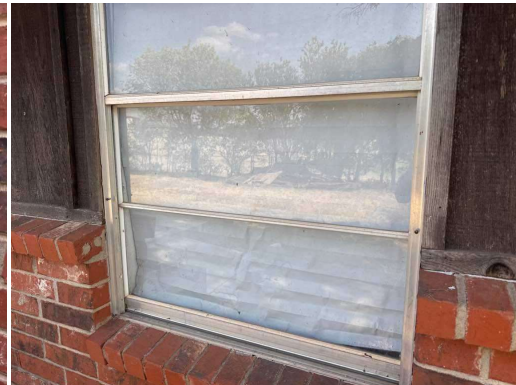
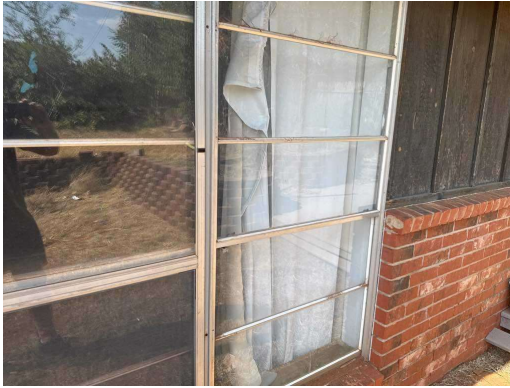
8. Defective

Storm Windows: Aluminum framed tempered glass - NW east and SE set is missing

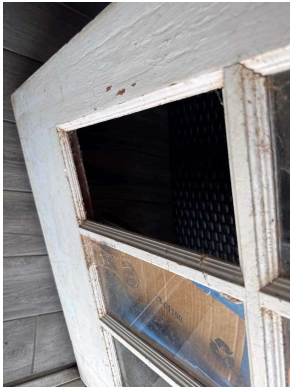
- 9. Acceptable Window Screens: Mesh where present
- 10. Acceptable Exterior Lighting: Surface mounted lamps front and rear
- 11. Acceptable Exterior Electric Outlets: 120 VAC GFCI
- 12. Acceptable Hose Bibs: Ball
- 13. Defective Patio Door: French door - Broken glass

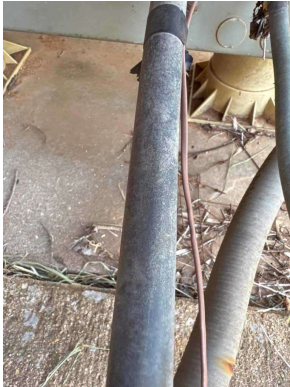
| 9. Marginal | Refrigerant Lines: Low pressure - Low pressure line insulation missing/damaged |

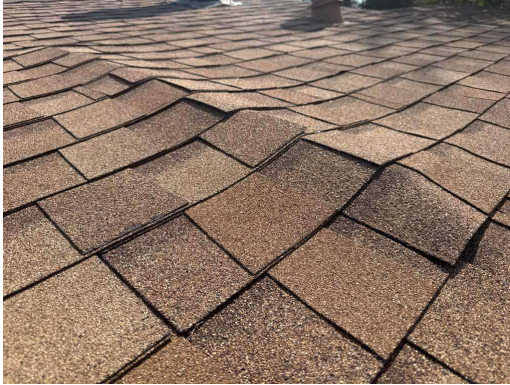
2. Defective Material: Asphalt shingle - Area of badly popped shingles present. Recommend licensed roofer evaluate further.

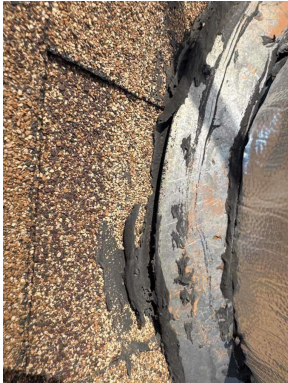
15. Marginal Chimney Flashing: Galvanized - Sealant needs to be replaced

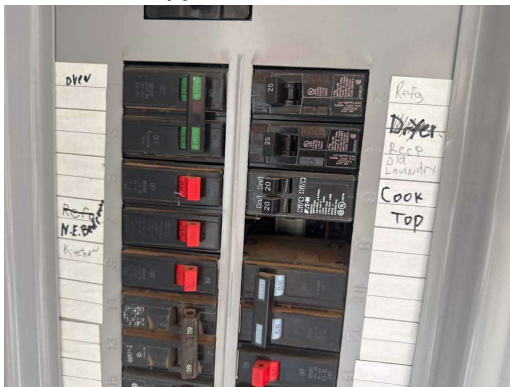
6. Acceptable Manufacturer: Seimens
7. Maximum Capacity: 200 Amps
8. Acceptable Main Breaker Size: 200 Amps
9. Marginal Breakers: Copper - Blank covers need to be installed

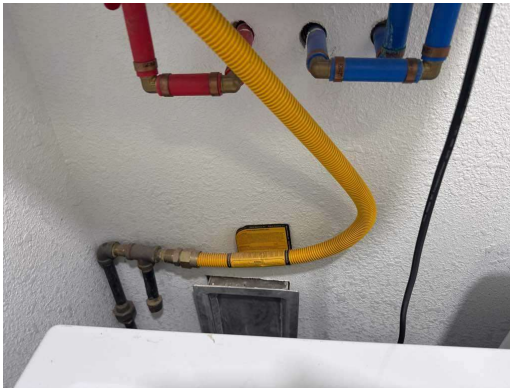
1. Acceptable Water Lines: Copper, PEX
2. Acceptable Main Water Shutoff: Meter
3. Acceptable Drain Pipes: PVC
4. Acceptable Service Caps: Accessible
5. Acceptable Vent Pipes: PVC
6. Not Inspected CSST: Present - The following statement is required by Oklahoma Title 158, Chapter 70, 2(E):  
Manufacturers believe the product is safer if properly bonded and grounded as required by the manufacturer's installation instructions. Proper bonding and grounding of the product can only be determined by a licensed electrical contractor.

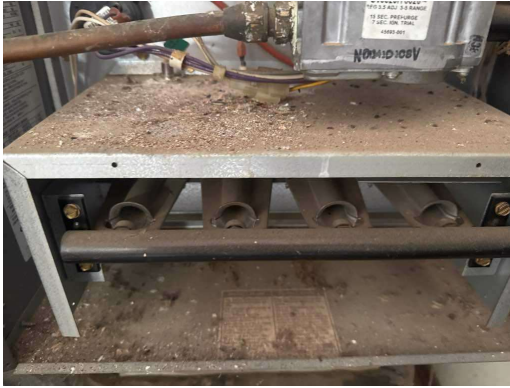
6. Acceptable Heat Exchanger: 4 Burner

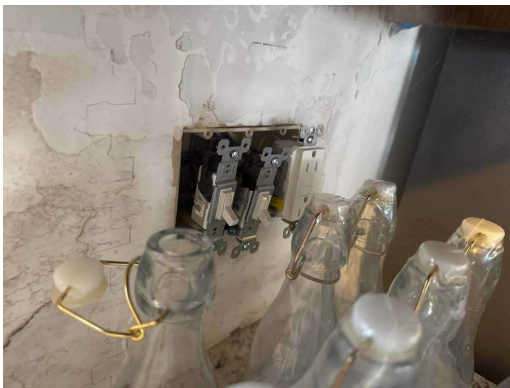
- 1. Defective Cooking Appliances: Electric powered, Gas powered - Front left burner is inoperative
- 2. Not Present Ventilator:
- 3. Defective Disposal: In-Sinkerator - Inoperative
- 4. Acceptable Dishwasher: General Electric
- 5. Not Present Trash Compactor:
- 6. Not Inspected Refrigerator: Hisense - Not connected to power
- 7. Not Present Microwave:
- 8. Acceptable Sink: Porcelain Coated
- 9. Marginal Electrical: 120 VAC GFCI - Covers need to be installed

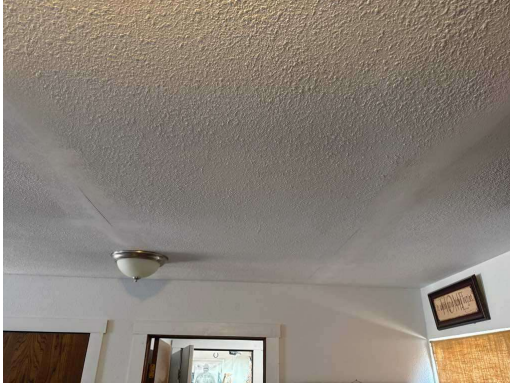
13. Marginal Ceiling: Texture paint - Open tape seams

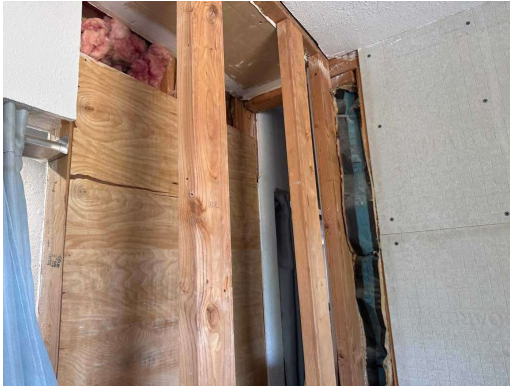
2. Marginal

Walls: Unfinished

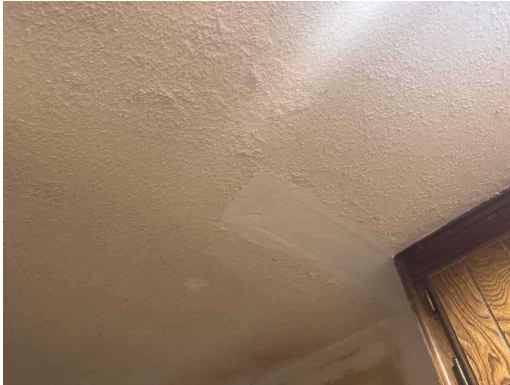
13. Marginal

Ceiling: Texture paint - Unfinished

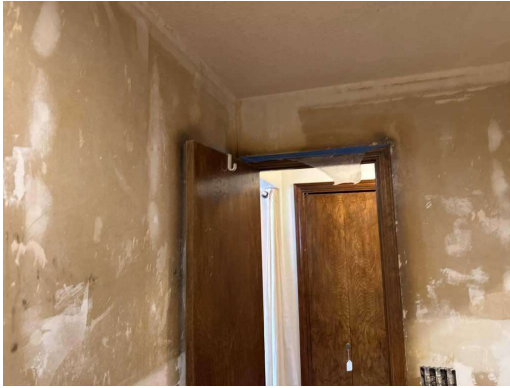
14. Marginal

Walls: Unfinished

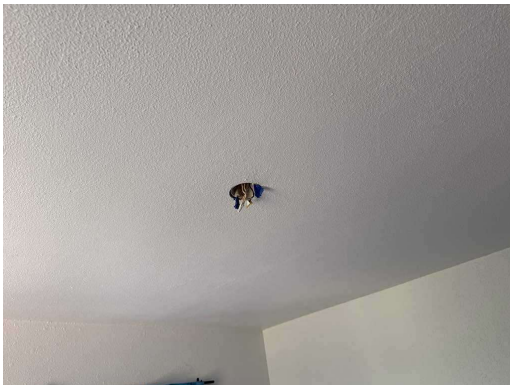
6. Marginal

Electrical: 120 VAC - Fixture not installed

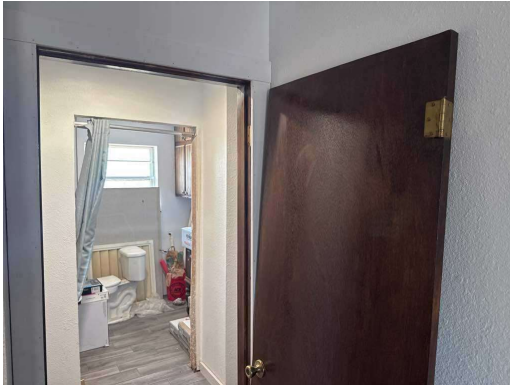
13. Marginal Doors: Hollow wood - Not installed

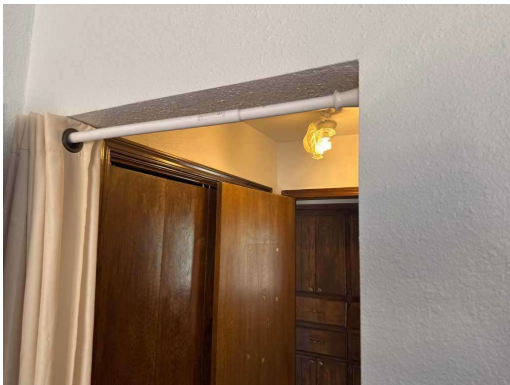
21. Not Present Doors:

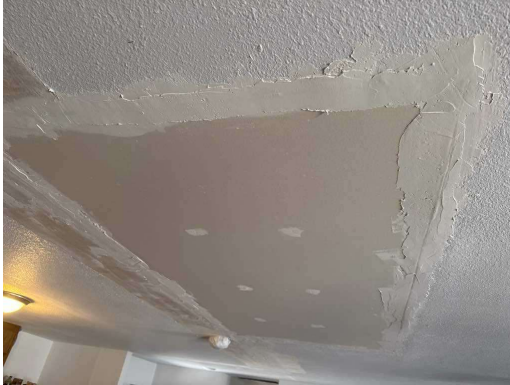
1. Marginal Ceiling: Texture paint - Unfinished repairs

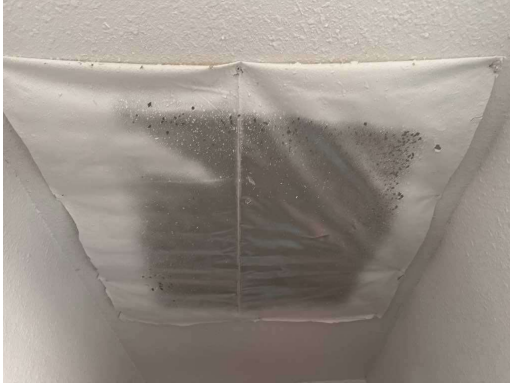
7. Marginal

Attic Fan: Belt drive - Unit is covered on the bottom

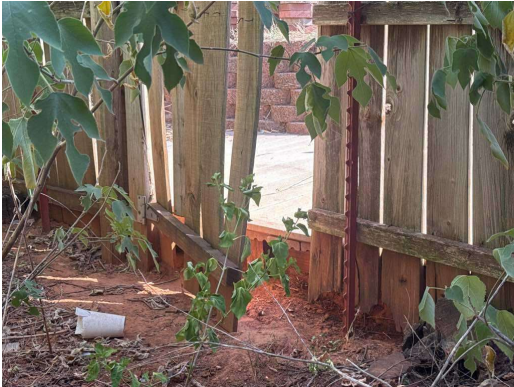
### 1. Fences: Chain link, Wood - Areas of repair needed

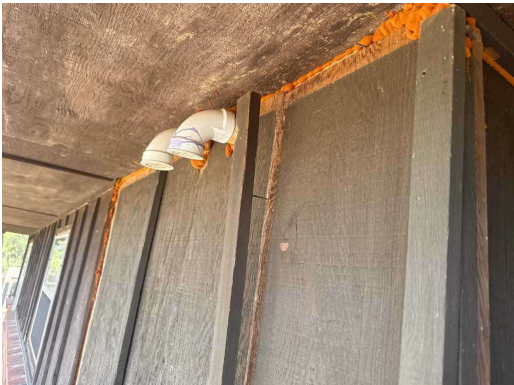
### 2. Siding: Wood - Repairs needed

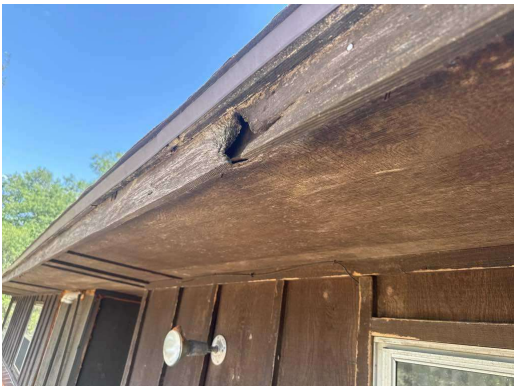
### 3. Fascia: Wood - Repairs needed

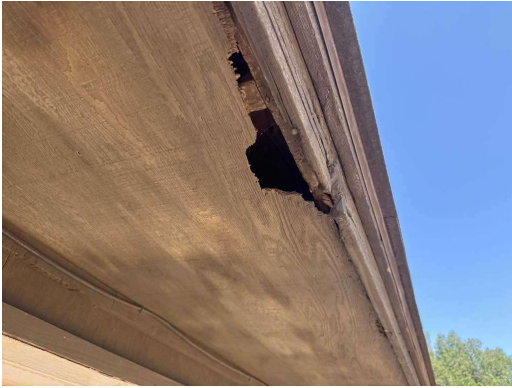
### 4. Soffits: Plywood - Repairs needed

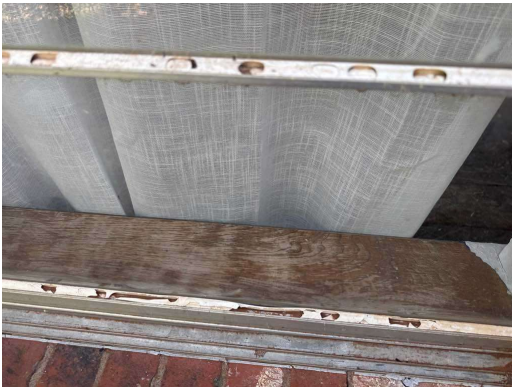
### 5. Windows: Aluminum single hung - Glazing needs repair

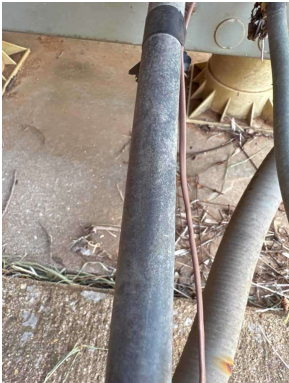
### 6. Main AC System Refrigerant Lines: Low pressure - Low pressure line insulation missing/damaged

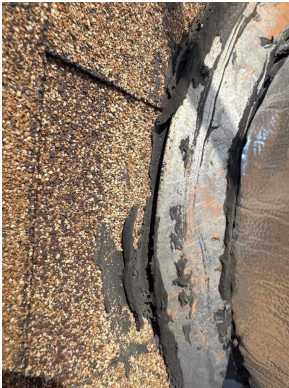
7. West Chimney Chimney Flashing: Galvanized - Sealant needs to be replaced

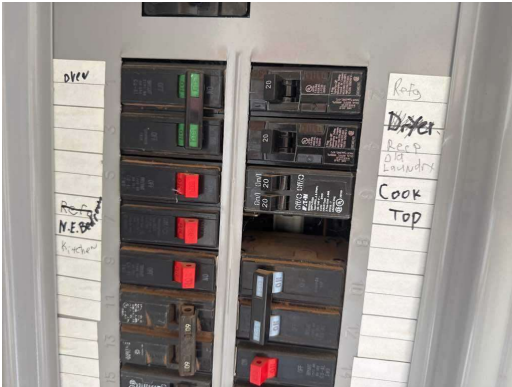
8. Garage Electric Panel Breakers: Copper - Blank covers need to be installed

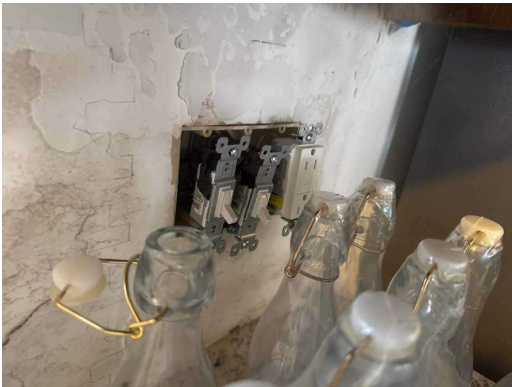
9. Kitchen Electrical: 120 VAC GFCI - Covers need to be installed

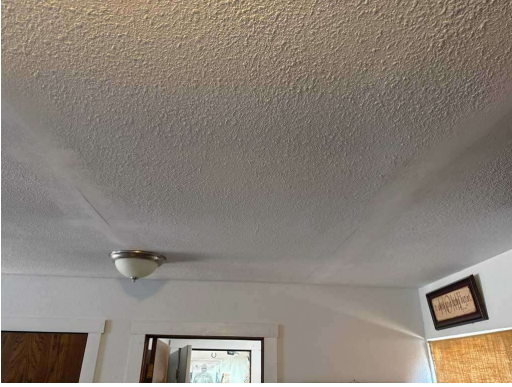
### 10. Kitchen Ceiling: Texture paint - Open tape seams

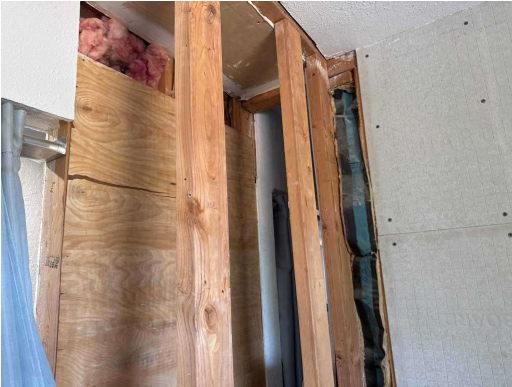
### 11. West Bathroom Walls: Unfinished

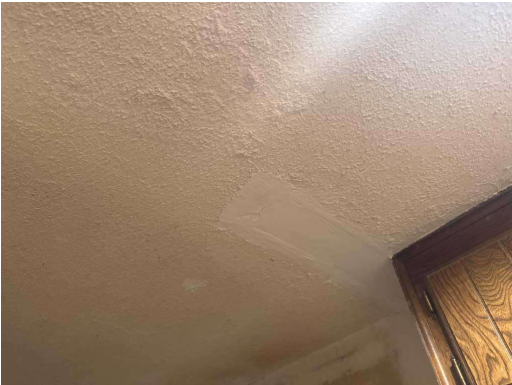
### 12. East Bathroom Ceiling: Texture paint - Unfinished

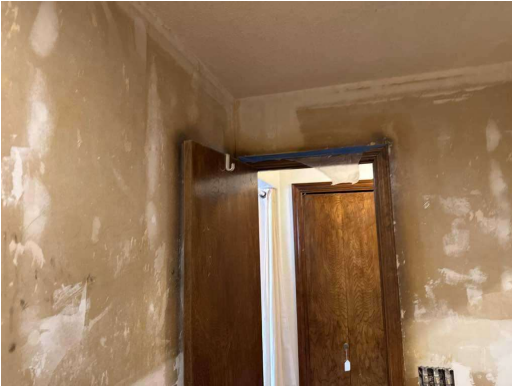
### 13. East Bathroom Walls: Unfinished

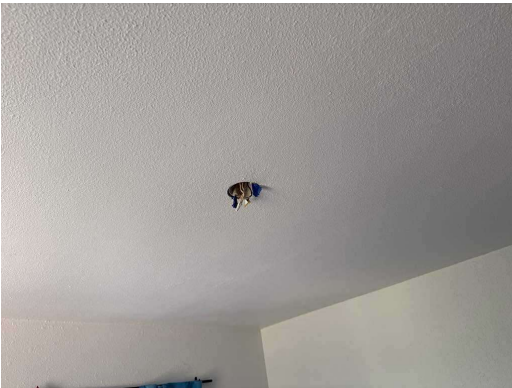
### 15. Northeast Bedroom Electrical: 120 VAC - Fixture not installed

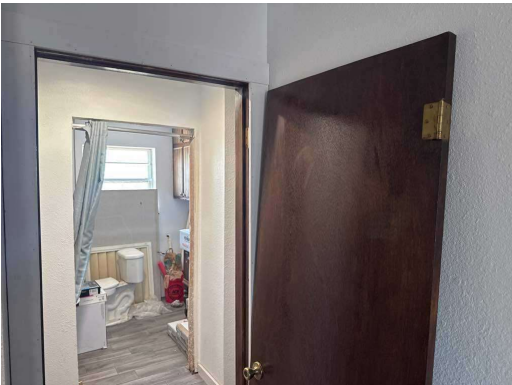
### 16. Southwest Bedroom Doors: Hollow wood - Not installed

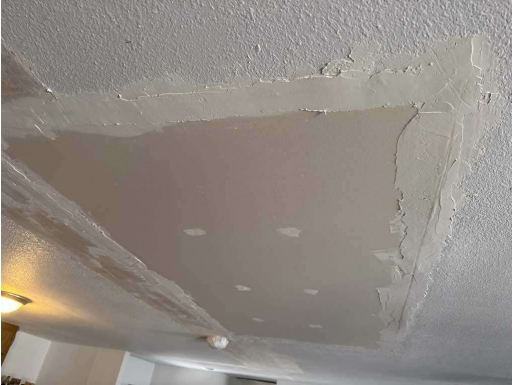
17. Living Room Living Space Ceiling: Texture paint - Unfinished repairs

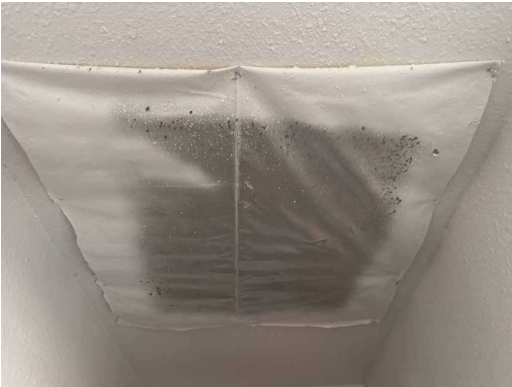
18. Main Attic Attic Fan: Belt drive - Unit is covered on the bottom

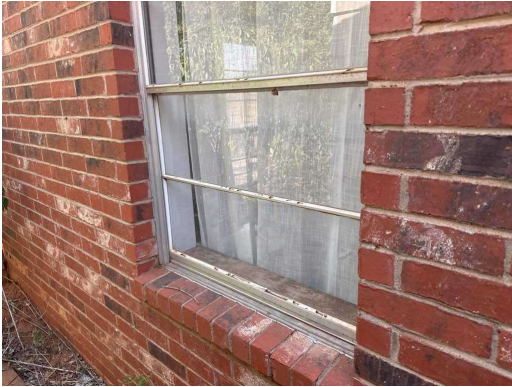
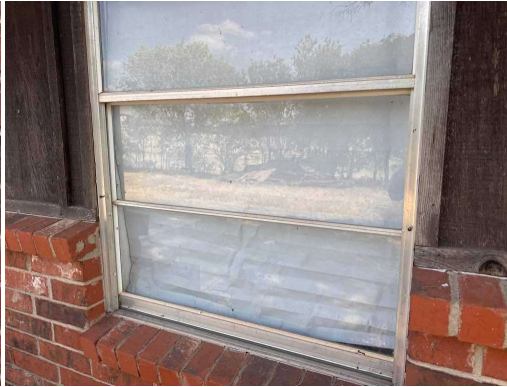
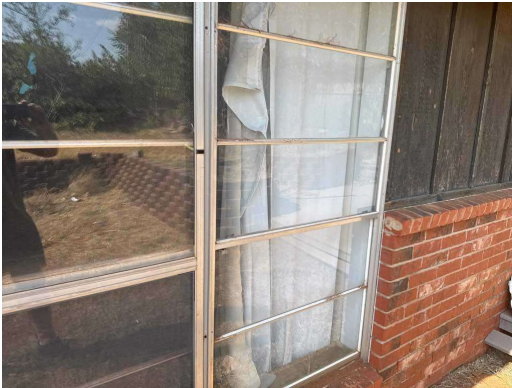
1. Door Bell: Hard wired - Inoperative
2. Storm Windows: Aluminum framed tempered glass - NW east and SE set is missing

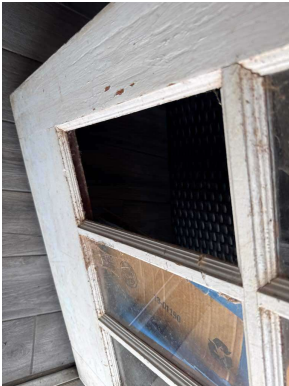
3. Patio Door: French door - Broken glass

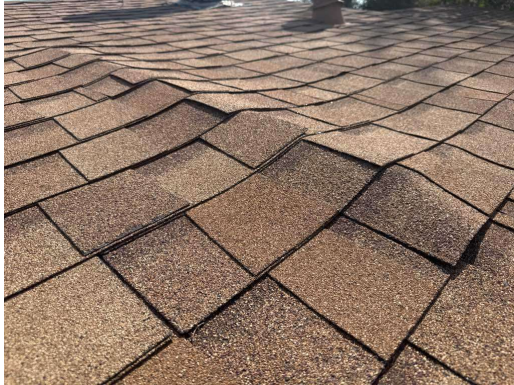
6. Main Roof Surface Material: Asphalt shingle - Area of badly popped shingles present. Recommend licensed roofer evaluate further.
