07BLD-00000-00156

237 CARACARA LN, COMO, CO 80432

RESIDENTIAL INSPECTION
FOR
PAUL HENDRICKS
4001 S. ELATI
ENGLEWOOD, COLORADO

RE: YOUR HOUSE PROJECT IN PARK COUNTY
237 Caracara Lane, lot 213 Elk Horn Ranch filling, Park County, Co. 80440

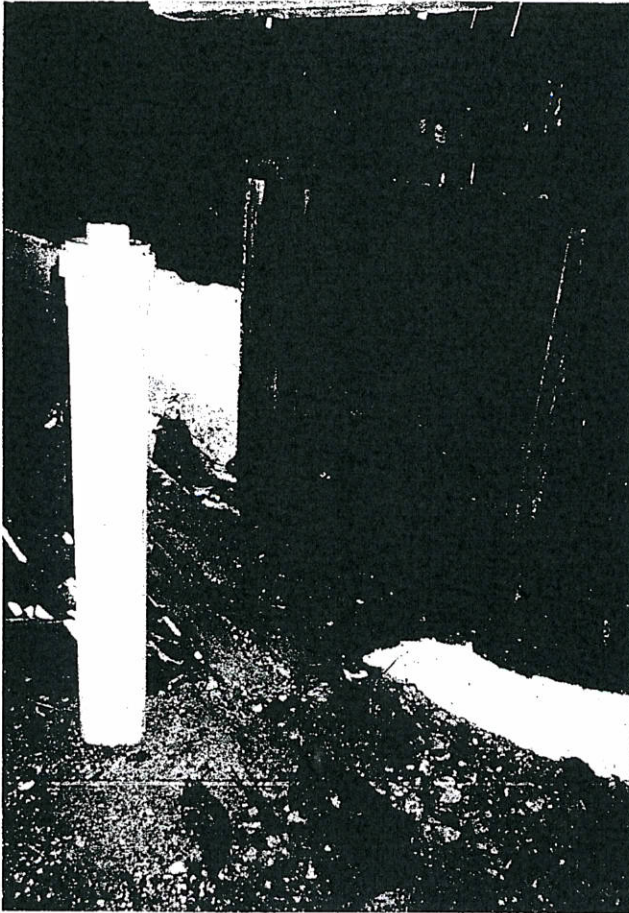
1. CRAWL SPACE ENTRY; SW CORNER
 - Top of 16" footing exposed
 - Horizontal closed cell insulation required
 - Closure and ventilation required

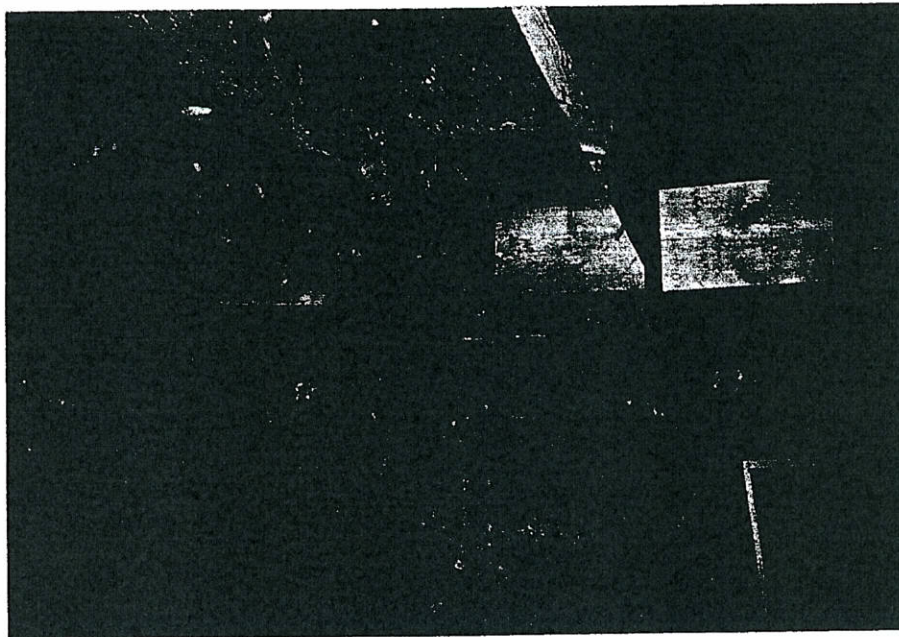
2. 2 x 10" FLOOR JOIST
 - 16" o.c. and 12' span
 - Blocking provided at supports and mid span

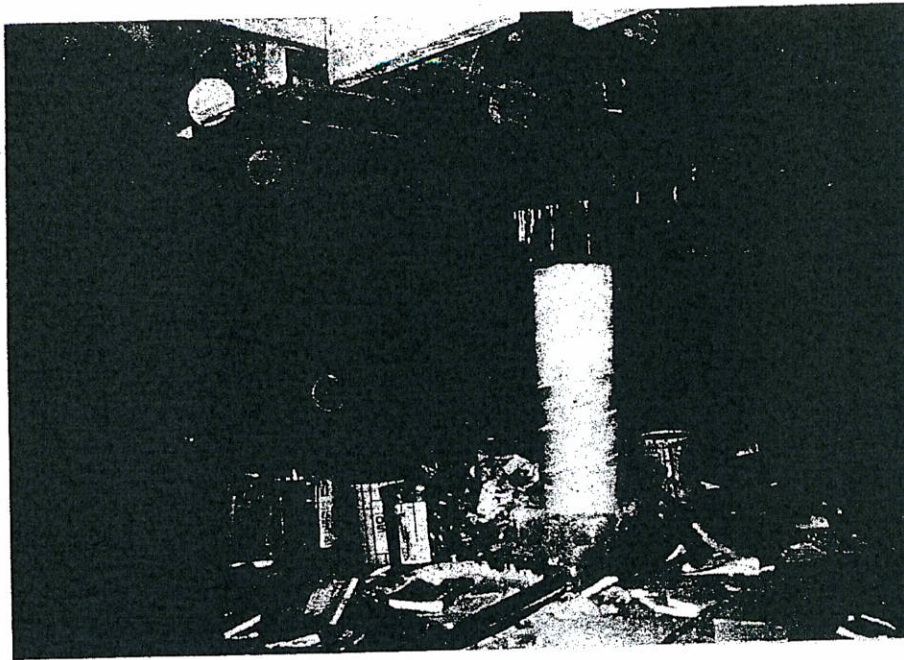
3. 12" DIAMETER CONCRETE PIER (3' HIGH) OVER 24"x21"x8" CONCRETE FOOTING
- Concrete footing bearing on undisturbed soil

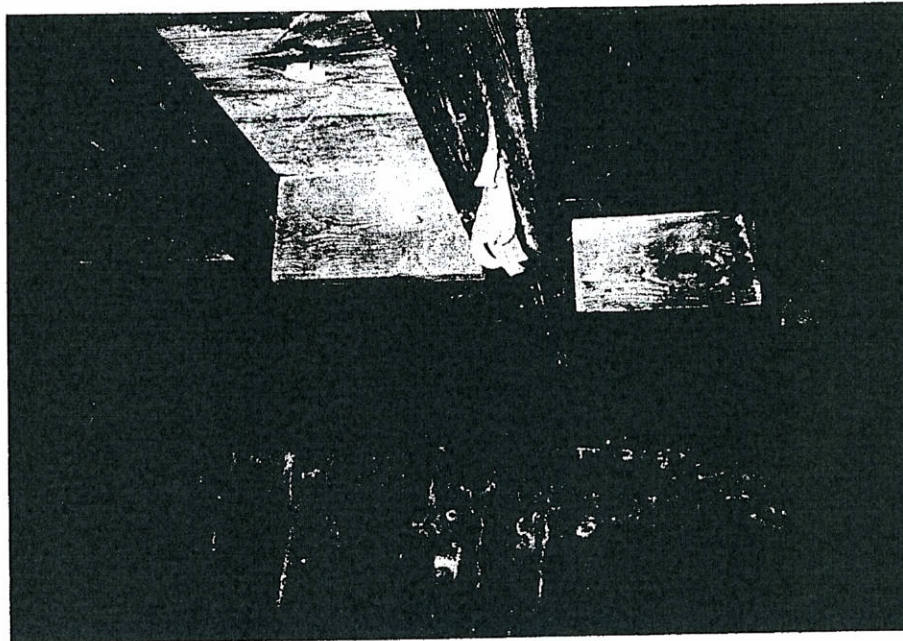
4. STATIONARY SUPPORT: 3 - 2" X 10"
- Bearing plate over 8" stem wall

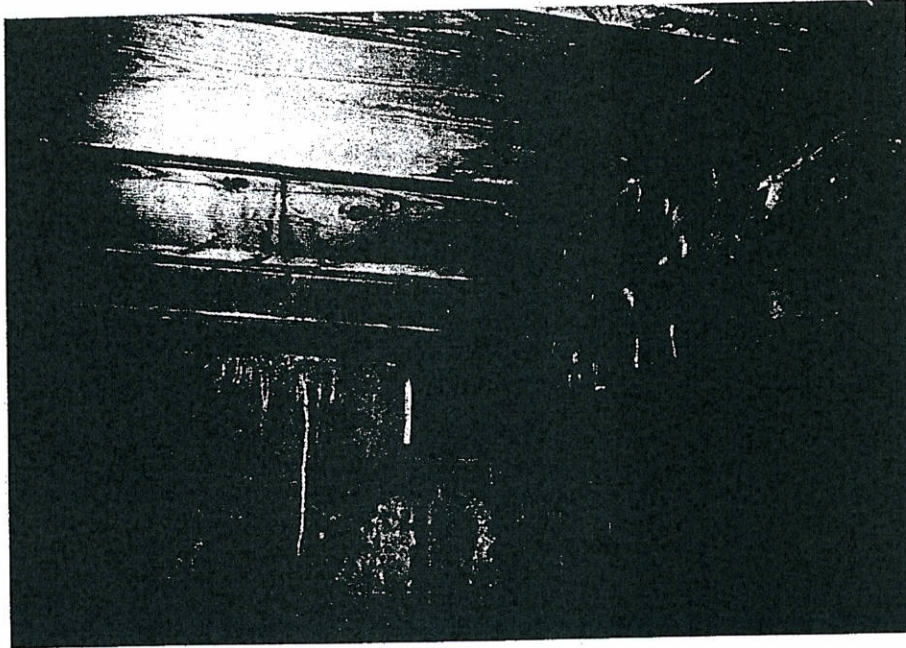
5. 8" STEM WALL NOTCHED FOR 3 - 2" X 10" CENTER SUPPORT BEAM
- Span 12' maximum

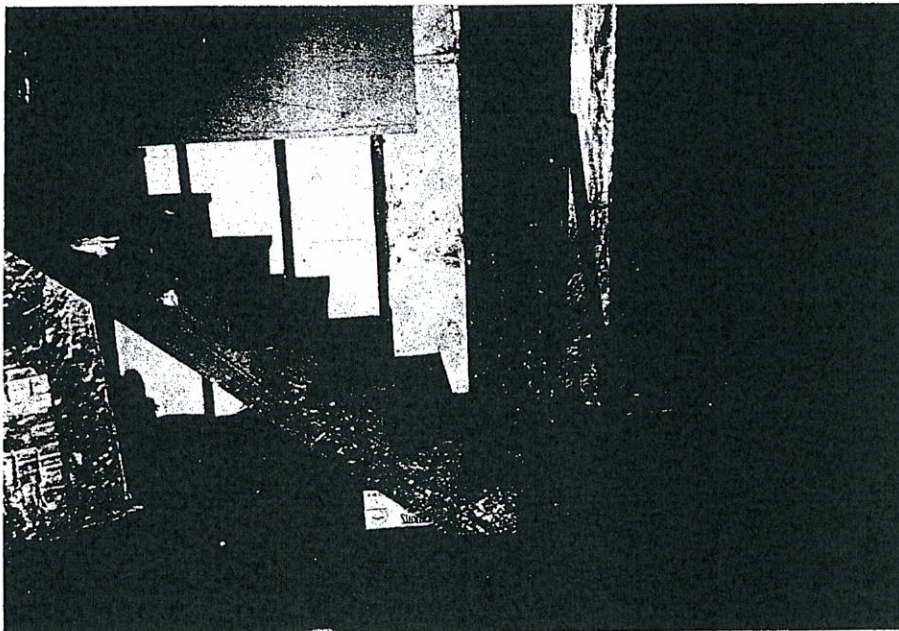
6. STAIRWAY SUPPORT STRINGERS
- Door to be replaced with exterior foam core opening to outside

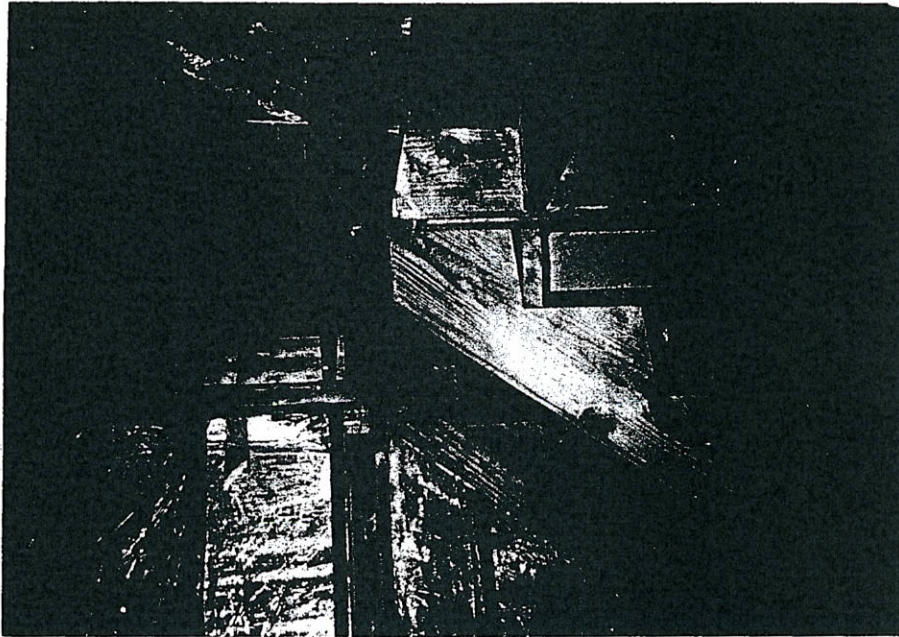
7. TRIPLE 2 X 8 SUPPORT OF STAIRWAY
- 2 x 12 treds
- 2 x 8 risers

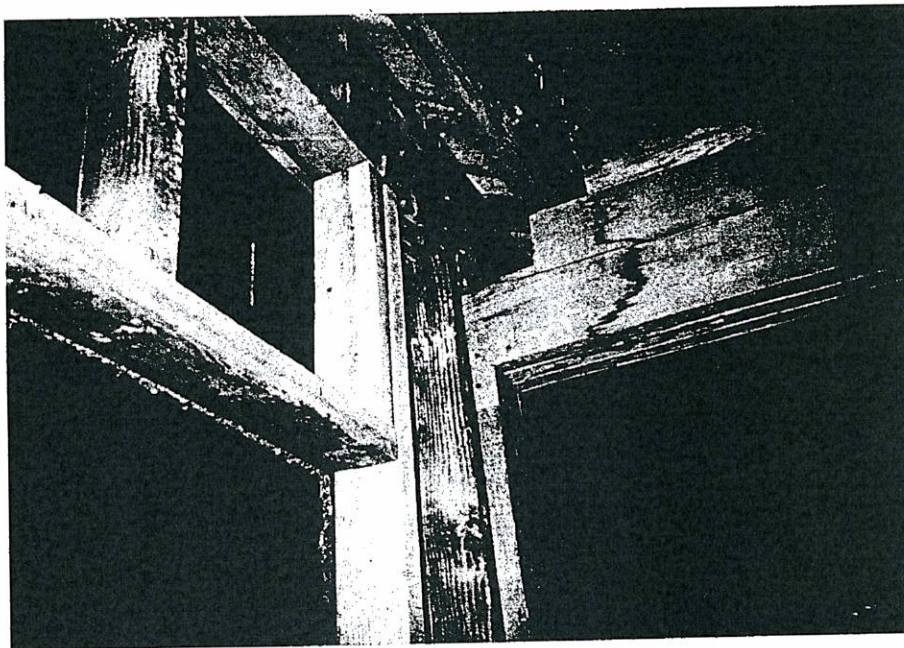
8. 3 - 2" X 10" NOTCHED OVER 4" X 6" COLUMN SUPPORT (5" X 5")
- Recommend double plate over column support

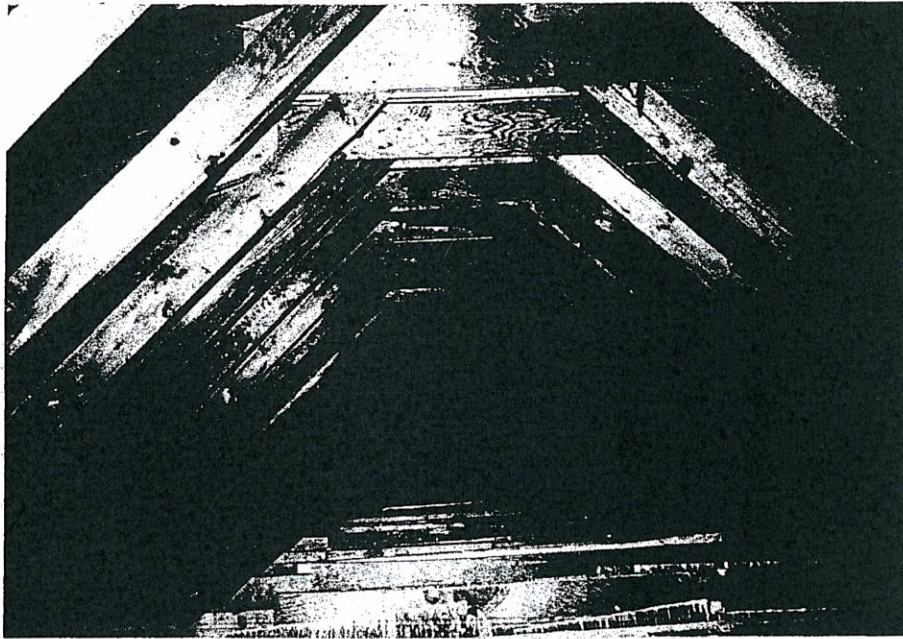
9. 2 X 6 TRUSSES AT 16" O.C.
- 2 X 6 top and bottom chords
- 2 X 4 diagonals

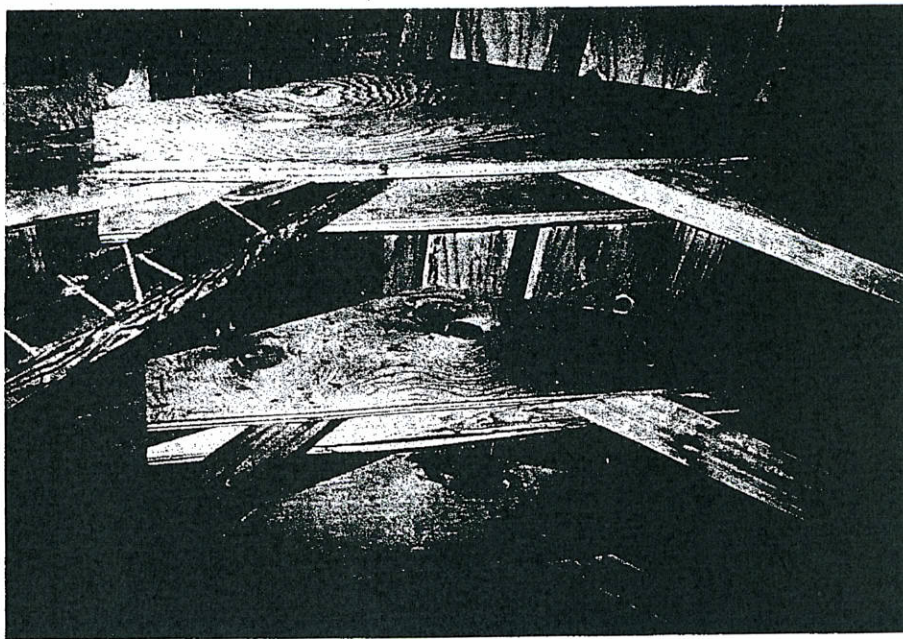
10. TRUSS JOINTS - TOP CHORD
- double 3/4" plywood plates: glued and nailed (44 - 48, #8 nails/joint)
- no sign of movement or truss deterioration

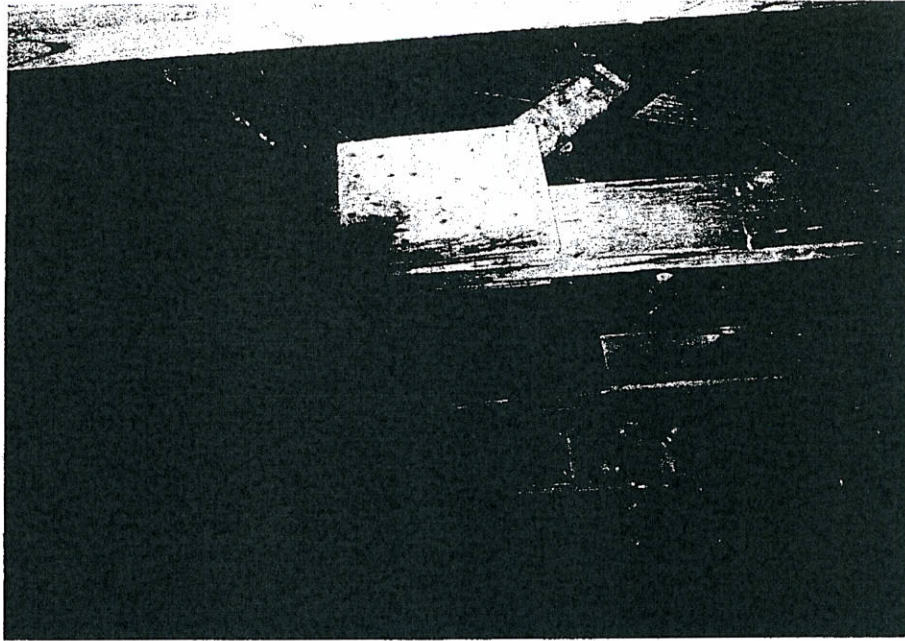
11. TRUSS JOINTS - BOTTOM CHORD

- double 3/4" plywood plate: glued and nailed (30 - #8 nails/joint)
- truss anchors used at all bearing plates over existing exterior walls
- no sign of movement or truss deterioration

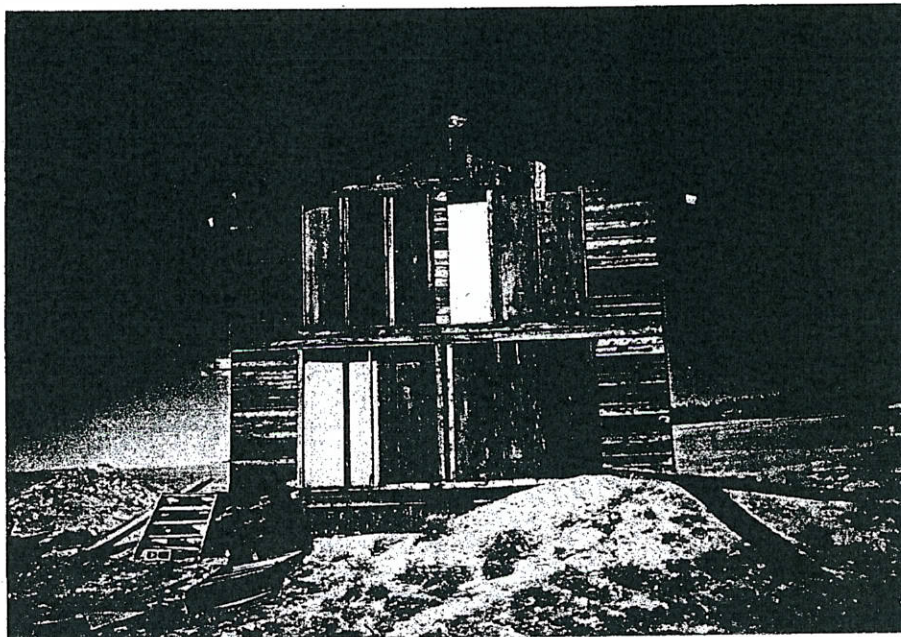
12. SOUTH ELEVATION

- replace soffit and brace to vertical support
- framed for 28" wide fixed pane windows
- 1" cedar siding

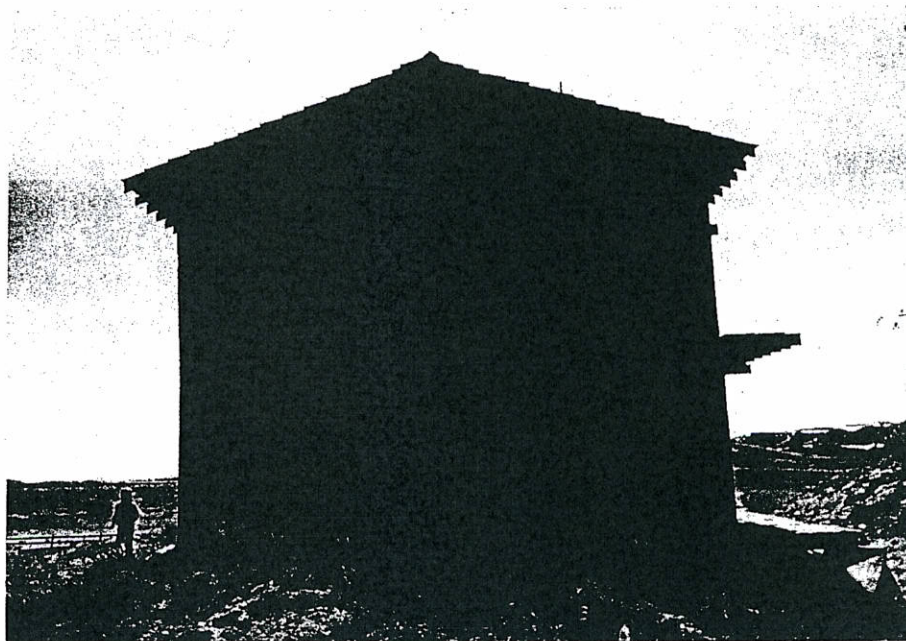
13. NORTH ELEVATION

- 1" cedar siding: all rotten or severely weathered materials to be replaced

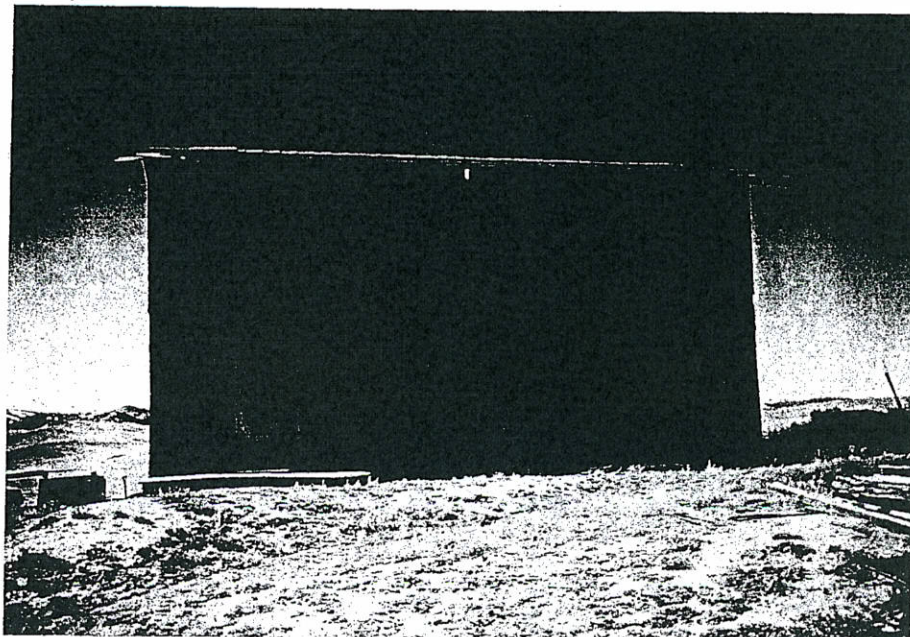
14. EAST ELEVATION

- Masonite siding - all weathered materials to be replaced
- cantilevered deck to be removed and replaced with concrete landing and stairway

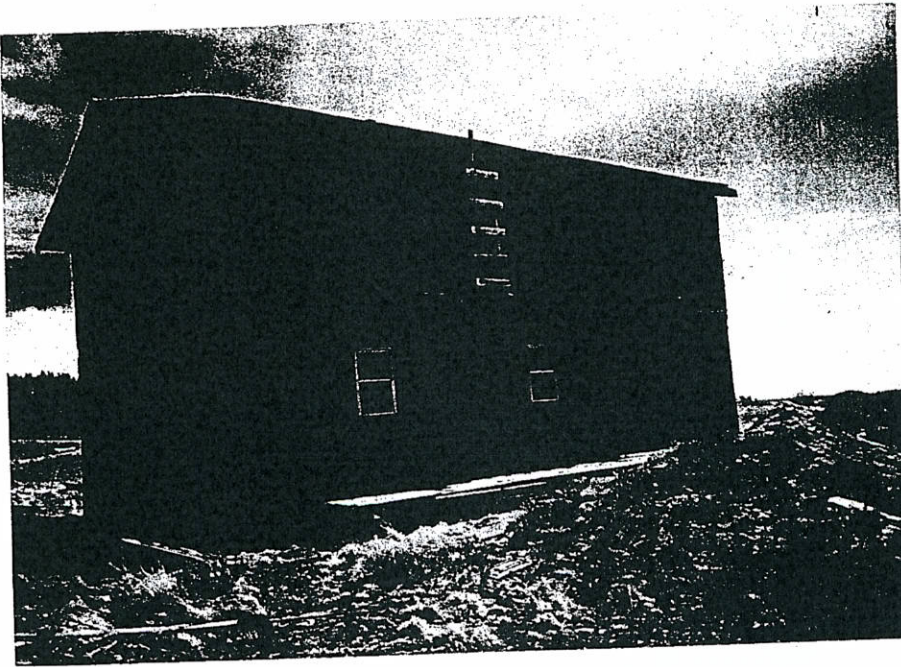
15. WEST ELEVATION

- Masonite siding - all weathered materials to be replaced
- remove cantilevered deck at 2nd floor
- remove exterior door
- replace lower cantilevered deck with concrete landing and stairway

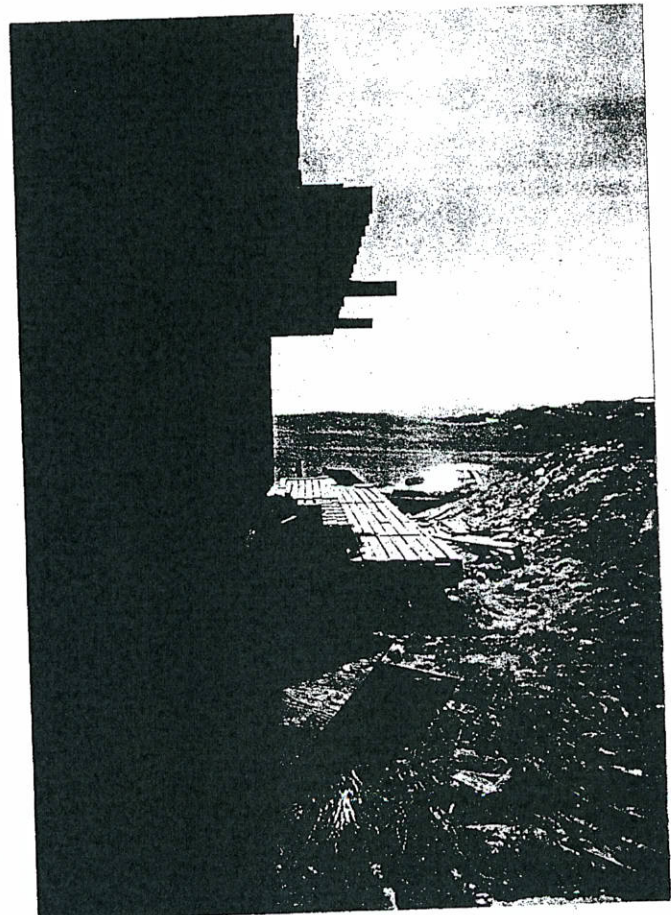
16. CANTILEVERED DECK (WEST WALL)

- 1st floor level: remove weathered and deteriorated decking (max length is 4')
- replace rim joint
- alternative: remove cantilevered deck and replace with concrete slab (allow for crawl space access)

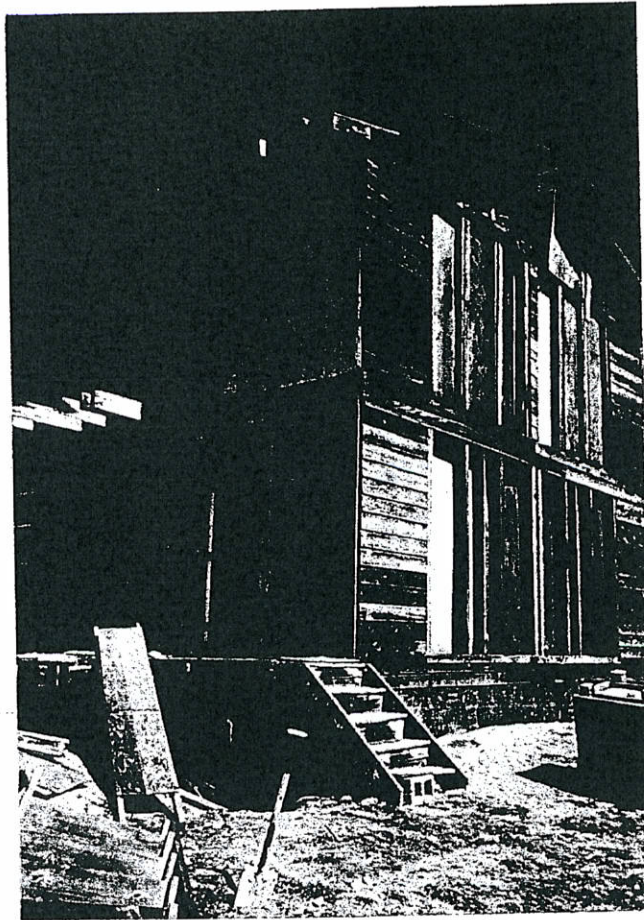
17. SW CORNER OF CABIN

- replace wood steps with concrete steps on concrete pier foundation
- reserve access to crawl space
- replace roof overhang along south wall
