Due Diligence  
**Volcano View Property**  
Bagaces, Costa Rica

**May, 2008**

The report is intended to evaluate the characteristics of the property located in Bagaces, Costa Rica, where it could be developed as a residential, commercial and tourist project, and to determine the possible restrictions and/or limitations due to the physical, environmental and legal framework.

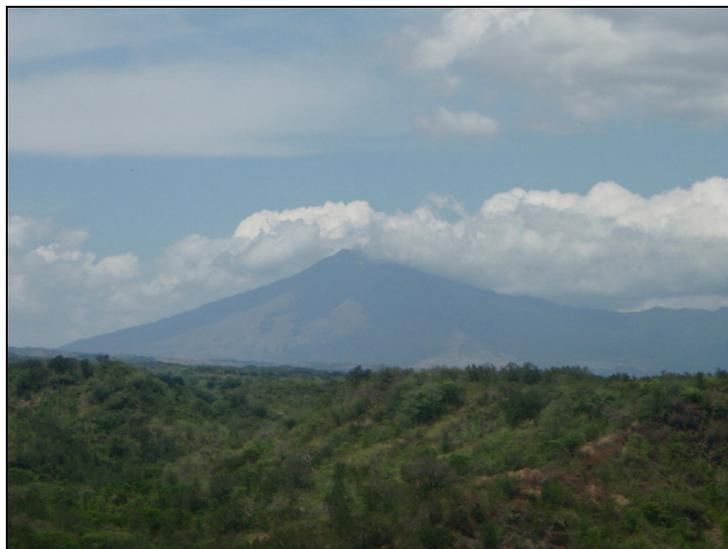
Photo No. 1: View of the highlands and slopes with the Miravalles Volcano in the background.

The property has a high percentage of land suitable for development. A series of acreage or “quintas” could be designed with views across the valleys and some steeper slopes leading down to the creek beds with a buffer zone around these. There are also large sections of level land atop the plateaus. Some sections of the plateaus end in abrupt rims rather than gentle slopes. Nevertheless there are no signs of ongoing instability and these drop-offs may serve as scenic look-out points.

The absence of fault planes and slide planes, based on the first field visit, is also a favorable characteristic of the property. There was no visible scarring of the land by landslides, this points to a high level of surficial stability which would also be reflected in reduced development costs.

The exact location of any building sites should be selected in such a way as to avoid any geological weak points which could be locally present, i.e.: geological contacts, lenses of pumice or clay, erosion prone slopes, slumps or slides planes etc.

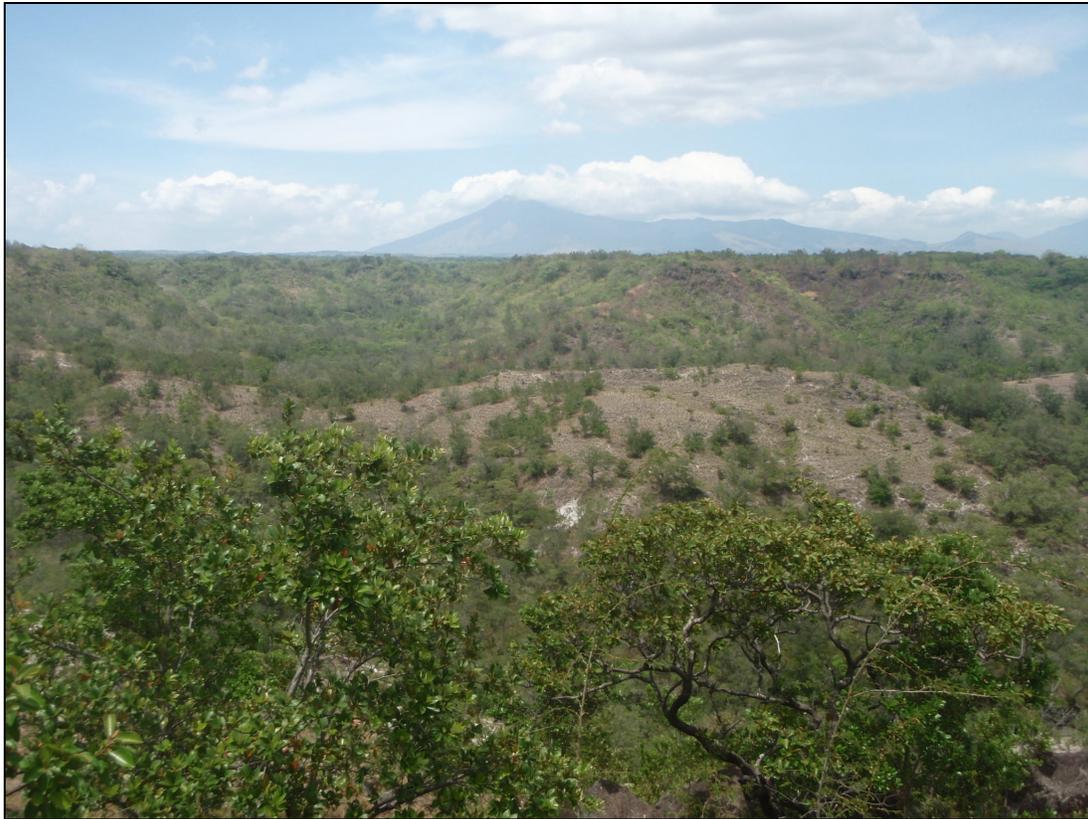
The areas of secondary forest has restriction for cutting of trees due to the forestry law, because it is prohibited in the protection zone of creeks and rivers (a strip 15 meters wide along each side of the creek) and in the areas classify as forest by the Forestry Administration (MINAE), that is the sectors with more than 60 trees per hectare with 15 cm of diameter at chest height.

The areas of bushes and small trees could not be classify as forest today, but due to the process of natural regeneration, it is estimated that if this process continues some sectors could be classify as forest in a period of five to ten years.

Photo 2: it shows the three most common vegetation units on the property, the front trees belong to secondary forest and the hill top is covered by pastures and surrounded by bushes.
