Perfection Home Inspections
Mesa, AZ 85203
602-524-2916
perfectionhomeinspections.com

Masterson, Sandy
671 E. Vermont Drive
Gilbert, AZ 85296

Inspected 2/12/19 1:30 PM
Built 2000
3000 sf

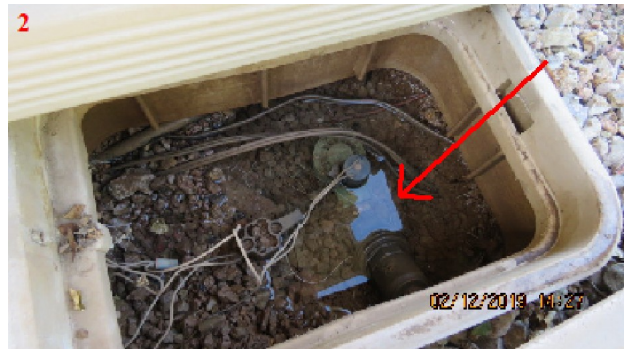
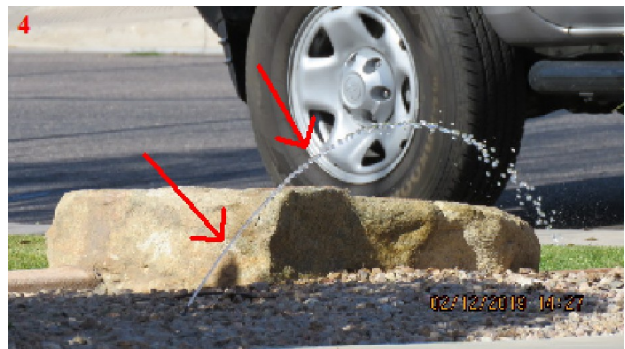
Service/Repair Sprinkler System - Vacuum Breaker

Sprinkler systems are not fully inspected as part of this home inspection. The sprinkler valves in the valve boxes are inspected by turning them on manually and looking for major leaks only. Sometime other items are noted because the system turns on automatically and defects are noticed at that time. Water in both valve boxes on the side of the garage is a good indication of a leak in the system. One or more sprinkler valve solenoids have rusted and split open. One or more sprinkler line are leaking or have missing heads. Recommend a qualified contractor evaluate and make all necessary repairs.

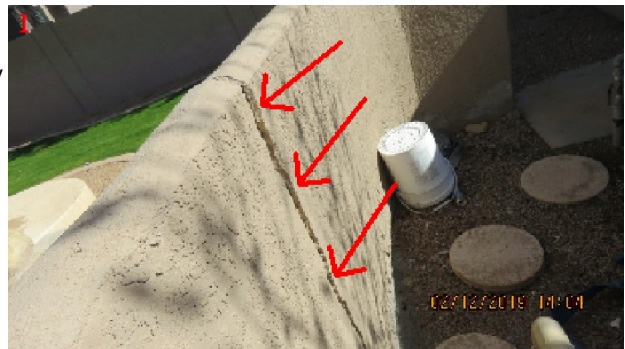
Service/Repair Yard Fences - Masonry

The pool equipment block fence wall is cracked with some movement. Recommend a qualified contractor evaluate and make all necessary repairs.

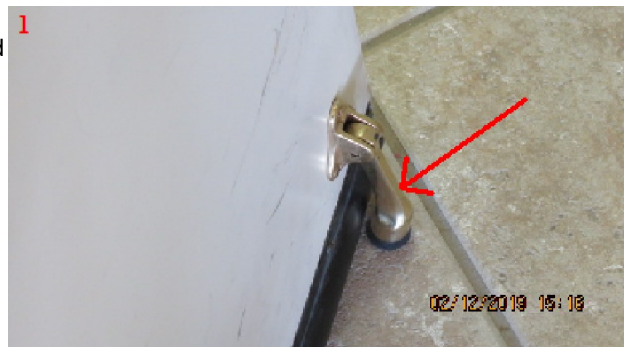
Garage doors to the home should be minimum of 1-3/8 inches thick solid wood or metal door with a self closing device. This is required for a 20 minutes fire rating normally required for opening between the garage and the home. Doors between a bedroom and the garage are not permitted.

No latch or door stopper of any type should be installed on the garage door to the house that keeps the door from automatically closing. This may allow carbon monoxide gas to enter the home. Recommend removing any type of such latch.

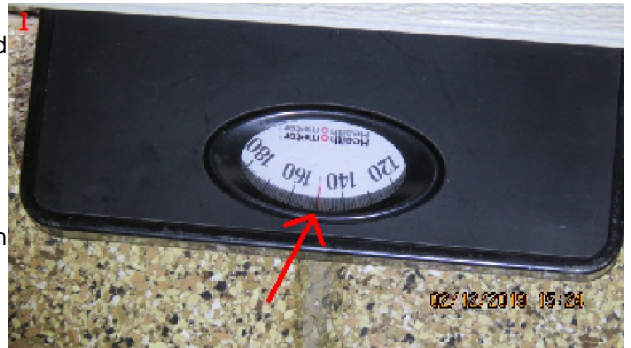
The automatic garage door opener did not stop and return the garage door when meeting obstacles. According to reports received by the U.S. Consumer Product Safety Commission (CPSC), approximately 60 children between the ages of 2 and 14 have been trapped and killed under automatic garage doors between March 1982 and 1997. I recommend all automatic garage doors openers stop and reverse when meeting obstacles to prevent someone or something from being smashed by the automatic door. Adjusting the automatic door opener to open and close with the proper tension normally requires turning a screw or nut on the opener. In this case less force is needed to close the door. All garage door openers manufactured after January 1, 1993 are required to have this auto-reverse function. Recommend a qualified contractor evaluate and make all necessary repairs. A scale 1.5" high was placed on the garage floor under the door to test the automatic stop and reverse function of this garage door opener. The garage door opener is holding down with a force of 150 pounds and did not automatically reverse and go back up.

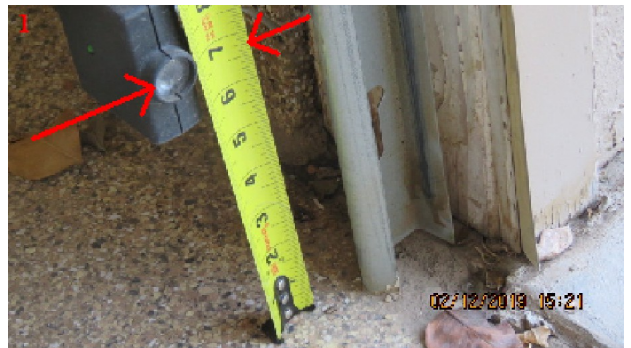
**Safety Concern****Garage Electronic Eye - More Than 6 Inches**

The electronic eye sensor beam used to stop the automatic garage door from closing if something is in its path is more than the recommended height of 6 inches above the garage floor. This is a safety hazard. Recommend installing this sensor eye beam 4 to 6 inches above the garage floor.

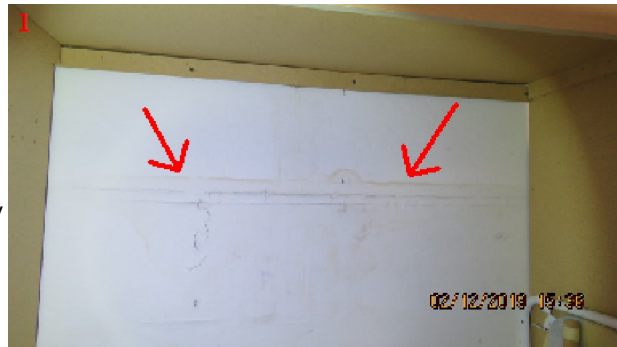
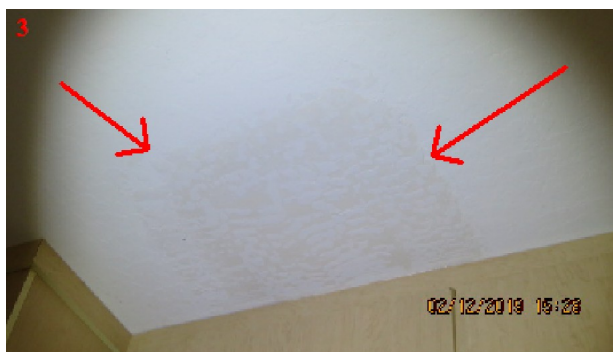
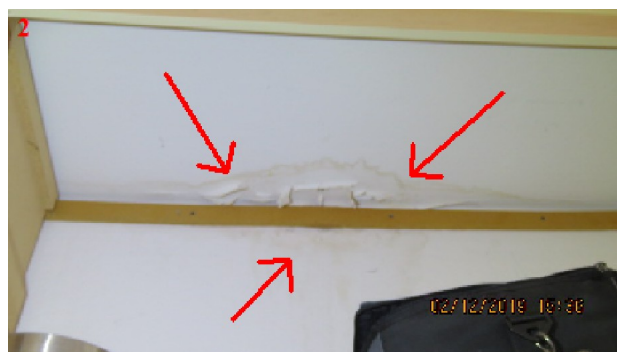
Water stains on the ceiling and wall on the west side in a cabinet. Recommend a qualified contractor evaluate and make all necessary repairs.

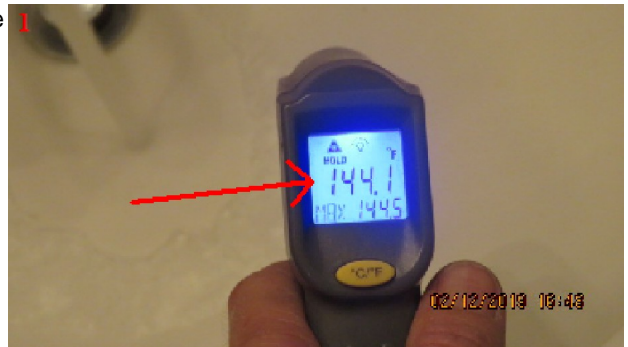
Safety Concern Operating Controls - Temperature Set Too High

Water temperature of 144 degrees was tested at kitchen sink. See picture. Water temperatures set too high can cause severe burns. Recommend lowering water temperature setting to 120 degrees on the gas water heater.

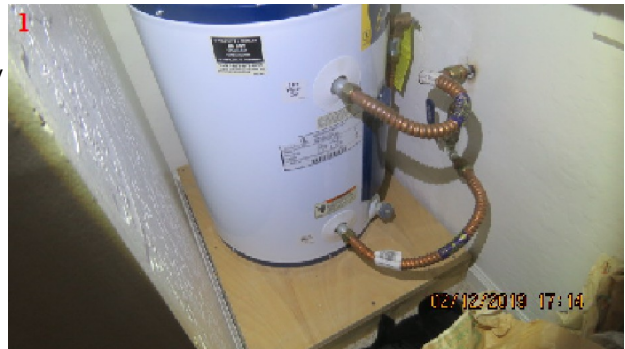
This water heater is located the west side bedroom closet.
No pan installed under the water heater in this closet.
Recommend a qualified contractor evaluate and make all necessary repairs.

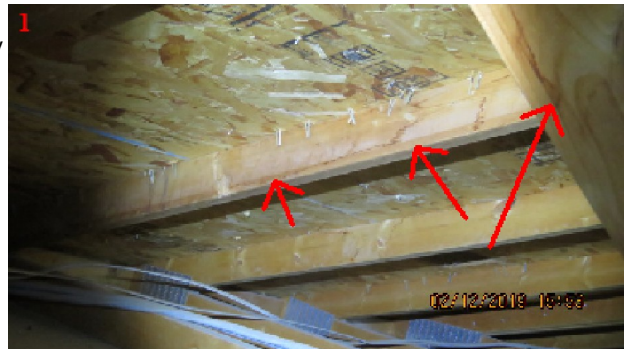
Water stains on a truss member in the garage attic.
Recommend a qualified contractor evaluate and make all necessary repairs.

Water stains on a truss member in the garage attic.

Recommend a qualified contractor evaluate and make all necessary repairs.

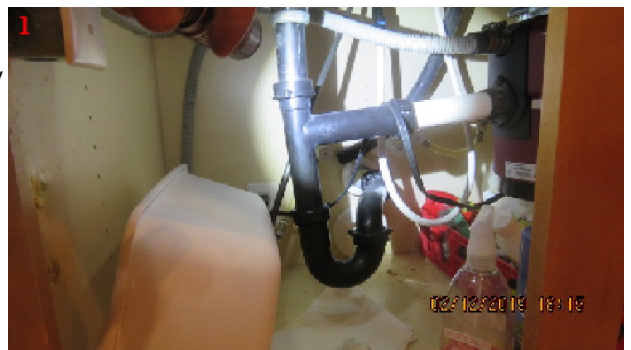
No plumbing drain vent found for the kitchen sink drain. This is an island so it needs a under this sink vent.
Recommend a qualified contractor evaluate and make all necessary repairs.

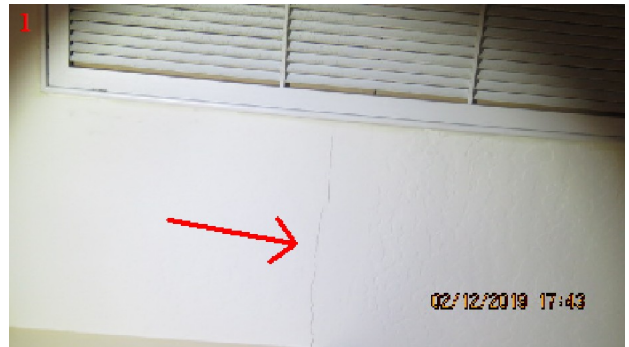
Some drywall/plaster cracks from normal settling found.
Recommend patching and painting when convenient.

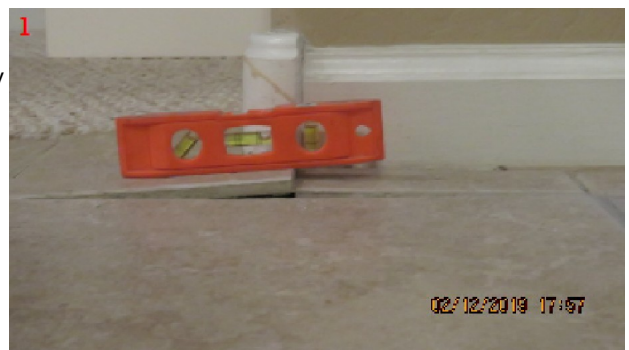
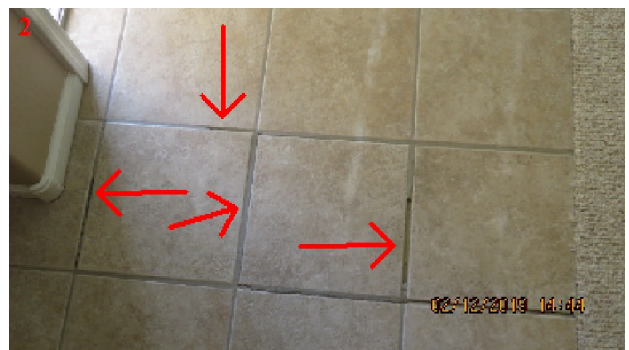
Cracked floor tile, raised floor tile and missing floor tile grout near the patio sliding glass door.
Recommend a qualified contractor evaluate and make all necessary repairs.

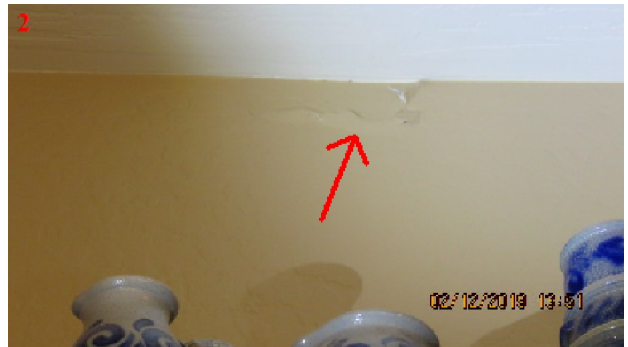
Dining area wall has rippled paint at the ceiling. This is normally caused by water. Recommend a qualified contractor evaluate and make all necessary repairs. See garage for water leaks.

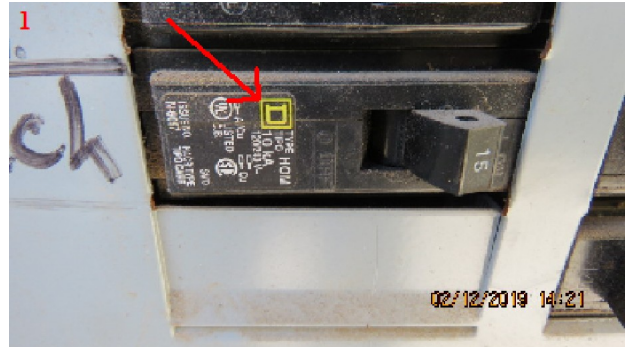
This panel has one or more breakers installed that are not made by the manufacturer. The wrong breakers can be a fire hazard and or a shock hazard. Recommend a qualified contractor evaluate and make all necessary repairs.

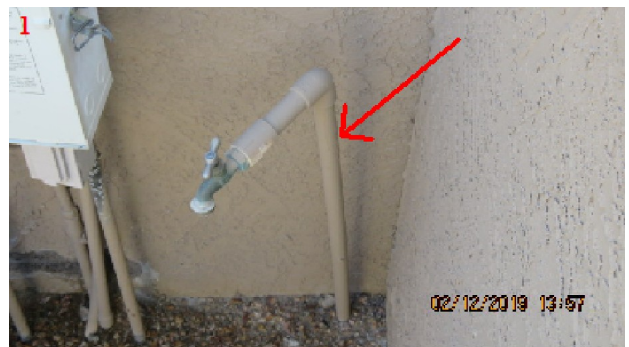
The hose bibb pipe in the back yard is not properly supported and may easily break creating a large water leak. Recommend properly supporting pipe. See picture

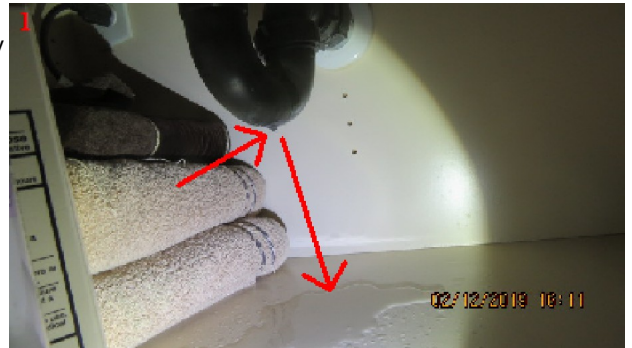
The left side master bath sink drain leaks.
Recommend a qualified contractor evaluate and make all necessary repairs.

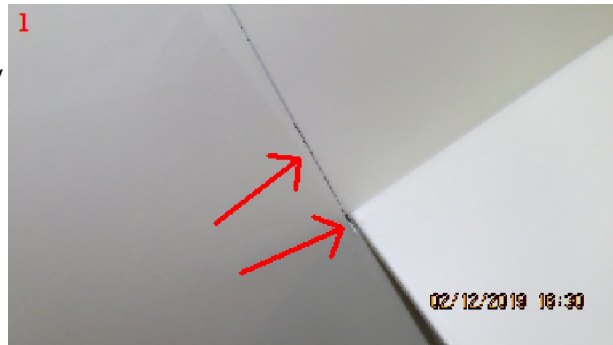
There is a gap in the grout between sections of the shower wall enclosure.
Recommend a qualified contractor evaluate and make all necessary repairs.

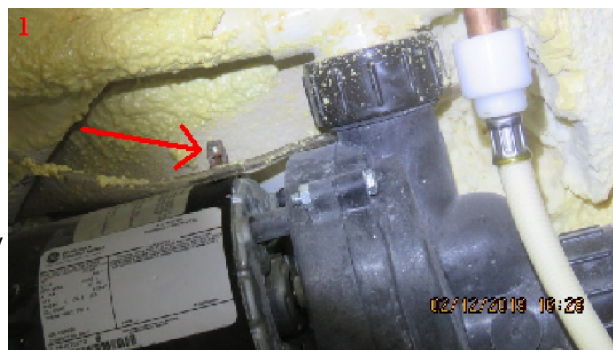
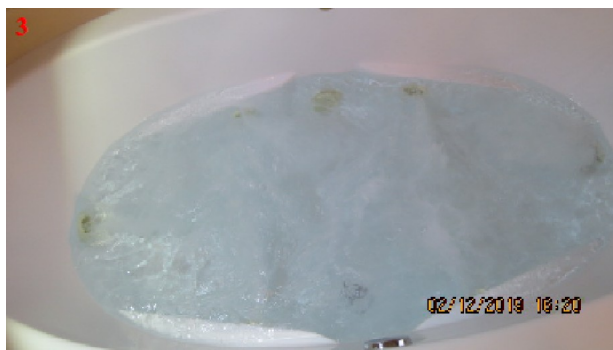
No ground/bond wire found on the spa tub motor. This is a shock hazard.
Recommend a qualified contractor evaluate and make all necessary repairs.

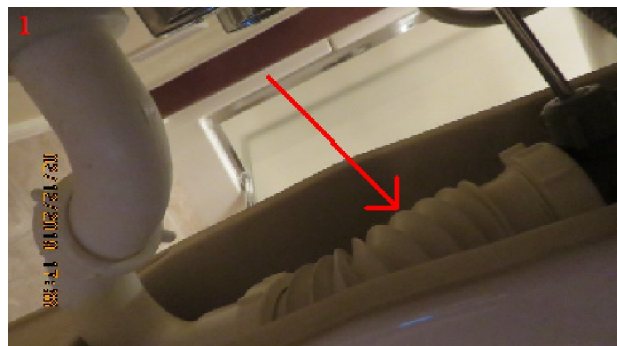
Flexible non smooth sink drain line. Recommend only smooth walled drain lines for all drain pipes to help avoid clogs.

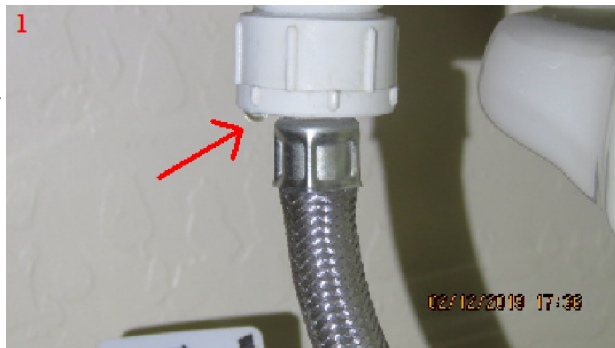
Water drips from the water supply pipe at the bottom of the toilet. Recommend a qualified contractor evaluate and make all necessary repairs.

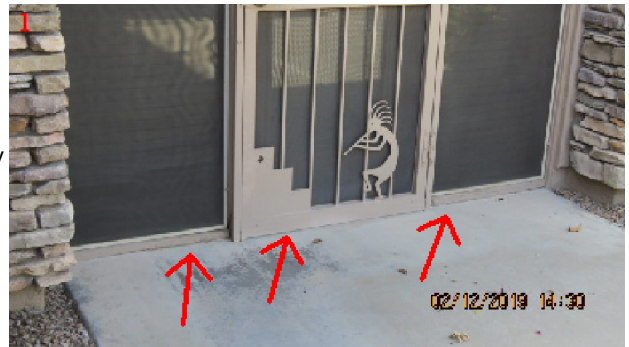
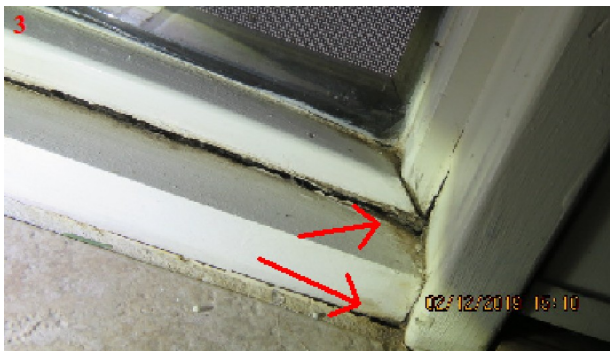
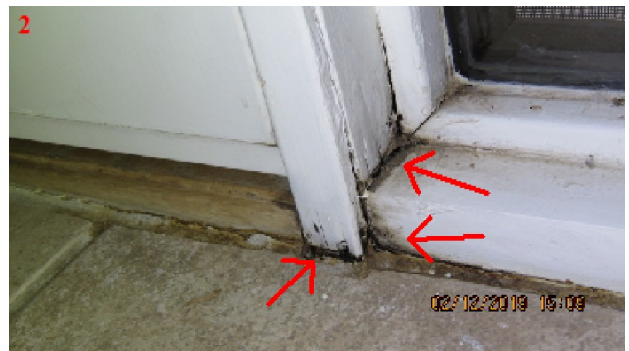
Some wood rot found on the inside at both sides of this door jamb and at the windows installed on both sides.
Recommend a qualified contractor evaluate and make all necessary repairs.

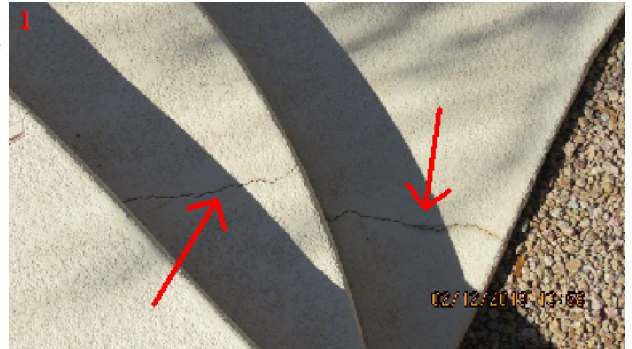
Cracks found in pool decking at the step up area. Recommend sealing cracks to help keep the cracks from spreading. See sample picture

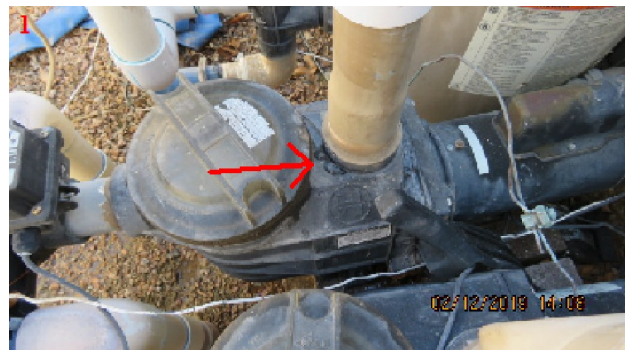
The pool filter pump leaks at the pipe to pump connection. Recommend a qualified swimming pool contractor evaluate and make all necessary repairs.

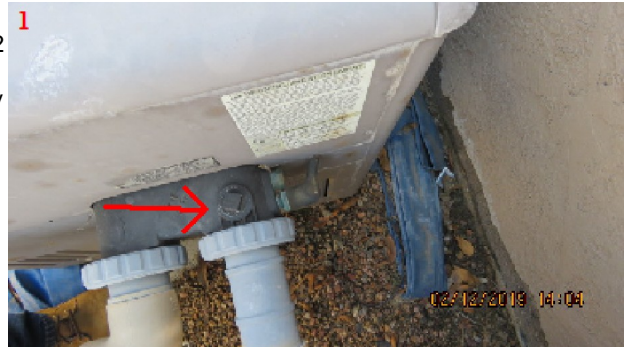
No temperature pressure relief valve pipe found for the pool heater.
Recommend all temperature pressure relief valve pipes be within 12 inches of the ground and pointed straight down.
Recommend a qualified contractor evaluate and make all necessary repairs

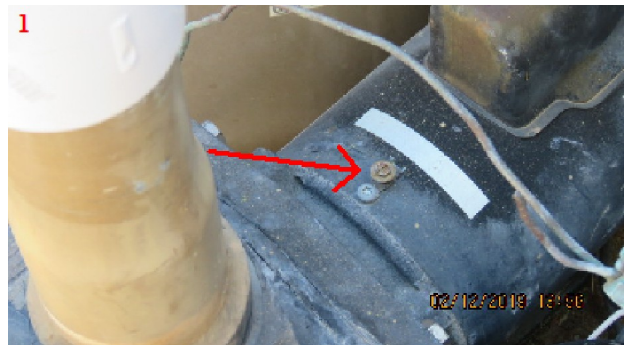
Safety Concern Bonding 5 Feet From Pool - Missing

One pool motor is not properly bonded. Recommend properly bonding pool motor. See picture
This is a shock hazard.
Recommend a qualified swimming pool contractor evaluate and make all necessary repairs.

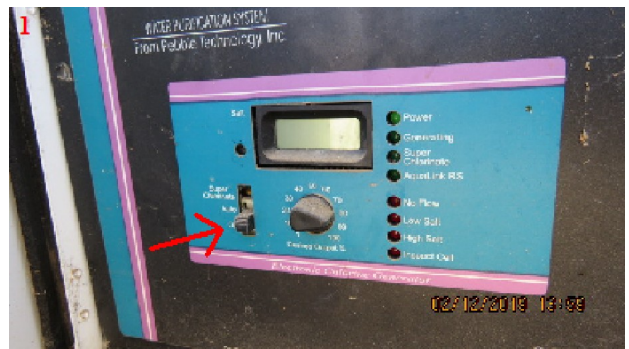
Automatic chlorinator installed is not turned on and not plugged in. Recommend a qualified swimming pool contractor evaluate and make all necessary repairs.

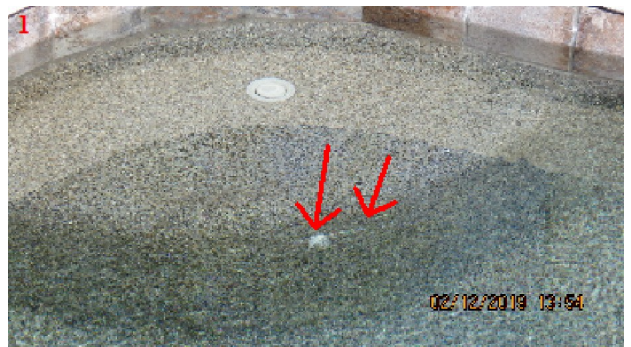
Something on the spa surface. Recommend further investigation.

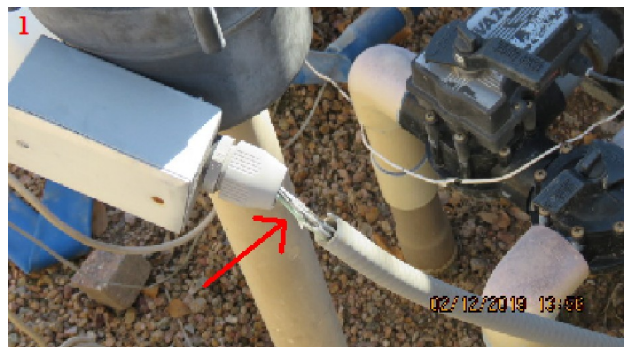
Safety Concern Air Pump - Tested

The conduit for the spa blower is not properly attached. The blower did not turn on when tested. Recommend a qualified swimming pool contractor evaluate and make all necessary repairs.
