## General Summary

**Home Spec of NC, Inc.**

252 Ryland Road  
Tyner NC 27980

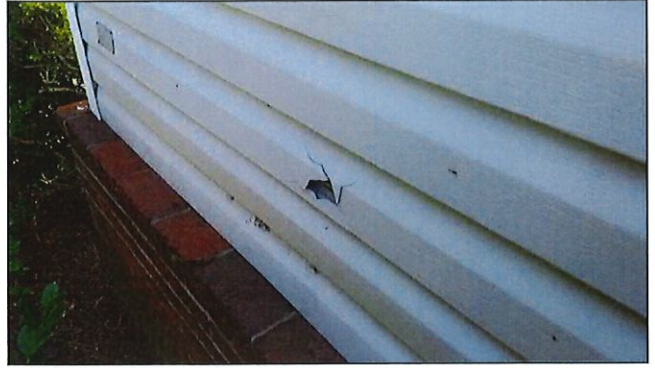
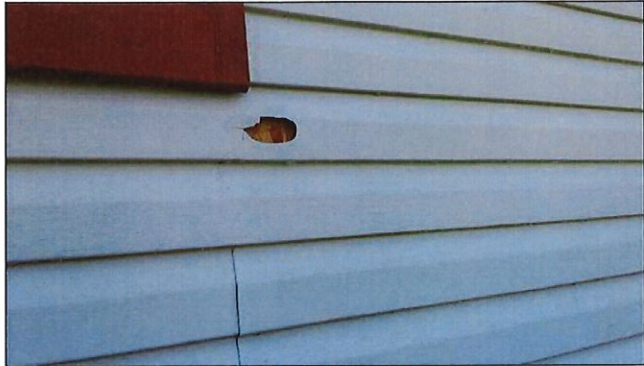
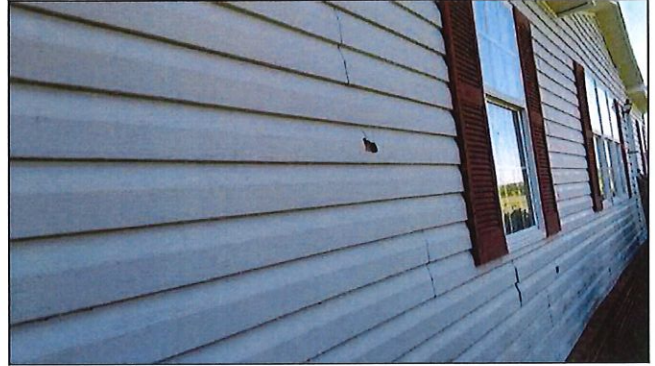
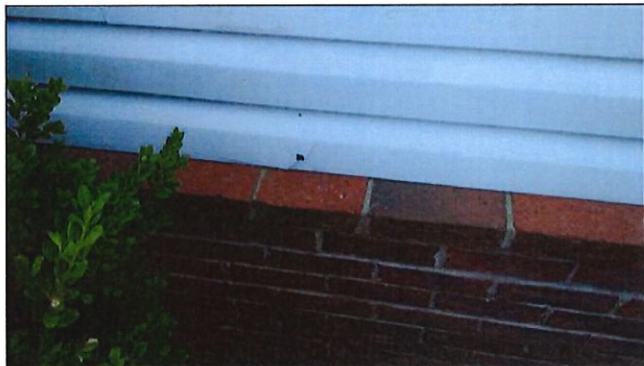
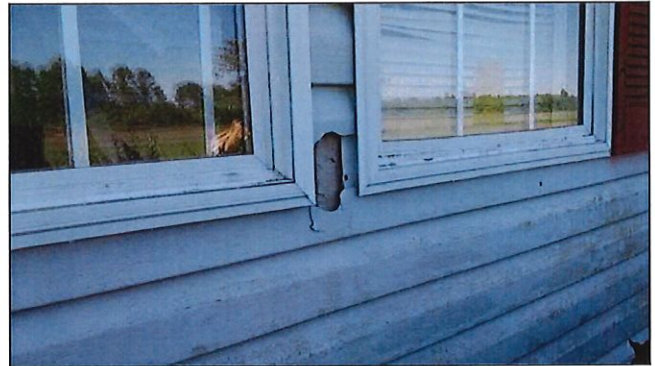
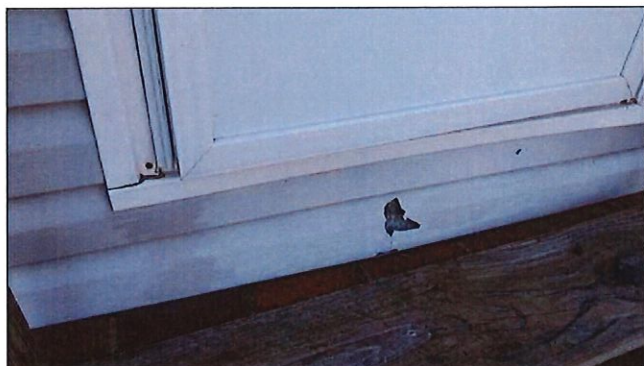
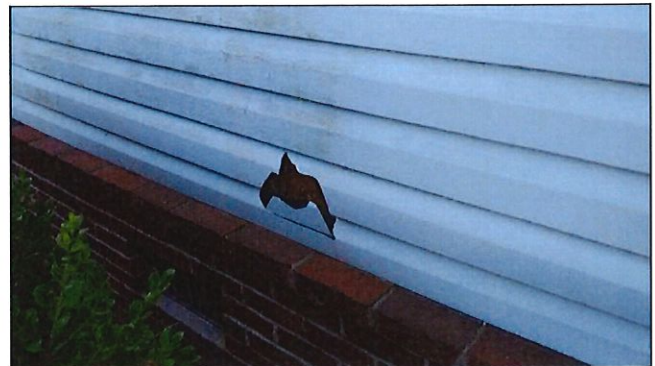
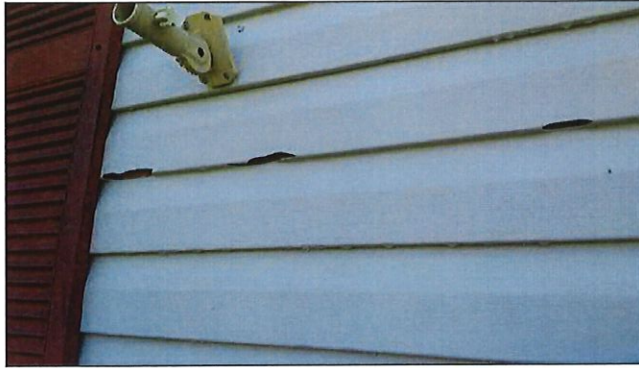
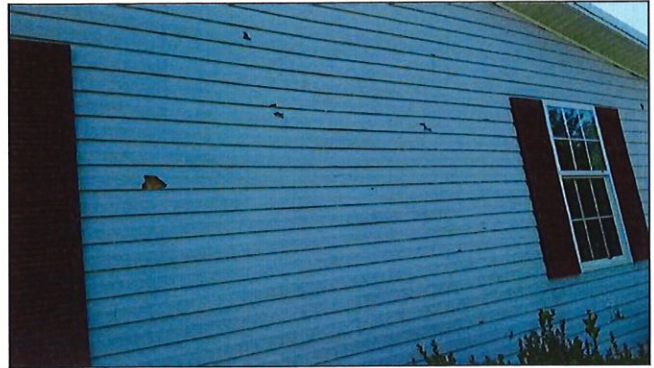
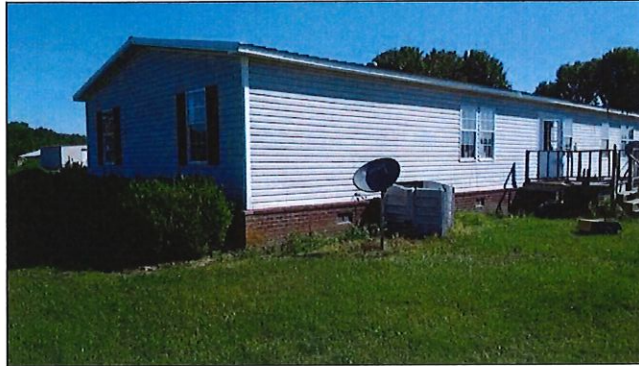
Numerous siding panels are showing broken and open areas. Examples: 1-12 These are all around the house.

Refer to a siding contractor for an evaluation and an estimate to repair or replace.

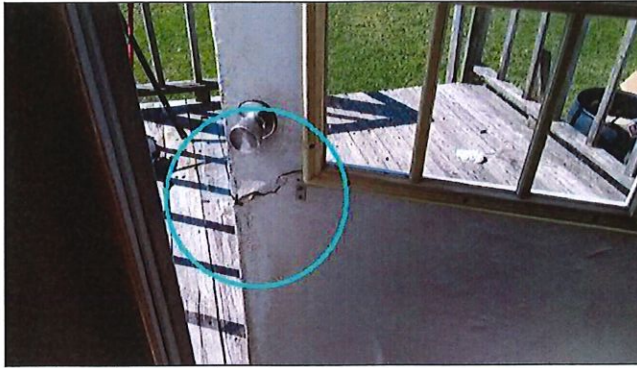
2.1 Item 1(Picture)

Rear door is broken and there is evidence of water leakage at the bottom corner of the opening. Item 1(Picture)  
Item 2(Picture)

Refer to a contractor for evaluation and repair or replacement.

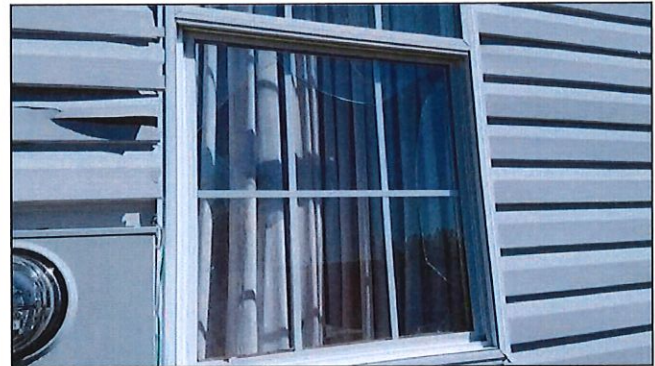
2.2 Item 2(Picture)

Window next to rear entrance. Item 2(Picture)

Refer to a window specialty contractor for repair of this broken glass.

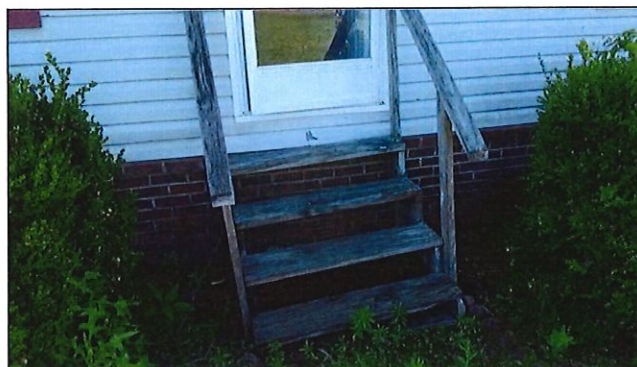
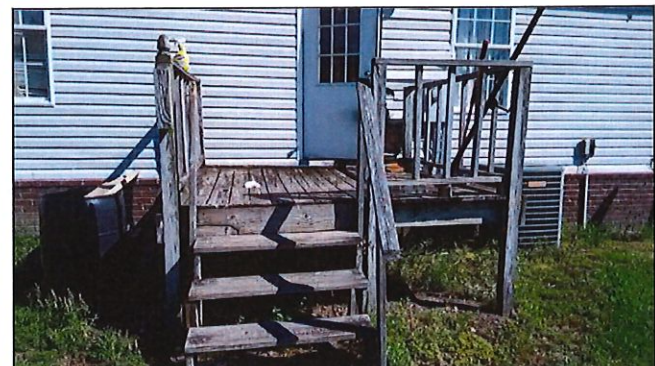
Front and rear steps show amateur workmanship and aged materials. Item 1(Picture) Item 2(Picture)

Plan on replacing these steps.

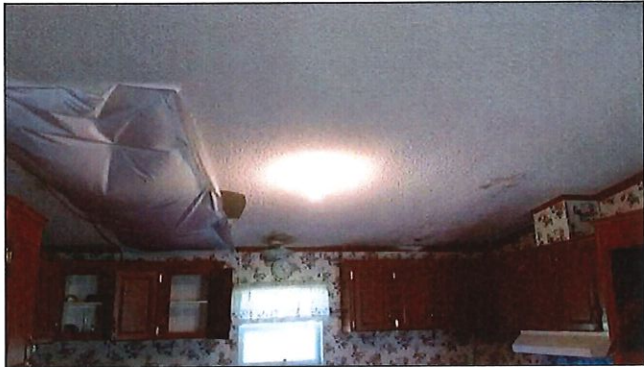
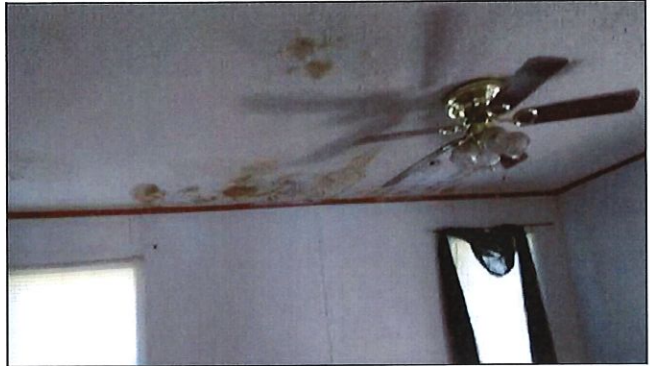
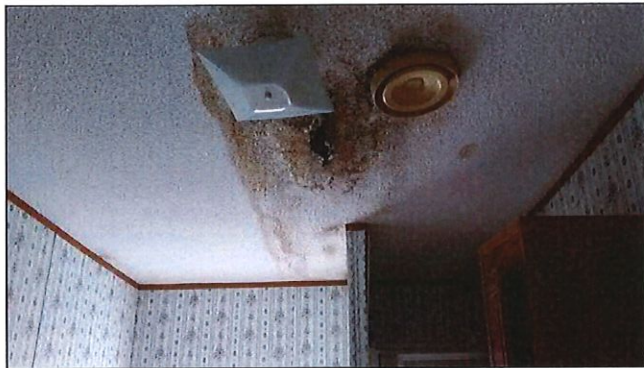
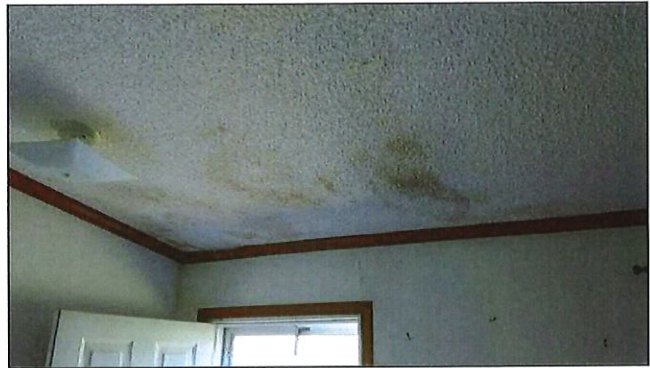
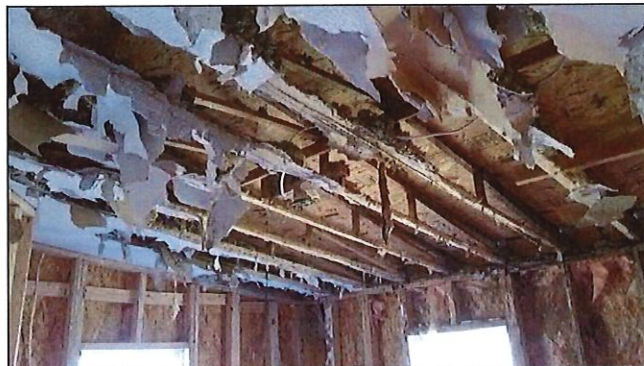
Multiple ceilings with water damage. Plan on replacing some of the drywall and sealing others to prevent stain bleed through. Examples: Item 1(Picture) Item 2(Picture) Item 3(Picture) Item 4(Picture) Item 5(Picture)

Refer to a drywall contractor.

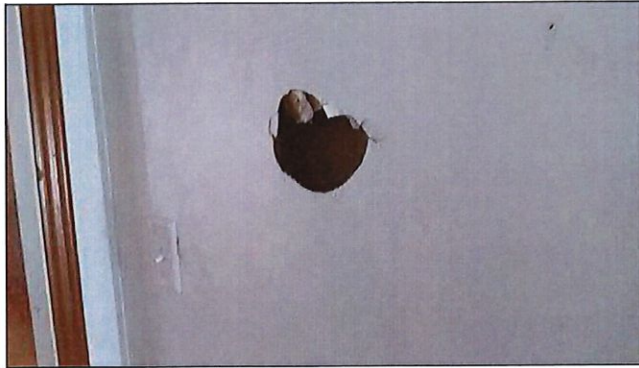
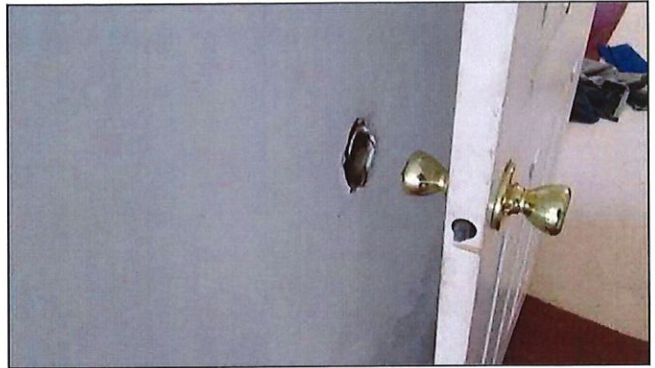
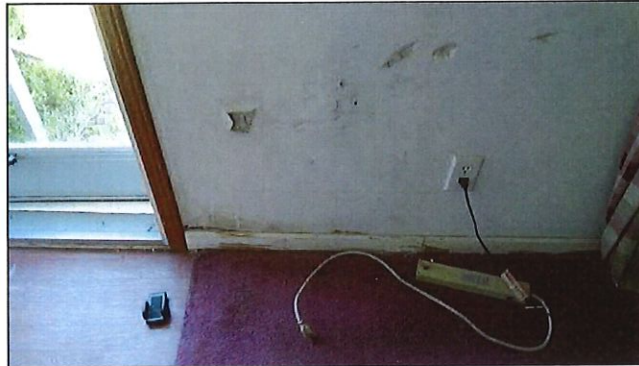
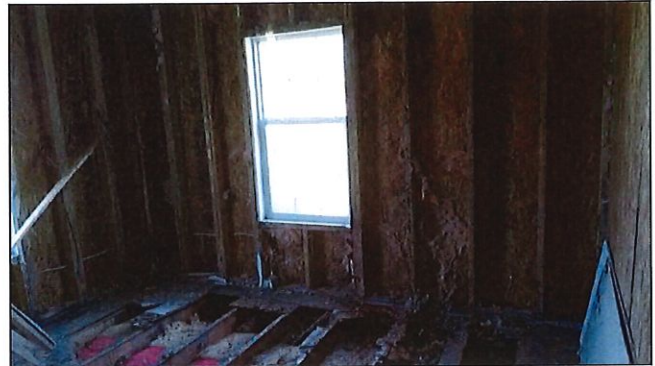
Wall damage is evident throughout. Examples: Item 1(Picture) Item 2(Picture) Item 3(Picture) Item 4(Picture)

Refer to a drywall contractor for an estimate.

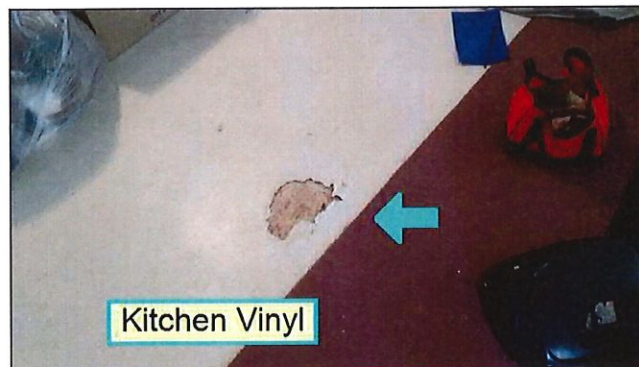
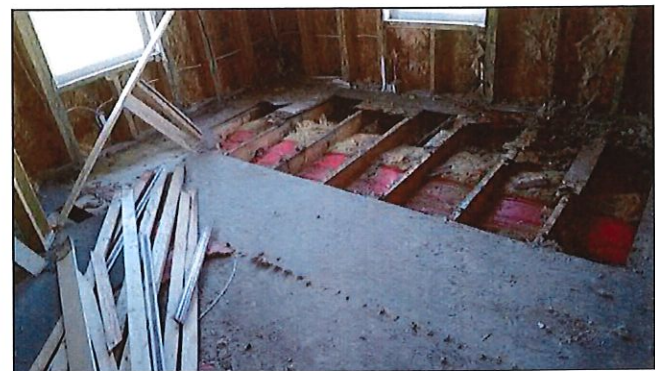
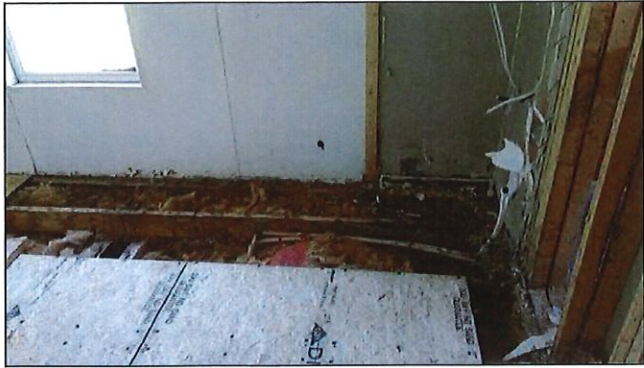
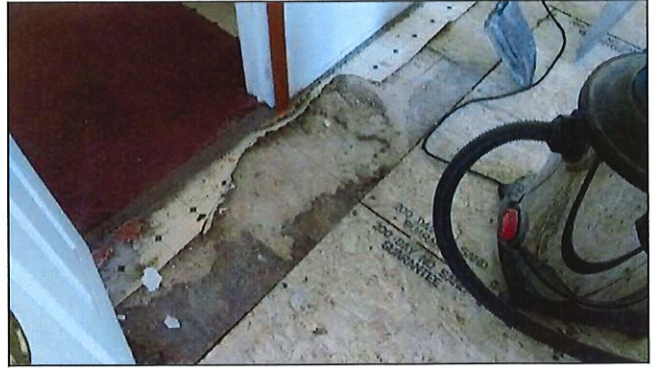
Essentially all floor coverings will need to be replaced. Some have already been removed for floor structural repairs.

Examples: Item 1(Picture) Item 2(Picture) Item 3(Picture) Item 4(Picture) All carpet needs to be removed and disposed.

Refer to a professional flooring mechanic.

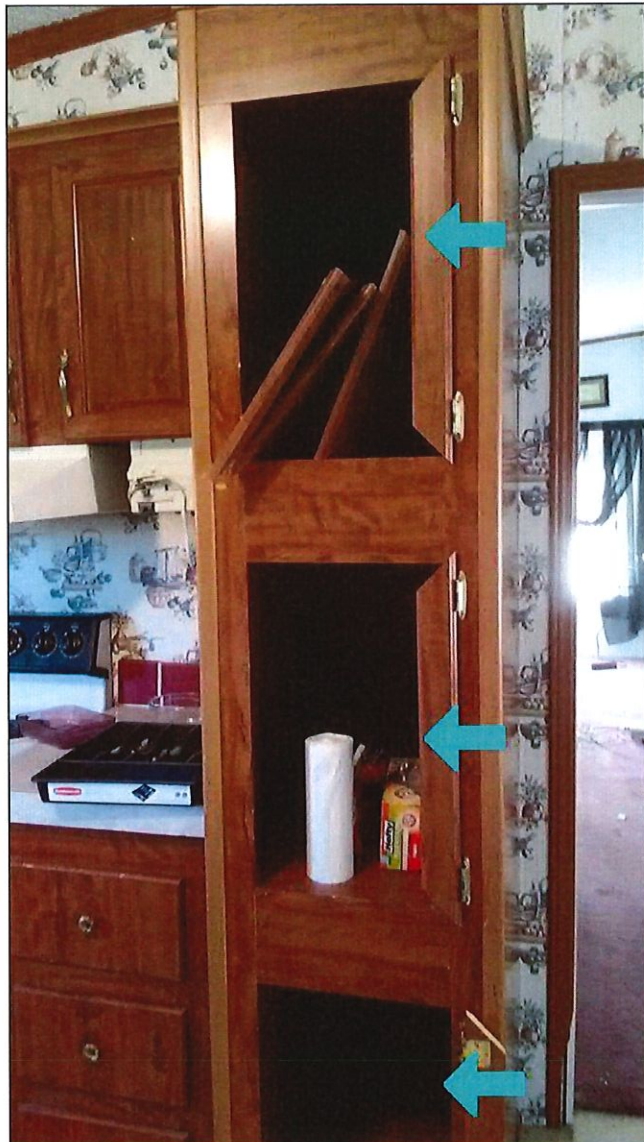
3.3 Item 3(Picture)

(2) Multiple damaged cabinet doors were found. Item 3(Picture)

Refer to a technician who can replace these doors.

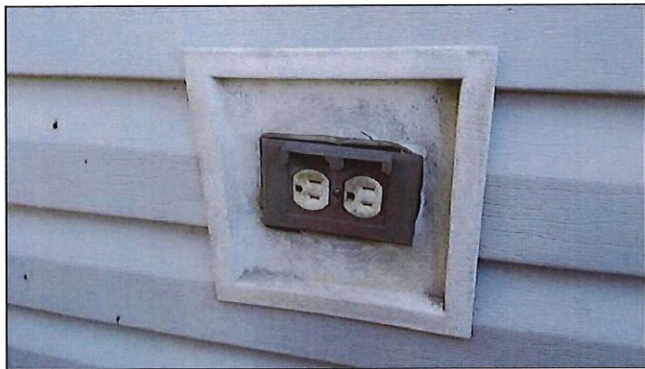
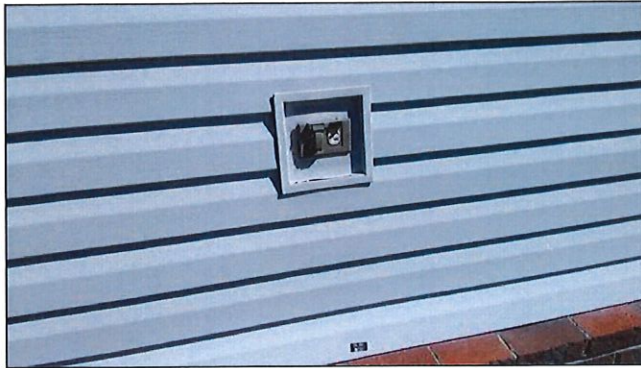
Outside receptacles need weather covers. Item 1(Picture) Item 2(Picture) Item 3(Picture)

Refer to a licensed electrician for evaluation and all necessary corrections.

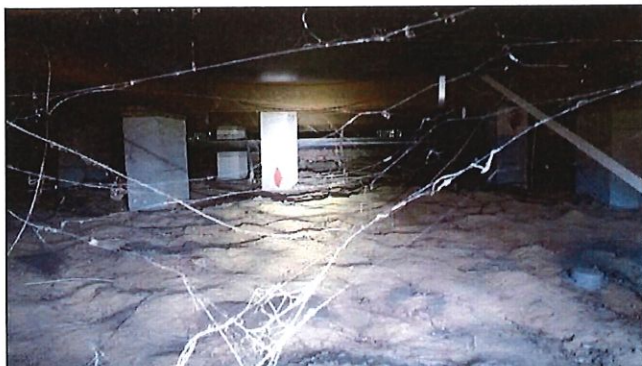
10.3 Item 1(Picture)

There is no vapor retarding sheeting installed over the dirt floor of this crawl space.

It is highly recommended to add a 100% coverage of the ground 6mil poly sheeting vapor retarder.
