SUMMARY

1212 Eagle View Dr NE, Pilot, VA
24138
Jay Garland
March 9, 2026

Randall Jenkins
Affordable Home Inspections
5409150107
rajones601@gmail.com

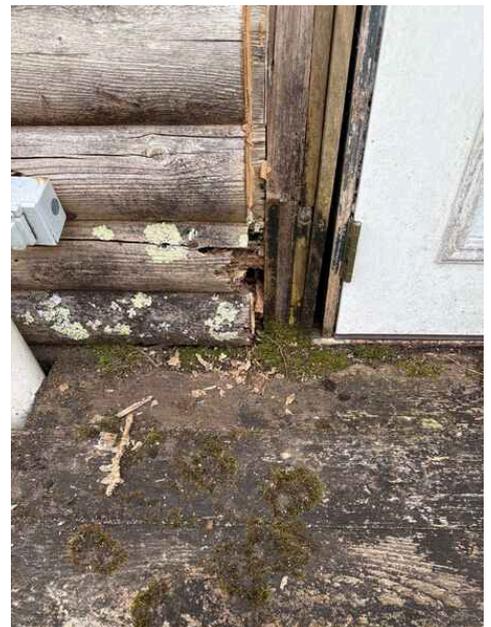
2.2.2 Siding, Flashing & Trim

WATER DAMAGE

Contact a qualified professional.

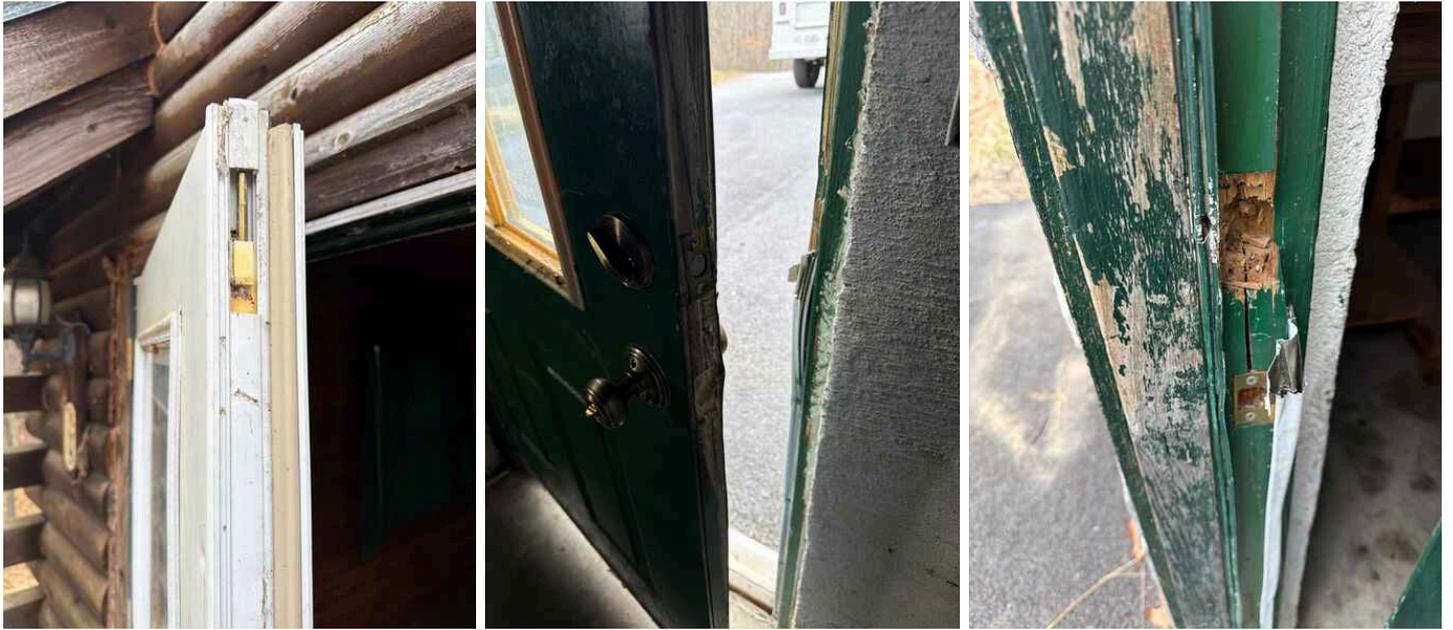
2.3.1 Exterior Doors

DOOR DOES NOT CLOSE OR LATCH

Door does not close or latch properly. Recommend qualified handyman adjust strike plate and/or lock.

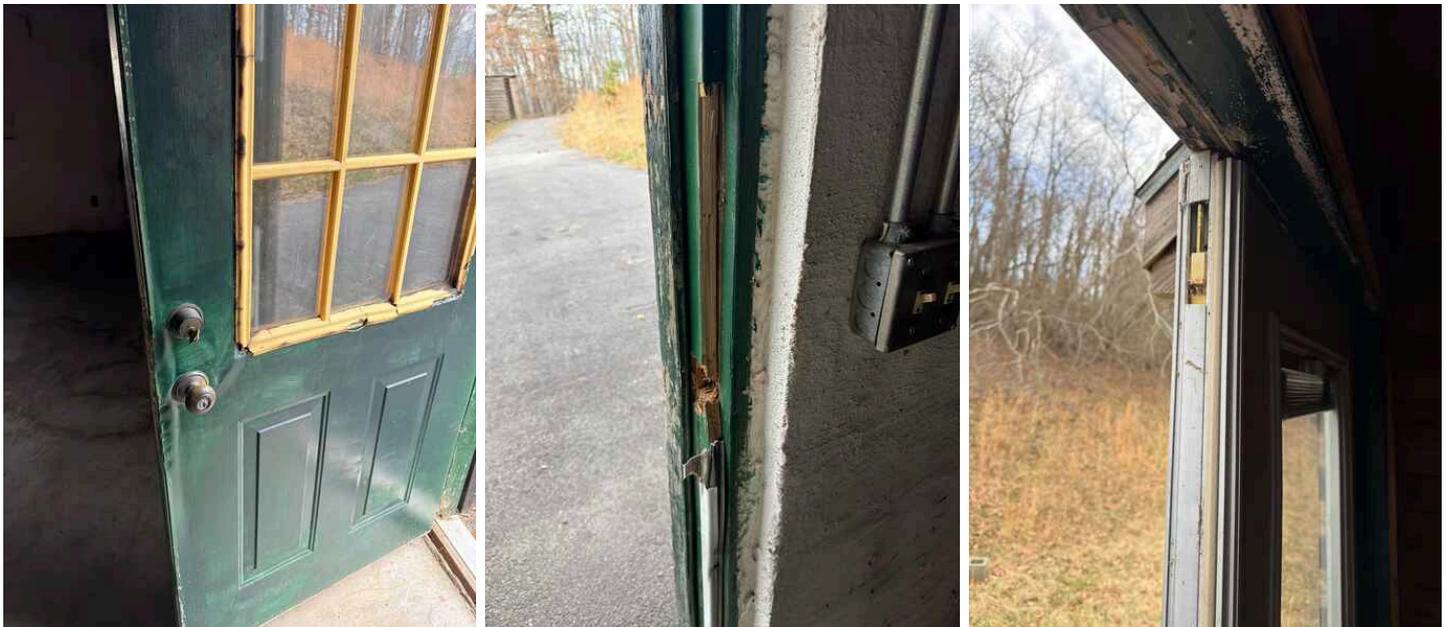
2.3.2 Exterior Doors

HARDWARE DAMAGED

One or more pieces of door hardware are damaged. Recommend repair or replace.

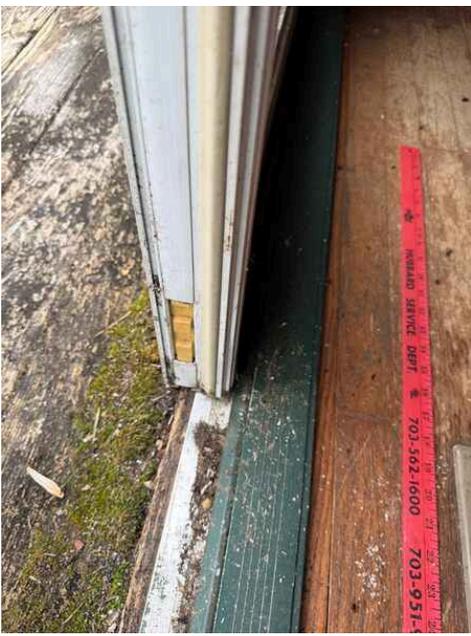
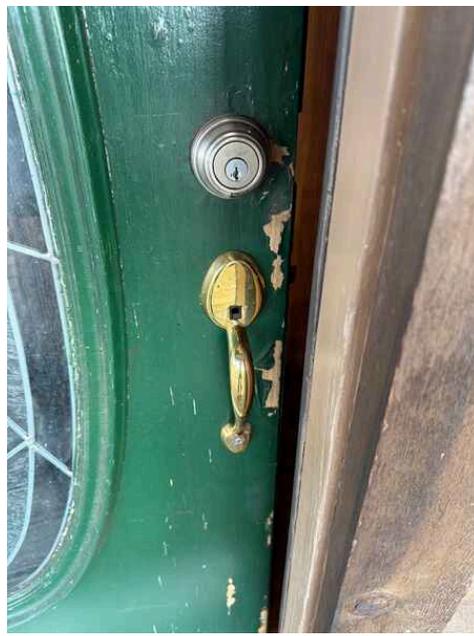
2.3.3 Exterior Doors

HARDWARE MISSING

Door is missing one or more pieces of hardware. Recommend replacing or upgrading.

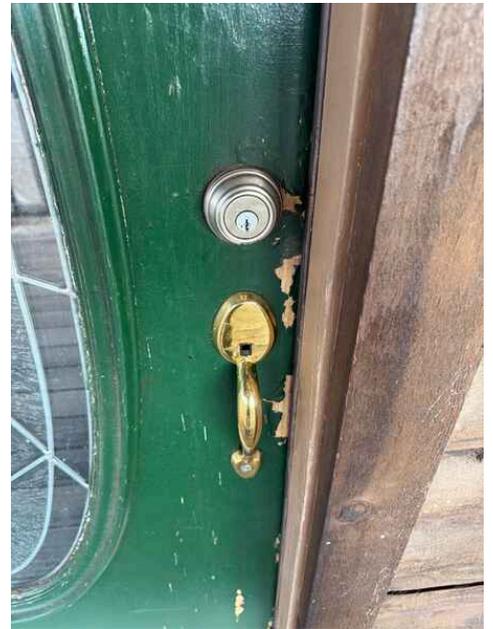
2.3.4 Exterior Doors

PAINT/REFINISH NEEDED

Door finish is worn. Recommend refinish and/or paint to maximize service life.

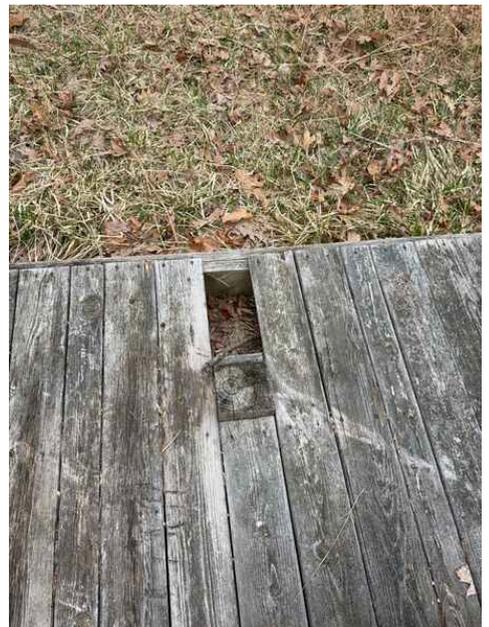
2.4.2 Decks, Balconies, Porches & Steps

DECK - ROTTED BOARDS

REAR DECK

One or more deck boards are showing signs of rot. Recommend a qualified deck contractor replace.

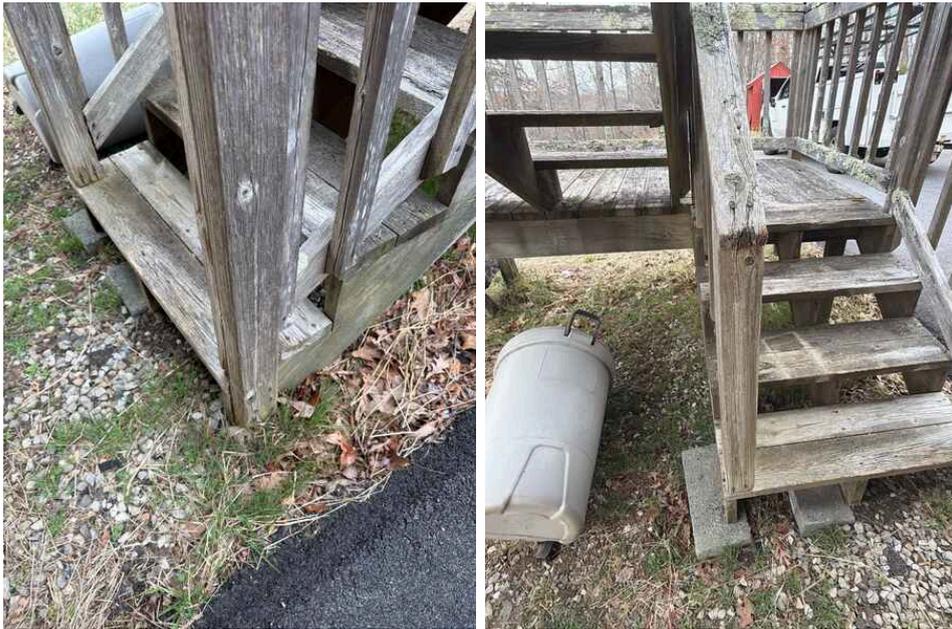
DECK - UNSTABLE SUPPORT

FRONT

One of more areas of the deck support appears unstable. This could cause a safety hazard and further deterioration of the deck. Recommend qualified deck contractor evaluate and repair.

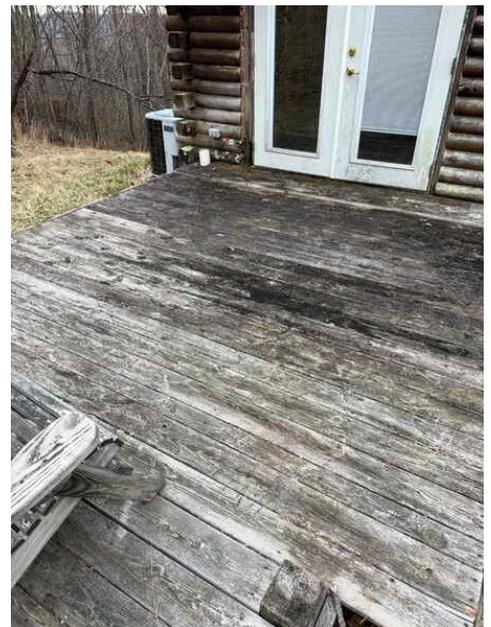
DECK - WATER SEALANT REQUIRED

REAR DECK

Deck is showing signs of weathering and/or water damage. Recommend water sealant/weatherproofing be applied.

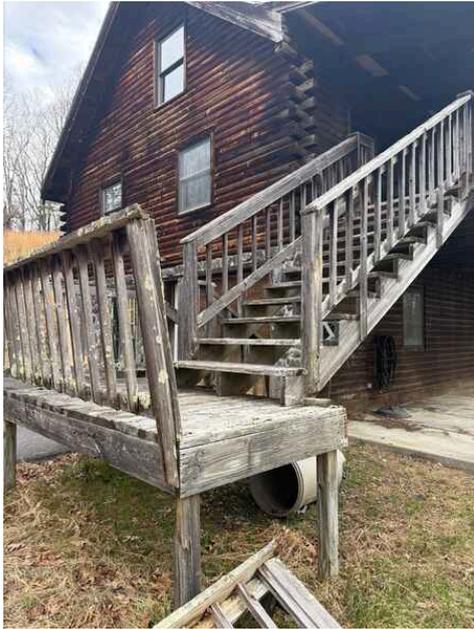
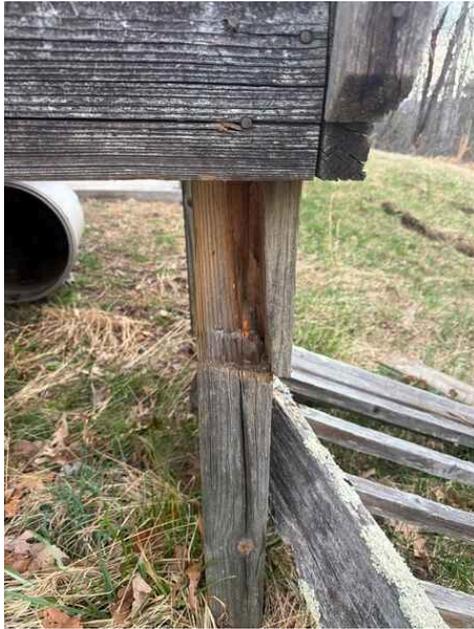
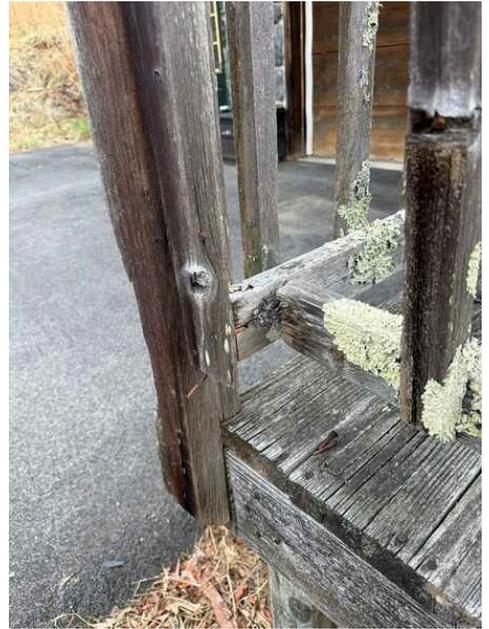
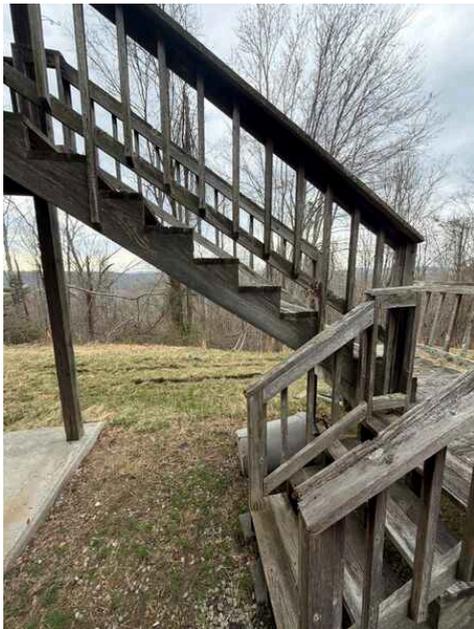
IMPROPER DECK CONSTRUCTION PRACTICES

FRONT DECK STAIRCASE

Deck was observed to have general poor construction. Recommend qualified deck contractor evaluate.

Contact a qualified deck contractor.

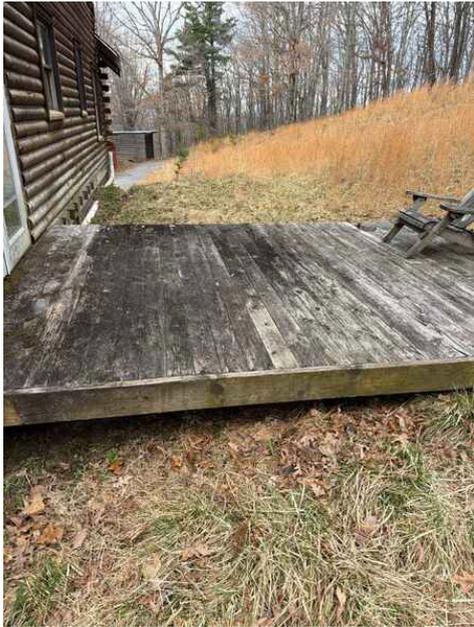
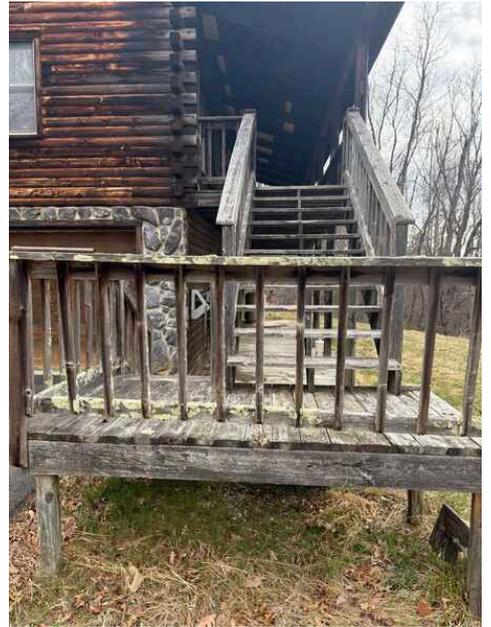
EVALUATION NEEDED

REAR, FRONT STAIRCASE

Due to the condition of the deck, I recommend a decking contractor to fully evaluate for repairs or replacement

Recommendation
Contact a qualified professional.

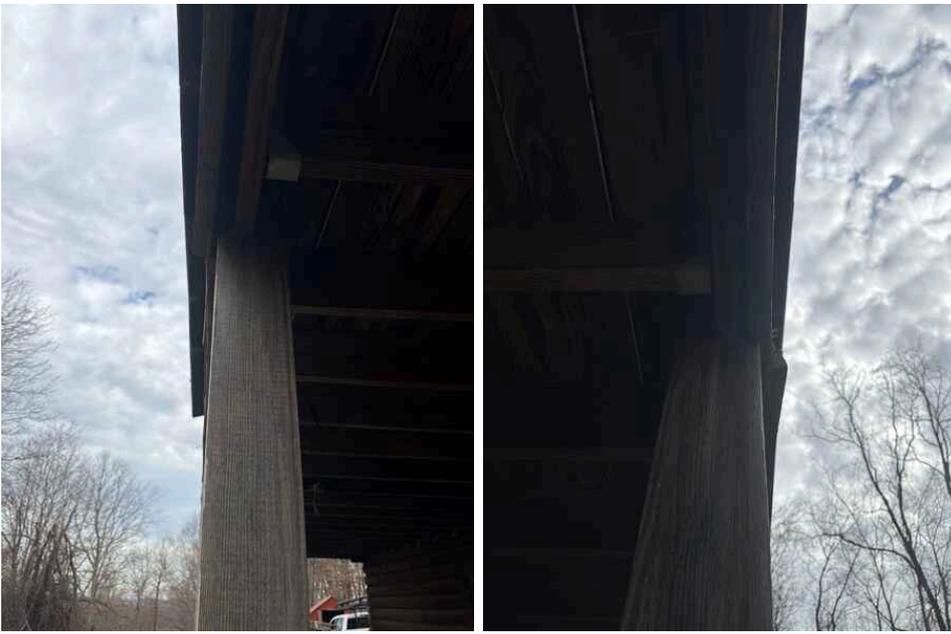
2.4.9 Decks, Balconies, Porches & Steps

MAIN GIRDER

Main girder is not fastened appropriately to supports

Recommendation
Contact a qualified professional.

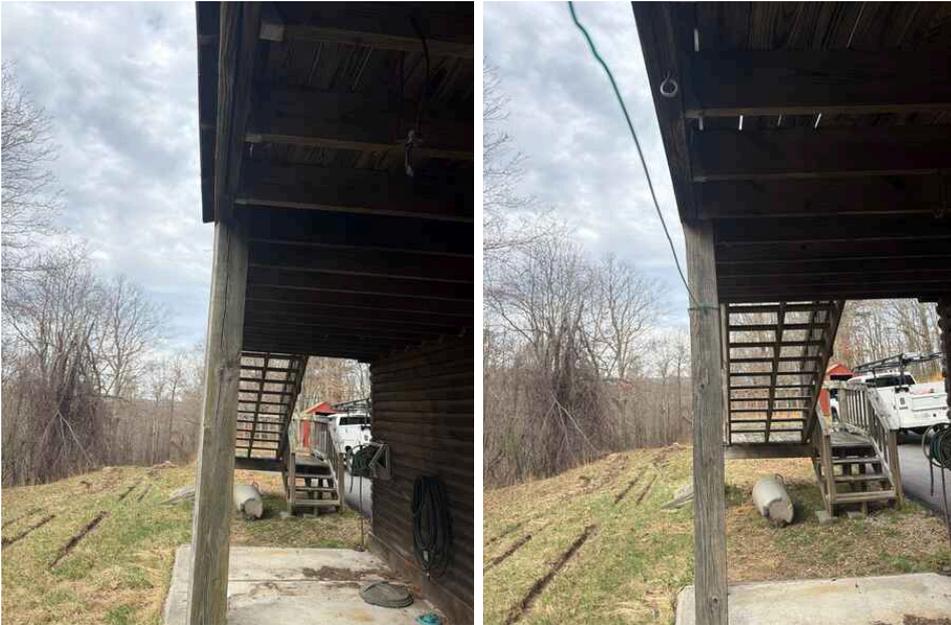
2.4.10 Decks, Balconies, Porches & Steps

DECK SUPPORT POSTS

One or more deck support posts show signs of twisting and/or bowing. Recommend decking contractor further evaluate for repairs or replacement.

Recommendation
Contact a qualified professional.

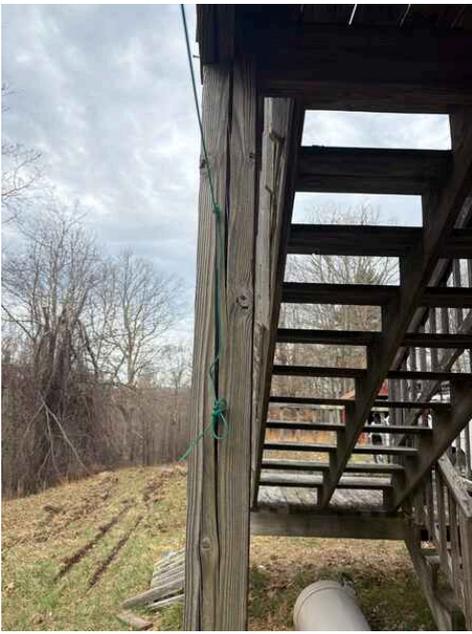
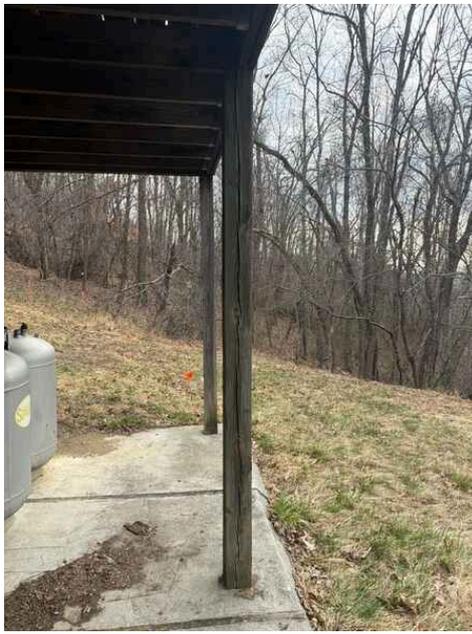
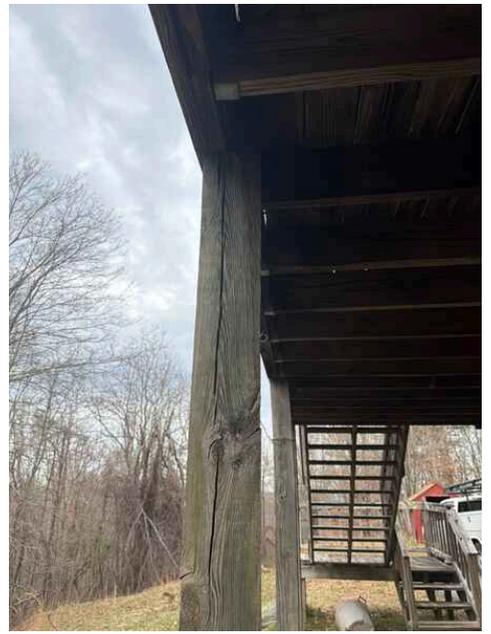
2.4.11 Decks, Balconies, Porches & Steps

SPLITTING DECK SUPPORT POSTS

One or more deck support posts showed signs of splitting. Recommend decking contractor to evaluate for repairs or replacement

Recommendation
Contact a qualified professional.

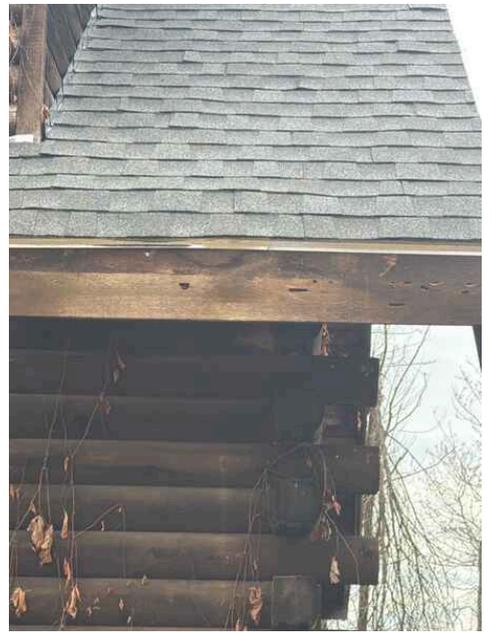
2.5.2 Eaves, Soffits & Fascia

FASCIA - DAMAGED

One or more sections of the fascia are damaged. Recommend qualified roofer evaluate & repair.

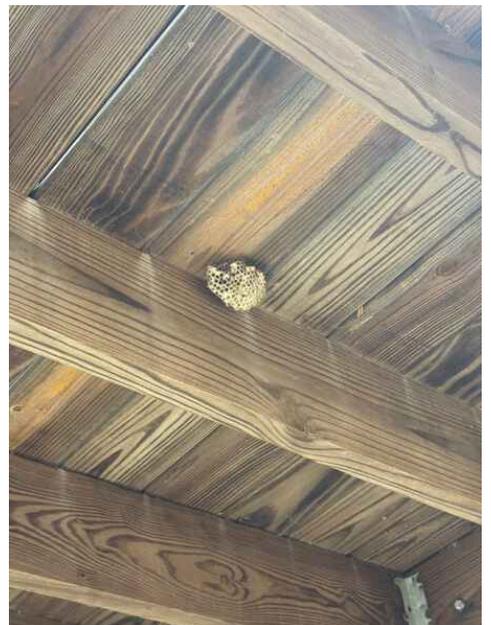
2.5.3 Eaves, Soffits & Fascia

WASPS NEST

Wasp nests were visible under the soffits. Recommend a qualified exterminator evaluate and remove.

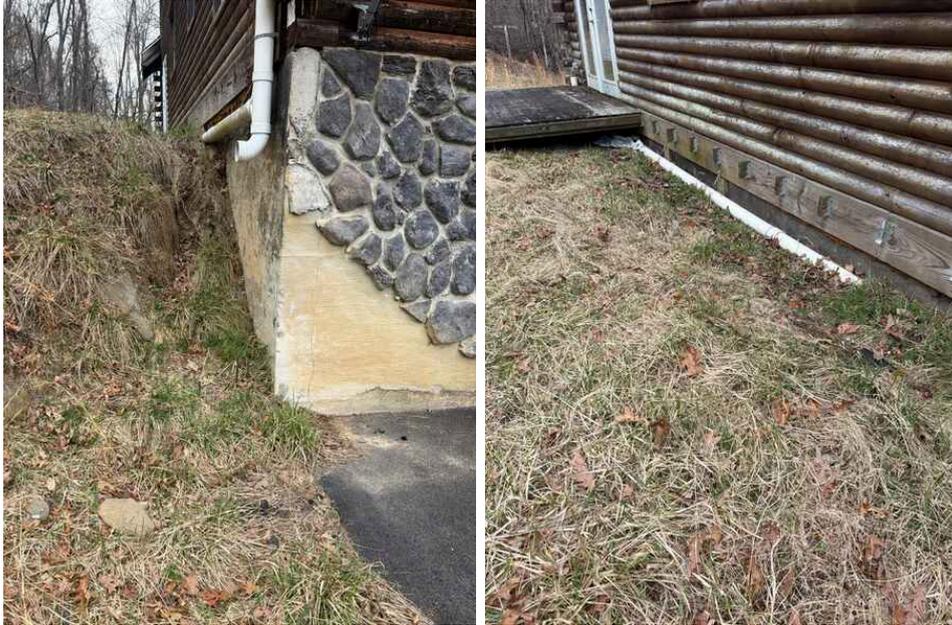
2.6.1 Vegetation, Grading, Drainage & Retaining Walls

NEGATIVE GRADING

Grading is sloping towards the home in some areas. This could lead to water intrusion and foundation issues. Recommend qualified landscaper or foundation contractor regrade so water flows away from home.

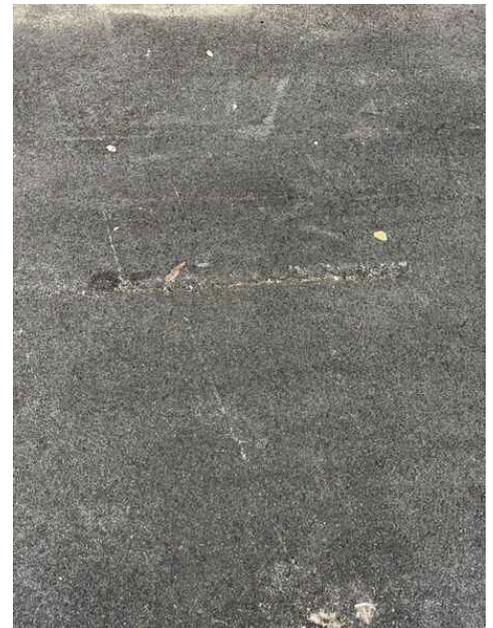
2.7.1 Walkways, Patios & Driveways

DRIVEWAY CRACKING - MINOR

Minor cosmetic cracks observed, which may indicate movement in the soil. Recommend monitor and/or have driveway contractor patch/seal.

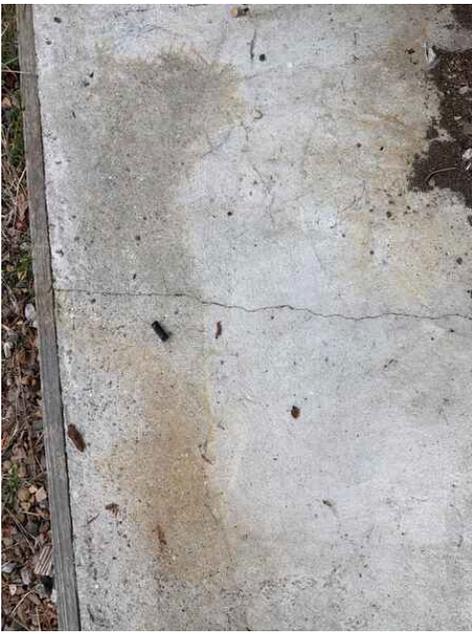
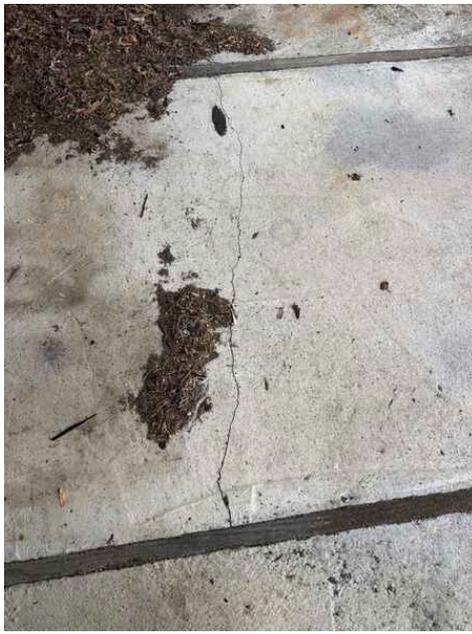
2.7.2 Walkways, Patios & Driveways

PATIO CRACKING - MINOR

Normal settling & cracking observed. Recommend monitor and/or patch/seal.

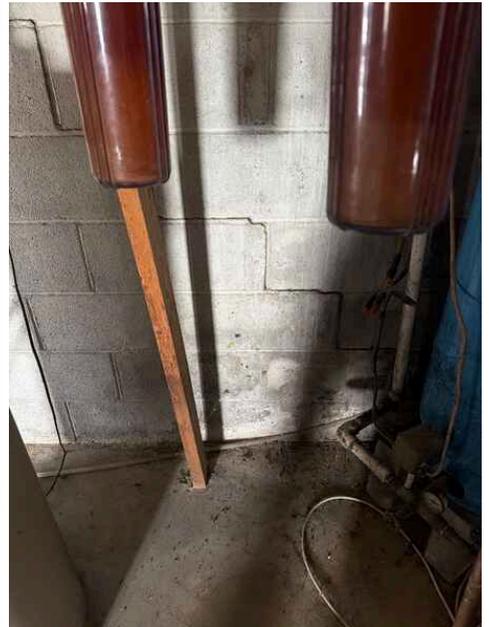
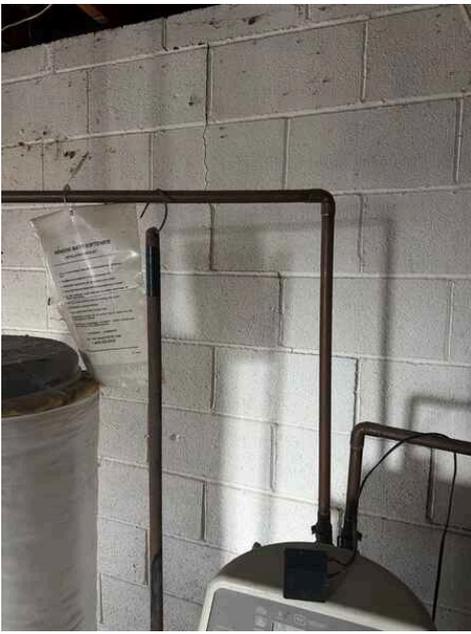
3.1.1 Foundation

FOUNDATION CRACKS - MINOR

Minor cracking was noted at the foundation. This is common as concrete ages and shrinkage surface cracks are normal. Recommend monitoring for more serious shifting/displacement.

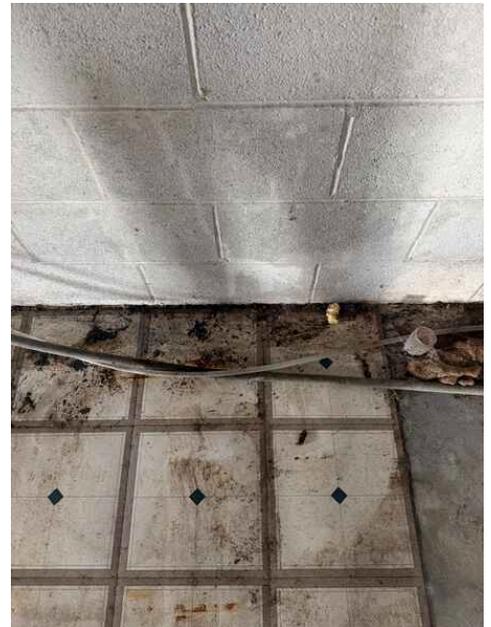
3.1.2 Foundation

WATER INTRUSION

Water intrusion was evident on the surface of the floor slab or in the basement/crawlspace. This can compromise the soil's ability to stabilize the structure and could cause damage. Recommend a qualified contractor identify the source of moisture and remedy.

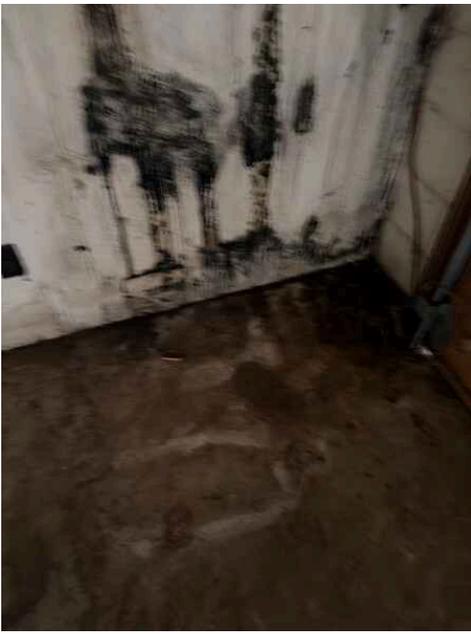
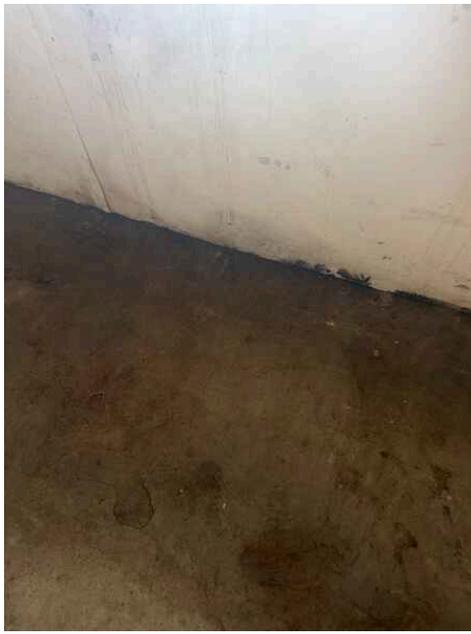
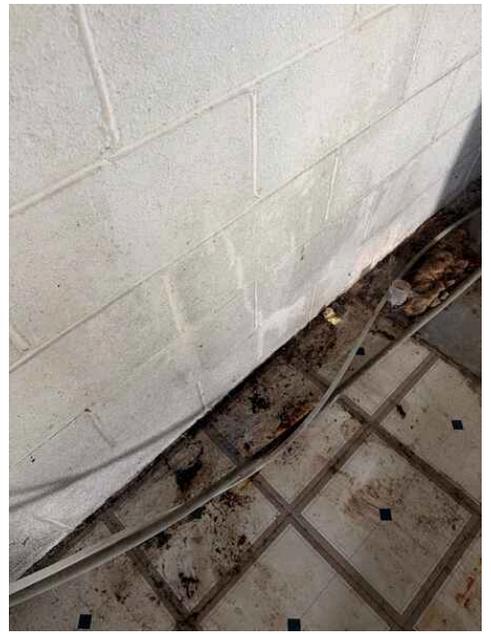
3.2.1 Basements & Crawlspace

STANDING WATER

BASEMENT FLOOR

Observed signs on basement floor that standing water may have been present. Recommend a qualified contractor evaluate and find potential moisture source. This is likely due to the lack of gutters installed

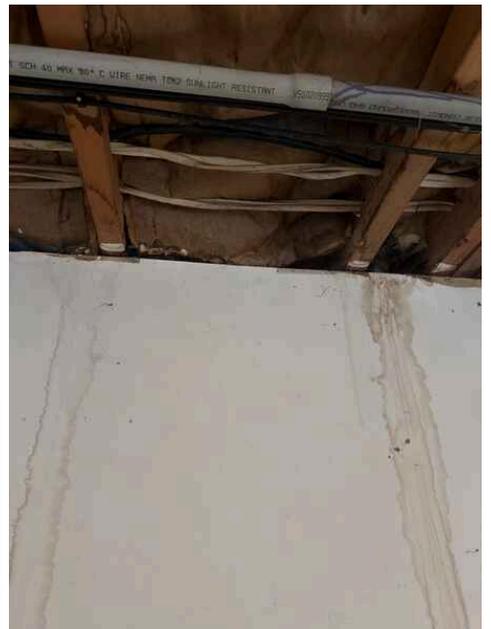
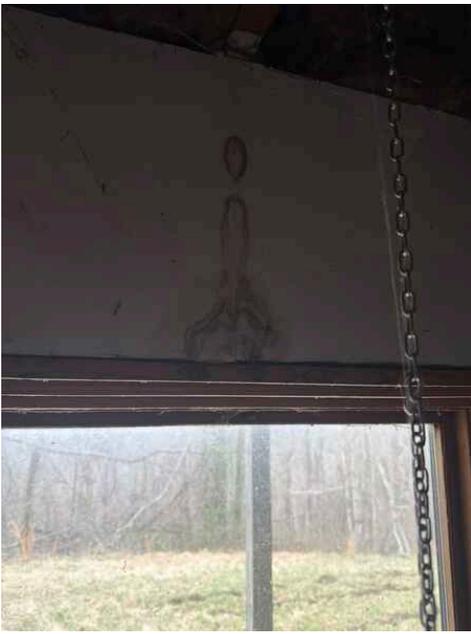
3.4.1 Wall Structure

EVIDENCE OF WATER INTRUSION

Wall structure showed signs of water intrusion, which could lead to more serious structural damage. Recommend a qualified contractor identify source or moisture and remedy.

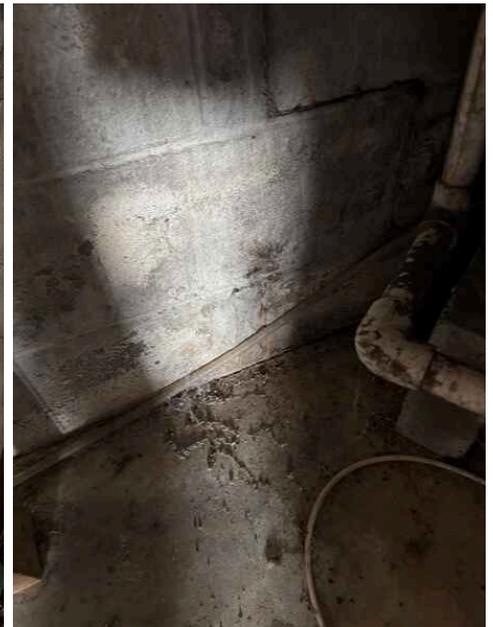
3.4.2 Wall Structure

ORGANIC GROWTH

Observed signs of organic growth in one or more areas in the wall structure. Recommend identifying source or moisture intrusion and sending samples to a lab for testing.

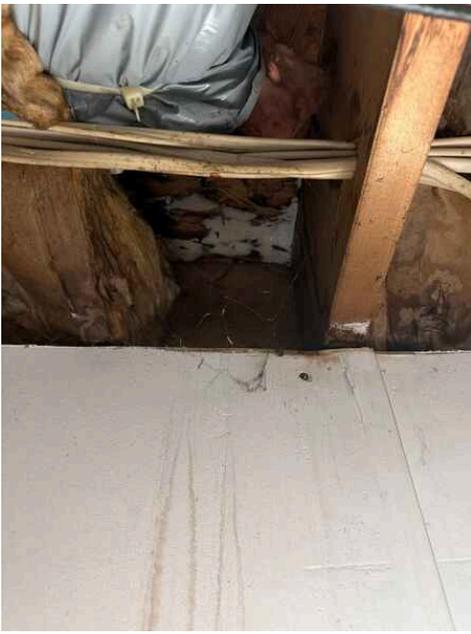
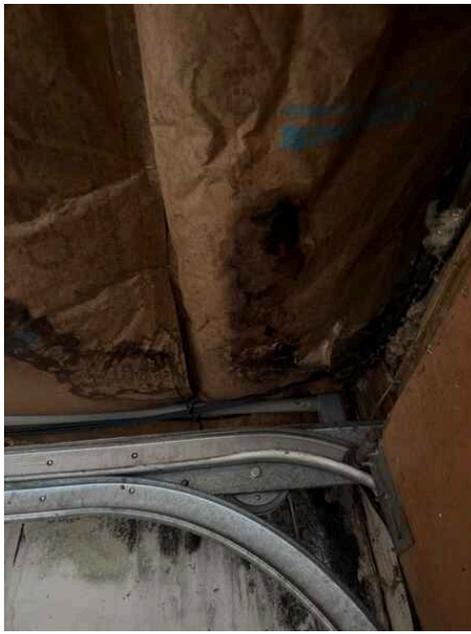
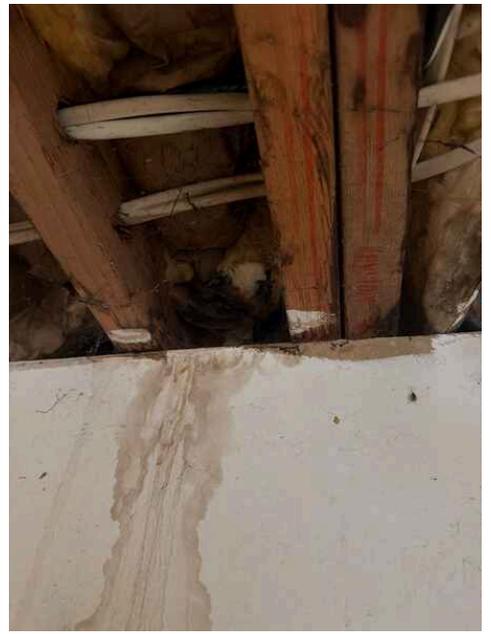
3.5.1 Ceiling Structure

EVIDENCE OF WATER INTRUSION

Ceiling structure showed signs of water intrusion, which could lead to more serious structural damage. Recommend a qualified contractor identify source or moisture and remedy.

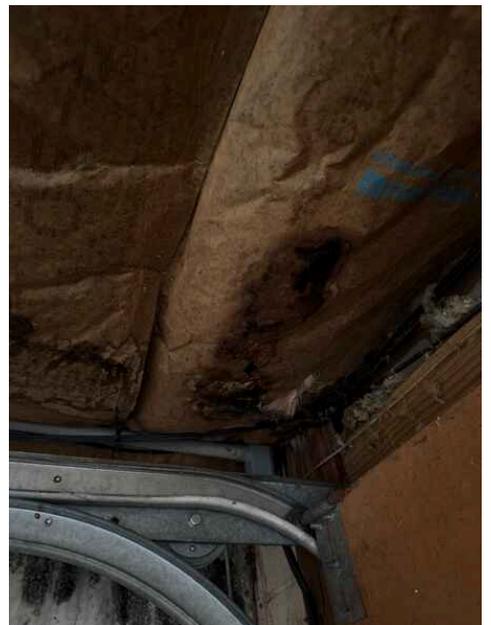
3.5.2 Ceiling Structure

ORGANIC GROWTH

BASEMENT CEILING

Observed signs of mold in one or more areas in the ceiling structure. Recommend identifying source or moisture intrusion and sending samples to a lab for testing.

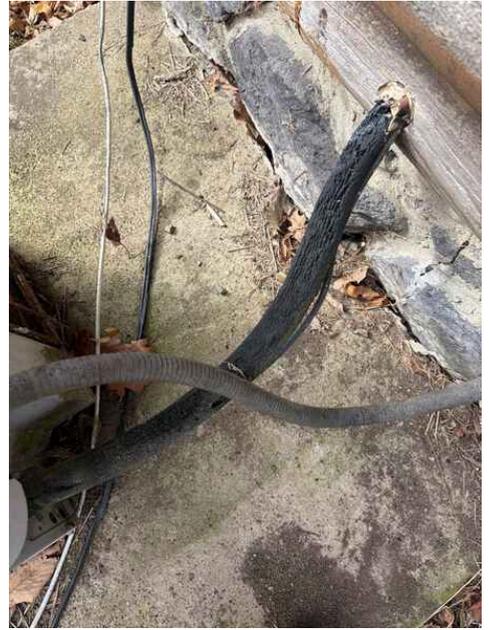
4.1.1 Cooling Equipment

INSULATION MISSING OR DAMAGED

Missing or damaged insulation on refrigerant line can cause energy loss and condensation.

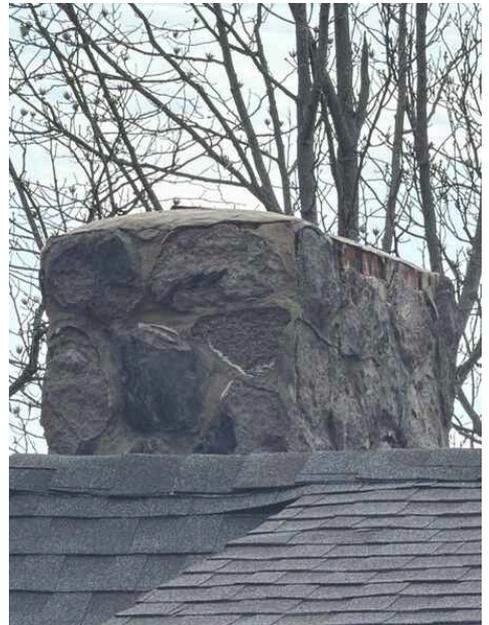
6.4.1 Skylights, Chimneys & Other Roof Penetrations

CHIMNEY CAP MISSING

No chimney cap was observed. This is important to protect from moisture intrusion and protect the chimney. Recommend a qualified roofer or chimney expert install.

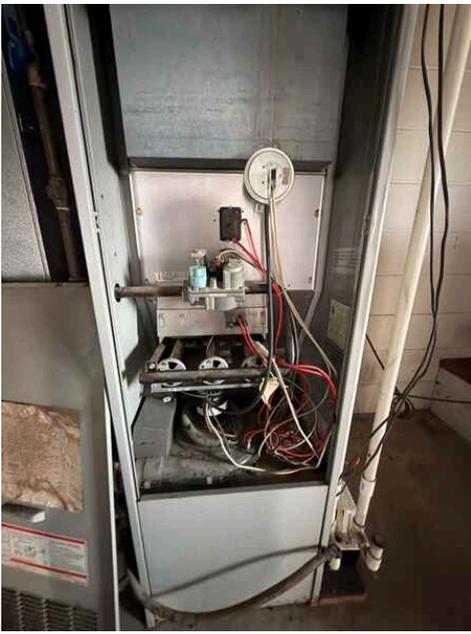
7.1.1 Equipment

NEEDS SERVICING/CLEANING

Furnace should be cleaned and serviced annually. Recommend a qualified HVAC contractor clean, service and certify furnace.

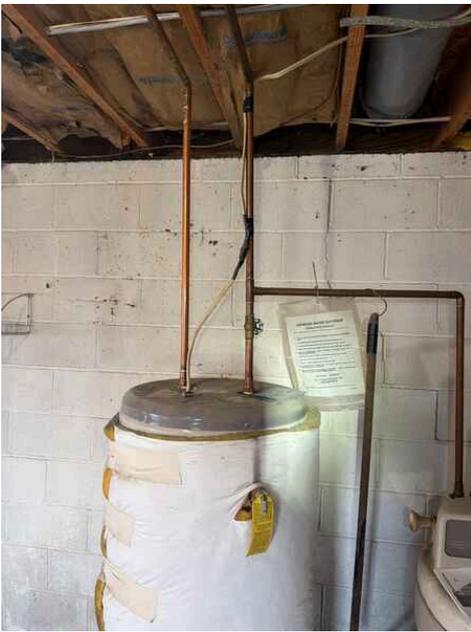
8.4.1 Hot Water Systems, Controls, Flues & Vents

NO EXPANSION TANK

No expansion tank was present. Expansion tanks allow for the thermal expansion of water in the pipes. These are required in certain areas for new installs. Recommend a qualified plumber evaluate and install.

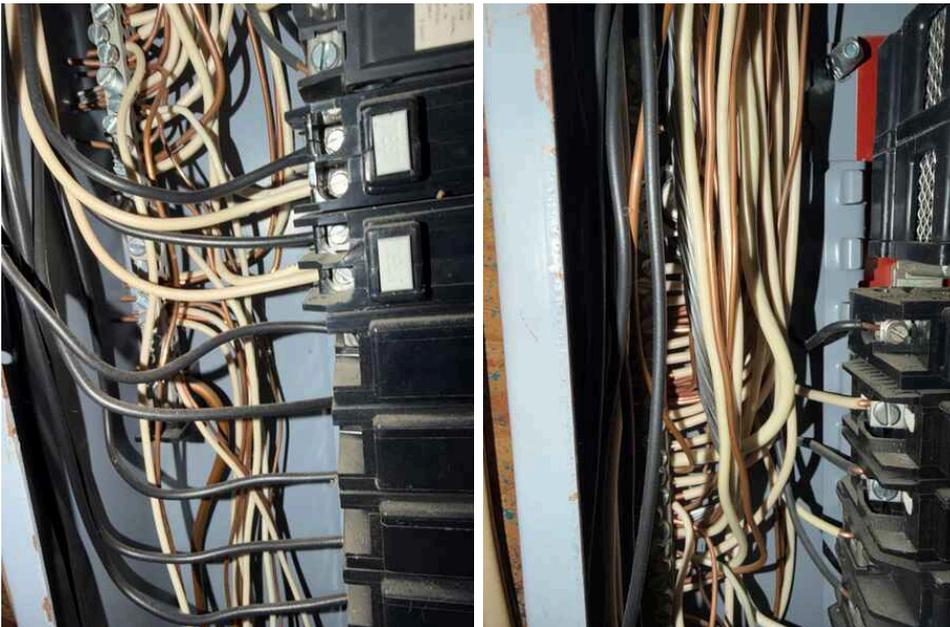
9.2.1 Main & Subpanels, Service & Grounding, Main Overcurrent Device

DOUBLE TAPPED NEUTRALS

Each neutral wire should be under its own lug. Have electrical contractor evaluate and repair as necessary

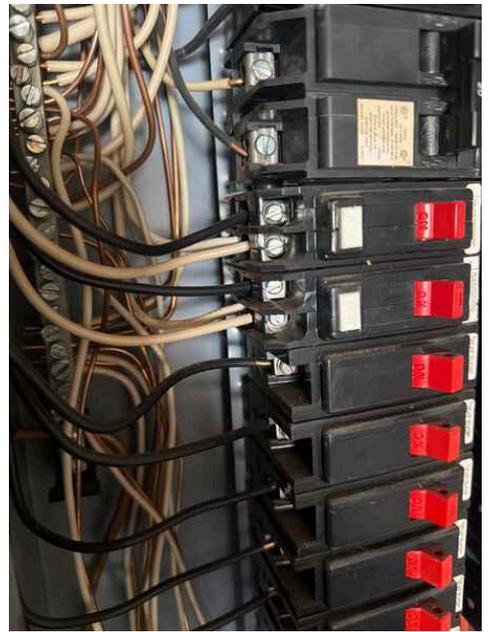
9.2.3 Main & Subpanels, Service & Grounding, Main
Overcurrent Device

WHOTE CONDUCTORS

One or more white neutral conductors being used as a hot not labeled

Contact a qualified professional.

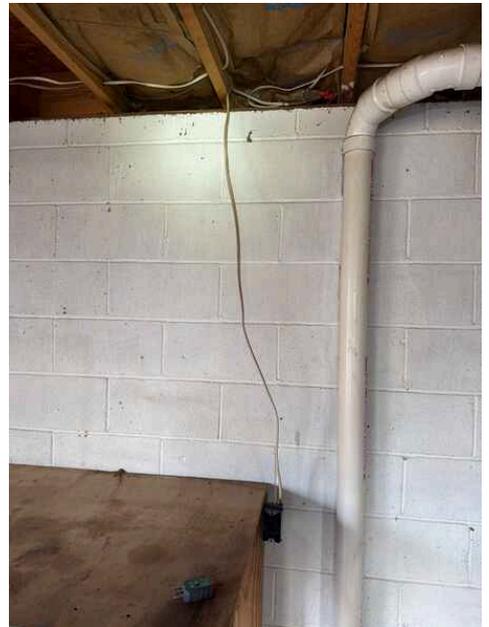
9.3.1 Branch Wiring Circuits, Breakers & Fuses

IMPROPER WIRING

Wording not secured or in conduit

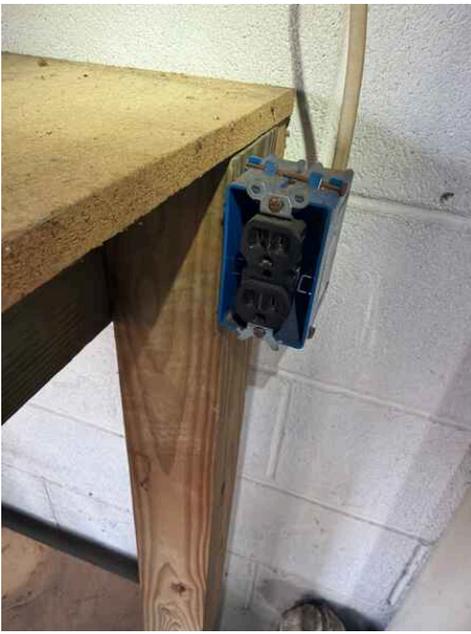
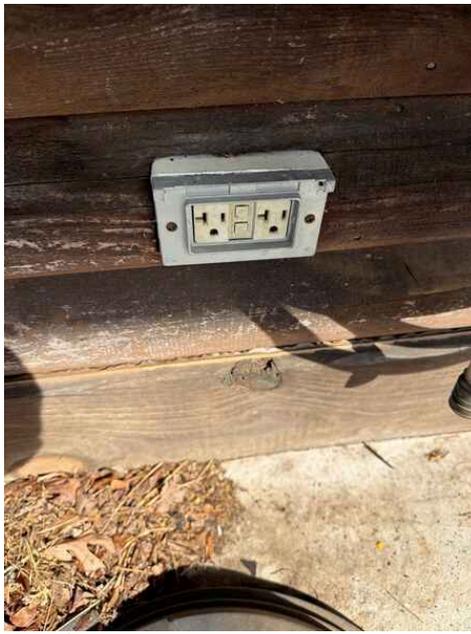
9.4.1 Lighting Fixtures, Switches & Receptacles

COVER PLATES MISSING

One or more receptacles are missing a cover plate. This causes short and shock risk. Recommend installation of plates.

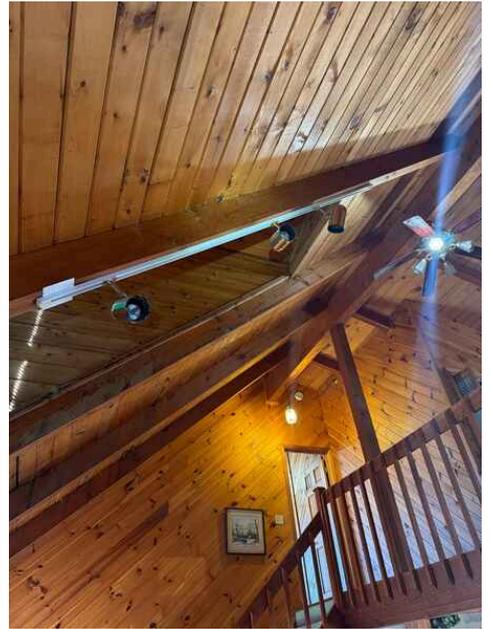
9.4.2 Lighting Fixtures, Switches & Receptacles

LIGHT INOPERABLE

One or more lights are not operating. New light bulb possibly needed.

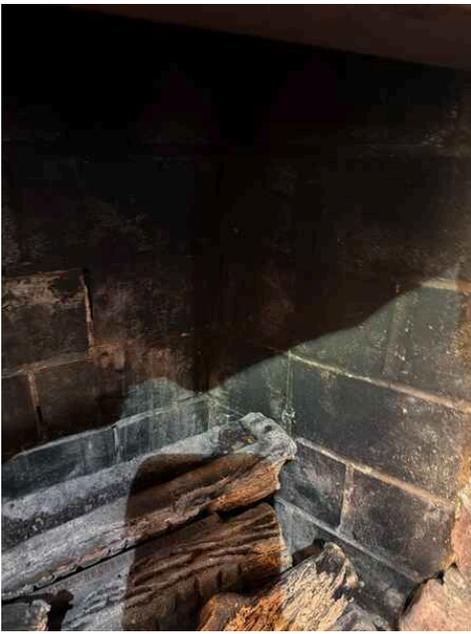
10.4.1 Cleanout Doors & Frames

CREOSOTE BUILDUP

There was a notable amount of creosote buildup in the flue. Recommend a qualified fireplace or chimney contractor inspected and sweep on annual basis.

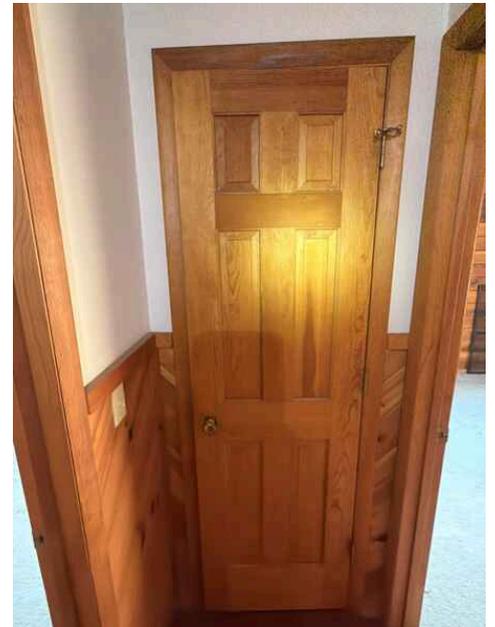
11.1.1 Doors

DOOR STICKS

HALL

Door sticks and is tough to open. Recommend sanding down offending sides.

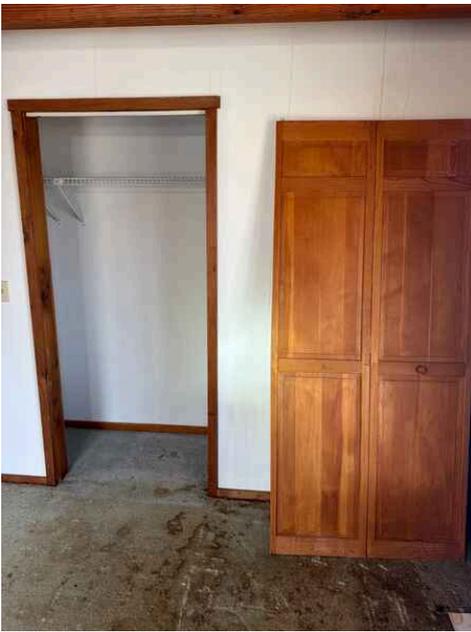
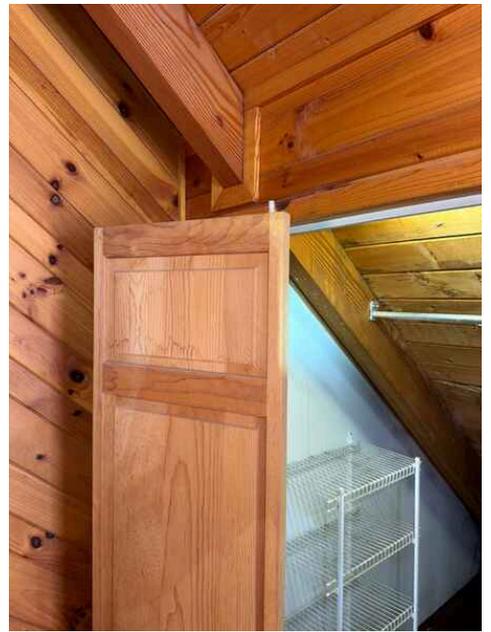
11.1.2 Doors

DOOR OFF TRACK

FRONT BEDROOM

Contact a qualified professional.

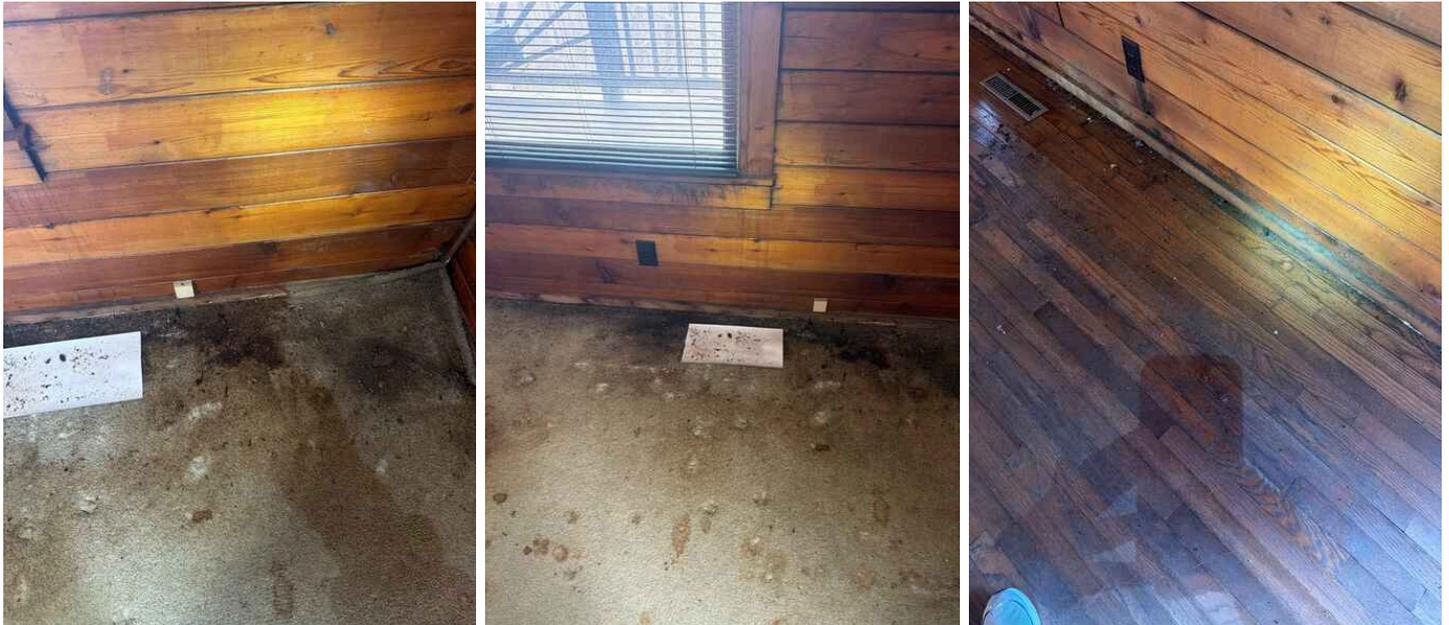
11.3.3 Floors

MOISTURE DAMAGE

Floors had areas of visible moisture damage. Recommend a qualified flooring contractor evaluate & repair areas of moisture.

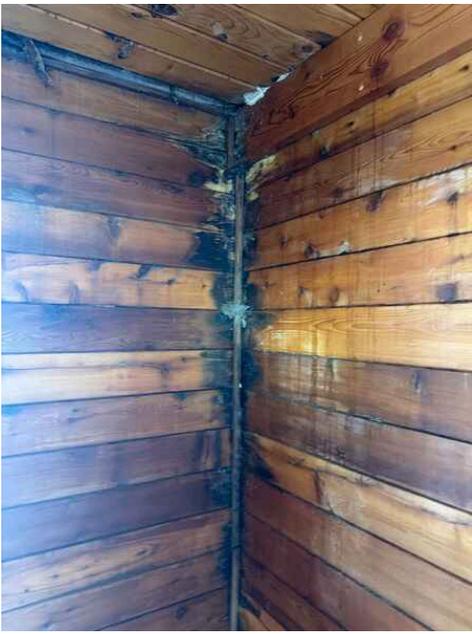
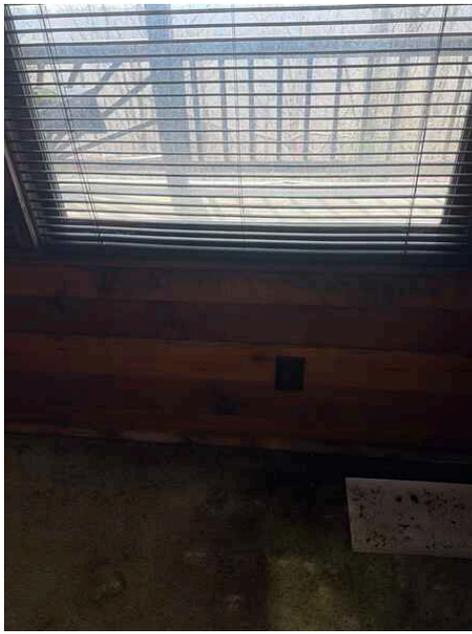
11.4.1 Walls

MOISTURE DAMAGE

Stains on the walls visible at the time of the inspection appeared to be the result of moisture intrusion. The source of moisture may have been corrected. Recommend further examination by a qualified contractor to provide confirmation.
